SKAGIT COOPERATIVE WEED MANAGEMENT AREA
Upper Skagit Knotweed Control Program
2013 Season Ending Report

Prepared by:
Michelle Murphy
Stewardship Manager
Skagit Fisheries Enhancement Group
PO Box 2497
Mount Vernon, WA 98273

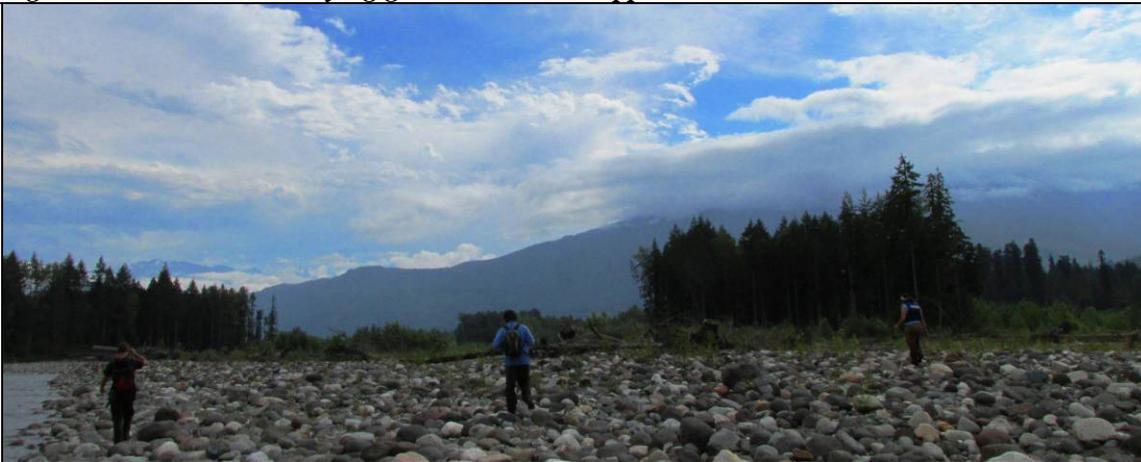
Figure 5. WCC Crew surveying gravel bar on the upper Sauk River.

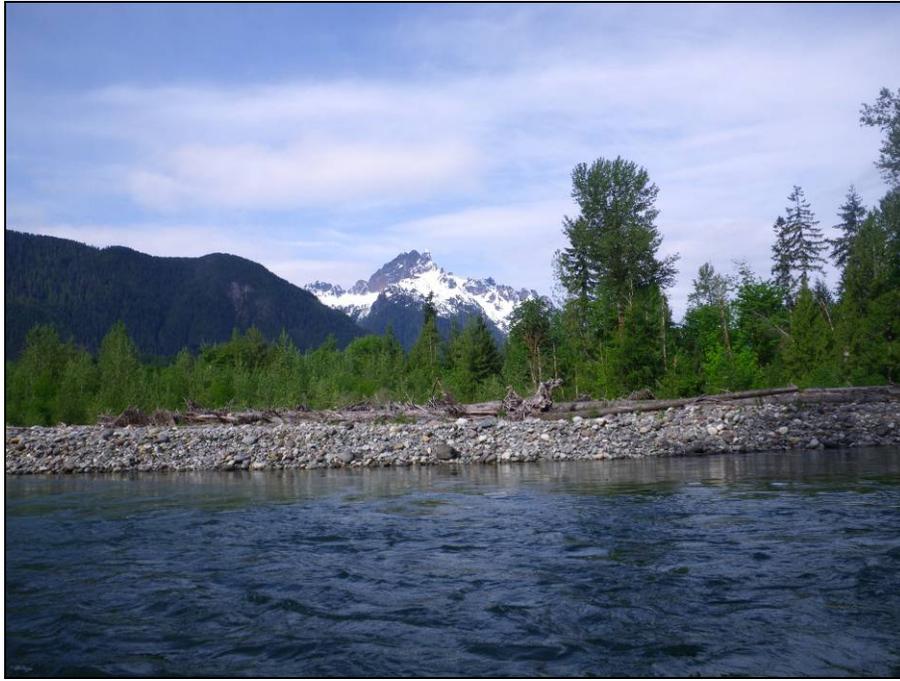
Figure 9. The Sauk River, above the White Chuck River, USFS land.

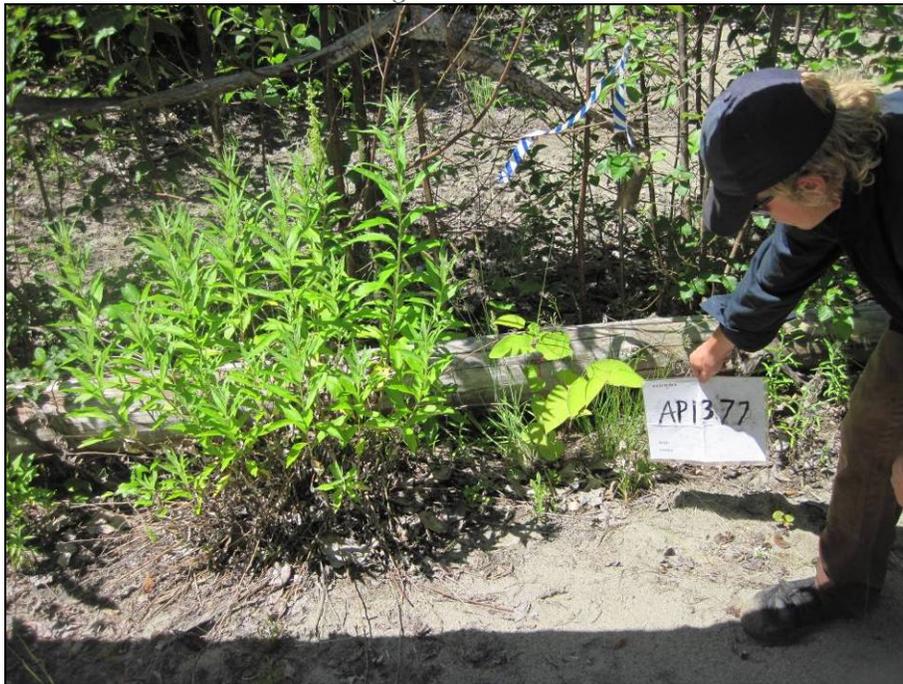
Figure 10. New patch, AP1377 has one small stem, which is common for new patches found in the project area. These small patches can be difficult to locate and are one of the challenges in controlling knotweed on the Sauk.

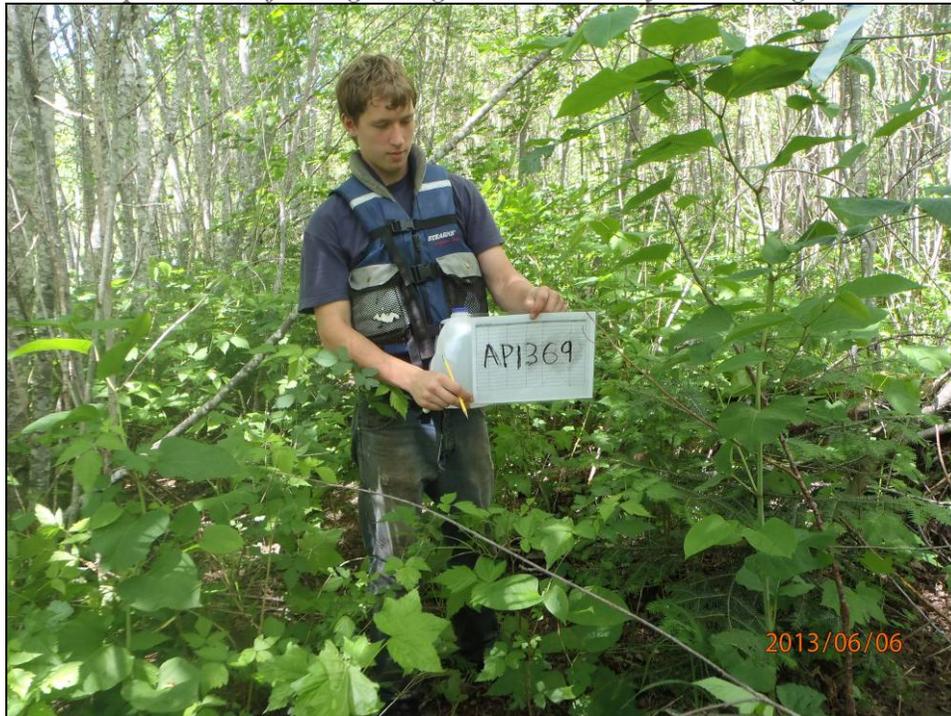
Figure 11. New Patch API369 found in the alder understory of the upper Sauk River. Many patches are found growing in the understory with low light.

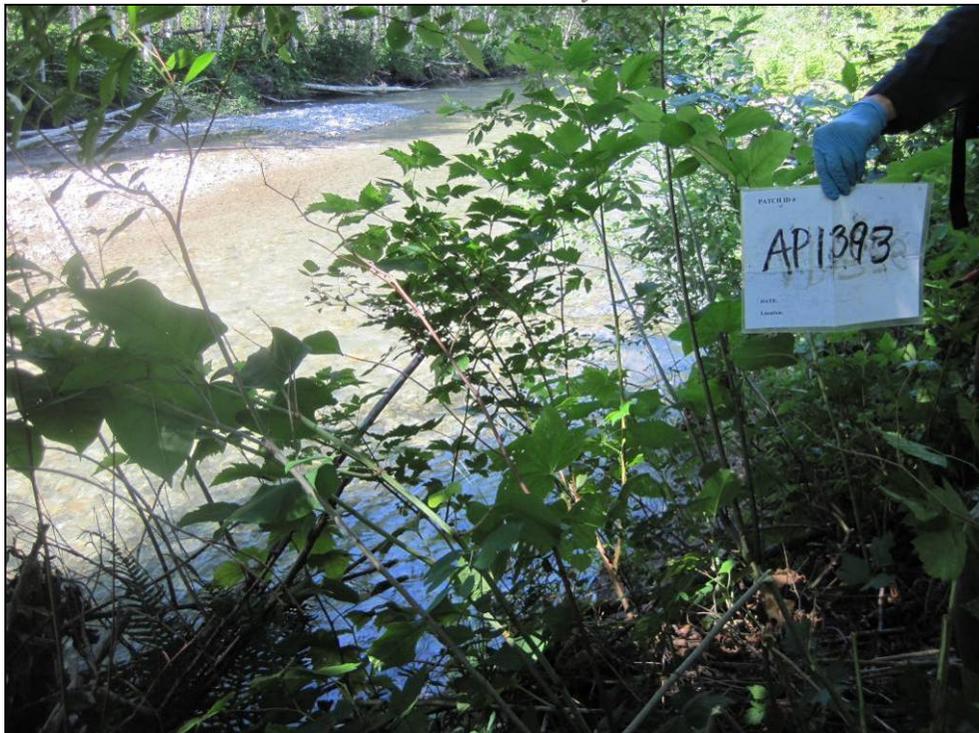
Figure 12. New Patch API393, found on one of the many back channels on the upper Sauk River, backchannels are the most common place new knotweed patches are found and can be difficult to locate and survey.

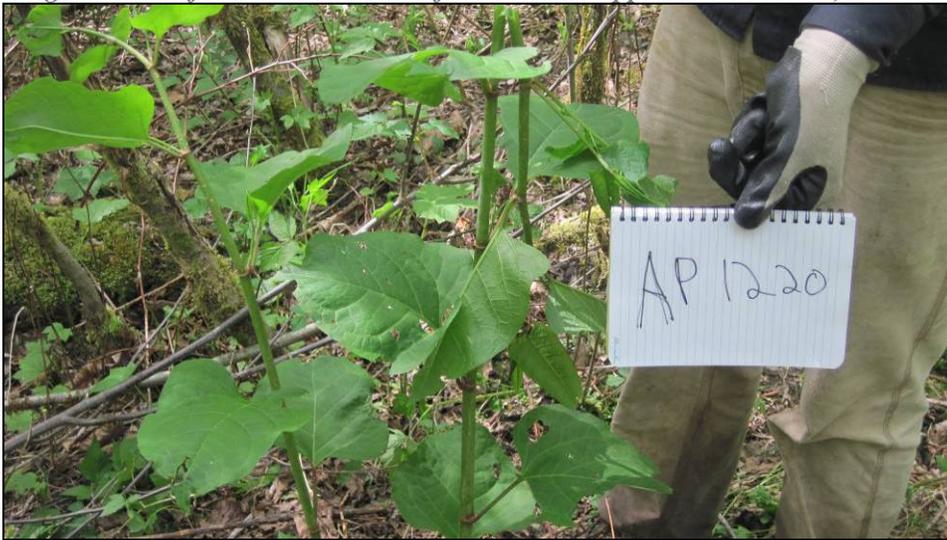
Figure 13. Before: Patch AP1220 found on the upper Sauk in 2012, with 4 stems.

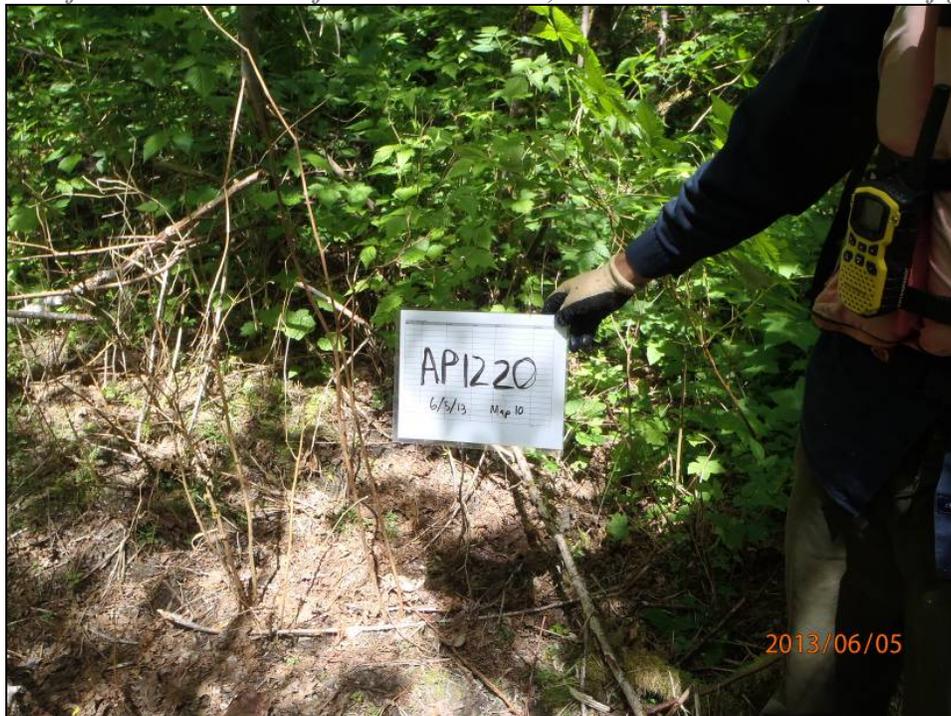
Figure 14. After: Patch AP 1220 found dead in 2013, was treated in 2012 (shown in figure13).

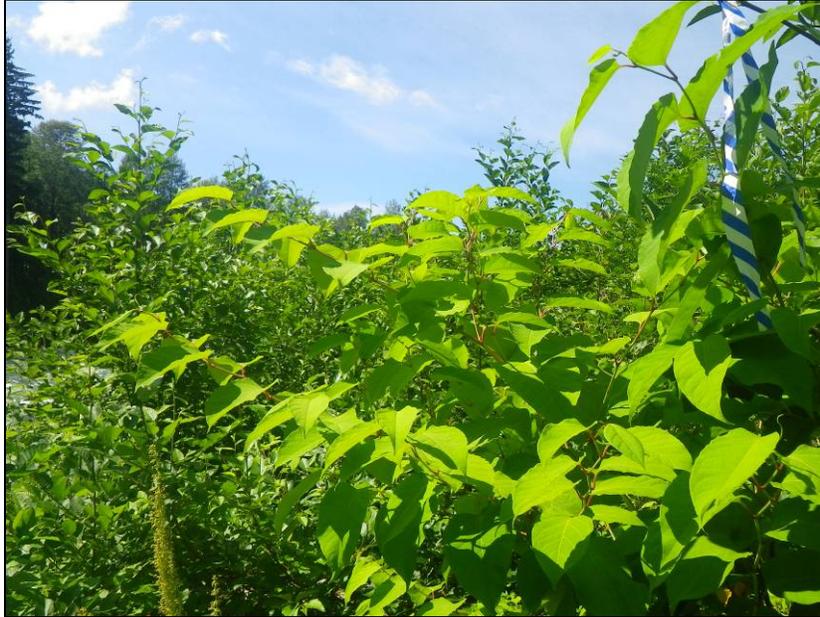
Figure 15. Before: AP 1215 found along the edge of the mainstem upper Sauk River in 2012, with a total of 15 stems.

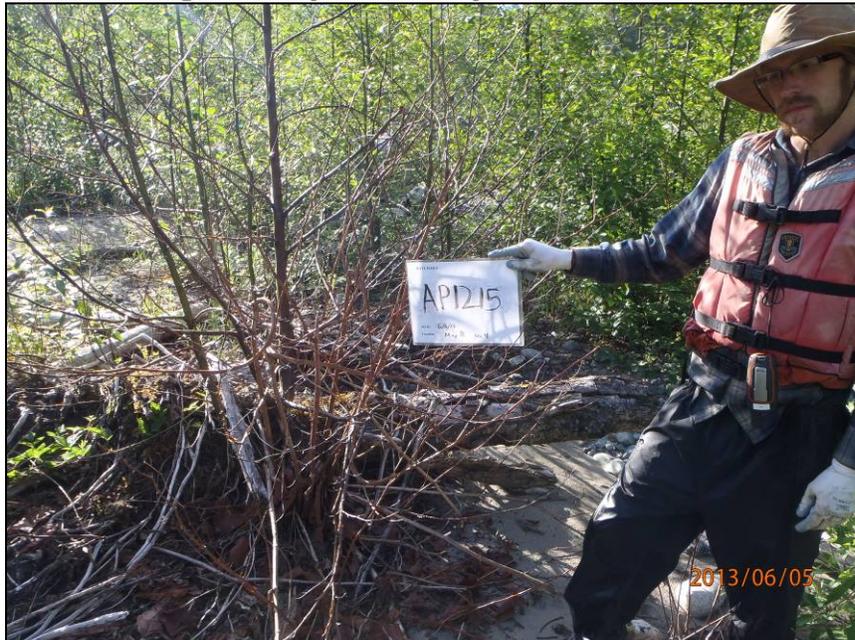
Figure 16. After: AP1215 found dead in 2012.

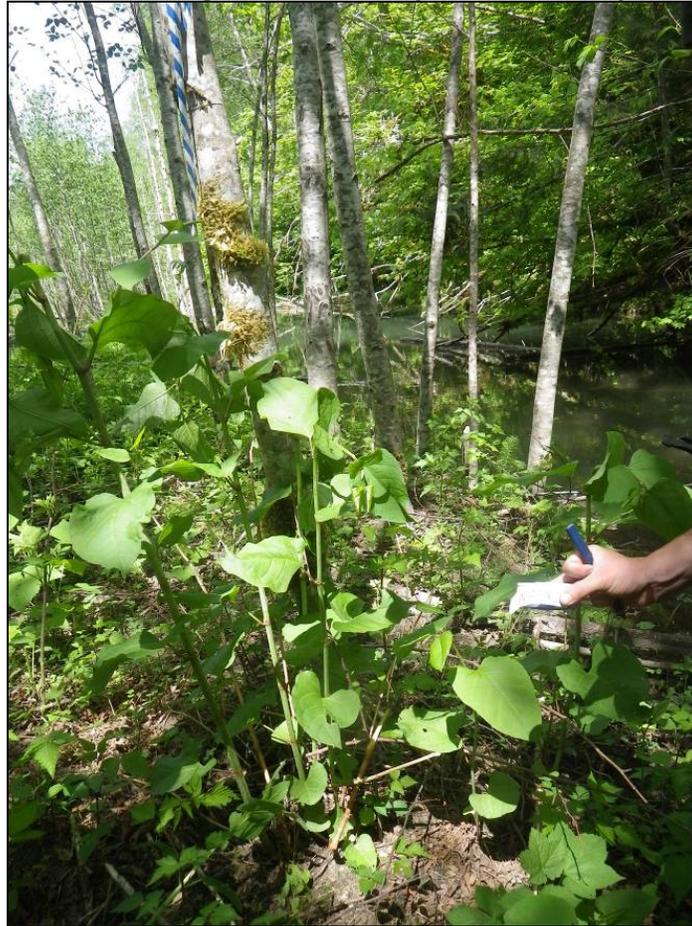
Figure 17. Before: AP1229 along a side channel of the Sauk River found in 2012 with 7 stems.

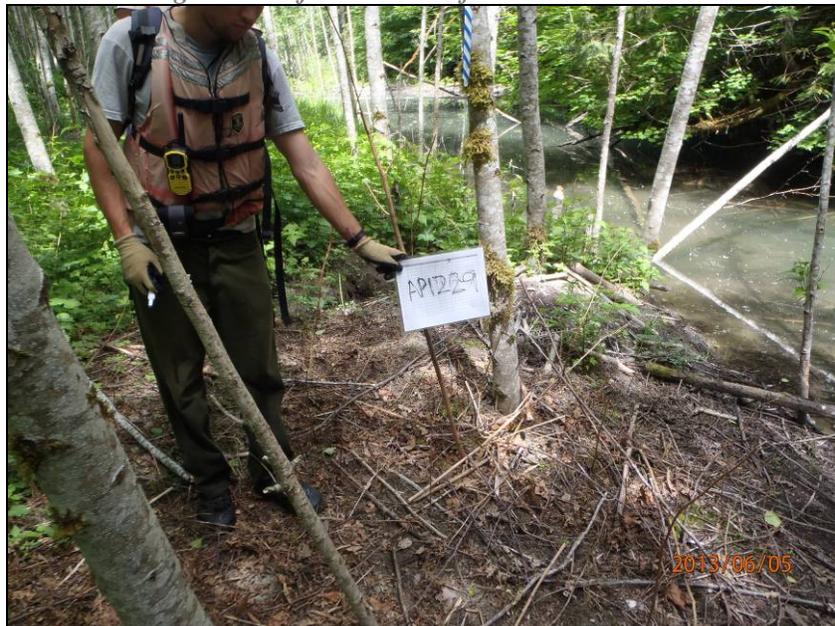
Figure 18. After: AP1229 found dead in 2013.

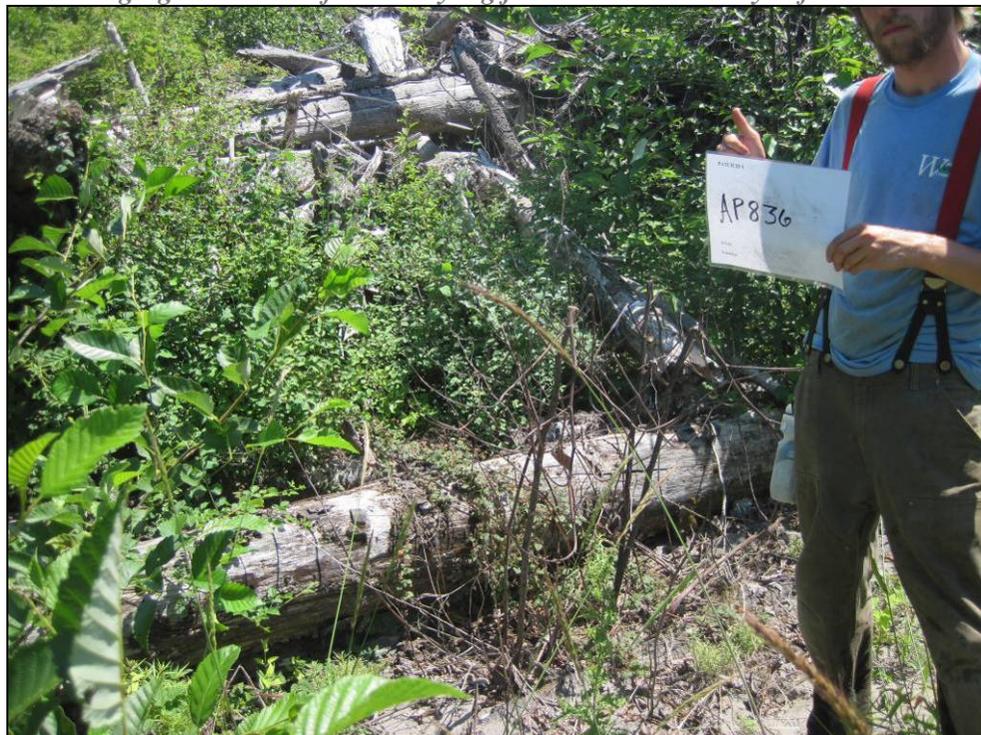
Figure 19. Patch AP836, located on the middle Sauk River, was found dead in 2013, the patch was live and treated in 2012 with 14 stems. The Terrain on the Sauk River, as shown in this photo is very challenging this is one of the many log jams which we surveyed for knotweed.

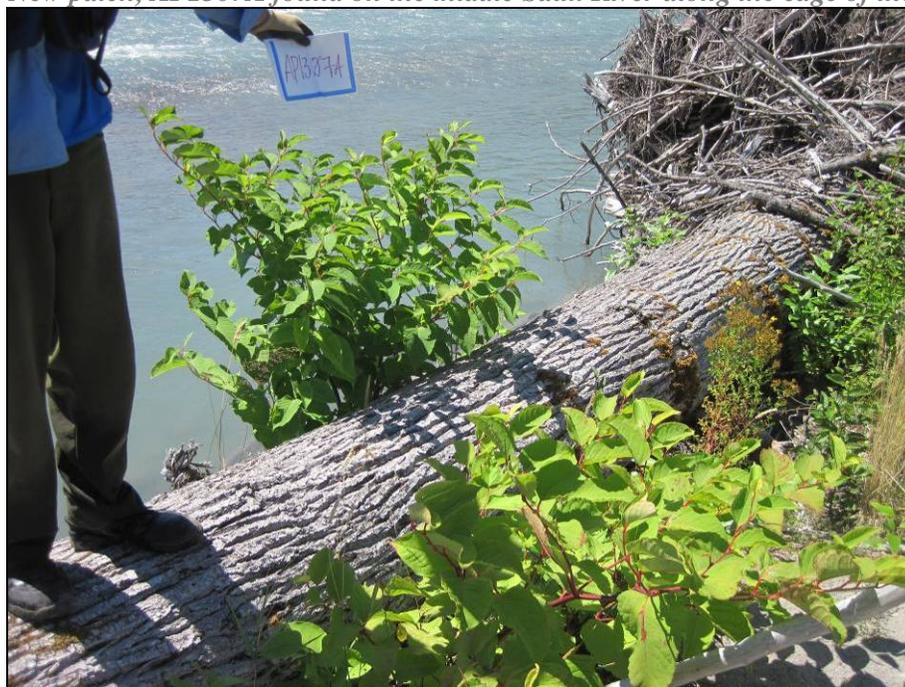
Figure 20. New patch, AP1307A found on the middle Sauk River along the edge of the mainstem.

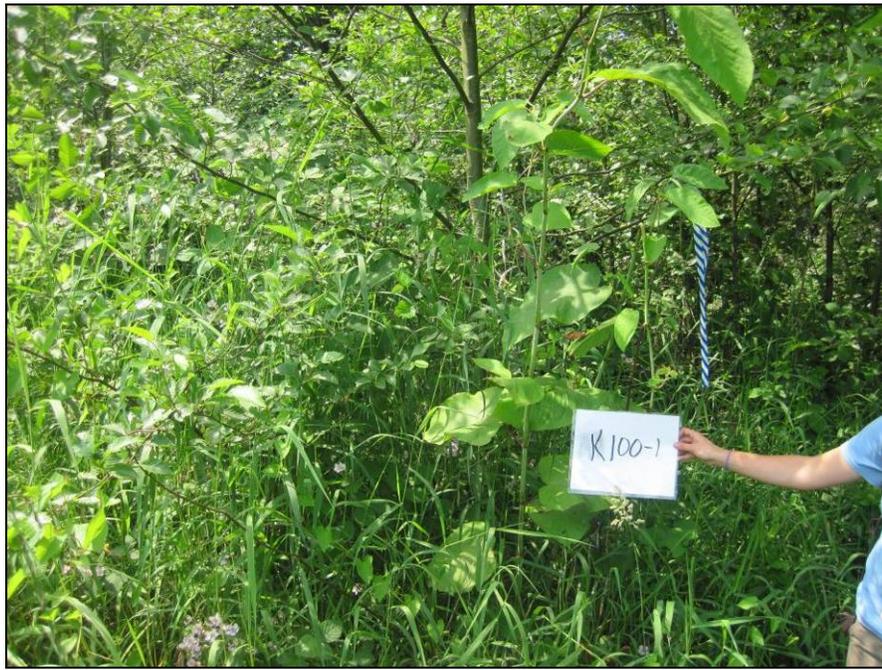
Figure 23. Patch K100-1 a single stem patch found on an old back channel of the Skagit just above Howard Miller Steelhead Park. This patch was originally identified in 2008, found dead after treatment in 2009 and then found live and treated from 2011-2013. In 2012 this patch had 4 stems. This patch's history represents the complicated nature of knotweed treatment and the importance of rigorous re-surveying.

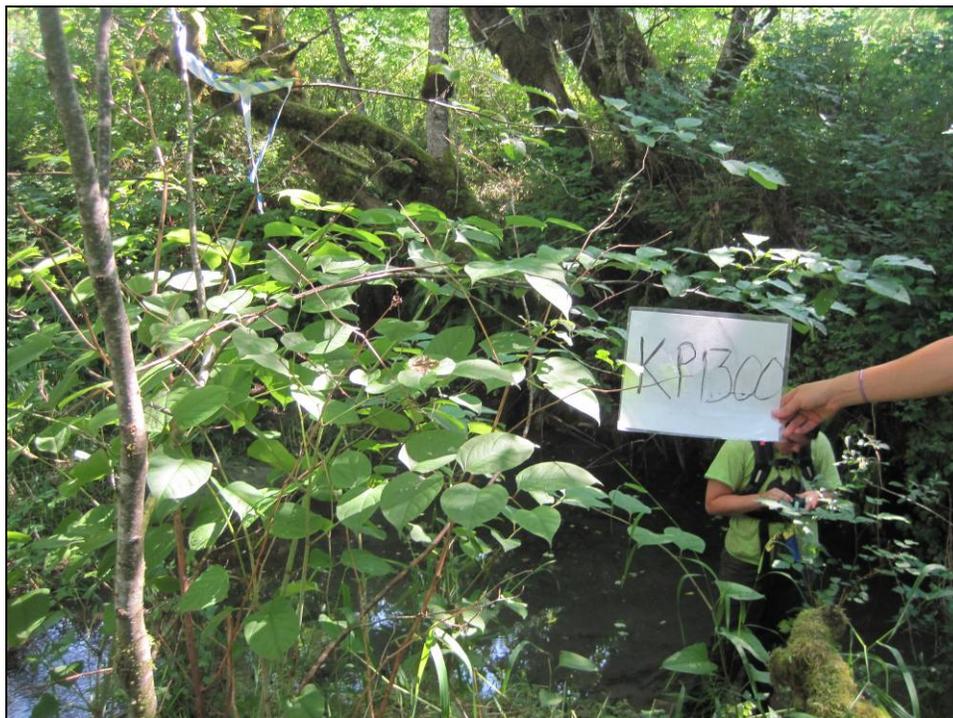
Figure 24. New patch KP1300 found in a back channel of the Skagit River below Marblemount. The patch was treated and had 10 stems.

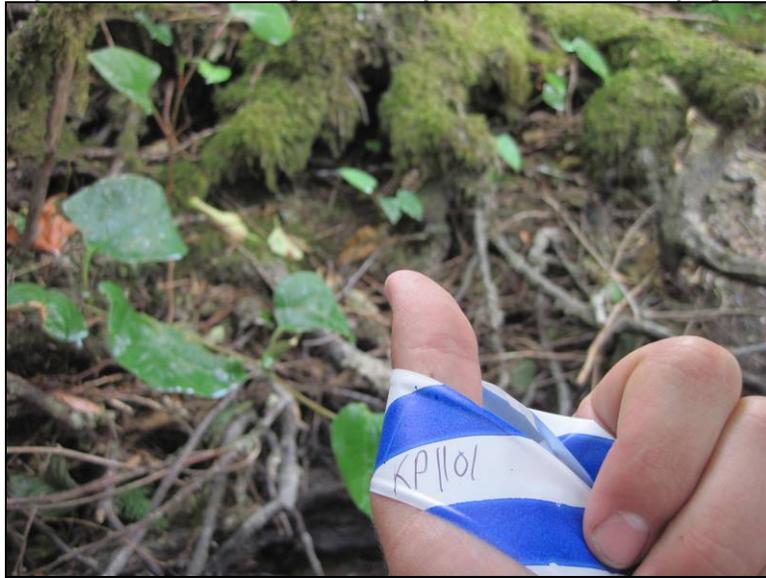
Figure 25. Patch KP1101 one of the few live patches found along the Skagit River in 2011 between Copper Creek and Marblemount. This patch was found dead in 2012 with the exception of two mutilated stems with no leaves. In 2013 the mutilated stems were gone and very small single stems (an average of 7 inches in height) of knotweed had emerged, none of these stems where symptomatic (chias).

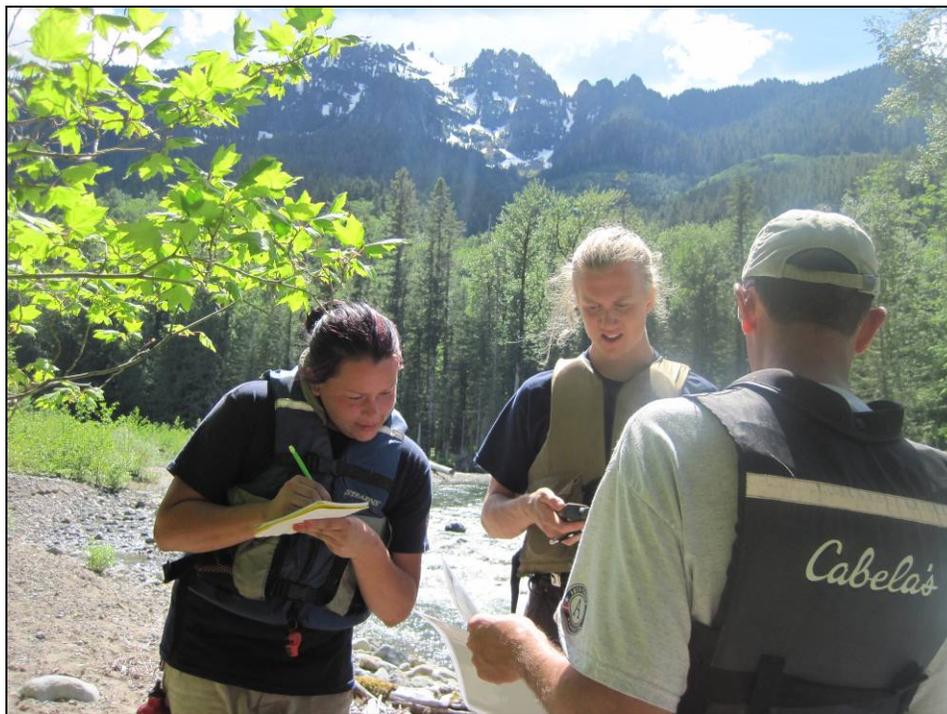
Figure 26. WCC crew shown recording patch data and taking GPS points. Crew leader Rob shown reviewing maps. A GPS point and notes are taken for every new patch found, all information is also recorded on laminated maps of the project sites.

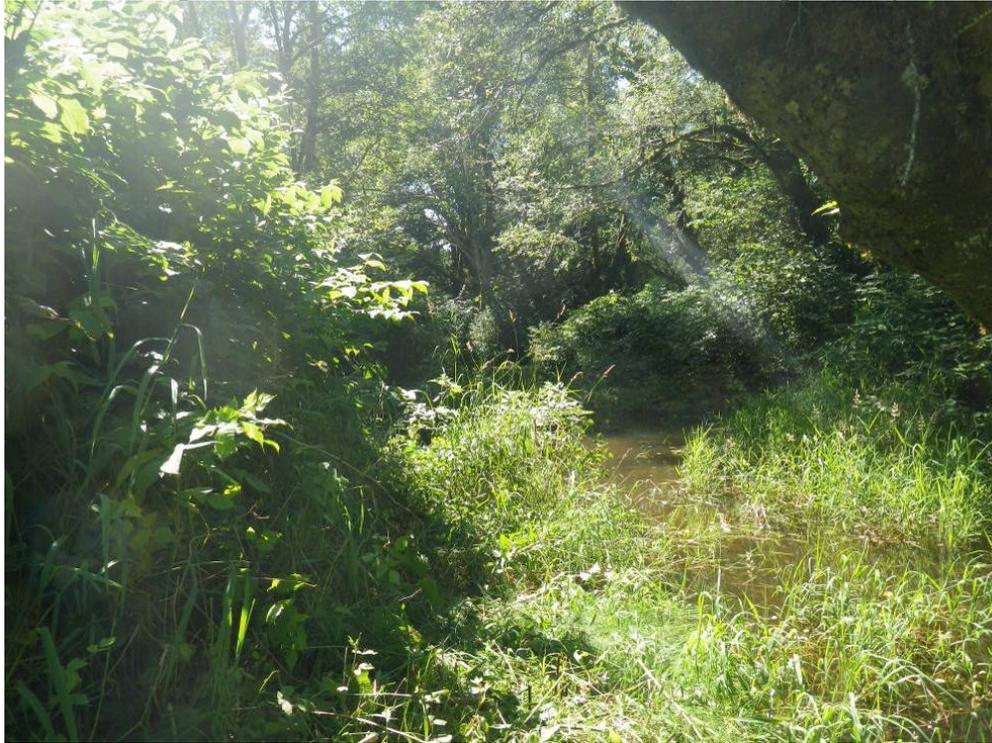
Figure 27. Before: KP1219 was the largest new patch found on the Skagit River in 2012 with and estimated 500 stems. This patch was located on a back channel that had not previously been surveyed.

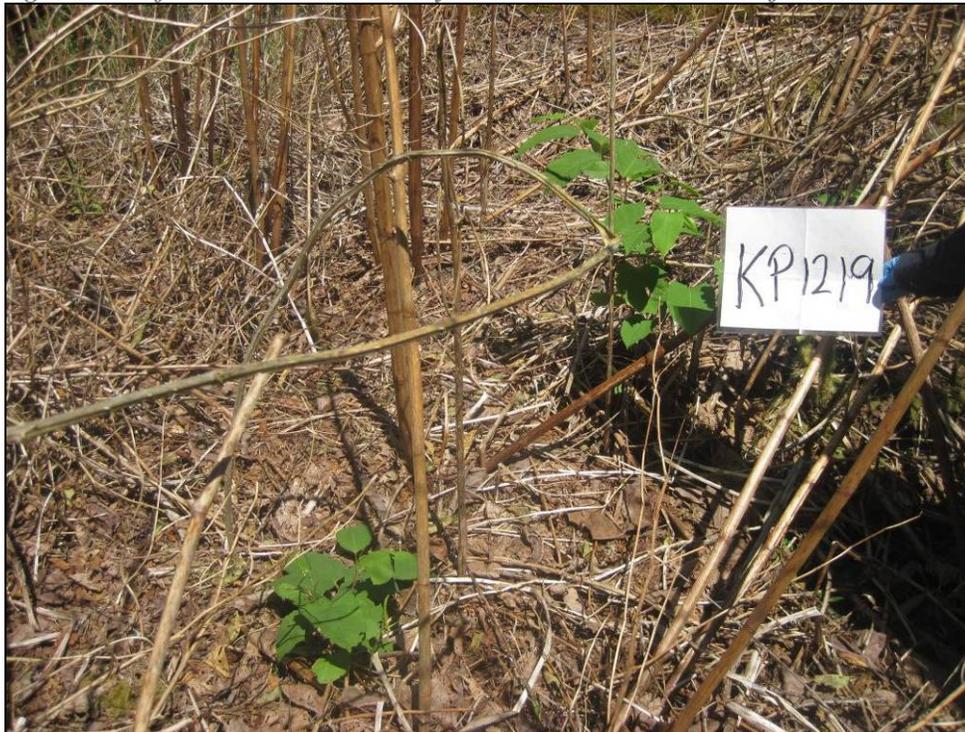
Figure 28. After: Patch KP1219 only had 20 live stems reduced from 500 in 2012

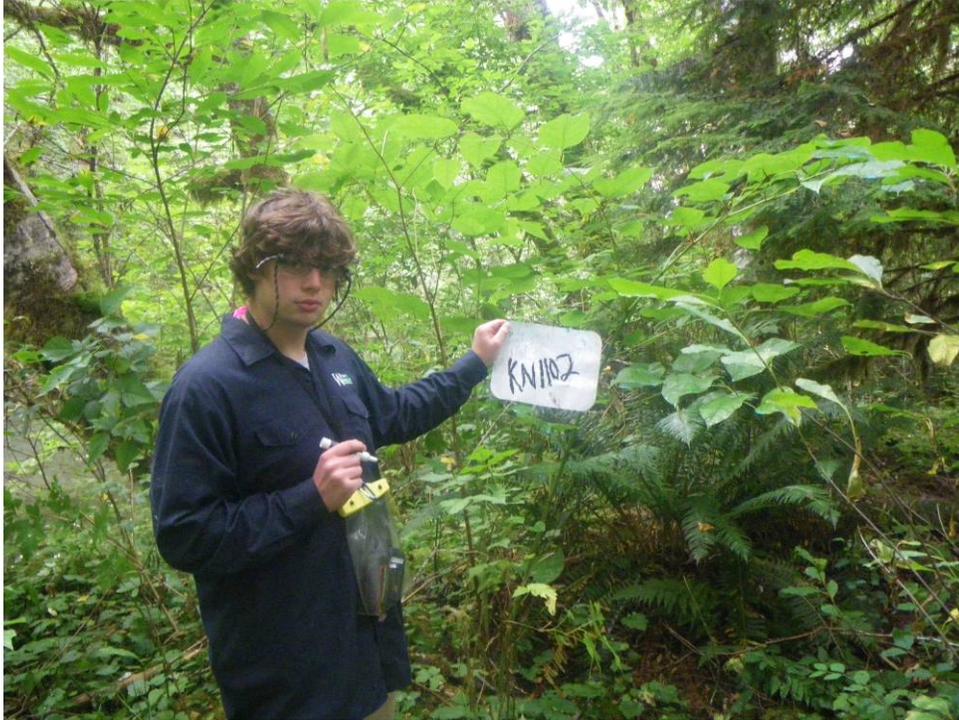
Figure 29. Before: Patch KN1102 was found 2011 with 6 stems, as shown in photo. This patch is located on a back channel of the upper Skagit on NPS lands. The patches was also found live in 2012 with 2 small stems.

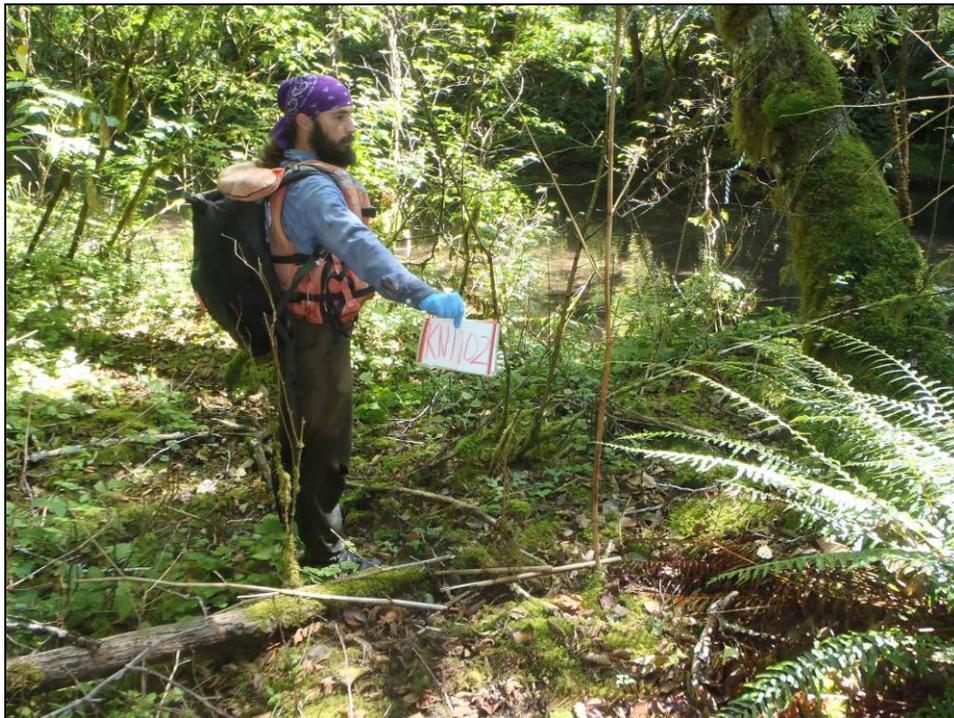
Figure 30. After: Patch KN1102 was found dead in 2013 after 2 years of treatment.

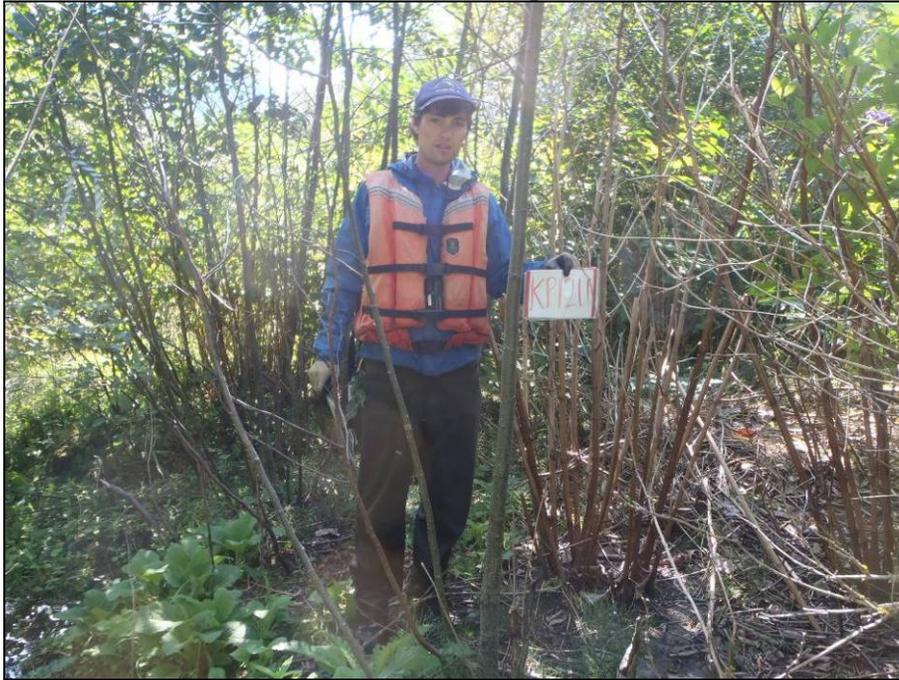
Figure 31. Patch KP1211 is located just off of the mainstem Skagit River and was one of 7 new live patches found on the Skagit within NPS lands in 2012, the patch had 25 stems. KP1211 was found dead in 2013, as seen in photo.

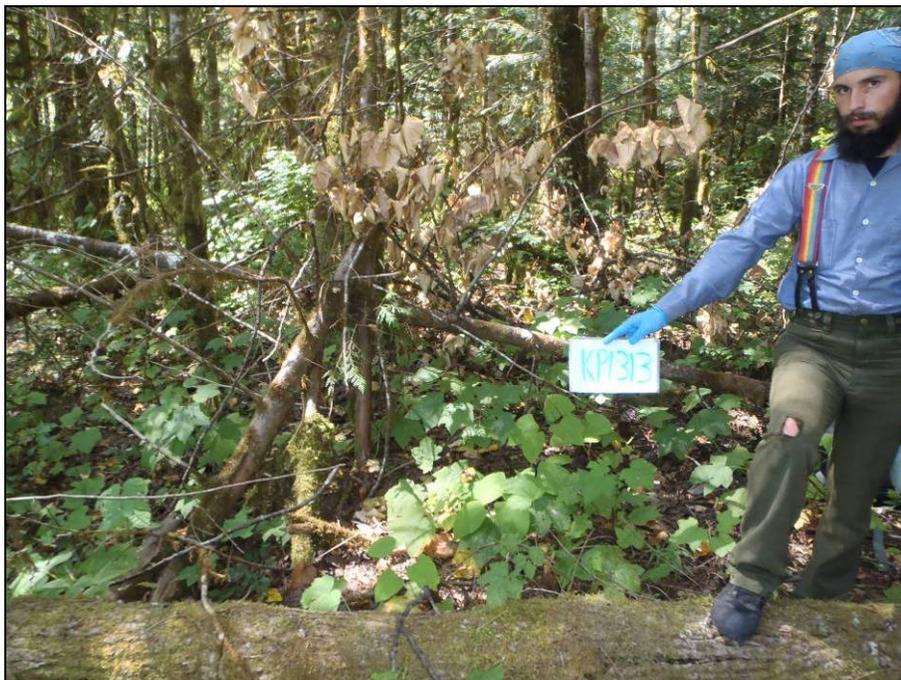
Figure 32. KP1313, was one of the new patches found during the 2013 survey season in an old back channel of Damnation Creek on NPS lands. All 6 of the new patches found on NPS lands were all in this area and small with between 1 and 4 stems.

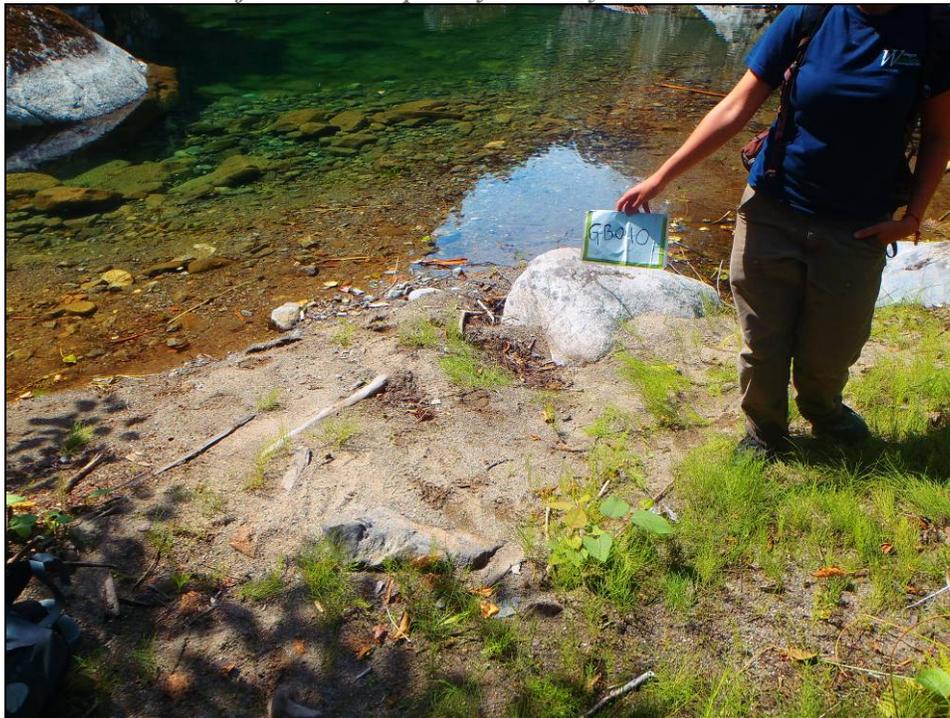
Figure 33. Patch GB010 was one of two live patches found in the Gorge Spillway in 2013. Each patch found in the spillway had only one stem.
