**SALMON AND STEELHEAD HABITAT LIMITING FACTORS
WATER RESOURCE INVENTORY AREAS 3 AND 4, THE SKAGIT
AND SAMISH BASINS**

By Carol J. Smith, Ph.D.
Washington State Conservation Commission
Lacey, Washington

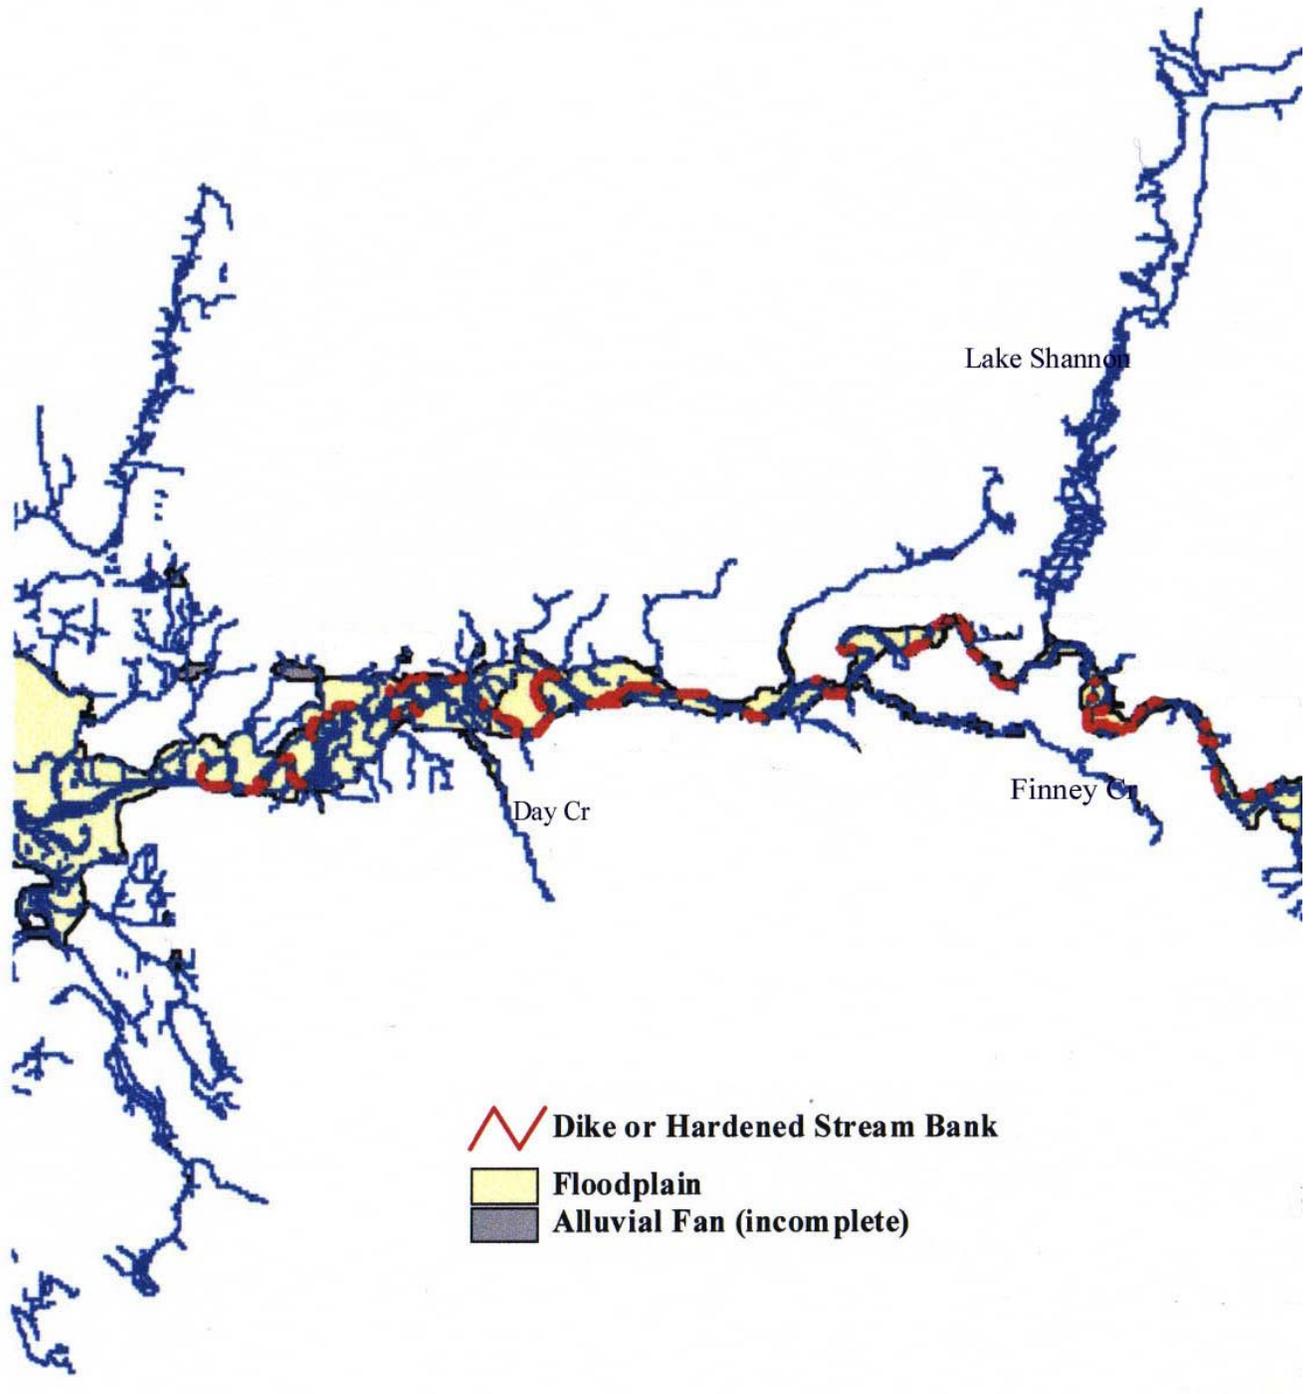
**Figure 13. Dikes and bank hardening along the middle and lower Skagit River
(Map from Beamer et al. 2000).**

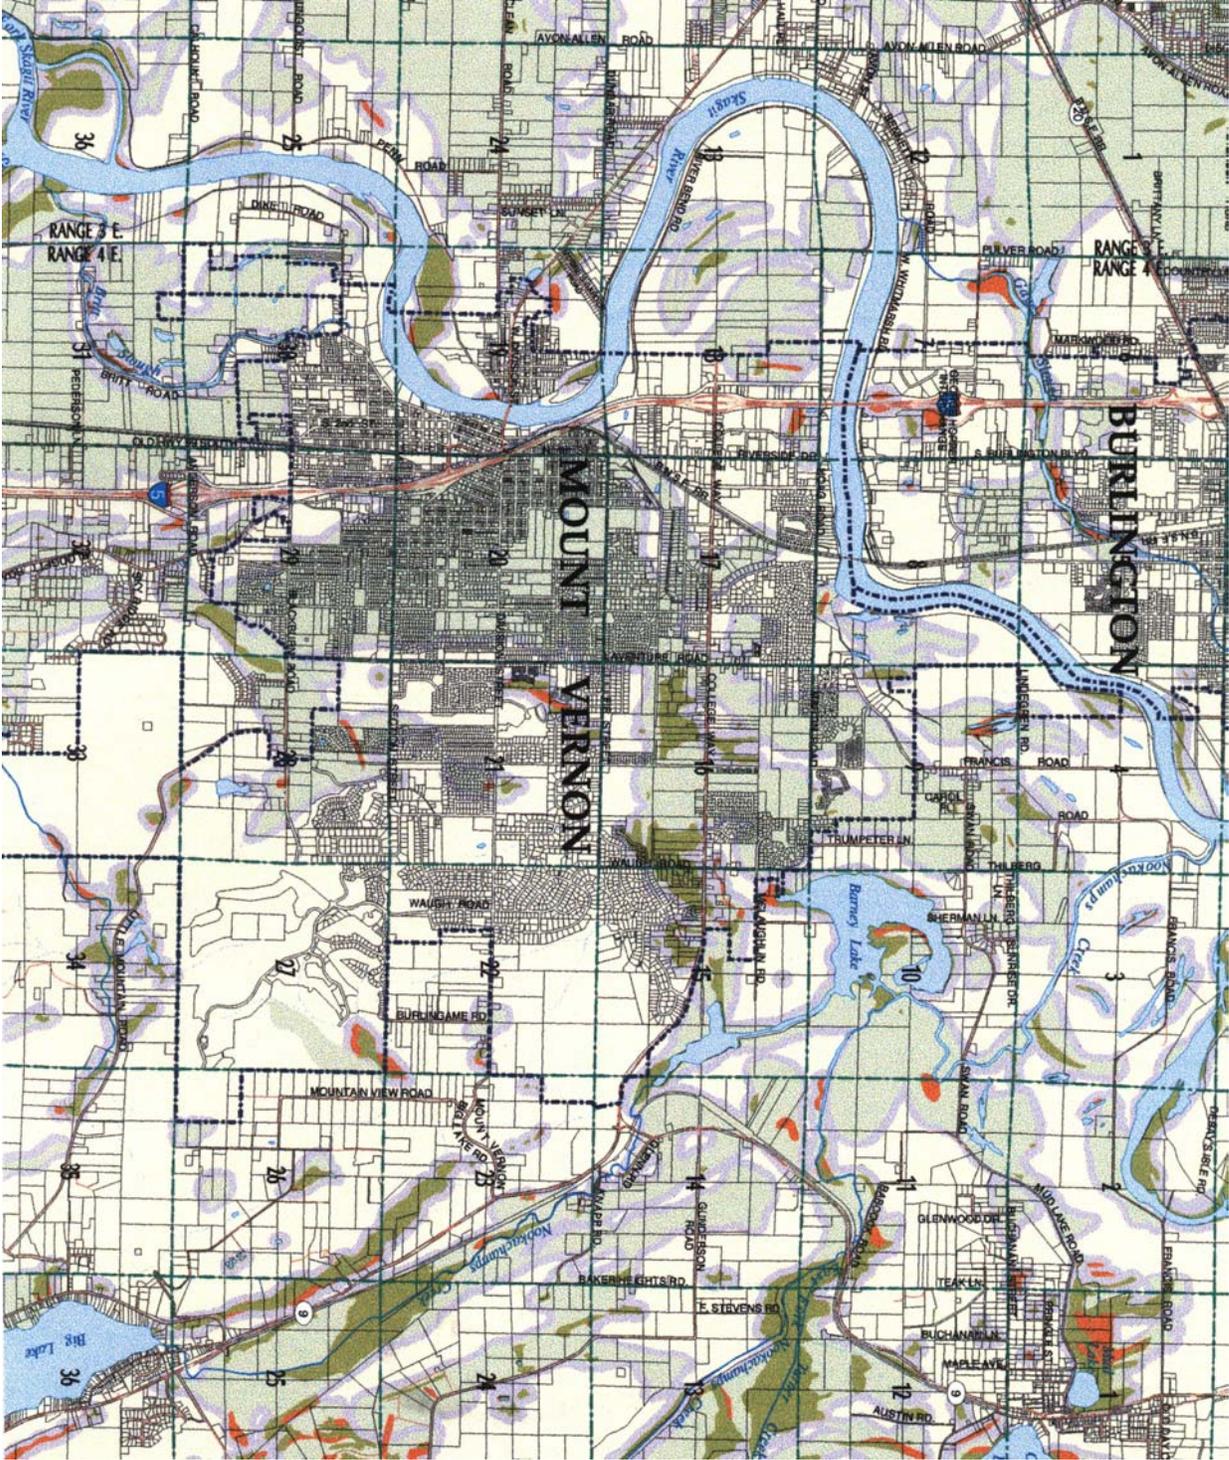
Figure 14. Wetland habitat (dark green and orange) and hydric soils (light green) in the Mount Vernon area (Skagit County Geographic Information Services 2002). The dark green areas represent data from the National Wetlands Inventory, while the orange areas have been interpreted from aerial photographs.

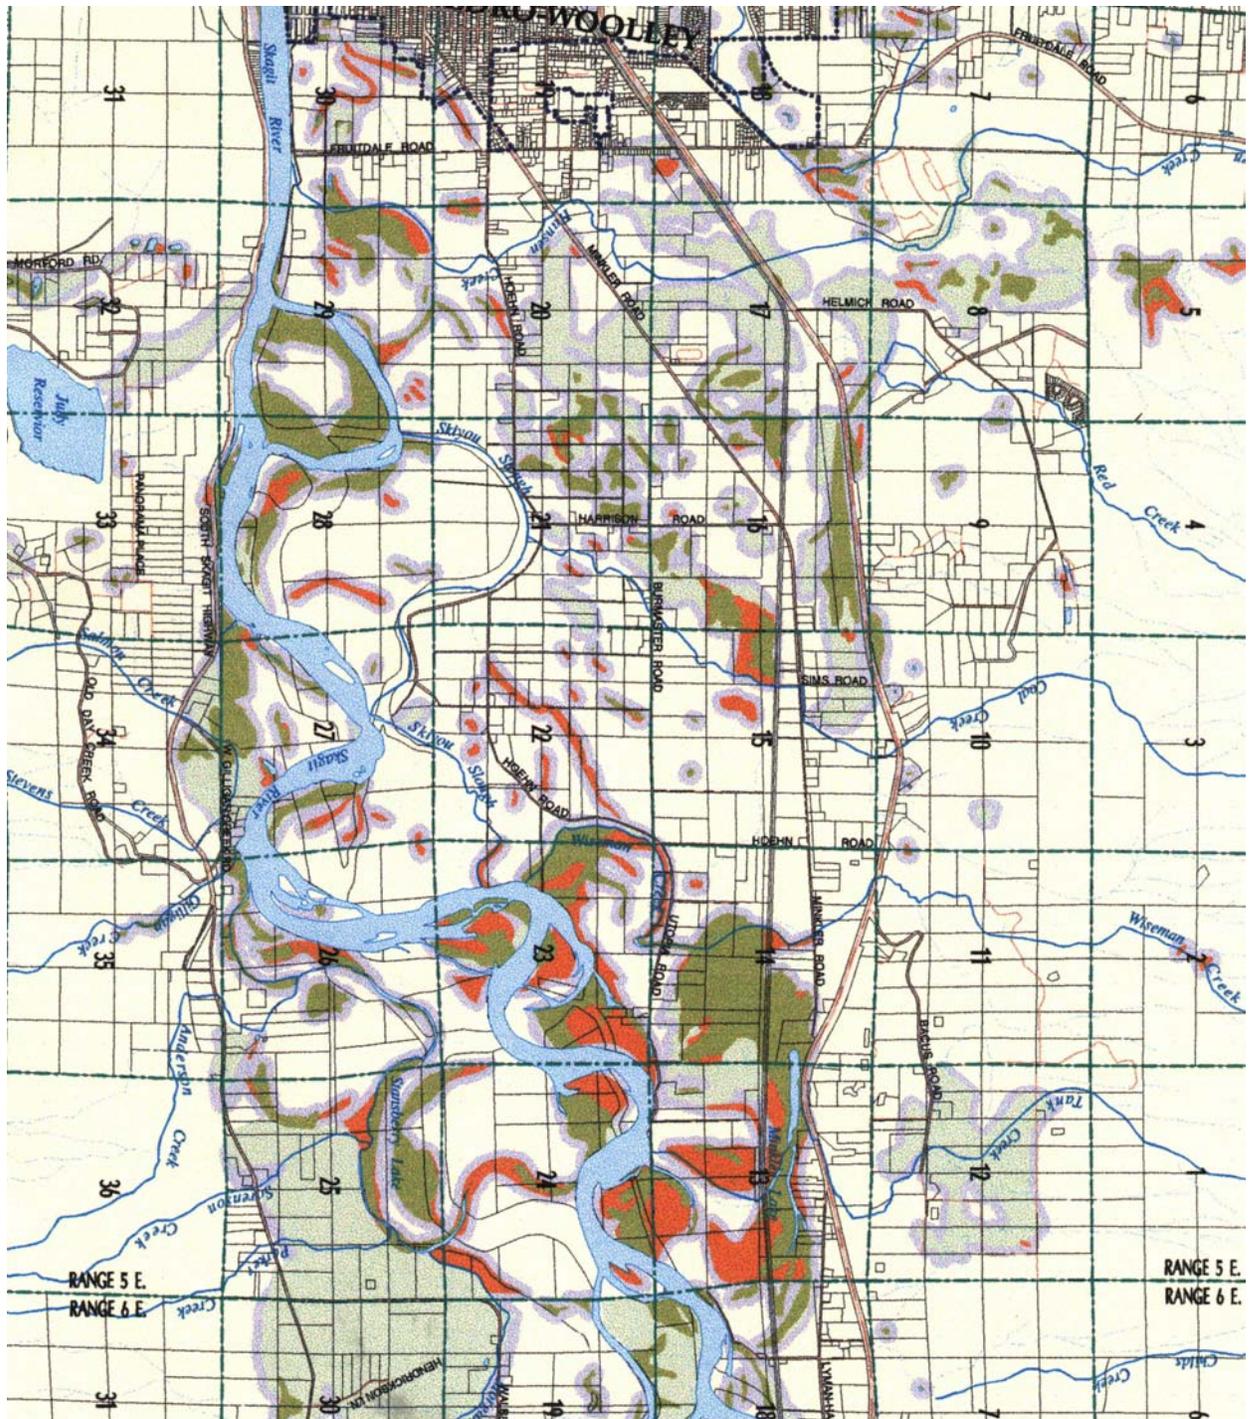
Figure 15. Wetland habitat (dark green and orange) and hydric soils (light green) in the Sedro Woolley area (Skagit County Geographic Information Services 2002). The dark green areas represent data from the National Wetlands Inventory, while the orange areas have been interpreted from aerial photographs.

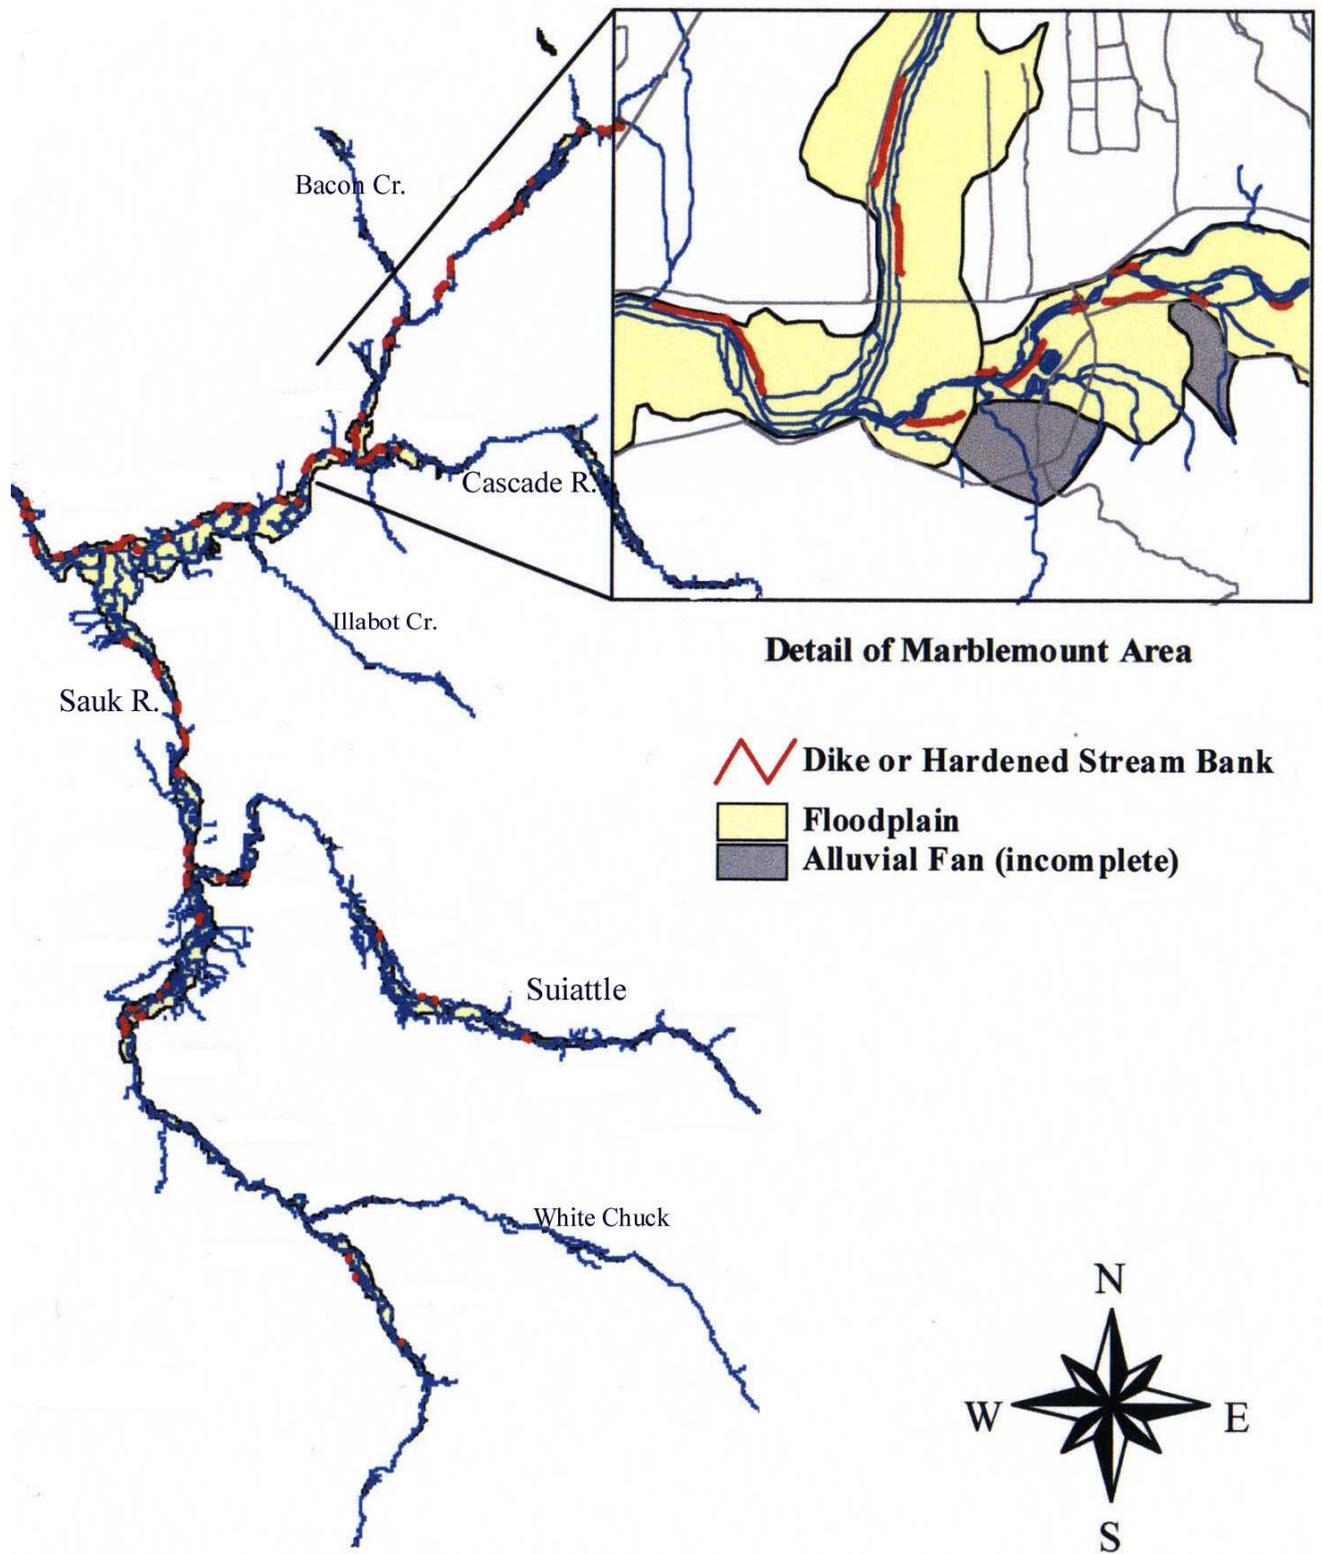
Figure 19. Dikes and bank hardening along the upper Skagit River and major tributaries (Map from Beamer et al. 2000).

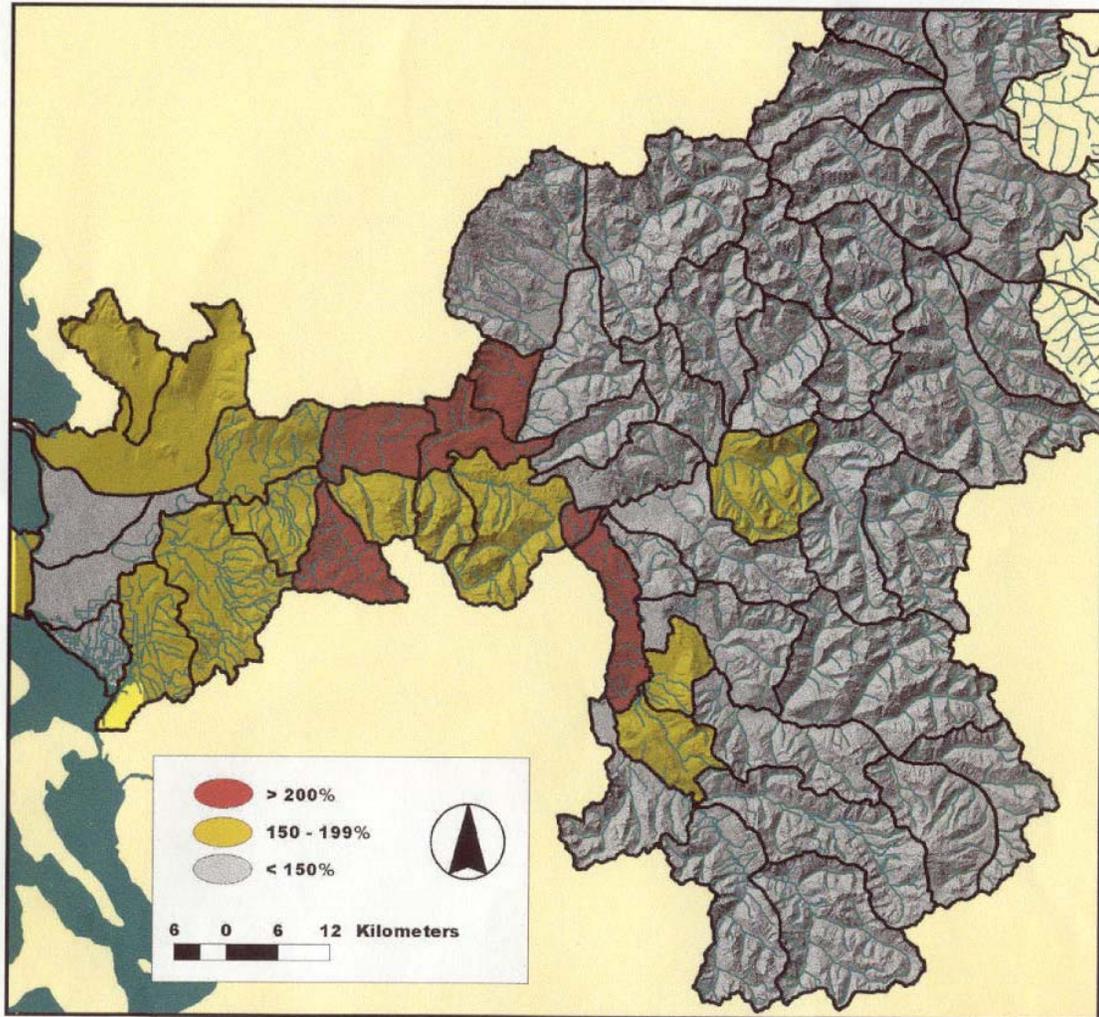
Figure 27. Estimated sediment supply rates in the Skagit and Samish Basins (Beechie and Feist, NMFS, unpublished data).

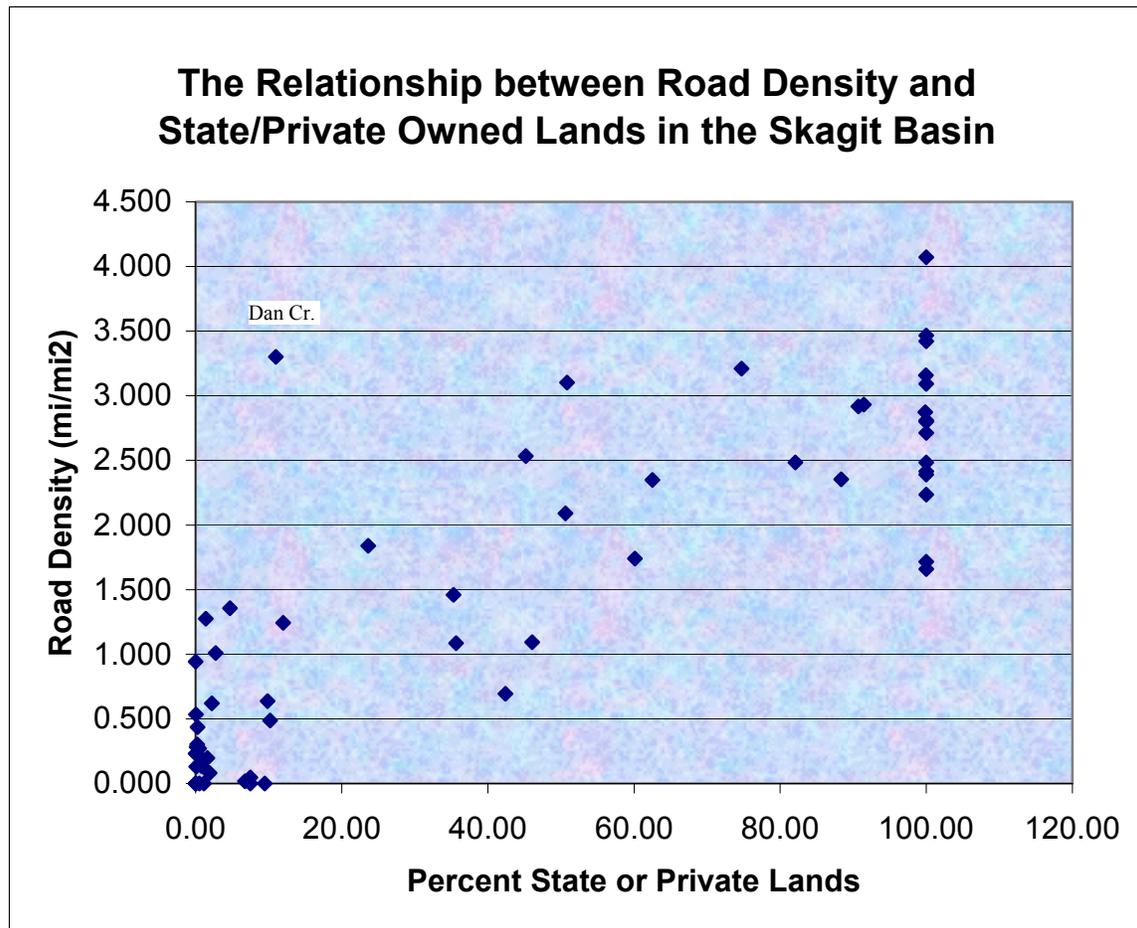
Figure 28. The relationship between road density (mi/mi²) and the percent of state and privately owned land on a WAU scale (raw data from Lunetta et al. 1997). The Person product moment correlation coefficient is 0.85 with a p<0.0001. Dan Creek is labeled because it is an outlier (but was still included in the analysis).

The salmonid habitat conditions in WRIAs 3 and 4 are related to land use. For example, the greater the percentage of state or private land contained within a WAU, the higher the road density (see Sediment Chapter). Road density is often a major indicator of sedimentation and fish blockage impacts, and contributes to hydrologic changes. Because of the link between land use and habitat degradations, it is not surprising that

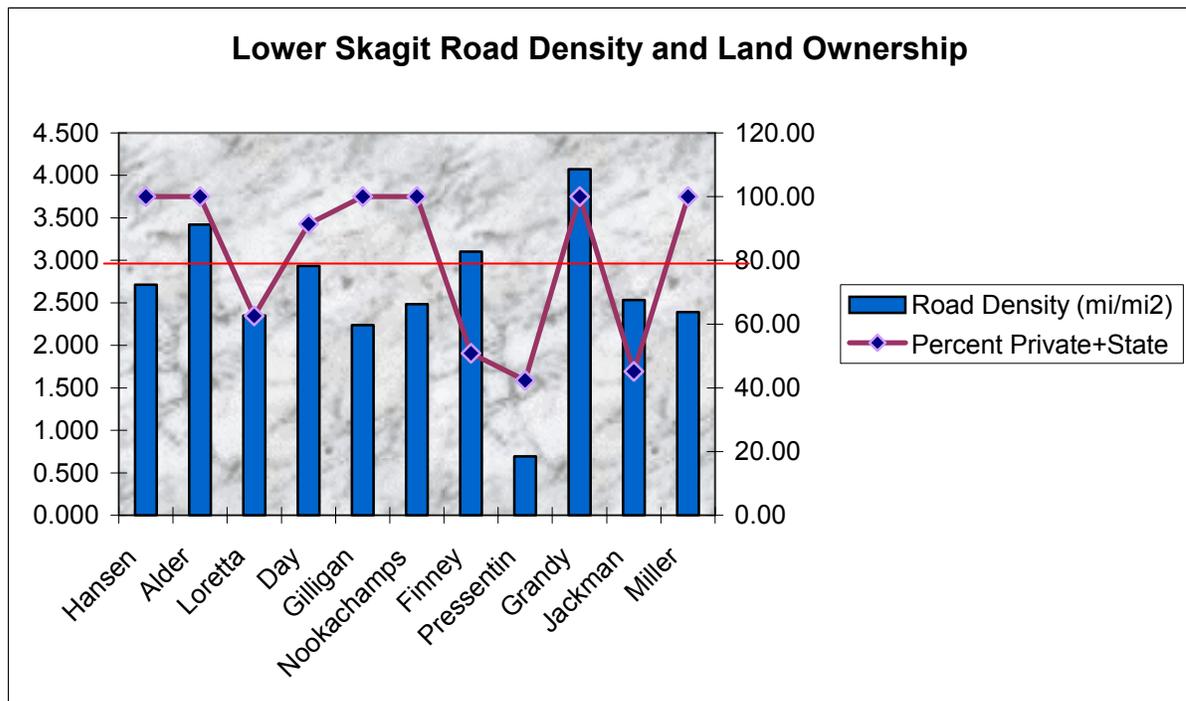
Figure 29. Road density and the percentage of state and privately owned lands on a WAU scale in the lower Skagit sub-basin. “Poor” road density values include those greater than 3 mi/mi². “Good” road density values are those less than 2 mi/mi². Presentin is the only WAU in the lower Skagit sub-basin with a “good” road density rating.

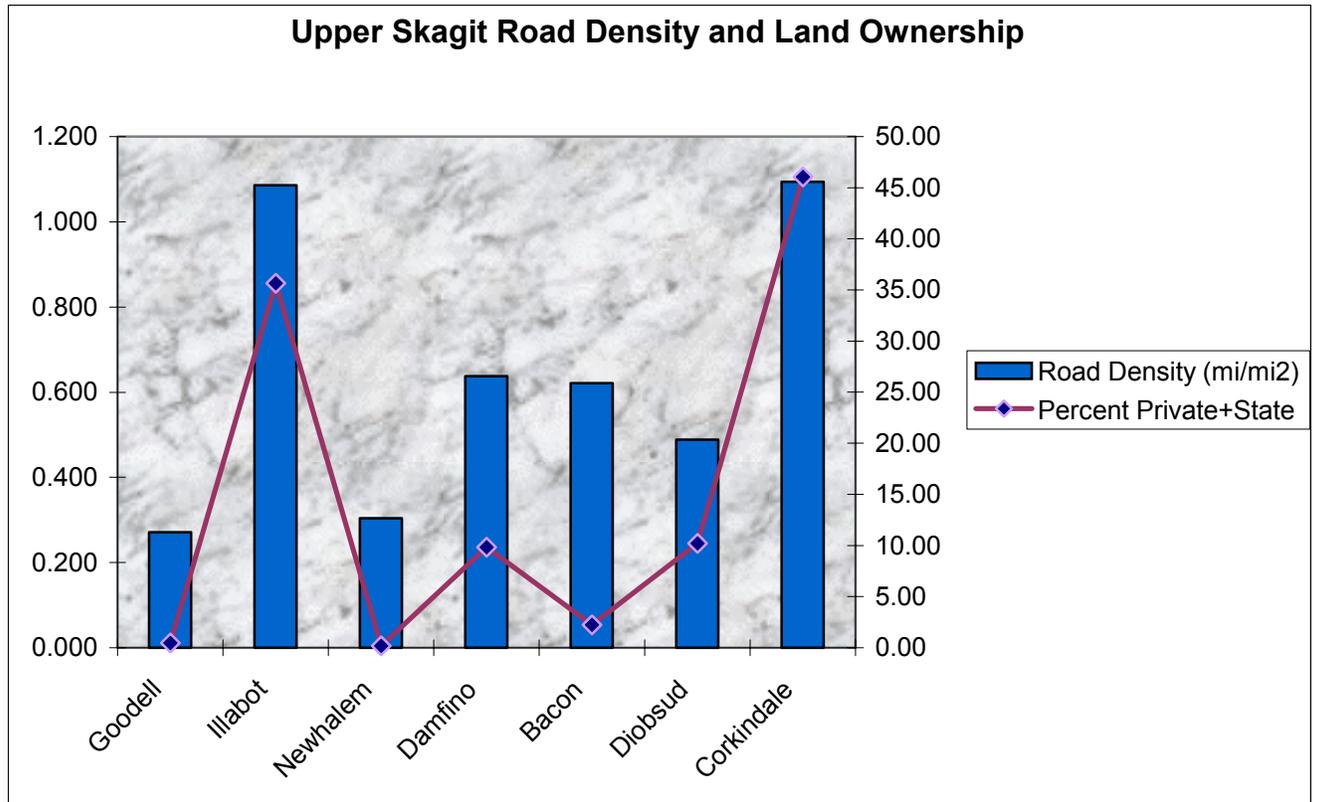
Figure 30. Road density and the percentage of state and privately owned lands on a WAU scale in the upper Skagit sub-basin excluding the Cascade River. “Poor” road density values include those greater than 3 mi/mi². “Good” road density values are those less than 2 mi/mi². All WAUs in this area had “good” road densities.

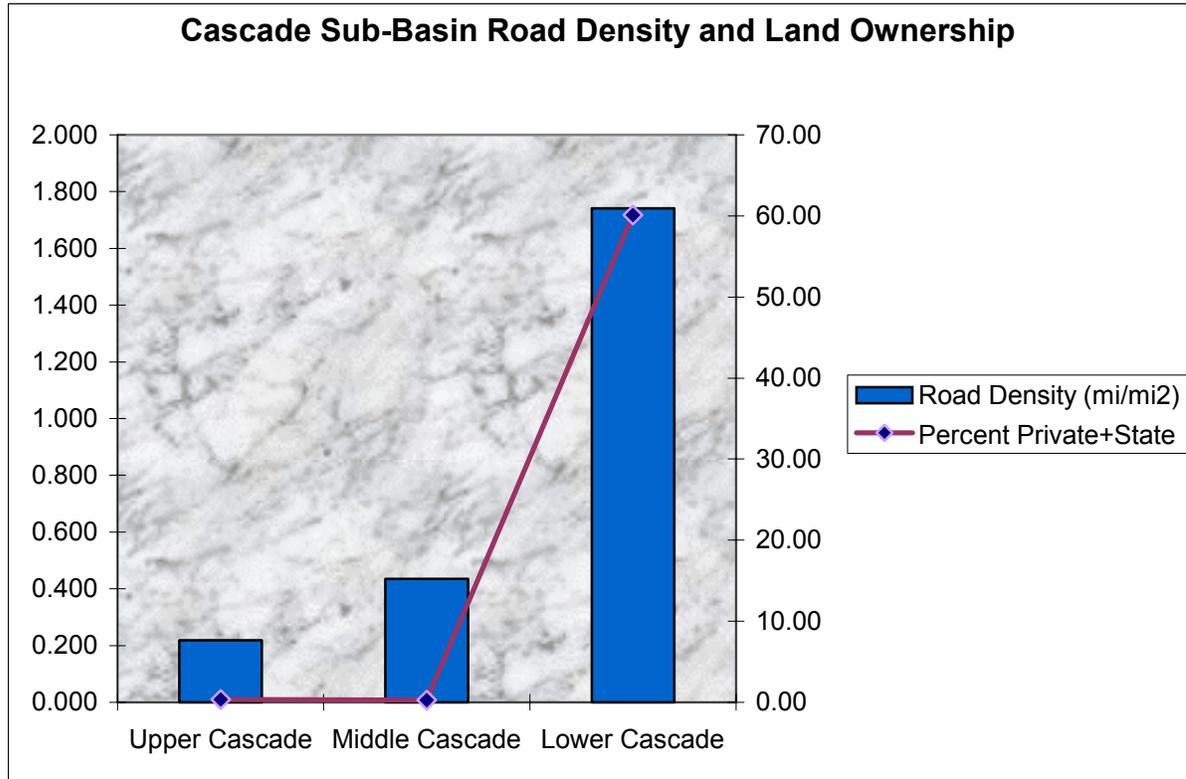
Figure 31. Road density and the percentage of state and privately owned lands on a WAU scale in the Cascade River drainage. “Poor” road density values include those greater than 3 mi/mi². “Good” road density values are those less than 2 mi/mi². All WAUs in this area had “good” road densities, although higher road densities were found in the lower Cascade (Jordan/Boulder) WAU that had considerably more private and state owned lands.

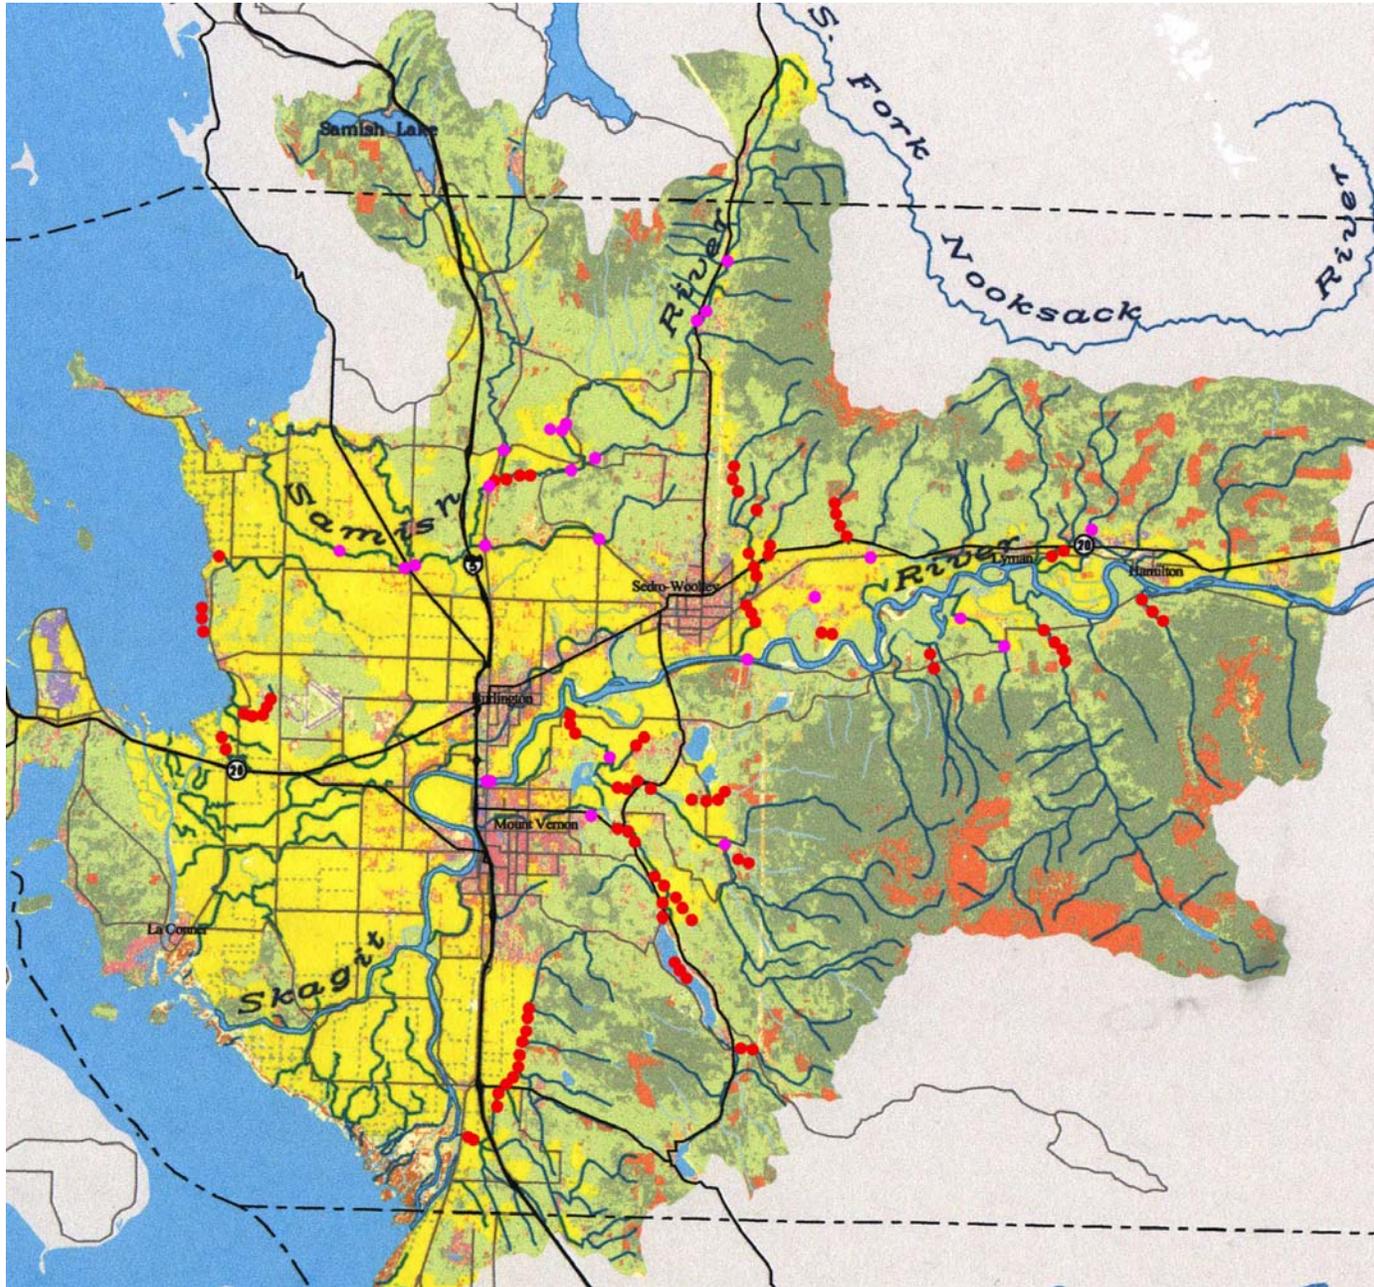
Figure 43. The location of “poor” rated water quality stream segments in WRIAs 3 and 4. Red dots denote 303(d) Listings except for fecal coliform, and pink dots are “poor” rated areas derived from other data sources. Data are superimposed on a land use/cover map from DOE. Yellow represents agricultural areas. Dark green is conifer forest, and light green is mixed forest.

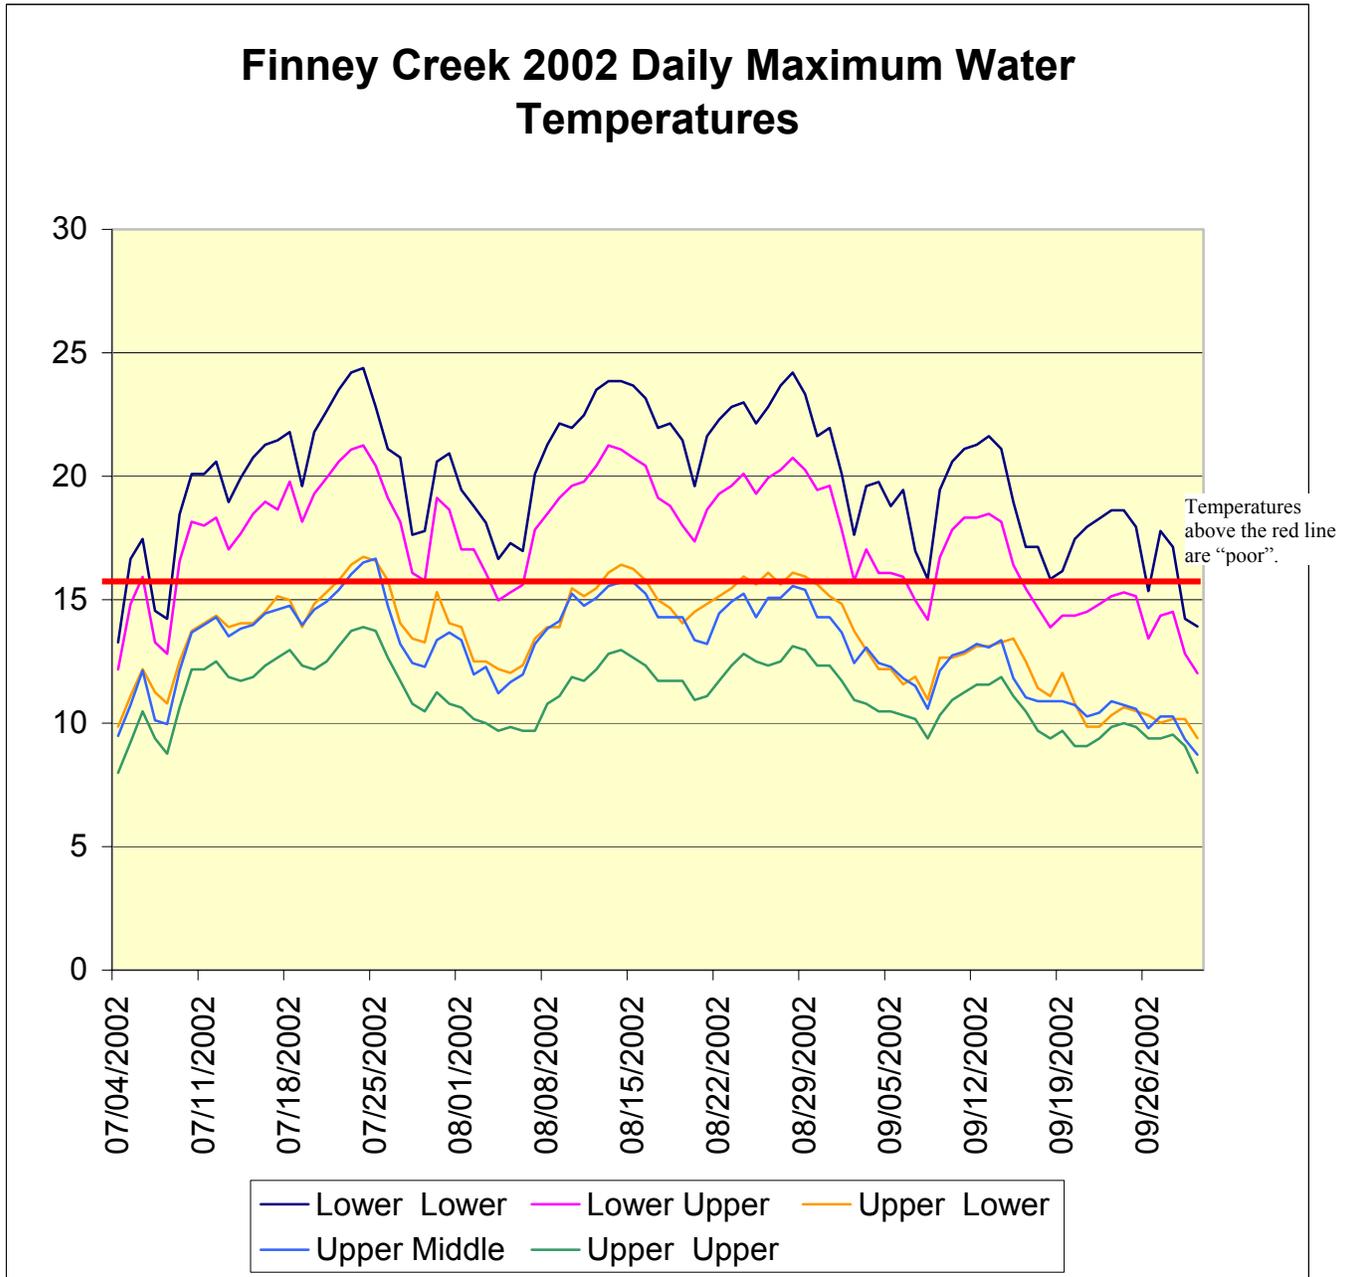
Figure 45. Daily maximum water temperatures in Finney Creek during 2002 (Stan Zyskowski, National Park Service unpublished data).

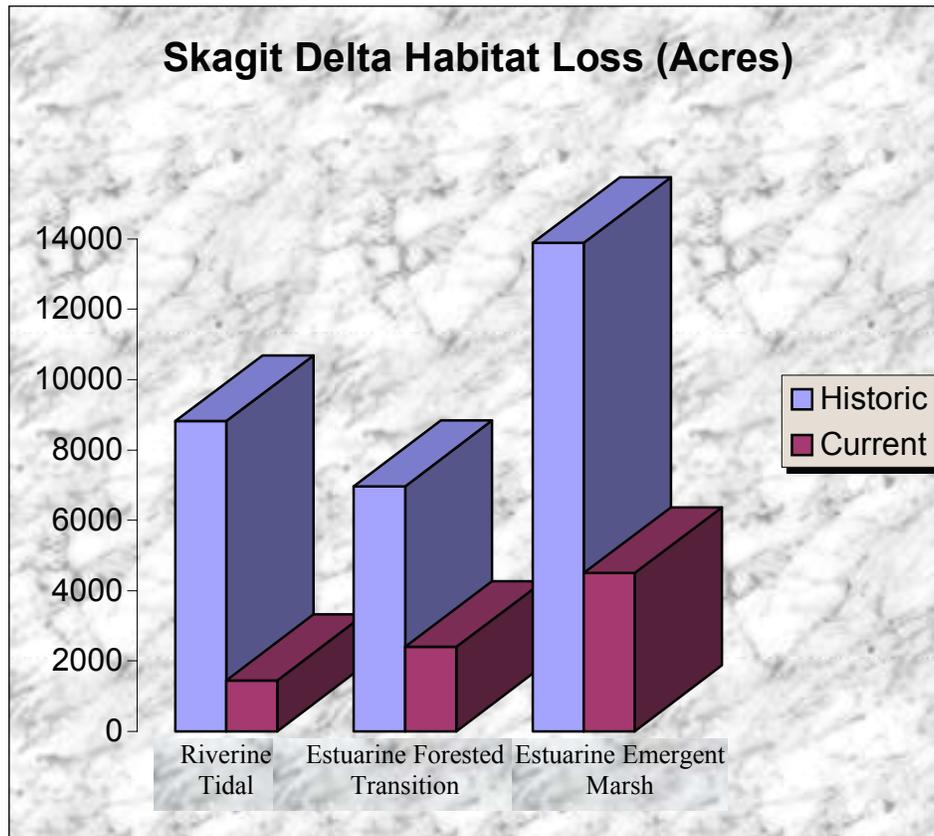
Figure 50. Loss of habitat in the Skagit Delta (data from Beamer et al. 2002a)

The loss (72%) of intertidal habitat in the Skagit delta (including the nearby sloughs) has been considerable and is of particular importance to chinook salmon (Beamer et al. 2002a). Dikes have isolated much of the historic delta habitat, and fish-blocking tidegates associated with the dikes are numerous. While many of the tidegates do not allow salmon access, they also prevent adequate tidal flushing. Further impacts to the isolated delta habitat, such as ditching, channelization, filling, riparian loss, and loss of habitat complexity have highly degraded the isolated habitat.

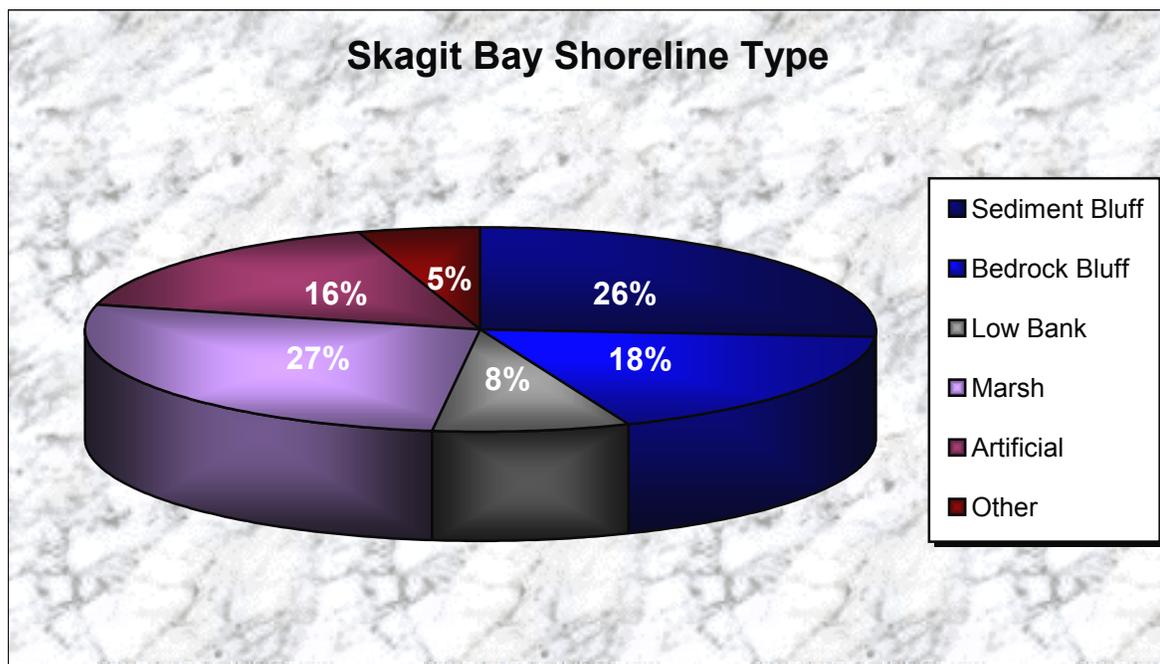
Figure 53. Classification of the Skagit Bay Shoreline (Nouffke and Beamer 2001).

By geomorphic classifications, the greatest area is comprised of flats, while the greatest percent of shoreline consists of flats and open beaches. The flats consist of 66% unvegetated fines and 34% eelgrass and fines. Open beaches have 39% unvegetated fines, 31% eelgrass and fines, 20% unvegetative coarse substrate, and two classifications that include green algae. Headlands are the most diverse of the habitat types with a variety of substrates and vegetation (kelp, algae, eelgrass). Coves consist of 53% unvegetated fines, 27% eelgrass and fines, and the remainder either green algae/fines, salt marsh, or unvegetated coarse substrate (Nouffke and Beamer 2001).

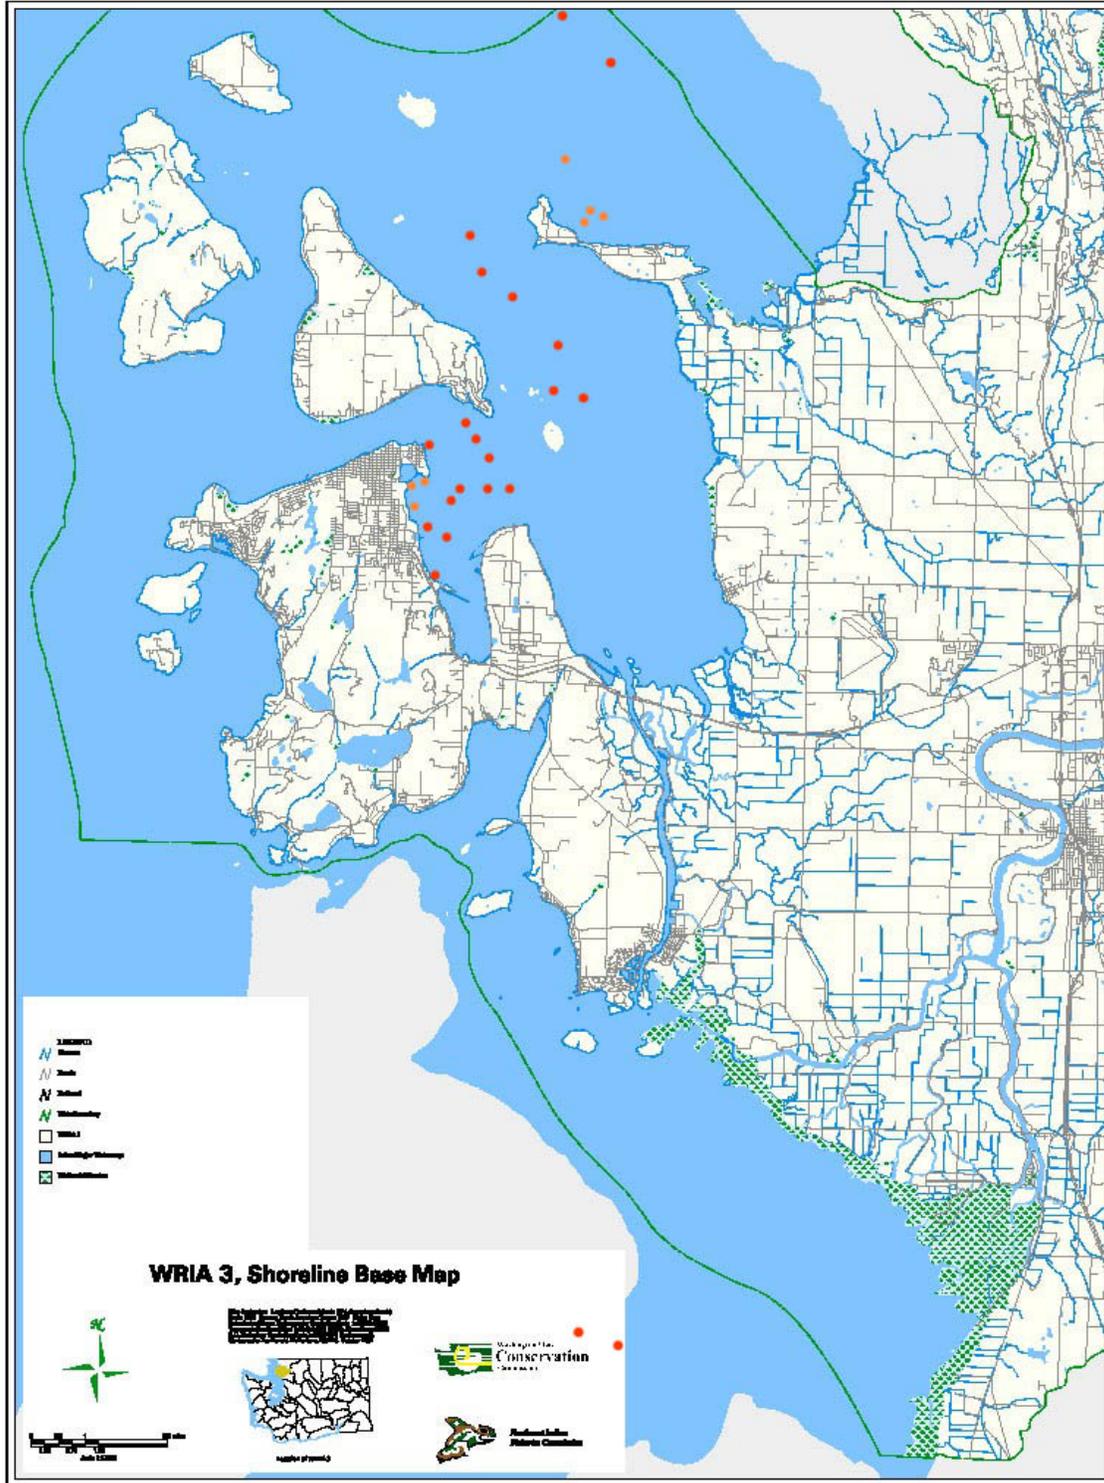
Figure 54. Sites of Sediment Quality Problems in and near WRIA 3 (data from Long et al. 1999). Red dots are sites with significant toxicity or contamination from Long et al. 1999. Orange dots are sites with elevated contaminants from Washington Department of Ecology Sediment Quality database.
