**Annual Incidental Take Report for 2017 – Bull Trout  
Skagit River Hydroelectric Project (FERC 553)  
Seattle City Light**

Prepared by: Ed Connor, Aquatic Ecologist  
April 30, 2018

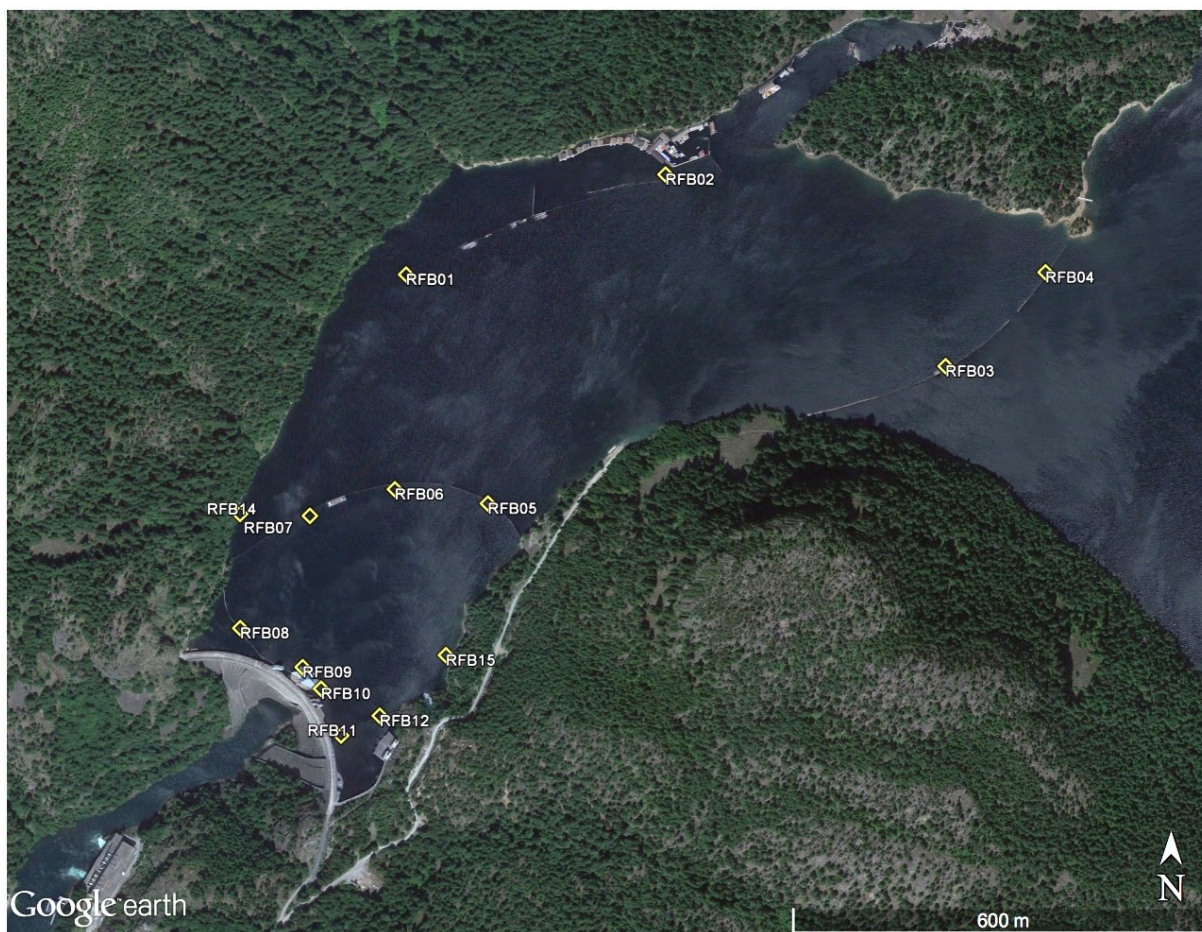
Figure 1. Acoustic receiver array in Ross Lake forebay for 2017.

A total of 18 acoustic receivers were active in Ross Lake during the 2017 monitoring period, with the majority of these (14) in the forebay, the deep basin area of the reservoir immediately upstream of Ross Dam (Figure 1; Table 1). The monitoring effort was greatest in Ross Lake because it supports higher numbers of bull trout compared to the other two project reservoirs.

The Ross Lake forebay acoustic receiver array was designed specifically to track movement of tagged bull trout in the area of the reservoir where entrainment of fish into the power intakes and spillways would occur. The configuration of forebay receivers allows for an accurate assessment of the vulnerability of bull trout in Ross Lake to both power intake and spillway entrainment. Two of the receivers, RFB11 and RFB 12, are located immediately in front of the Ross Dam intake structure to monitor the entrainment of bull trout into the two power tunnel intakes (Figure 1). The power intake tunnels are located about 185 ft below the surface of the reservoir at full pool. These two receivers, along with receivers situated at the Ross Dam boathouse (RFB10) and along the shore just north of the intake facility (RFB15), were used to monitor the area of the forebay where bull trout would be vulnerable entrainment into the power intakes. Any fish entrained into the power intakes would subsequently pass through the turbines, and then into Diablo Lake via the Ross Powerhouse tailrace. Three receivers, RFB08, RFB09, and RFB10, were located immediately in front of Ross Dam to monitor the entrainment of fish into the spillways during spill events.

Four receivers were used to monitor the movement of bull trout in the middle area of the forebay: RFB05, RFB06, RFB07, and RFB14 (Figure 1). Finally, four receivers were also used to monitor fish in the outer forebay area: RFB01 and RFB02 located near Ross Lake Resort, and RFB03 and RFB04 located on a long boom located at the far outer forebay area. For the 2017 monitoring period, the Ross Dam forebay receivers were downloaded in March 2017, October 2017, and April 2018.

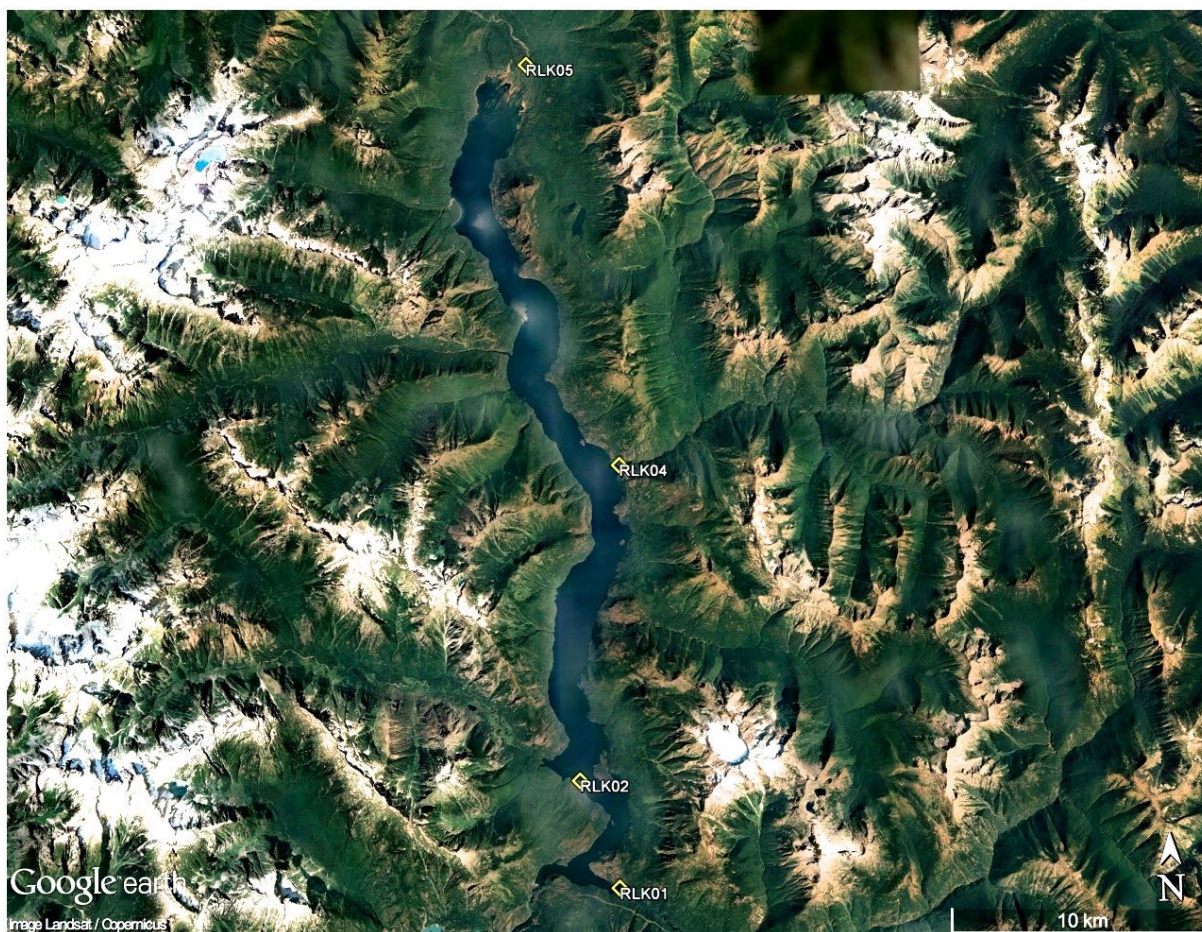
Figure 2. Acoustic receiver array in Ross Lake outside the forebay for 2017.

In addition to the forebay receiver array, four receivers were also stationed near the mouths of major tributaries to Ross Lake to detect the movement of tagged bull trout in these streams for spawning (Figure 2). Receivers were located outside of the mouth of Ruby Creek (RLK01), in Big Beaver Creek (RLK02), and in Lightning Creek (RLK04). A tributary receiver (RLK05) was also stationed in the upper Skagit River, British Columbia approximately 0.8 miles upstream of the reservoir. For the 2017 monitoring period, the Ross Lake receivers were downloaded in March 2017, October 2017, and April 2018.

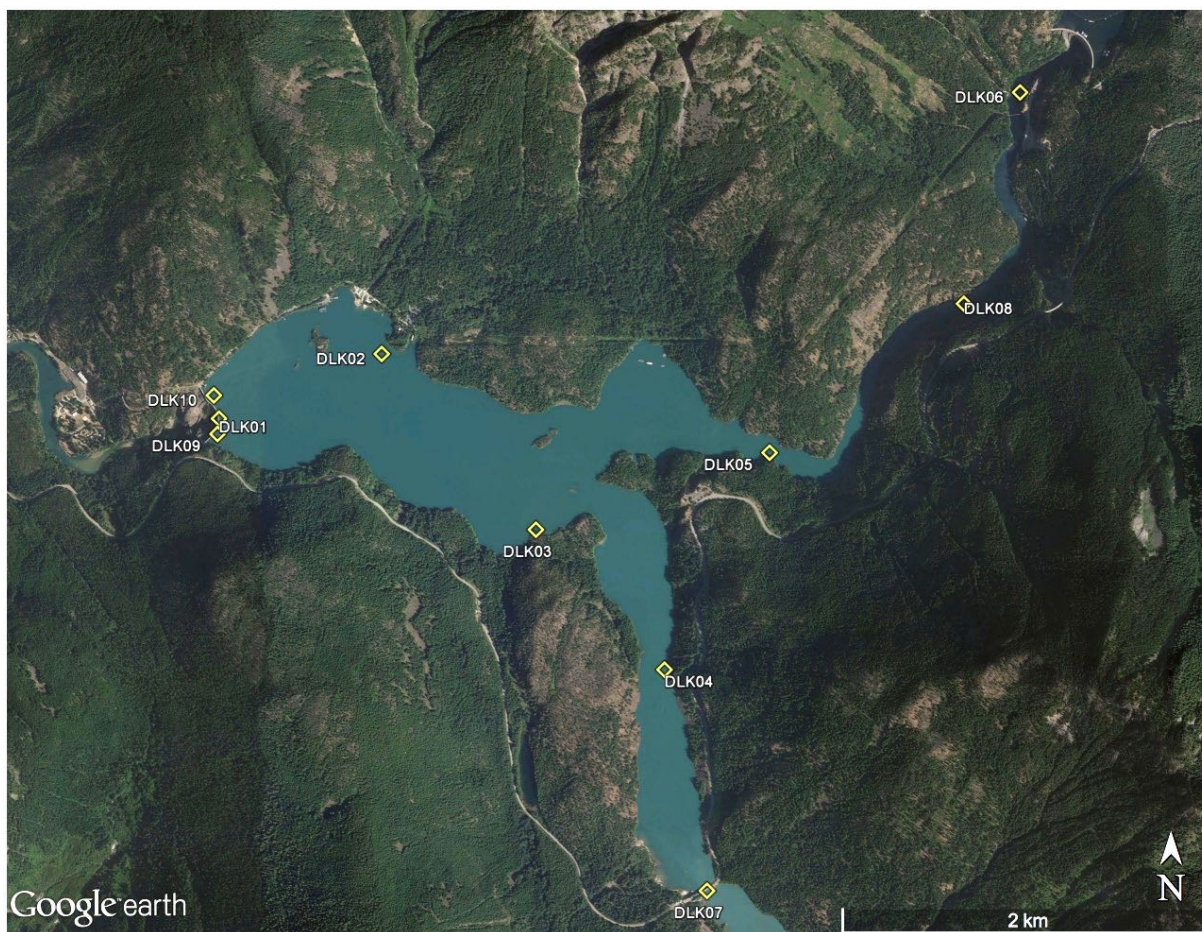
Figure 3. Acoustic receiver array in Diablo Lake for 2017.

A total of 10 receivers were deployed in Diablo Lake for bull trout monitoring purposes in 2017 (Figure 3; Table 2). The most downstream of these receivers (DLK01) was stationed at Diablo Dam near the power intakes. Two additional receivers were deployed in 2017 in response to prolonged spills that occurred at Diablo Dam due to generator maintenance (i.e., rewind of Generator Unit 31). One of the receivers (DLK09) was located at the south spillways where most of the spill was released during 2017, and the other (DLK10) was located near the north spillways and intakes.

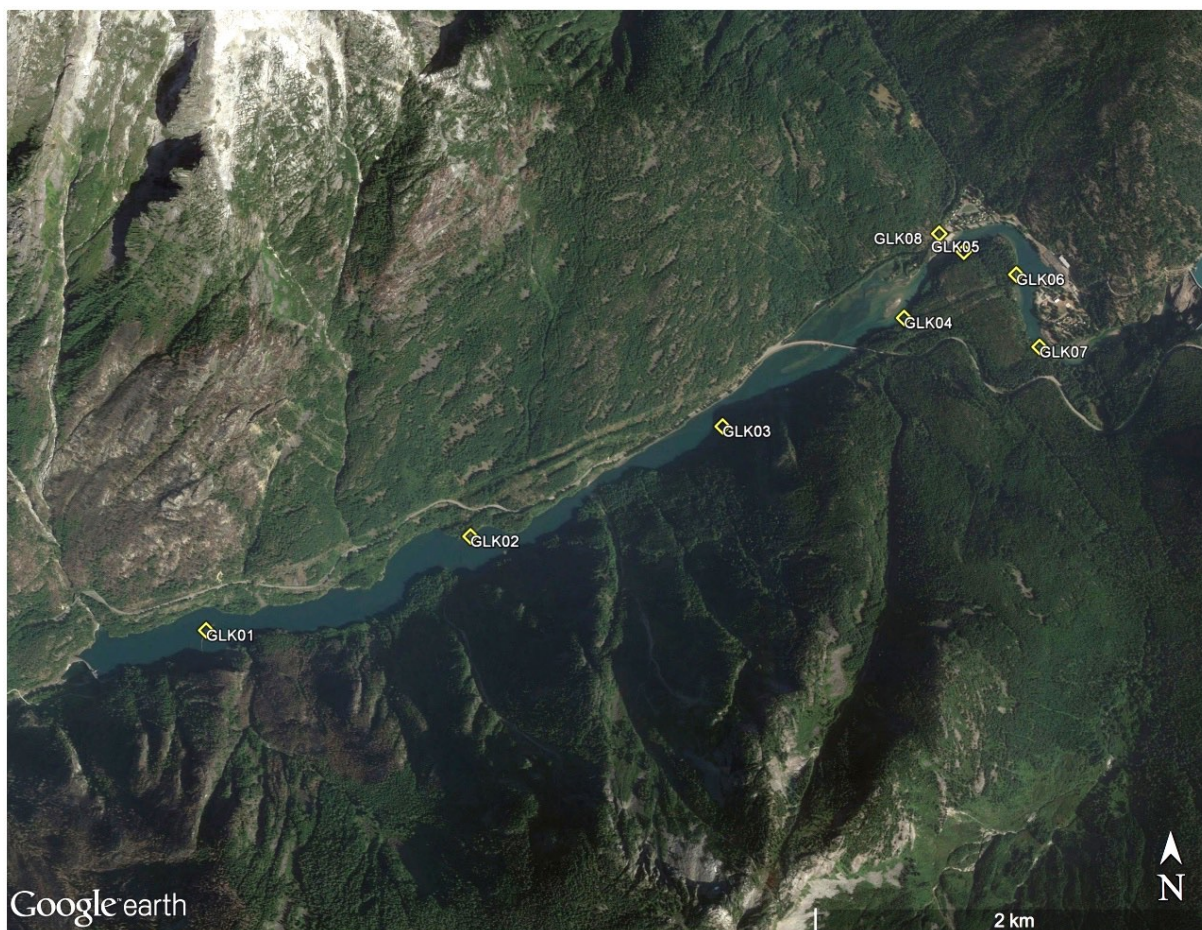
Figure 4. Acoustic receiver array in Gorge Lake for 2017.

A total of eight receivers were deployed in Gorge Lake during the 2017 bull trout monitoring period (Figure 4; Table 3). The most downstream of these receivers (GLK01) was located in the forebay of Gorge Dam. This receiver was located just upstream of Gorge Dam, and was used to detect the entrainment of tagged bull trout into the power intake tunnels. This receiver was also important for detecting the entrainment of bull trout into the Gorge Dam spillways, since any bull trout passing into this area of the reservoir would also be vulnerable to entrainment during periods of spill.

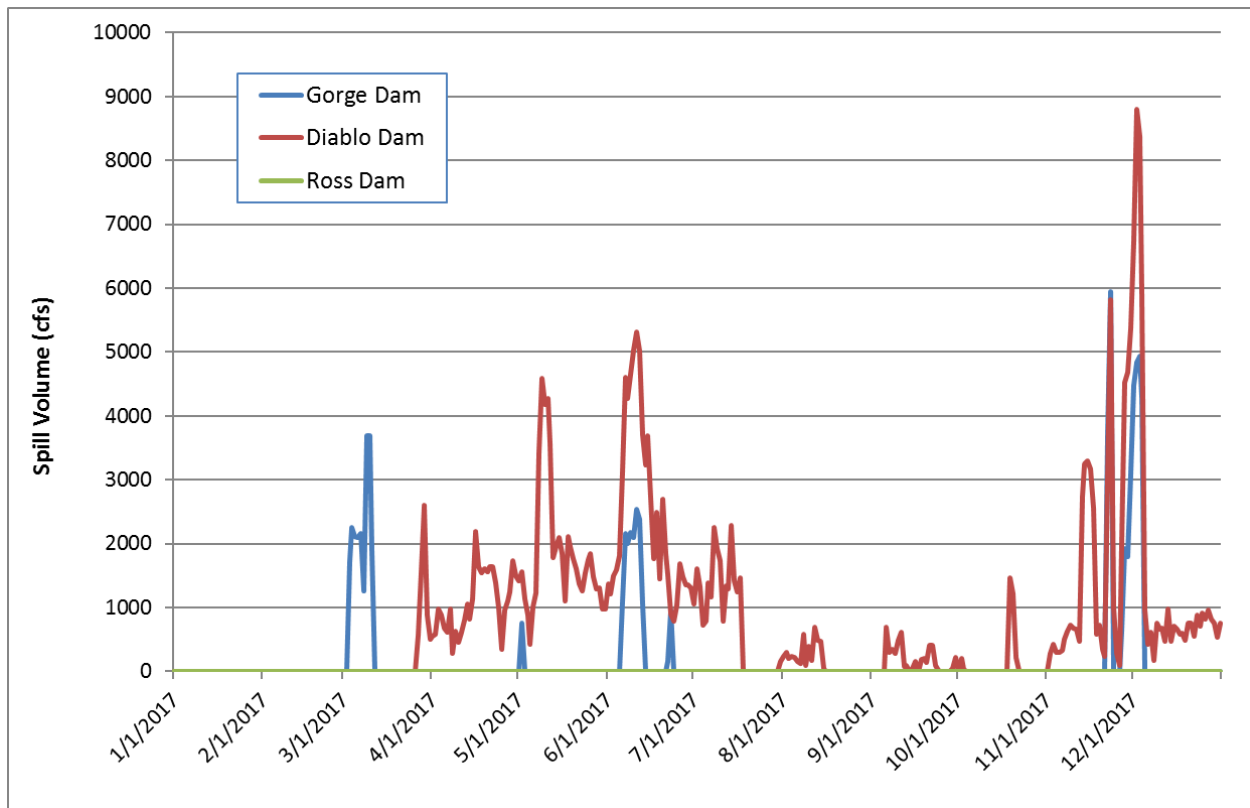
Figure 5. Spill timing and spill volumes at Ross, Diablo, and Gorge dams in 2017.

There were zero days of spill at Ross Dam in 2017 (see Figure 5). Spills at this dam are rare due to the large storage capacity of Ross Lake, with an average of three (3) days of spill per year observed from 2013 through 2016.

At Gorge Dam, spills were associated with large Pacific storms that occurred in early March and early December, and from high snowmelt runoff in early June (Figure 5). Spills were observed on 29 days at Gorge Dam in 2017, compared to an average yearly total of 28 days from 2013 through 2016. Thus, the number of spill days observed at Gorge Dam in 2017 was very close to the average value.
