THE EFFECT OF WATER FLOW REGULATION AT GORGE DAM ON  
STRANDING OF SALMON FRY IN THE SKAGIT RIVER  
1969-1970

State of Washington  
DEPARTMENT OF FISHERIES  
Management and Research Division

John S. Thompson  
Fisheries Biologist

December 1970

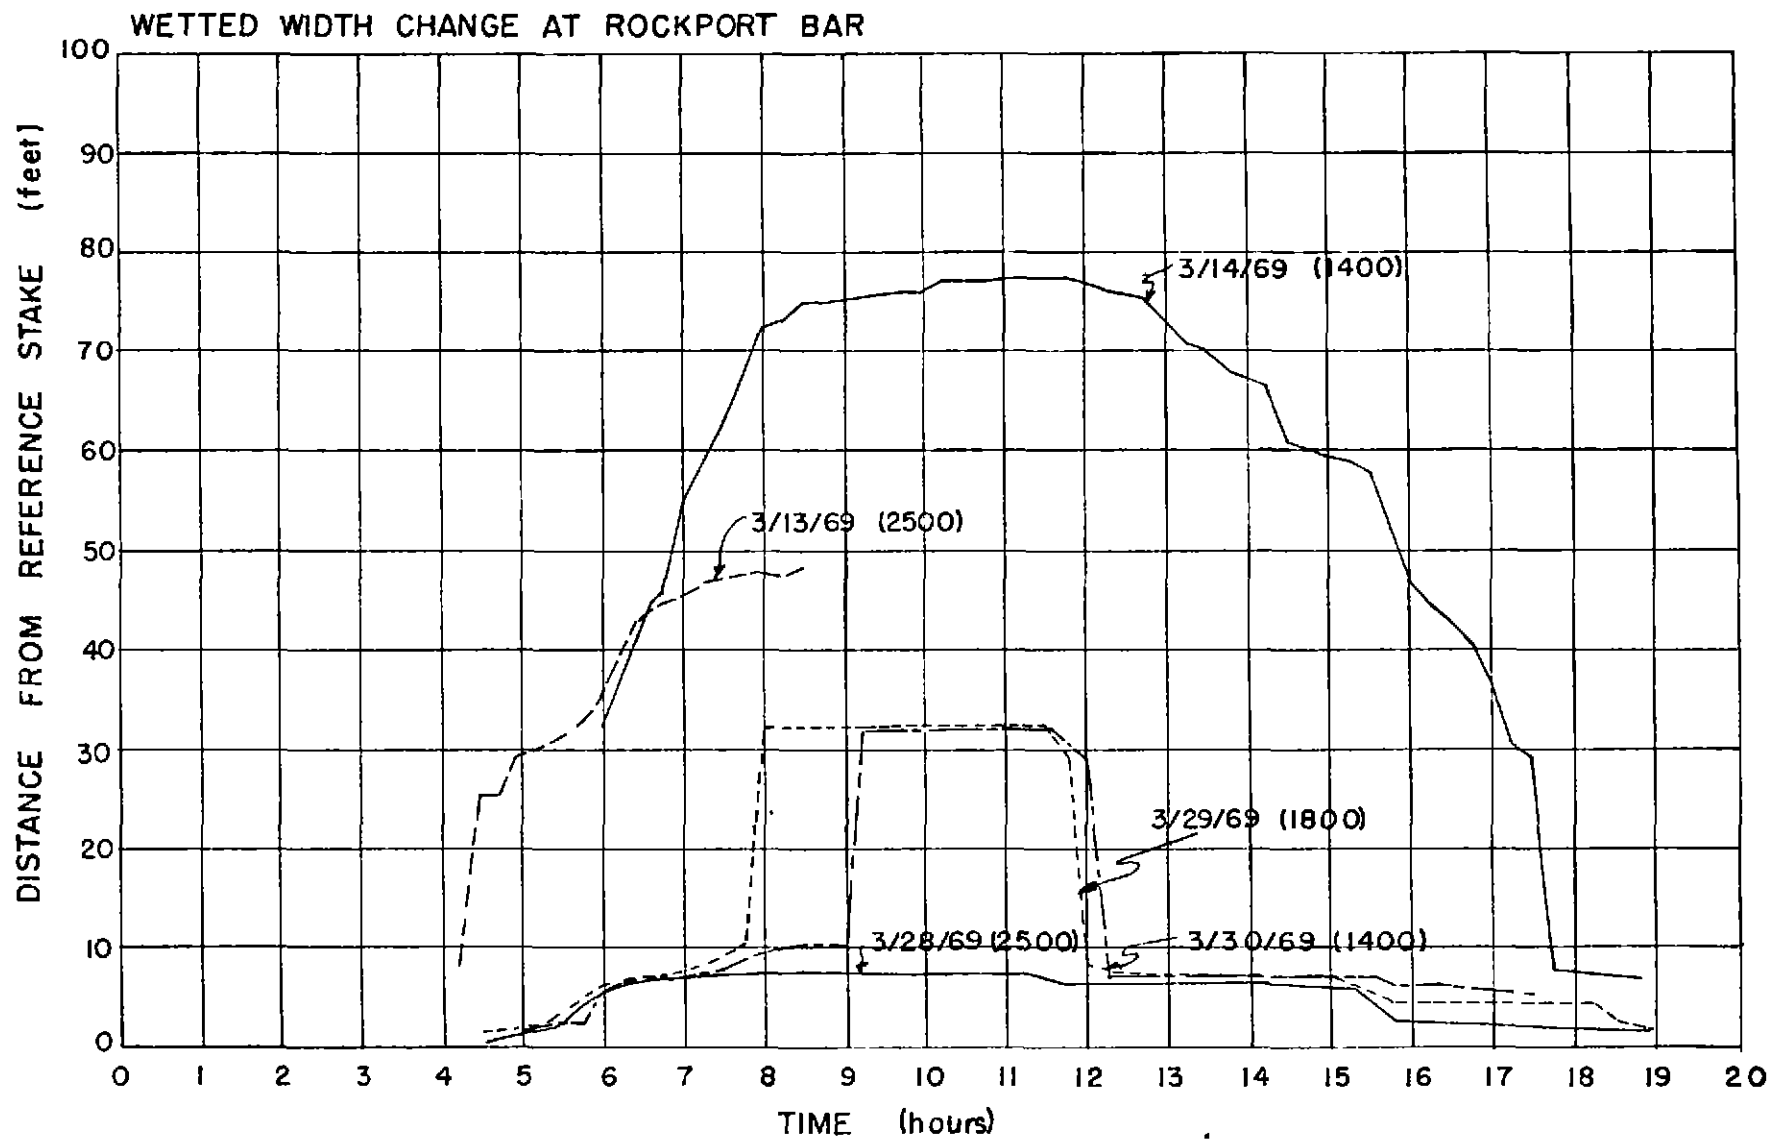
Figure 9. Wetted width change at Rockport Bar Reference Line during low flow tests, 1969.

The reference line at Rockport was exposed for a distance of 77 ft (Figure 9).

Rockport Bar. The flow reduction to 2,500 cfs at Newhalem resulted in 13 fry stranding in the pothole area and trapping about 75 fry within the confines of the pothole area that were not killed. Very little bar area was uncovered by this low test (Figure 9).

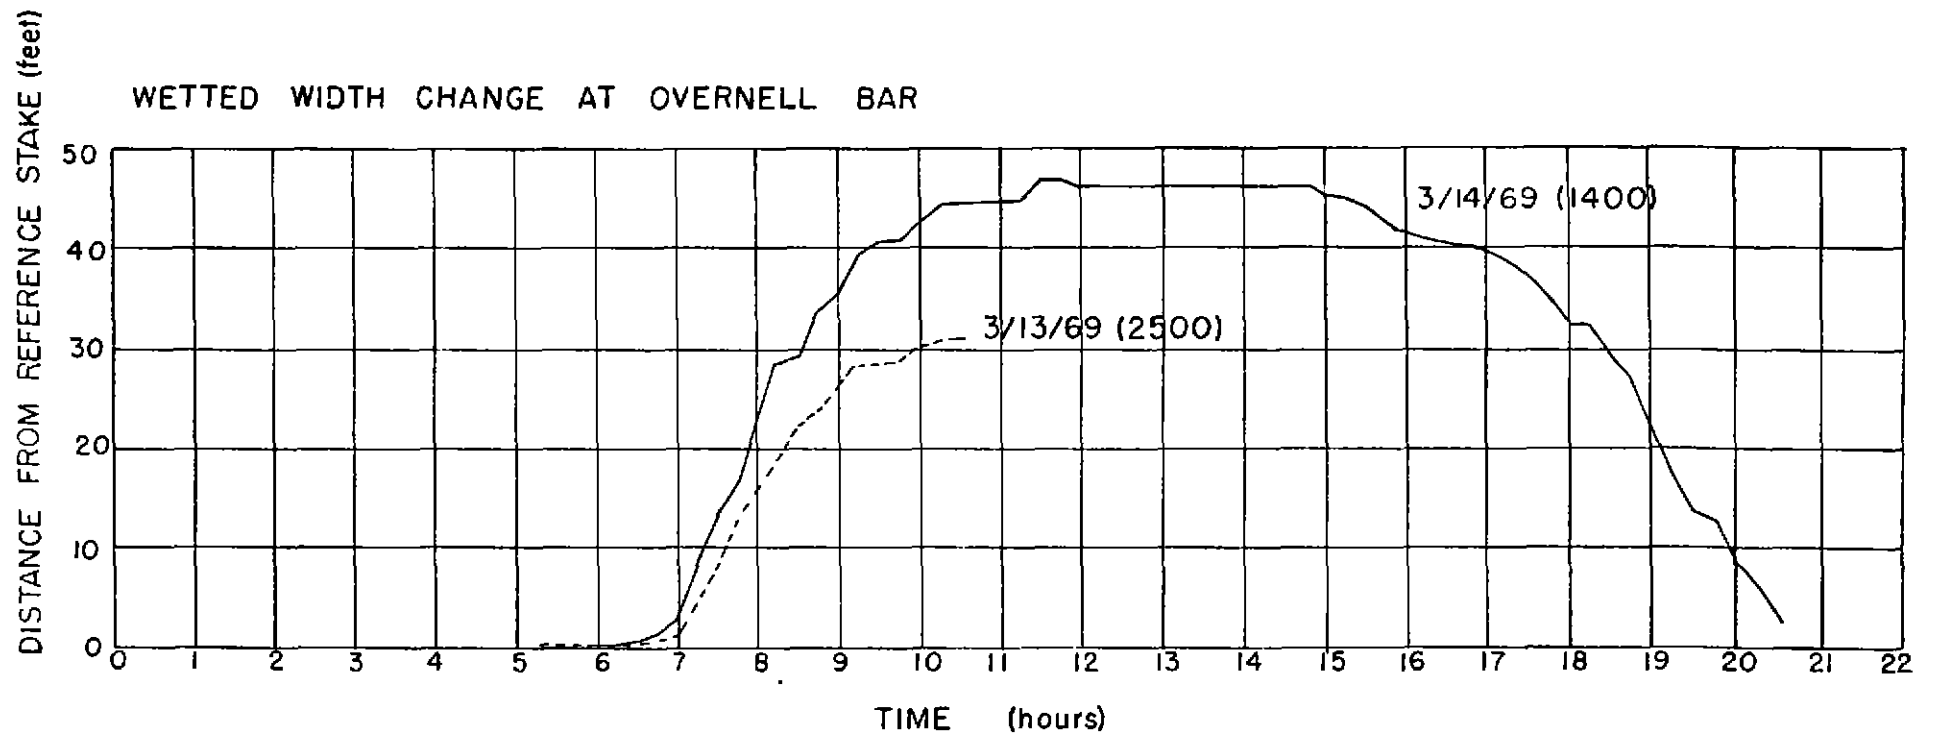
Figure 10. Wetted width change at Overnell Bar Reference Line during low flow tests, 1969.

The reference line located on the clean gravel beach indicated the water receded about 46 feet horizontally during the low flow test of 1,400 cfs (Figure 10). An exposed reference line would have been considerably longer if it had been located on the large flat area of the bar where limited stranding was observed.

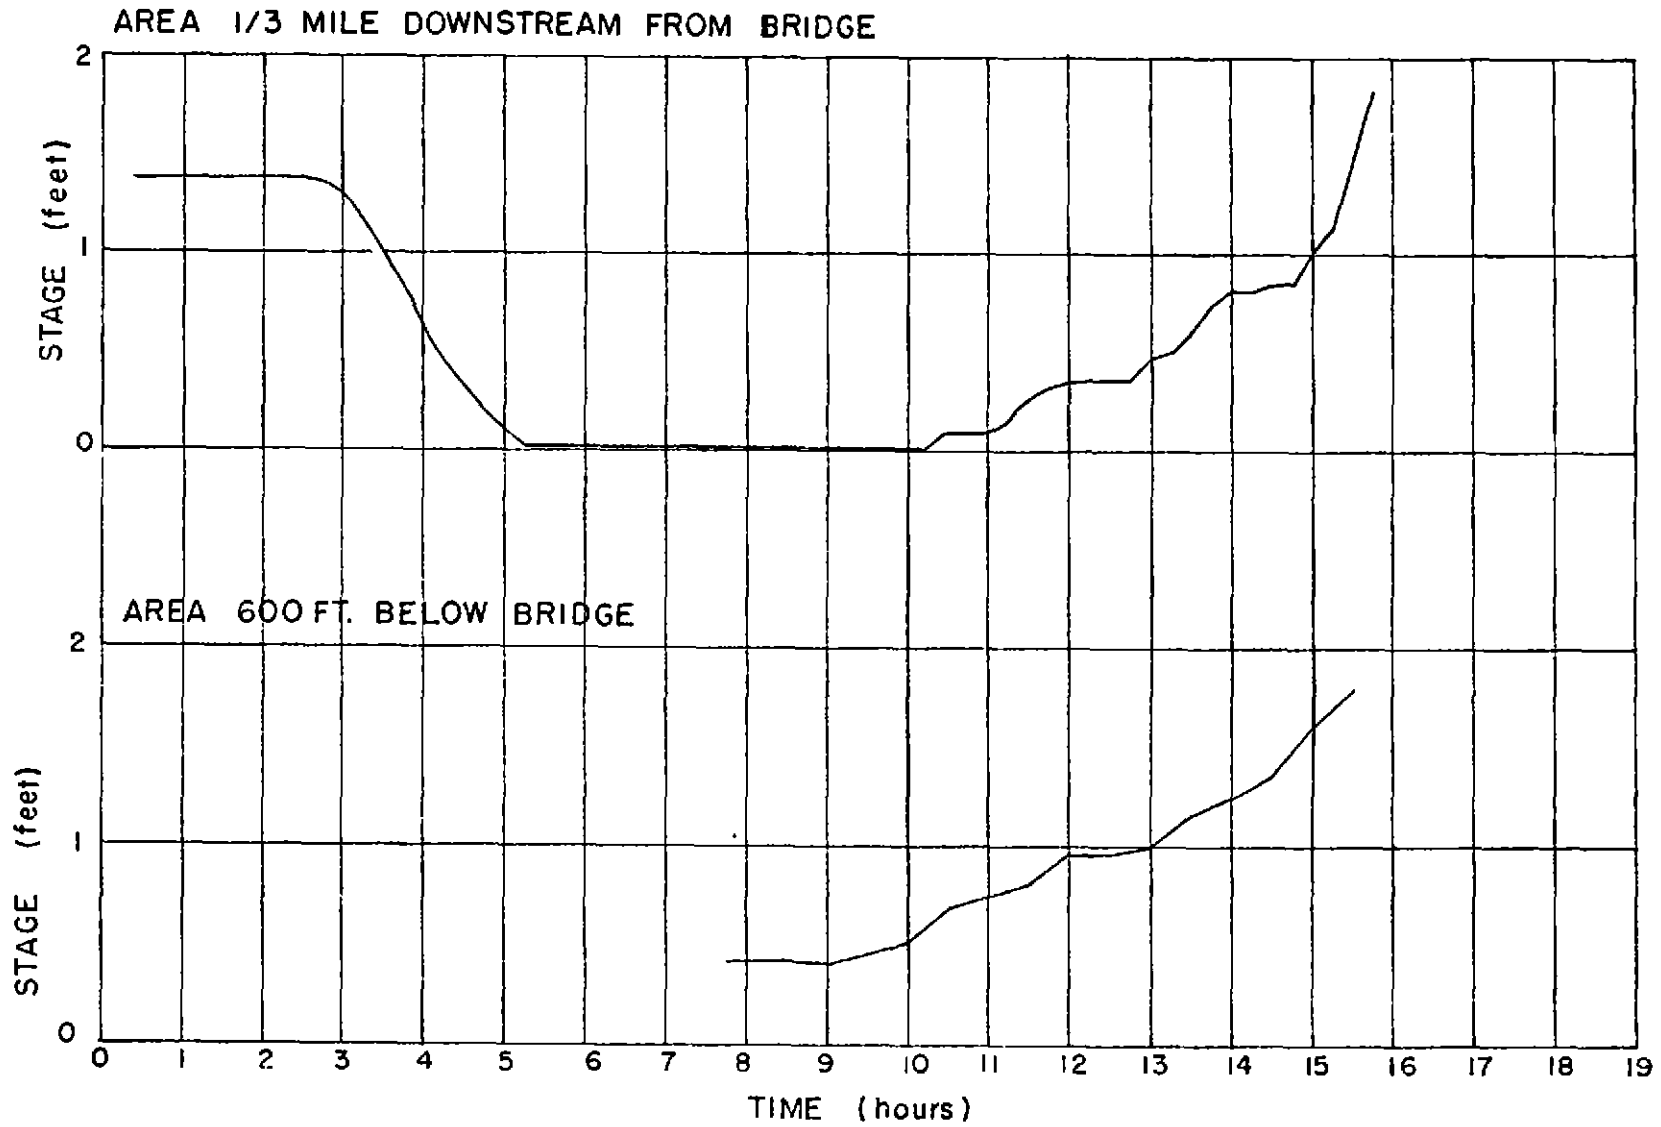
RIVER STAGES AT MARBLEMOUNT BAR  
3/14/69

Figure 11. River stage as measured on both reference lines at Marblemount Bar, March 14, 1969.

A time lag of approximately 2 hours and 30 minutes was required for the first effect of the flow reduction to be measured at Marblemount Bar (Figures 11 and 14). About 3 hours were required for first influence of increased flows. The river stage during the very destructive flow reduction on March 14 reduced about 1.4 ft in 2 hours and 45 minutes, and the most rapid decline in water elevation was about .6 ft per hour over a 2-hour period. Nearly the same rate of drop was observed on March 29, 1969, but the river stage change was not as great.

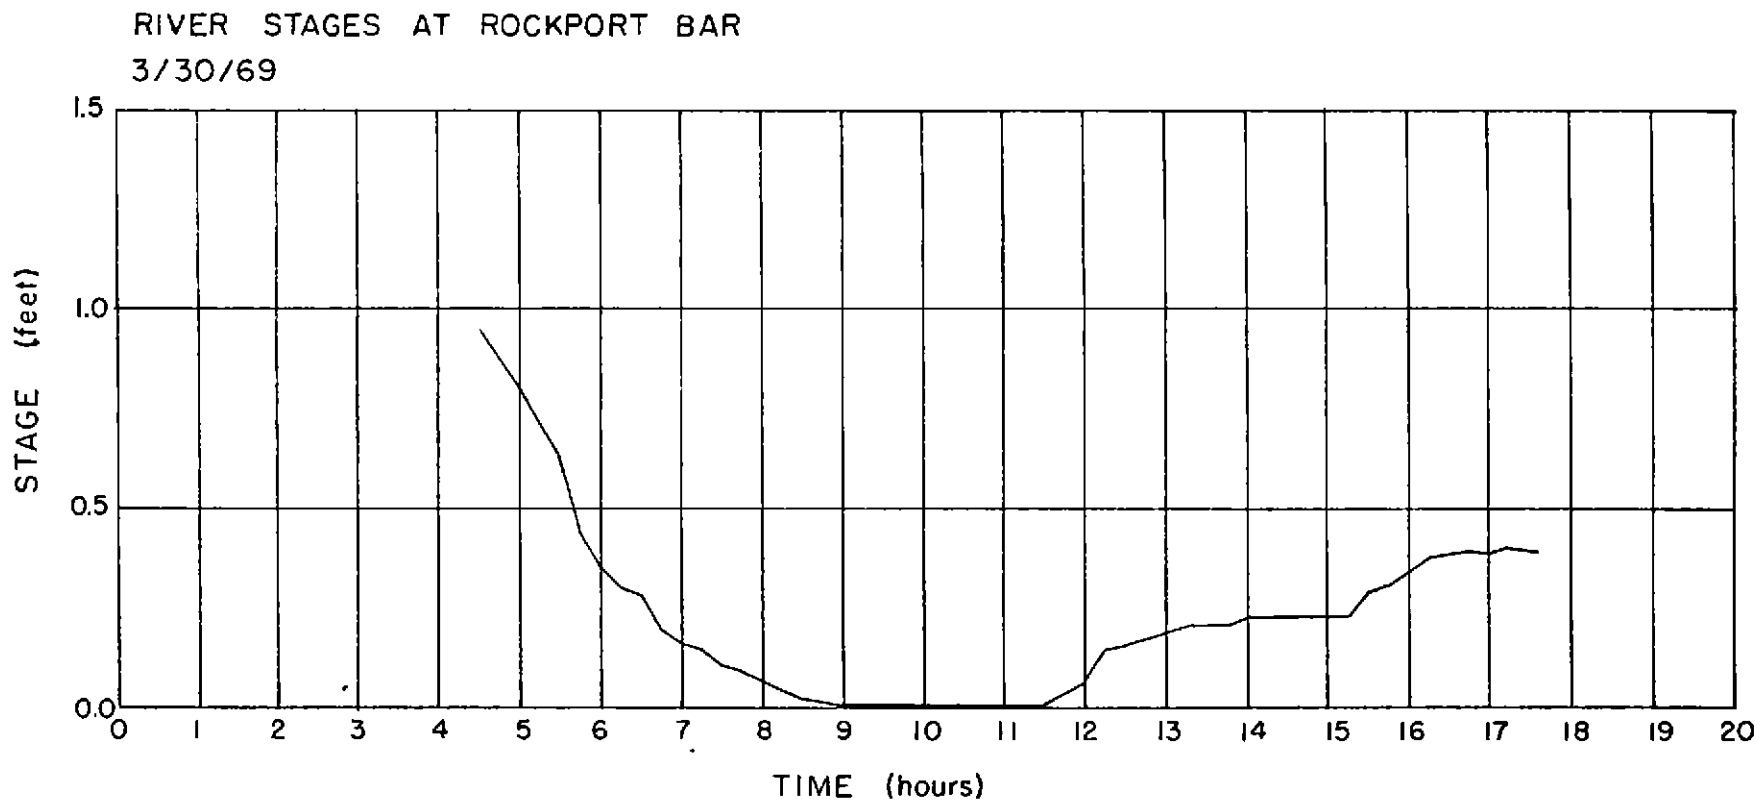
Figure 18. River stage at Rockport Bar, March 30, 1969.

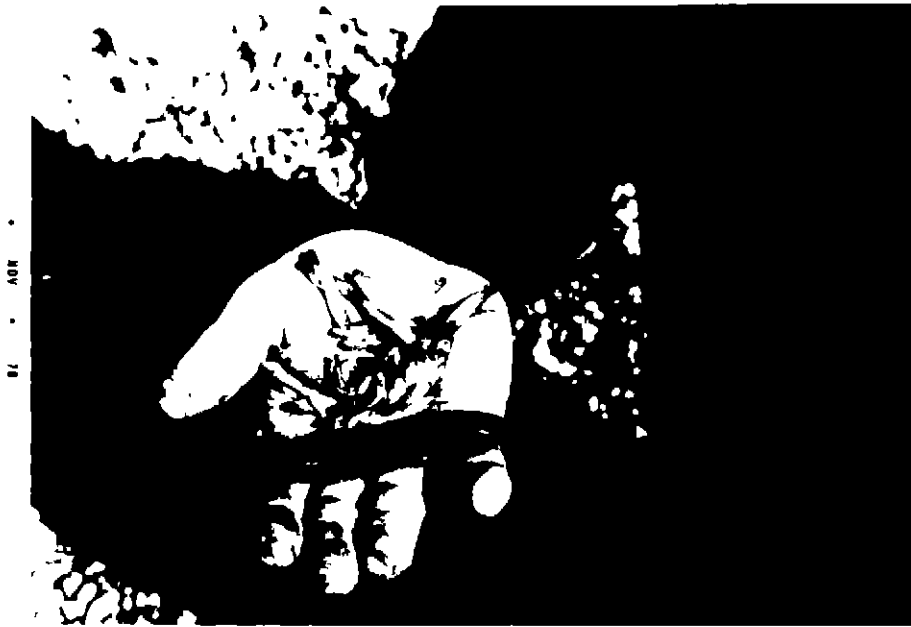
Plate 5. Stranded fry and 1 trout obtained from a sample area near Illabot Creek.
