# **SKAGIT RIVER HYDROELECTRIC PROJECT**

**FERC No. 553**

## **HISTORIC RESOURCES MITIGATION AND MANAGEMENT PLAN**

**City of Seattle  
City Light Department**

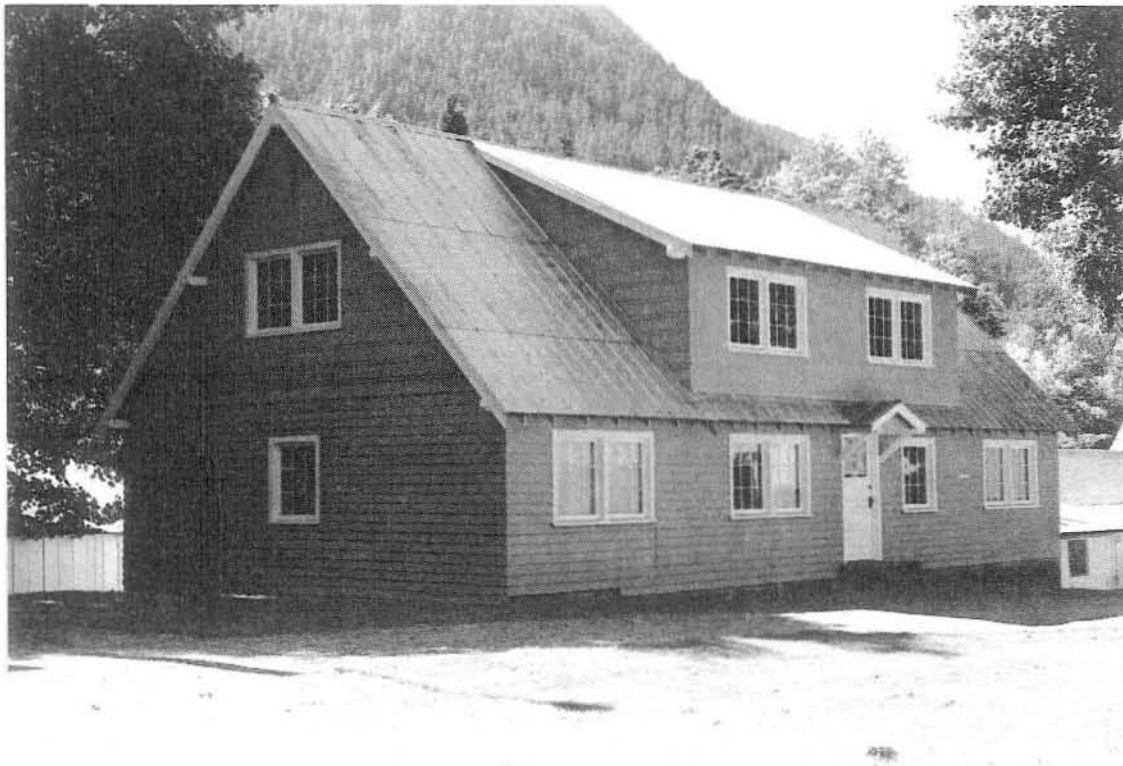
**NEW COOK'S BUNKHOUSE #10**

One of two bunkhouses built for Seattle City Light employees in the mid-1930s, during the second phase of the town's development. Except for metal roof covering, it retains original features, including siding, windows, doors, and interior configuration and millwork.

The building is in good condition and is currently used for storage.

In planning the conversion to a research facility, care should be taken that the interior adaptation does not adversely affect the exterior features of the building. Original building fabric, including windows, doors and over-doors, should be retained and repaired as needed. If new elements are required, replacements should match the original in size, design, texture, and, where possible, materials.

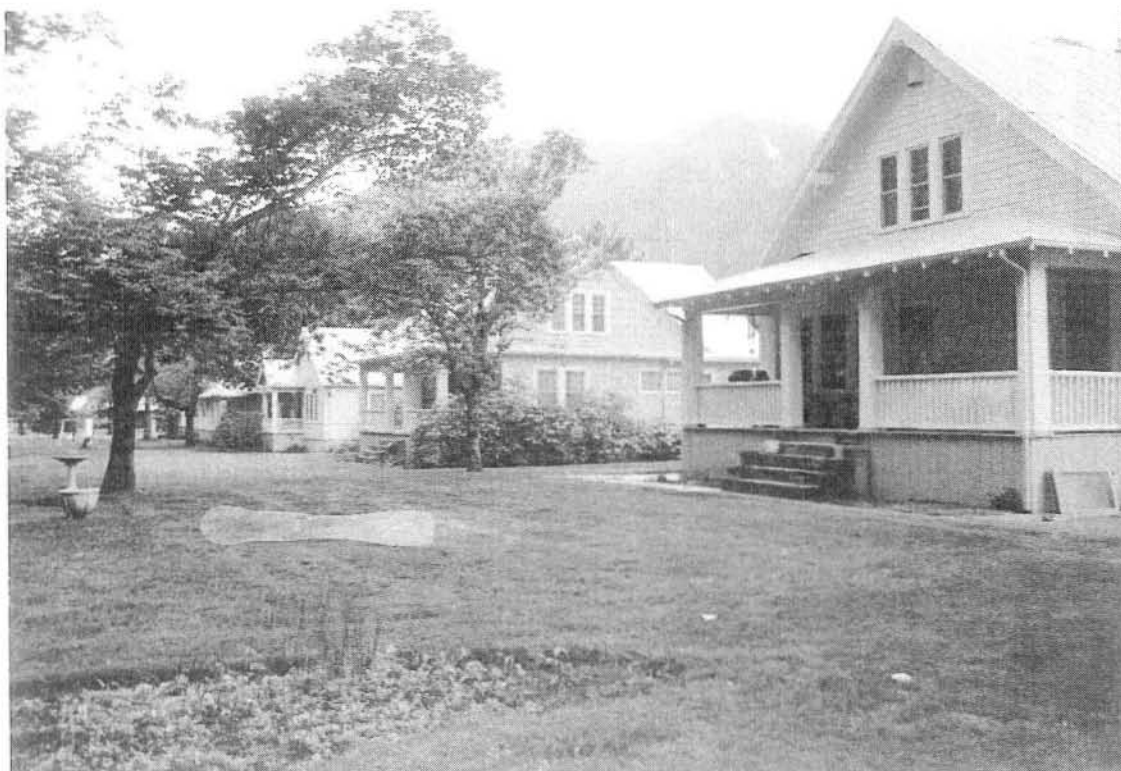
**SILK STOCKING ROW HOUSES**Issues/Actions 1990

As landlord, Seattle City Light maintains and repairs the houses for renter occupants. Substantial refurbishing is done when houses are vacated. The buildings are all in good condition and well maintained.

Recent alterations have included the replacement of original multi-paned, double-hung, wood-sash windows with PVC-sash windows that incorporate flat strips sandwiched between double glazing to simulate muntins. This has resulted in some loss of visual quality (three dimensional character, shadow lines) of the original wood muntins. Some original exterior wood doors have been replaced with metal doors that have glazing in a non-historic configuration.

Future maintenance and repairs should adhere to the Skagit Maintenance Guidelines (when they are developed). In the interim, apply the Skagit Project Preservation Standards, paying special attention to Standards #2, 5, 6, and 8.

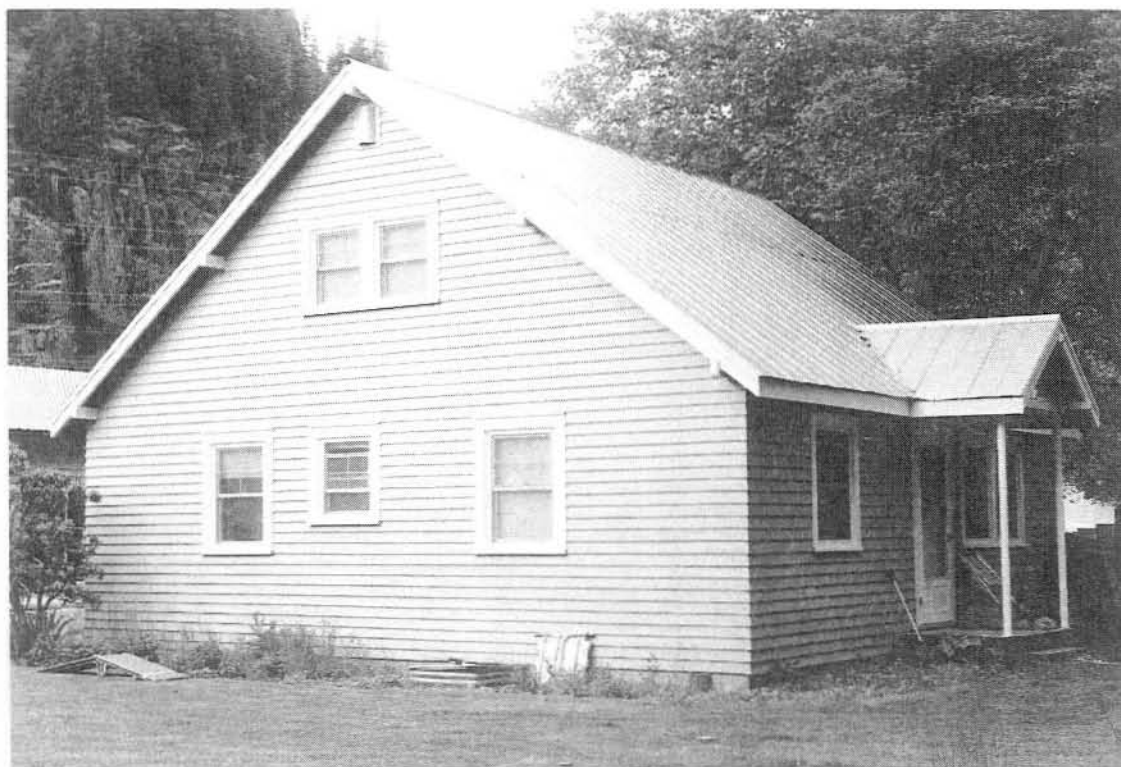
**SCHOOLTEACHER'S HOUSE**

As landlord, Seattle City Light maintains and repairs the house for renter occupants. The building is in good condition and well maintained.

The original wood shingle roof covering has been replaced with a standing seam metal roof. Other alterations are similar to those that have affected the Silk Stocking Row houses.

Future maintenance and repairs should adhere to the Skagit Maintenance Guidelines when they are developed. In the interim, apply the Skagit Project Preservation Standards, paying special attention to Standards #2, 5, 6 and 8.

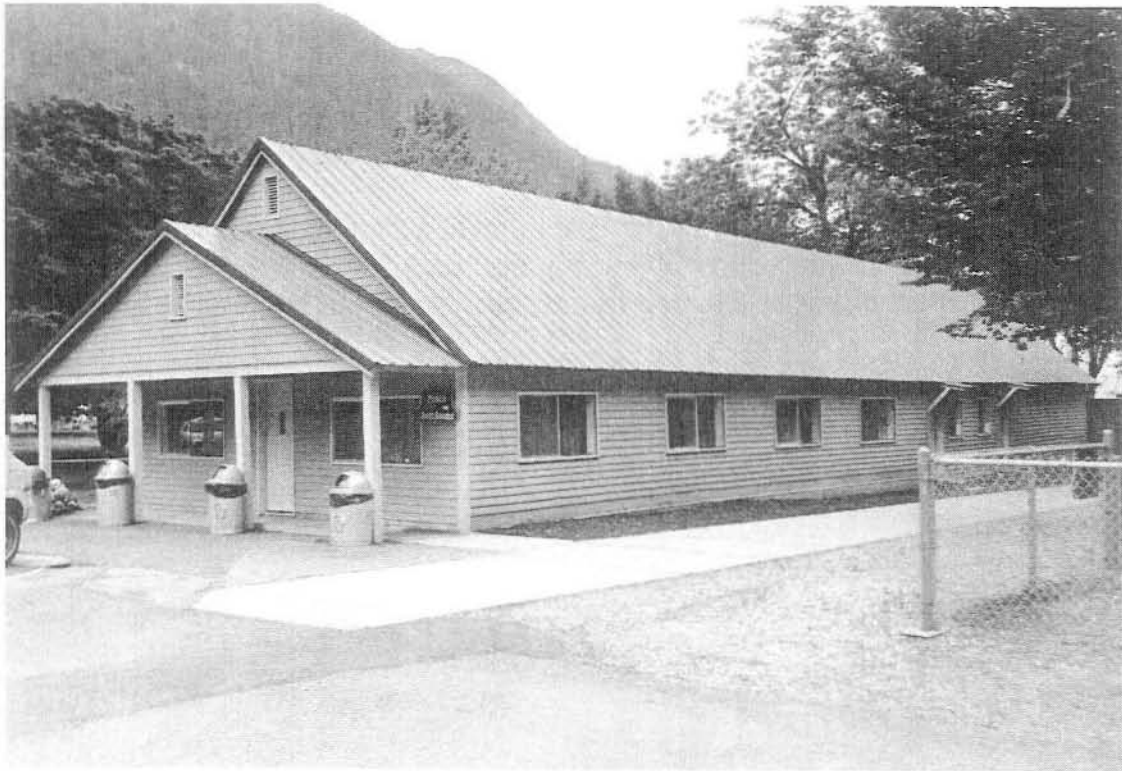
**THE HOTEL (BUNKHOUSE #23)**

The Hotel is in good condition and is well maintained. It is in continuous use as lodging for Seattle City Light staff or other overnight visitors.

The building's original massing has been changed by the addition of a full-width porch with a gable roof of lower pitch at the east facade. The original 9-light, single-hung, wood-sash windows have been replaced with metal sash sliding windows, and the original wood doors have been replaced with metal raised panel doors. The original wood shingle roof covering has been replaced with a metal standing seam roof. The recent installation of a concrete foundation has stabilized the structure, and rewiring and the addition of insulation has made the building more habitable.

While all of these measures have prevented the loss or deterioration of the building, the alterations have diminished or eliminated many of its original character-defining features and contributed to a loss of integrity.

Continuing maintenance and repair of the Hotel should adhere to the Skagit Project Preservation Standards and follow the procedures outlined in Section 3.3. Future work may offer the opportunity to restore character-defining features that have been removed or altered.

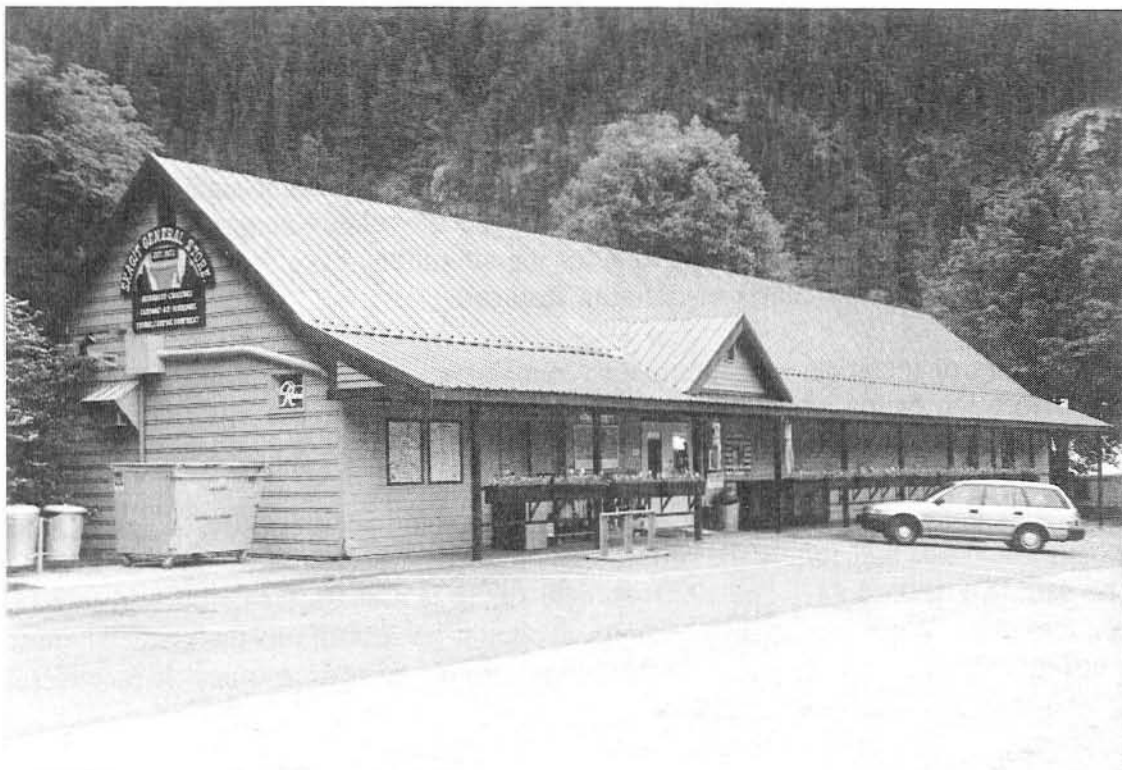
**COMMISSARY**Issues/Actions 1990

The building has been in continuous use as a general store since its construction in the first year of the camp's existence. It still serves City employees living in the Skagit area and also caters to tourists during the summer season. It is in good condition and is well maintained.

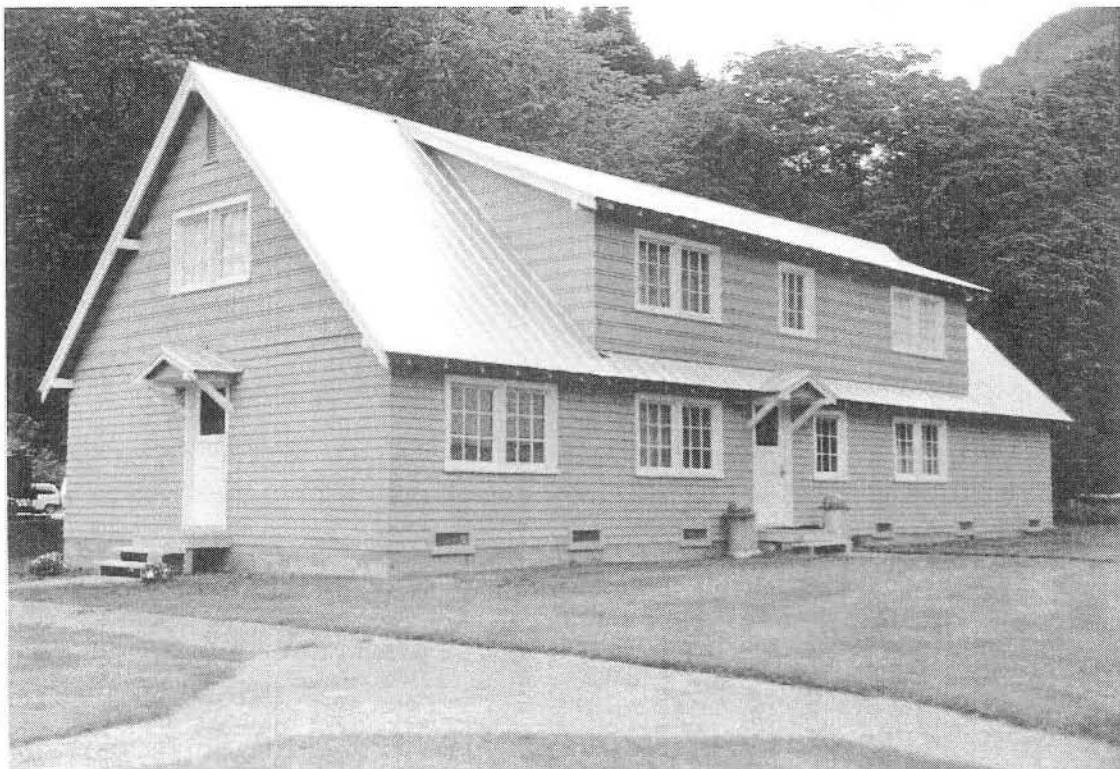
**TOURIST DORMITORY (BUNKHOUSE #70)**

One of two bunkhouses built for Seattle City Light employees in the mid-1930s, during the second phase of Newhalem's development. Except for metal roof covering, it retains original features, including siding, windows, doors, and interior configuration and millwork.

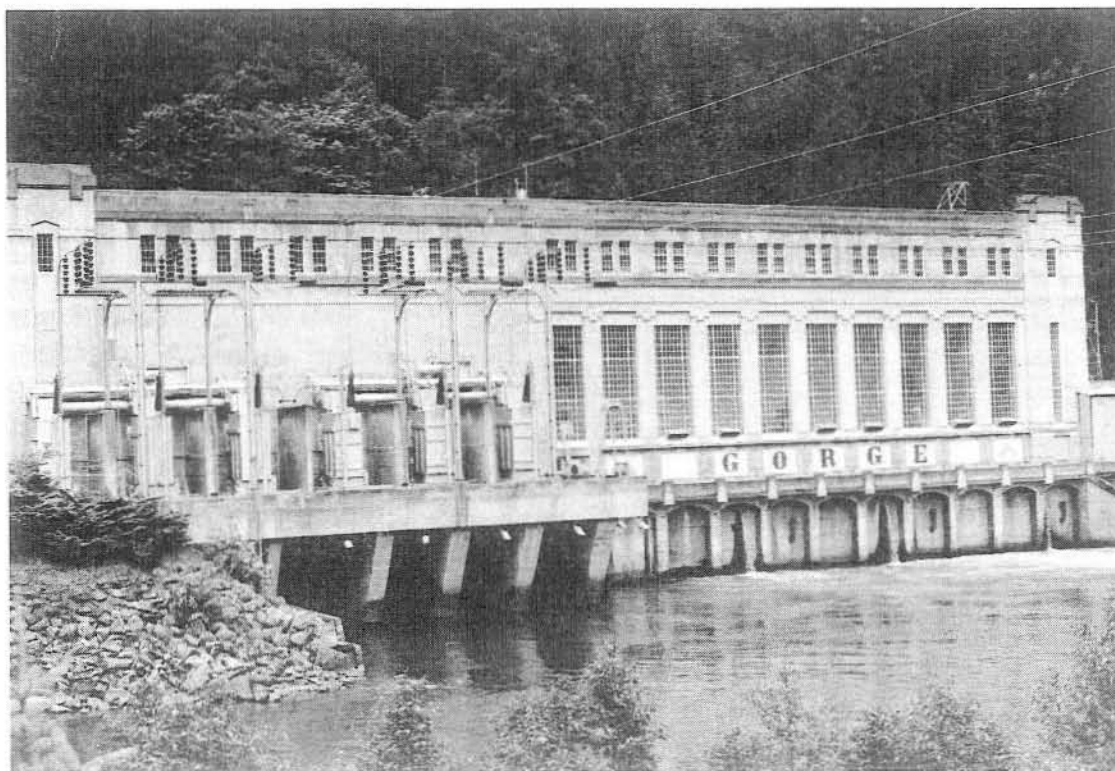
**GORGE POWERHOUSE**Issues/Actions 1990

The Gorge Powerhouse has excellent integrity; the 1949 addition on the north is sympathetic to the design of the original 1924 building. The generating equipment has been updated in the past and will continue to be improved as new technology and regulations dictate changes.

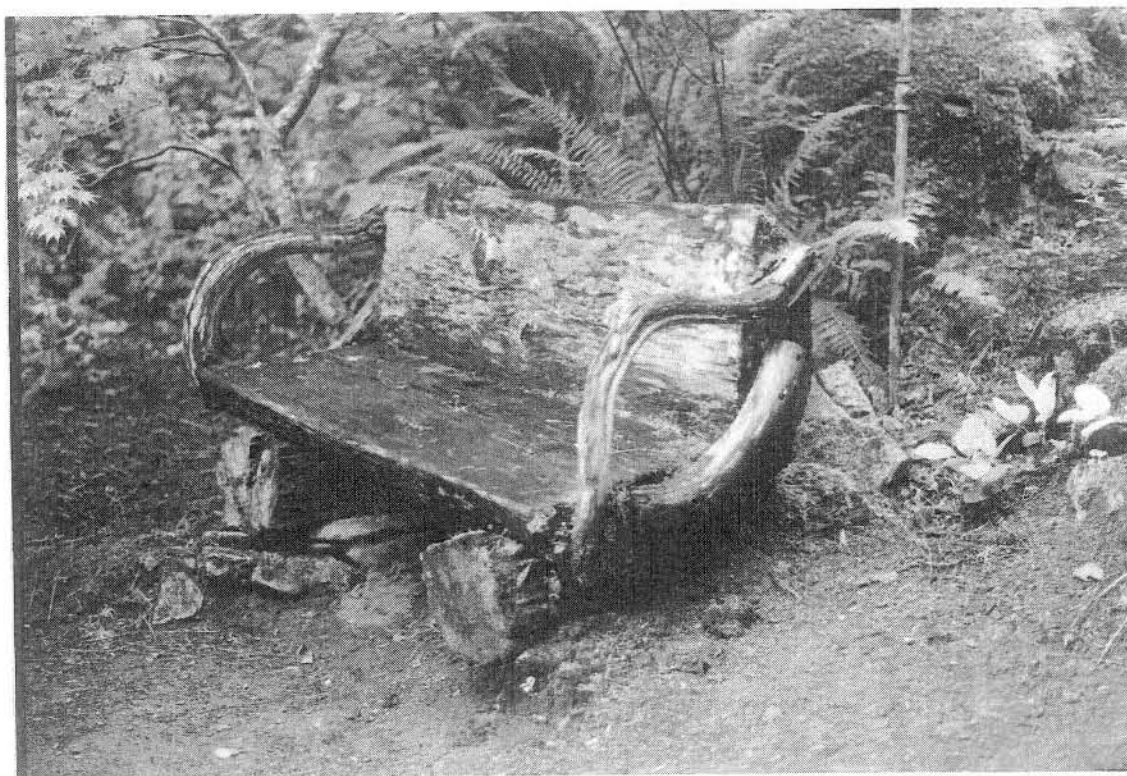
**LADDER CREEK FALLS TRAIL AND GARDENS**Issues/Actions 1990

The gardens were at their zenith in the late 1930s but declined after the Skagit Tours were interrupted by World War II. Post-war refurbishing and later attempts at recreating the lighting system make it unclear what parts of the gardens retain integrity.

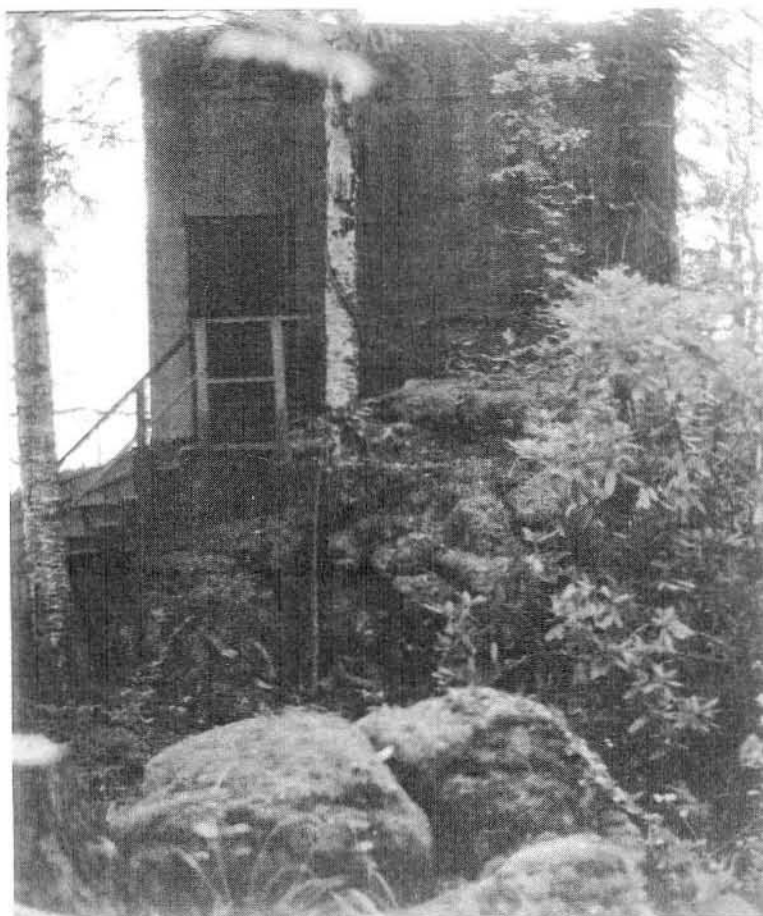
**GRAVITY OIL TANK HOUSE**Issues/Actions 1990

The structure was used to store oil for the gravity oil lubrication system for the equipment in Gorge Powerhouse until the mid-1980s. During the 1930s it also housed the recording equipment necessary to provide amplified music throughout the Ladder Creek Falls area while visitors were touring the gardens.

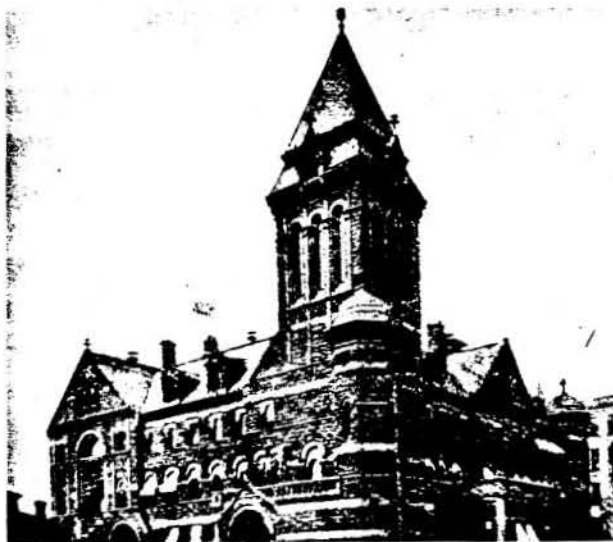
Figure 1. This 1891 Courthouse and Post Office in Rochester, New York, has built-in energy conserving features such as, heavy masonry walls, operable windows, an interior skylighted atrium which provides light and ventilation, and roof-top ventilators which keep the building cooler in the summer. Also note the presence of awnings in this old photograph.

The most obvious (and almost universal) inherent energy saving characteristic was the use of *operable windows* to provide natural ventilation and light. In addition, historic commercial and public buildings often include interior light/ventilation courts, roof-top ventilators, clerestories or skylights (see figure 1). These features provide energy efficient fresh air and light, assuring that energy consuming mechanical devices may be needed only to supplement the natural energy sources. Any time the mechanical heating and air conditioning equipment can be turned off and the windows opened, energy will be saved.

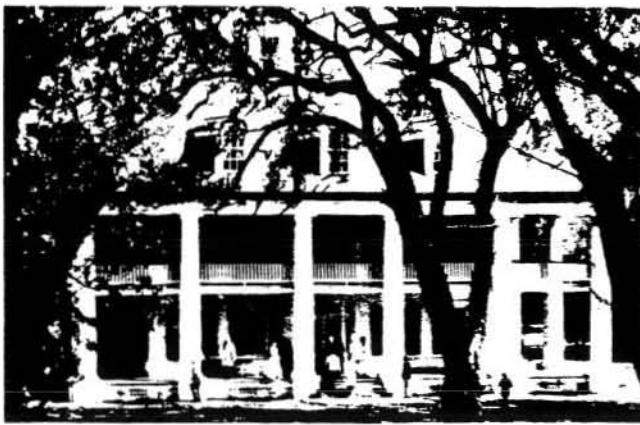
Figure 3. Southern mansions typify climate conscious design. The wide roof overhangs, exterior porches, shade trees, heavy masonry walls (painted white), and living quarters on the second floor (to catch evening breezes and escape the radiant heat from the earth's surface) all are energy saving characteristics which provide reasonably comfortable living spaces without mechanical air conditioning. (Photo: Marcia Axtmann Smith)

There are other physical characteristics that enable historic buildings to be energy efficient. For instance, in the warmer climates of the United States, buildings were often built to minimize the heat gain from the summer sun. This was accomplished by introducing exterior balconies, porches, wide roof overhangs, awnings and shade trees. In addition, many of these buildings were designed with the living spaces on the second floor to catch breezes and to escape the radiant heat from the earth's surface. Also, exterior walls were often painted light colors to reflect the hot summer sun, resulting in cooler interior living spaces (see figure 3).

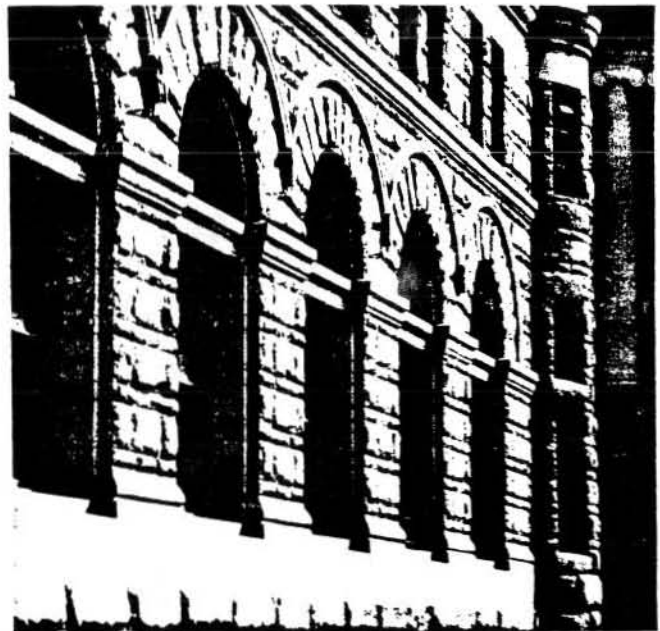
Figure 4. Heavy masonry walls in office buildings dramatically reduce the need for summer cooling because the thermal inertia (M factor) of the massive wall increases its thermal resistance (R factor), thus delaying the heat transfer into the building until late afternoon when the office workers have gone home. (Photo: Baird Smith)

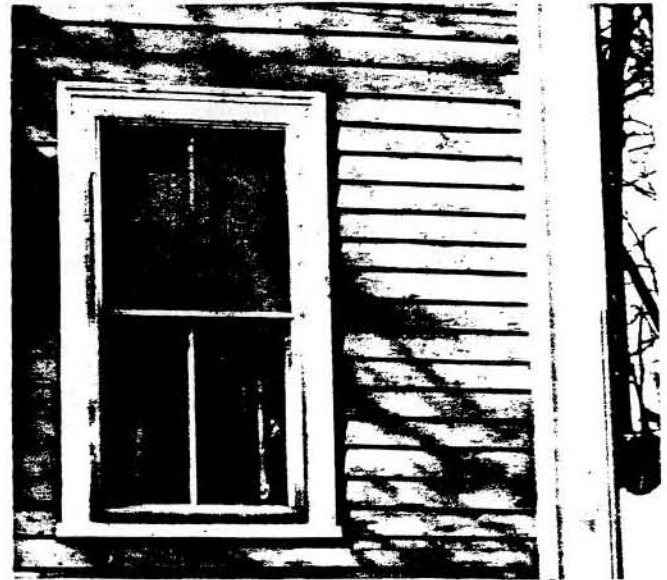
Figure 6. The addition of triple track storm windows, as shown here, greatly improves the thermal performance of existing window assemblies, with a minimal impact on the appearance of the building. (Photo: Baird Smith)

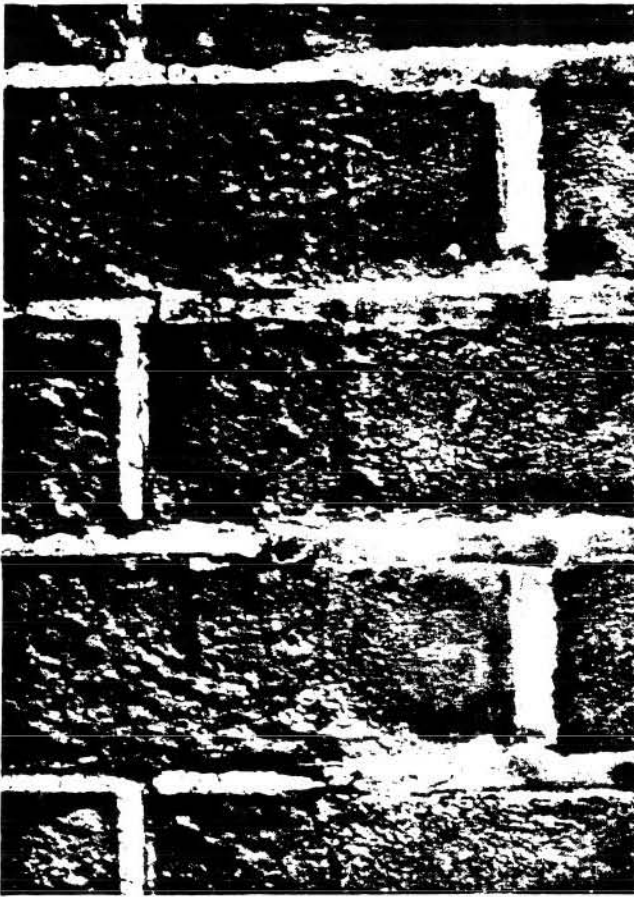
**Abrasively Cleaned vs. Untouched Brick.** Two brick rowhouses with a common façade provide an excellent point of comparison when only one of the houses has been sandblasted. It is clear that abrasive blasting, by removing the outer surface, has left the brickwork on the left rough and pitted, while that on the right still exhibits an undamaged and relatively smooth surface. Note that the abrasive cleaning has also removed a considerable portion of the mortar from the joints of the brick on the left side, which will require repointing.

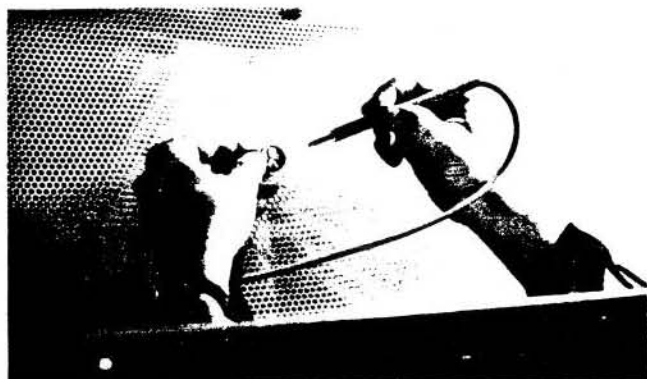
**Micro-Abrasive Cleaning.** This small, pencil-sized micro-abrasive unit is used by some museum conservators to clean small objects. This particular micro-abrasive unit is operated within the confines of a box (approximately 2 cubic feet of space), but a similar and slightly larger unit may be used for cleaning larger pieces of sculpture, or areas of architectural detailing on a building. Even a pressure cleaning unit this small is capable of eroding a surface, and must be carefully controlled.

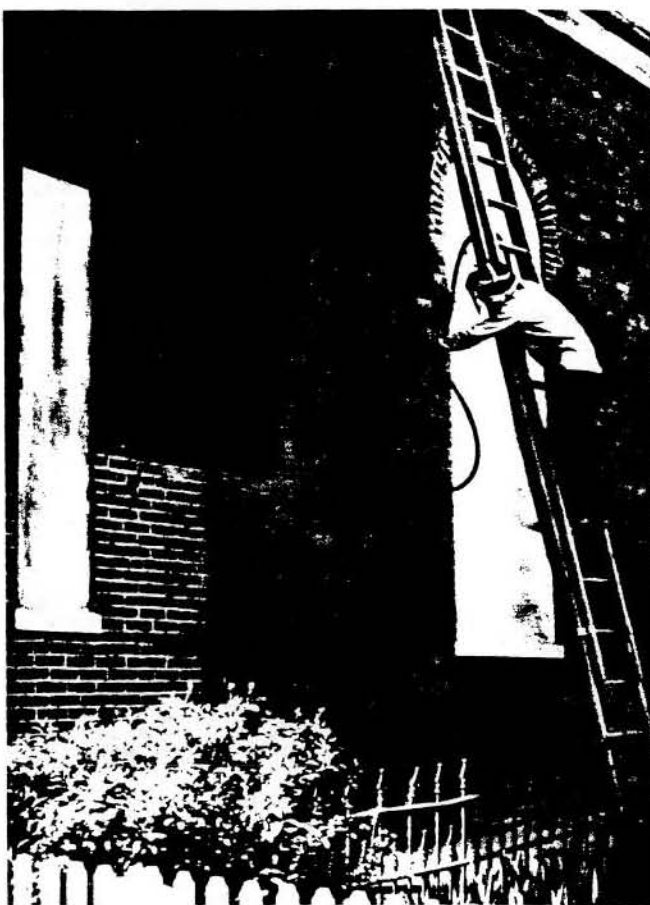
**"Line Drop."** Even though the operator of the sandblasting equipment is standing on a ladder to reach the higher sections of the wall, it is still almost impossible to have total control over the pressure. The pressure of the sand hitting the lower portion of the wall will still be greater than that above, because of the "line drop" in the distance from the pressure source to the nozzle. (Hugh Miller)

**Pressure:** The damaging effects of most of the variable factors involved in abrasive cleaning are self evident. However, the matter of pressure requires further explanation. In cleaning specifications, pressure is generally abbreviated as "psi" (pounds per square inch), which technically refers to the "tip" pressure, or the amount of pressure at the nozzle of the blasting apparatus. Sometimes "psig," or pressure at the gauge (which may be many feet away, at the other end of the hose), is used in place of "psi." These terms are often incorrectly used interchangeably.

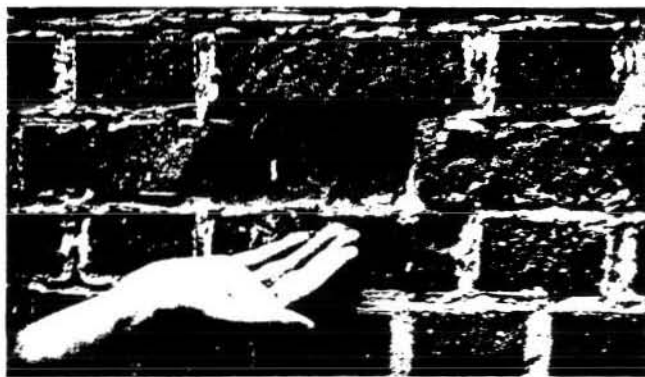
**Spalling Brick.** This soft, early 19th-century brick was sandblasted in the 1960s; consequently, severe spalling has resulted. Some bricks have almost totally disintegrated, and will eventually have to be replaced. (Robert S. Gamble)

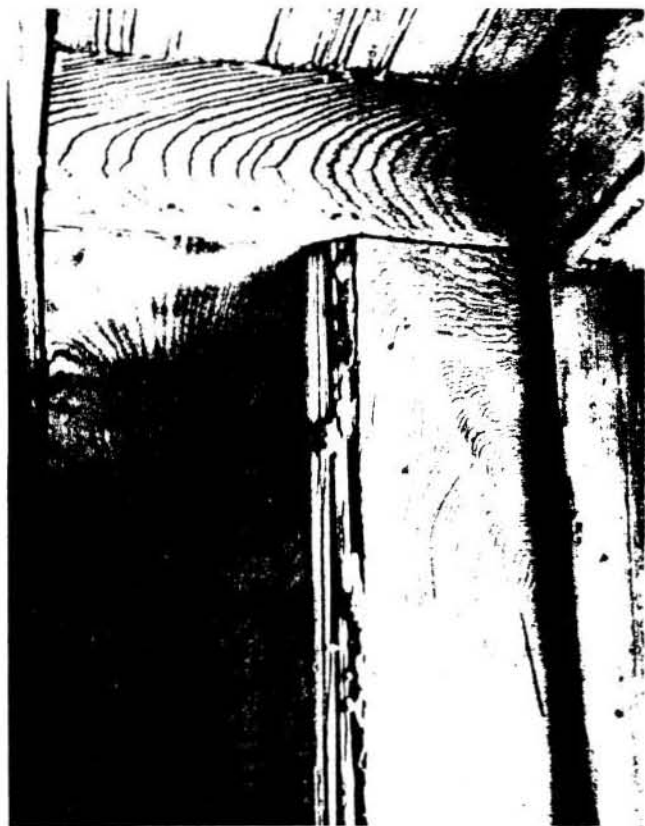
**Abrasive Cleaning of Wood.** This wooden windowsill, molding and paneling have been sandblasted to remove layers of paint in the rehabilitation of this commercial building. Not only is some paint still embedded in cracks and crevices of the woodwork, but more importantly, grit blasting has actually eroded the summer wood, in effect raising the grain, and resulting in a rough surface.

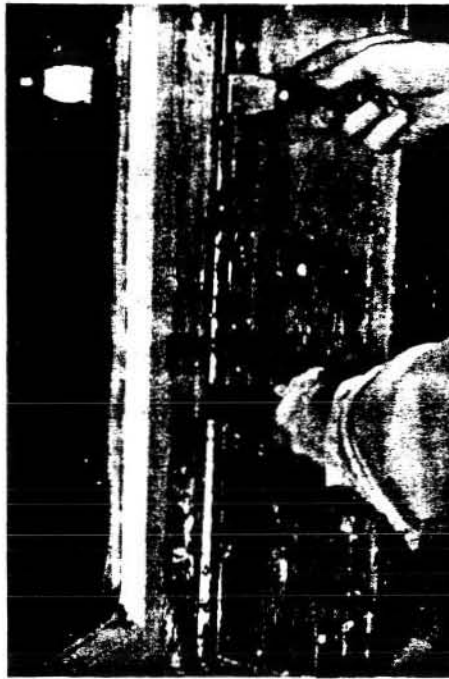
Figure 4b. After removing paint from the seam between the interior stop and the jamb, the stop can be pried out and gradually worked loose using a pair of putty knives as shown. To avoid visible scarring of the wood, the sash can be raised and the stop pried loose initially from the outer side. Photo: John H. Myers

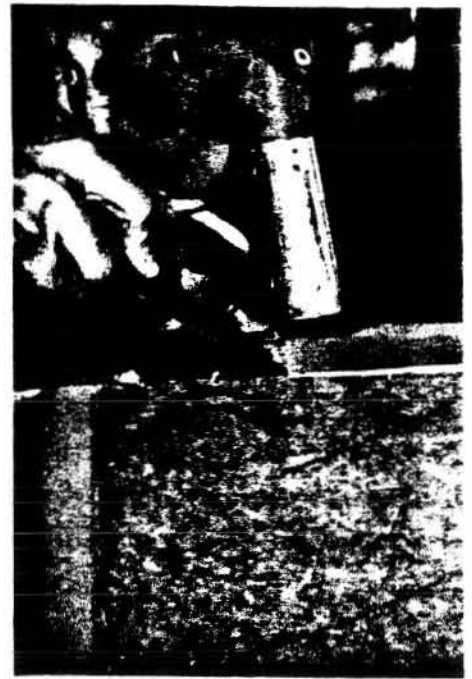
Figure 4c. Sash can be removed and repaired in a convenient work area. Paint is being removed from this sash with a hot air gun while an asbestos sheet protects the glass from sudden temperature change. Photo: John H. Myers

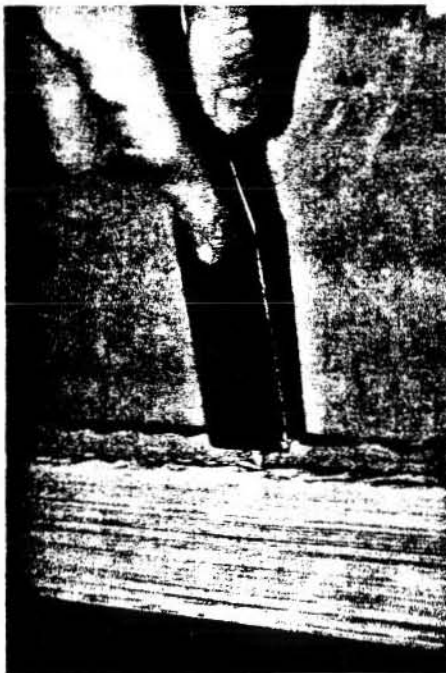
Figure 4d. Reglazing or replacement of the putty requires that the existing putty be removed manually, the glazing points be extracted, the glass removed, and the back putty scraped out. To reglaze, a bed of putty is laid around the perimeter of the rabbet, the pane is pressed into place, glazing points are inserted to hold the pane (shown), and a final seal of putty is beveled around the edge of the glass. Photo: John H. Myers

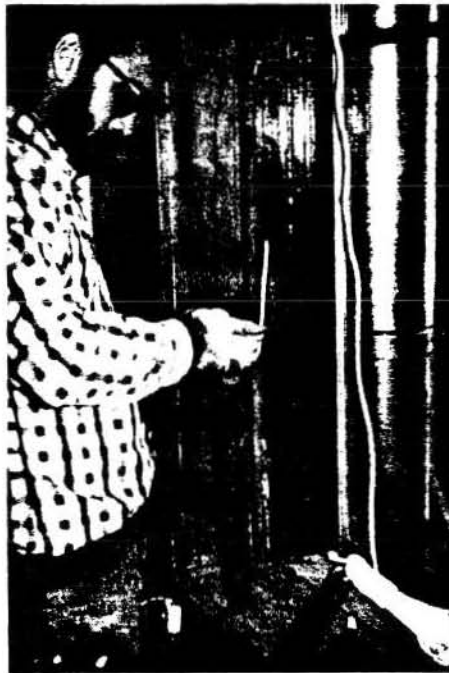
Figure 4e. A common repair is the replacement of broken sash cords with new cords (shown) or with chains. The weight pocket is often accessible through a removable plate in the jamb, or by removing the interior trim. Photo: John H. Myers

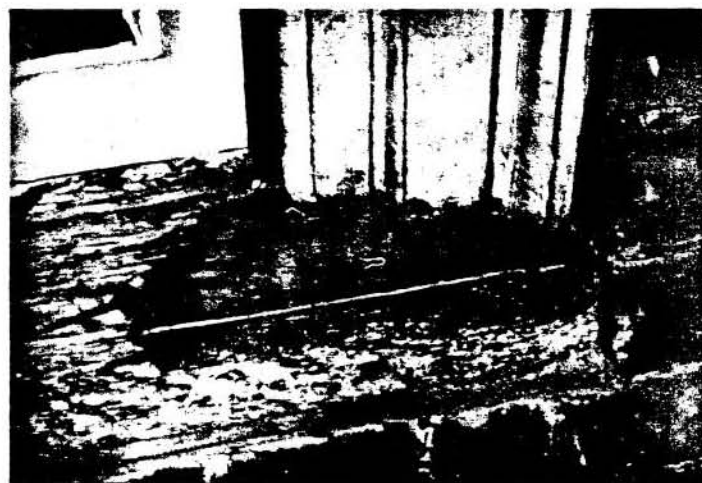
Figure 5. This illustrates a two-part epoxy patching compound used to fill the surface of a weathered sill and rebuild the missing edge. When the epoxy cures, it can be sanded smooth and painted to achieve a durable and waterproof repair. Photo: John H. Myers

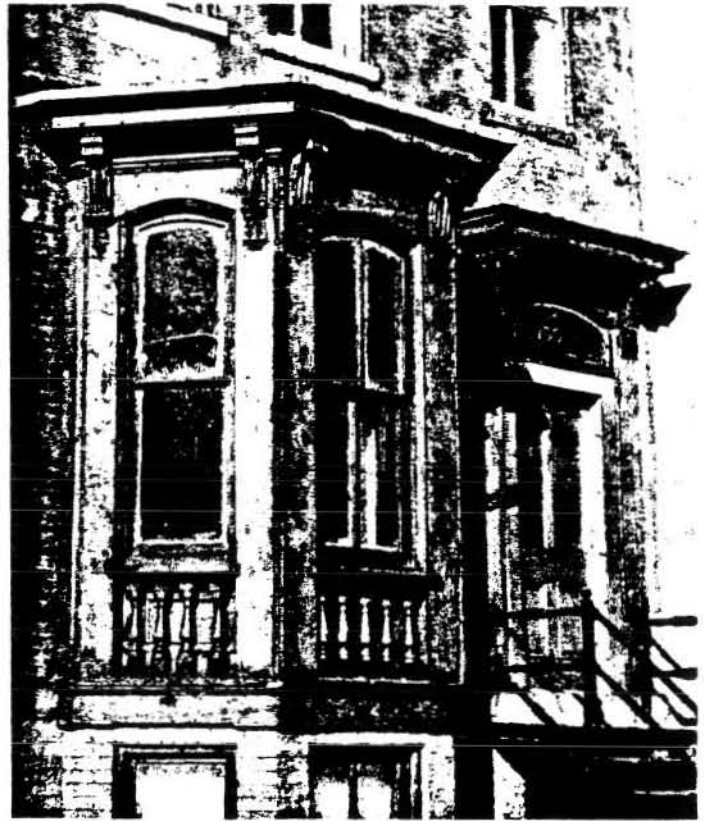
Fig. 2 A traditionally painted bay window has been stripped to bare wood, then varnished. In addition to being historically inaccurate, the varnish will break down faster as a result of the sun's ultraviolet rays than would primer and finish coats of paint. Photo: David W. Look, AIA.

been identified, the general approach should be to remove paint to the next sound layer using the gentlest means possible, then to repaint (see figure 2). Practically speaking as well, paint can adhere just as effectively to existing paint as to bare wood, providing the previous coats of paint are also adhering uniformly and tightly to the wood and the surface is properly prepared for repainting—cleaned of dirt and chalk and dulled by sanding. But, if painted exterior wood surfaces display continuous patterns of deep cracks or if they are extensively blistering and peeling so that bare wood is visible, then the old paint should be completely removed before repainting. The only other justification for removing all previous layers of paint is if doors, shutters, or windows have literally been “painted shut,” or if new wood is being pieced-in adjacent to old painted wood and a smooth transition is desired (see figure 3).

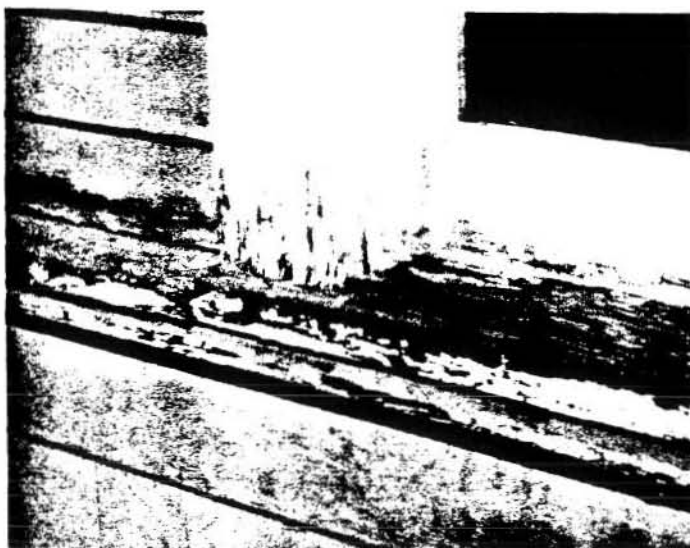
Fig. 4 Paint films wear unevenly depending on exposure and location. Exterior locations which are susceptible to accelerated deterioration are horizontal surfaces such as window sills. These and similar areas will require repainting more often than less vulnerable surfaces. In the case of this window sill where paint has peeled off and adjacent areas have cracked and alligatored, the paint should be totally removed. Prior to repainting, any weathered wood should be rejuvenated using a solution of 3 cups exterior varnish, 1 oz. paraffin wax, and mineral spirits/paint thinner/or turpentine to make 1 gallon. Liberal brush application should be made. This formula was tested over a 20-year period by the U.S. Department of Agriculture's Forest Products Laboratory and proved to be just as effective as water-repellent preservatives containing pentachlorophenol. After the surface has thoroughly dried (2-3 days of warm weather), the treated surface can be painted. A high quality oil-base primer followed by two top coats of a semi-gloss oil-enamel or latex-enamel paint is recommended. Photo: Baird M. Smith, AIA.

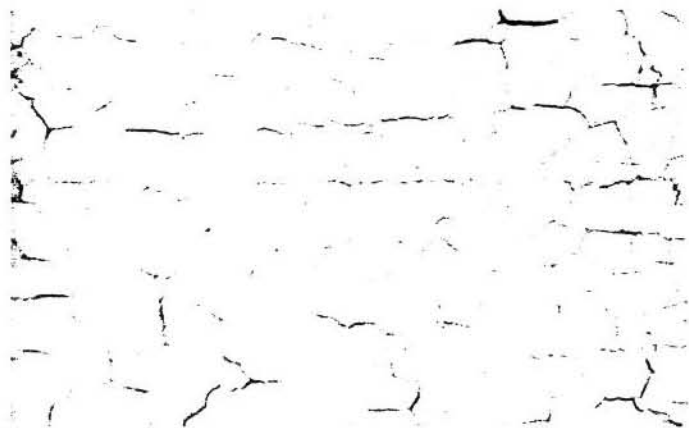
Fig. 5 Crazing—or surface cracking—is an exterior surface condition which can be successfully treated by sanding and painting. Photo: Courtesy, National Decorating Products Association.

Crazing—fine, jagged interconnected breaks in the top layer of paint—results when paint that is several layers thick becomes excessively hard and brittle with age and is consequently no longer able to expand and contract with the wood in response to changes in temperature and humidity (see figure 5). As the wood swells, the bond between paint layers is broken and hairline cracks appear. Although somewhat more difficult to detect as opposed to other more obvious paint problems, it is well worth the time to scrutinize all surfaces for crazing. If not corrected, exterior moisture will enter the crazed surface, resulting in further swelling of the wood and, eventually, deep cracking and alligatoring, a Class III condition which requires total paint removal.

Crazing can be treated by hand or mechanically sanding the surface, then repainting. Although the hairline cracks may tend to show through the new paint, the surface will be protected against exterior moisture penetration.

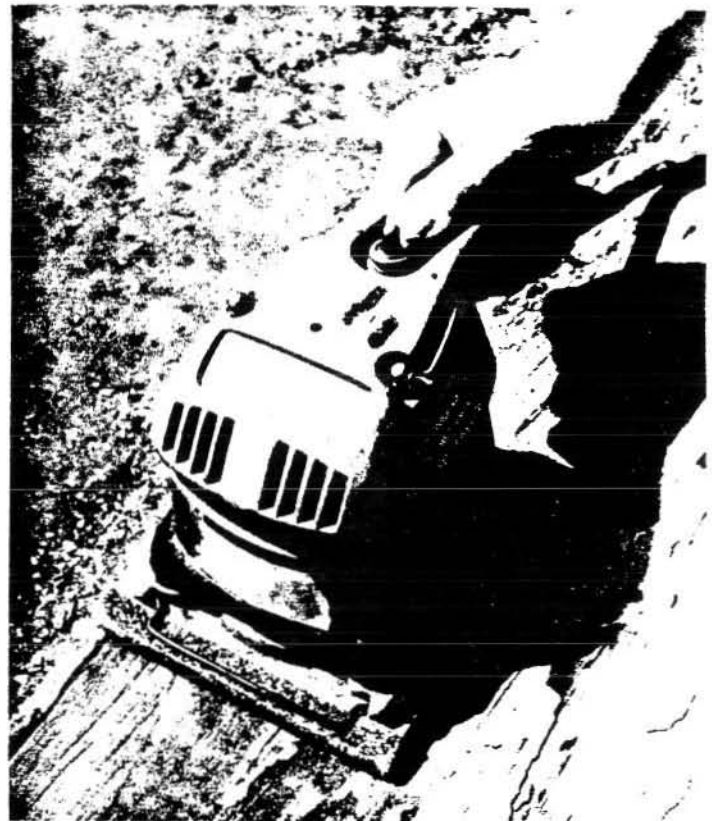
Fig. 11 The orbital sander can be used for limited paint removal, i.e., for smoothing flat surfaces after the majority of deteriorated paint has already been scraped off. Photo: Charles E. Fisher, III.

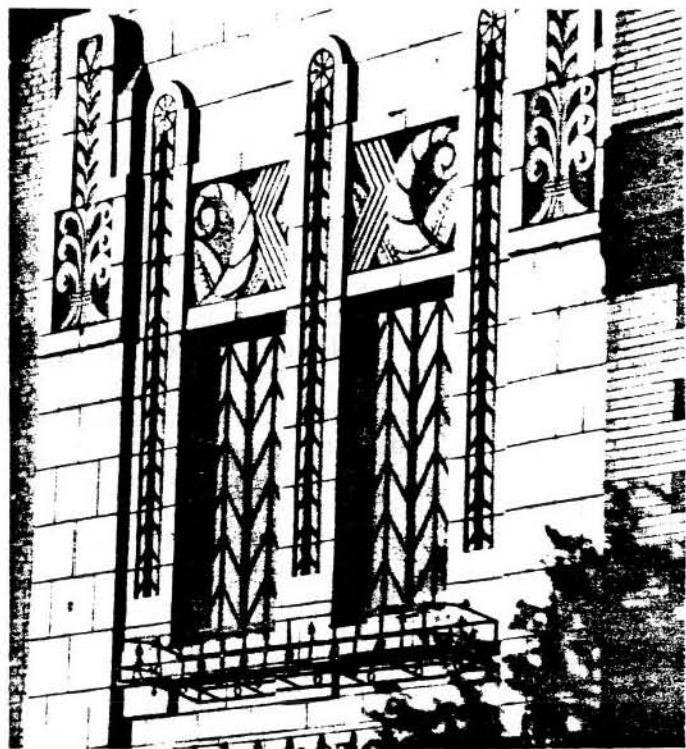
*Fig. 1 Often highly distinctive in design and craftsmanship, rolled steel windows play an important role in defining the architectural character of many later nineteenth and early twentieth century buildings. Art Deco, Art Moderne, the International Style, and Post World War II Modernism depended on the slim profiles and streamlined appearance of metal windows for much of their impact. Photo: William G. Johnson.*

Windows are among the most vulnerable features of historic buildings undergoing rehabilitation. This is especially the case with rolled steel windows, which are often mistakenly not deemed worthy of preservation in the conversion of old buildings to new uses. The ease with which they can be replaced and the mistaken assumption that they cannot be made energy efficient except at great expense are factors that typically lead to the decision to remove them. In many cases, however, repair and retrofit of the historic windows are more economical than wholesale replacement, and all too often, replacement units are unlike the originals in design and appearance. If the windows are important in establishing the historic character of the building (see fig. 1), insensitively designed replacement windows may diminish—or destroy—the building's historic character.

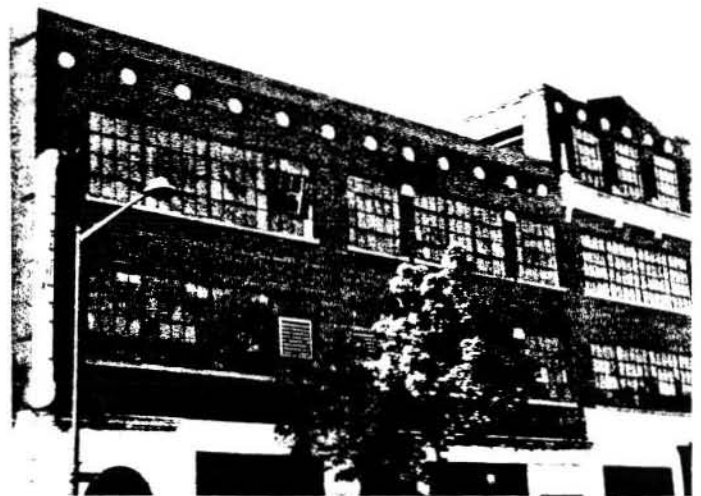
*Fig. 5 Windows often provide a strong visual element to relatively simple or unadorned industrial or commercial buildings. This design element should be taken into consideration when evaluating the significance of the windows. Photo: Michael Auer.*

Other elements in assessing the relative importance of the historic windows include the design of the windows and their relationship to the scale, proportion, detailing and architectural style of the building. While it may be easy to determine the aesthetic value of highly ornamented windows, or to recognize the importance of streamlined windows as an element of a style, less elaborate windows can also provide strong visual interest by their small panes or projecting planes when open, particularly in simple, unadorned industrial buildings (see fig. 5).

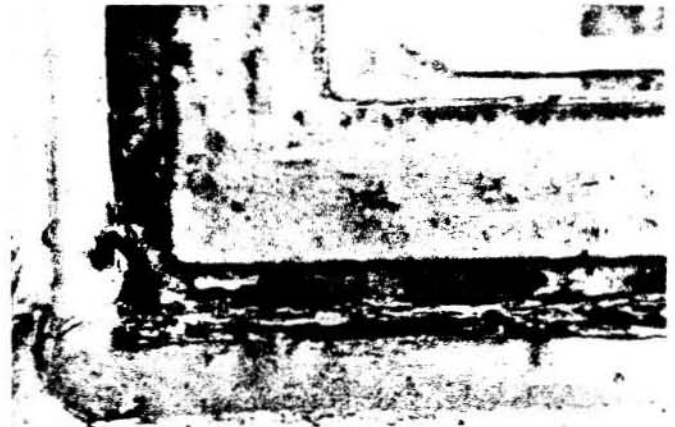
Fig. 6 b. View from the exterior showing the deteriorated condition of the lower corner of a window prior to repair. While the sash was in relatively good condition, the frame behind was rusted to the point of inhibiting operation.

Fig. 6. The repair and thermal upgrading of the historic steel windows at the State Capitol, Lincoln, Nebraska. This early twentieth century building, designed by Bertram Goodhue, is a National Historic Landmark. Photos: All photos in this series were provided by the State Building Division.

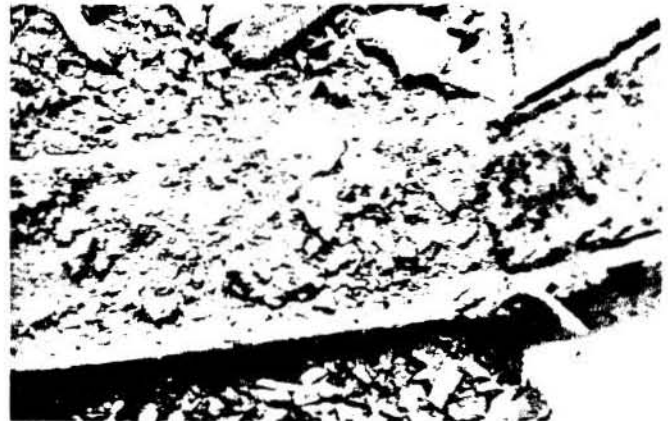
Fig. 6 d. View looking down towards the sill. The subframes appeared very rusted, but were in good condition once debris was vacuumed and surface rust was removed, in place, with chemical compounds. Where necessary, epoxy and steel filler was used to patch depressions in order to make the subframe serviceable again.

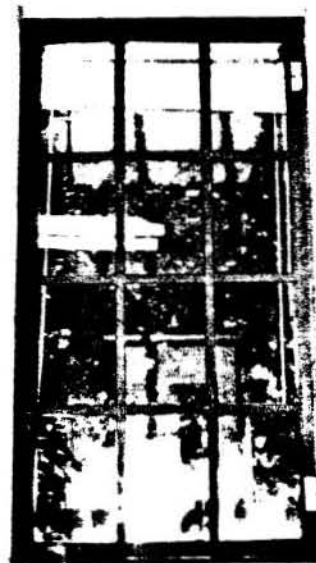
Fig. 6 f. View from the outside of the completely refurbished window. In addition to the steel repair and the installation of vinyl weatherstripping, the exterior was caulked with polyurethane and the single glass was replaced with individual lights of thermal glass. The repaired and upgraded windows have comparable energy efficiency ratings to new replacement units while retaining the historic steel sash, frames and subframes.

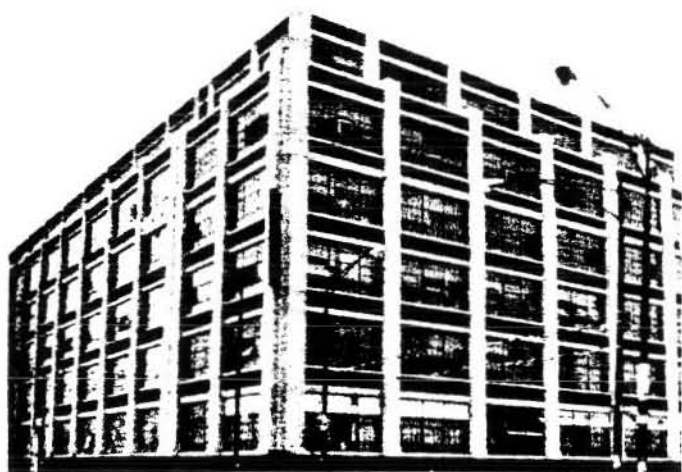
Fig. 10 a. A six-story concrete manufacturing building prior to the replacement of the steel pivot windows. Photo: Charles Parrott.

historic windows, most of these manufacturers can reproduce the historic configuration if requested, and the cost is not excessive for large orders (see figs. 10a and 10b). Some manufacturers still carry the standard pre-World War II multi-light windows using the traditional 12" x 18" or 14" x 20" glass sizes in industrial, commercial, security, and residential configurations. In addition, many of the modern steel windows have integral weatherstripping, thermal break construction, durable vinyl coatings, insulating glass, and other desirable features.

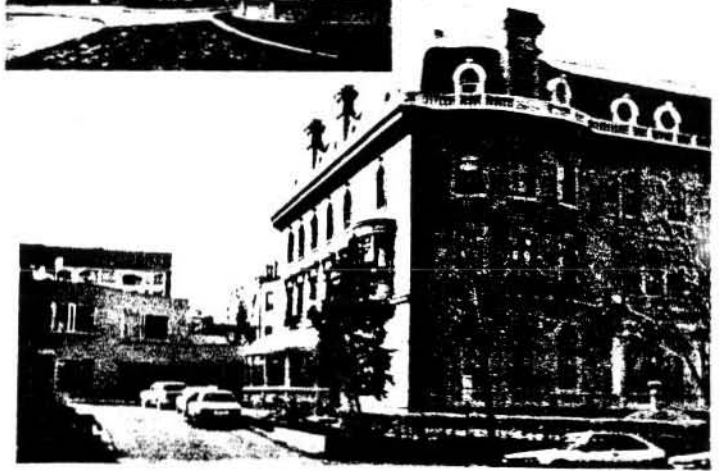
Historic residential structure with new office addition. This approach preserves significant historic materials and features.

Built in 1903 as the private residence of a wealthy mine owner, the 3½ story building utilizes a variety of materials, including granite, limestone, marble, and cast iron. Of special interest is the projecting conservatory on a prominent side elevation. The Walsh-McLean House in Washington, D.C., has been used as the Indonesian Embassy since 1954. When additional administrative space was required for the embassy in 1981, loss of significant exterior materials was minimized by utilizing a narrow hyphen connector that cuts through a side wall behind the distinctive conservatory. Finally, the modestly scaled addition is well set back on the adjoining site, thus preserving the historic character of this individually-listed property.
