# **SKAGIT RIVER HYDROELECTRIC PROJECT**

**FERC No. 553**

## **HISTORIC RESOURCES MITIGATION AND MANAGEMENT PLAN**

**City of Seattle  
City Light Department**

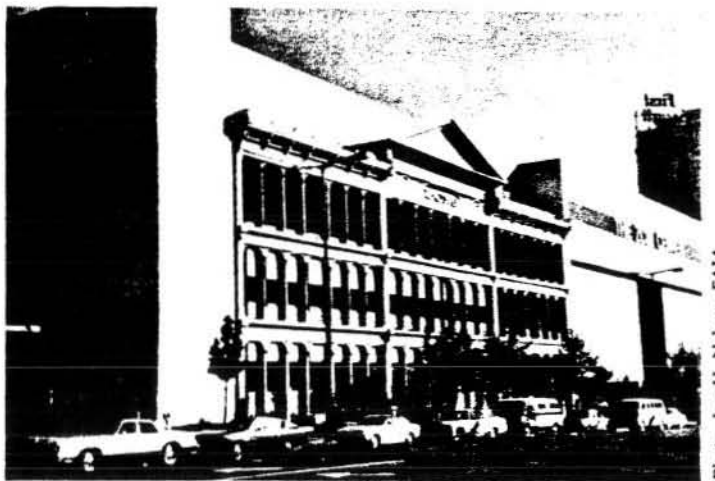
Historic cast-iron storefront re-installed as facade on modern department store. This approach results in the destruction of significant materials and features.

Where there is need for a substantially larger building, the most destructive approach is to demolish everything but the facade of the historic building. In the example above, the 3-story-cast-iron front was originally the facade of a large, 19th century department store. In the 1970s, when the rest of the building was demolished, the metal facade was dismantled, then re-assembled on a new site where it has become the ornamental entrance to a modern department store.

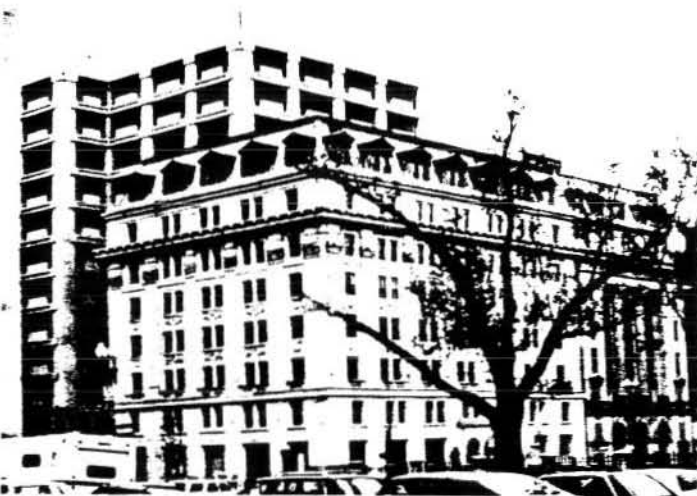
Historic theater and office building with new office addition. This approach results in the destruction of significant materials and features.

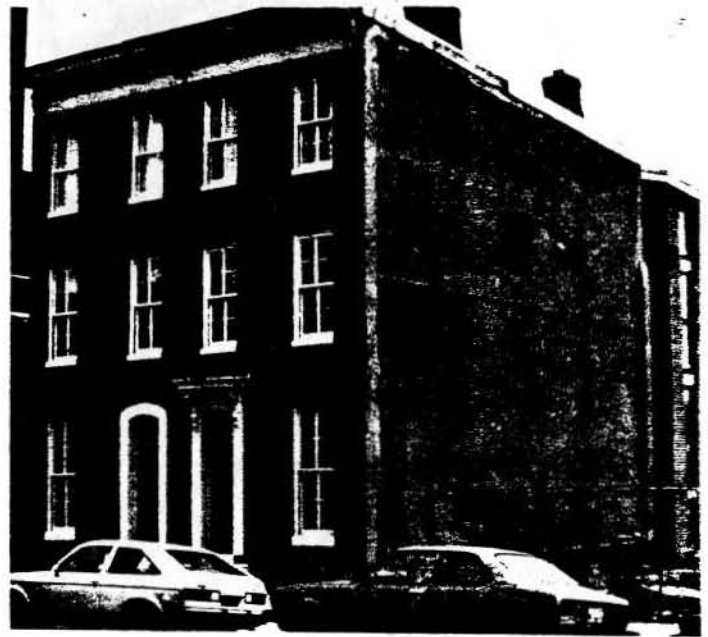
**Historic townhouse with compatible new stairtower addition. This approach preserves the historic character.**

Creating two separate means of egress from the upper floors may be a fire code requirement in certain types of rehabilitation projects. This may involve a second stair within the historic building or an exterior fire stair. To meet preservation concerns, an exterior fire stair should always be subordinate to the historic structure in size and scale, and preferably, placed on a secondary side or rear elevation. Finally, as in any other type of addition, the material and color should be compatible with the historic character of the building. Because this modest brick stairtower has been placed on a rear elevation as a subsidiary unit, the form, features and detailing of the historic building have been preserved.

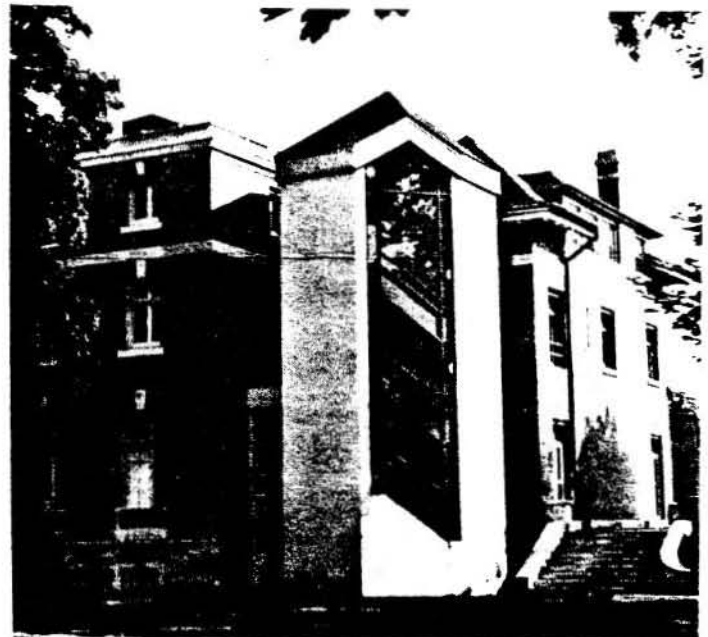
**Historic university building with incompatible new stairtower addition. This approach changes the historic character.**

In contrast, this stairtower has been constructed on a highly visible side elevation and, together with its width and height, has obscured the historic form and roofline. The materials and color of the addition further enhance its prominence.

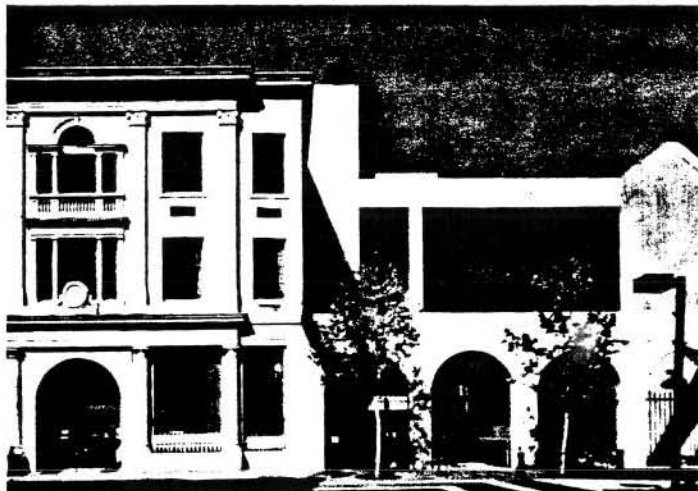
**Historic bank with compatible new bank addition. This approach preserves the historic character.**

The overall size of an 1893 bank in Salem, Massachusetts, was nearly doubled in 1974 when a new addition was constructed on an adjacent lot, yet the addition is compatible with the historic character. A deep set-back and similarity in scale permit the historic form to be appreciated; the addition is also compatible in materials and color. Finally, the pattern of arched and rectangular openings of the historic building is suggested in the new work.

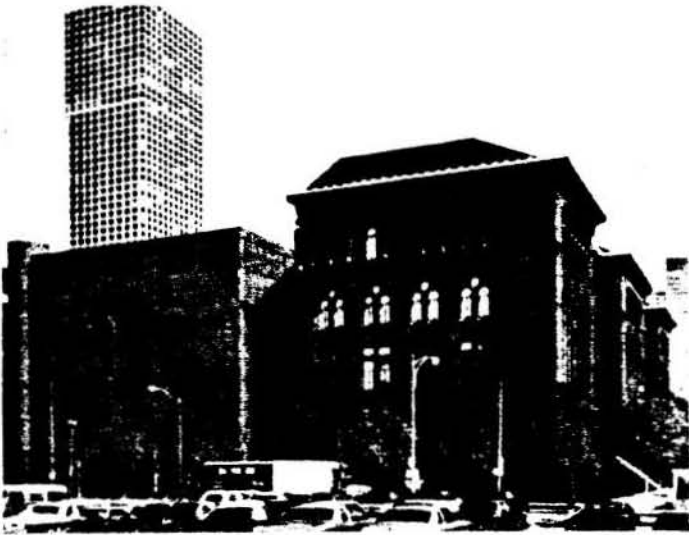
Historic library with new addition for "uncommon" and rare books. This approach preserves the historic character.

Designed by architect Henry Ives Cobbs and completed in 1892, the Newberry Library in downtown Chicago extends the length of a city block and features a series of elongated, arch-headed windows. In 1981, when additional space was required with light and humidity control for storage of the rare book collection, a 10-story, windowless brick addition was linked to the historic block on side and rear elevations. Although constituting major expansion, the new wing still reads as a subsidiary unit to the substantially larger historic library complex. Its simple rectangular shape and lack of ornamentation stand in contrast with the highly articulated historic library complex; the rhythm of the historic windows is suggested in the windowless addition through a series of recessed square and arched bands. This is one example of a solution that is considered compatible with the historic character.

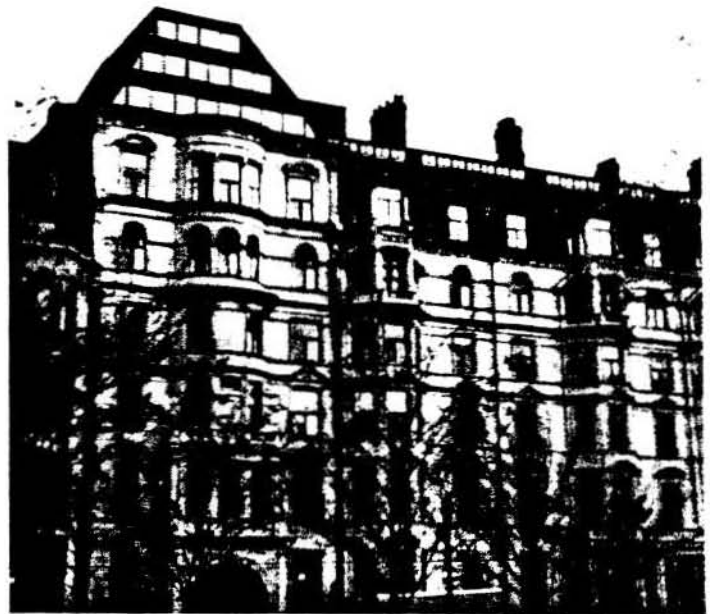
Historic residential buildings with incompatible three-story rooftop addition. This approach changes the historic character.

The historic character of one building or an entire row of buildings may be radically altered by even one highly visible, inappropriately scaled rooftop addition. This is partly because the proportions or dimensions of a historic building play such a major role in determining its identity. Major expansion at the roofline alters the proportions and profile of the building—a change that is particularly noticeable when seen in outline against the sky. A modest clerestory addition (extending across townhouses to the right) is almost overlooked because the focal point of the row is a three-story, pyramidally-shaped glass and metal addition whose mass, size, and scale overpowers the block's residential character.

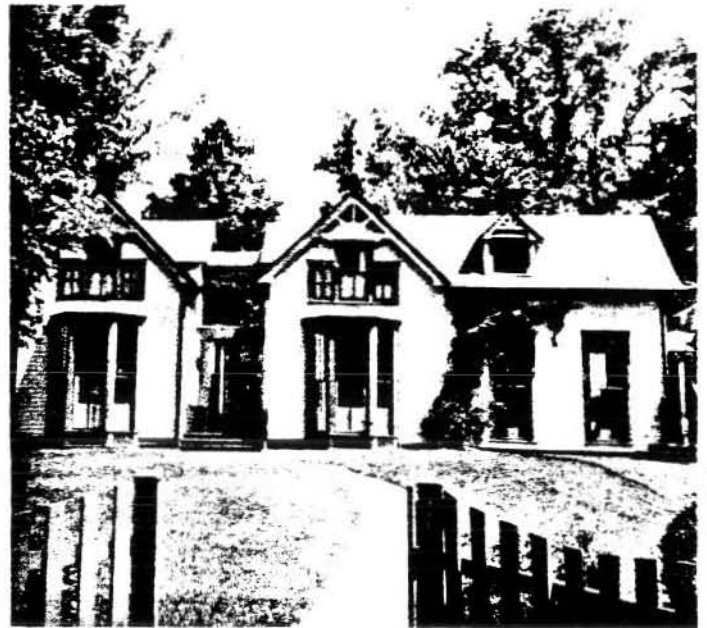
**Private residence with new addition.** This approach does not protect the historical significance of the resource because it fails to make a visual distinction between what is old and what is new.

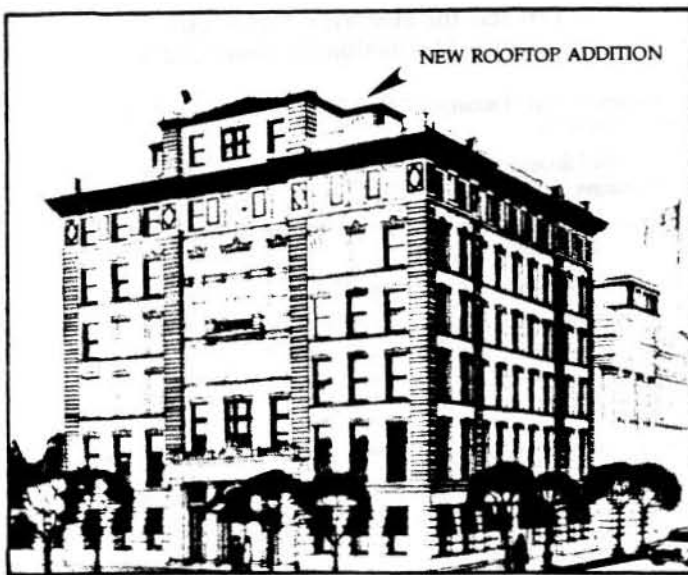
Historic city hall with new rooftop office addition. This approach does not protect the historical significance of the resource because it fails to make a visual distinction between what is old and what is new.

The drawing shows a proposed penthouse addition to a former municipal building. Originally a flat-roofed structure with a modestly detailed cornice, the proposed new addition has changed the proportions and profile, creating a verticality and degree of ornamentation that never existed historically. These changes have effectively *re-defined* the historic character. With its highly replicative ornamentation, the addition has become an integral component of the historic design. The result is that a passerby would probably not be able to tell that the rooftop addition is new and not part of the original construction.

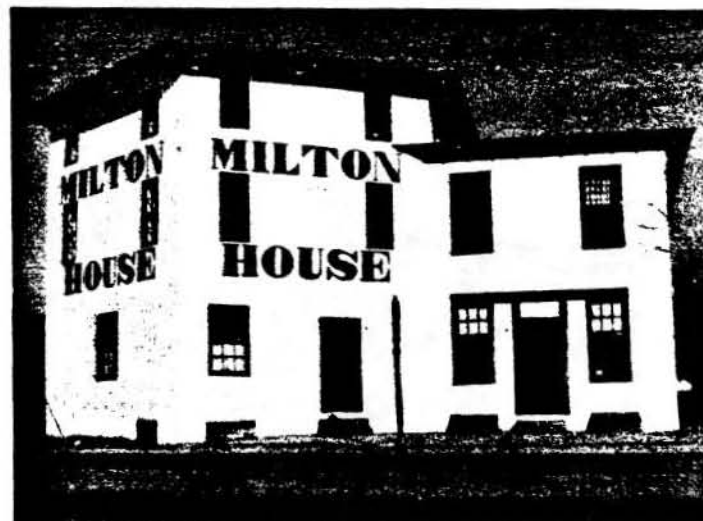
Fig. 1. Milton House, Milton, Wisconsin (1844). An early example of gravel wall construction with 12- to 15-inch thick monolithic concrete walls coated on the exterior with stucco. Photo: William B. Coney.

Despite its early use, concrete was slow in achieving widespread acceptance as a building material in the United States. In 1853, the second edition of Orson S. Fowler's *A Home for All* publicized the advantages of "gravel wall" construction to a wide audience, and poured gravel wall buildings appeared across the United States (see fig. 1). Seguin, Texas, 35 miles east

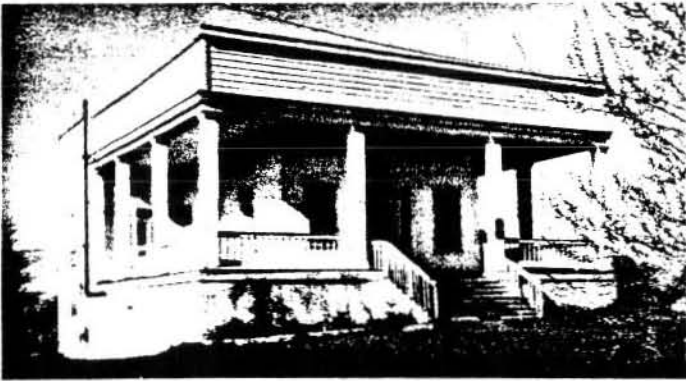
Fig. 2. Sebastopol House, Seguin, Texas (1856). This Greek Revival dwelling is one of the few remaining poured-in-place concrete structures in this Texas town noted for its construction of over 90 concrete buildings in the mid-nineteenth century. The high parapets surrounding the flat roof were lined and served as a water reservoir to cool the house. Photo: Texas Historical Commission.

of San Antonio, came to be called "The Mother of Concrete Cities" for some 90 concrete buildings made from local "lime water" and gravel (see fig. 2). Impressed by the economic advantages of poured gravel wall or "lime-grout" construction, the Quartermaster General's Office of the War Department embarked on a campaign to improve the quality of building for frontier military posts. As a result, lime-grout structures were built at several western posts, such as the buildings that were constructed with 12- or 18-inch-thick walls at Fort Laramie, Wyoming between 1872 and 1885. By the 1880s sufficient experience had been gained with unreinforced concrete to permit construction of much larger buildings. The Ponce de Leon Hotel in St. Augustine, Florida, is a notable example from this period (see fig. 3).

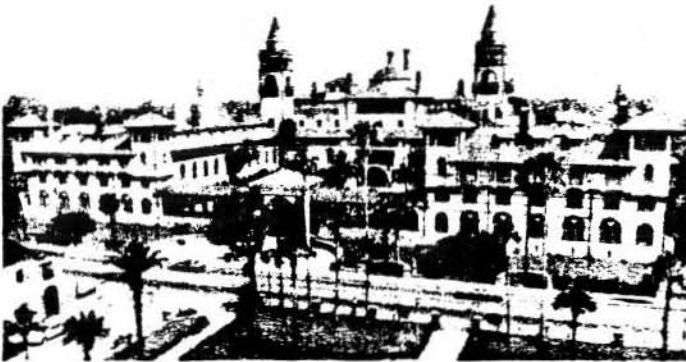
Fig. 3. Ponce de Leon Hotel, St. Augustine, Florida (1885-87). An example of unreinforced concrete used on a grand scale, this Spanish Colonial Revival hotel was designed by Carrere and Hastings and commissioned by railroad magnate Henry Flagler. The building now serves as the main campus hall for Flagler College. Photo: Flagler College.

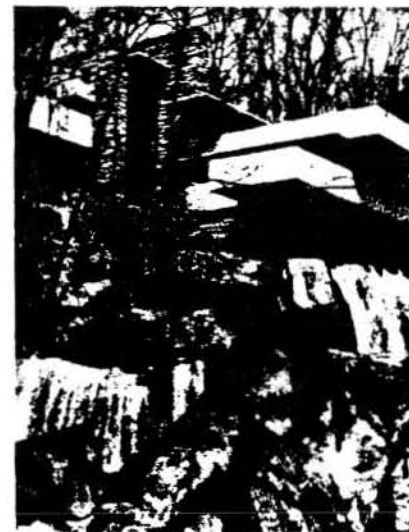
Fig. 5. "Fallingwater," near Mill Run, Pennsylvania (1936-37). This dramatic reinforced concrete residence by Frank Lloyd Wright is anchored into bedrock on the hillside and cantilevered over the stream. The great tensile strength of reinforced concrete made this type of construction possible. Photo: Paul Mayen.

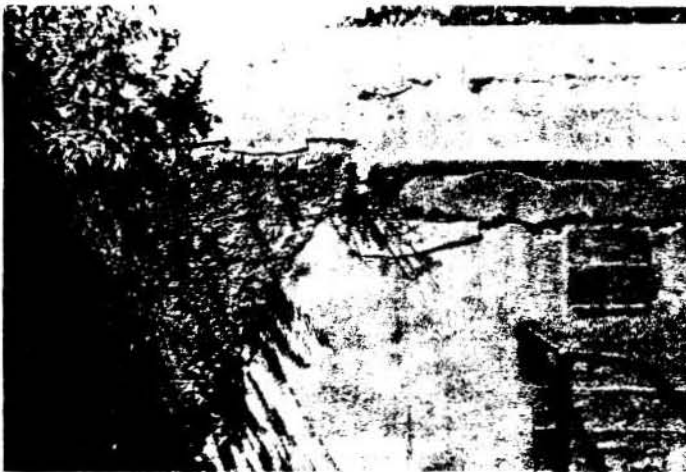
Fig. 6. Battery Fortifications, Ft. Washington, Maryland (1891-97). This unreinforced concrete fortification exhibits several kinds of deterioration: the diagonal structural crack due to uneven settlement, the long horizontal crack at the cold joint, the spalling of the concrete surface coating, and vegetative growth. Photo: Sharon C. Park, AIA.

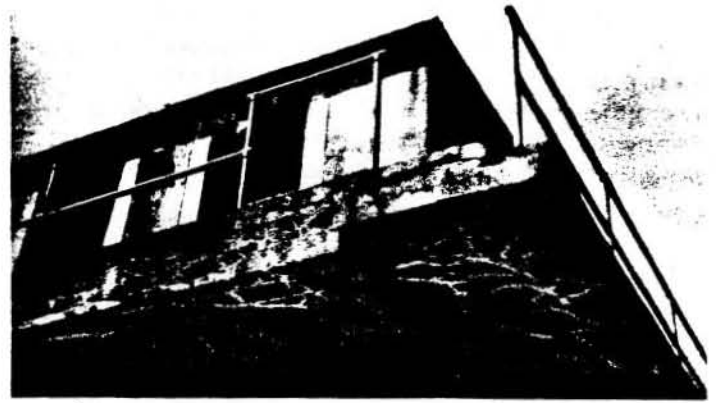
Fig. 7. Battery Commander's Station, Ft. Washington, Maryland (1904). This reinforced concrete tower with a cantilevered balcony is showing serious deterioration. Water has penetrated the slab, causing freeze-thaw spalling around the posts and corrosion of the reinforcing bars. This internal corrosion is causing expansion inside the slab and creating major horizontal cracks in the concrete. Under the balcony can be seen the network of hardened white calcified deposits, which have exuded through cracks in the concrete as a result of alkali-aggregate reaction. Photo: Lee H. Nelson, FAIA.

Deterioration in concrete can be caused by environmental factors, inferior materials, poor workmanship, inherent structural design defects, and inadequate maintenance (see figs. 6, 7, and 8).

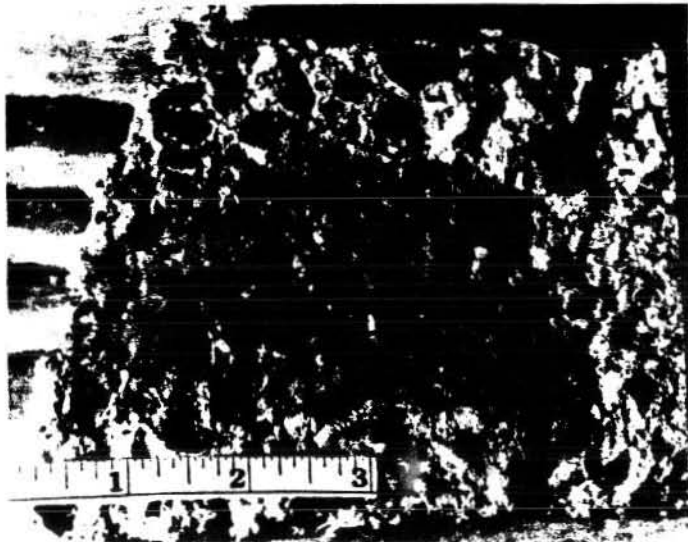
Fig. 10. Testing of actual samples of concrete in the lab may be necessary to determine the strength and condition of the concrete. In this sample, the surface, which is lighter than the sound concrete core, shows that carbonation has taken place. Carbonation reduces the alkalinity in concrete and may hasten corrosion of reinforcing bars close to the surface. Photo: Stella L. Marusin.

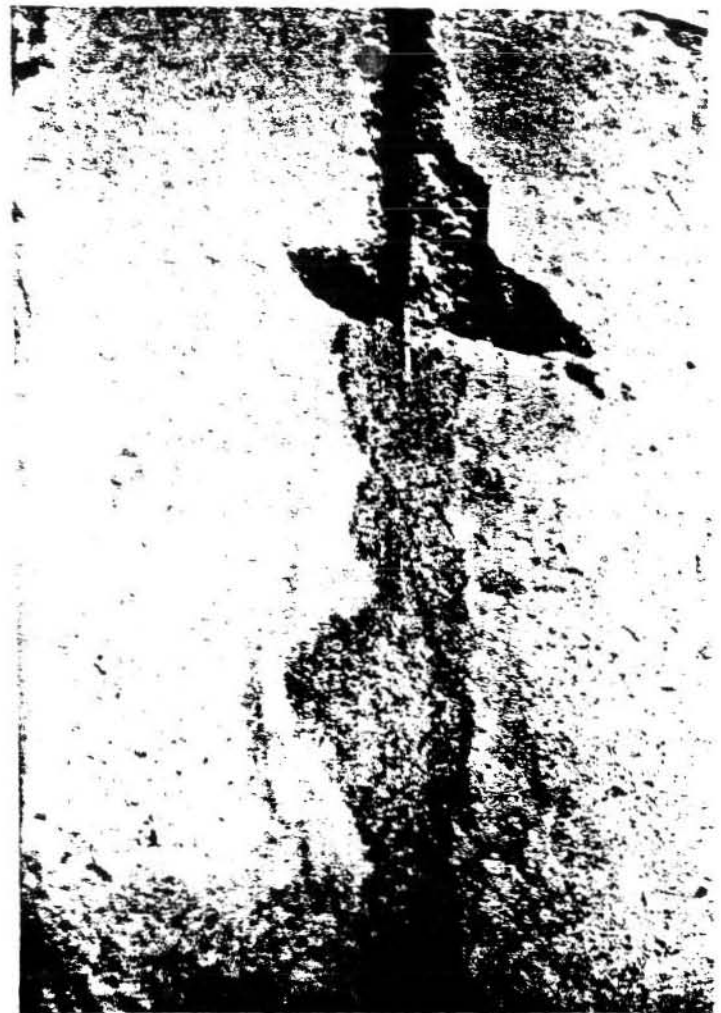
Fig. 12. Without proper preparation and correction of a pre-existing problem, repairs will fail. Insufficient concrete at the surface caused this patch around a reinforcing bar to fail within a year. In this case, a structural engineer should have assessed the need for this rod so close to the surface. Redundant rods are often cut out prior to patching. Photo: Alonzo White.

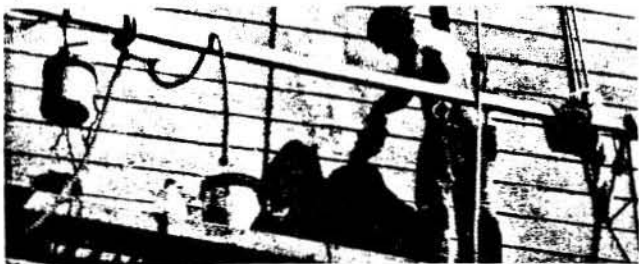
Fig. 13g. A soft brush is used to smooth the patch and to blend it with the adjacent historic concrete.

Fig. 13a-i. Virginia Heating Plant, Arlington, Virginia (1941). This reinforced concrete building exhibits several serious problems, including cracking, spalling, and corrosion of reinforcing bars. As a result of careful planning and close supervision, successful repairs have been carried out. Photos: Alonzo White and Sharon C. Park, AIA.

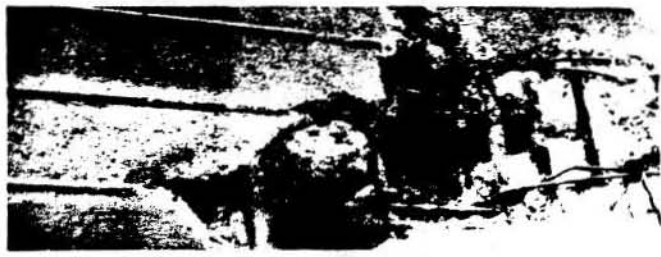
Fig. 13b. Upon removal of the deteriorated surface, a pocket of poorly mixed concrete (mostly sand and gravel) was easily chiseled out. The reinforcing rods were in good condition.

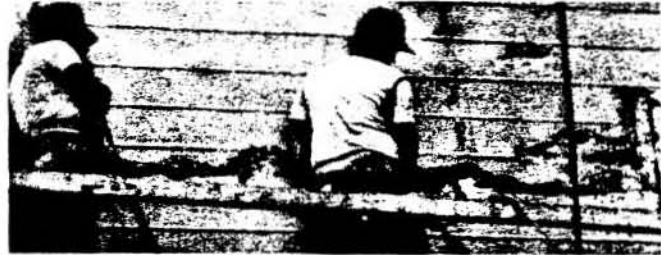
Fig. 13d. Deteriorated or redundant reinforcing bars are removed after evaluation by a structural engineer. An acetylene torch is being used to cut out the bars.

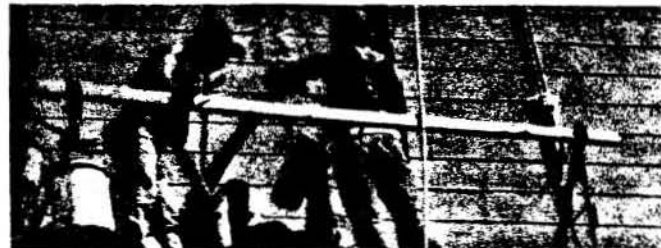
Fig. 13f. Workmen are applying patching concrete and using a trowel to form ridges to match the appearance of the historic concrete ridges that were originally created by the form boards.

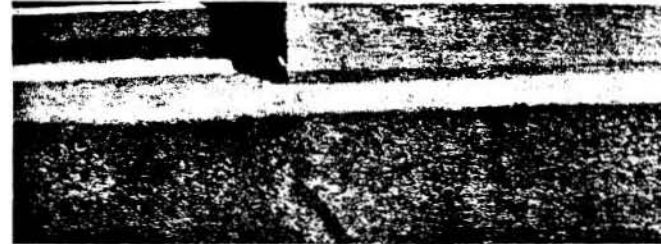
Fig. 13h. This active crack at a window sill and in the foundation wall has been filled with a flexible sealant. This area was subsequently painted with a masonry paint compatible with the sealant.

*Repair of Cracking.* Hairline, nonstructural cracks that show no sign of worsening normally need not be repaired. Cracks larger than hairline cracks, but less than approximately one-sixteenth of an inch, can be repaired with a mix of cement and water. If the crack is wider than one-sixteenth of an inch, fine sand should be added to the mix to allow for greater compactibility, and to reduce shrinkage during drying. Field trials will determine whether the crack should be routed (widened and deepened) minimally before patching to allow sufficient penetration of the patching material. To ensure a long-term repair, the patching materials should be carefully selected to be compatible with the existing concrete as well as with subsequent surface treatments such as paint or stucco.

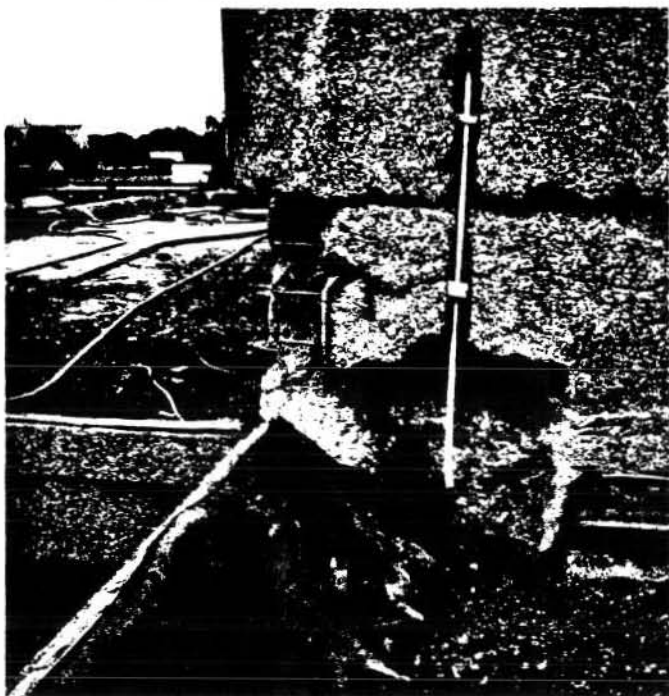
Fig. 14a. Spalled concrete was most noticeable at locations of concentrated rebars. Deteriorated concrete, the 1960s stucco finish, and corrosion were removed by grit-blasting. Photo: Robert Bell.

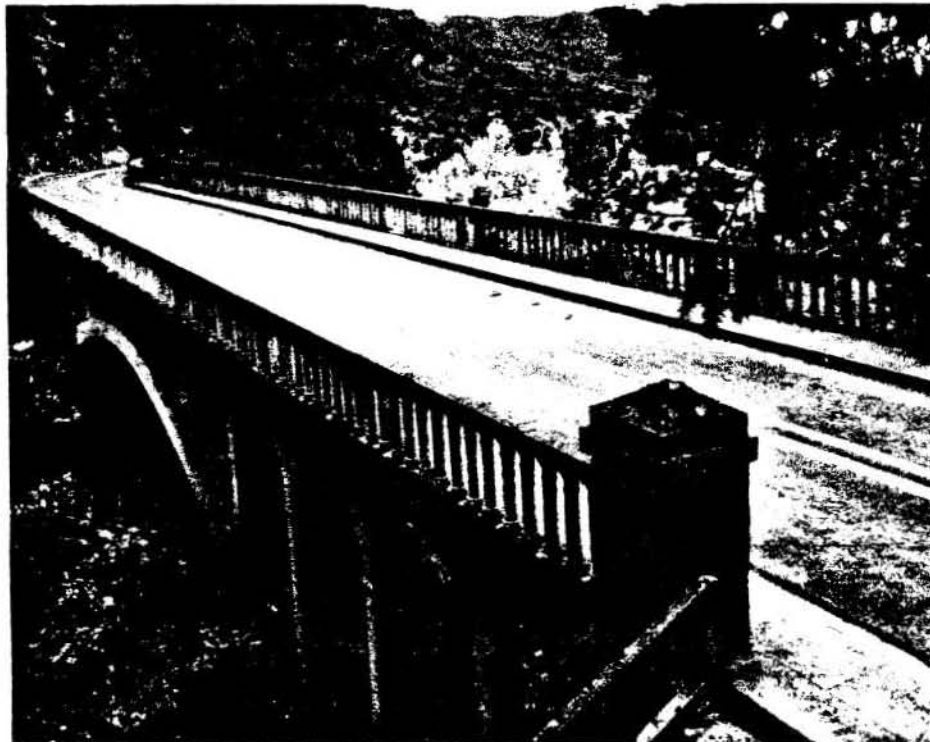
Fig. 15c. The new concrete spindles have been installed. This sensitive renovation reused the historic concrete cap railing and stone piers, as they were still in sound condition.

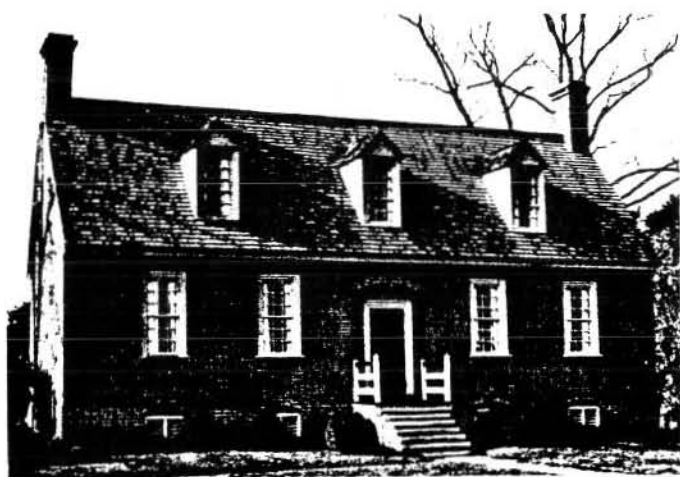
1. The Rolfe-Warren House, a tidewater Virginia property, was restored to its 18th-century appearance in 1933. The handsplit and dressed wooden shingles are typical of the tidewater area with special features such as curved butts, projecting ridge comb and closed swept valleys at the dormer roof connections. Circa 1970 Photo: Association for the Preservation of Virginia Antiquities.

Wooden shingle roofs are important elements of many historic buildings. The special visual qualities imparted by both the *historic shingles* and the *installation patterns* should be preserved when a wooden shingle roof is replaced. This requires an understanding of the size, shape, and detailing of the historic shingle and the method of fabrication and installation. These combined to create roofs expressive of particular architectural styles, which were often influenced by regional craft practices. The use of wooden shingles from the early settlement days to the present illustrates an extraordinary range of styles (see illus. 1, 2, 3, 4).

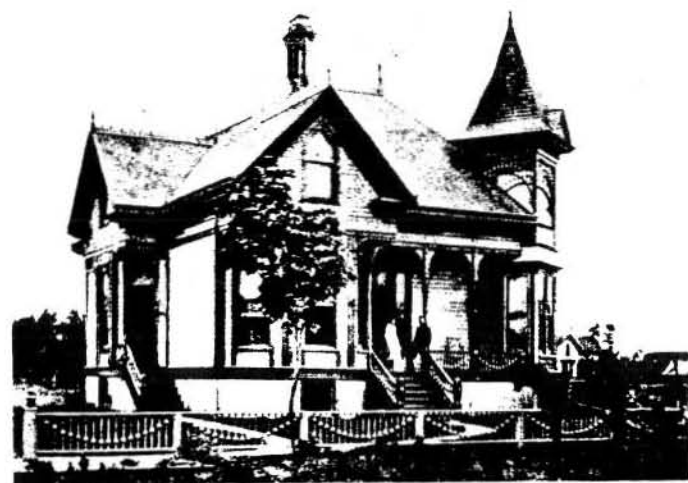
3. Readily available and inexpensive sawn shingles were used not only for roofs, but also for gables and wall surfaces. The circa 1891 Chambers House, Eugene, Oregon used straight sawn butts for the majority of the roof and hexagonal butts for the lower portion of the corner tower. Decorative shingles in the gable ends and an attractive wooden roof cresting feature were also used. Photo: Lane County Historical Society.

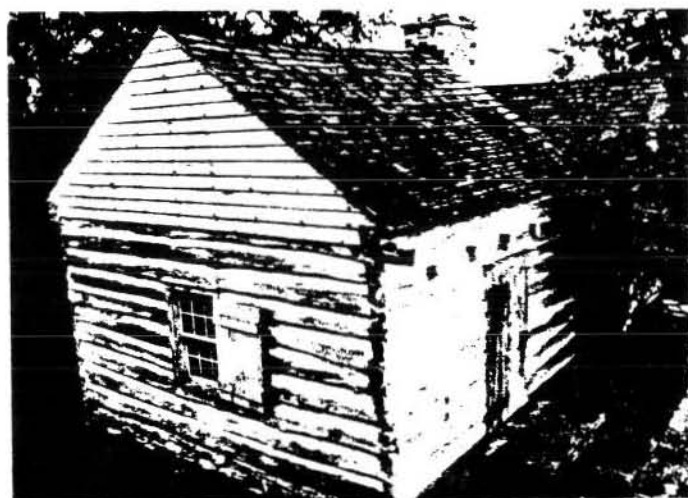
2. Handsplit and dressed shingles were also used on less elaborate buildings as seen in the restoration of the circa 1840 kitchen at the Winedale Inn, Texas. The uneven surfaces of the handsplit shingles were generally dressed or smoothed with a draw-knife to keep the rainwater from collecting in the wood grain and to ensure that the shingles lay flat on the sub-roof. Photo: Thomas Taylor.

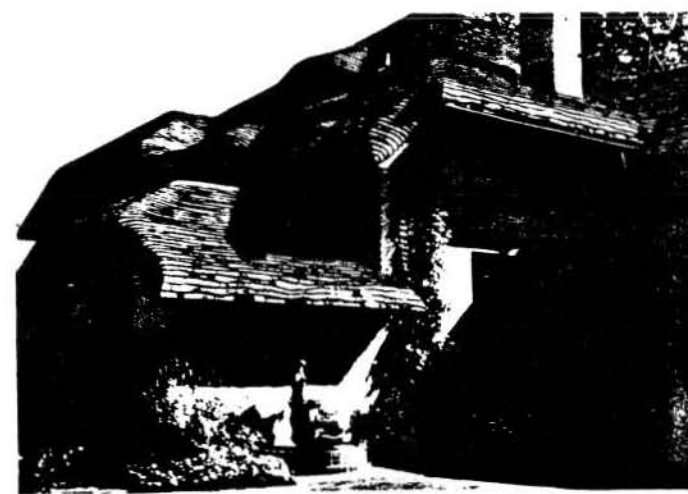
4. With the popularity of the revival of historic styles in the late 19th and early 20th centuries, a new technique was developed to imitate English thatch roofs. For the Tudor Revival thatch cottages, steaming and curving of sawn shingles provided an undulating pattern to this picturesque roof shape. Photo: Courtesy of C.H. Roofing.

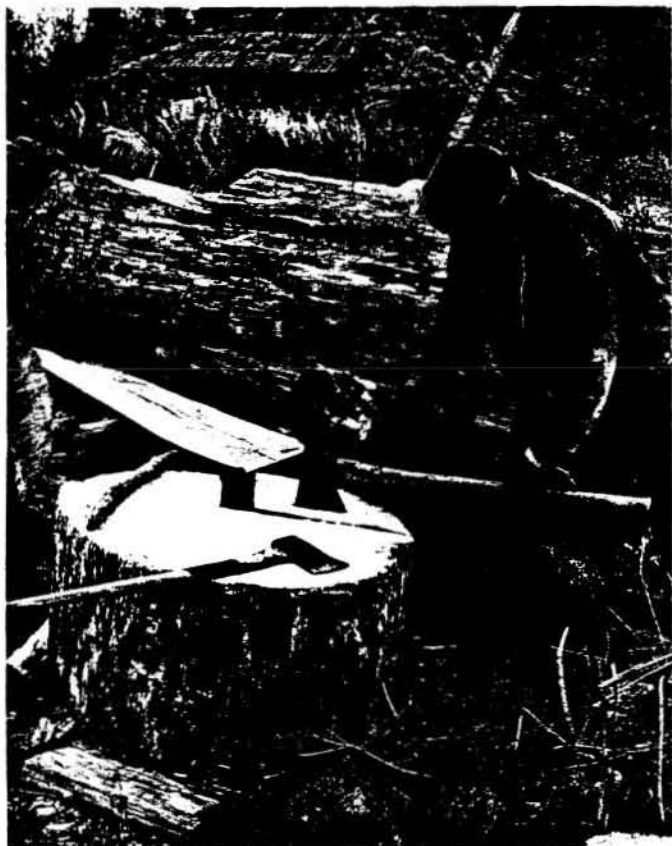
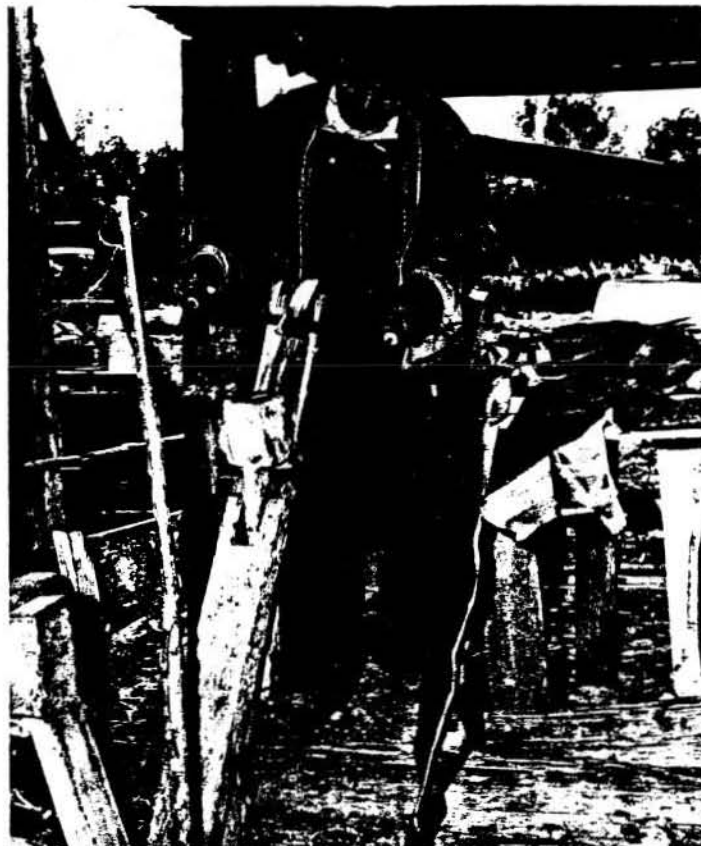
5. Custom Handsplitted shingles are still made the traditional way with a mallet and froe or ax. For these cypress shingles, a "bolt" section of log (photo A) the length of the shingle has been sawn and is ready to be split into wedge-shaped segments. Handsplitted shingles are fabricated with the ax or froe cutting the wood along the grain and separating, or riving, the shingle away from the remaining wedge. The rough surfaces are dressed on a shavinghorse using a draw-knife as shown above (photo B). Note the long wooden shingles covering the work shed in photo A. Photos: Al Honeycutt, North Carolina Division of Archives and History.

**Shingle Fabrication.** Historically wooden shingles were usually thin (3/8"-3/4"), relatively narrow (3"-8"), of varying length (14"-36"), and almost always smooth. The traditional method for making wooden shingles in the 17th and 18th centuries was to handsplit them from log sections known as bolts (see illus. 5A). These bolts were quartered or split into wedges. A mallet and froe (or ax) were used to split or rive out thin planks of wood along the grain. If a tapered shingle was desired, the bolt was flipped after each successive strike with the froe and mallet. The wood species varied according to available local woods, but only the heartwood, or inner section, of the log was usually used. The softer sapwood generally was not used because it deteriorated quickly. Because handsplit shingles were somewhat irregular along the split surface, it was necessary

to dress or plane the shingles on a shavinghorse with a draw-knife or draw-shave (see illus. 5B) to make them fit evenly on the roof. This reworking was necessary to provide a tight-fitting roof over typically open shingle lath or sheathing boards. Dressing, or smoothing of shingles, was almost universal, no matter what wood was used or in what part of the country the building was located, except in those cases where a temporary or very utilitarian roof was needed.

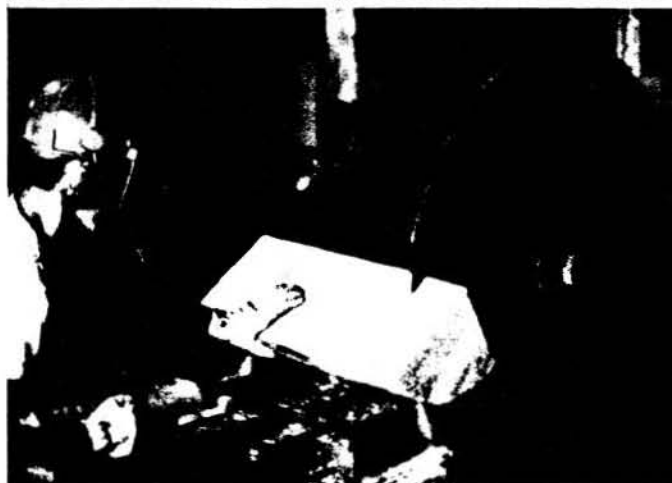
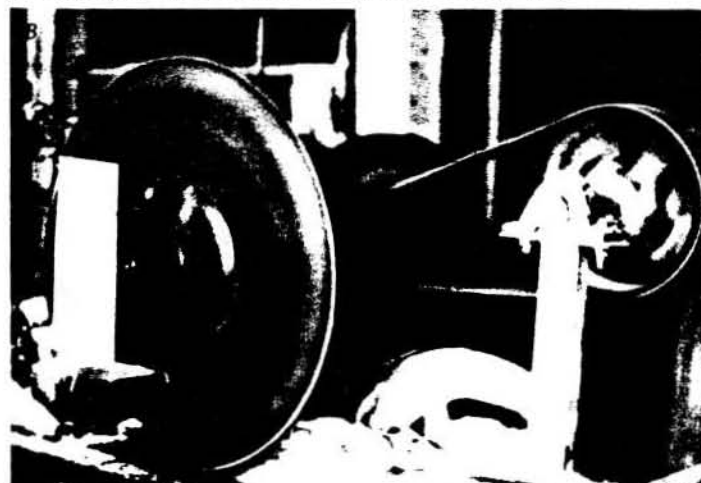
6. Modern machine-made shingles are sawn. Shown are: (photo A) Eastern White Pine quarter split shingle block on equalizer saw being trimmed to parallel the ends; and (photo B) the restored 19th-century shingle mill saw cutting tapered fitches or shingles. The thickness and taper can be precisely controlled. Photo: Steve Ruscio, The Shingle Mill.

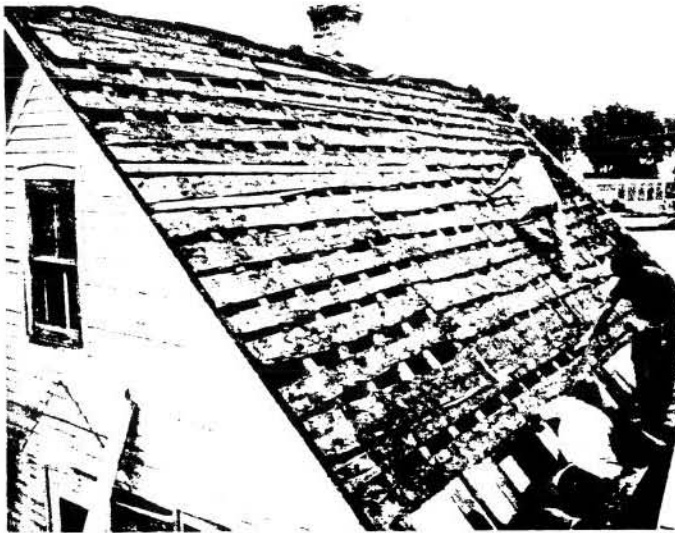
7. The reroofing of the circa 1856 Stovewood House in Decorah, Iowa, revealed the original open sheathing boards and pole rafters. Sawn cedar shingles were used as a replacement for the historic cedar shingles seen still in place at the ridge. A new starter course is being laid at the eaves. Photo: Norwegian-American Museum, Decorah, Iowa.

In order to have a weathertight roof, it was important to have adequate coverage, proper spacing of shingles, and straight grain shingles. Many roofs were laid on open shingle lath or open sheathing boards (see illus. 7). Roofers typically laid three layers of shingles with approximately 1/3 of each shingle exposed to the weather. Spaces between shingles (1/8"–1/2" depending on wood type) allowed the shingles to expand when wet. It was important to stagger each overlapping shingle by a minimum of 1-1/2" to avoid a direct path for moisture to penetrate a joint. Doubling or tripling the starter course at the eave gave added protection to this exposed surface. In order for the roof to lay as flat as possible, the thickness, taper and surface of the shingles was relatively uniform; any unevenness on handsplit shingles had already been smoothed away with a drawknife. To keep shingles from curling or cupping, the shingle width was generally limited to less than 10".

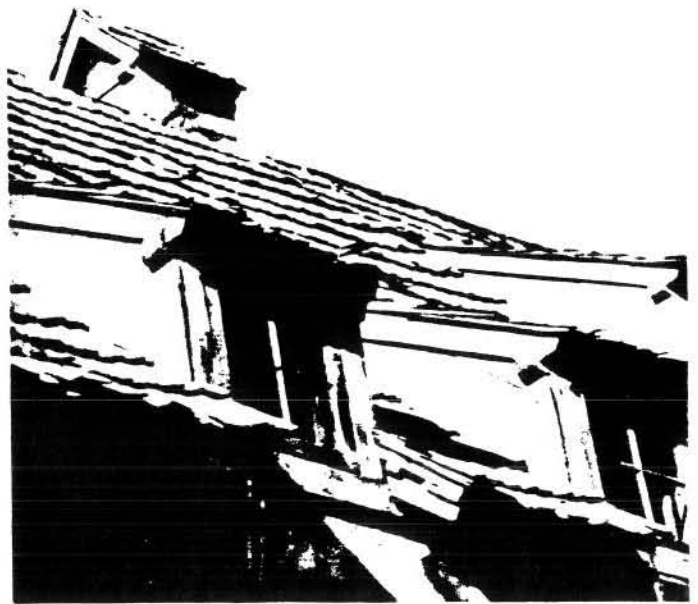
8. The long biaxially tapered handsplit shingles on the Ephrata Cloisters in Pennsylvania were overlapped both vertically and horizontally. The insert sketch shows channels under the shingles that provided ventilation and drainage of any trapped moisture. The aged appearance of these handsplit and dressed shingles belies their original smoothness. Replacement shingles should match the original, not the aged appearance. Photo: National Park Service; Sketch: Reed Engle.

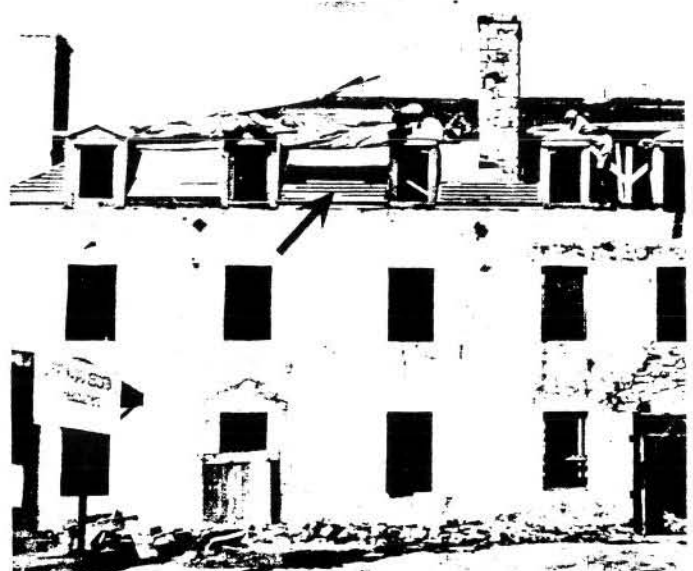
9. This 1927 view of the reroofing of the French Castle at Old Fort Niagara, N.Y., shows the wooden sleepers being laid (see arrow) over solid sheathing in order to raise the shingles up slightly to allow under-shingle ventilation. Note that the horizontal strips are not continuous to allow airflow and trapped moisture to drain away. This cedar roof has lasted for over 60 years in a harsh moist environment. Photo: Old Fort Niagara, Assoc. Inc.

Not all shingles were laid in evenly spaced, overlapping, horizontal rows. In various regions of the country, there were distinct installation patterns; for example, the biaxially-tapered long shingles occasionally found in areas settled by the Germans (see illus. 8). These long shingles were overlapped on the side as well as on top. This formed a ventilation channel under the shingles that aided drying. Because ventilation of the shingles can prolong their life, roofers paid attention to these details (see illus. 9).

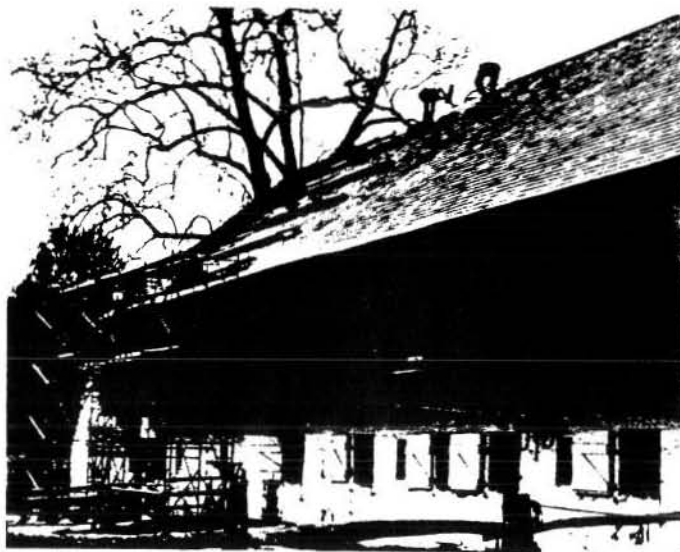
11. The replacement sawn red cedar shingles matched the deteriorated shingles exactly for this barn re-roofing. The old shingles, seen to the far left, were removed as the new shingles were installed. Even the horizontal coursing matched because the exposure length for both old and new shingles was the same. Photo: Williamsport Preservation Training Center.

mation regarding the early shingles used. Before specifying a replacement roof, it is important to *establish the original shingle material, configuration, detailing and installation* (see illus. 11). If the historic shingles are still in place, it is best to remove several to determine the size, shape, exposure length, and special features from the unweathered portions. If there are already replacement shingles on the roof, it may be necessary to verify through photographic or other research whether the shingles currently on the roof were an accurate replacement of the historic shingles.

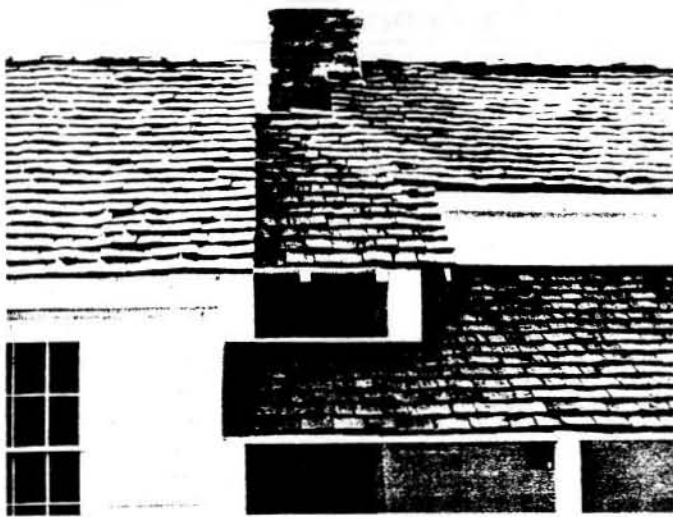
12. Inappropriately selected and installed wooden shingles can drastically alter the historic character of a building. This tavern historically was roofed with handsplit and dressed shingles of a relatively smooth appearance. In this case, a commercially available shake was used to effect a "rustic" appearance. Photo: National Park Service.

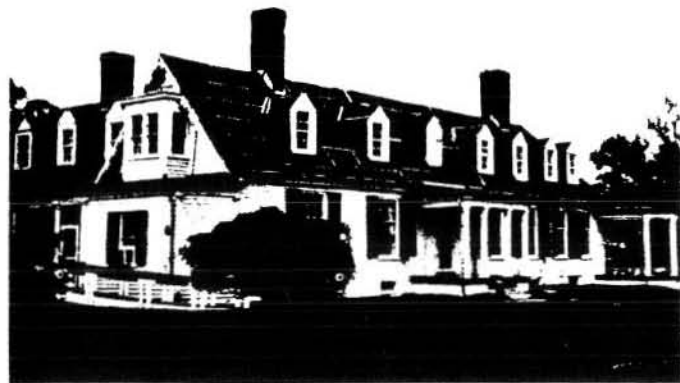
A. The later non-historic shingles were removed from Appomattox Manor (circa 1840 with later additions) and roofing paper was installed for temporary protection during the re-shingling.

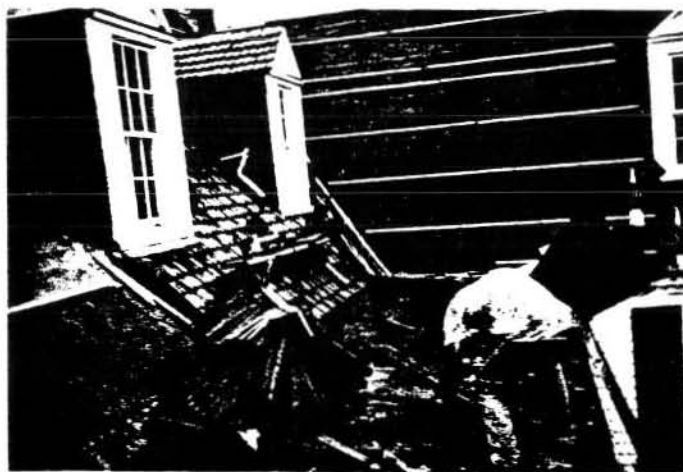
C. The replacement shingles (see specifications above), matched the historic shingles and were of such high quality that little hand dressing was needed at the site. The building paper, a temporary protection, was removed as the shingles were installed on the sheathing boards.

**Type of nails and flashing:** double hot dipped galvanized nails sized to penetrate sheathing totally; metal flashing to be 20 oz. lead-coated copper, or terne-coated stainless steel; additional flashing reinforcement to be aluminum foil type with fiber backing to use at hips, ridges, eaves, and valleys.

**Type of sheathing:** uninsulated attic, any deteriorated 3/4" sheathing boards, spaced 1/2"-3/4", to be replaced in kind.

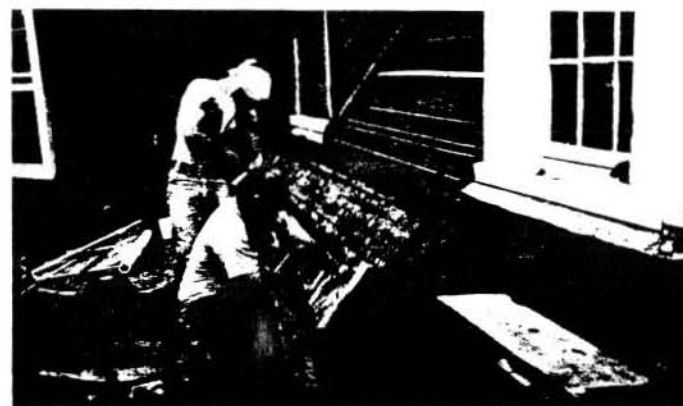
E. In order to achieve a "Class B" fire-rating, the shingles were dipped in fire-retardant chemicals and allowed to dry prior to installation. Iron oxide was added to this chemical dip to stain the shingles to match the historic red color. These coatings will need periodic reapplication.

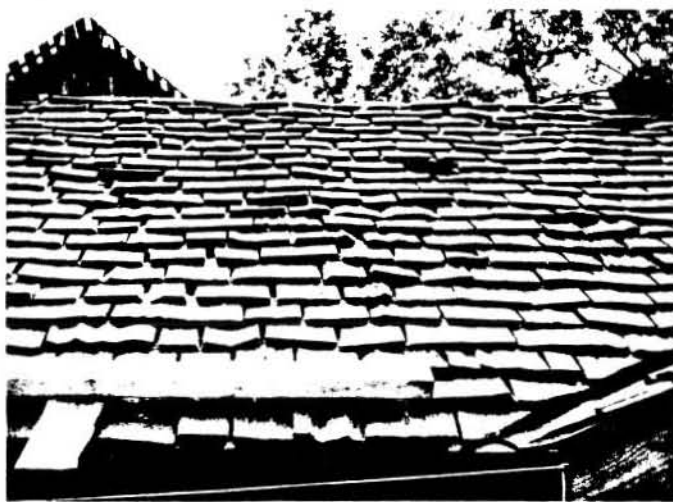
15. These commercially available roofing products with rustic split faces are not appropriate for historic preservation projects. In addition to the inaccurate appearance, the irregular surfaces and often wide spaces between shingles will allow wind-driven moisture to penetrate up and under them. The excessively wide boards will tend to cup, curl and crack. Moss, lichens and debris will have a tendency to collect on these irregular surfaces, further deteriorating the roofing. Photo: Sharon C. Park.

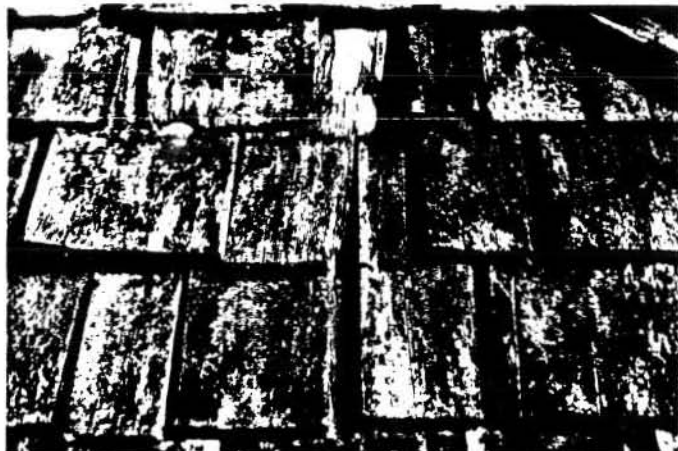
16. Routine maintenance is necessary to extend the life of the roof. On this roof, the shingles have not seriously eroded, but the presence of lichens and moss is becoming evident and there are a few cracked and missing shingles. The moss spores should be removed, missing shingles replaced, and small pieces of metal flashing slipped under cracked shingles to keep moisture from penetrating. Photo: Williamsport Preservation Training Center.

Periodic maintenance inspections of the roof may reveal loose or damaged shingles that can be selectively replaced before serious moisture damage occurs (see illus. 16). Keeping the wooden shingles in good condition and repairing the roof, flashing and guttering, as needed, can add years of life to the roof.
