GEORGETOWN STEAM PLANT

HISTORIC STRUCTURE & CULTURAL LANDSCAPE REPORT

OCTOBER 9, 2013

BOLA ARCHITECTURE + PLANNING

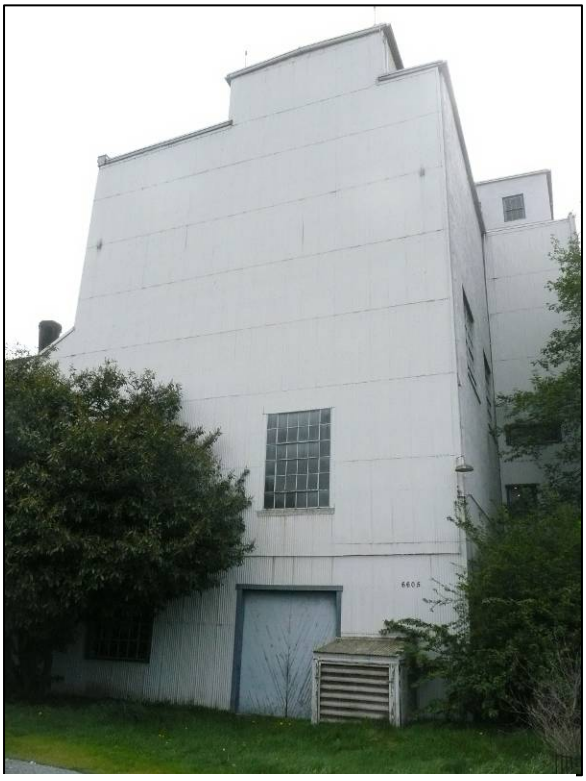
The east and south walls of the 1918 Addition are framed with wood and limited steel framing, and clad with corrugated steel panels, measuring approximately 2' wide by 8' tall, with exposed fasteners. The lower 16' of wall is sheathed with building paper at the inside face. The drawings for the 1918 Addition indicate that the eastern wall of the original Engine Room, including the framing, cladding and windows, were to be disassembled and moved to the new wall location, approximately 37' east, but it is unclear from a review of the existing openings and framing if the wall materials were relocated or new materials were provided. Construction drawings and specifications from 1985 indicate that the corrugated metal siding and roofing were to be replaced as part of that scope of work.

Figure 58: East wall of the 1918 Addition with corrugated metal cladding.

Figure 59: East and south walls of the 1918 Addition with corrugated metal cladding.

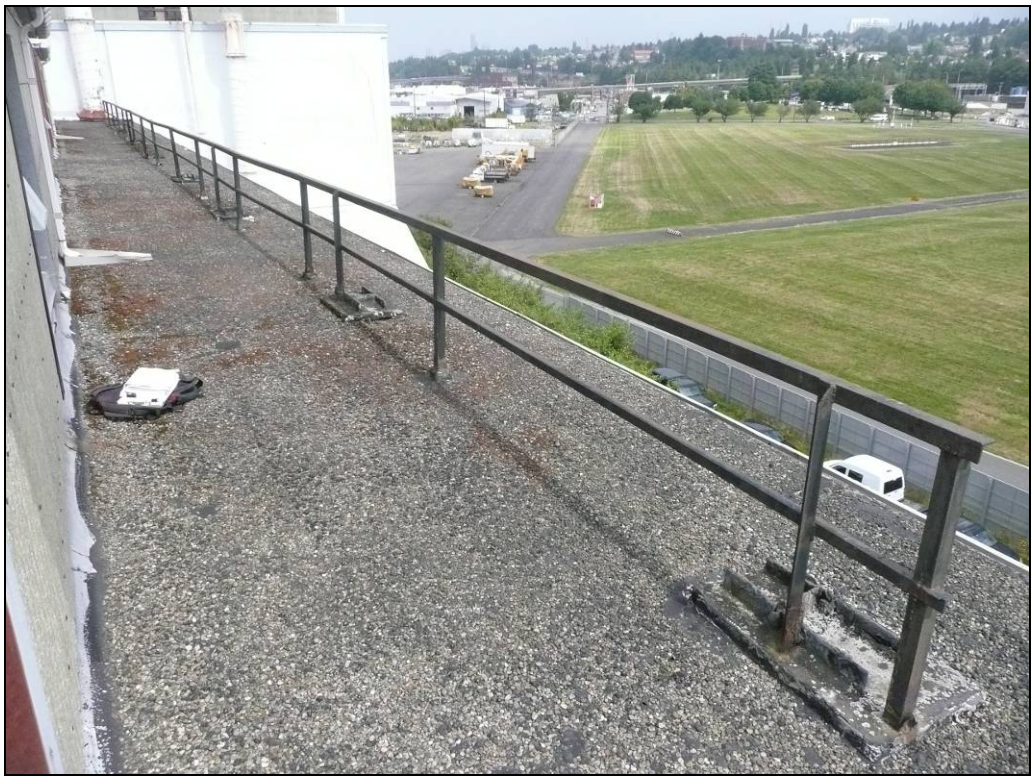
The rooftop exhaust stacks and vents contribute to the industrial character and understanding of the function of the facility, while the ladders and railings provide accessibility and some level of safety for roof maintenance. The eight black exhaust stacks date from ca. 1939, when the original masonry stacks on the south end of the building were removed as part of FAA flight path mitigation. The access ladders to the various roof levels were replaced in 1984, according to SCL Archives drawing #D-20068. Painted steel angle railings, attached to large steel base plates in pitch pockets, are present on the east and west sides of the main roof of the boiler wing. The north end of the west railing is not attached to the terminating wall.

Figure 67: Steel angle railing on the east side of the Boiler Room roof, with steel mounting plates and pitch pockets.

The metal should be repaired or replaced where eroded beyond repair, surface prepared, and painted. Asbestos paint coatings have been found on the large black exhaust stacks and adjacent vent stacks. Some of the equipment is provided with cable stays, secured to the roof, and terminated with pitch pockets. Pitch pockets are also used at the base of various penetrations and roof attachments. These pitch pockets should be replaced with a proper flashing to reduce risk of water infiltration.

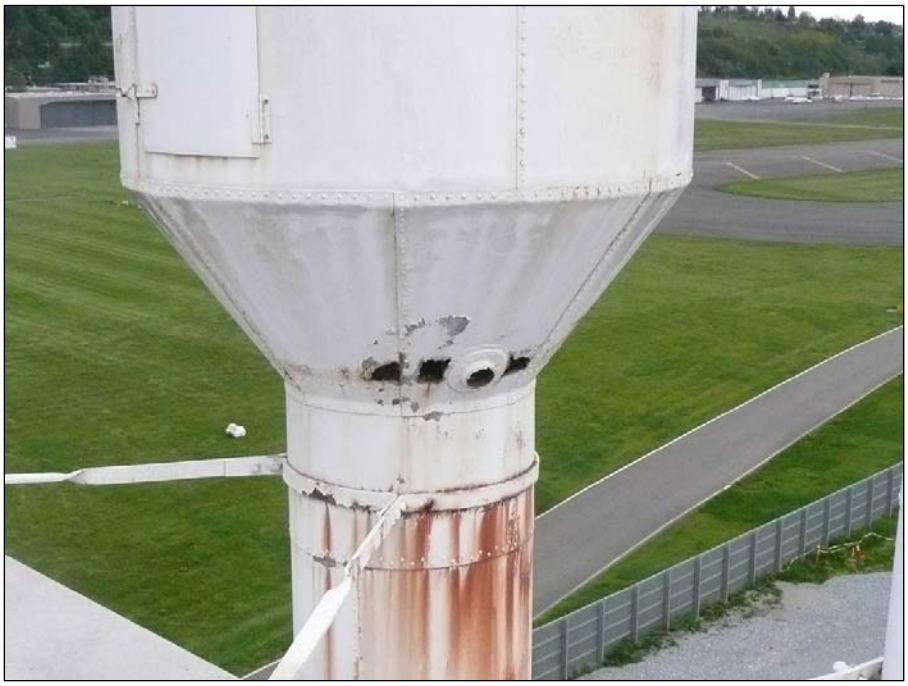
Figure 68: Detail of exhaust vent where the sheet metal has rusted through, providing access for water and pests.

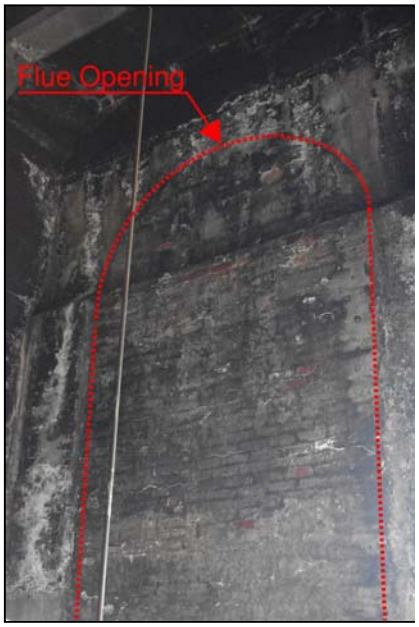
Figure 1-4: Masonry Infilled Flue Opening

The major areas of concerns with the wall are the masonry infill sections in the upper part of the wall (where the horizontal flues used to exit the building) shown in Figure 1-4, and the areas adjacent to the windows. In both cases, the issue is that water is entering the building through and around these elements. Since the brick infill is expected to be unreinforced, there is no steel to corrode at the point where water enters the building. However, the water continues down the inside face of the wall and onto the second floor and has resulted in the corrosion of reinforcing steel in the wall and floor below. The resulting deterioration of the wall is of particular concern with respect to the seismic performance of the building. An example of this can be seen in Figure 1-5.

As work on the building envelope is planned, we recommend giving priority to the south wall. This wall should be the first wall addressed because it is in the worst condition, and is a key component of the seismic force resisting system. The importance of this is further discussed in our seismic evaluation report.

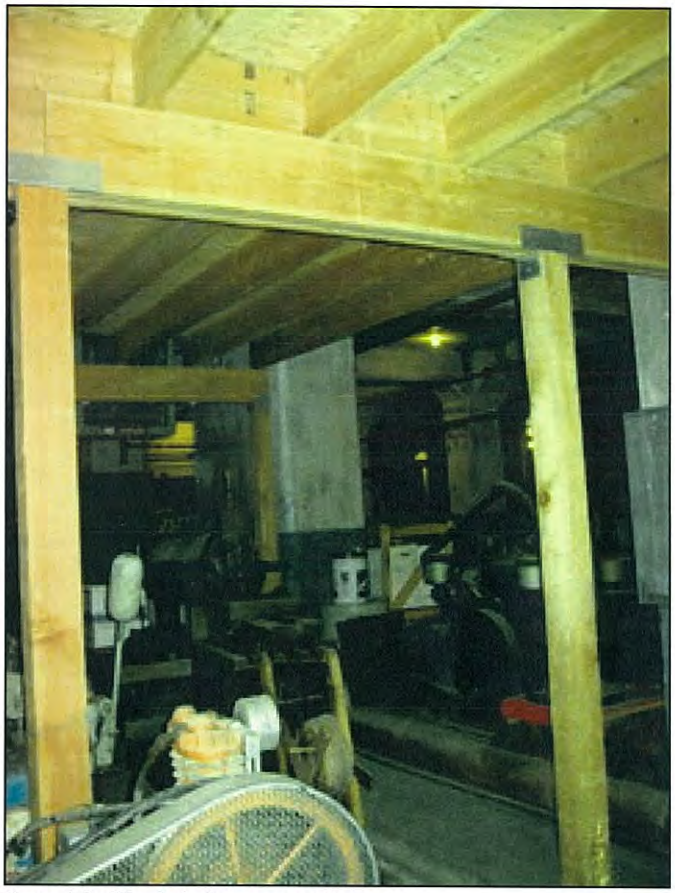
We understand that in the 1990s, the ash hoppers were partially demolished, see Figure 1-3. This partial demolition has created a potential life safety condition due to the potential for falling debris that has only been partially mitigated. Of the eight ash hoppers on the east side, the southern seven were partially demolished. We could not observe the condition of the structure in this area as it was hidden by a steel platform; see Figure 1-4, that was added in the 1990s to mitigate this hazard. We were unable to find documentation for the construction, but the platform appeared to be in good condition. Six of the eight ash hoppers on the east side were partially demolished. The third, fourth, and fifth ash hoppers from the south have been partially mitigated by constructing a wood platform, see Figure 1-5, to protect against falling debris. Like the steel platform on the east side, we were unable to find documentation for the construction, but the platform appeared to be in good condition. The north most ash hoppers remaining on the west side have had no mitigation performed and present an imminent hazard due to falling debris.

Figure 1-5: Wood platform on west bay.

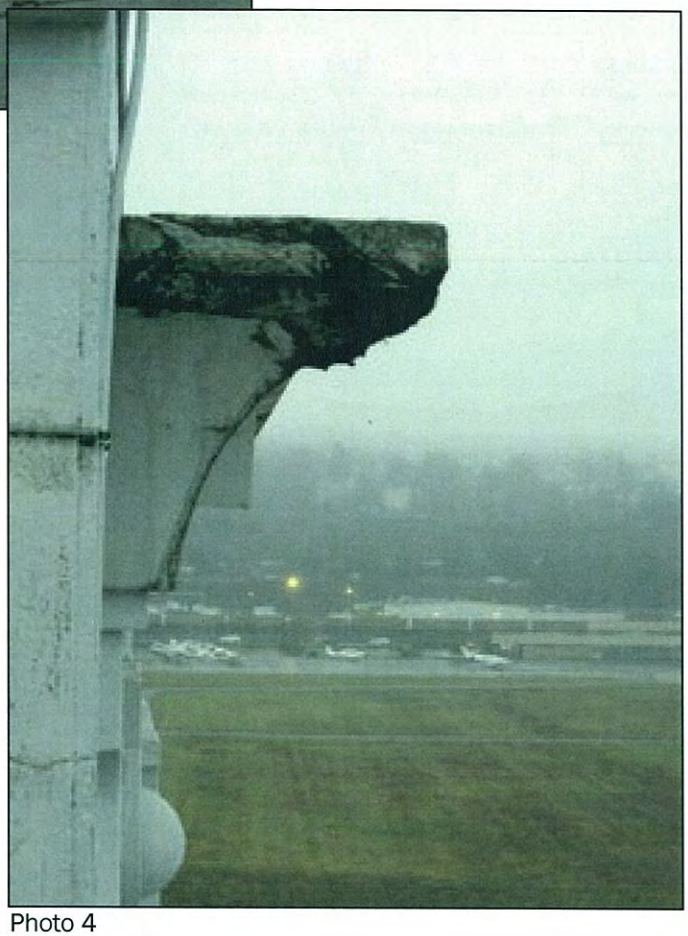
Photo 3 – Top of south façade with cracks and exposure of concrete.
Photo 4 – Top of south façade at west ledge.

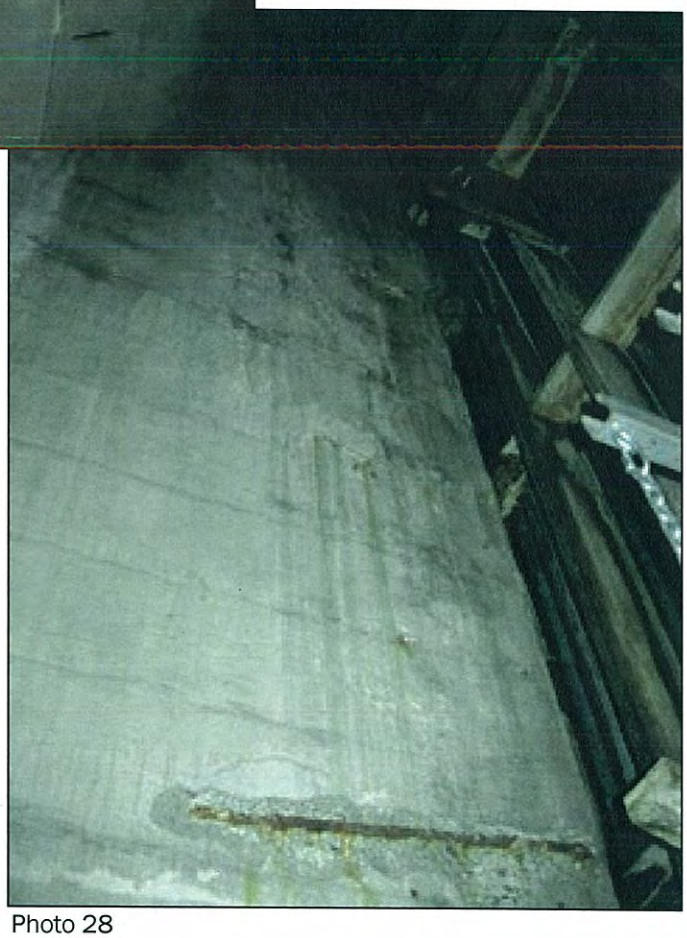
Photo 27 – Steel corrosion at underside of roof slab.
Photo 28 – Concrete staining and reinforcement corrosion at the east addition at the second floor.

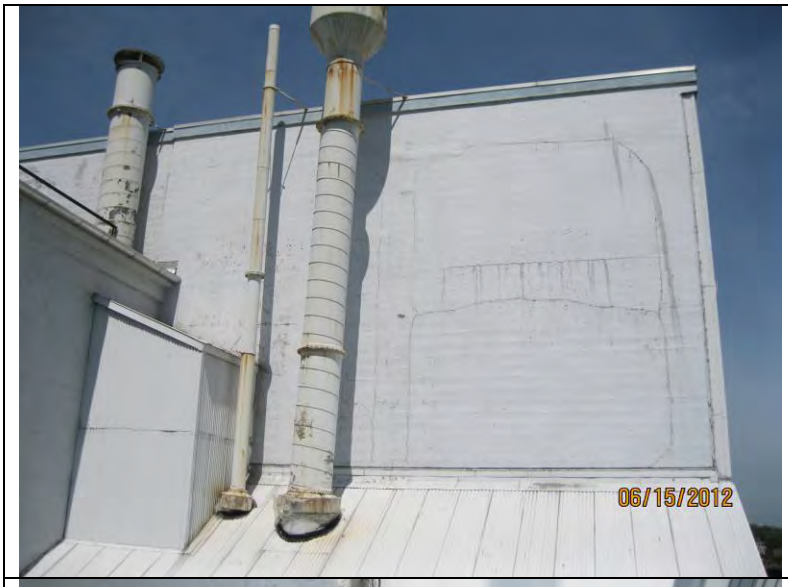
Photo 29: South facing wall at engine room addition. Corrugated metal roofing below.

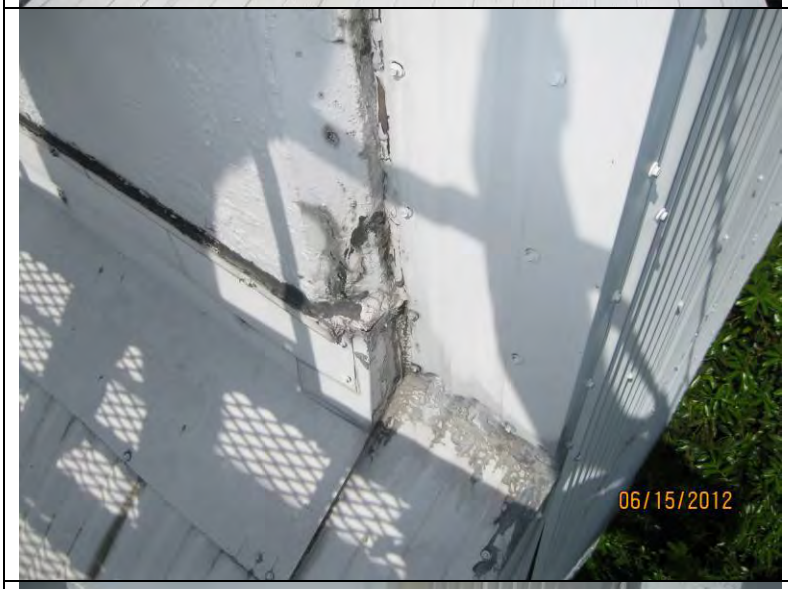
Photo 30: Corner of corrugated metal roof is not well flashed. Flashing should extend beyond corner. Sealant joint needs to be replaced or covered with sheet metal..
	Photo 31: Stack penetrations through corrugated metal roof need to be reflashed and sealed, as the metal flashing is rusted through in locations.

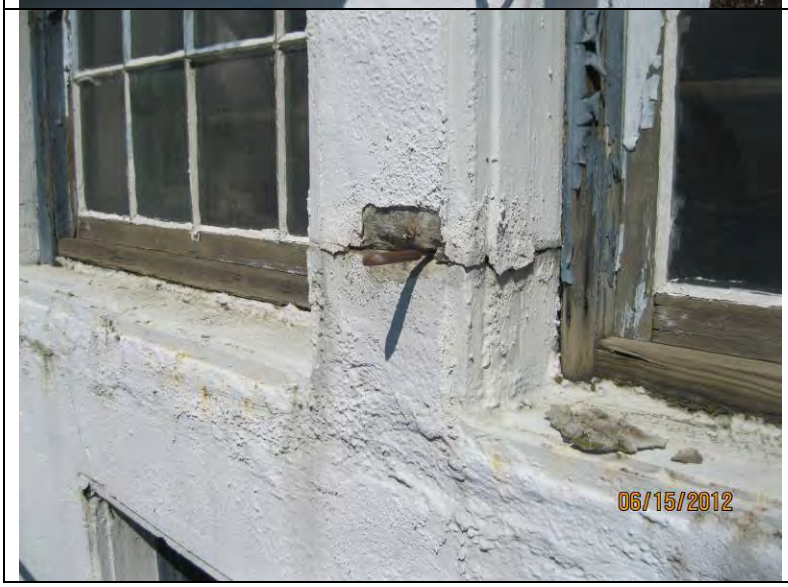
Photo 44: Sealant knife inserted into what appears to be an open cold joint in the concrete between windows, south elevation.

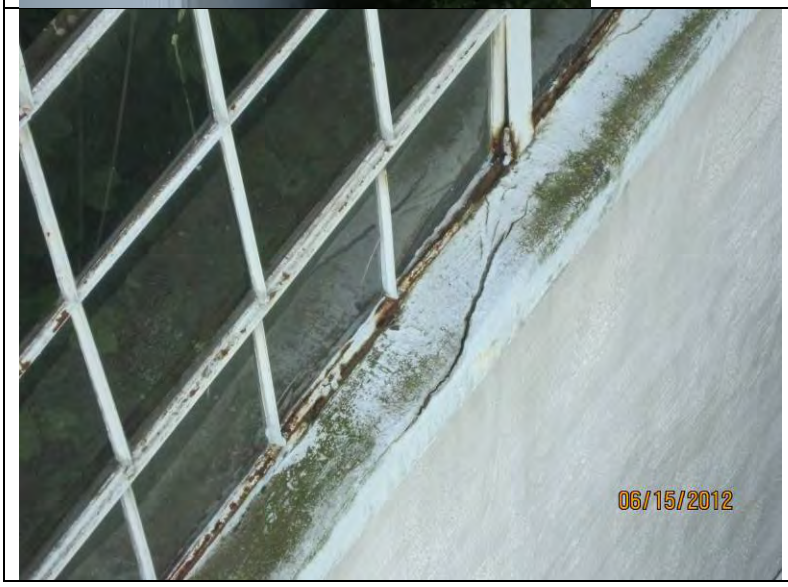
Photo 55: Rusted steel framed window and spalled concrete sill material.

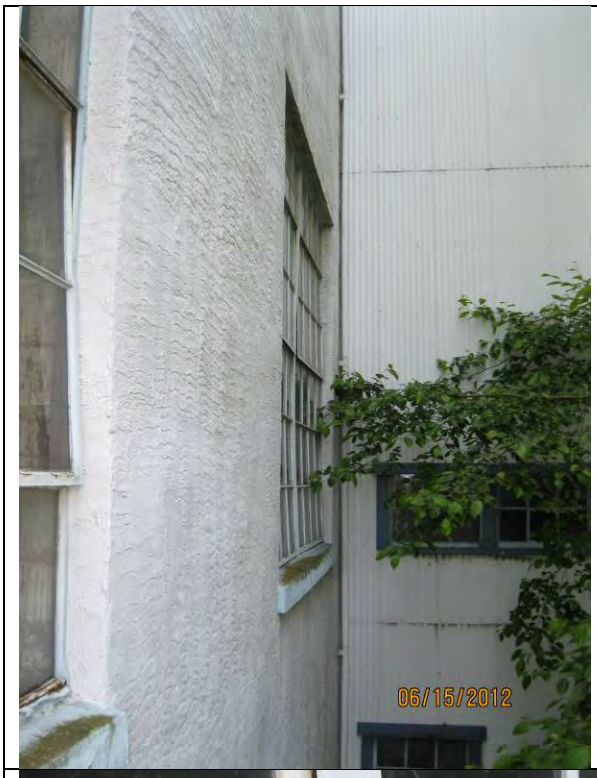
Photo 56: Steel windows are deflected inward at north wall of 1918 addition.
	Photo 57: Rusted steel window at north elevation of 1918 addition.

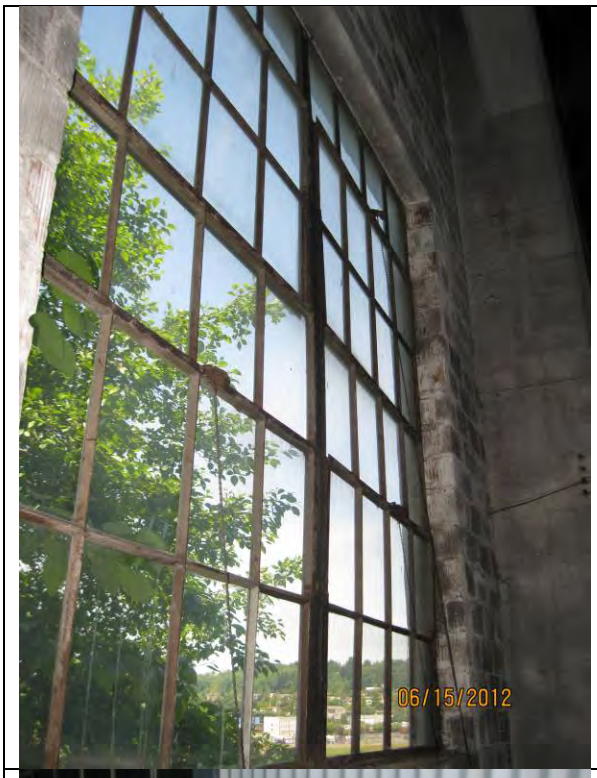
Photo 58: Window deflecting inward at north elevation of addition. Note hollow clay tile at interior wall.
		Photo 59: Steel siding below grade at east elevation of addition.

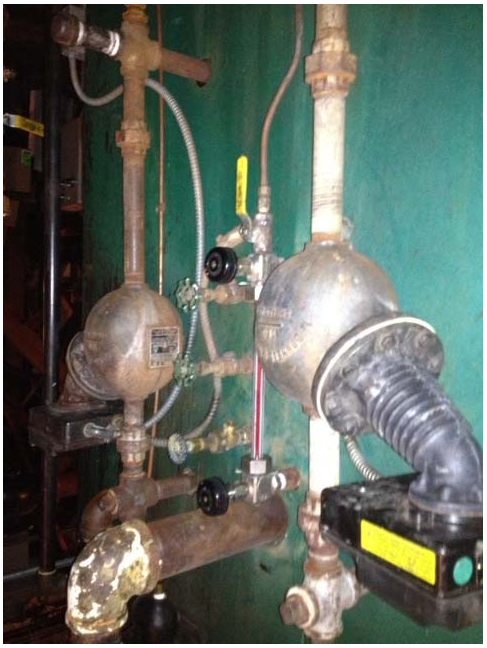
Image 11: Corrosion on boiler, piping

2. Corrosion on the boiler exterior and accessible areas inside the boiler should be wire brushed and primed to minimize further corrosion.

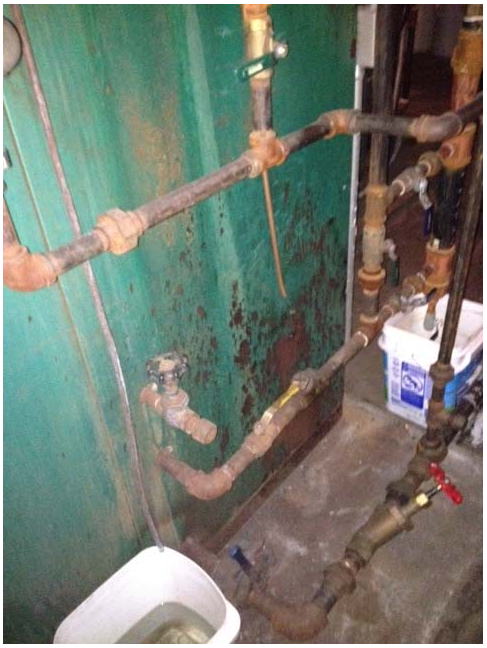
Image 12: Corrosion on boiler, piping

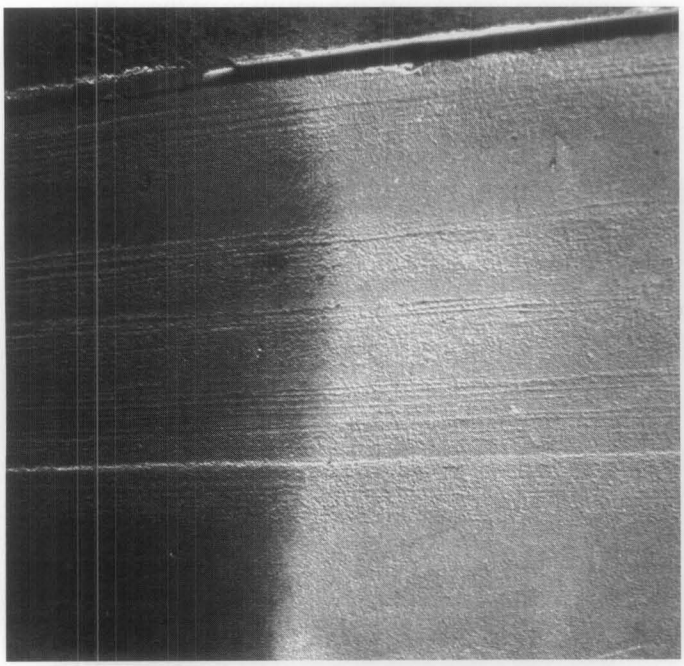
Figure 20. (Left) A comparison of the limestone surface of a 1920s office building before and after "cleaning" with a proprietary abrasive process using fine glass powder clearly shows the effectiveness of this method. But this is an abrasive technique and it has "cleaned" by removing part of the masonry surface with the dirt. Because it is abrasive, it is generally not recommended for large-scale cleaning of historic masonry, although it may be suitable to use in certain, very limited cases under controlled circumstances. (Right) A vacum chamber where the used glass powder is collected for environmentally safe disposal is a unique feature of this particular process. The specially-trained operators in the chamber wear protective clothing, masks and breathing equipment. Photos: Tom Keohan.

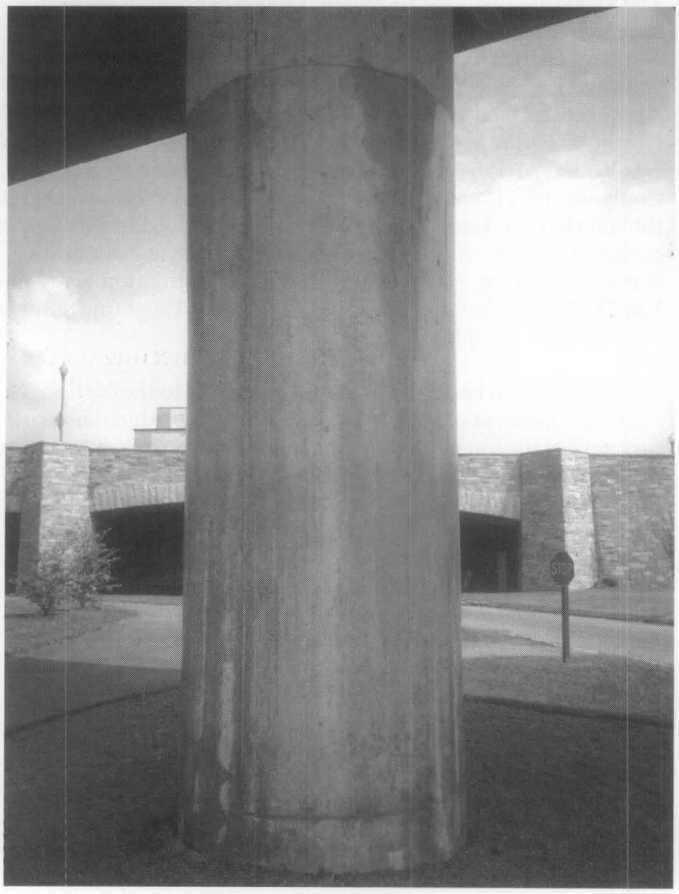
Figure 26. The anti-graffiti or barrier coating on this column is very shiny and would not be appropriate to use on a historic masonry building. The coating has discolored as it has aged and whitish streaks reveal areas of bare concrete where the coating was incompletely applied.

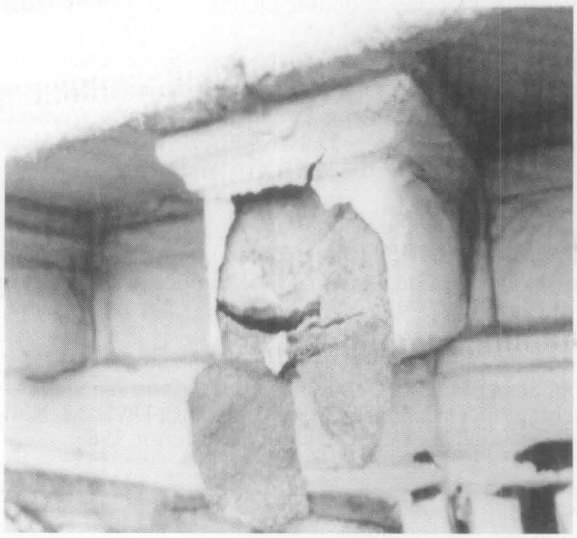
In addition, the water eventually will get out by the path of least resistance. If this path is toward the interior, damage to interior finishes can result; if it is toward the exterior, it can lead to damage to the masonry caused by built-up water pressure (Fig. 27).

Figure 27. Instead of correcting the roof drainage problems, an elastomeric coating was applied to the already saturated limestone cornice. An elastomeric coating holds moisture in the masonry because it does not "breathe" and does not allow liquid moisture to escape. If the water pressure builds up sufficiently it can cause the coating to break and pop off as shown in this example, often pulling pieces of the masonry with it. Photo: National Park Service Files.

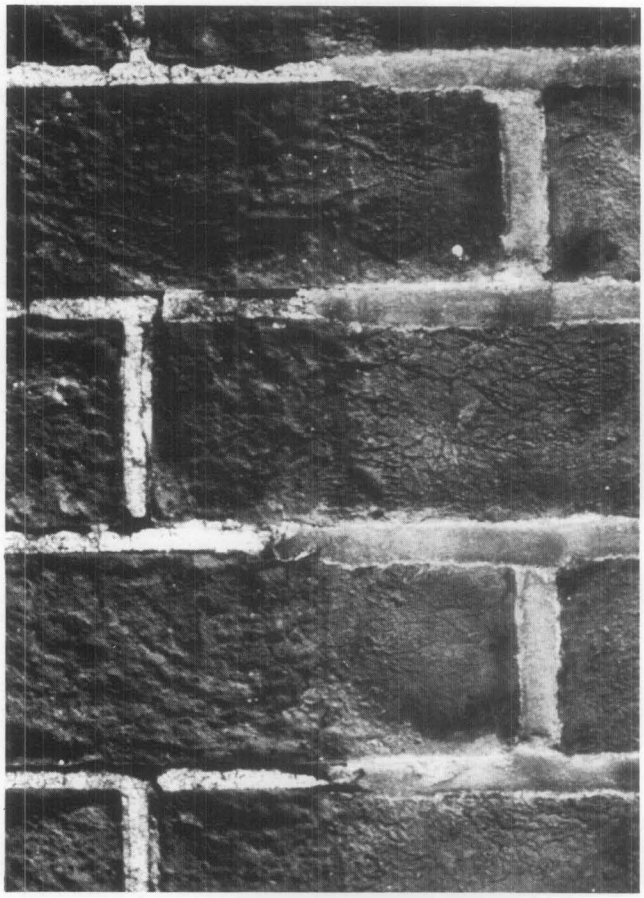
Abrasively Cleaned vs. Untouched Brick. *Two brick rowhouses with a common façade provide an excellent point of comparison when only one of the houses has been sandblasted. It is clear that abrasive blasting, by removing the outer surface, has left the brickwork on the left rough and pitted, while that on the right still exhibits an undamaged and relatively smooth surface. Note that the abrasive cleaning has also removed a considerable portion of the mortar from the joints of the brick on the left side, which will require repointing.*

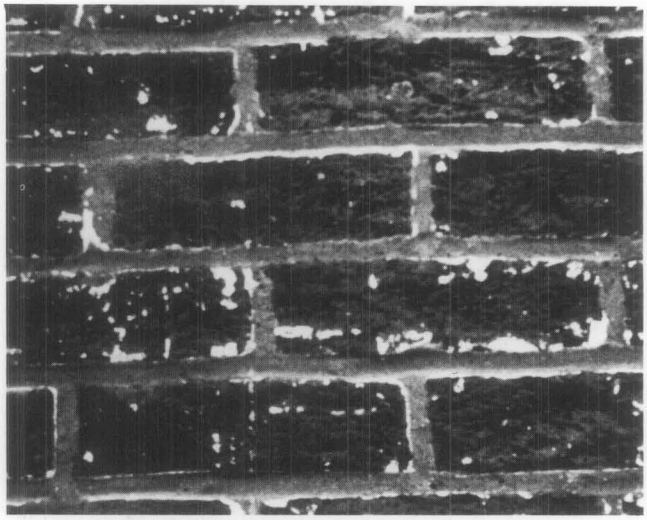
Abrading the Surface without Removing the Paint. *Even though the entire outer surface layer of the brick has been sandblasted off, spots of paint still cling to the masonry. Sandblasting or other similarly abrasive methods are not always a successful means of removing paint.*

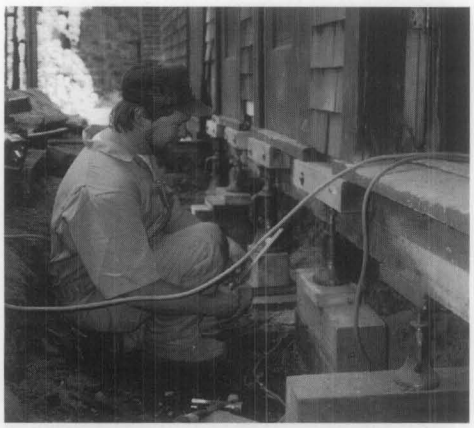
B. Wood sills set on grade were replaced with concrete pier foundation and new wooden sill plates. Changes were not visible on the exterior (see C). Photo: WPTC, NPS.

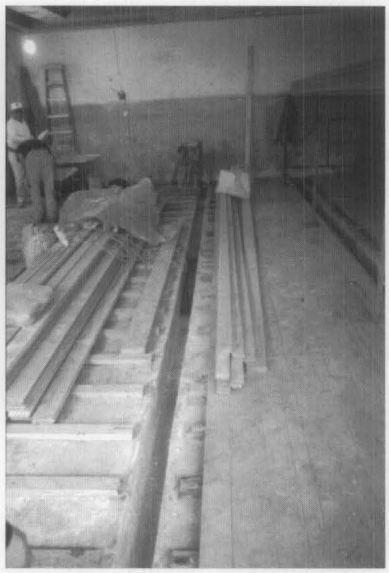
D. In a flood plain, rotted joists were replaced with a concrete slab and sleepers designed to drain water. Spaced flooring allowed drainage and room for damp wood to swell without buckling. Harper's Ferry Center, NPS.

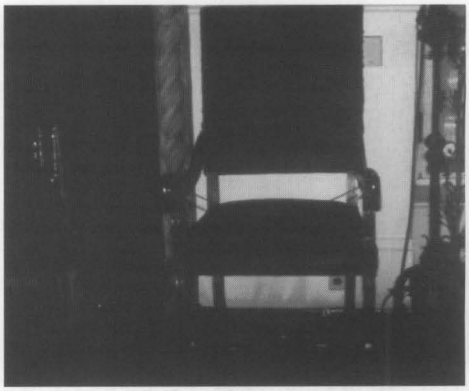
F. Triple glazed windows replaced the originals to control condensation. Photo: © Isabella Stewart Gardner Museum, Boston.

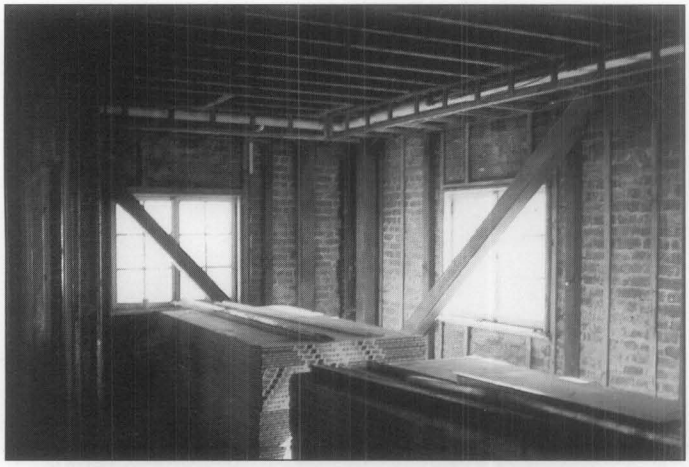
2. Standard approaches to seismic retrofit, as seen with the diagonally braced frame crossing in front of the historic windows, are visually intrusive. Solutions, such as using hidden moment frames around the perimeter of the window, will meet the goals of historic preservation and seismic retrofit. Photo: Steade Craigo.

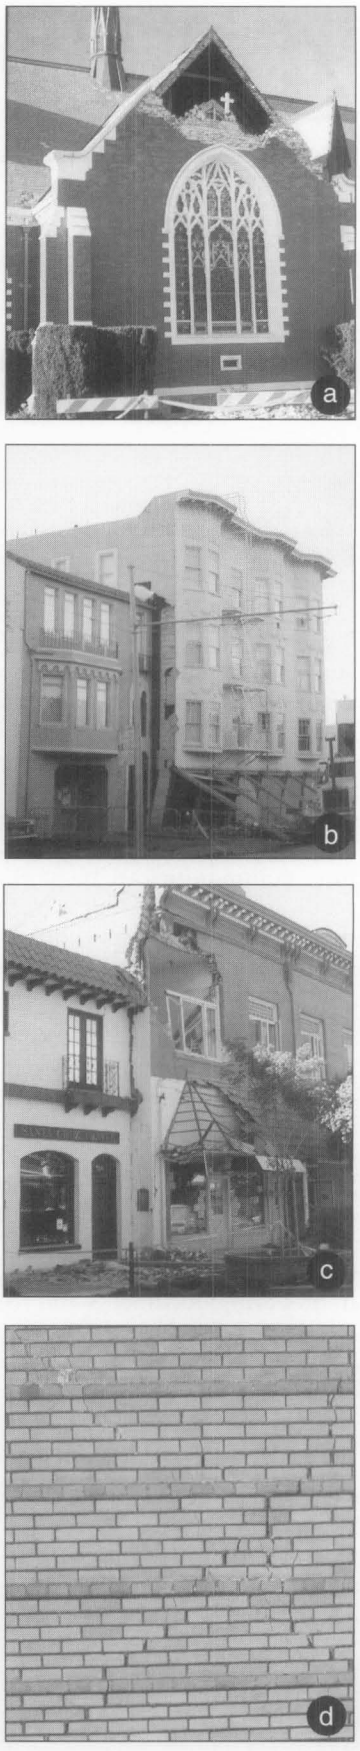
3. Forces from moderate to serious earthquakes caused a) the untied gable to fail, b) the first floor to collapse c) cracks from the pounding effect of adjacent buildings, and d) and diagonal cracks in exterior masonry between windows to form. Photos: David Look.

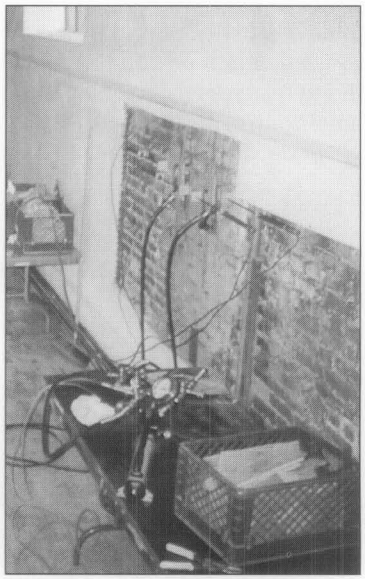
5. A careful program of in-place testing is essential to evaluate the existing seismic capacity of a building. This masonry push-test uses hydraulic jacks to estimate the shear capacity of the wall. Test locations should be in areas that do not destroy significant features and repairs should be carried out carefully. Photo: Architectural Resources Group, San Francisco.

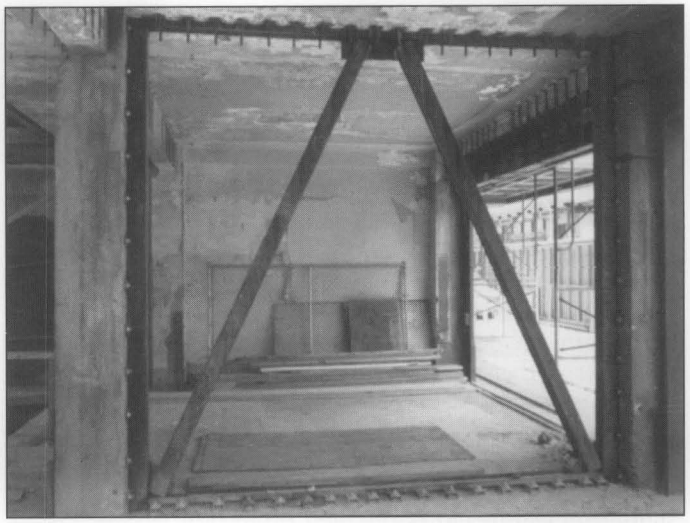
7. More extensive seismic issues can be addressed through structural reinforcement, the most common methods using anchor ties and braces. Shown here is an interior diagonal frame, to be covered, which will dampen and transfer seismic loads in a designed path from foundation to roof. Photo: David Look.

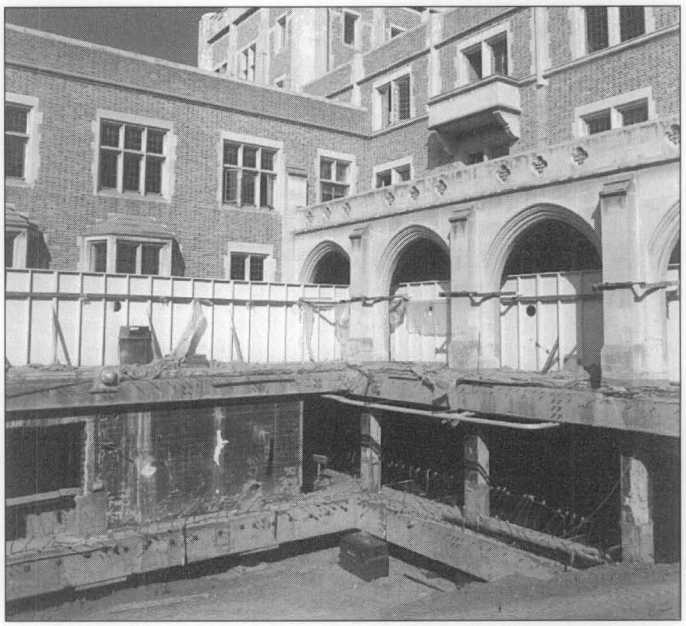
8. Full seismic restructuring to ensure that buildings survive a major earthquake with a minimum of damage may involve extensive reinforcement. Upon completion, the changes to this ca. 1932 Gothic Revival building to add base isolation at the foundation were not visually apparent. Photo: © Jonathan Farrer, courtesy University of California at Los Angeles (UCLA), Capital Programs.

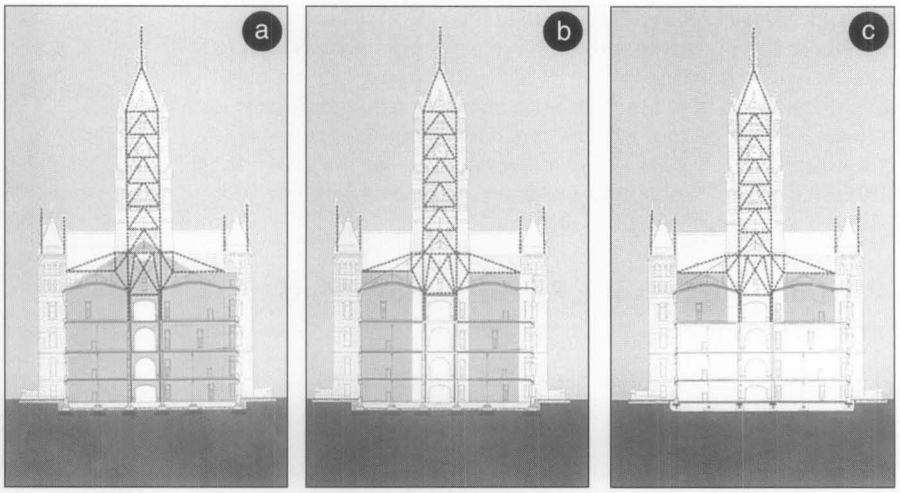
9.These studies for a public building compared, in the shaded areas, the amount of historic material that would be affected by (a) the Uniform Building Code requirements, (b) engineering alternatives that protected significant historic materials, and (c) the use of base isolation systems. The cost for implementing the 3 proposals was similar, and while proposal (c) was selected there were many positive aspects to both (b) and (c). Photos: George Siekkinen, with permission from Ehrenkrantz, Eckstut, & Kuhn Architects.

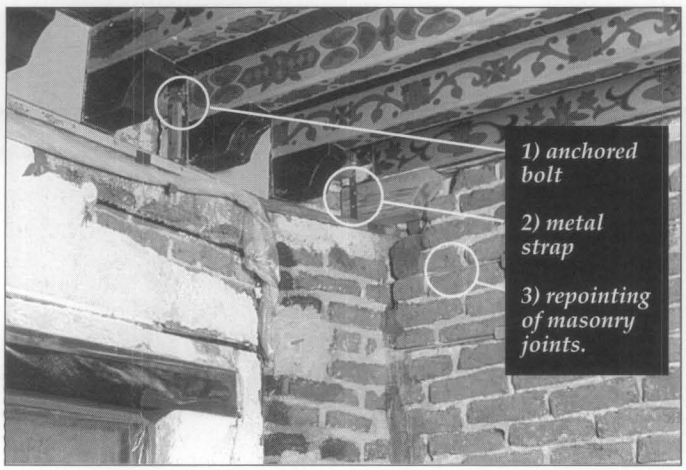
11. Limited intervention should correct obvious structural deficiencies, such as tying vulnerable elements together and repointing masonry. Seen here is 1) anchored bolt, 2) metal joist strap, and 3) repointing and reinforcing masonry joints. Upon replastering and painting these reinforcements will not be visible. Photo: Historic Preservation Partners for Earthquake Response.

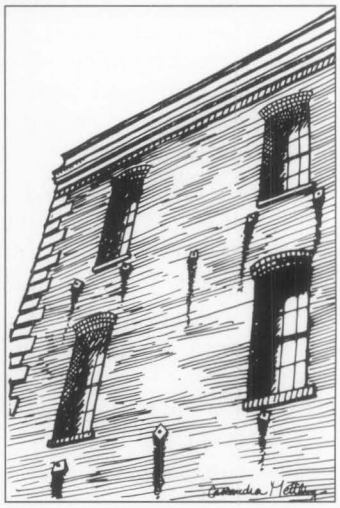
Not Recommended
- The anchor bolts on this building were placed in a haphazard fashion. More care should be taken to align the anchor bolt washers. Also, painting the washers can reduce the unsightly rust streaks that result from weathering.
- Do not place anchor bolts at locations with high relief ornamentation.

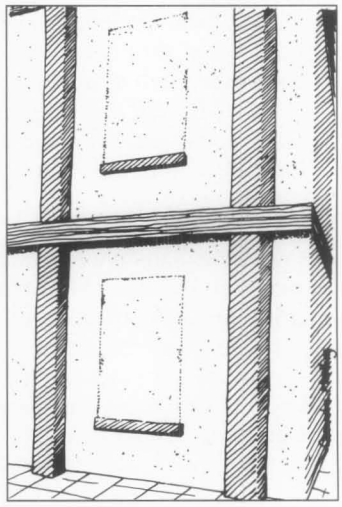
Not Recommended
- Infill techniques such as this are not encouraged. Suggestion of a former window opening should have been emphasized by slightly recessing the former opening.
