PHASE I ENVIRONMENTAL SITE ASSESSMENT

Property:
614 Roy Street Property
614 Roy Street
Seattle, Washington

Prepared for:
City of Seattle Department of Finance and Administrative Services
700 5th Avenue
Seattle, Washington

Report Date:
May 13, 2015

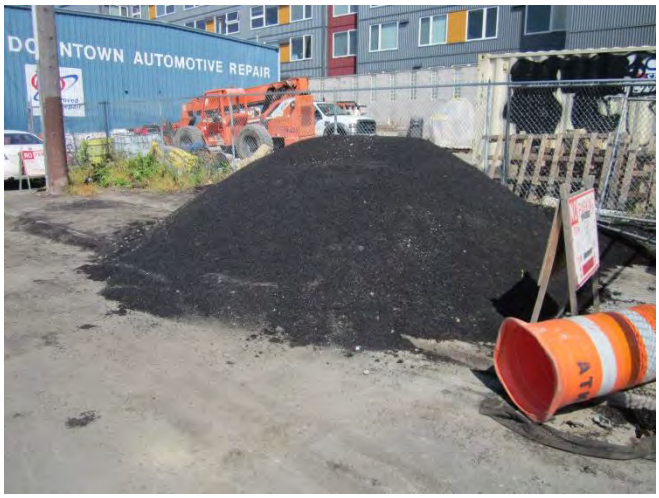
Stressed Vegetation		X	None was observed on the Property or adjoining properties.		X
Possible Fill or Grading	X		A pile of asphalt is stored on the sidewalk south of the Property.		X
Chemical/TPH/Swamp-Gas Odors	X		A petroleum odor was noted inside the flammable materials cabinet. No spills or stains were observed.		X
Stormwater or Surface Erosion		X	Stormwater appears to be directed into the adjoining right-of-ways to the south and the east.		X
Wells and Potable Water		X	No wells were observed on the Property. A groundwater monitoring well was observed in the sidewalk north of the south-adjoining property.		X

Photograph 6. Asphalt stored on the south-adjoining sidewalk.
