## Inspection Report

**Prepared for: Phinney Neighborhood Association - Bill Fenimore**

**Property Address:**  
Greenwood Senior Center  
525 N 85th St  
Seattle WA 98103

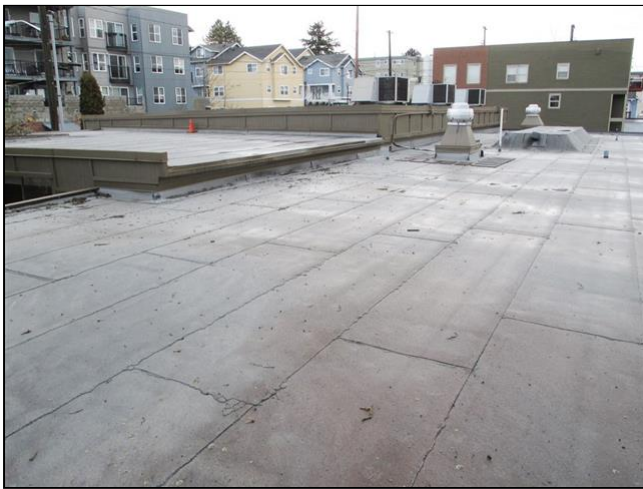
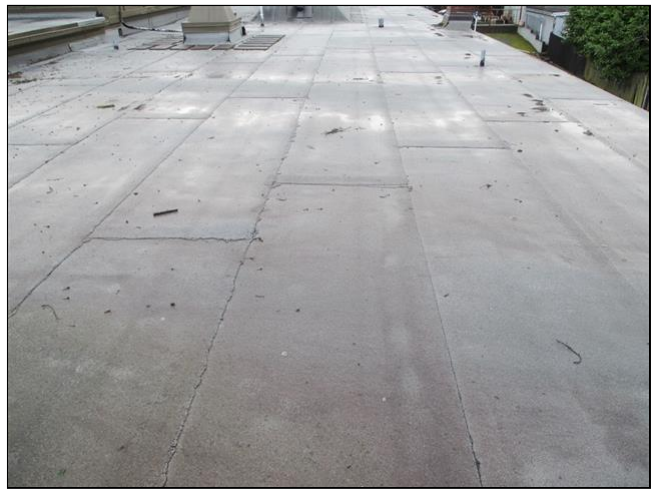
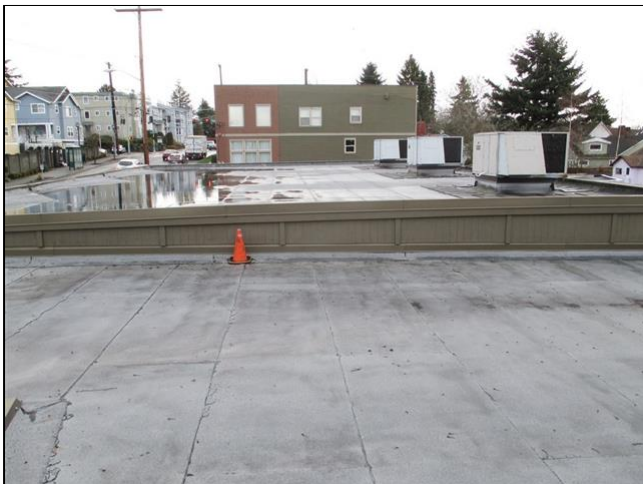
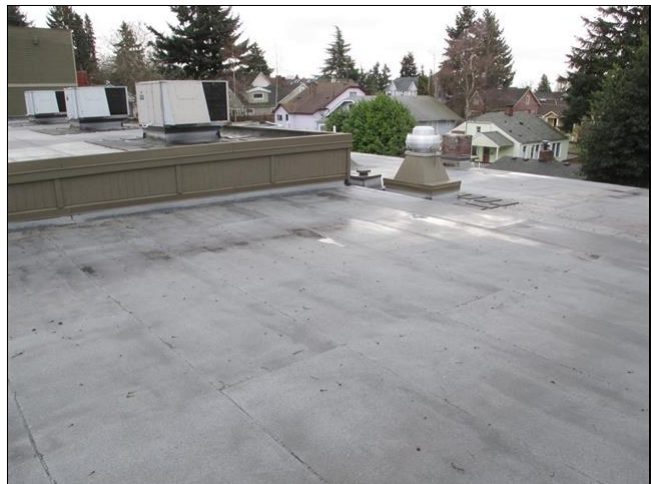
The building has a flat/low sloped roof system and is covered with a modified bitumen roofing material. Flat/low sloped roofs are designed to be waterproof not just water resistant, and to last approximately 20 years. They are rarely flat, and generally slope toward drains in or near surrounding parapet walls. However, it is common for water to pond on these roofs. Water should drain and/or evaporate off the roofing materials within 24 hours after it rains. If it does not, it may be an indication that the drainage needs to be improved. Flat roof systems can be problematic and must be maintained. The roofing material will contract and expand in the daily and sometimes radical temperature extremes, and eventually buckle, split, separate, and finally deteriorate. When this happens, the roof is susceptible to leaks. Although gradual decomposition of the roofing materials is inevitable, most leaks result from poor maintenance or poor installation. Therefore, regardless of the age of the roofing materials, they should be cleaned regularly, so that the roofing material can be easily inspected for damage and to increase its reflectivity, which will help prolong the useful life of the roof.

View of the roof

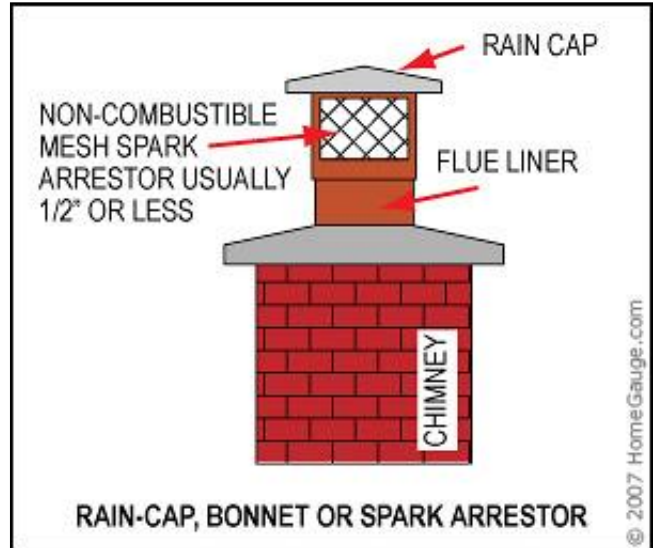
Install a weather cap on the chimney

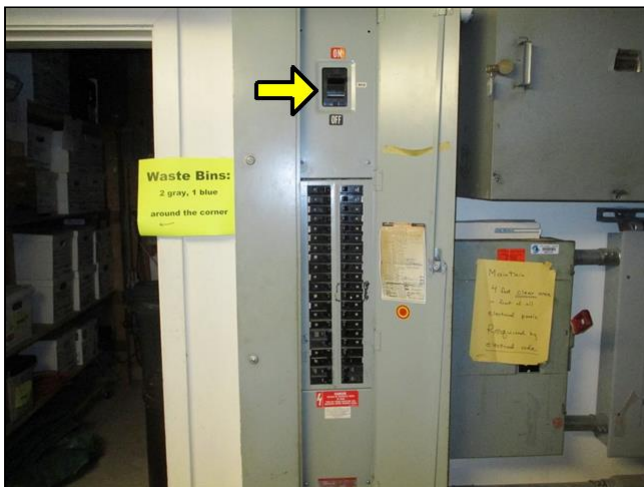
The building is powered by a 350-amp, 120/240 volt panel, located in the utility room in the basement.

Main electrical disconnect breaker

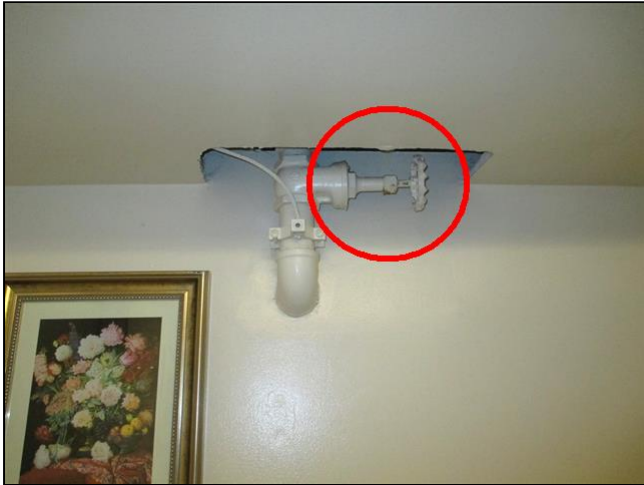
The main shut off valve is located in the downstairs bathroom.

Main water shutoff valve

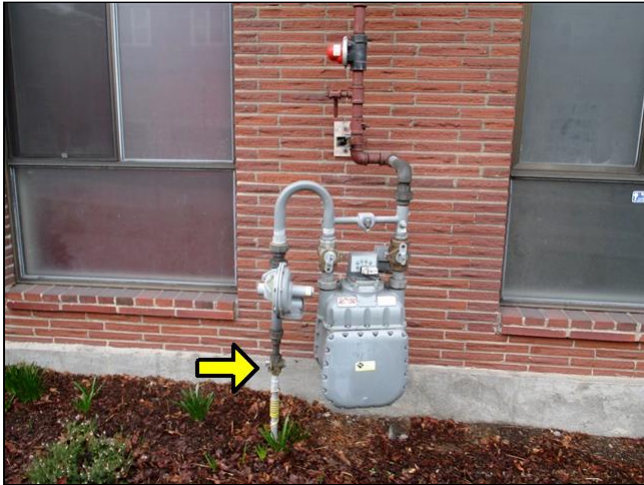
The main fuel shut off is at the gas meter outside.

Main gas shutoff valve

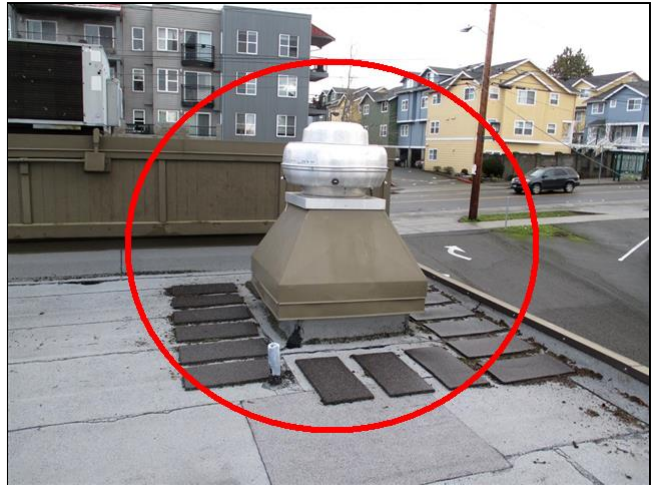
Roof mounted section of the kitchen exhaust fan

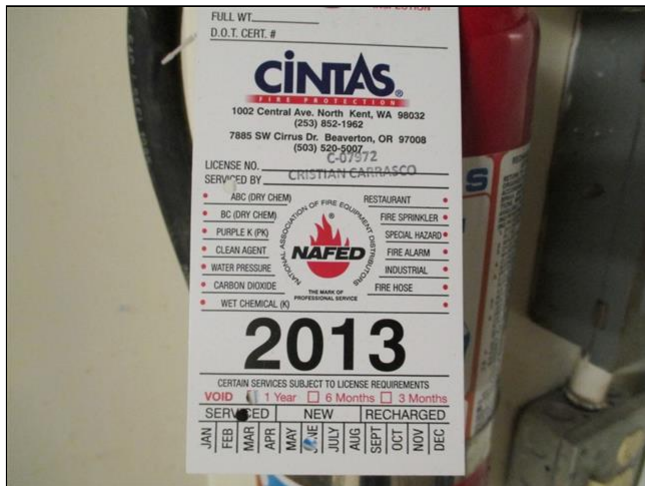
There are fire extinguishers located throughout the building. The fire extinguishers were fully charged and their inspection tags were current. The extinguishers were last inspected in June 2013 by Cintas Fire Protection. Their phone number is 253-852-1962.

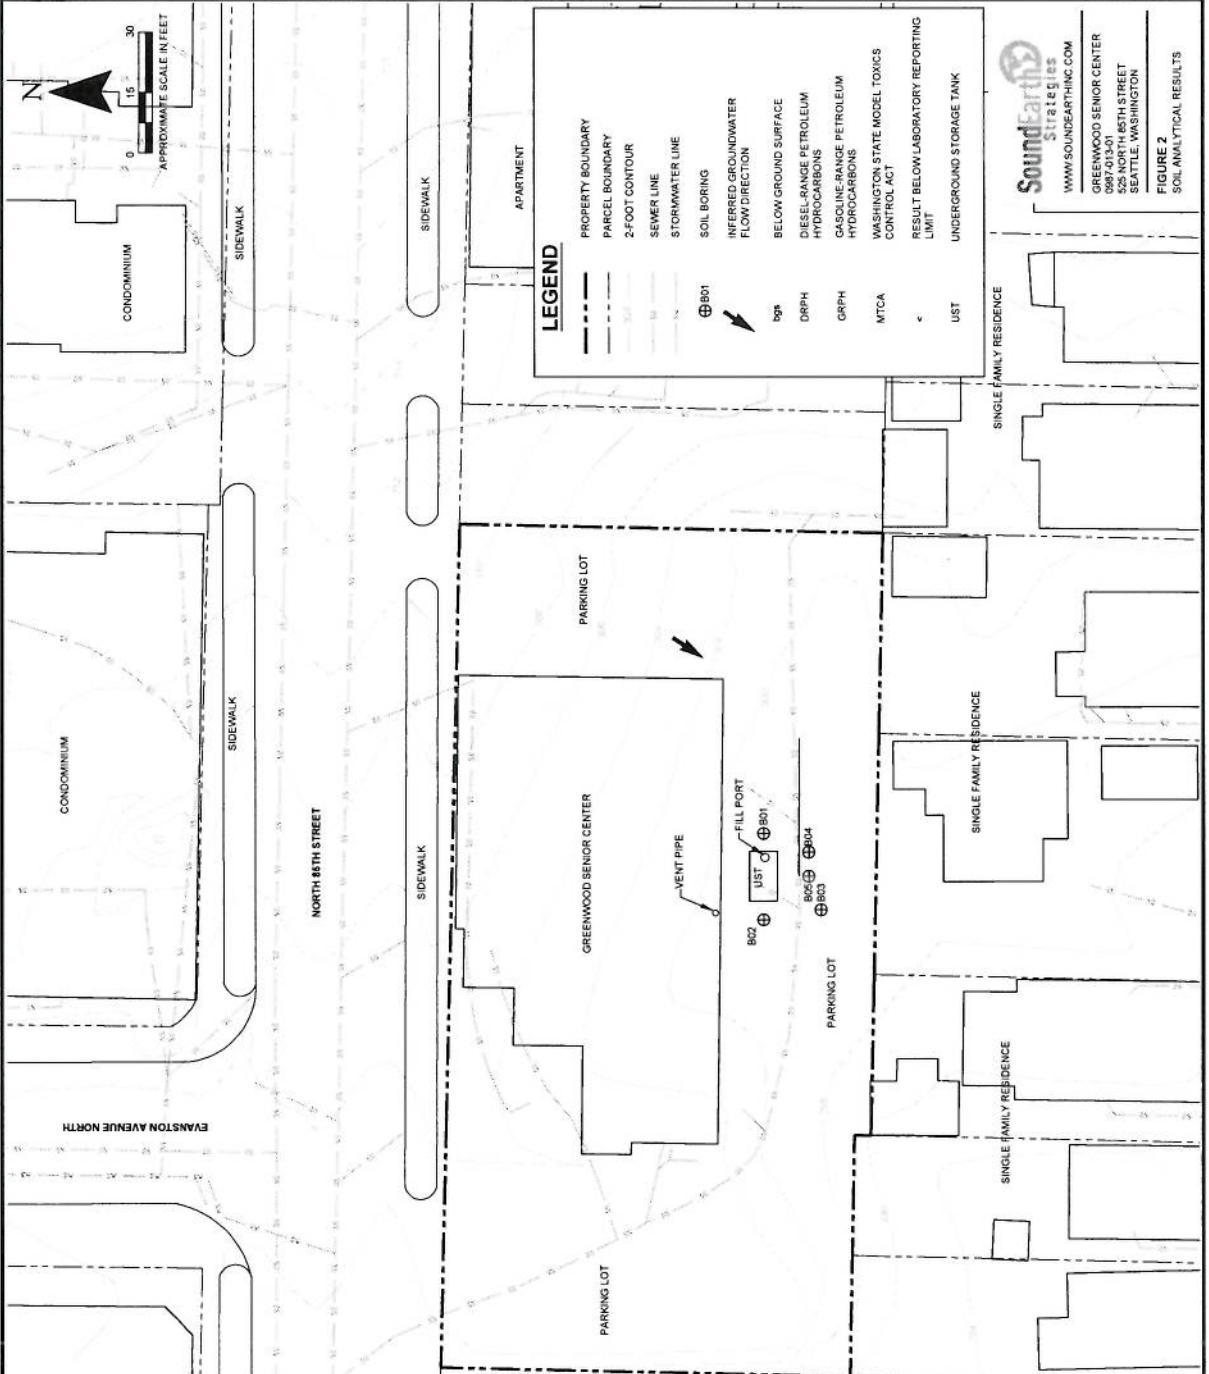
**SoundEarth**  
 STRATEGIES  
 WWW.SOUNDEARTHINC.COM  
 GREENWOOD SENIOR CENTER  
 525 NORTH 85TH STREET  
 SEATTLE, WASHINGTON  
**FIGURE 2**  
 SOIL ANALYTICAL RESULTS

Laboratory testing of the soil samples submitted for analysis did not reveal concentrations of DRPH or ORPH that exceeded the laboratory’s lower reporting limit in any of the soil samples. The results for DRPH and ORPH were also below the MTCA Method A cleanup levels (Figure 2; Table 1). A copy of the laboratory analytical report is provided as Attachment B.

Boring ID	Date Sampled	Depth (feet bgs)	Analytical Results	
			DRPH	ORPH
B01	01/30/15	10	<50	<250
B02	01/30/15	10	<50	<250
B03	01/30/15	13	<50	<250
B04	01/30/15	10	<50	<250
B05	01/30/15	10	<50	<250
MTCA Method A Cleanup Level			2,000	2,000
