2019 Project Review Sheet (2020 Construction)

Project #	19-271
Project Title:	Repair sidewalk
Location:	Neighborhood: Belltown, 98121 Area: Northwest corner of 5th Avenue and Blanchard Street from end of building to mid-block

YVYC 2019: Project 19-271, Northwest corner of 5th Avenue and Blanchard Street from end of building to mid-block

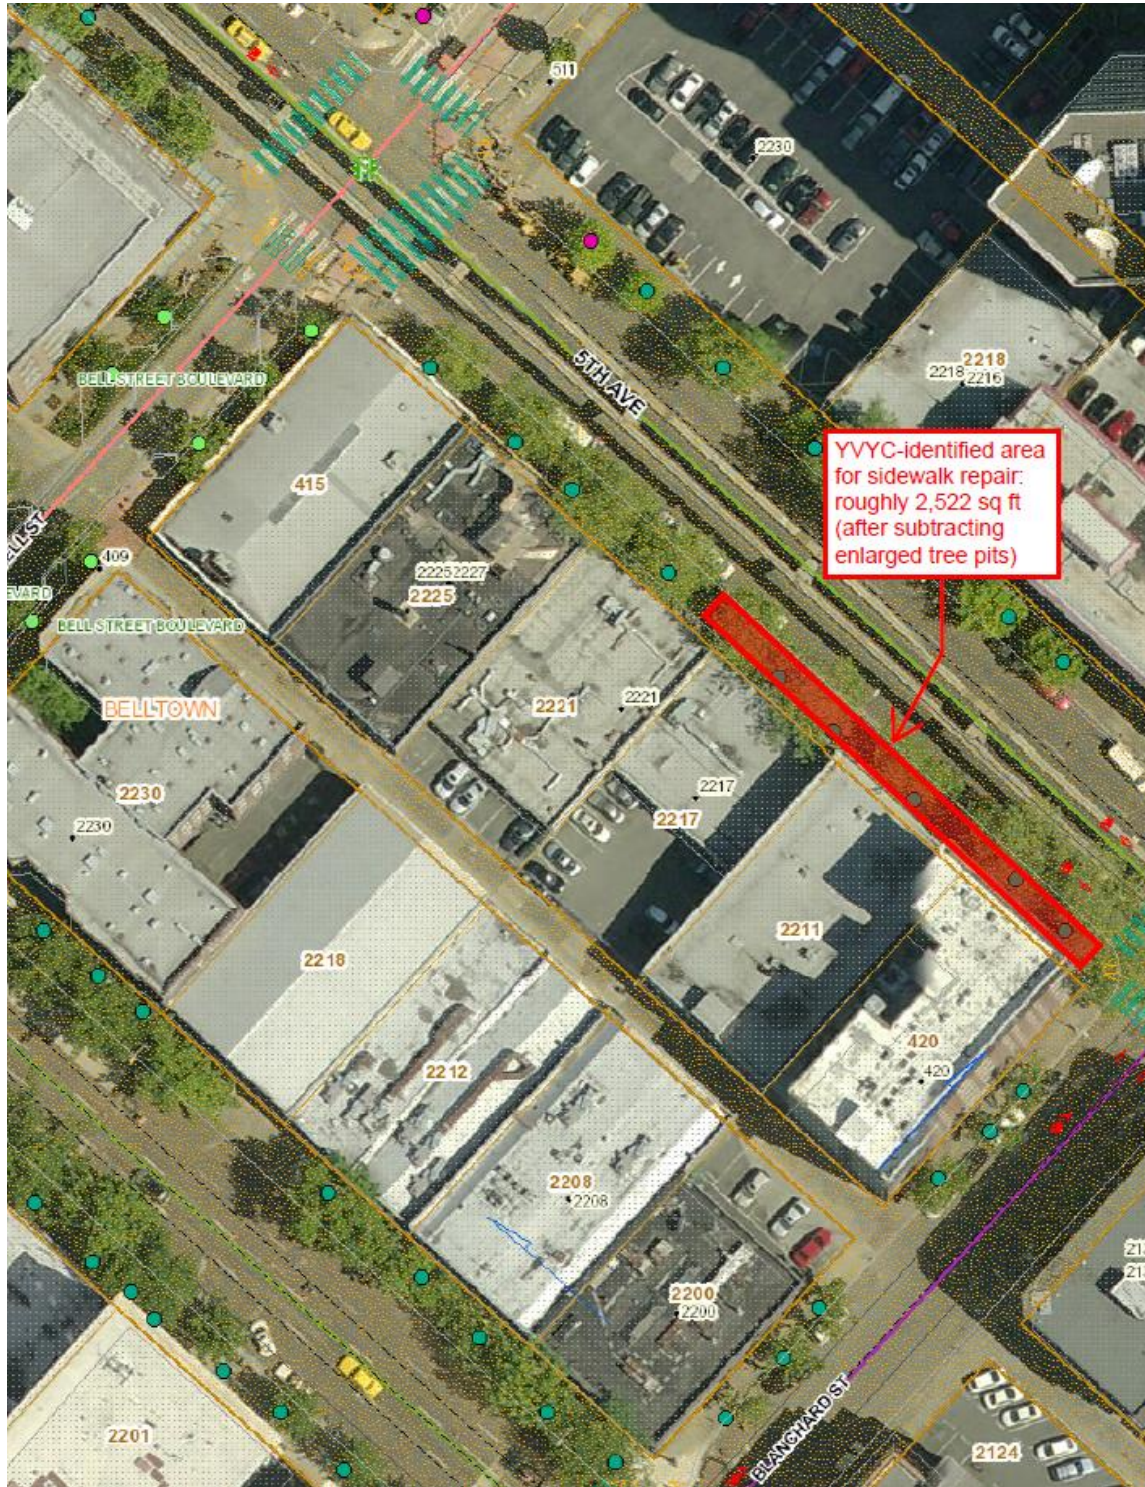
Image:

During a site visit in July 2019, SDOT identified roughly 2,522 square feet of sidewalk that qualified for maintenance work on the west side of 5th Avenue from Blanchard Street to roughly mid-block. The sidewalk from the midblock north to Bell Street was recently repaired and replaced. The identified location for sidewalk maintenance accounts for enlarging 5 tree pits to 9' x 12' each and a section (27' x 10') near Blanchard Street around a Seattle Public Utilities vault that would remain. The 5 enlarged tree pits will be treated with a flexible porous pavement.
