MAGNUSON COMMUNITY CENTER SEATTLE PARKS AND RECREATION

ARCHITECTURAL AND ENGINEERING
MAINTENANCE EVALUATION STUDY

September 2017

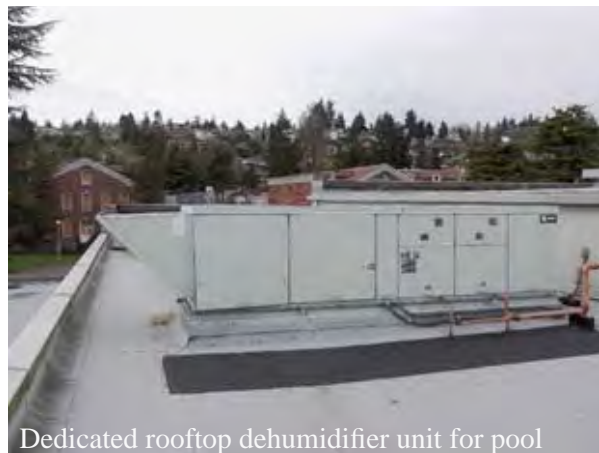
Dedicated rooftop dehumidifier unit for pool

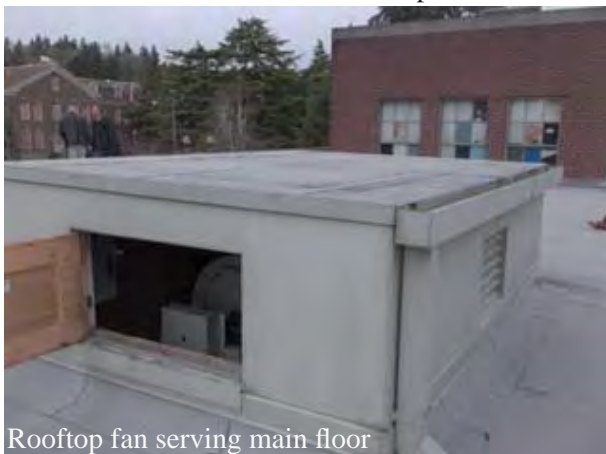
- A centrifugal exhaust fan serves the Women's restroom and locker rooms for the ground level and is located on the roof in a penthouse. Exhaust for ground floor restroom and locker rooms is via a mechanical shaft located in an adjacent closet on the main floor.
- Electrical power to the exhaust fan appears to be disconnected.
- Exhaust fan is corroded and in poor condition.

Rooftop fan serving main floor

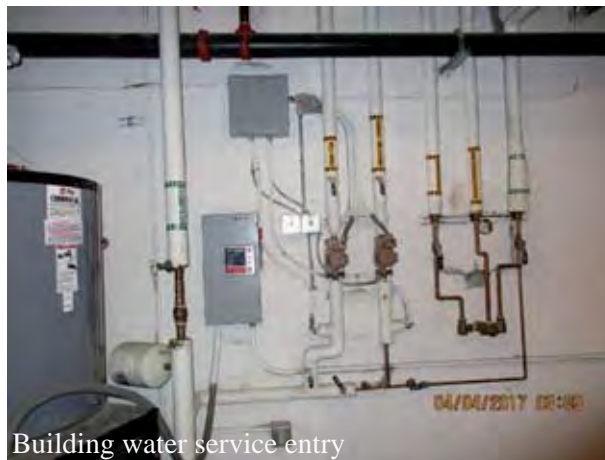
Water entry is located in the ground floor boiler room. The valve assembly includes a pilot controlled Automatic Control Valve and 4" Double Detector Checkvalve. Hot water is provided by a 120 gallon Rheem electric hot water heater, model ES120-30-G. Water circulates in two loops, one at 120 F and one at 105 f, with a 1/8hp Taco pump for each recirculation loop. Visible water piping is copper. Water lines installed as part of the 2003 remodel are insulated, labeled and overall in good condition.

Building water service entry

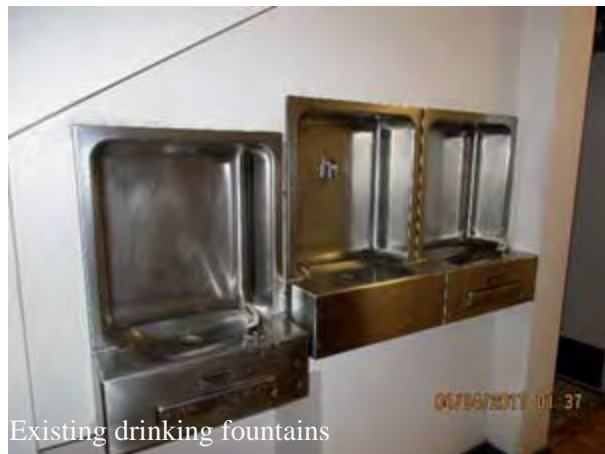
- Existing stainless steel drinking fountains and cuspidor located at the southeast entrance to the gymnasium are in good condition and appear relatively new. One drinking fountain is located at a lower height.

Existing drinking fountains

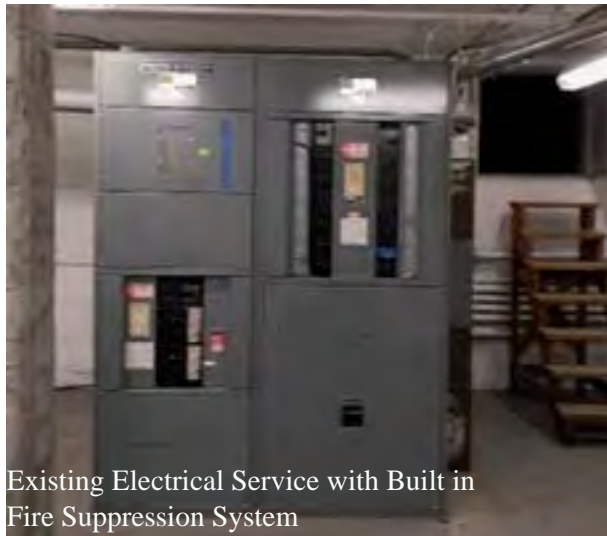
The existing electrical service is 800A 120/208V 3ph 4W, and split to (4) service rated disconnect circuit breakers - (1) 225A CB is turned off, (1) 400A CB is turned off, (1) 400A feeding the theatre dimming panel is on and (1) 600A feeding the whole community center normal loads. There are branch circuit panels A, B, D, E, F, H, M, S and LAUNDRY PANEL that are fed from this (1) 600Amp panel

Existing Electrical Service with Built in Fire Suppression System

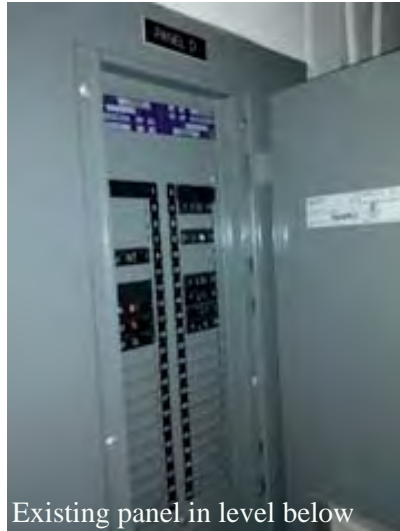
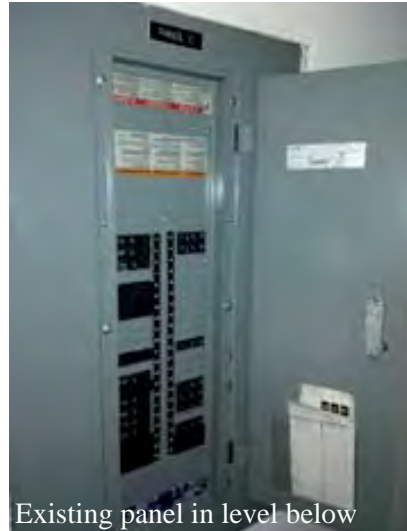
Existing panel in level below

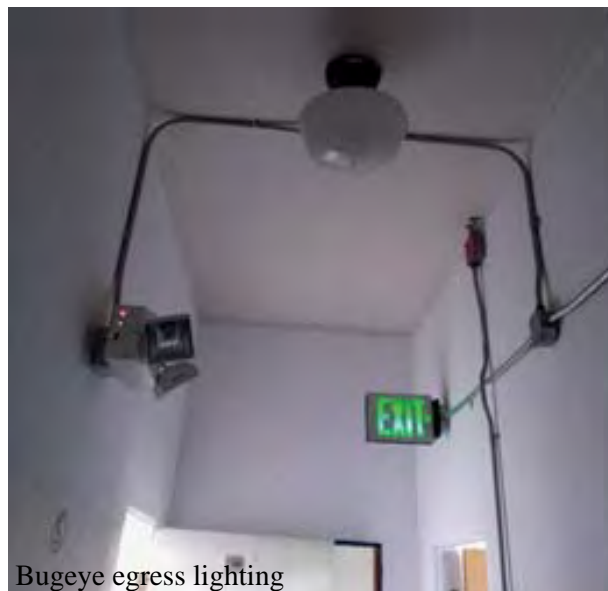
Per the as-built drawing and site observation, we believe battery backup bug-eye lighting fixtures with integrated batteries are used for egress lighting throughout the building, its battery power also feeding the exit signs as an emergency source. The egress lighting coverage is not sufficient for the scope of work area. Exit signs are observed in the large room, but not in the smaller room and restrooms.

Bugeye egress lights feeds exit signs emergency power (Middle, Left-side of image below)

Bugeye egress lighting

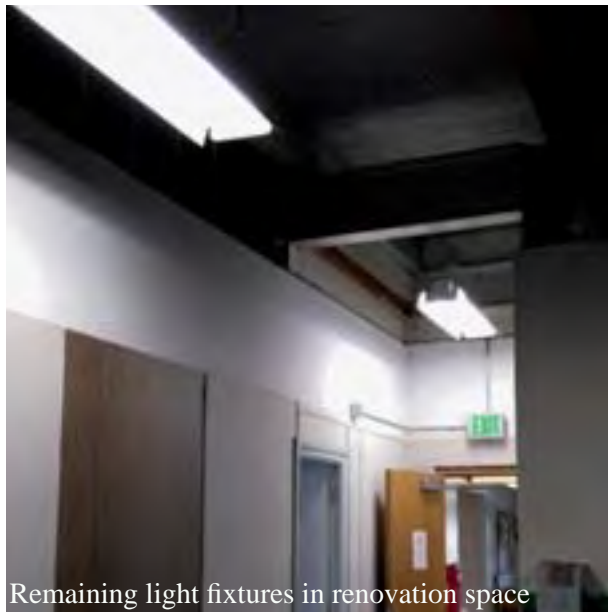
Interior lighting fixtures were originally installed in 1941, and all fixtures in the Lobby and Gym were renovated during the 2003 remodel. In the scope of work area large empty space, it has only (3) lighting fixtures observed at the west entrance. There are no lighting fixtures in the rest of this space.

Remaining light fixtures in renovation space

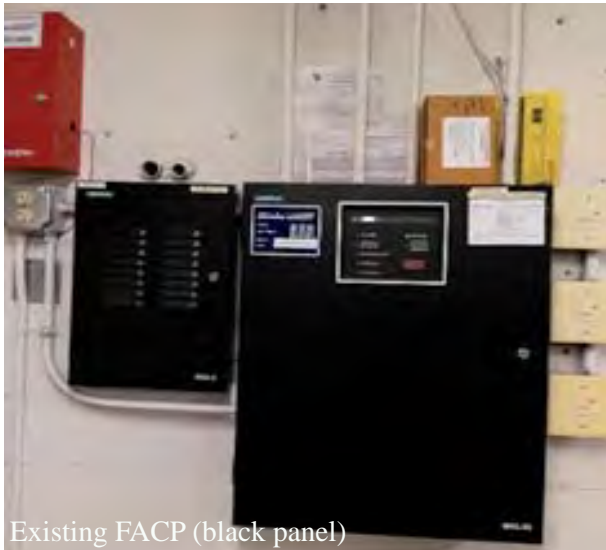
The existing fire alarm control panel model is a Siemens MXL-IQ and is installed in the electrical vault room. The panel is an intelligent addressable fully programmable type fire alarm control panel, it has been tested and inspected annually by Guardian security, and the latest test result passed in August of 2016. There is no fire alarm remote annunciator (FARA) observed in the building. The existing fire alarm system is in good working condition.

Existing FACP (black panel)

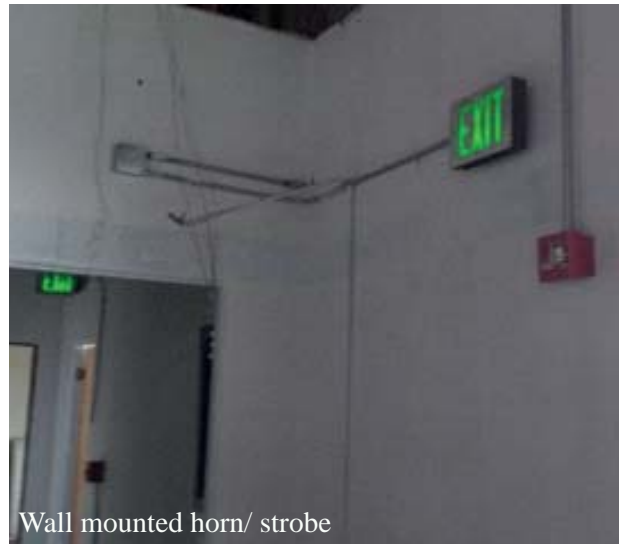
Wall mounted fire alarm horns/strobe are observed in the scope of work area and current coverage meets code requirements.

Wall mounted horn/ strobe

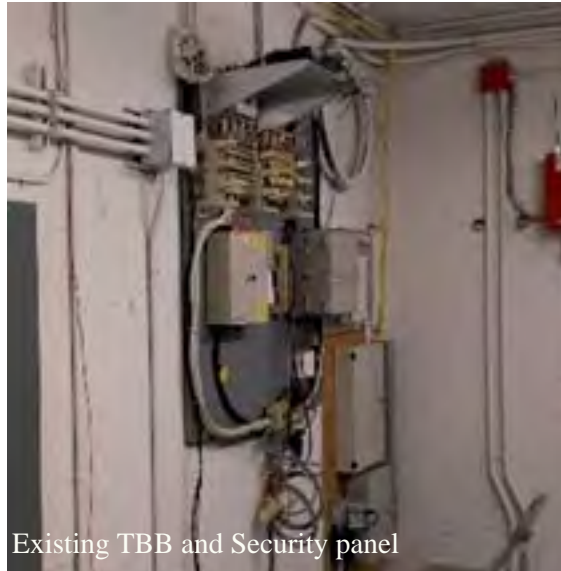
The existing building security panel is located in the electrical vault room. The system was renovated during the 2003 remodel and is in good shape

Existing TBB and Security panel
