# **SEATTLE PARKS AND RECREATION**

## **MAGNUSON BUILDING 2 STRUCTURAL/SEISMIC ANALYSIS (WC2362)**

### **Final Report**

**July 26, 2010**

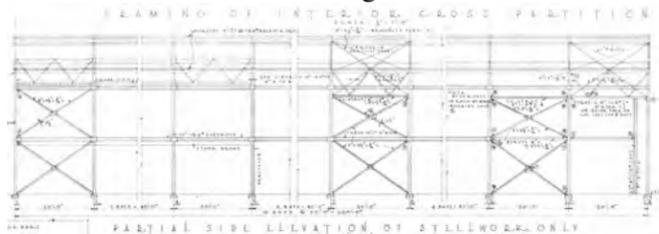
| Item | Category | Location | Budget | Pros | Cons | Comments |
|---|---|--|---|---|---|---|
| <b>Upgrade Hangar Braced Frames</b> | Building Seismic Mitigation | North and South sides of hangar<br> | \$150,000 | Provides overall seismic stability to the north hangar and the north two-story wing in the east-west direction. | Costly and disruptive. | <i>Some elements are missing. Critical to seismic performance of the hangar. Some resistance exists, but it is likely to be overwhelmed in a major seismic event.</i> |

The north bay lacks seismic resistance in the east-west direction. The original high bay bracing is modified or missing in some cases. This bracing supports both the high bay roof and the two story occupied tenant space. Reestablishing this bracing, with new members and connections for current forces, is one option for increasing resistance at these lines. Another option is to provide concrete shear walls in some of the bays.

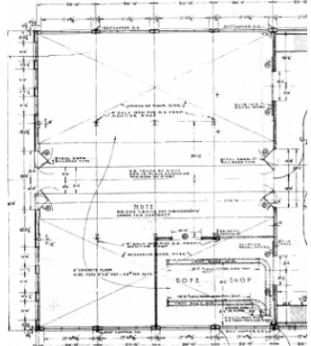
| Item | Category | Location | Budget | Pros | Cons | Comments |
|---|---|--|---|---|---|---|
| <b>Add shear walls at west mezzanine area</b> | Building Seismic Mitigation | West 80 feet of hangar<br> | \$50,000 | Provides independent seismic stability to this area. | Costly. May not be necessary. Some walls exist. | <i>Further analysis may show this area to be acceptable.</i> |

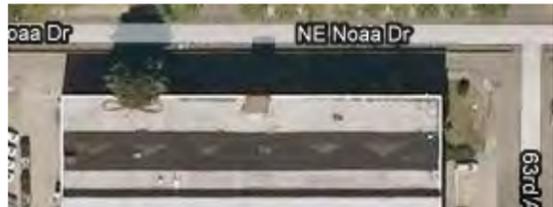
The roof membrane is past the end of its design life. Leakage has occurred in many areas, and particularly in the North Wing.

| Item | Category | Location | Budget | Pros | Cons | Comments |
|---|---|--|---|---|---|--|
| <b>Reroof north two story area</b> | Building Condition | Roof<br> | \$170,000 | Prevents further damage and deterioration, extends building life, addresses occupant comfort. | None. | <i>Investigate for mold. Roofing options, including insulation, will affect price. Estimate shown is for no additional insulation.</i> |

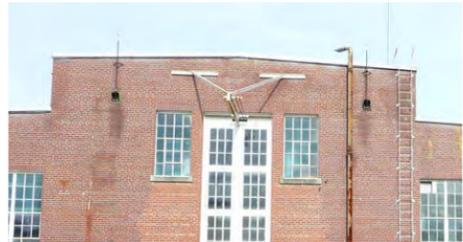
On the west side of the north hangar, the brick masonry appears to be pulling away from the supporting steel frame. Solutions to this apparent failure include rebolting the masonry to the steel angle at the top of the wall, or providing a light gage steel stud strongback wall to support the URM.

| Item | Category | Location | Budget | Pros | Cons | Comments |
|---|---|--|---|---|---|--|
| <b>Repair West Side Masonry</b> | Building Condition, Non-structural Seismic Mitigation | Center of North Side West wall<br> | \$15,000 | Preserves building stability. | | <i>Use light gage steel stud backup, or reconnect steel framing to walls with new bolts.</i> |

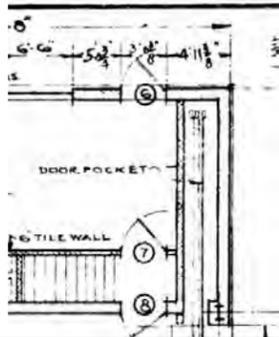
| Item | Category | Location | Budget | Pros | Cons | Comments |
|--|---|---|---|---|---|---|
| <b>Strengthen Hollow Clay Tile Walls Near Exit Paths</b> | Non-structural Seismic Mitigation | Especially at the NE Corner in the north wing.<br> | \$25,000 | Increased exiting safety. | Cost. | Damaged walls may block exit paths. Consider carbon fiber wrap reinforcing. |
