# **Taylor Creek Sediment Study**

**Seattle, Washington**

**July 2007**

**Perkins Geosciences**

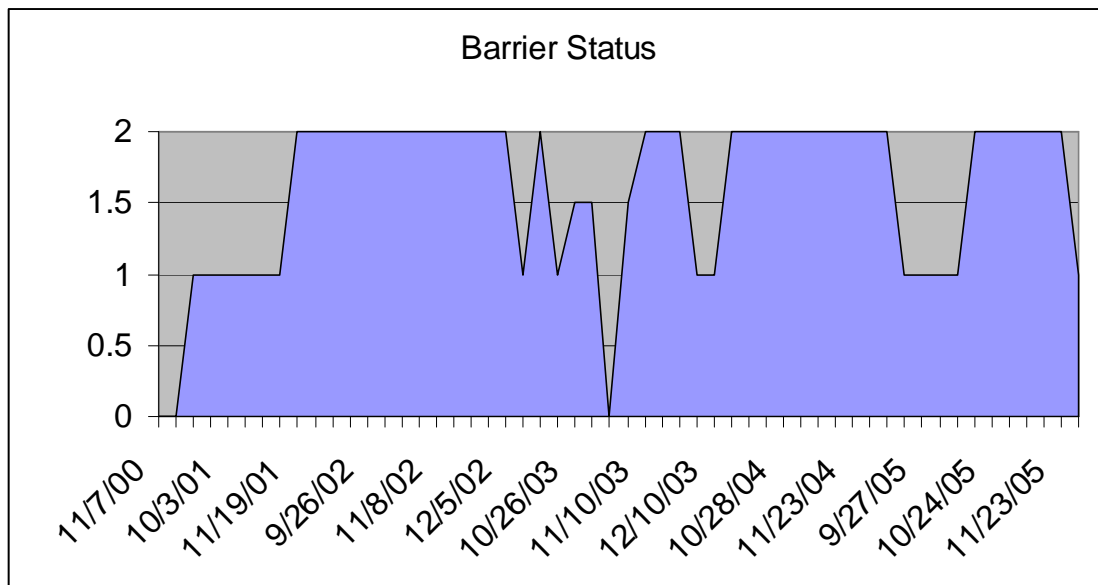
Wild Fish Conservancy assessed spawning use and barrier status of lower Taylor Creek and its delta in nearly-weekly surveys for the 2000 through 2006 spawning seasons (November, December, and parts of October and January). Based on their data, the delta is probably a barrier to spawning coho and sockeye salmon except during high stream flows or early in the season while lake level is still high enough to flood the delta. The delta appeared to be a fish barrier on 62% of the surveyed days in the 2000-2005 spawning seasons (Figure 10).

**Figure 10. Barrier status of the Taylor Creek delta on surveyed dates between 11/7/00 and 12/20/05. 0 = passable at low flows, 1 = partial barrier passable at moderate flows, 2 = barrier passable only during high flow events. Figure created by Katherine Lynch, SPU, from weekly stream survey reports by Bill McMillan, Wild Fish Conservancy.**

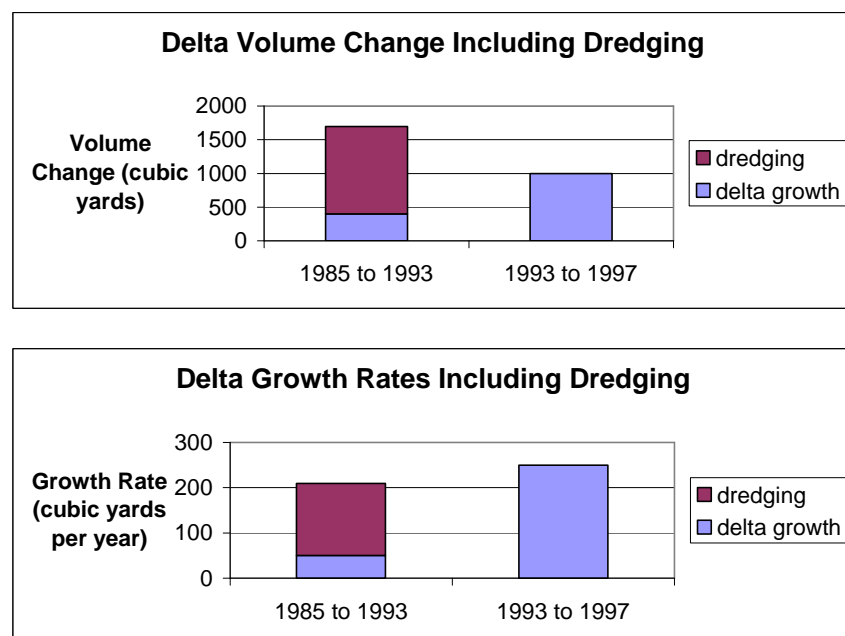
The delta grew about 400 yd<sup>3</sup> from 1985 through 1993, but several times that volume was removed by dredging (Figure 11). From 1993 through 1997, the delta grew about 1000 yd<sup>3</sup> with no reported dredging. The estimated delta growth rates including dredging were 210 yd<sup>3</sup>/yr (range 160-310) for 1985-1993 and 250 +/- 80 yd<sup>3</sup>/yr for 1993-1997 (Table 5). The average rate for the two time periods combined was about 220 yd<sup>3</sup>/yr.

**Figure 11. Delta volume changes and growth rates including sediment removed by dredging.**

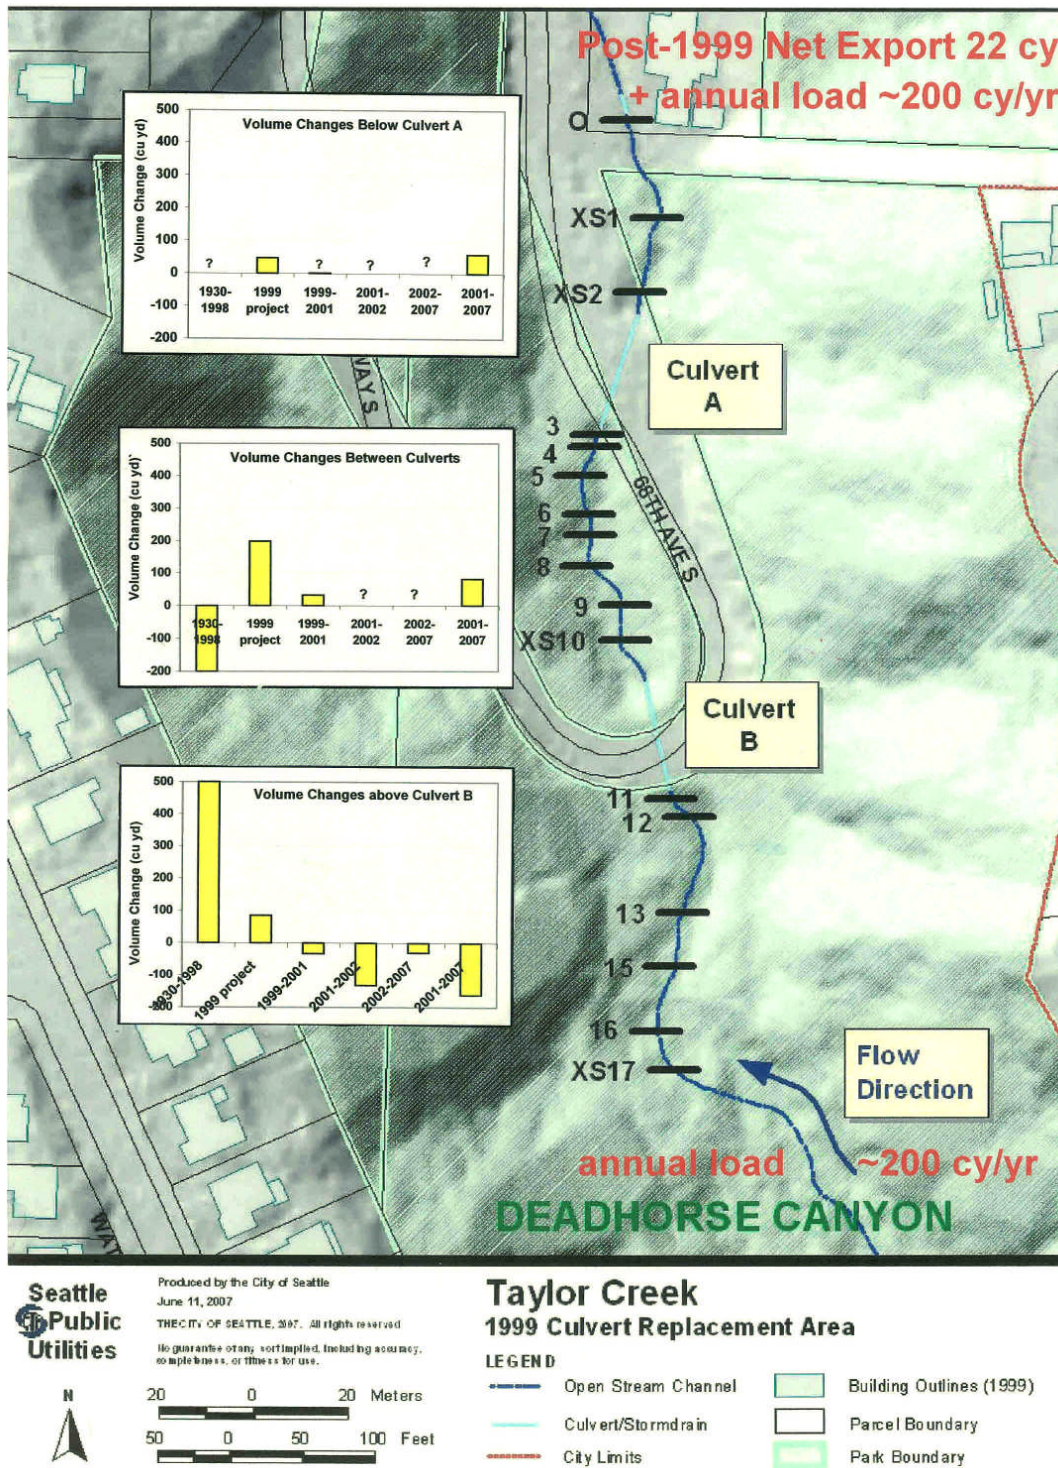
Figure 13 and Table 6 summarize changes in sediment volume in the culvert-replacement area. About 200 yd<sup>3</sup> of the pre-1999 sediment deposits above the upper culvert (B) were eroded after culvert replacement. The erosion rate above Culvert B was highest between summer 2001 and summer 2002. Sediment eroded from upstream of Culvert B mostly deposited downstream between the culverts. In most areas between the two culverts, the streambed has risen 0.5 to 1.5 feet for a net gain of about 110 yd<sup>3</sup>. Most of the gravel that was added to Taylor Creek between the two culverts is still in place, buried by sediment from upstream. The initial slug of sediment made its way farther downstream over several years and reached Culvert A by 2003 or earlier. About 60 yd<sup>3</sup> were deposited below Culvert A, mostly within Lakeridge Park.

There has been a net export of about 22 yd<sup>3</sup> from the culvert replacement zone over the eight years since the culverts were replaced. This is equivalent to one tenth of one average year of coarse sediment supply, based on the delta's average growth rate of 220 yd<sup>3</sup> per year (Section 3.1.3). The exported sediment came primarily from above Culvert B, either from erosion of the old deposits behind the former undersized culvert or directly from Deadhorse Canyon. The culvert replacements have changed the location of sediment deposition in the canyon mouth area. Instead of depositing sediment upstream from Culvert B, the creek now deposits sediment between the culverts and just downstream from Culvert A, which is the natural location for an alluvial fan.

Figure 13. Site map of alluvial fan/canyon mouth area showing locations of replaced culverts and surveyed cross-sections. Graphs show changes in sediment storage.

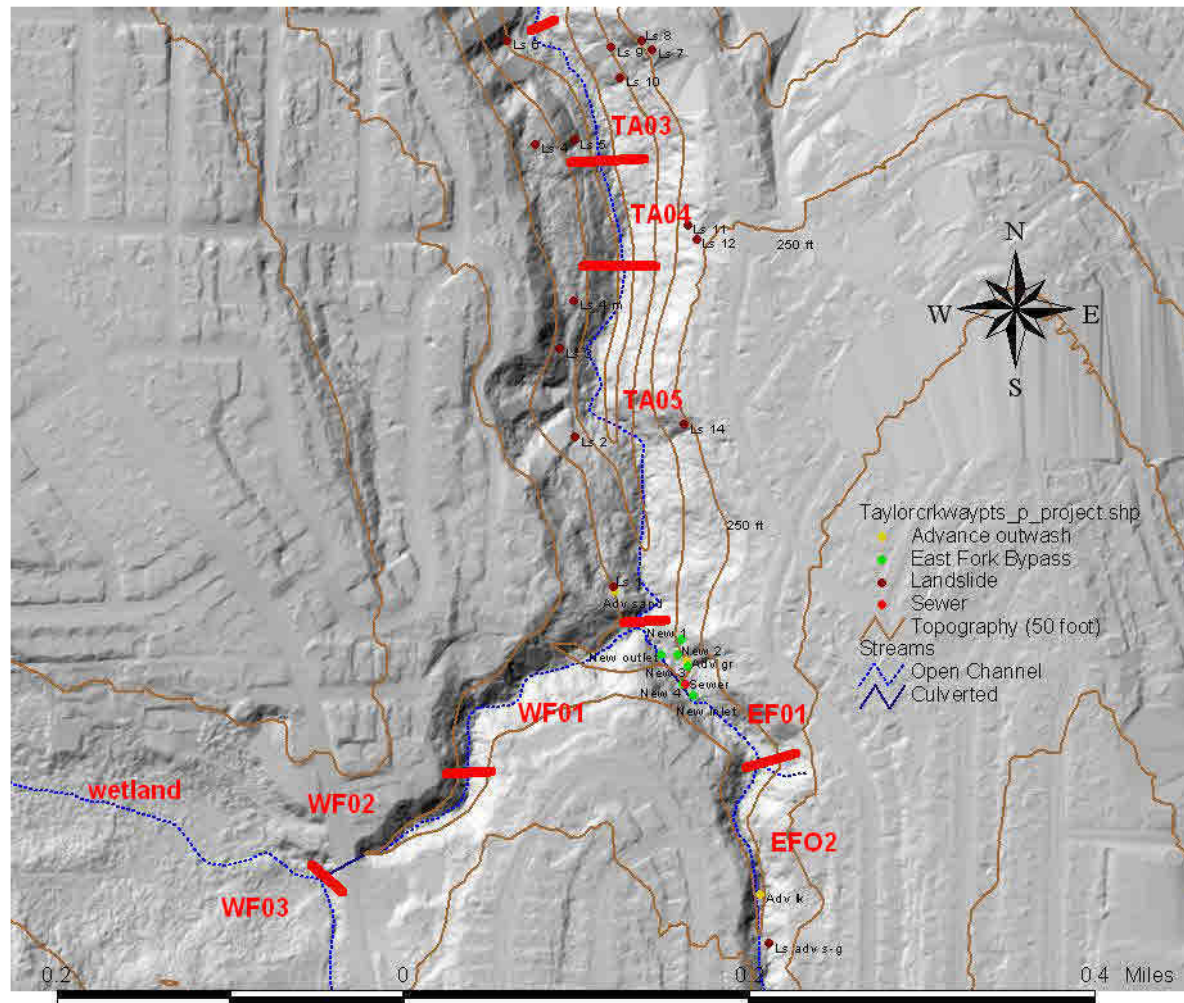
Vashon advance outwash, a very erodible source of sand and gravel, is rare in Taylor Creek but is a significant source of delta sediment. It is exposed along the stream only in the uppermost 420 feet of the East Fork Valley (Reach EF02) upstream from Lakeridge Park and the Seattle city limits (Figure 21). The valley walls are about 30 feet high which limits the size of landslides (Figure 22). Two large, valley-spanning debris jams have trapped some of the sediment and provide grade control, thereby reducing downcutting (Figure 23).

**Figure 22. Photograph of a 30-foot-high landslide in Vashon advance outwash gravel, East Fork Valley reach.**
