SEATTLE PUBLIC LIBRARIES UNIVERSITY BRANCH

TREE REMOVAL

APPLICATION FOR CERTIFICATE OF APPROVAL

**Arborist Report
DRAFT**

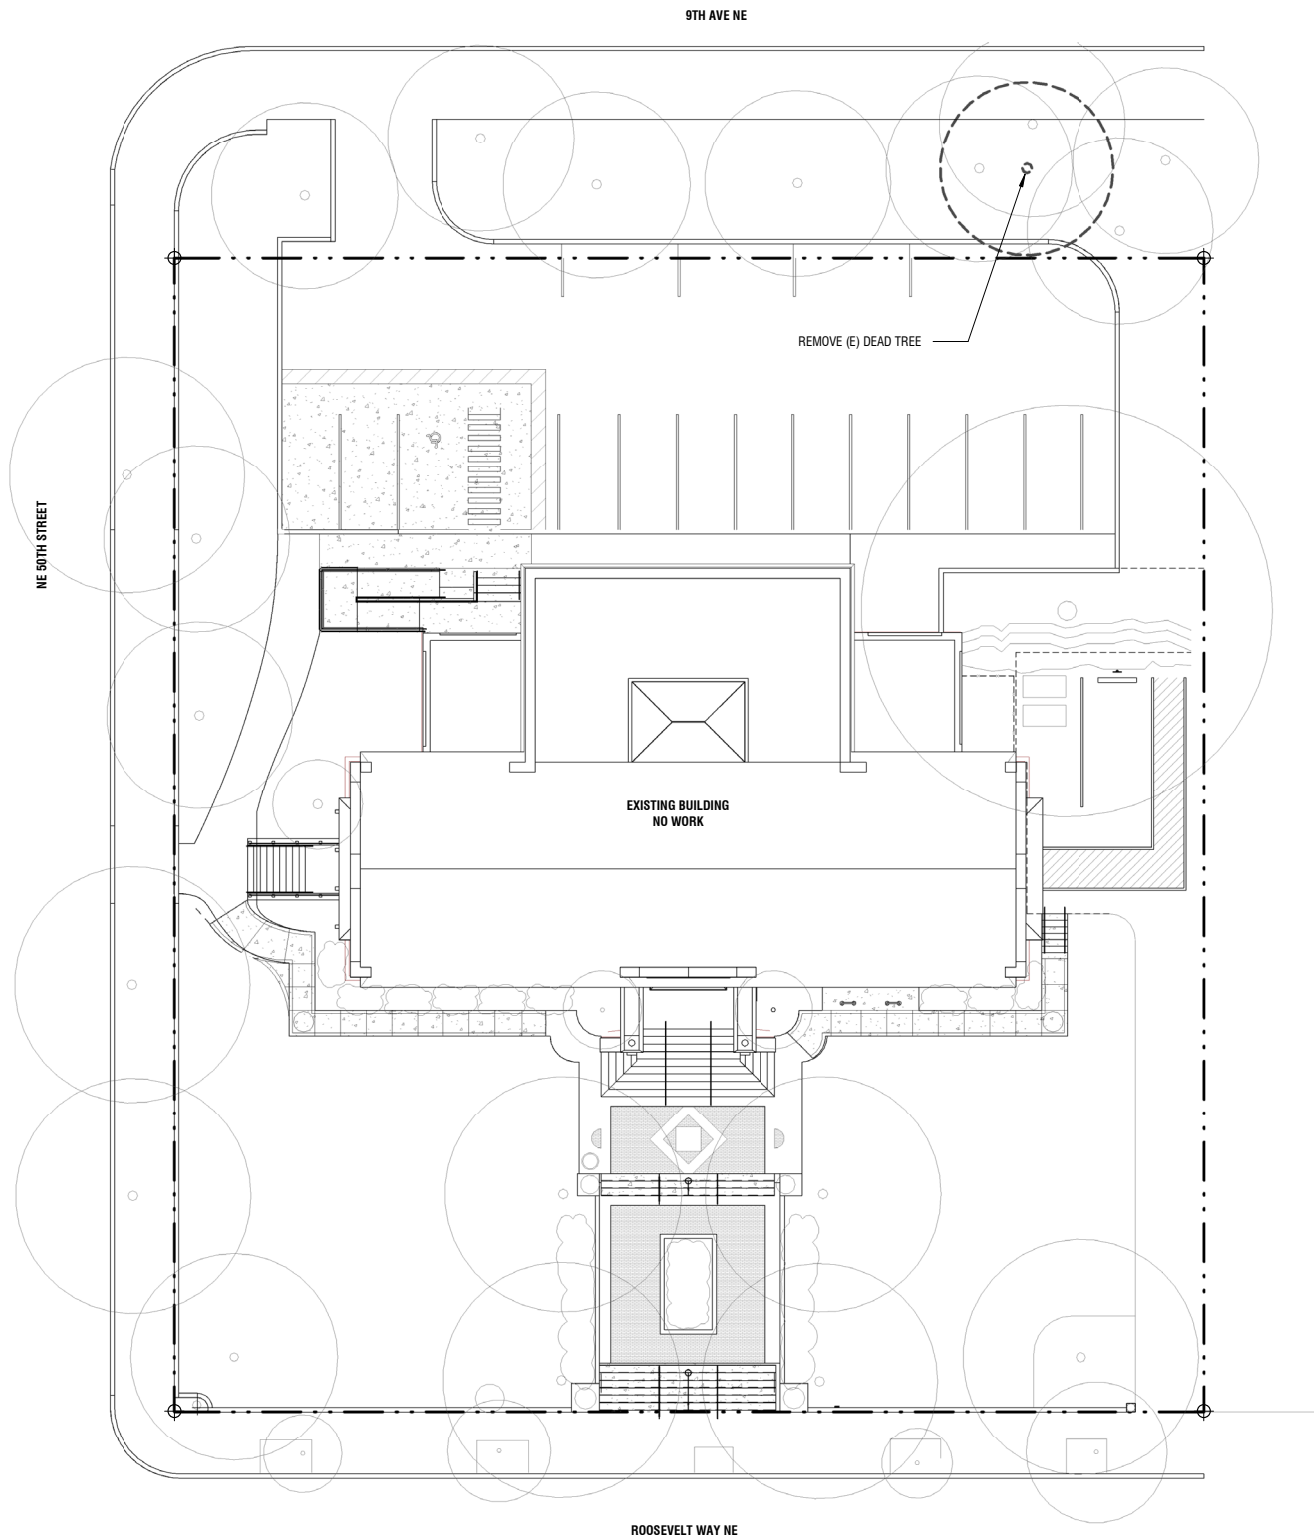
Existing tree *Chamaecyparis Lawsoniana* "Lawson Cypress". Proposal includes removal of this tree in 2022. See attached arborist report for site photos and condition assessment.
