**GEOTECHNICAL REPORT
DEADHORSE CANYON SEWER
SEATTLE, WASHINGTON**

**Work Authorization No.: E314059
December 2014**

**Seattle Public Utilities
Geotechnical Engineering**

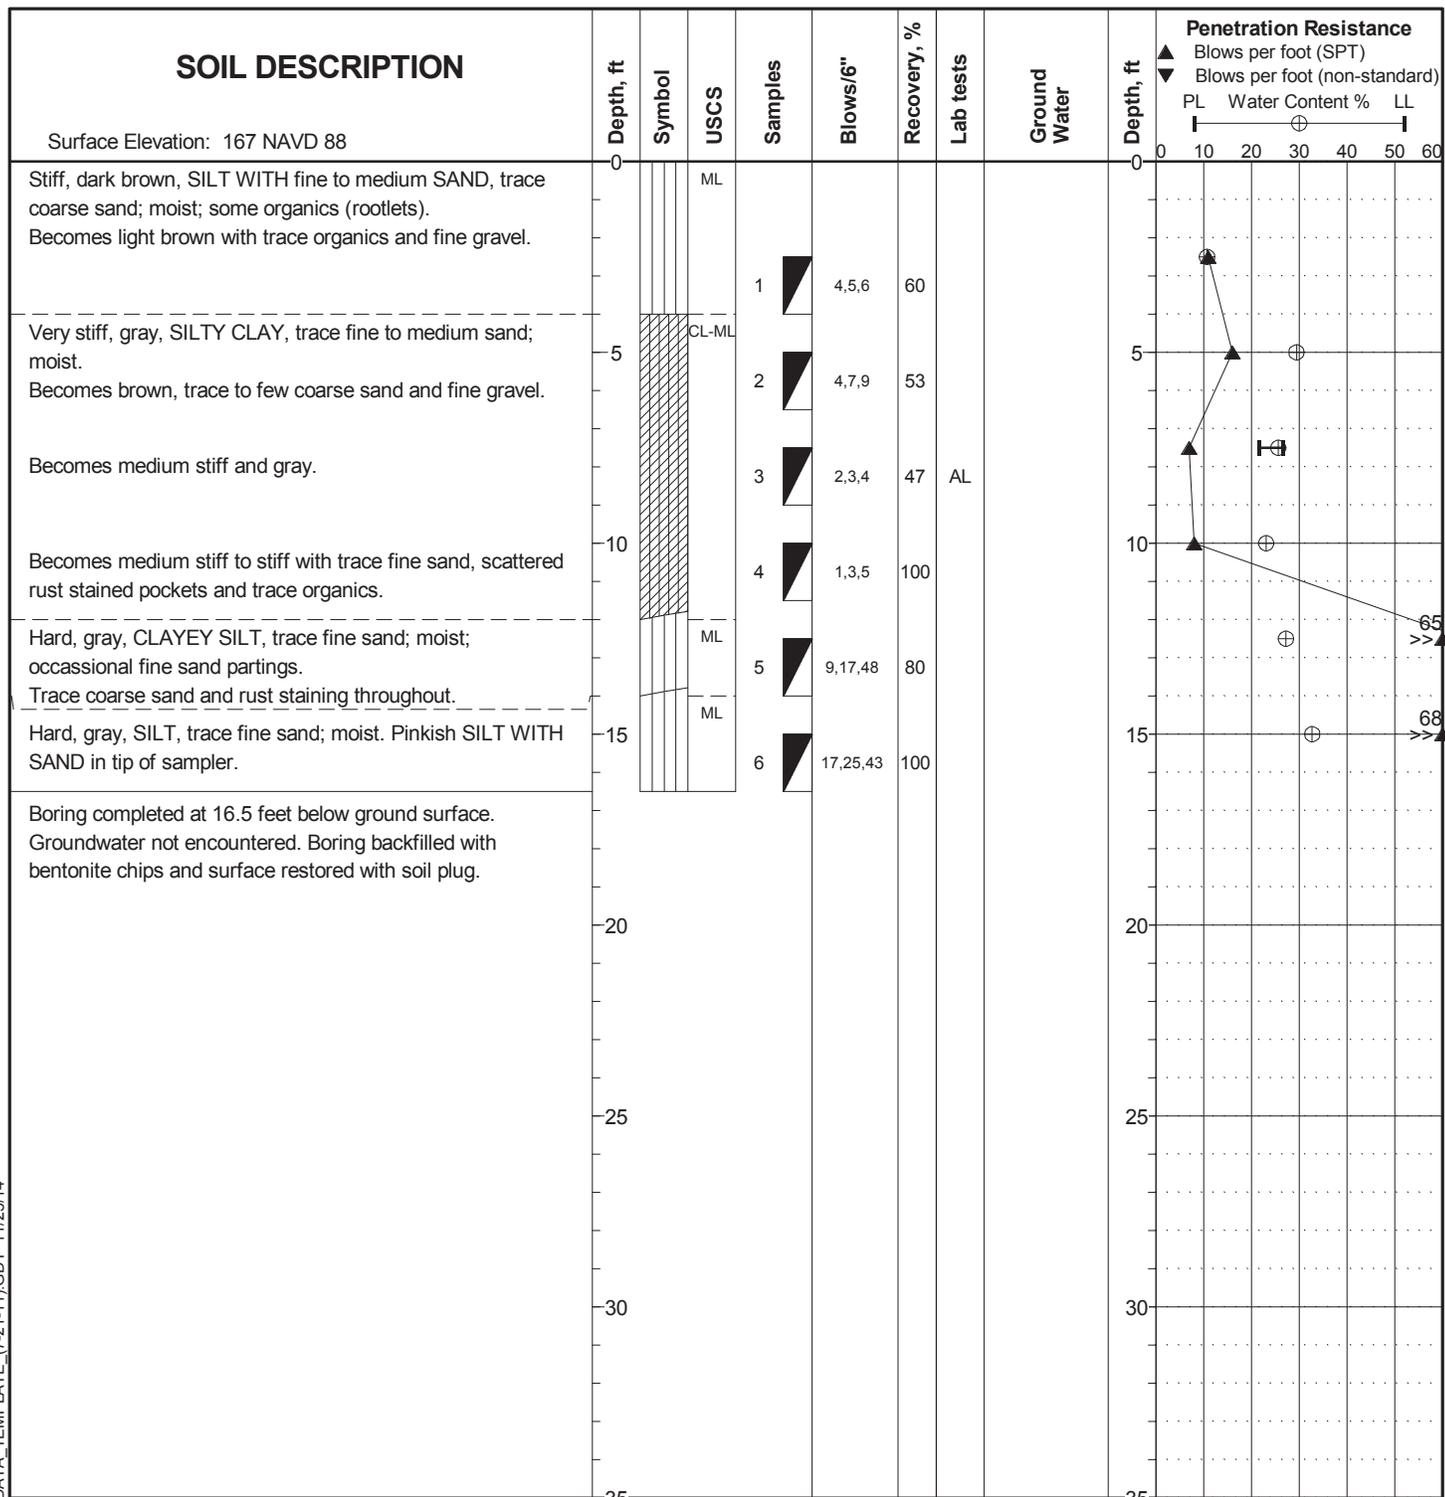
FIGURE A-2

Date Completed: 9/25/2014
 Driller: CN Drilling
 Equipment: Acker
 Drilling Method: 4-1/2 inch OD HSA
 Hammer System: Cathead

Approximate Location: 100 feet N of large bridge crossing the bridge, 52 feet E of center of trail and 23 feet W of creek. (N: 187235.8 E: 1291095)

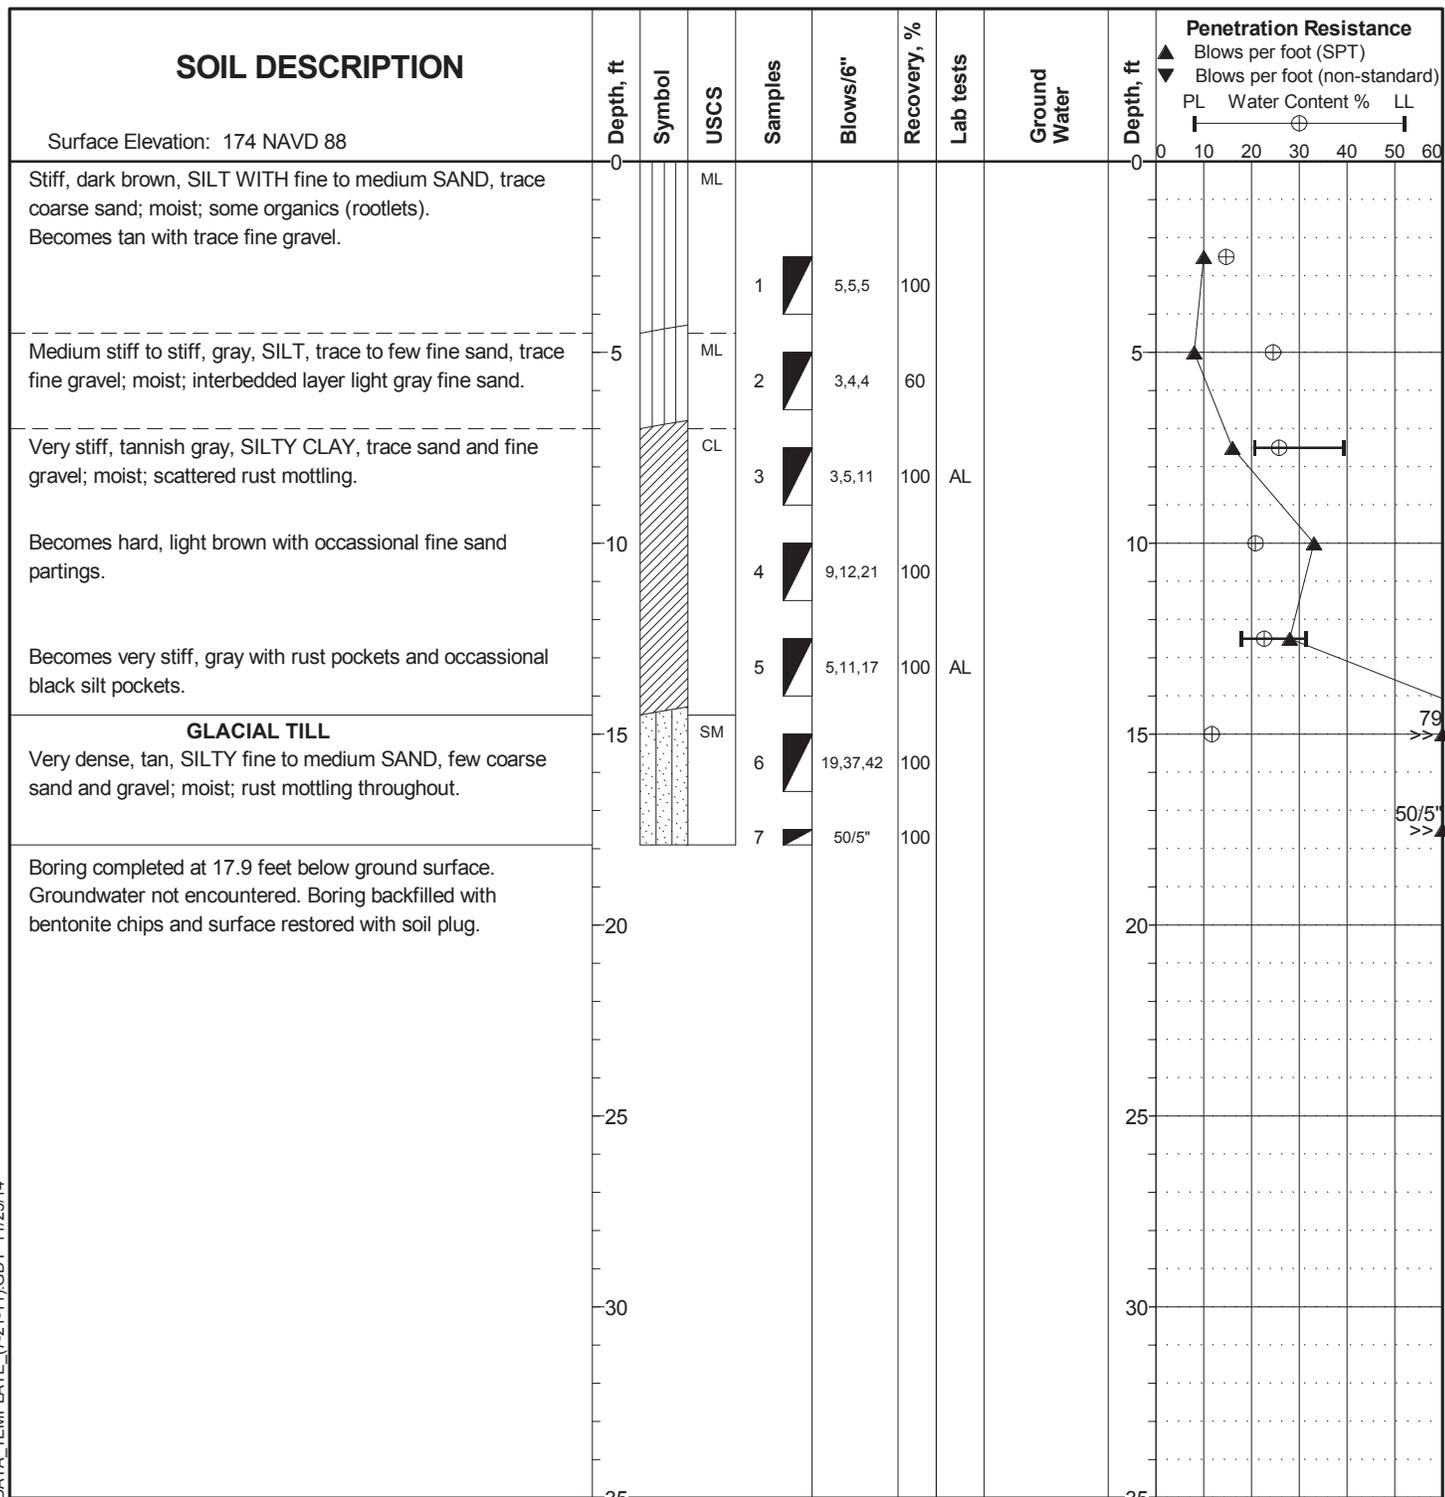
FIGURE A-3

Date Completed: 9/25/2014
 Driller: CN Drilling
 Equipment: Acker
 Drilling Method: 4-1/2 inch OD HSA
 Hammer System: Cathead

Approximate Location: 100 feet N of large bridge crossing the bridge, 21 feet W of B-101 and 30 feet E of center of trail. (N: 187229.3 E: 1291080.8)

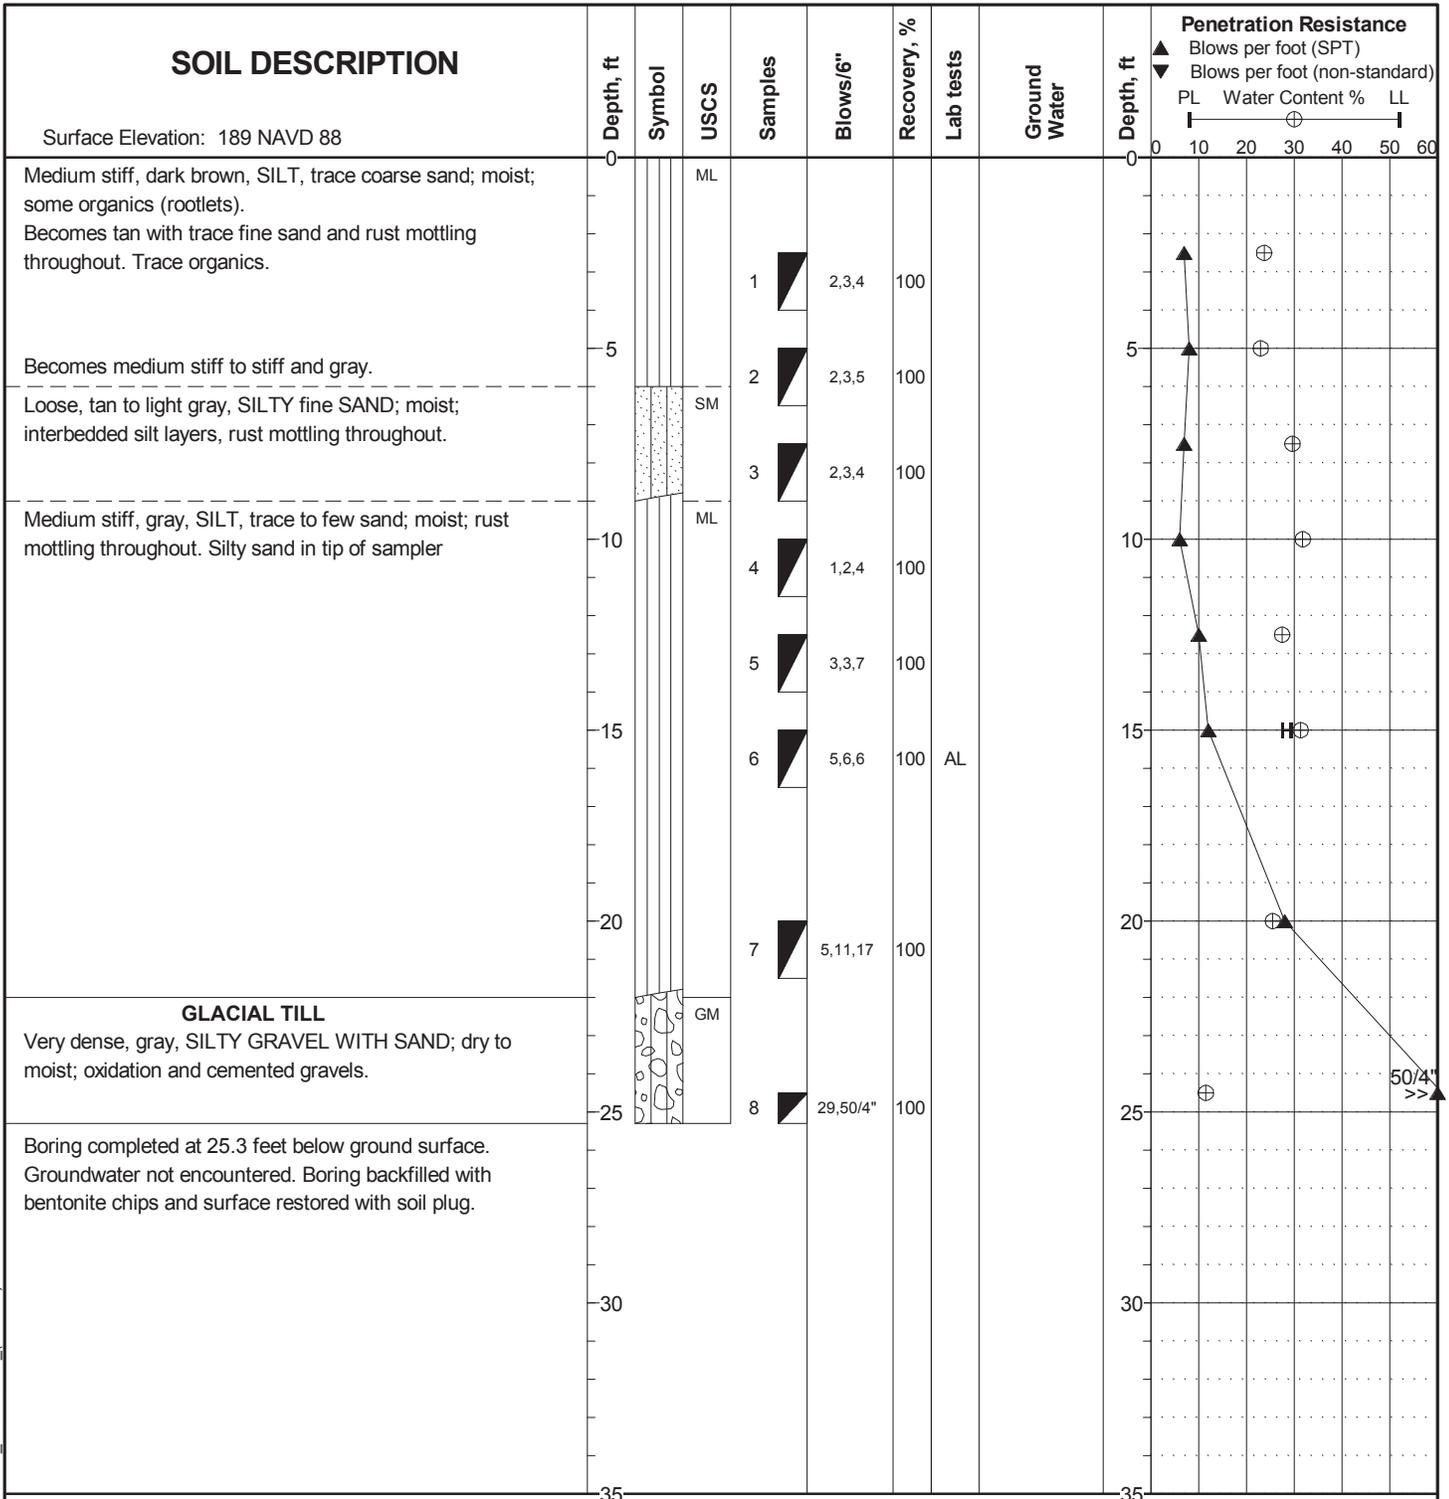
Date Completed: 9/25/2014
 Driller: CN Drilling
 Equipment: Acker
 Drilling Method: 4-1/2 inch OD HSA
 Hammer System: Cathead

Approximate Location: 100 feet N of large bridge crossing the creek, 21.5 feet W of center of trail and 54.5 feet from B-102. Approximately 35 feet E of large cedar. (N: 187205.6 E: 1291030.4)
