Final Report

Alaskan Way Viaduct Independent Technical Review

Prepared for
Seattle Department of Transportation

April 10, 2015

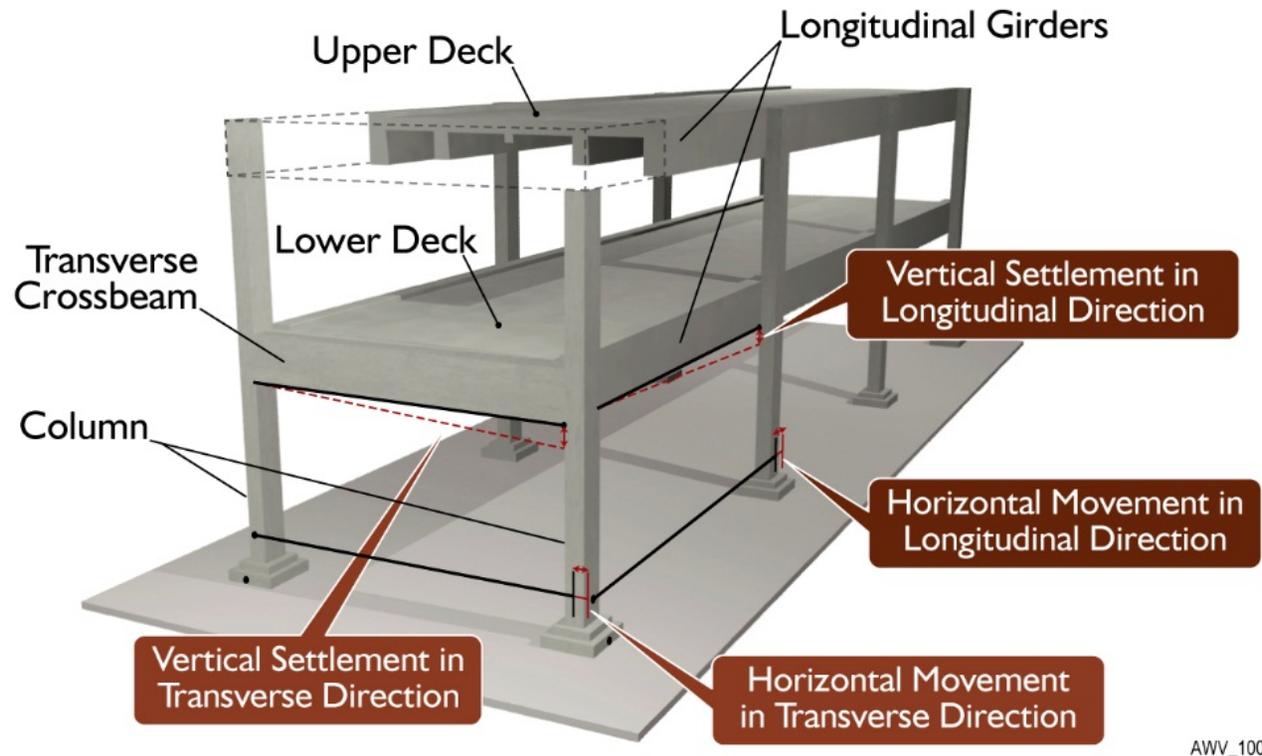
FIGURE 2-2
Differential Movements

Settlement can cause distress in components of a structure, depending on the magnitude and location of the settlement. For multi-column rigid frame structures like the Alaskan Way Viaduct, distress can result from differential movements between supports within the frame. As Figure 2-1 shows, the portion of the viaduct structure from Bents 91 to 121 was specified in the SR99 Bored Tunnel Design-Build Project to require mandatory mitigation of settlement due to tunneling. Settlement mitigation required the design-build contractor, STP, to perform a ground settlement analysis that assessed the expected ground deformations and impacts on the viaduct structure due to tunneling. STP was also required to perform a structural evaluation that included design and implementation of structural strengthening measures where the structural demands were in excess of the capacity. The imposed demands included dead and live loads and structure movements consisting of differential vertical and horizontal movement between columns within a bent (transverse direction) and between bents (longitudinal direction). These imposed movement demands are summarized in Table 2-1 and are shown graphically in Figure 2-2.

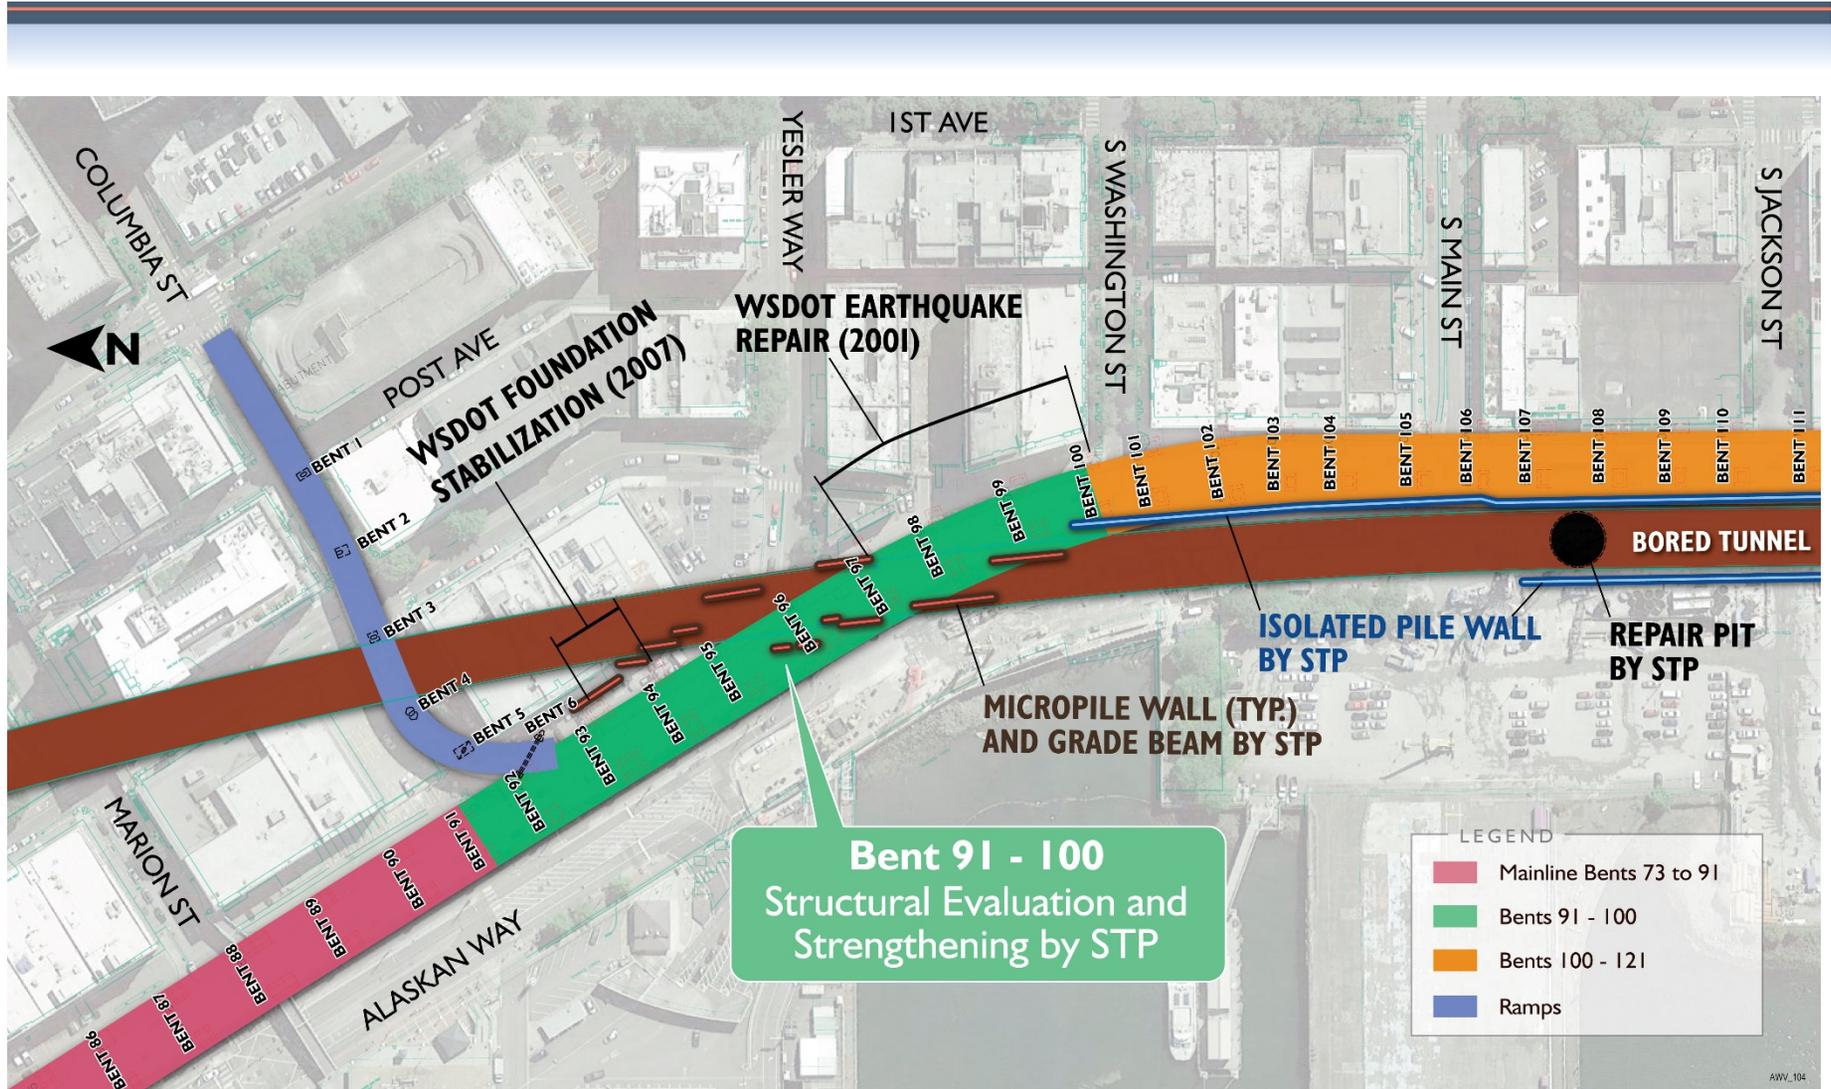
FIGURE 3-1
AWV Mainline Bents 91-100

The Alaskan Way Viaduct mainline structure between Bents 91 and 100 is a double-decked reinforced concrete structure consisting of three semi-independent three-span rigid frames: Bents 91S-94N, Bents 94S-97N, and Bents 97S-100N, as shown in Figure 3-1. The span lengths vary between 68'-6" and 84'-11", with a total length of each frame equaling approximately 222'. At each bent location, the frame consists of two columns connected by transverse crossbeams at both upper and lower deck level. Bents are connected longitudinally by a series of longitudinal girders. The deck slabs at the upper and lower deck level are supported by the longitudinal girders and a number of small longitudinal and transverse stringers. Each frame is separated from the adjacent frame with expansion joints. The columns of the adjacent frame at the expansion joint share a common footing.

Approximately 4 to 5 years after the Nisqually Earthquake, the foundations of Bents 93 and 94 were found to have experienced significant settlement. In response, WSDOT performed foundation stabilization for these two bents in 2007 to limit further settlement. The foundation stabilization system included installing micropiles around the existing pile caps and pile cap strengthening.

Review of available survey data found that the viaduct structure has experienced significant longitudinal and transverse differential settlement between Bents 91 and 100. The maximum magnitude of the vertical differential settlement appears to have exceeded 5 inches between Bents 94 and 95 and 6.5 inches between Bents 99 and 100 (Figure 2-6). Compared with vertical survey data, the availability of horizontal survey data is limited. Based on the horizontal survey data available, the magnitude of horizontal differential movement appears to be small.

As required by the SR99 Bored Tunnel Project, the design-build contractor, STP, performed settlement mitigation measures, as well as structural evaluation and targeted retrofit for this portion of the viaduct structure. As shown in Figure 3-1, settlement mitigation measures consisted of below-grade micropile curtain walls and grade beams aimed at reducing the anticipated settlement of the viaduct structure due to tunneling operations.

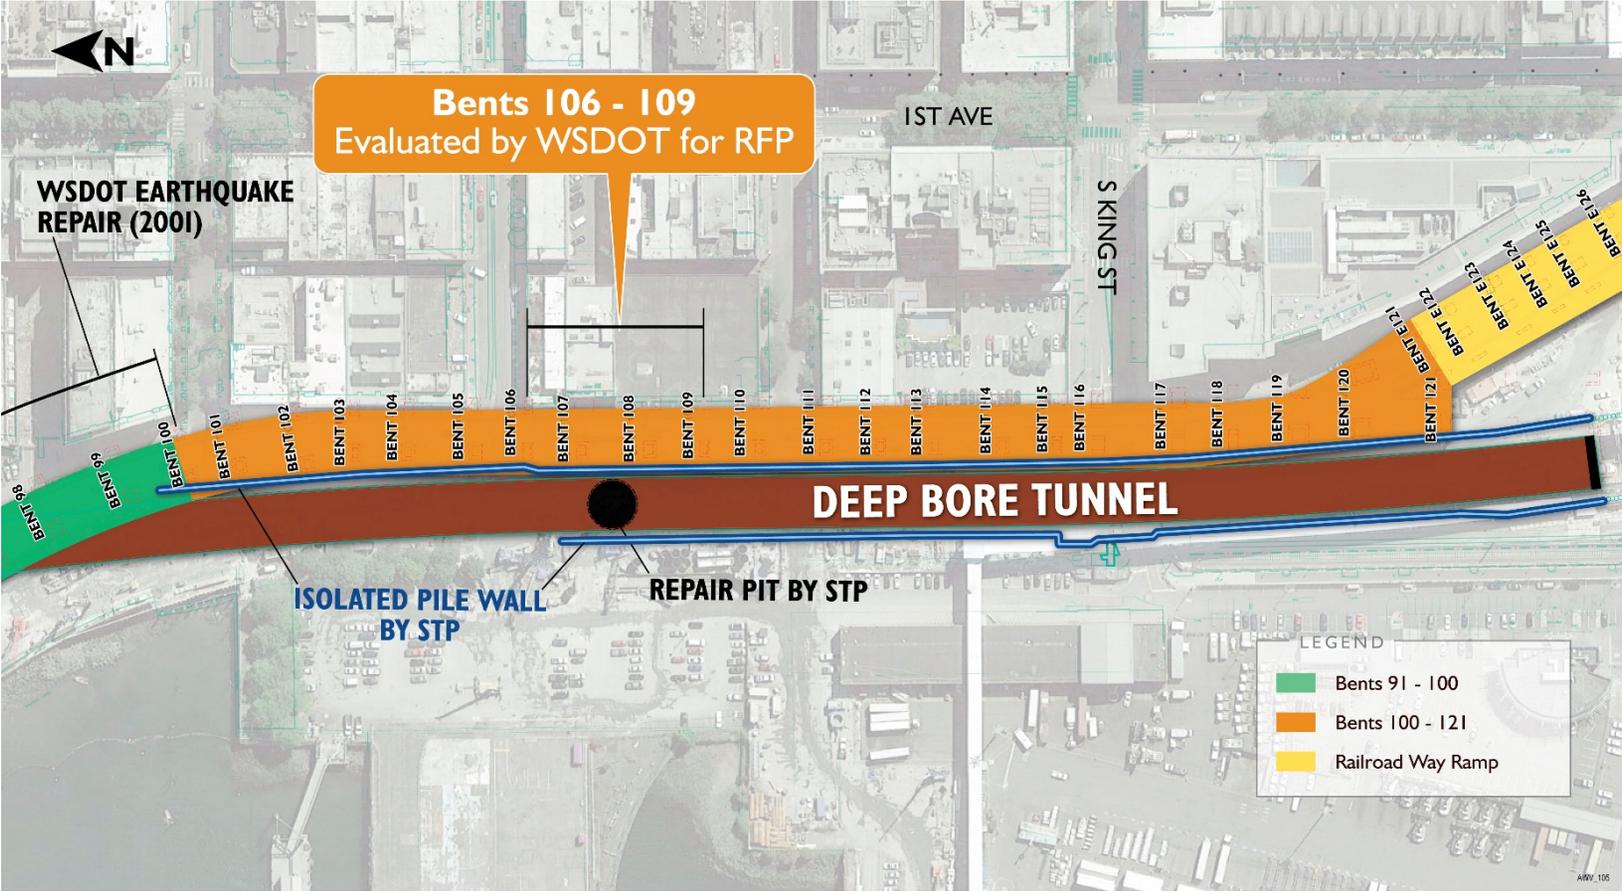
FIGURE 3-6
AWV Mainline Bents 100-121

The Alaskan Way Viaduct mainline structure between Bents 100 and 121 shown in Figure 3-6 is a double-decked reinforced concrete structure consisting of seven semi-independent three-span rigid frames. The lengths of the frames vary between approximately 180' and 222'. With the exception of the south-most frame between Bents 118 and 121, the configuration of each frame is similar to the viaduct structure between Bents 91 and 100. The frame between Bents 118 and 121 is somewhat irregular as the upper and lower deck of the viaduct branch off to the east to connect to the Railroad Way Ramp. To support the widened deck in this area, Bent 121 consists of four columns connected transversely by struts.

WSDOT's column survey data for this segment of the viaduct did not start until December 2014, while GEOSCOPE survey data for this segment did not start until mid-2012. So the review was focused on the gutter line survey data. Review of available survey data found that the viaduct structure has experienced low to moderate differential settlement between Bents 100 and 121. The maximum magnitude of the vertical differential settlement approaches 1.5 inches near Bent 119, as shown in Figure 2-6. It should be noted that the reported settlements are from a single source (gutter line survey) and most of the reported differential settlement appears to have occurred prior to April 2001. Settlement values have seen relatively small changes since October 2014. Similar to Bent 91 to 100, the availability of the horizontal survey data is limited. Based on the available data, the magnitude of the horizontal differential movement appears to be small.

For the SR99 Bored Tunnel Project RFP, WSDOT retained a consultant to evaluate a typical frame within this portion of the viaduct, between Bents 106 and 109, to assess the impacts to the viaduct caused by potential tunneling settlement. The evaluation suggested that strengthening is required to provide a sufficient safety margin against settlement-induced overstress.

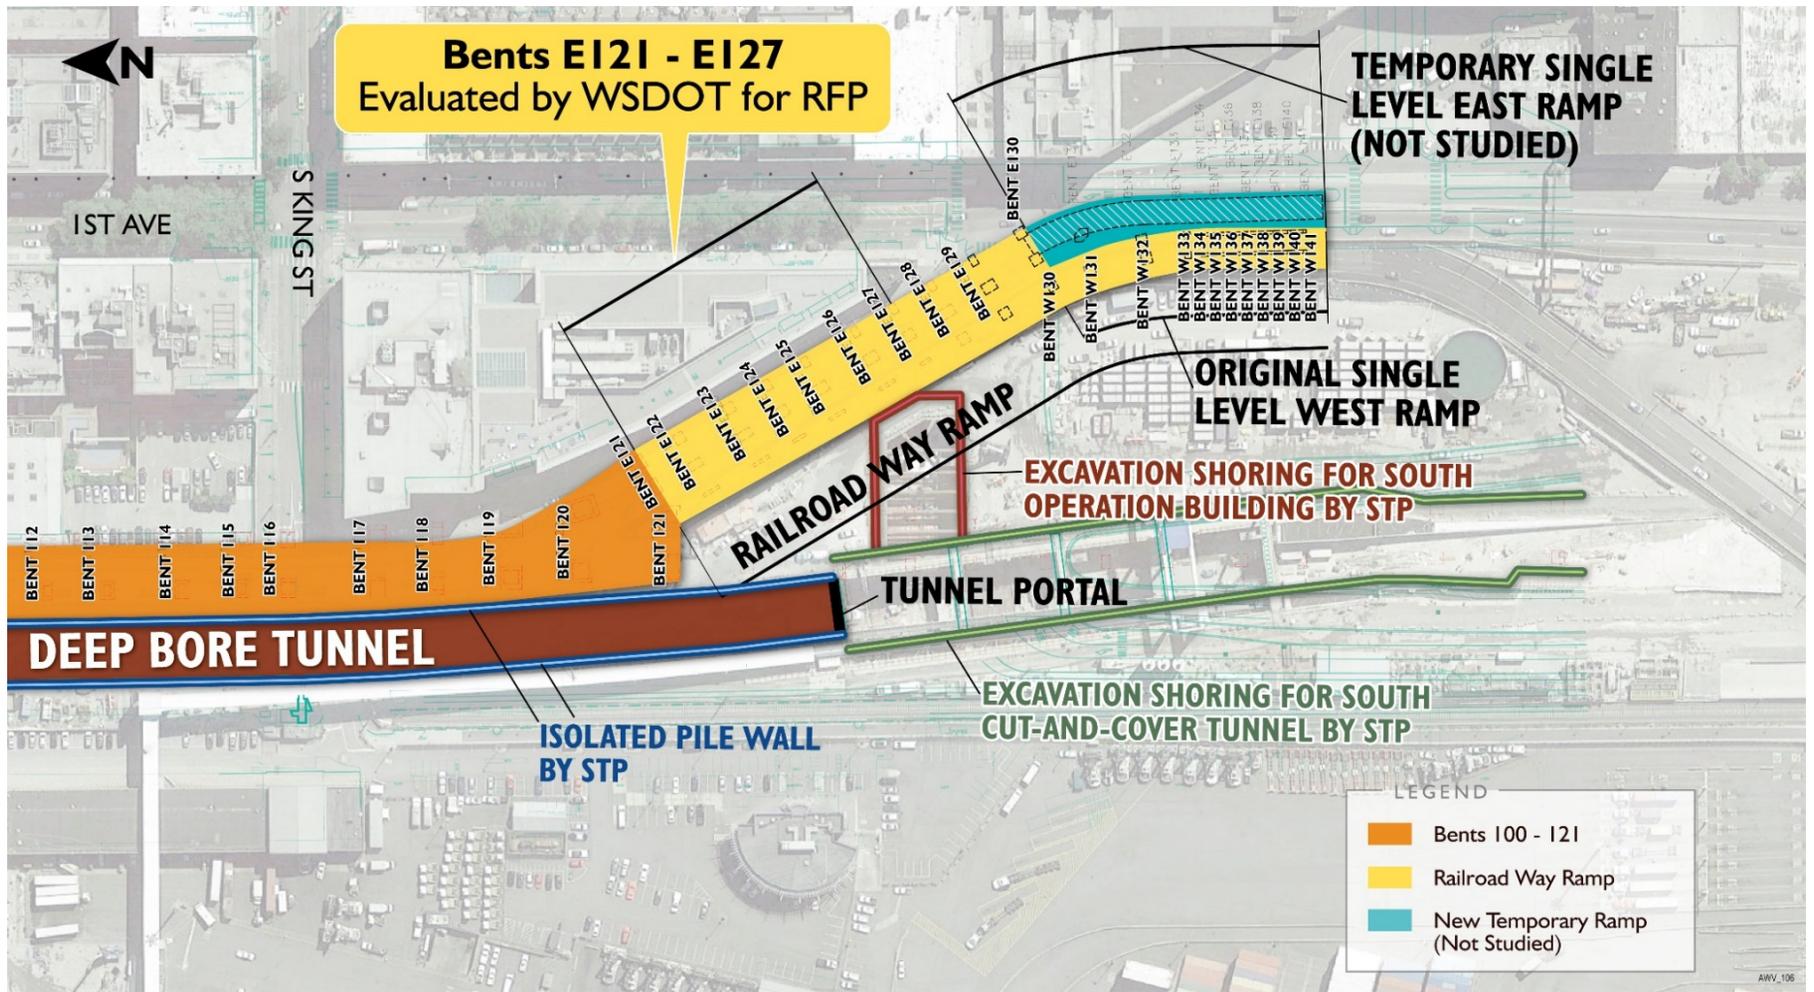
FIGURE 3-7
Railroad Way Ramp Bents E121-W141

South of Bent 121, the original mainline viaduct structure was removed. All traffic on the viaduct is being routed onto the Railroad Way Ramp, which veers to the east of the viaduct mainline alignment and touches down at First Avenue, as shown in Figure 3-7. Between Bent E121 to the north and E130 to the south, the Railroad Way Ramp consist of three two-level, three-span, semi-independent rigid reinforced concrete frames. Each frame consist of two parallel decks at different heights with a length of approximately 138'. At each bent location, the frame consists of three columns connected by transverse crossbeams and struts at upper and lower deck level, as shown in Figure 3-8. Bents within a frame are connected longitudinally by a series of longitudinal girders. The deck slabs at the upper and lower deck level are supported by the longitudinal girders and a number of small transverse stringers. Each frame is separated from the adjacent frames with expansion joints. The columns of the adjacent frames at the expansion joint share a common footing. Split columns are used at several expansion joints.

The structural assessment performed by WSDOT's consultant was based on a set of hypothetical differential settlements. The magnitude of the transverse differential settlements was 0.5-inch in the vertical direction and 0.5-inch in the horizontal direction. No longitudinal differential settlements were used in the analysis. The reason for not considering longitudinal differential settlement appears to be due to the fact that differential settlements were anticipated to be primarily in the transverse direction, resulting from excavation of the adjacent South Operation Building and South Portal (see Figure 3-7).

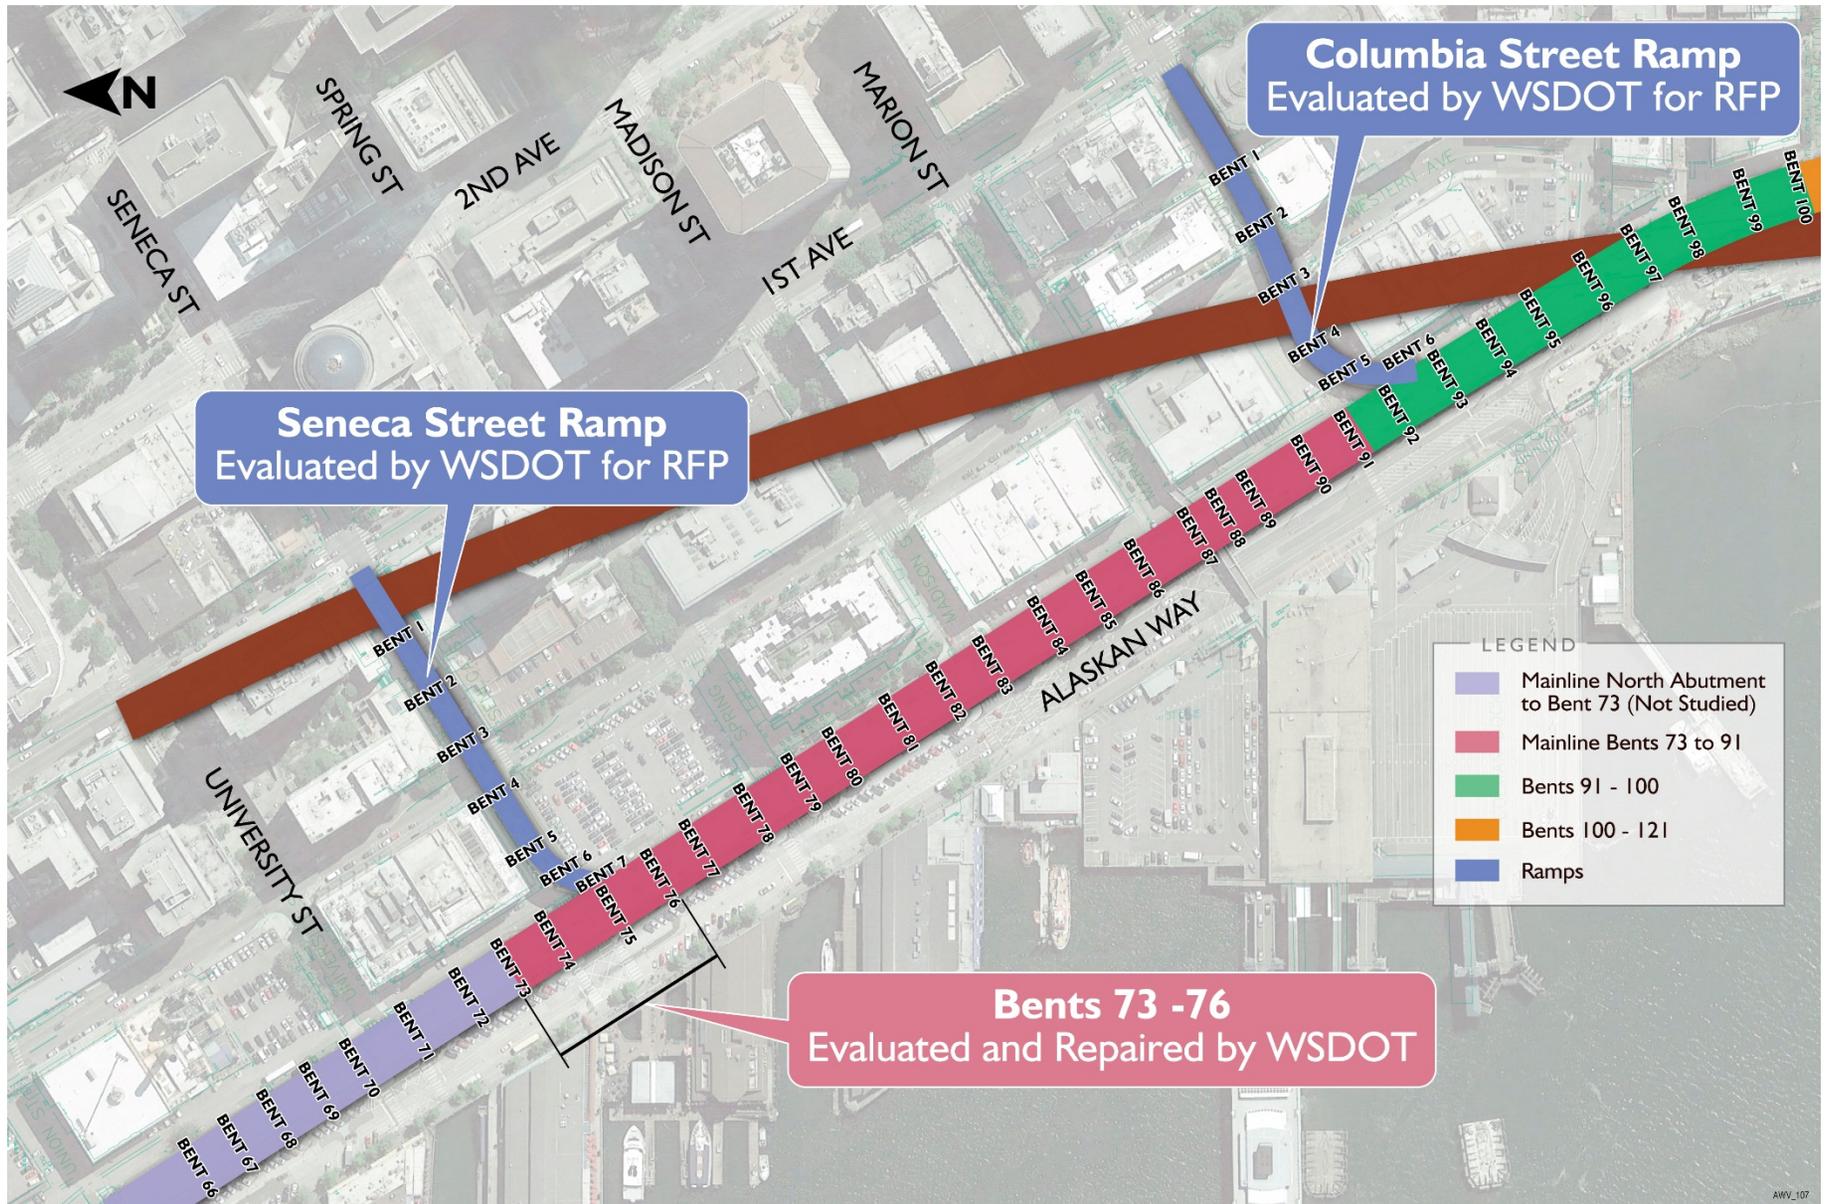
FIGURE 3-10
Columbia and Seneca Street Ramps and Mainline Bents 73-91

The Columbia and Seneca Street Ramps are shown in Figures 3-10 and 3-11. The Columbia Street Ramp consists of a six-span precast prestressed concrete girder structure supported mostly on single column bents. The superstructure is simply-supported between the bents. The west-most bent, Bent 6, is a straddle bent consisting of two columns connected transversely by a crossbeam, as shown in Figure 3-11. The Seneca Street Ramp consists of a seven-span precast prestressed concrete girder structure supported mainly on single column bents. Like the Columbia Street Ramp, the superstructure is simply-supported between the bents. The two west-most bents, Bents 6 and 7, are straddle bents consisting of two columns connected transversely by a crossbeam, as shown in Figure 3-11.

The straddle bents at the western end of the ramp structures are more sensitive to transverse differential settlement because at these locations the ramp is supported by a rigid frame. The settlement assessment by WSDOT's consultant for Bent 6 of the Columbia Street Ramp included consideration for 4 inches of historical vertical differential settlement, which is evidenced by the small downward settlement at mainline Bent 92, which shares the foundation with the north column of Bent 6 of the Columbia Street Ramp, and the much larger settlement at Bent 93, which is adjacent to the south column of Bent 6. These settlements are shown in Figure 2-6 and are corroborated by inspection reports.

WSDOT's consultant did not perform a structural assessment of the two straddle bents at the Seneca Street Ramp. There was reported historic settlement in the vicinity although the magnitude of such settlement is unknown. No report of significant structure distress or cracking was found in the inspection reports. Moreover, due to the distance of the west end of the ramp from the proposed tunnel alignment, this portion of the ramp is located outside the zone of influence for tunnel-induced settlement. It is recommended that the settlement at Bents 6 and 7 of the Seneca Street Ramp to be actively monitored. Further evaluation may be required if the magnitude of the differential settlement becomes significant.

The predicted tunneling settlement at Bent 6 is relatively small compared with the historical settlement and does not appear to be a significant concern. It is recommended that this bent to be actively monitored. Should the differential settlement at Bent 6 continue to increase, further evaluation may be necessary.

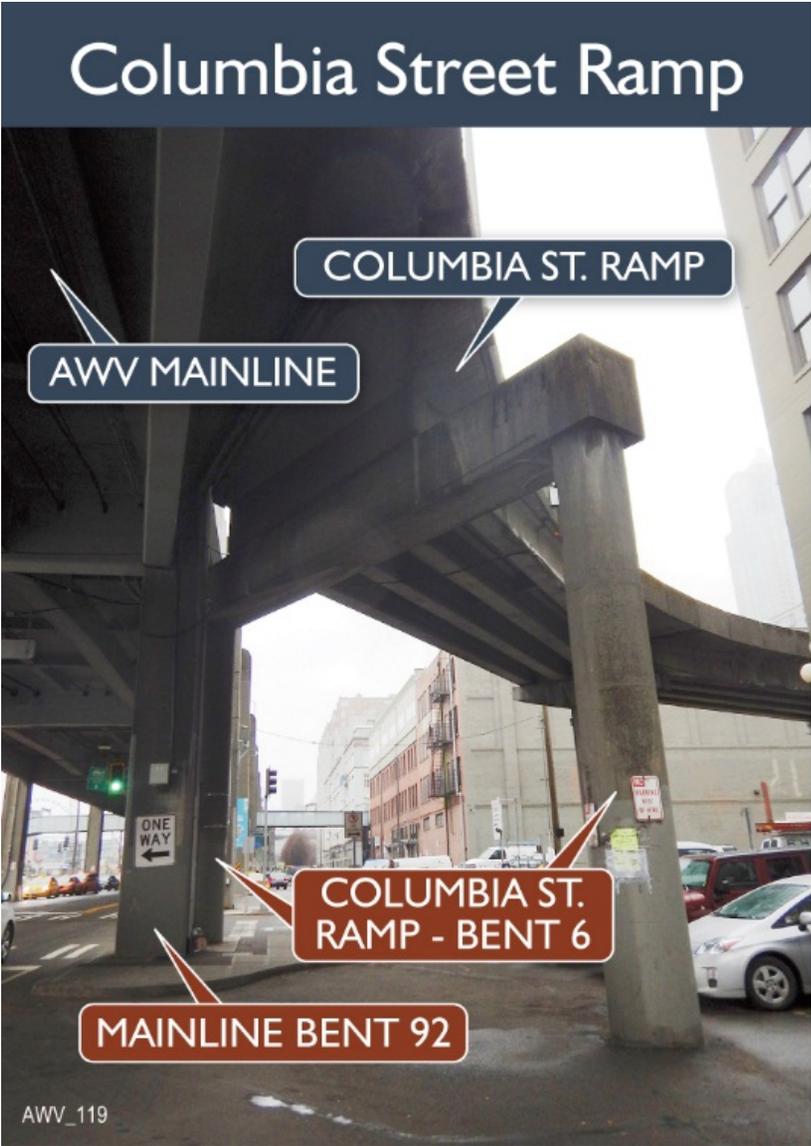
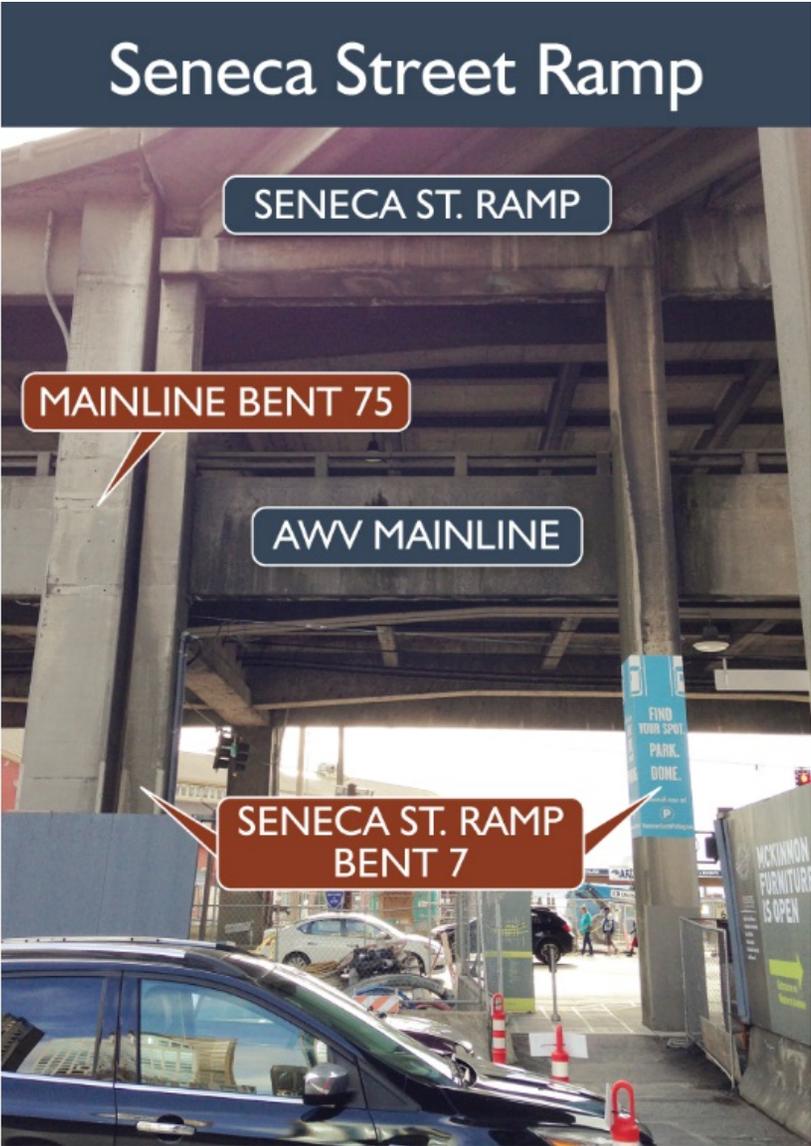
FIGURE 3-11
Columbia and Seneca Street Ramps

CH2M HILL generally agrees with the approach used in the settlement assessment of Bent 6 but notes that the analysis did not include evaluation of the foundations nor several potential critical shear locations in the crossbeam. A cursory check of these critical locations seemed to suggest that the
