DAYBREAK STAR INDIAN CULTURAL CENTER
SEATTLE PARKS AND RECREATION
ARCHITECTURAL AND ENGINEERING
MAINTENANCE EVALUATION STUDY
City of Seattle, Washington
September 2017

DAYBREAK STAR INDIAN CULTURAL CENTER EVALUATION

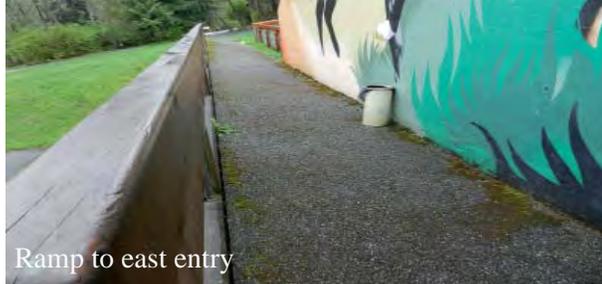
Ramp to east entry

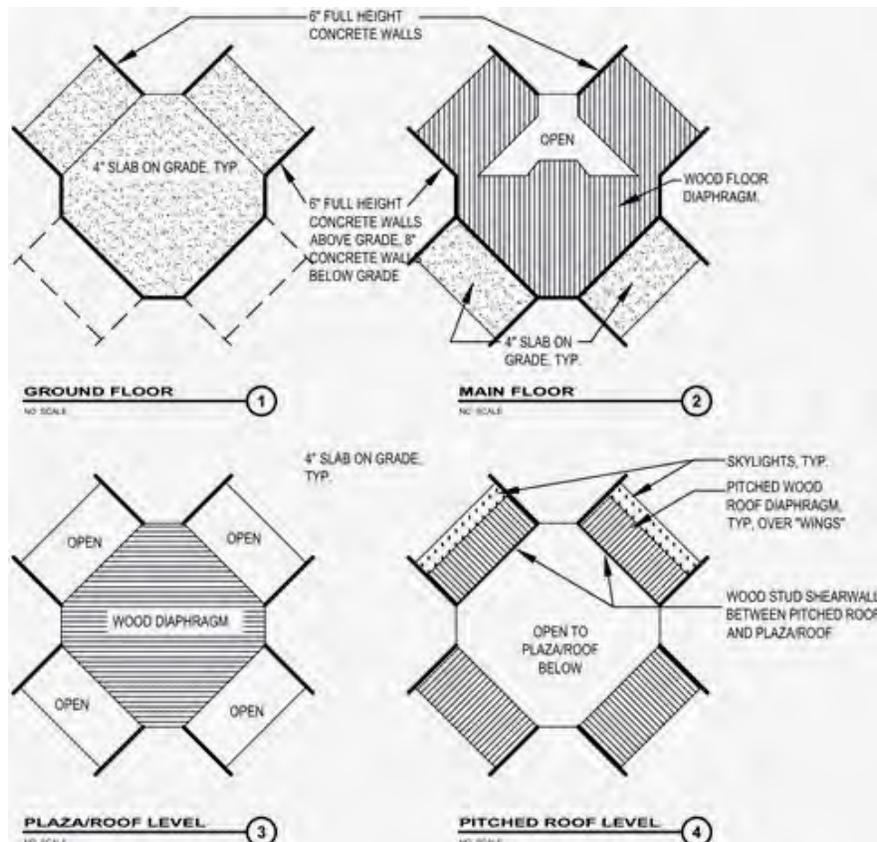
Although the original record drawings do not call out the type of lateral force resisting system for the Daybreak Star Center, it is obvious that this is a bearing/shearwall system. Lateral wind and seismic forces are distributed through the roof and floor diaphragms to the exterior and interior shearwalls and into the foundation. (Note the higher wind load mentioned at the beginning of this report.) The floor and roof diaphragms are wood framed. Plywood was added to the diaphragms to enhance their lateral load carrying capacity. The shearwalls consist mainly of the reinforced concrete walls described above. The only wood stud shearwalls are the walls between the high, pitched roofs and the Plaza/Roof at the south edges of the northwest and northeast wings. This is illustrated below.

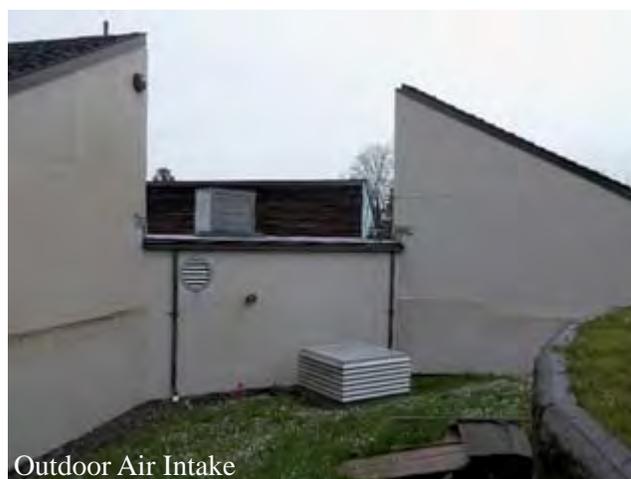
The outdoor air intake needed for ventilation for all the four (4) H&V units is via penthouse louvers which appears to have been installed c. 2006.

Outdoor Air Intake

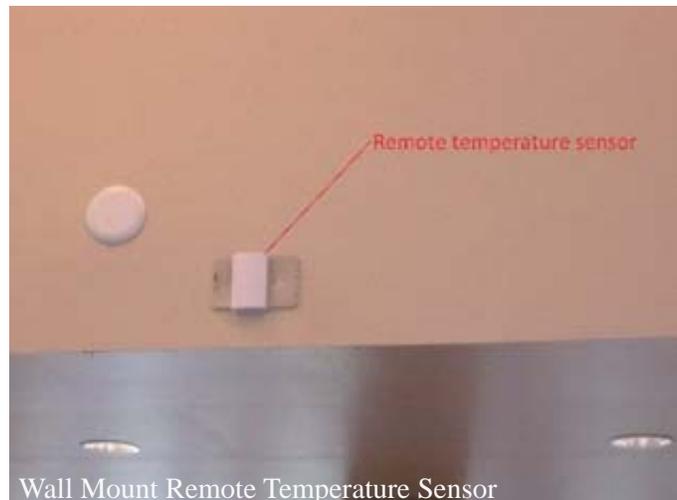
Wall Mount Remote Temperature Sensor

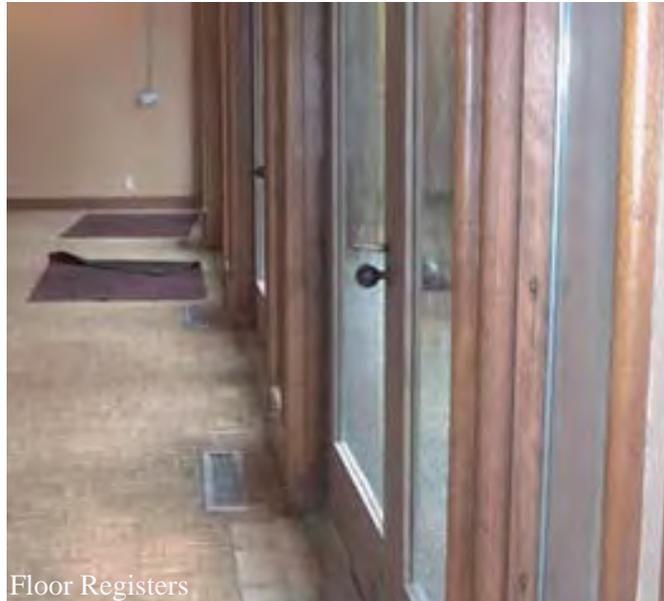
CLASSROOMS – UPPER LEVEL SOUTHWEST WING

- Fan motor was replaced around three (3) years ago with a new ABB Variable Frequency Driver (VFD).
- It was observed in some classrooms that the floor return grille is located near the toilet, so it is likely some odors will be distributed to spaces via return air to the H&V unit it serves.

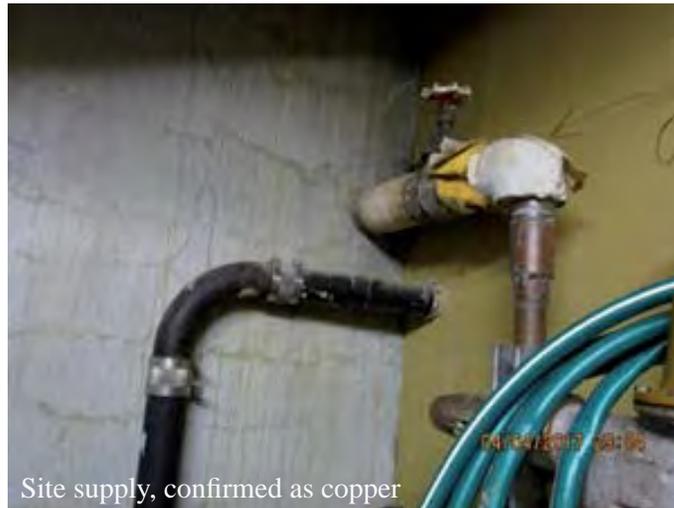
Most existing piping is hidden in walls and not visible. Visible piping at the water entry is copper.

Site supply.

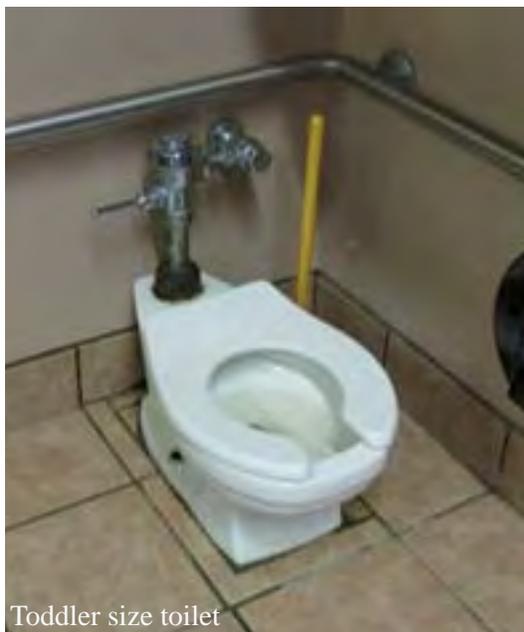
Toddler size toilet

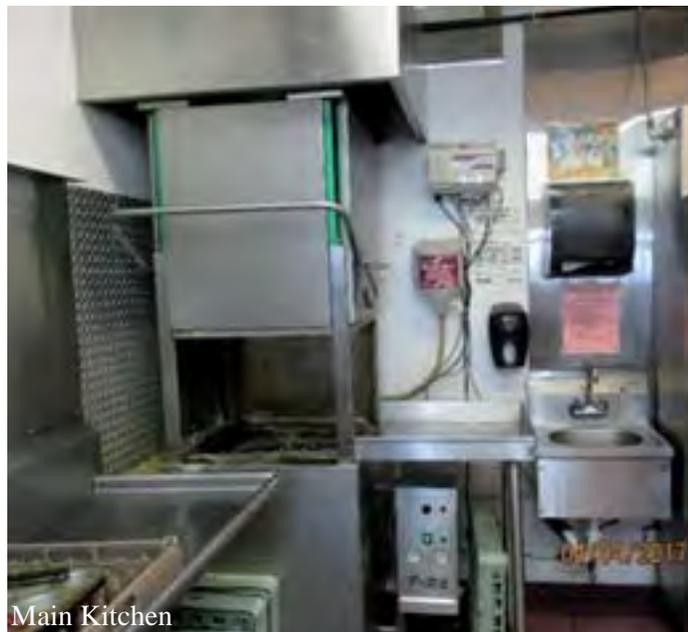
Fixtures include a three compartment sink with pre-rinse, commercial grade corner type dishwasher with auto chemical/detergent feed, a separate stainless steel handwash sink, and a grease hood with fire protection system.

Main Kitchen

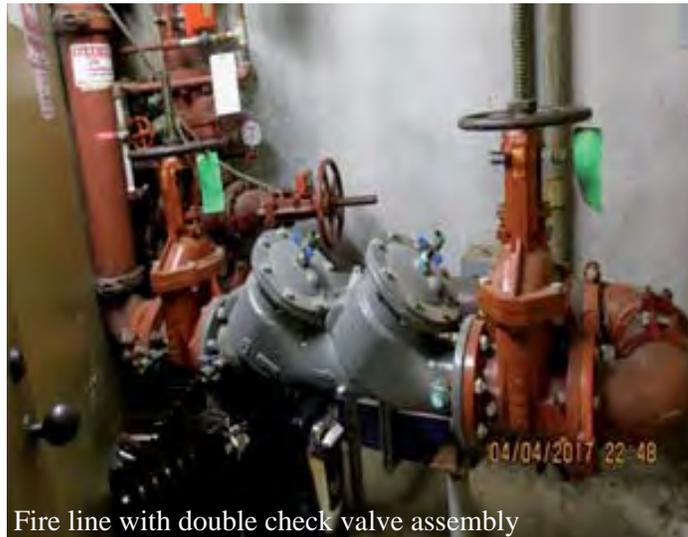
The building is served by a 6" fire line. Fire system control valves, including a 6" double check valve, are located in a dedicated closet on the lower level.

Fire line with double check valve assembly

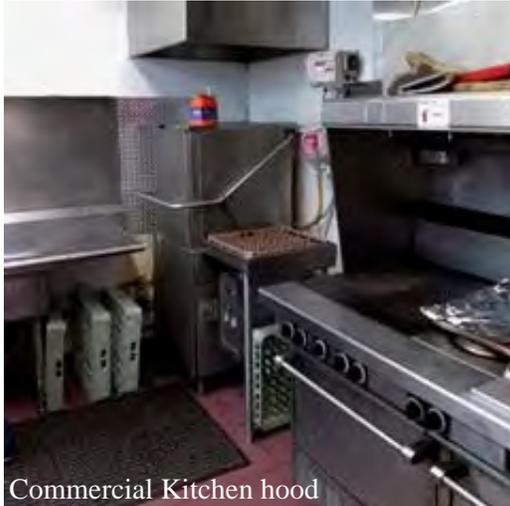
There is a kitchen located behind the reception desk on the lower level, which accommodates an electric range and exhaust hood. The exhaust hoods are type I commercial hoods with a fire suppression system.

Commercial Kitchen hood

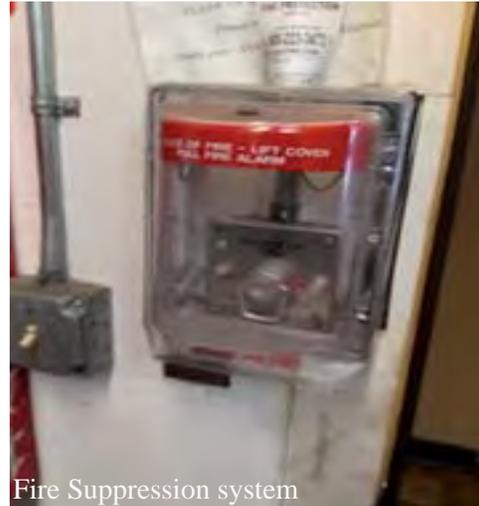
Fire Suppression system

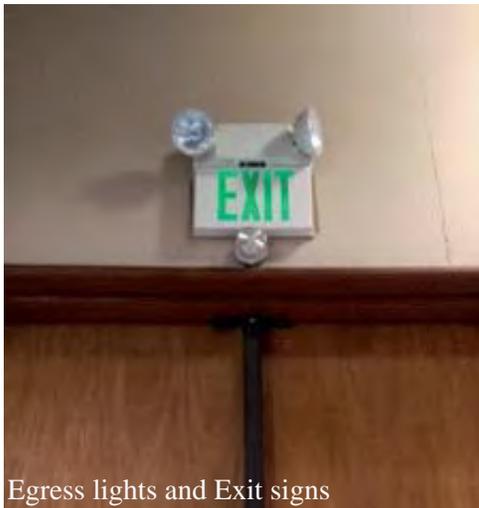
Battery backup bug-eye lighting fixtures are powered by integrated battery throughout the building and also feed the exit signs. Egress lighting and exit signs are observed in some rooms, but not all areas. We think the coverage is not sufficient to meet current code requirement. Also in some rooms, there are no illuminated exit signs, only temporary paper exit signs observed.

Egress lights and Exit signs

1. Replace all receptacles in rooms that are designated as daycare facility with tamper-resistance type receptacles to meet current code requirement for child care facilities.
2. Replace paper exit signs with illuminated exit signs fed from battery backup unit. Add egress lights required by building code to cover all areas within the building.

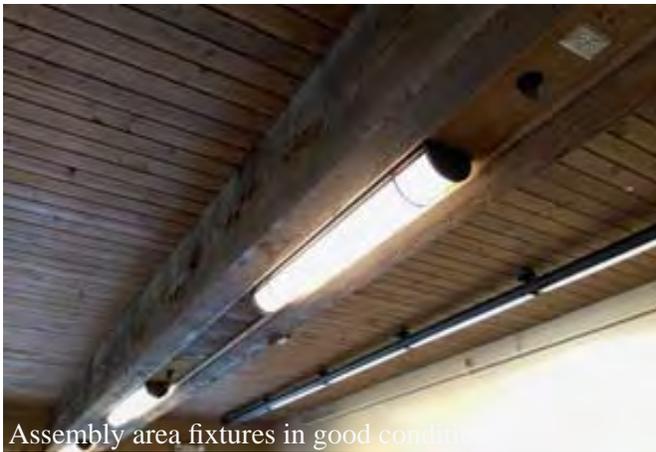
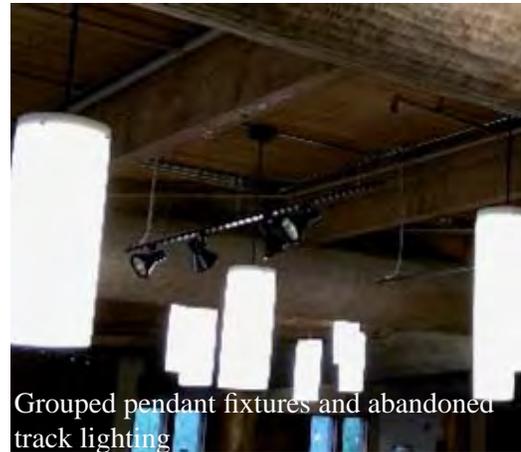
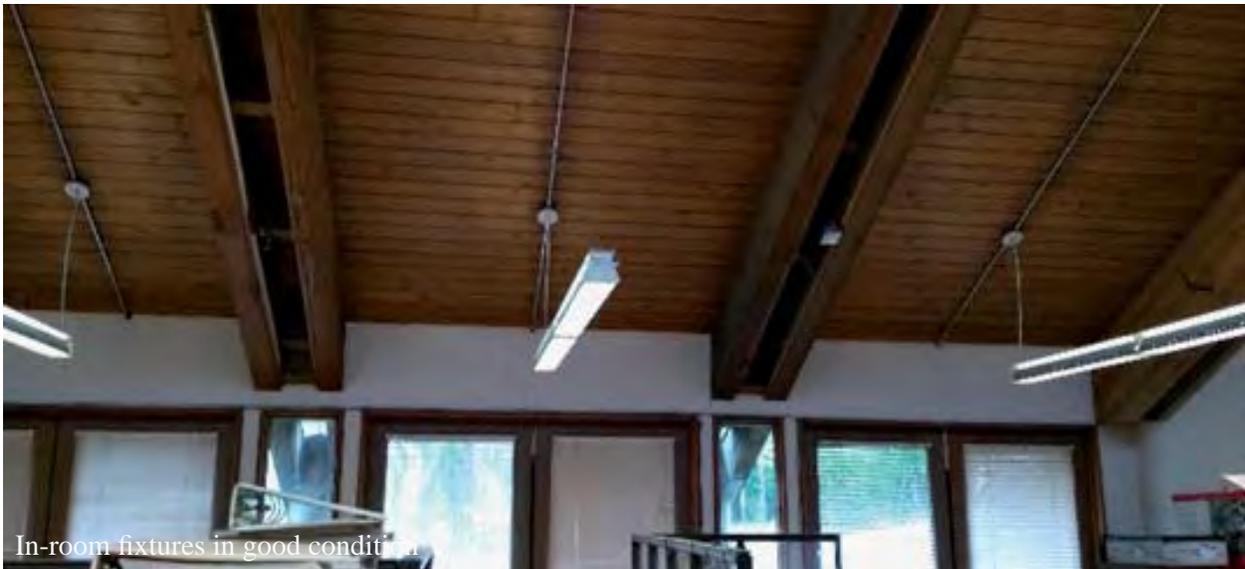
Interior lighting fixtures were originally installed in 1977, however the most current lighting layout does not match 1977 as-built drawings. Only a few track lights are observed on the mezzanine level, which are abandoned but not removed yet. In the Lobby atrium, there are modern grouped pendant lights observed and in the Classrooms, pendant and wall mounted fixtures are in good working condition. In the Lobby assembly space, there are more surface mounted lights observed, which are still in good shape. We observed the lighting fixtures in the rest of the building have been replaced since 1977, but without record drawings, we are not sure when the renovations happened.

5. Replace the whole building electrical distribution system if there will be a major renovation happening within the next 10 years. The electrical distribution system will reach the end of service life at that time.
6. Replace the whole fire alarm detection system for the building, since the system will be discontinued by the manufacturer in the long term, and it will be hard to find replacement parts on the market for maintenance.
7. Provide a central lighting control system to respond to daylighting as well as occupancy condition to save building energy.

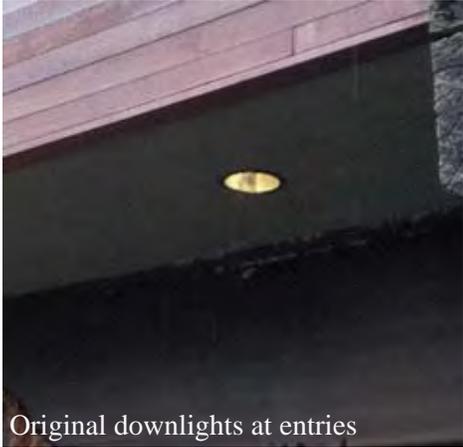
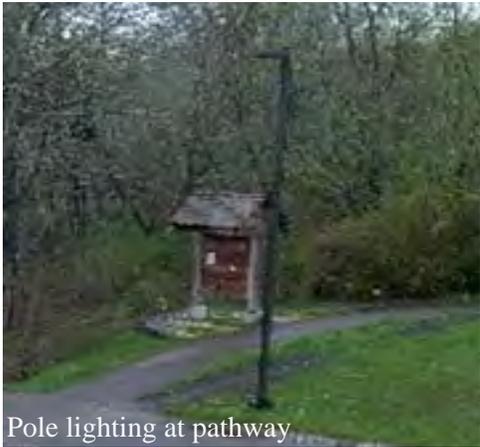
Exterior lighting was observed around the building perimeter and at the south side field. There are perimeter downlights installed at each building entrance which appear to be original to the building. Square shape pole lighting was observed at the pathway around building.

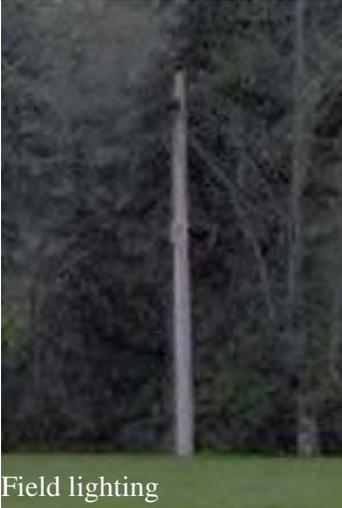
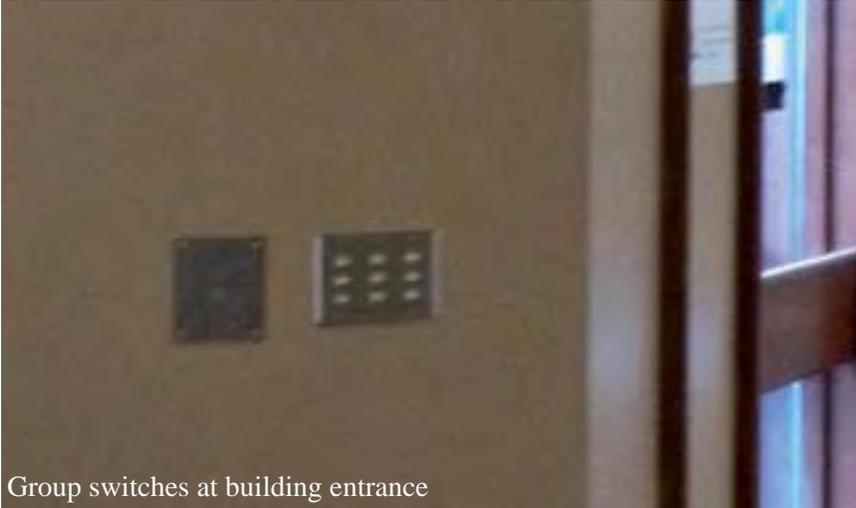
There was no lighting control panel observed during our site visit. Based on the group lighting switches observed at the lobby entrance, we think the building lighting is controlled by group fixtures via the line voltage switch at the entrance.

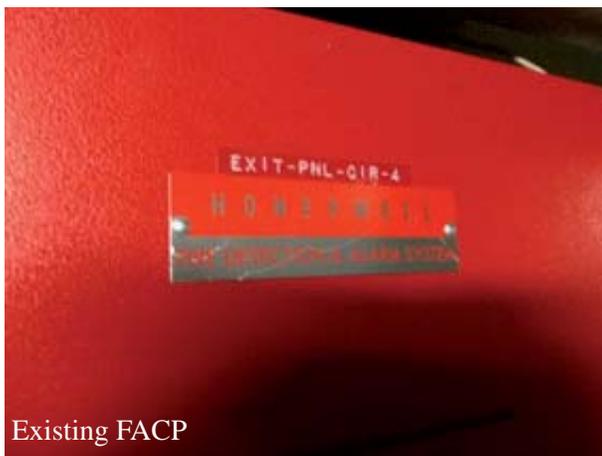
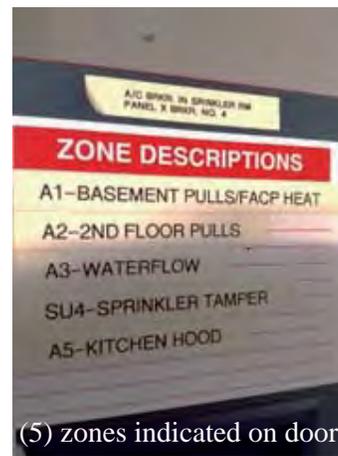
The fire alarm control panel is installed in Mechanical room 109. It is an (8) zone, non-addressable fire alarm control panel (only 5 zones shown on front door) manufactured by Honeywell. This fire alarm panel has been discontinued by manufacturer. The fire alarm system is inspected annually by Fire Protection Inc (FPI) and the latest result has no deficiencies found in July of 2016. No fire alarm remote annunciator (FARA) is observed in the building.

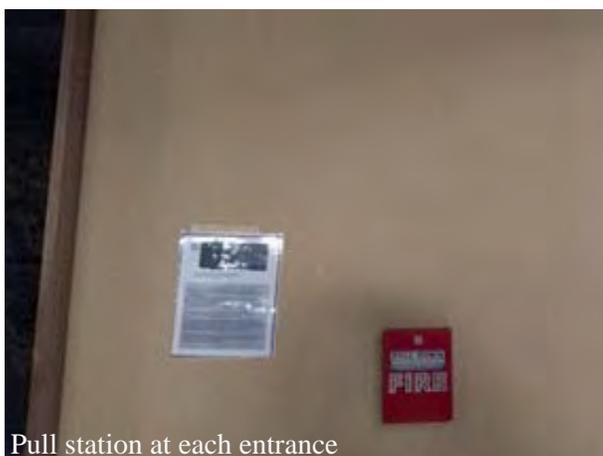
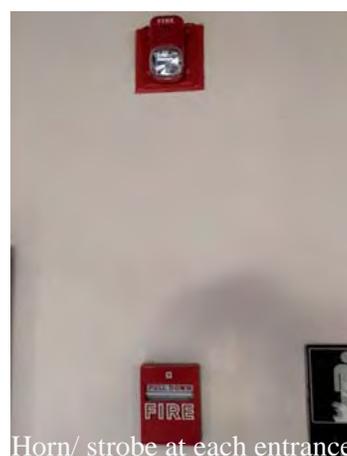
Fire alarm manual pull stations are observed at the entrance and each exit door, which meets code requirements. We didn't find smoke detector coverage as the building is fully sprinklered and smoke detectors were not required when it was built.

Wall mounted fire alarm horns/strobe and fire alarm bell are mixed and observed in public areas.
