MADRONA BATHHOUSE
SEATTLE PARKS AND RECREATION
ARCHITECTURAL AND ENGINEERING
MAINTENANCE EVALUATION STUDY

City of Seattle, Washington
September 2017

MADRONA BATH HOUSE EVALUATION

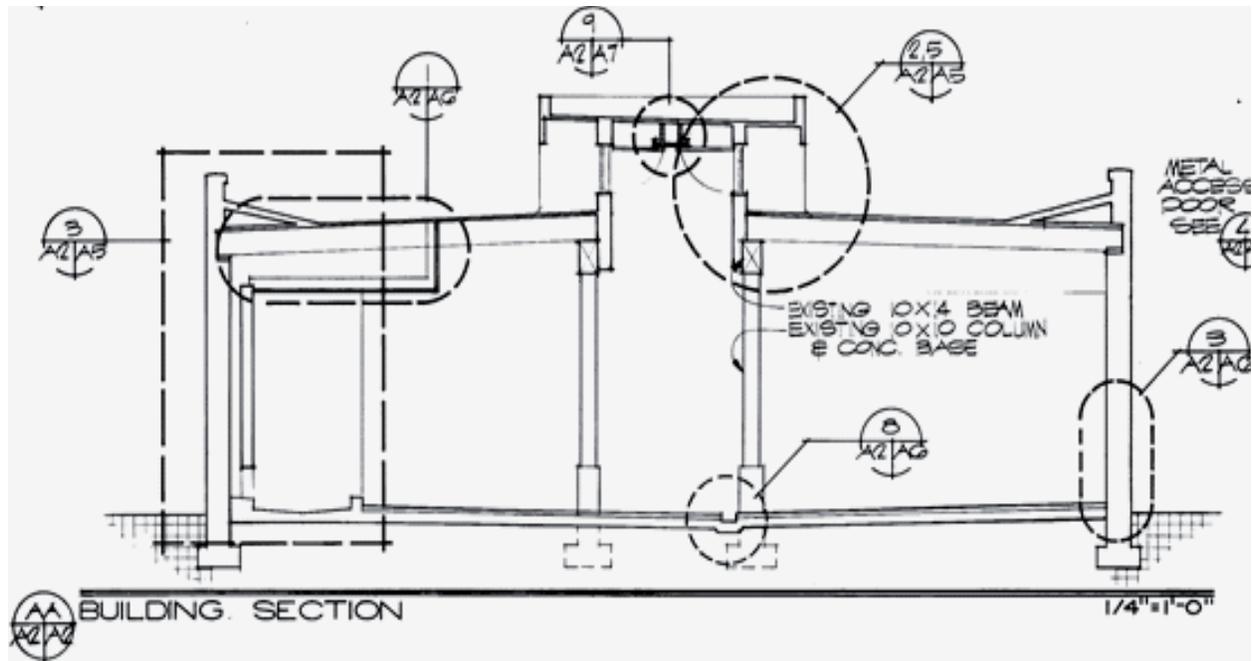
In 1983 the north portion of the building was structurally modified. The entire roof structure, except for the existing 10x14 roof beams and 10x10 timber support columns, was removed and replaced. The exterior URM walls remain, except for the north exterior wall. This wall was removed and replaced with a 6" reinforced concrete wall which retains approximately three feet of soil.

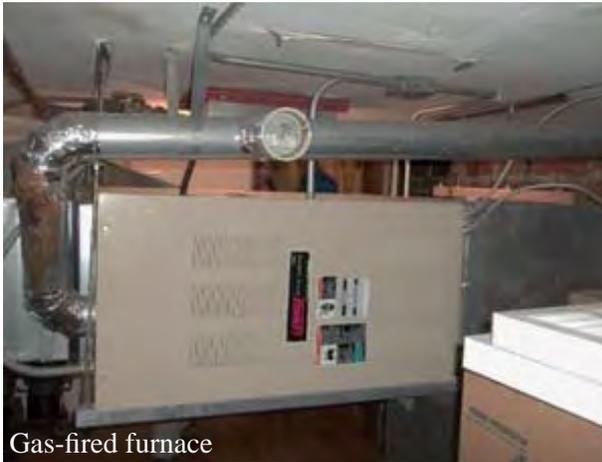
- The space temperature setpoint on the wall thermostat was 70F; the registered space temperature on thermostat was 70F.

Gas-fired furnace

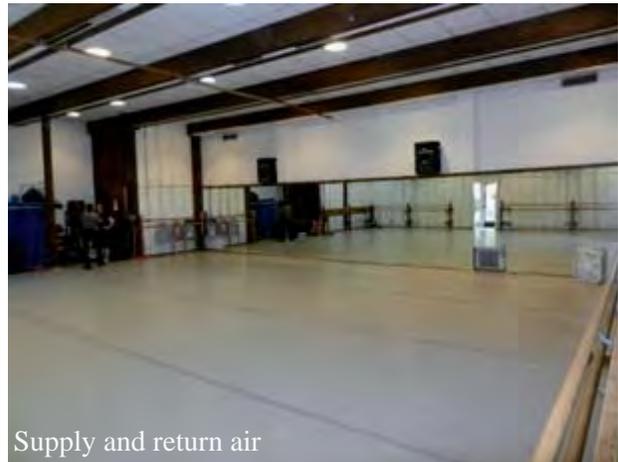
Supply and return air

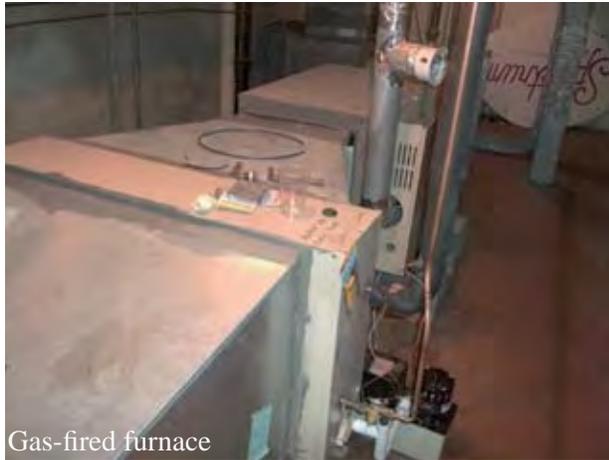
- The space temperature setpoint on the wall thermostat was 70F; the registered space temperature on thermostat was 71F, which is within control tolerance.
- There are three (3) skylight backdraft dampers, all set in a fixed open position.
- The floor return grilles were found to be blocked by chairs.

Gas-fired furnace

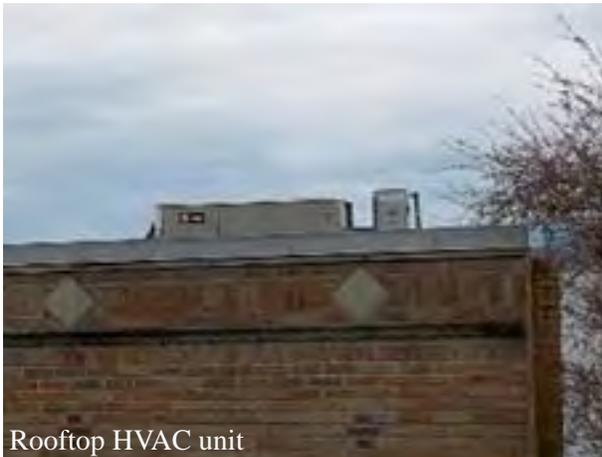
- The space temperature setpoint on the wall thermostat was 70F; the registered space temperature on thermostat was 70F.
- Most of the return grilles are clogged by dust, cleaning of these return grilles is recommended.

Rooftop HVAC unit

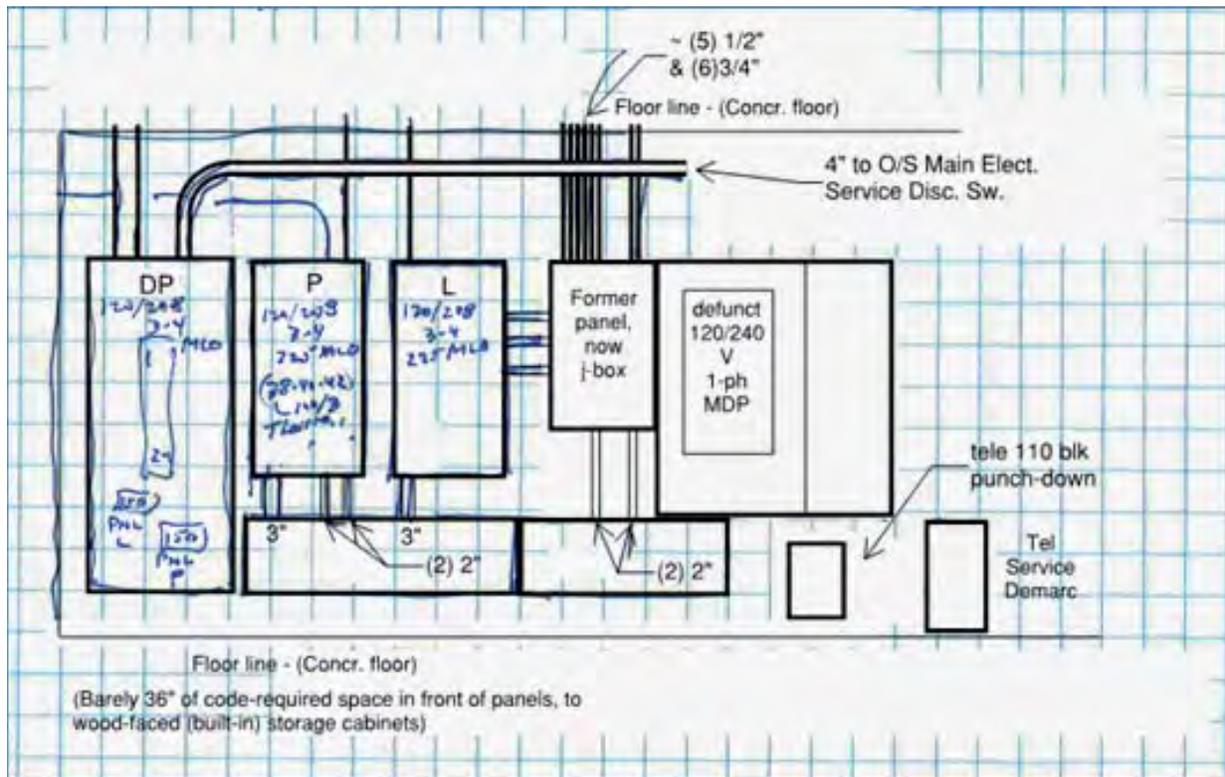
The existing electrical service is 600A 120/208V 3ph 4W, with the existing former single-phase main service panel serving as a large wireway/junction box.

Panel DP is reasonably new and in good, serviceable condition, as are Panels 'P' and 'L'. There appears to be adequate power capacity for future renovations, however additional panel circuit breaker space will be required, and with the space being limited within the main electrical room, the recommendation is to provide a feeder from Panel 'DP' to a new branch circuit panel located in a convenient location on the main floor, to serve new lighting and power needs.

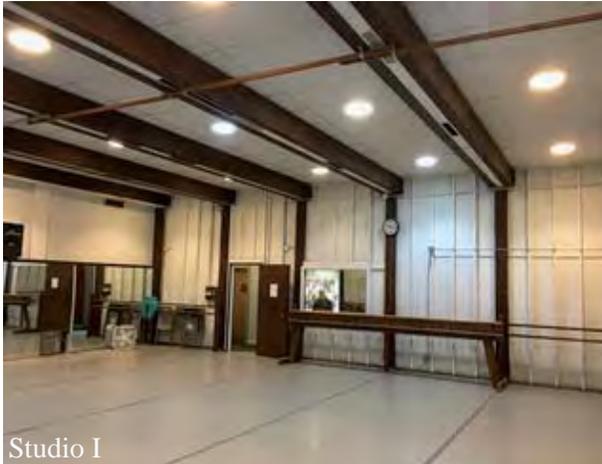
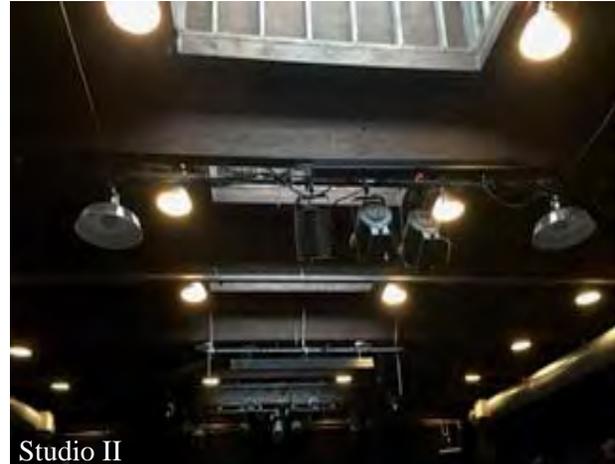
Interior lighting in Studios I is HID lighting. This was a standard for high-ceiling spaces 20 to 30 years ago, but is very harsh, with excessive glare for this application. Studio II on the second floor incorporates Performance Lighting, mounted to battens.

7. The current interior lighting in the building is in serviceable condition, however we recommend replacement with contemporary luminaires and automated control to provide building energy conservation.

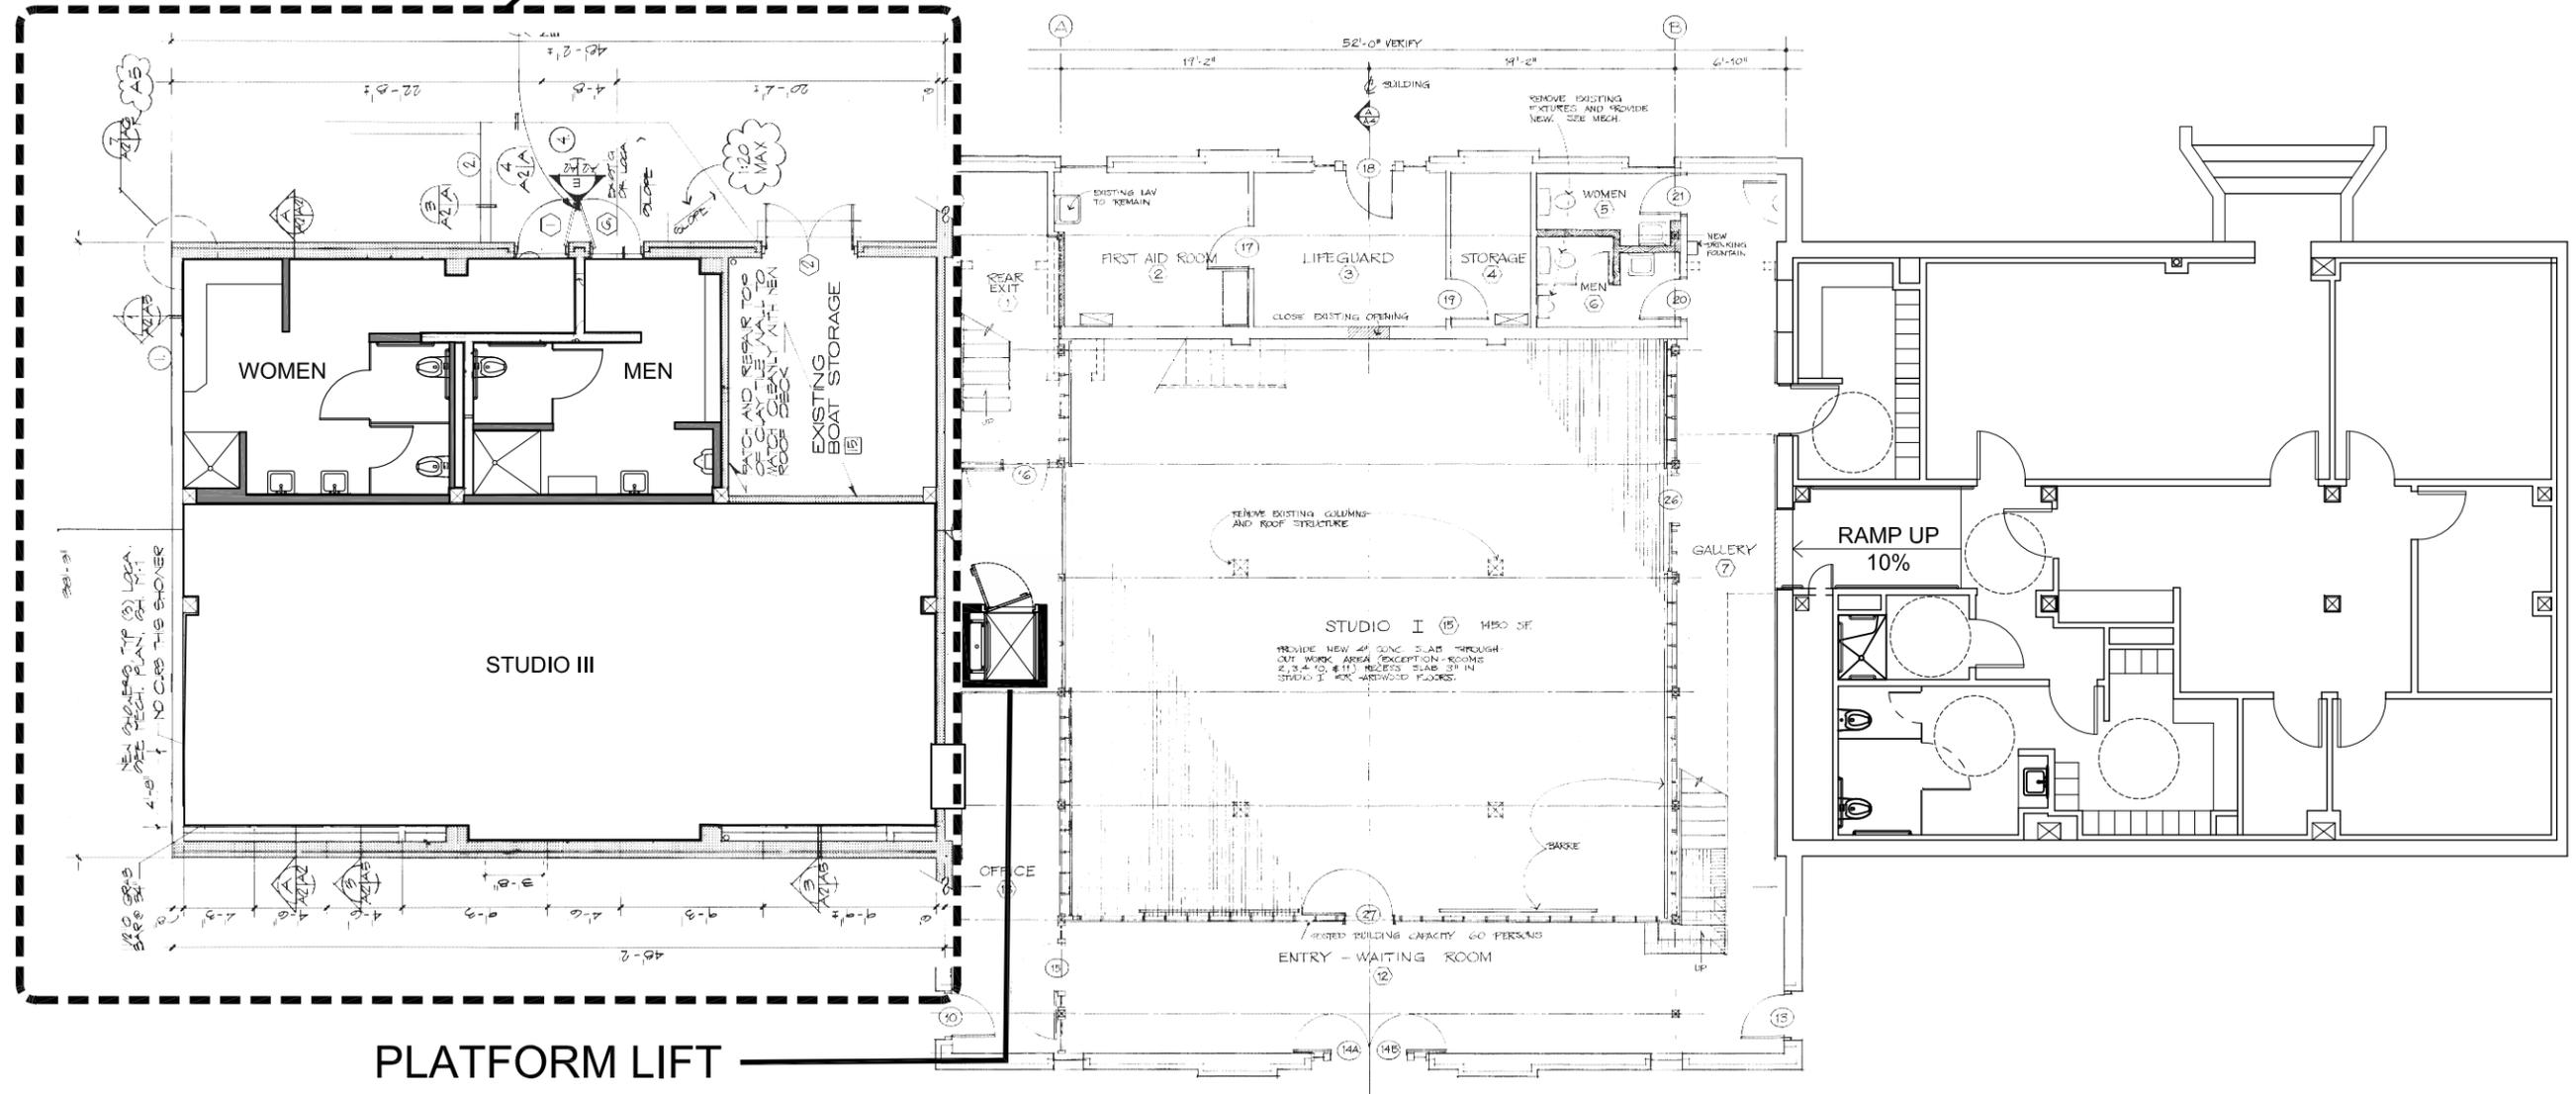
FIRST FLOOR CONCEPT PLAN
 SD1.0
 29 JULY 2017
 NOT TO SCALE

RECONFIGURE CHANGING ROOMS
 INTO ADDITIONAL STUDIO SPACE AND
 SMALLER CHANGING ROOMS

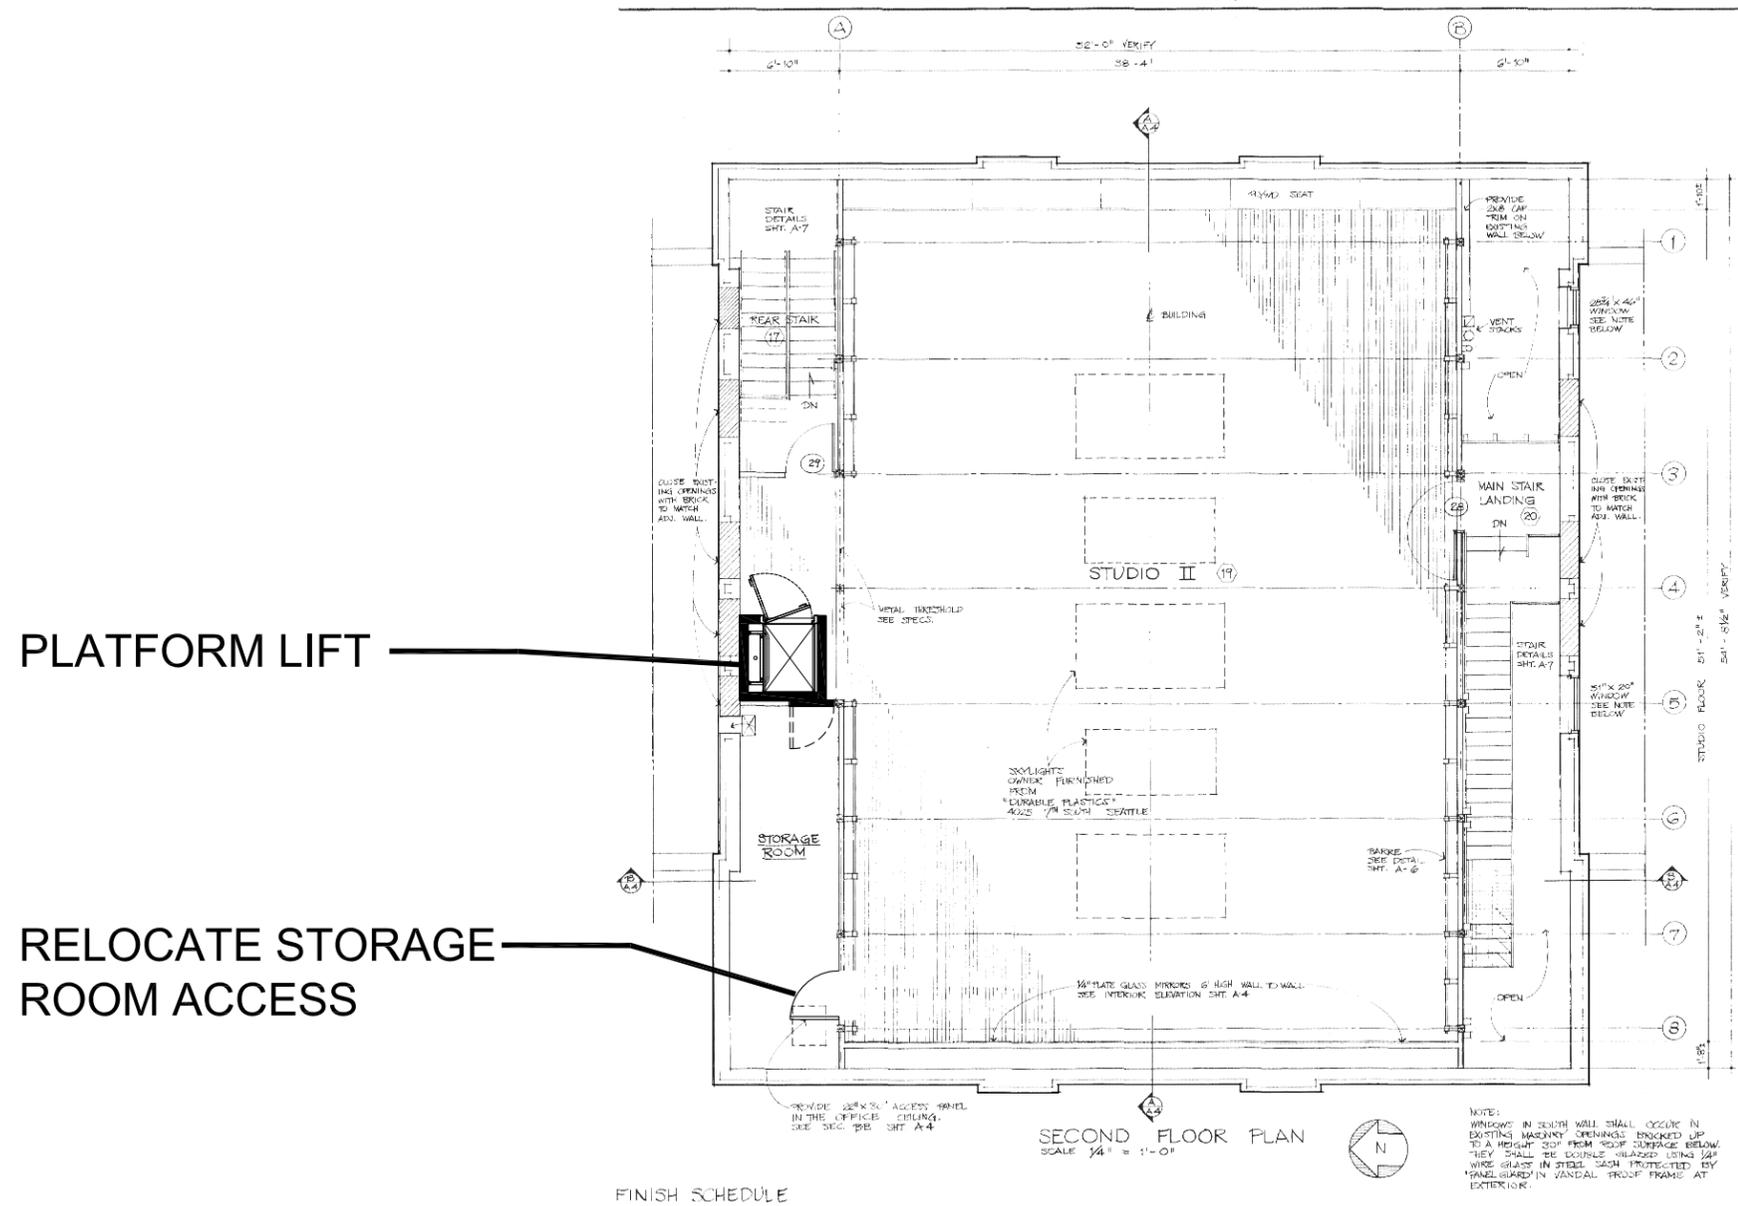
PLATFORM LIFT

RELOCATE STORAGE ROOM ACCESS
