Phase 2B

Glass Canopies Installed

December 6, 2012

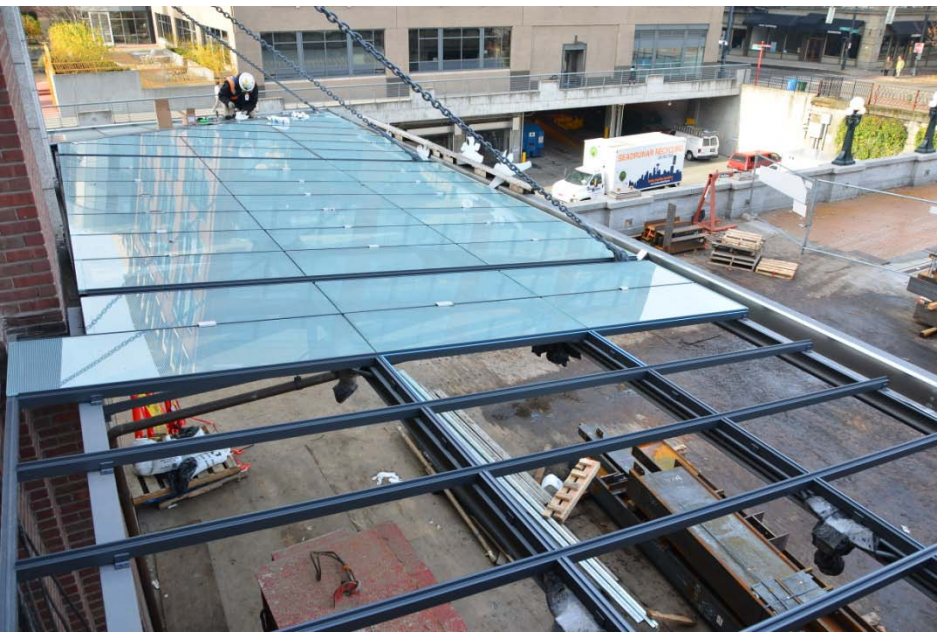
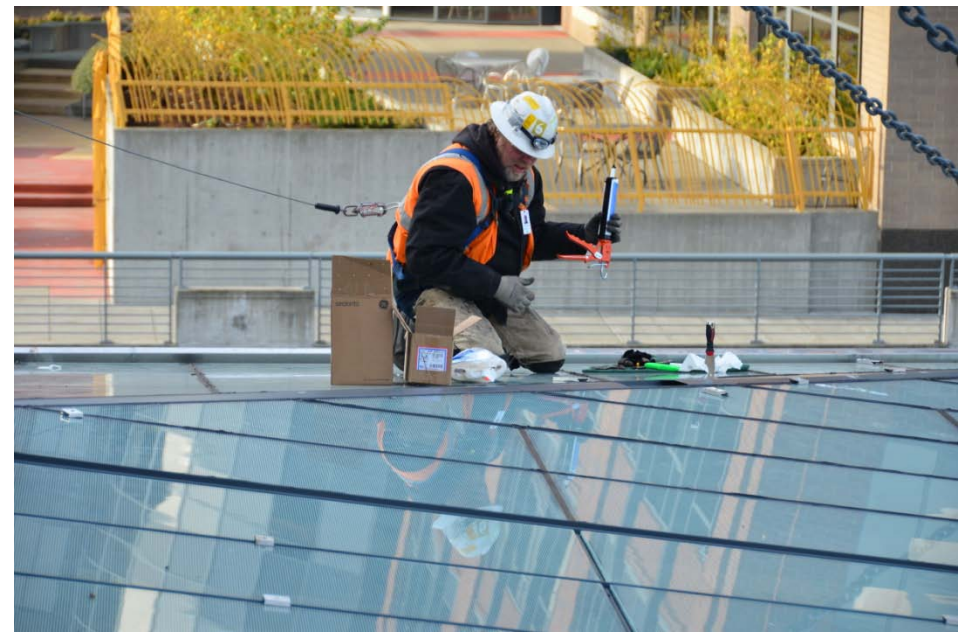
The north canopy gets a new glass roof. The strong $\frac{1}{4}$ " safety tempered glass is strong enough to hold an average weight adult. New efficient lighting had been installed in a previous phase. Ornamental copper fascia and crestring will also be installed along the perimeter of this canopy.

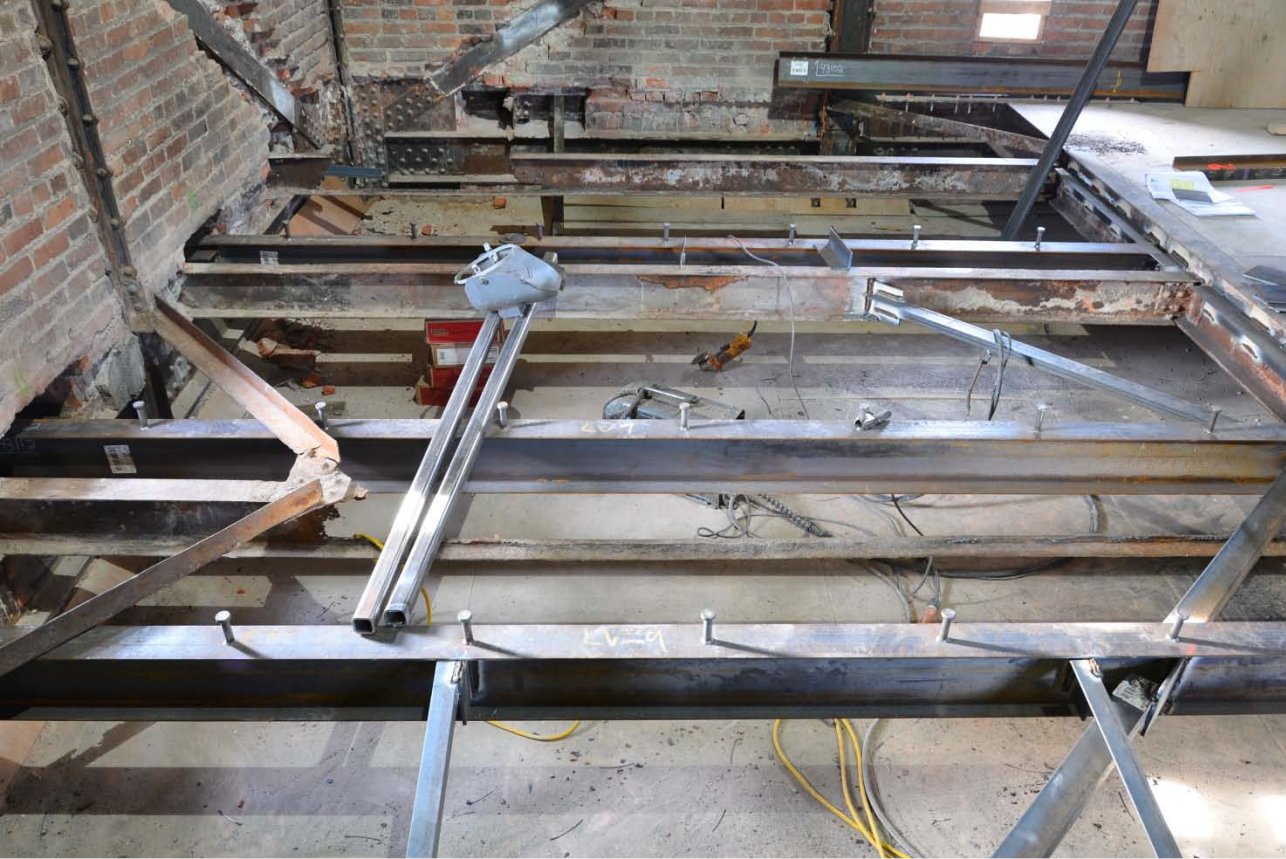
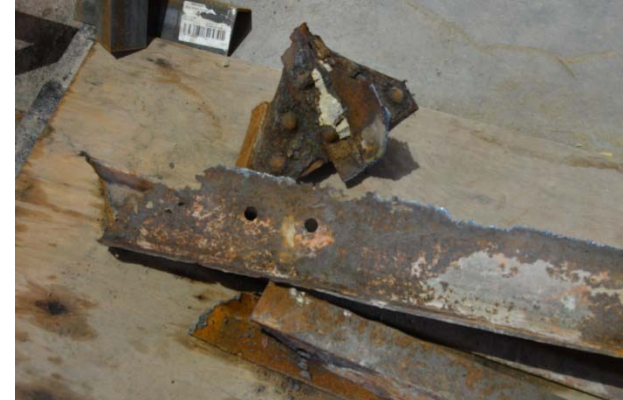
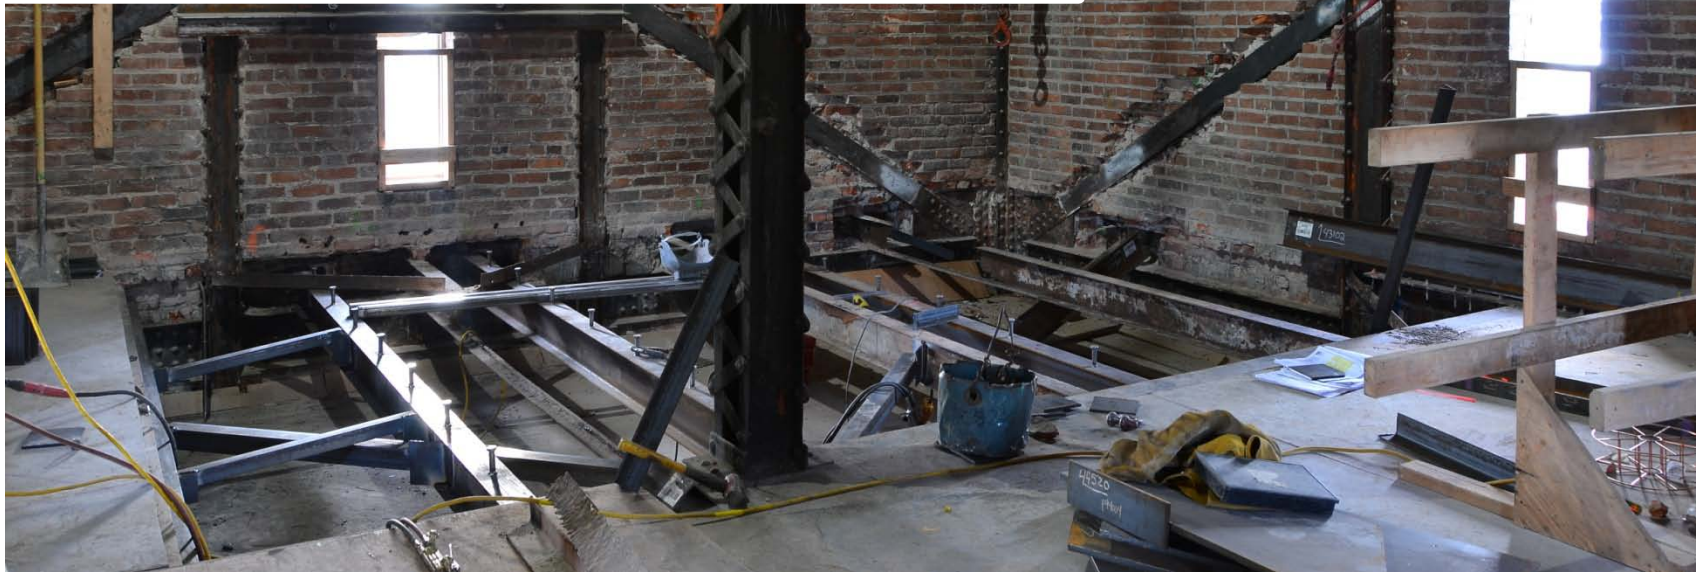
New structural beams installed to prep for metal deck casting on the 9th tower floor. Original corroded steel shown below.

All structural steel will be painted for corrosion resistance.

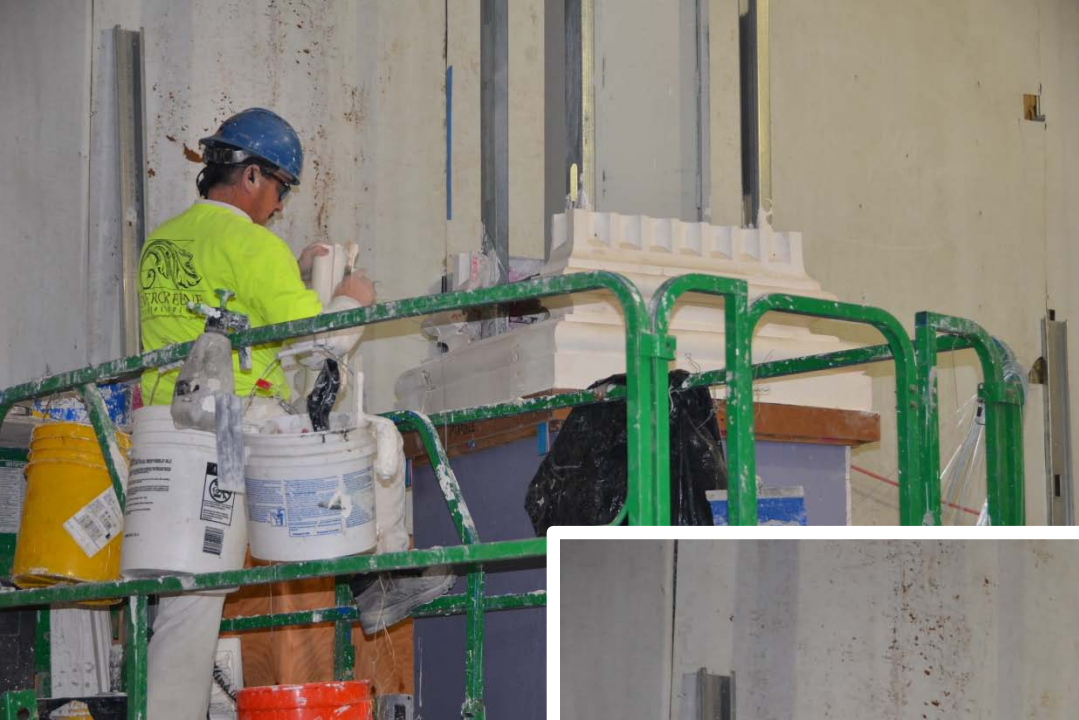
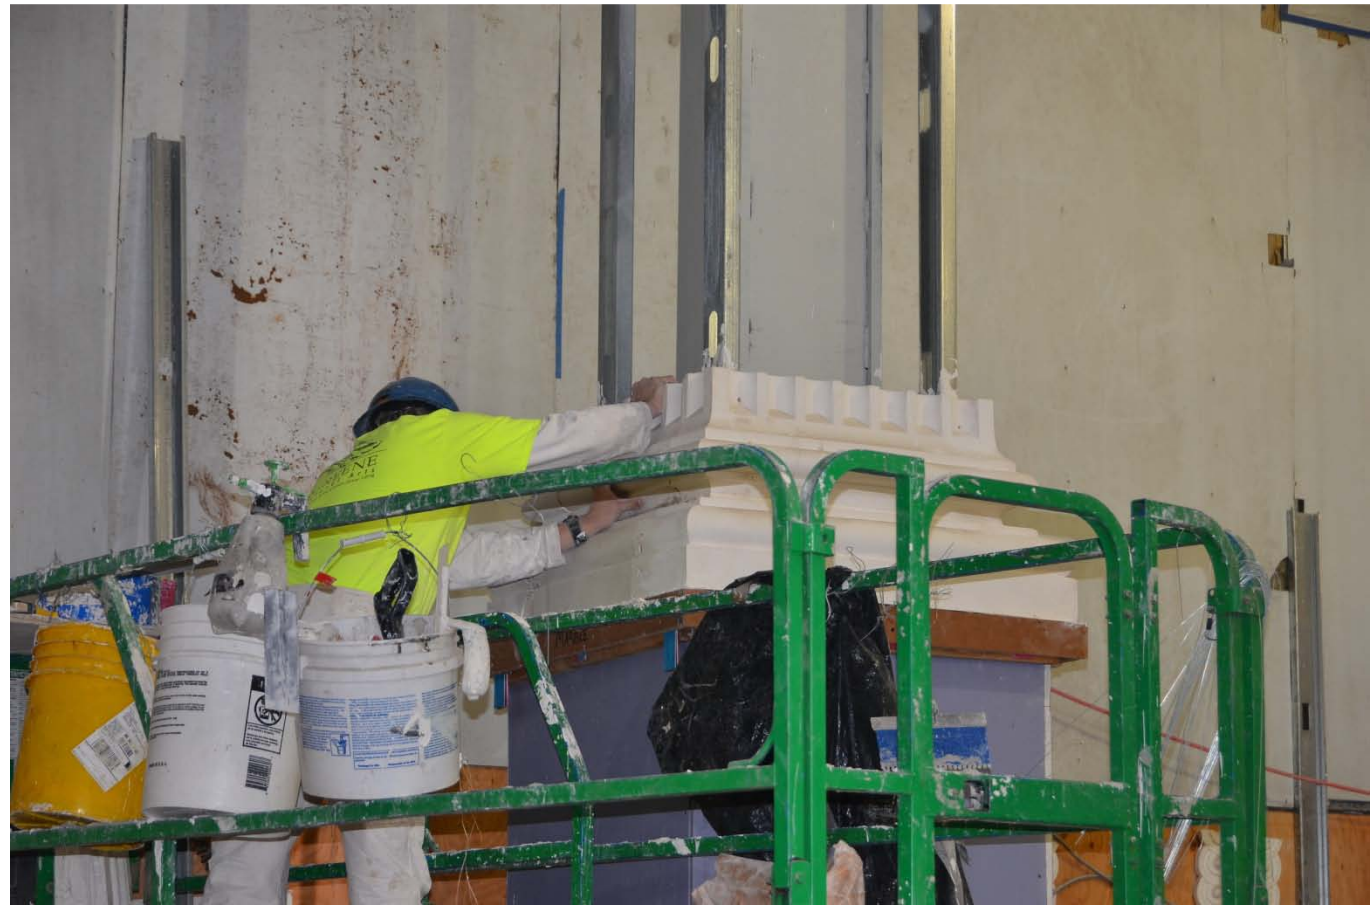
Ornamental plaster pieces are being installed around the columns located in an area north of the main waiting room.

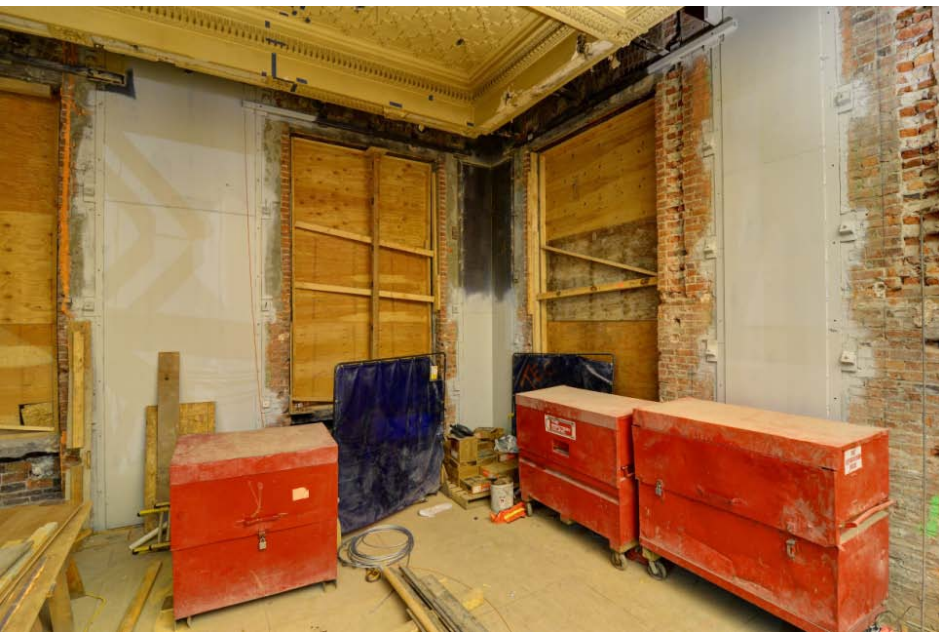
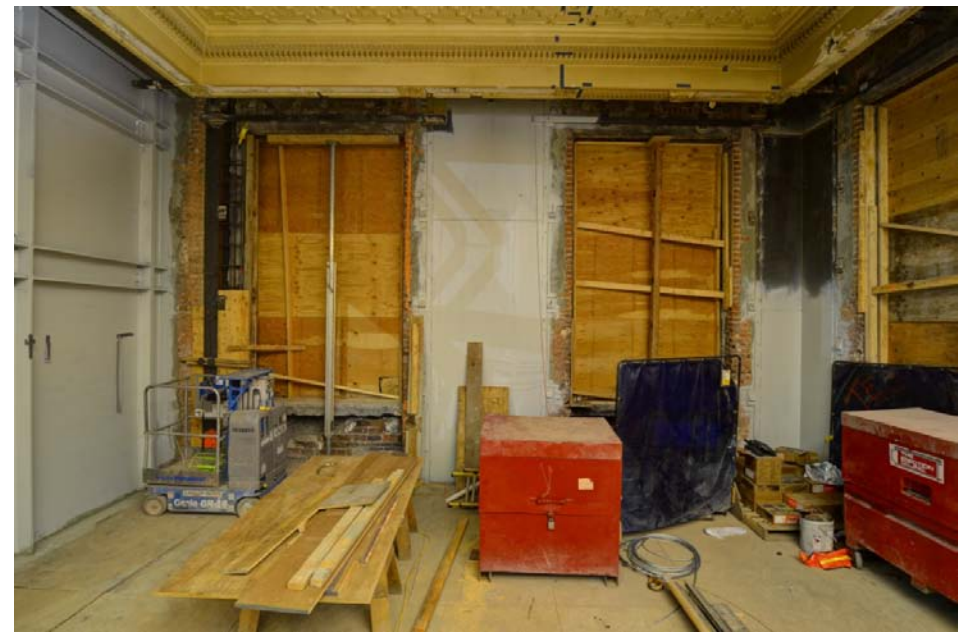
A new steel shear wall separates the intimate women's waiting room from the lofty main waiting room.

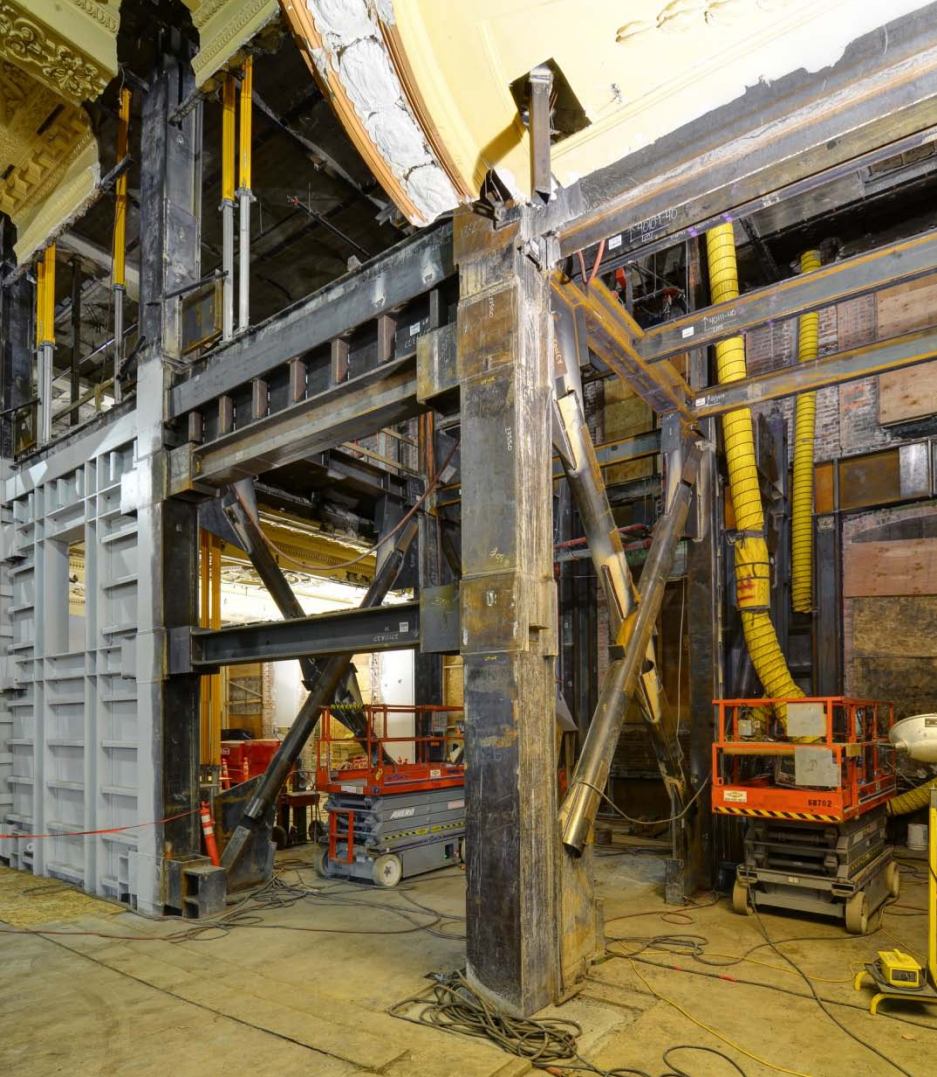
New brace frame

New stairwell installation in previous Men's room will provide a new code required exit between the 3rd floor and terminal level. The rosette plaster ceiling is also used in the 2nd floor interior balcony that overlooks the main waiting room.

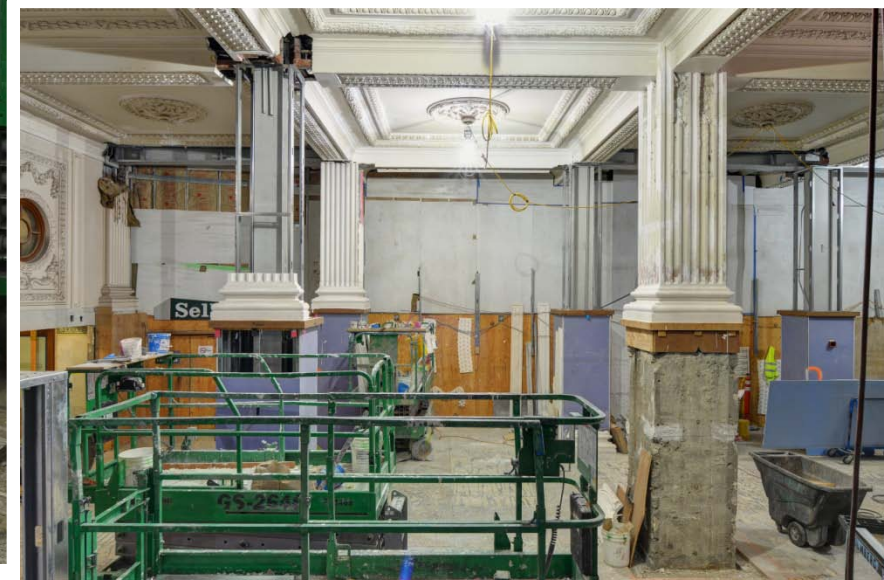
Columns in various states of restoration are shown in the left photo. The original column on the far right was similar in size to the small steel column in the middle. New seismic steel pieces now surround the column on all sides. All other columns will be wrapped this way.

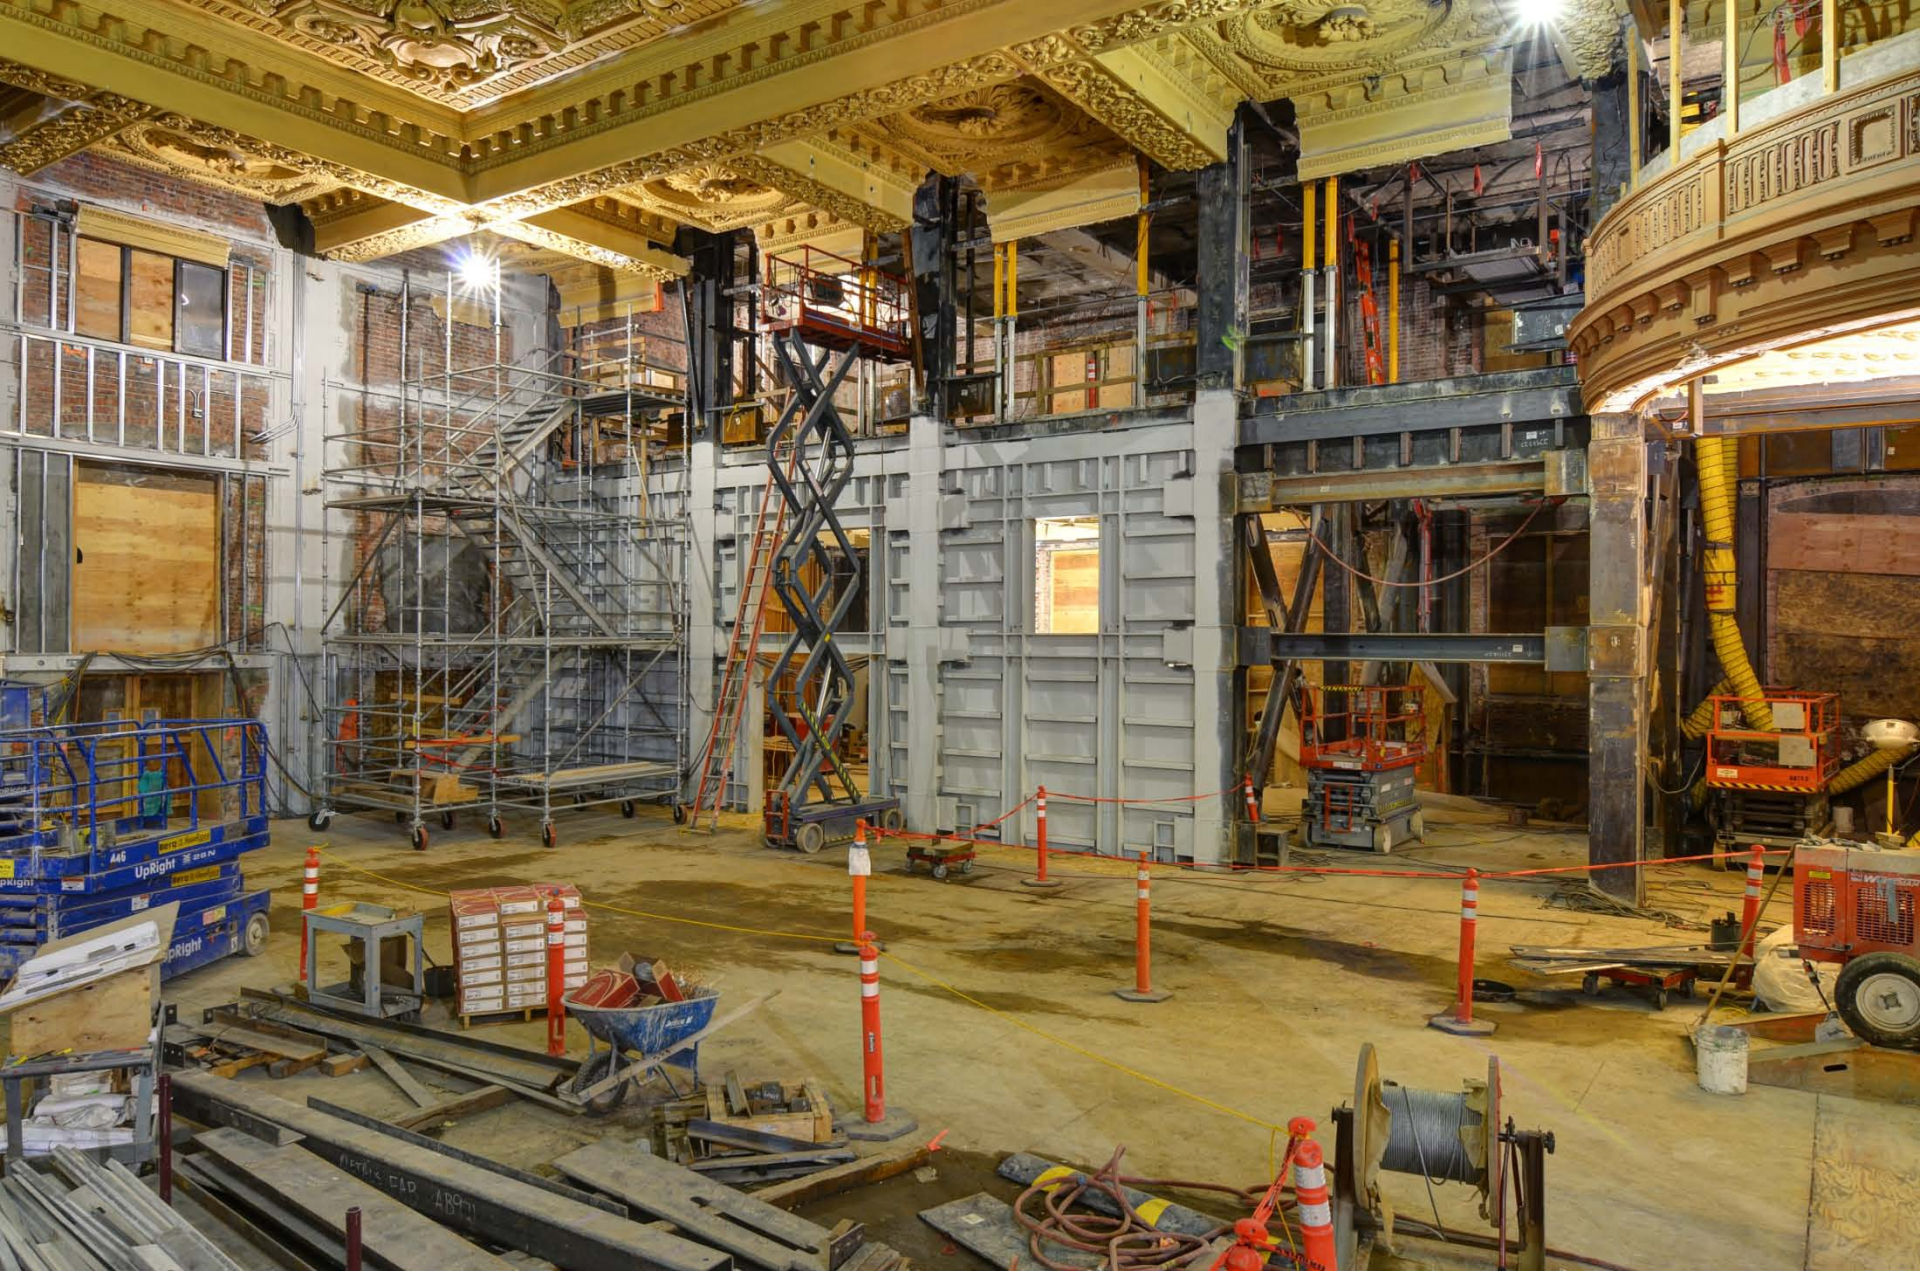
New steel columns, beams, trusses, bracing, piles and decking ensures the structural steel of the station are connected to withstand future seismic forces.
