Arborist Report

To: Mill Creek Residential Trust LLC. c/o Matt Quigley
Site: 1032 S Jackson St., Seattle, WA 98104; Parcel# 8591900145
Re: Tree Inventory and Assessment
Date: April 27, 2022
Project Arborist: Sean Dugan, Registered Consulting Arborist # 457
ISA Board Certified Master Arborist #PN- 5459B
ISA Qualified Tree Risk Assessor
Referenced Documents: Site Plan A100 (Tiscareno Associates; plotted January 31, 2022)
Attached: Tree Inventory - Table of Trees
Aerial Photograph with Tree Locations

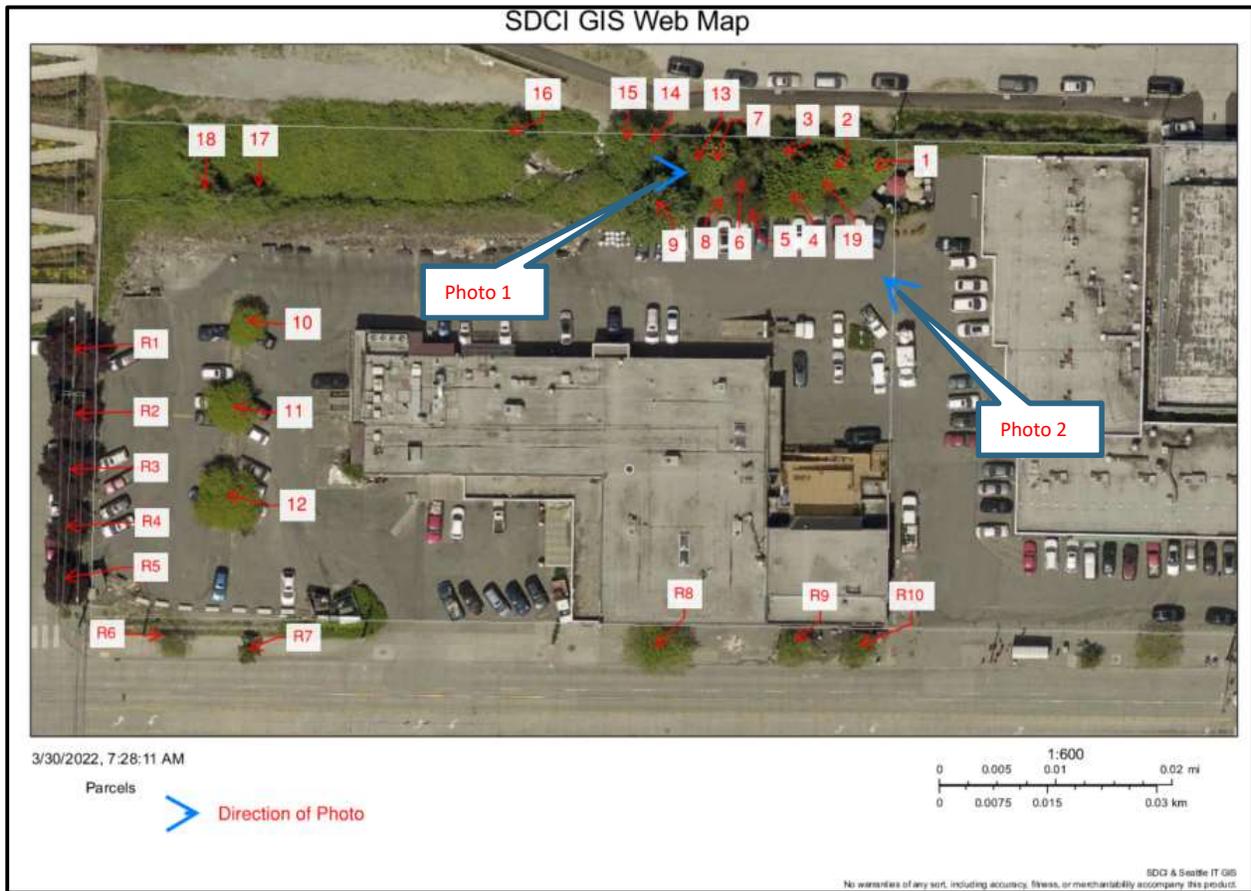
Figure 1. Aerial photograph with tree locations. (Source: Seattle GIS Web Map accessed March 30, 2022)

A steep slope and potential slide environmental critical area (ECA) are located on the site (see Figure 2). An unmaintained landscape swath is located along the north portion of the property above a rockery retaining wall. Several trees on the slope show symptoms consistent with slope creep (soil movement down slope). Several trees have failed at the roots in the shallow soils in this area.

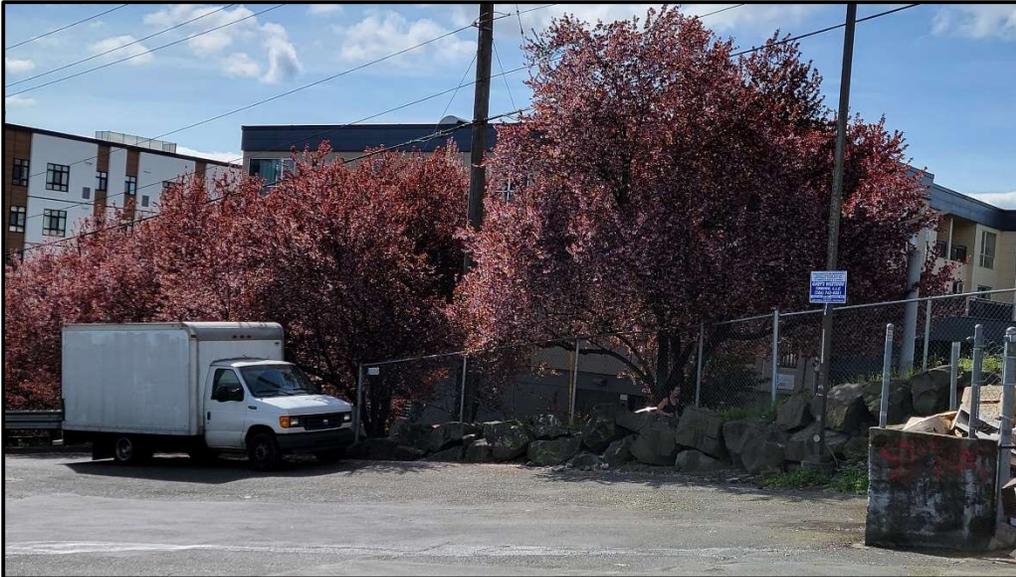
Photograph 13. View looking to the west at the trees in the right-of-way.

I inventoried 10 trees within the adjacent rights-of-ways (ROW) to the west and south of the subject site. All ten trees are proposed to be retained.
