NCH at Pike Market

Neighborcare Health Exterior Improvements

SCOPE OF WORK:

- 1st & 2nd Floor Door Replacment
- Replace 1st (003A)& 2nd floor(212B) exterior door with new hollow metal doors and hardware.
- Exterior Stairwell Security Improvement
- Provide enclosure over entire stairwell with gate for security control and safety.

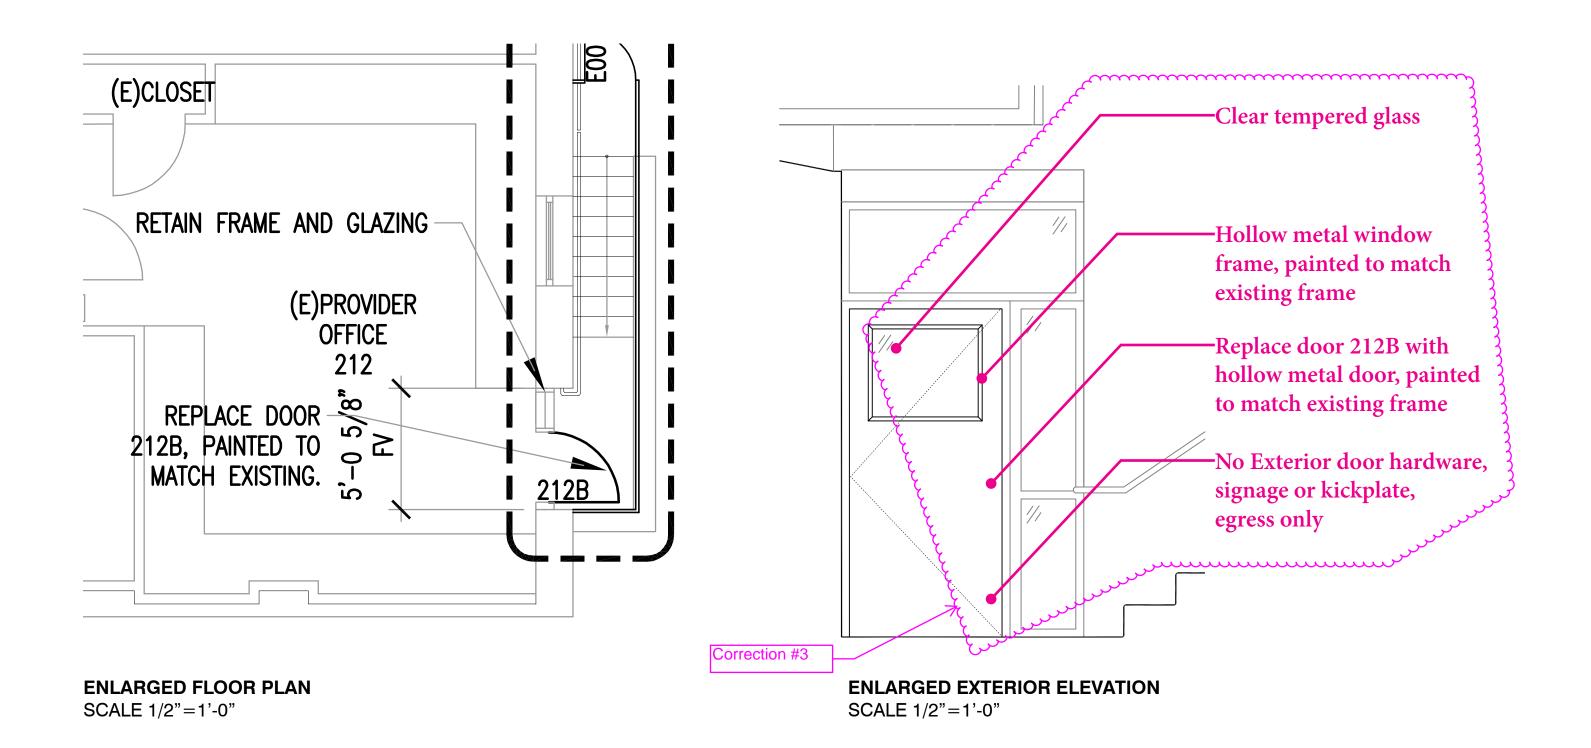
DOOR DESIGN PROPOSAL - EXIT 212B DOOR

EXISTING LITE AT EXTERIOR DOOR IS SHATTERED AND TEMPORARILY SECURED WITH PLYWOOD. ADJACENT LITES APPEAR NOT DAMAGED. EXISTING DOOR SWINGS OUT, WITH CLOSER INTO STAIRWELL.

REPLACE DOOR AND HARDWARE, PAINT TO MATCH EXISTING FINISH.

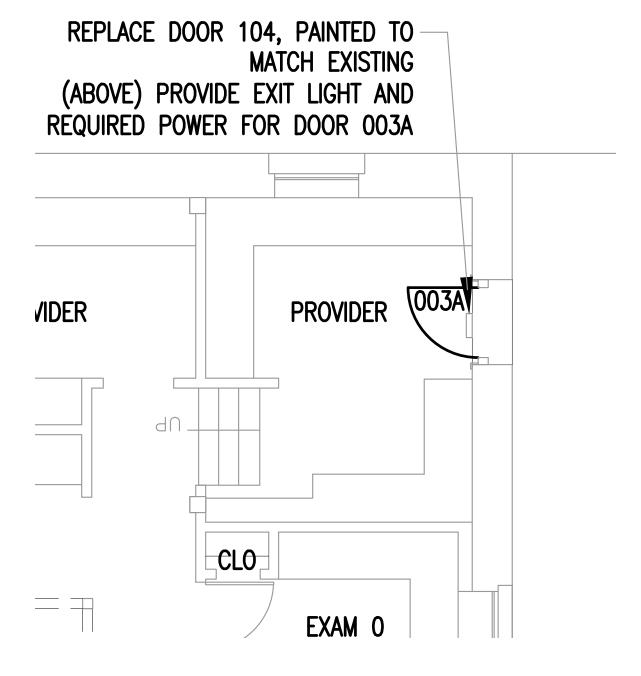
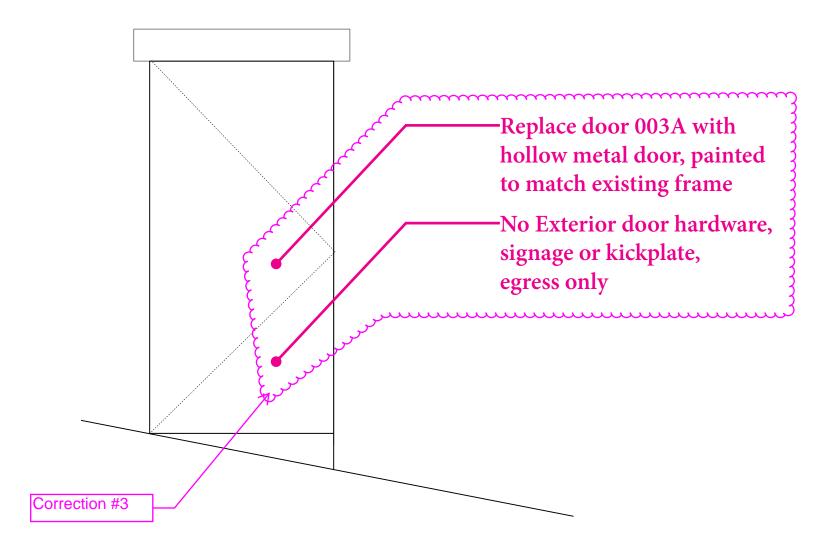
DOOR DESIGN PROPOSAL - EXIT 003A DOOR

EXISTING EXTERIOR DOOR IS CHIPPED AND FLAKING OF EXISTING PAINT AND MARKINGS OF GRAFFITI **REMAIN WHERE UNABLE TO** REMOVE.

REPLACE DOOR AND HARDWARE. PAINT TO MATCH EXISTING FINISH.
