Pioneer Square Preservation Board

Areaway Repair: 616 1st Ave S

May 20, 2026

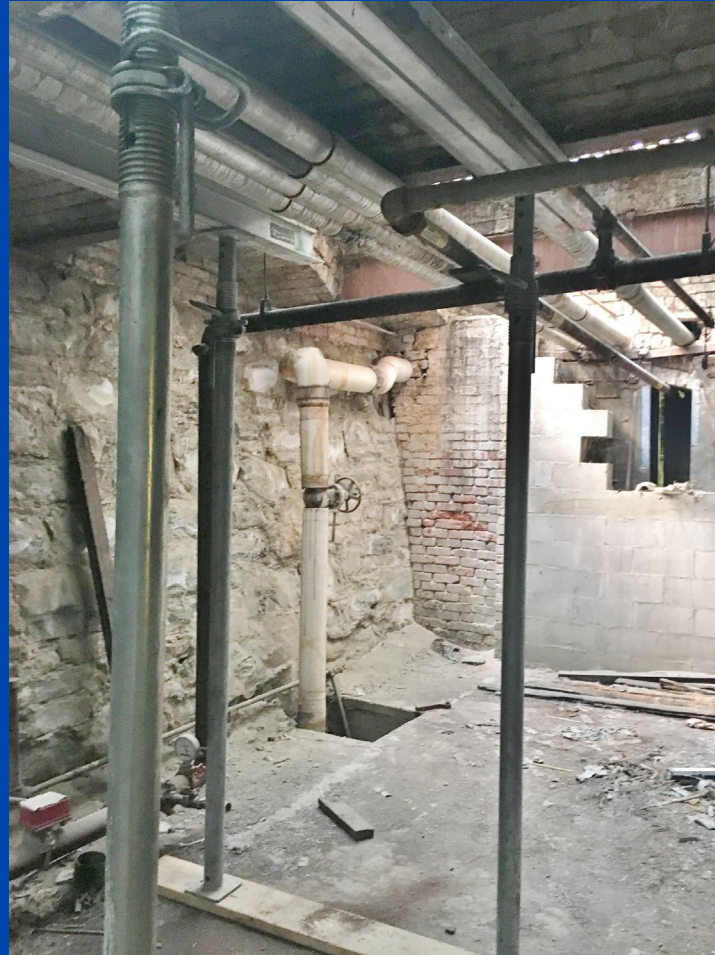
General Condition of Space

- Condition
 - Intact no observed damage
 - Disturbed due to utility cuts
 - Post utility cut debris

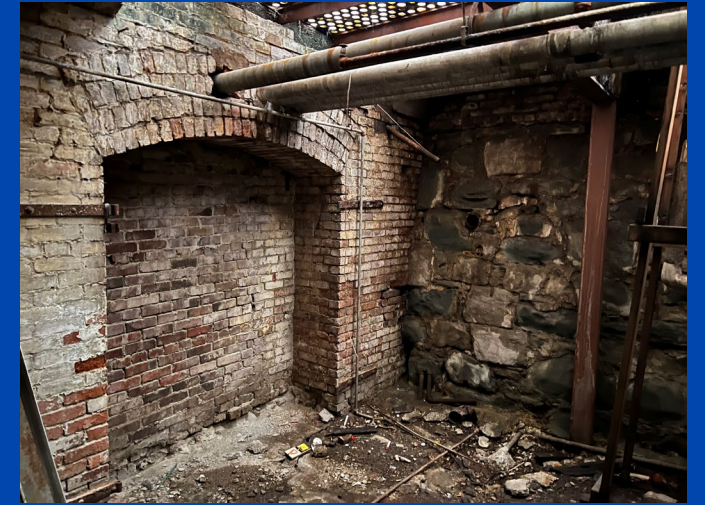
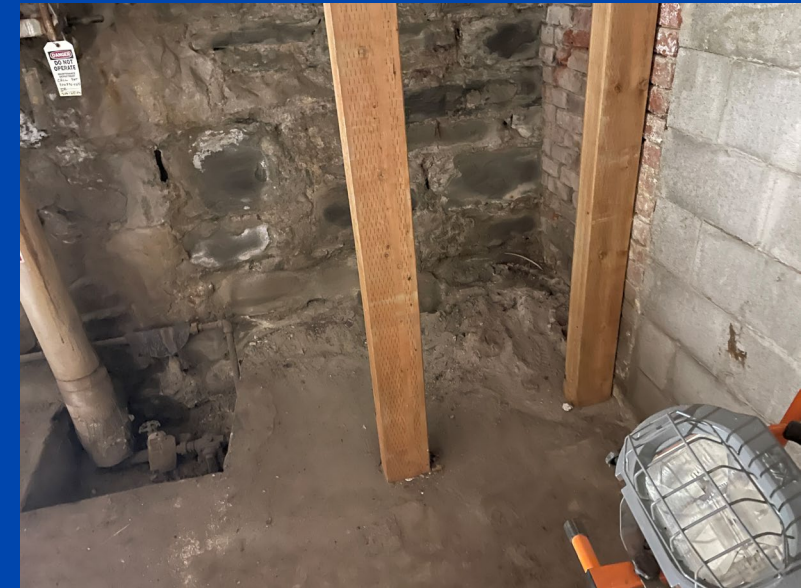
Pre-accident Condition

Post-accident Condition

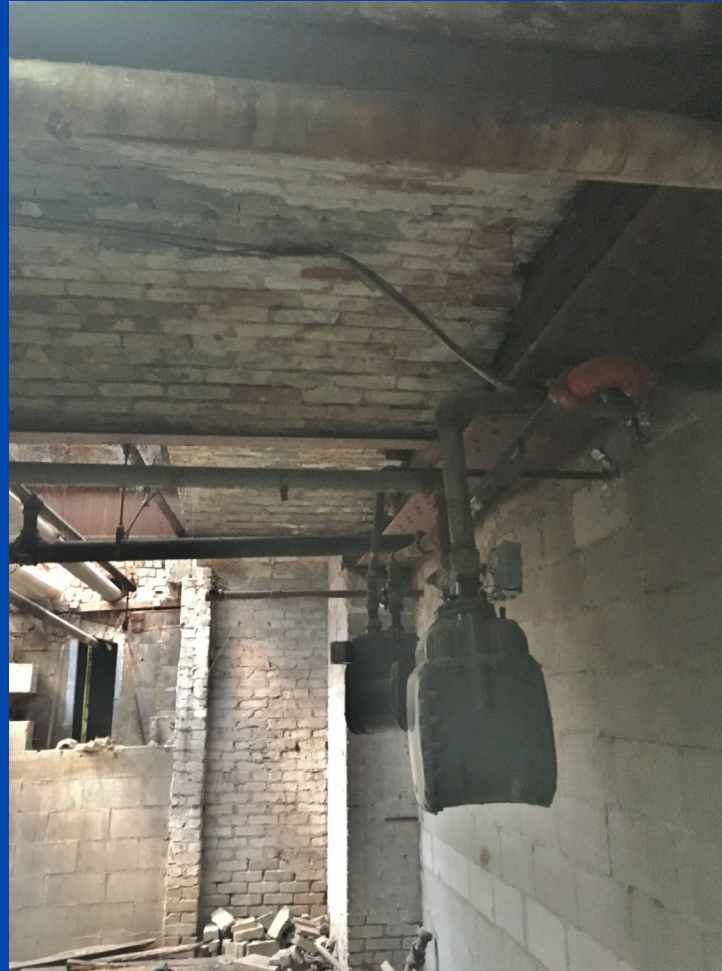
Masonry Arch Ceiling

- Condition
 - Intact
 - Loose brick and mortar

- Masonry Arch Ceiling
 - Re-secure dislodged bricks
 - Tuck point as needed

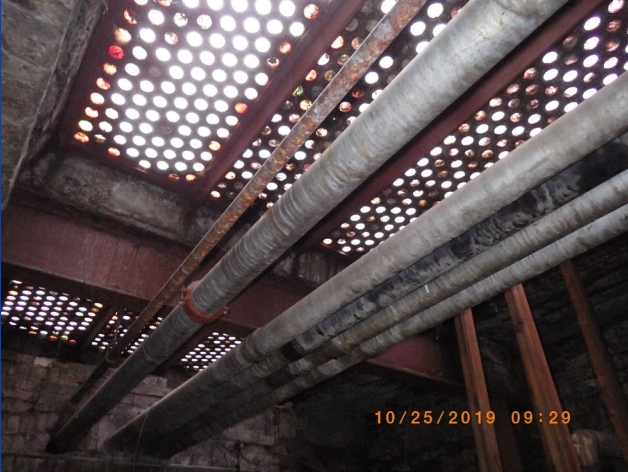
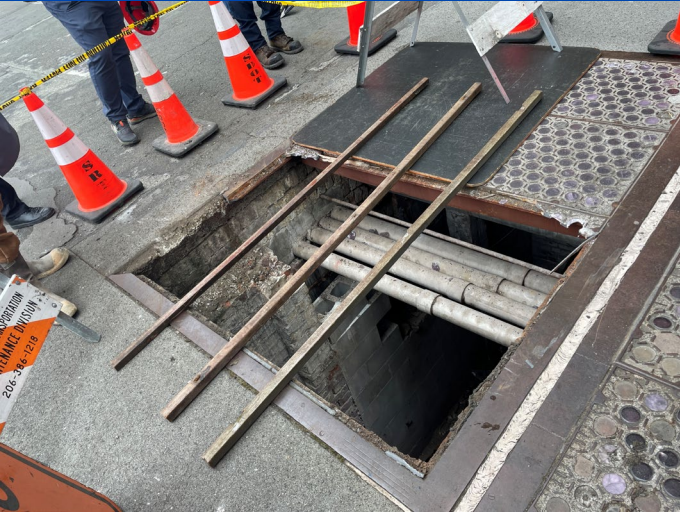
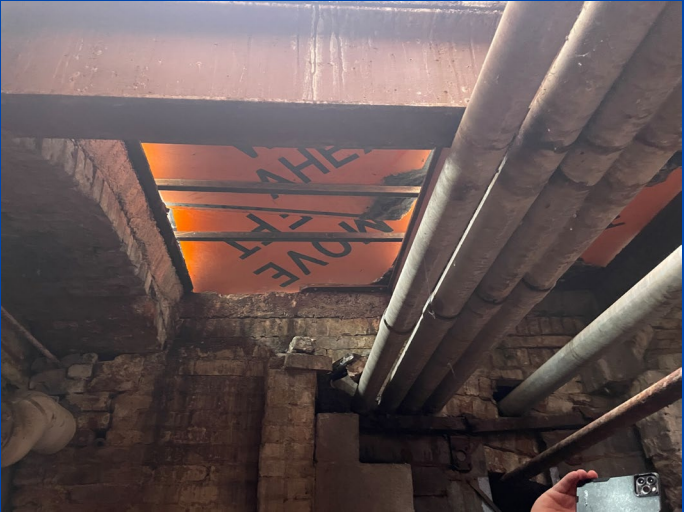
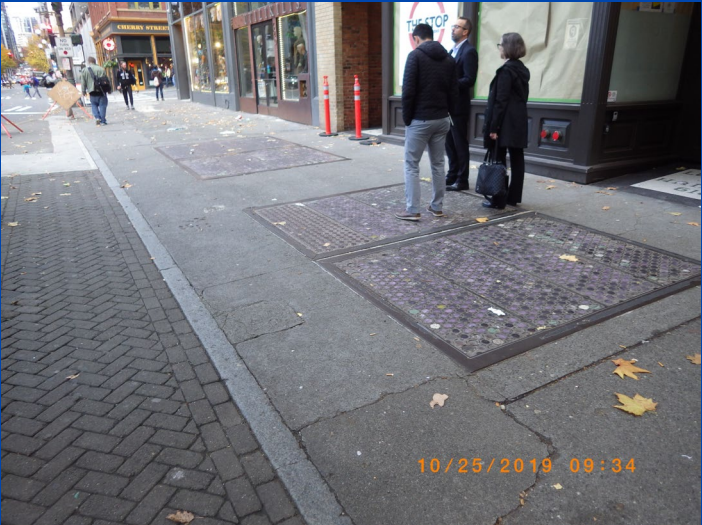
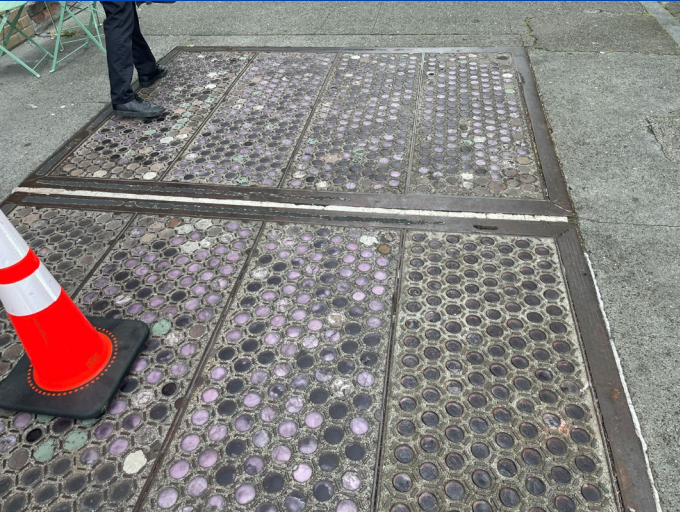
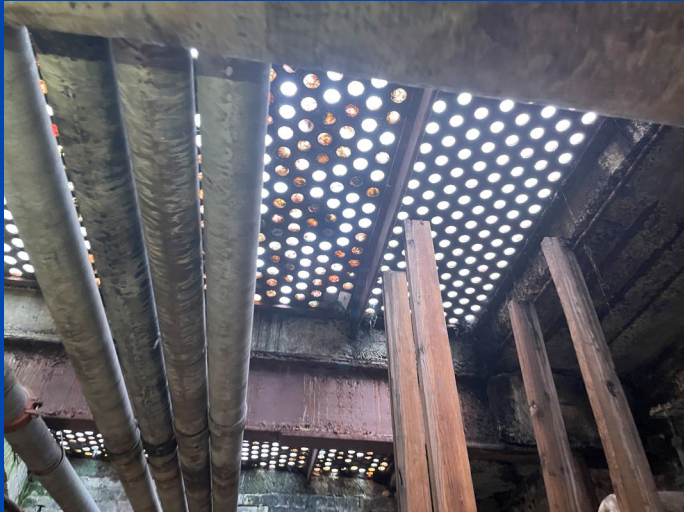
Skylight Assembly

Pre-accident Condition

Post-accident state

- North assembly
 - 4 of the 8 panels significant damage
 - Remaining panels have cracks at various locations
 - Frame broken or have cracks
- South assembly
 - Panels have cracks at various location
 - Cracks through frame elements

- Fabricate new skylight assembly
- Reconstruct concrete ledge supporting frame
- Remove and replace portion of sidewalk between joint lines of

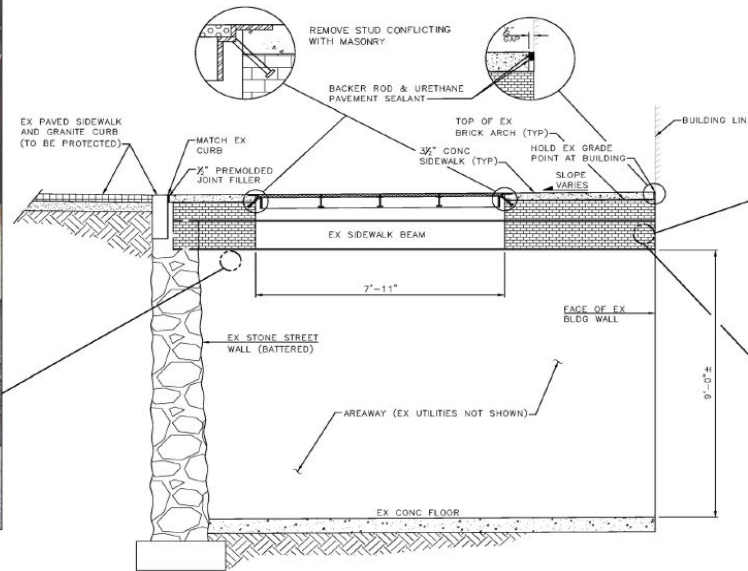
SECTION B-B 01
SCALE: 1"=20"

REPAIR #1

1. REPAIRS #1, #2A, AND #2B ARE TO RESET THE LOOSE BRICKS TO ORIGINAL CONDITION AND FILL ALL THE EXISTING CRACKS AROUND THE REPAIR AREAS.
2. THE REPAIR MORTAR SHALL BE SIKAQUICK VOH OR APPROVED EQUAL. SIKAQUICK VOH SHALL BE INSTALLED AS RECOMMENDED BY THE MANUFACTURER.
3. IF ADDITIONAL BRICKS ARE NEEDED, THERE ARE A PILE OF BRICKS INSIDE THE BUILDING BASEMENT.
