Seattle City Light - Vault 22V-4 Repair and Transformer Installation 117 S. Main Street, Seattle

Existing Conditions for Vault 22V-4

Existing Vault Hatch Cover

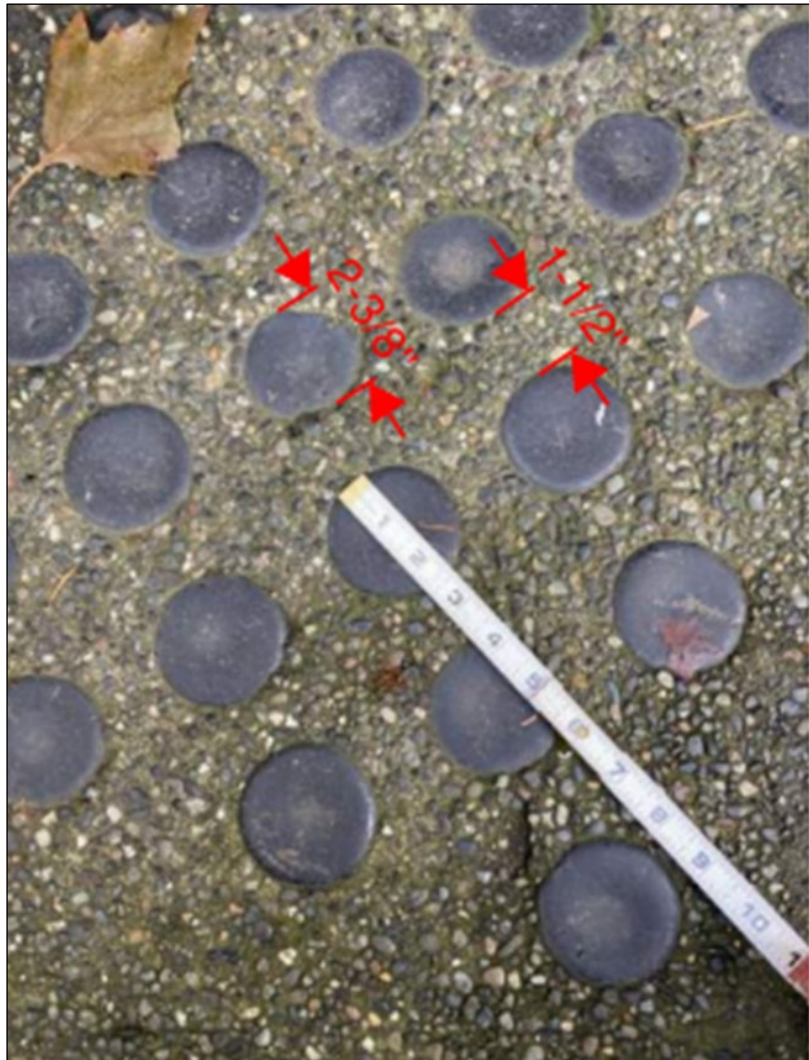
The existing cover as seen in figure 11 (outlined in red) and figure 13 (detail view of figure 11) has round glass pavers with a diameter of 2 inches. The east panel (outlined in blue in figure 11, detail view in figure 12) has round glass pavers that are 2-3/8 inches in diameter. Figure 14 is a partial view of the blue outlined area in figure 11, showing the dimensions of the panel, spacing between pavers and the existing pattern.

Figure 11 – Vault at 117 S. Main St. The blue outlined area shows the portion that will remain in place and will not be altered. The red outlined area shows the area we are proposing to change. (*) Note: The glass pavers here are not true prisms that allow light into the underground space. They are embedded in the upper portion of the concrete panel and do not extend through the depth (thickness) of the concrete panel. (Source: Seattle City Light, 2023.)

As noted earlier, the proposed replacement is a hybrid three-panel vault hatch cover. This would have two-thirds steel grate for ventilation and one-third concrete with TBD round glass pavers embedded on the surface to match the existing as close as possible from the options available from CircleRedmont (CR) and with input from the PSPB. The concrete hatch cover with round glass pavers would be manufactured by CR and shipped to City Light. The steel grates are supplied to City Light from another manufacturer (see figures 15 and 16). All three panels (e.g., concrete with glass pavers, and two steel grates) would be installed by City Light in the configuration noted in figure 17.
