LAKE COURT APARTMENTS

BRIEFING January 31, 2025

JANUARY 2025
WINDOW SURVEY, UNITS 1, 22, 109, AND 112

EMERGENCY WINDOW REPLACEMENT

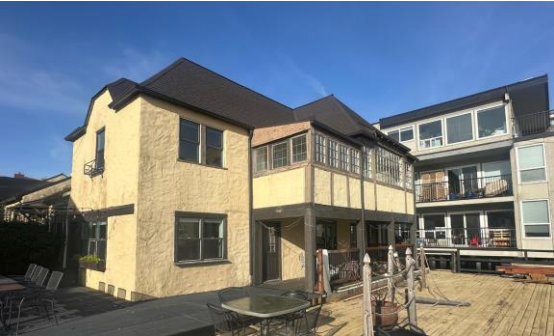
1_5	DESCRIPTION & CONDITION	SCORE
Window	Double hung 4-over-4 leaded glass with one stained glass corner. Poor condition	3
Frame	Wood frame	4
Sash	wood double hung with mold at interior bottom rail	3
Glass	4 light leaded clear glass in each sash, single pane with a stained glass corner in the upper sash	3
Paint	poor condition, peeling at glazing putty	2
Sill	Painted wood fair condition	3
Casing	painted stool and apron, with painted wood flange trim	3
Hardware	Painted metal	3

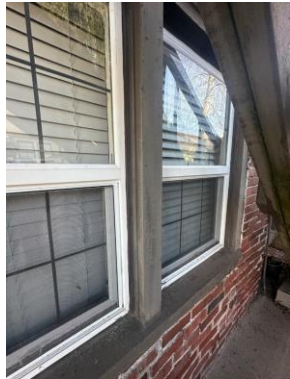
WINDOW 112_1

112_1	DESCRIPTION & CONDITION	SCORE
Window	Double replacement vinyl single hungs with interior grids and central mullion	4
Frame	Painted wood frame	4
Sash	two non-original vinyl single hung	4
Glass	insulated double pane units with interior grids	2
Paint	brown paint at exterior frame, sash are unpainted	3
Sill	Painted wood sill	4
Casing	NA	NA
Hardware	NA	NA

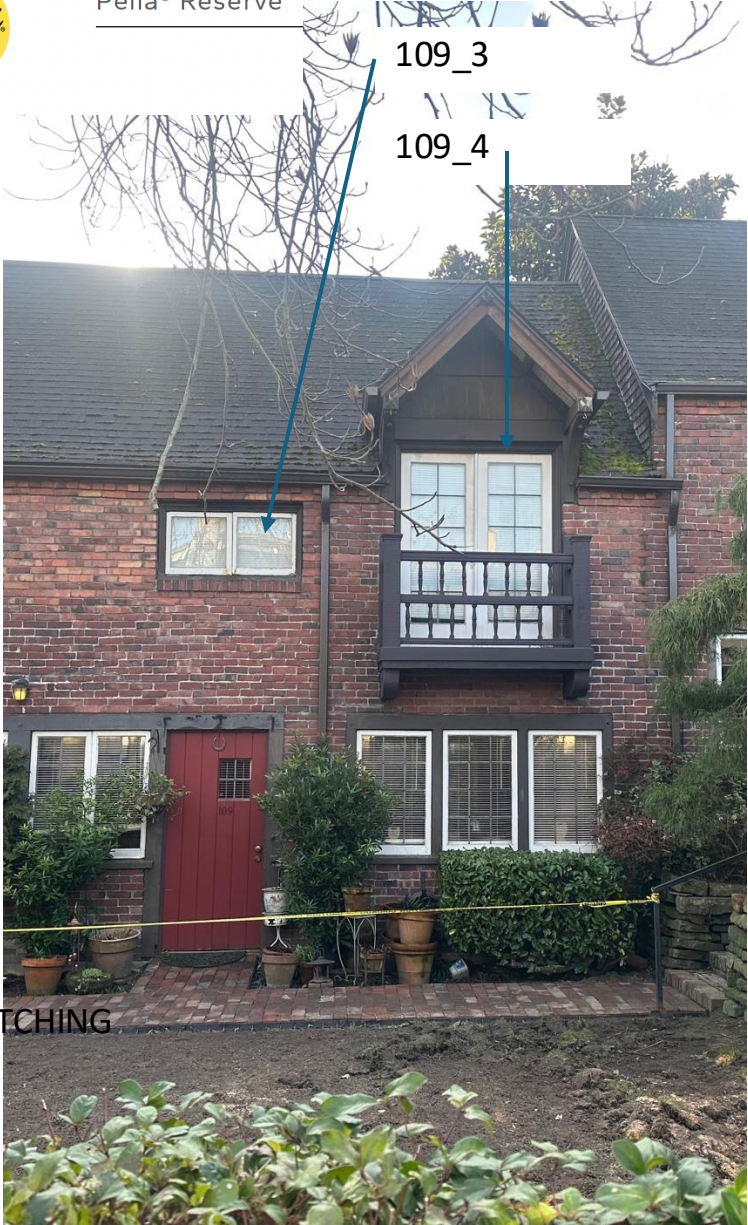
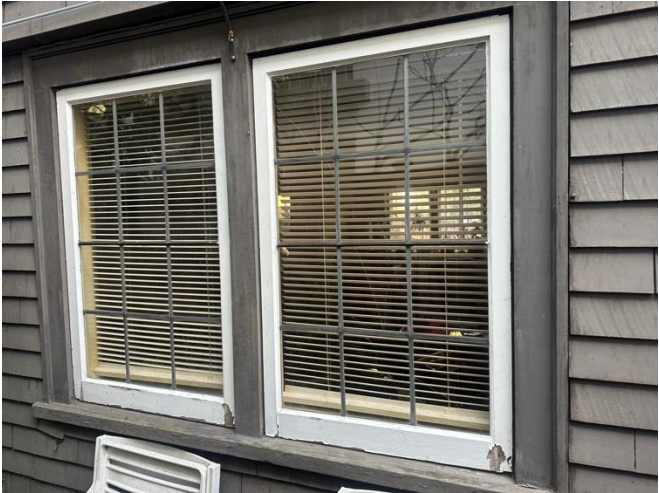
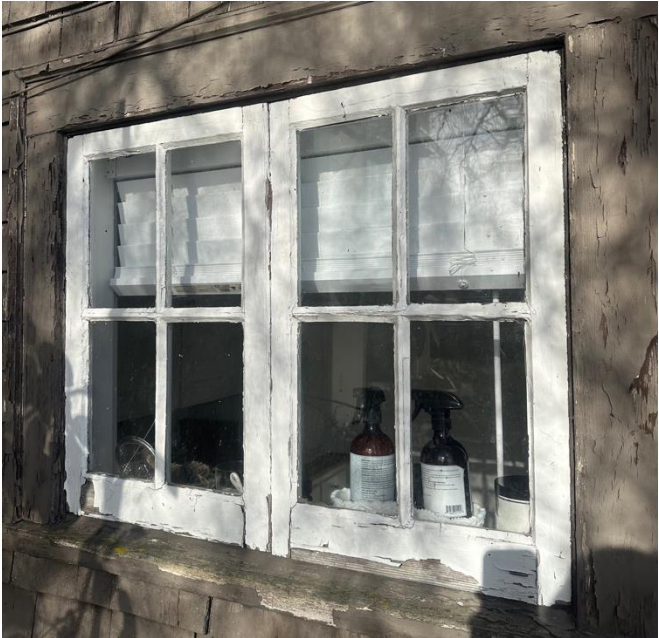
109_3	DESCRIPTION & CONDITION	SCORE
Window	French casement. doesn't close properly, allows moisture into unit	2
Frame	Painted wood brickmold frame	3
Sash	two painted wood casement sash, poor condition with rot and deteriorating joints	1
Glass	single pane. putty is deteriorating	2
Paint	brown paint at exterior frame, poor condition white paint at sash	1
Sill	NA	NA
Casing	NA	NA
Hardware	NA	NA

109_4	DESCRIPTION & CONDITION	SCORE
Window	French casement door □ doesn't close properly, allows moisture into unit	3
Frame	Painted wood brickmold frame □	4
Sash	two painted wood door leaves, rot and mold at bottom rail	2
Glass	each leaf has 10 light clear single pane with horizontal saddle bars	3
Paint	brown paint at exterior frame, poor condition white paint at door leaves	1
Sill	NA	NA
Casing	NA	NA
Hardware	NA	NA

REPLACE CASEMENTS W/
LIGHT CONFIGURATIONS
REPLACE 109_3 WW/
(2) 4 LIGHT SASH
REPLACE DOORS 109_4
W/ MATCHING 10-LIGHT

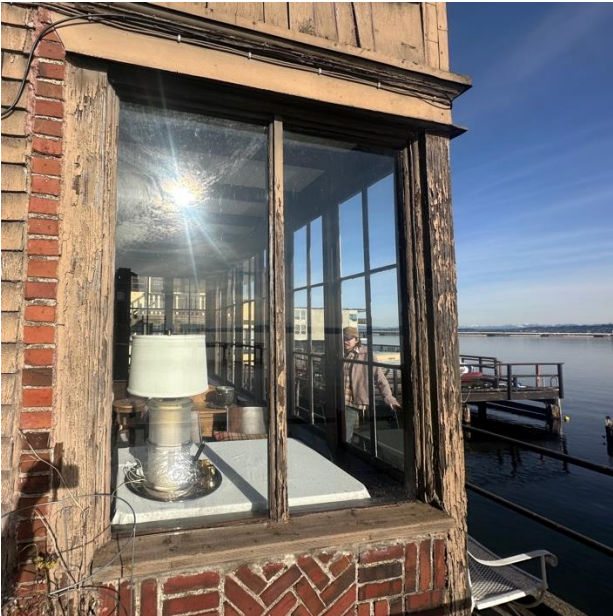
112_5	DESCRIPTION & CONDITION	SCORE
Window	two leaded glass casements with center mullion allows moisture into unit	1
Frame	Painted wood frame with softening wood due to rot	1
Sash	two 12-light wood casements in poor condition	1
Glass	each sash has 12 clear leaded glass panes with a horizontal saddlebar	2
Paint	poor condition brown paint flaking to bare wood	0/1
Sill	non-original pressure treated wood sill	1
Casing	NA	NA
Hardware	NA	NA

REPLACE 112_1 W/
4-OVER-4
REPLACE 112_5 W/
6 LIGHT REPLACE
ALL OTHERS W/ MATCHING
PANE CONFIGURATIONS
