Subject: Gas Works Park Cracking Towers – Pedestrian Appurtenance Removal Certificate of Approval Application

Certificate of Approval Request

GAS WORKS PARK "CRACKING TOWERS": EMERGENCY SELECTIVE DECONSTRUCTION

Re: Condition Survey
Gas Generator
Gas Works Park
MTE Project No. S1062

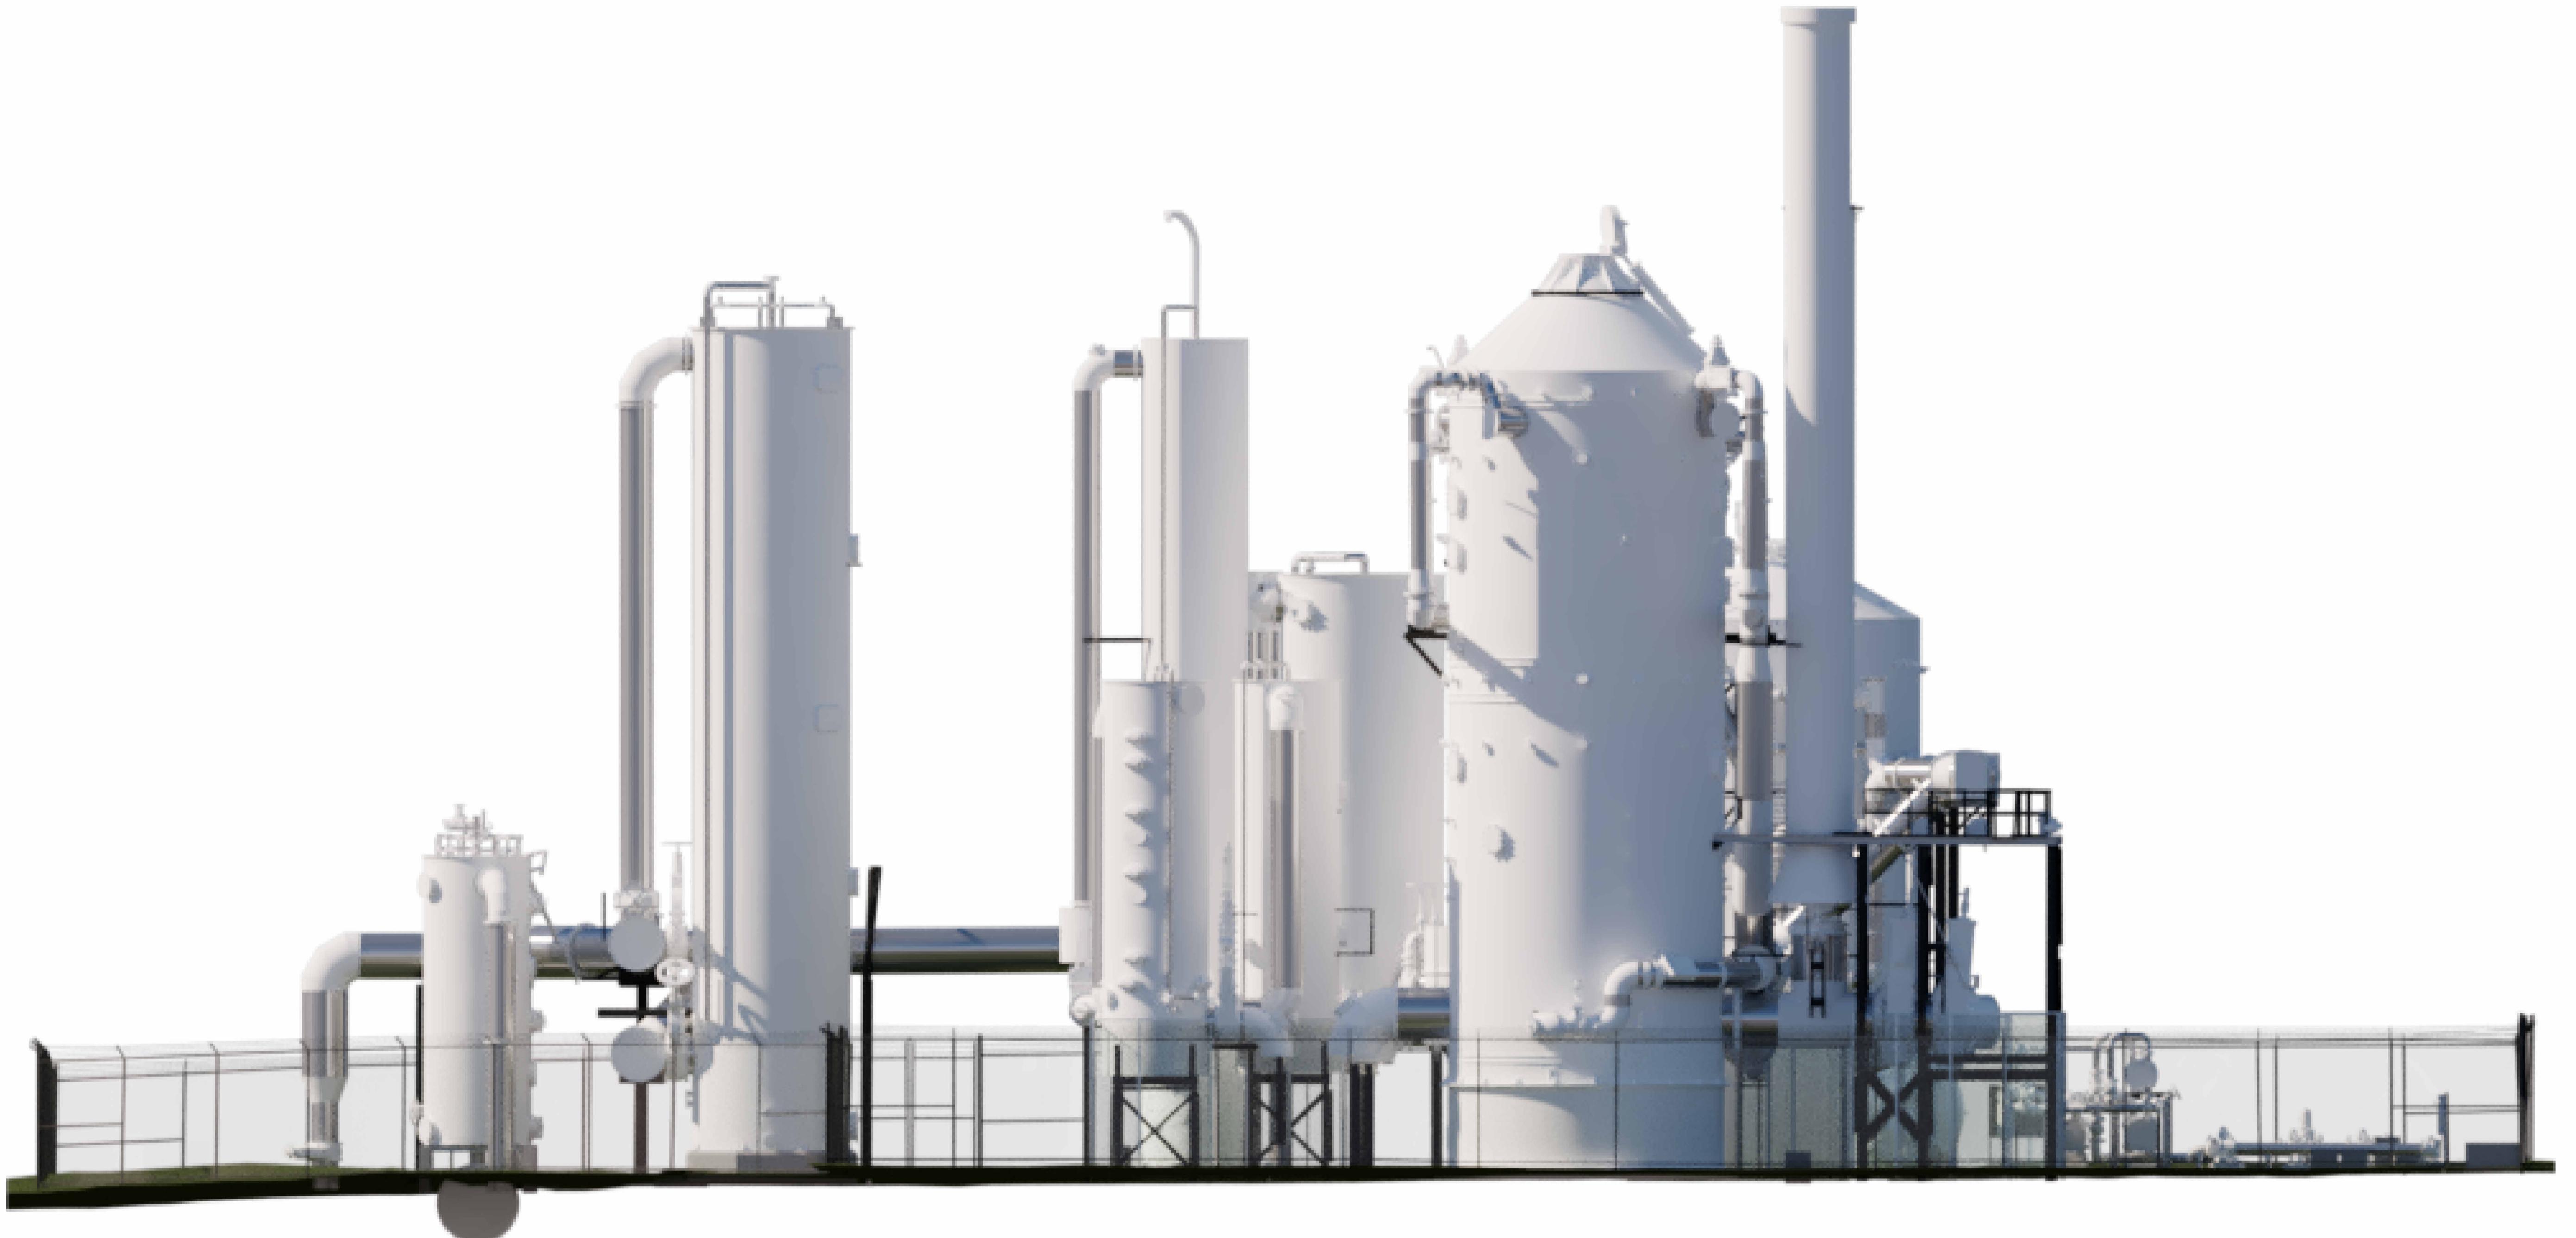
POST DECONSTRUCTION SOUTH
ELEVATION
AS NOTED
②

- SCOPE INCLUDES REMOVAL OF CATWALKS, LADDERS, AND ASSOCIATED SUPPORT FRAMING. REVIEW IN-FIELD CONDITIONS WHERE PIPING SYSTEMS NOT SCHEDULED FOR REMOVAL MAY BE SUPPORTED BY CATWALK STRUCTURES.
- REFER TO HAZMAT SURVEY FOR WORKER SAFETY AND DISPOSAL PROCEDURES RELATED TO LEAD-CONTAINING COATINGS.
- REMOVE ALL STRUCTURAL SUPPORTS DOWN TO GRADE. NOTE: EXISTING SOILS CONTAIN HYDROCARBONS—DO NOT DISTURB NATIVE SOIL.

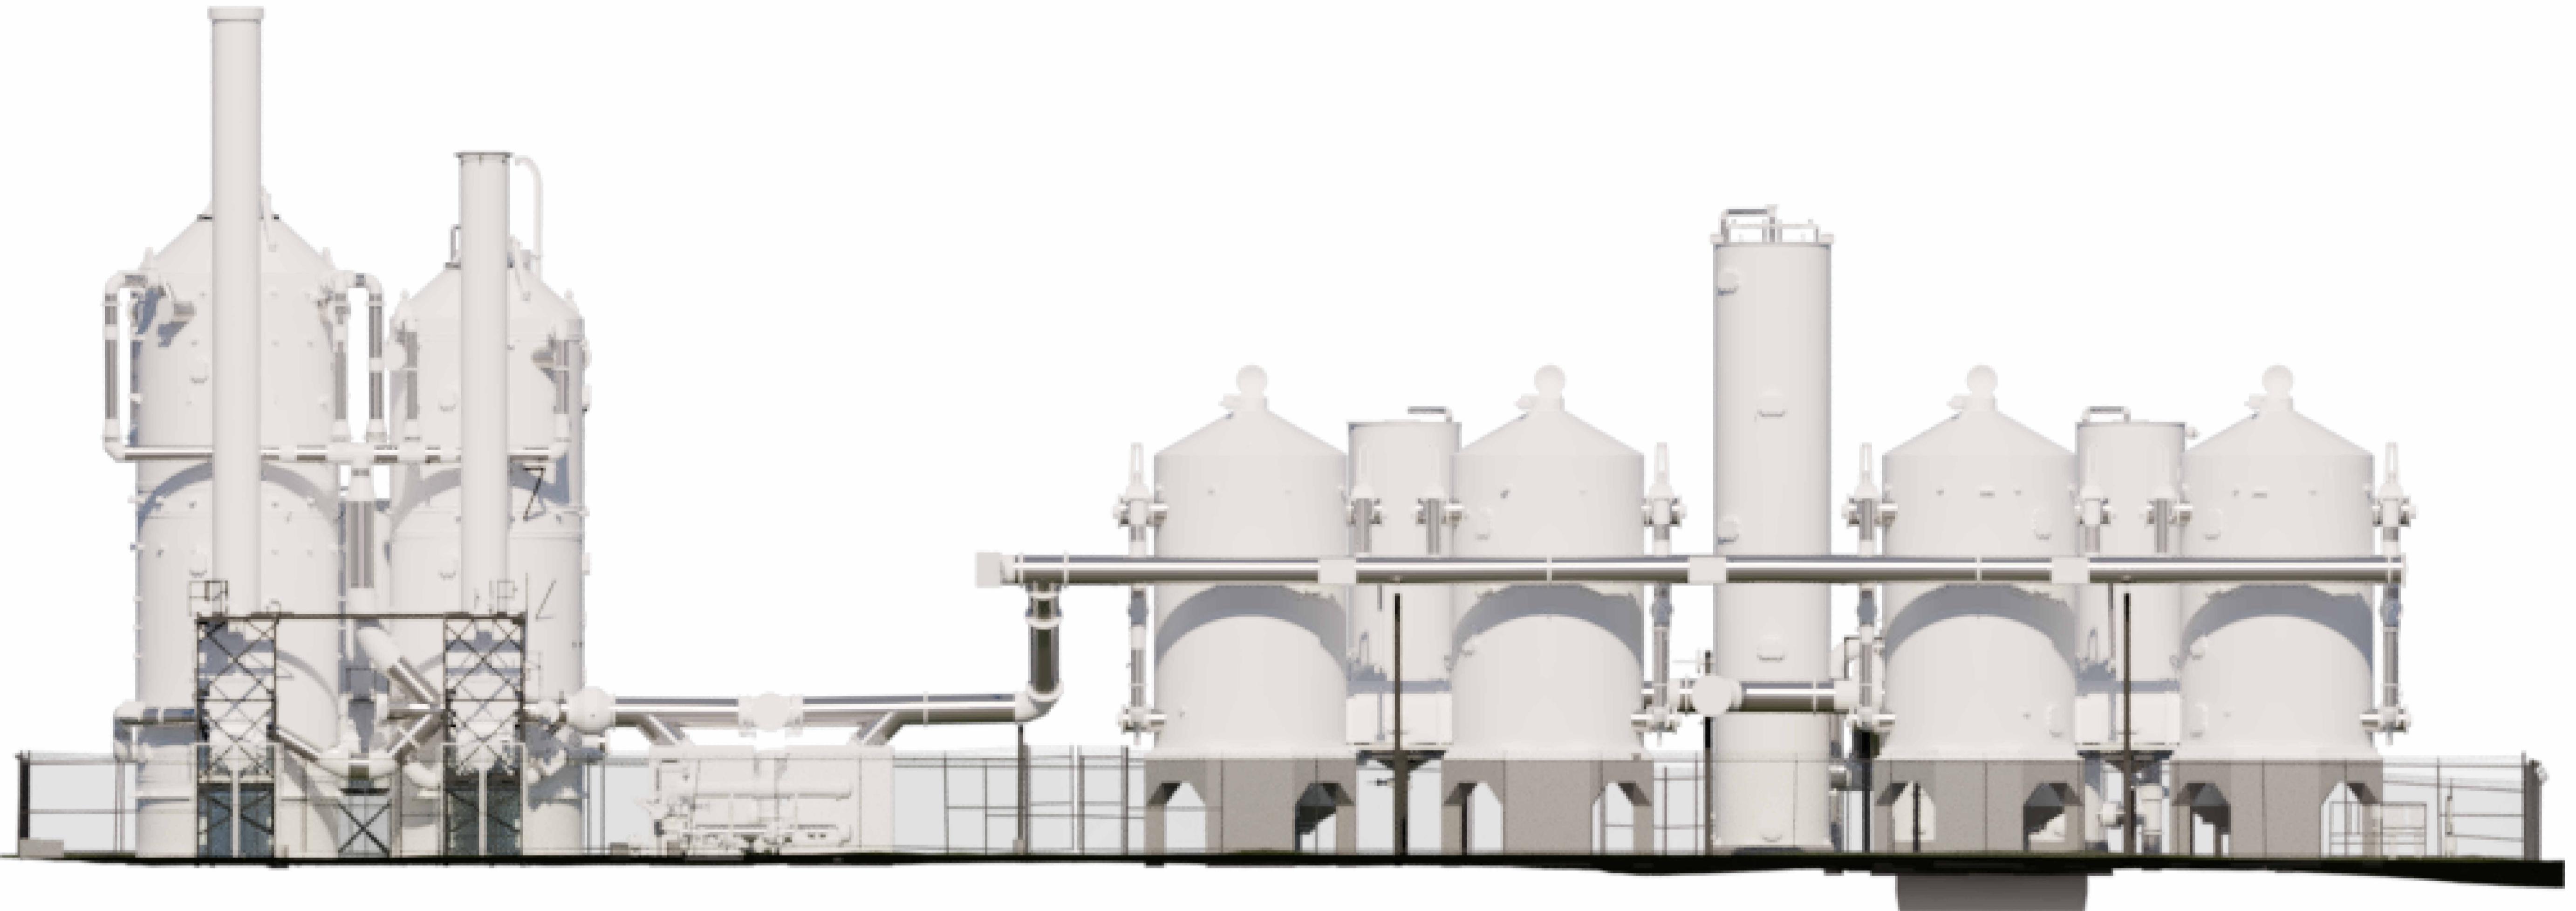
POST DECONSTRUCTION EAST
ELEVATION
AS NOTED
②

- SCOPE INCLUDES REMOVAL OF CATWALKS, LADDERS, AND ASSOCIATED SUPPORT FRAMING. REVIEW IN-FIELD CONDITIONS WHERE PIPING SYSTEMS NOT SCHEDULED FOR REMOVAL MAY BE SUPPORTED BY CATWALK STRUCTURES.
- REFER TO HAZMAT SURVEY FOR WORKER SAFETY AND DISPOSAL PROCEDURES RELATED TO LEAD-CONTAINING COATINGS.
- REMOVE ALL STRUCTURAL SUPPORTS DOWN TO GRADE. NOTE: EXISTING SOILS CONTAIN HYDROCARBONS—DO NOT DISTURB NATIVE SOIL.

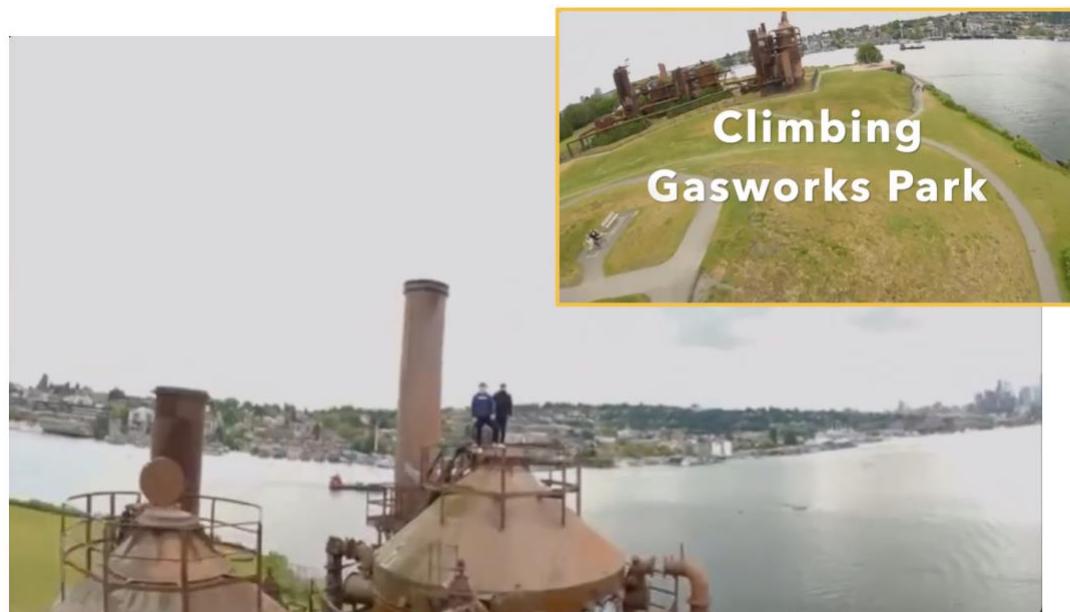
video from September of 2021 titled “Climbing Gasworks Park”⁴ depicts (via body worn cameras) individuals approaching the fence perimeter, traversing through the interior of the perimeter, and climbing the structure: two individuals are depicted climbing the structure up to the top, with additional drone video of their ascension; see Figure 7.

Figure 7. Still captures from the “Climbing Gasworks Park” video (see inset of title screen) posted on YouTube. The video was taken with body worn cameras and a drone camera, and depicts two individuals approaching the fencing perimeter, traversing through the interior of the perimeter, and climbing the structure, with the still capture above depicting their ascension towards the end of the video.

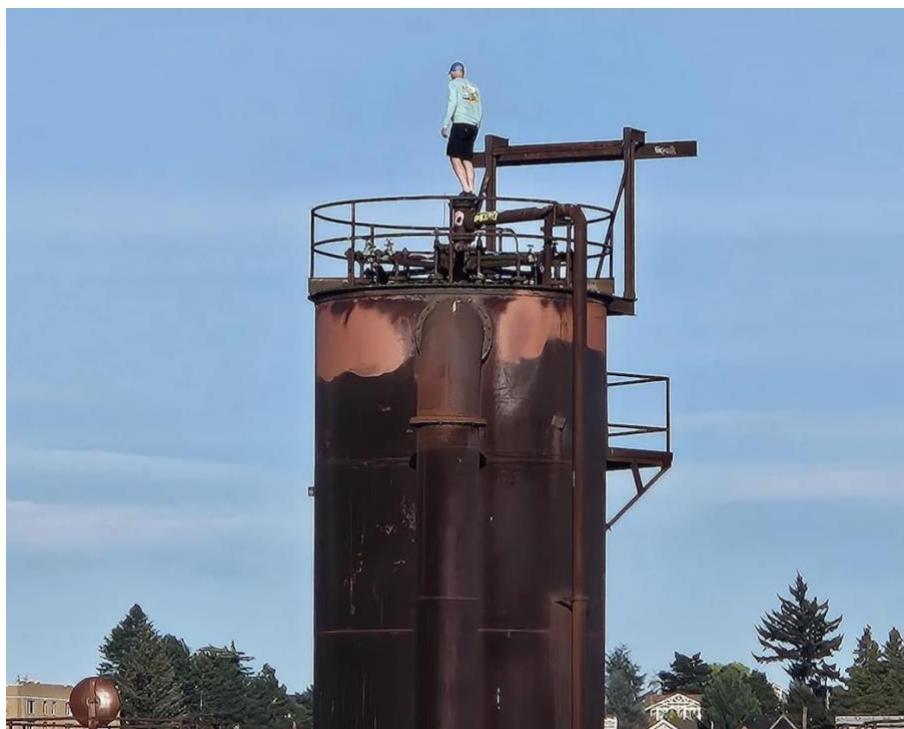
Figure 8. A photograph uploaded to a 2-year-old Reddit post titled “Guy climbed to the top of the Gas Works Park plant,” depicting an individual on top of one of the towers.

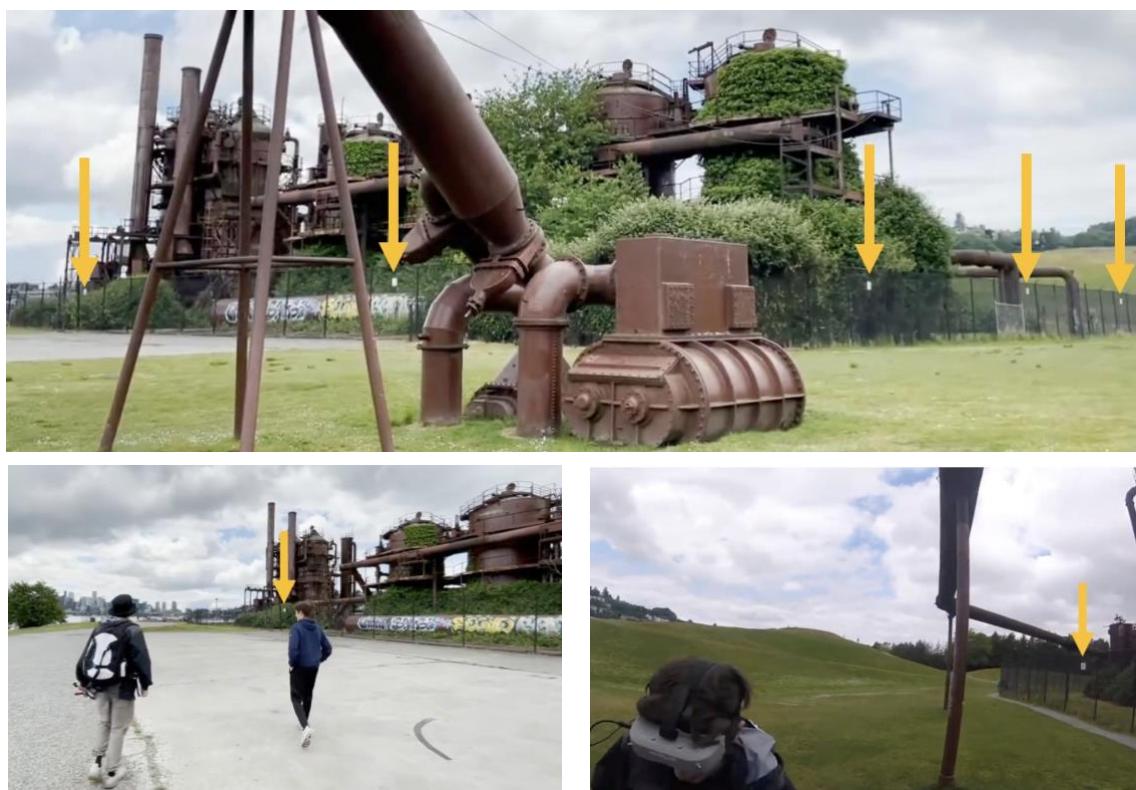
Based on the scientific literature above, the extant “NO TRESPASSING” signs posted on the perimeter fence are not an effective deterrence for individuals who are motivated to penetrate the fence barricade and/or access the structure. Furthermore, based on the science of warning effectiveness, changes to the signs—e.g., modifications to the language, size, or location of the signs, and/or enhancement of their visibility through supplemental artificial lighting—are unlikely to increase their effectiveness and/or overcome the exorbitantly stronger influence that an individual’s motivations have on warning compliance. For example, while it is possible that the likelihood that park users notice the sign(s) is negatively affected in nighttime conditions—e.g., given that the prior fall incidents have all occurred at night—the scientific literature on warning effectiveness does not support a proposition that supplemental artificial lighting (i.e., that illuminates the signs at night) will increase compliance with the posted signs. Consistent with this, Figures 7 and 8 depict individuals accessing the interior of the fenced area and climbing the structure in daytime conditions in which the signs are visible. For example, in the “Climbing Gasworks Park” video¹⁵ posted to YouTube (see Figure 7), while the video does not show the specific point where the individuals gain access to the interior perimeter area, it does show their approach to the east fencing and their preparation of camera equipment near the west fencing, immediately prior to the video cutting to their traversal of the interior perimeter area, and in both of these areas the “NO TRESPASSING” signs appear to be visible; see Figure 13. In summary, while the extant signs posted on the perimeter fence of the Gas Works Park structure are reasonable, appropriate, and provide sufficient information to the public that access to the structure is not permitted, based on the human factors literature, these signs will not be an effective deterrence to individuals who fail to notice the signs and/or are motivated to penetrate the fence barricade and access the structure.

Figure 13. Still captures from the “Climbing Gasworks Park” YouTube video depicting the Gas Work Park structure (top), and individuals approaching the east fence (bottom left) and preparing their camera equipment near the west fence (bottom right). The orange arrow in each capture indicates what appears to be posted signs on the fence that is consistent in shape and appearance with the “NO TRESPASSING” signs.
