Early Guidance Meeting for
'Certificate of Approval'
JCCCW // Building 3 // Roof Replacement

Japanese Community and Cultural Center of Washington

1414 S. Weller Street, Seattle, WA 98144

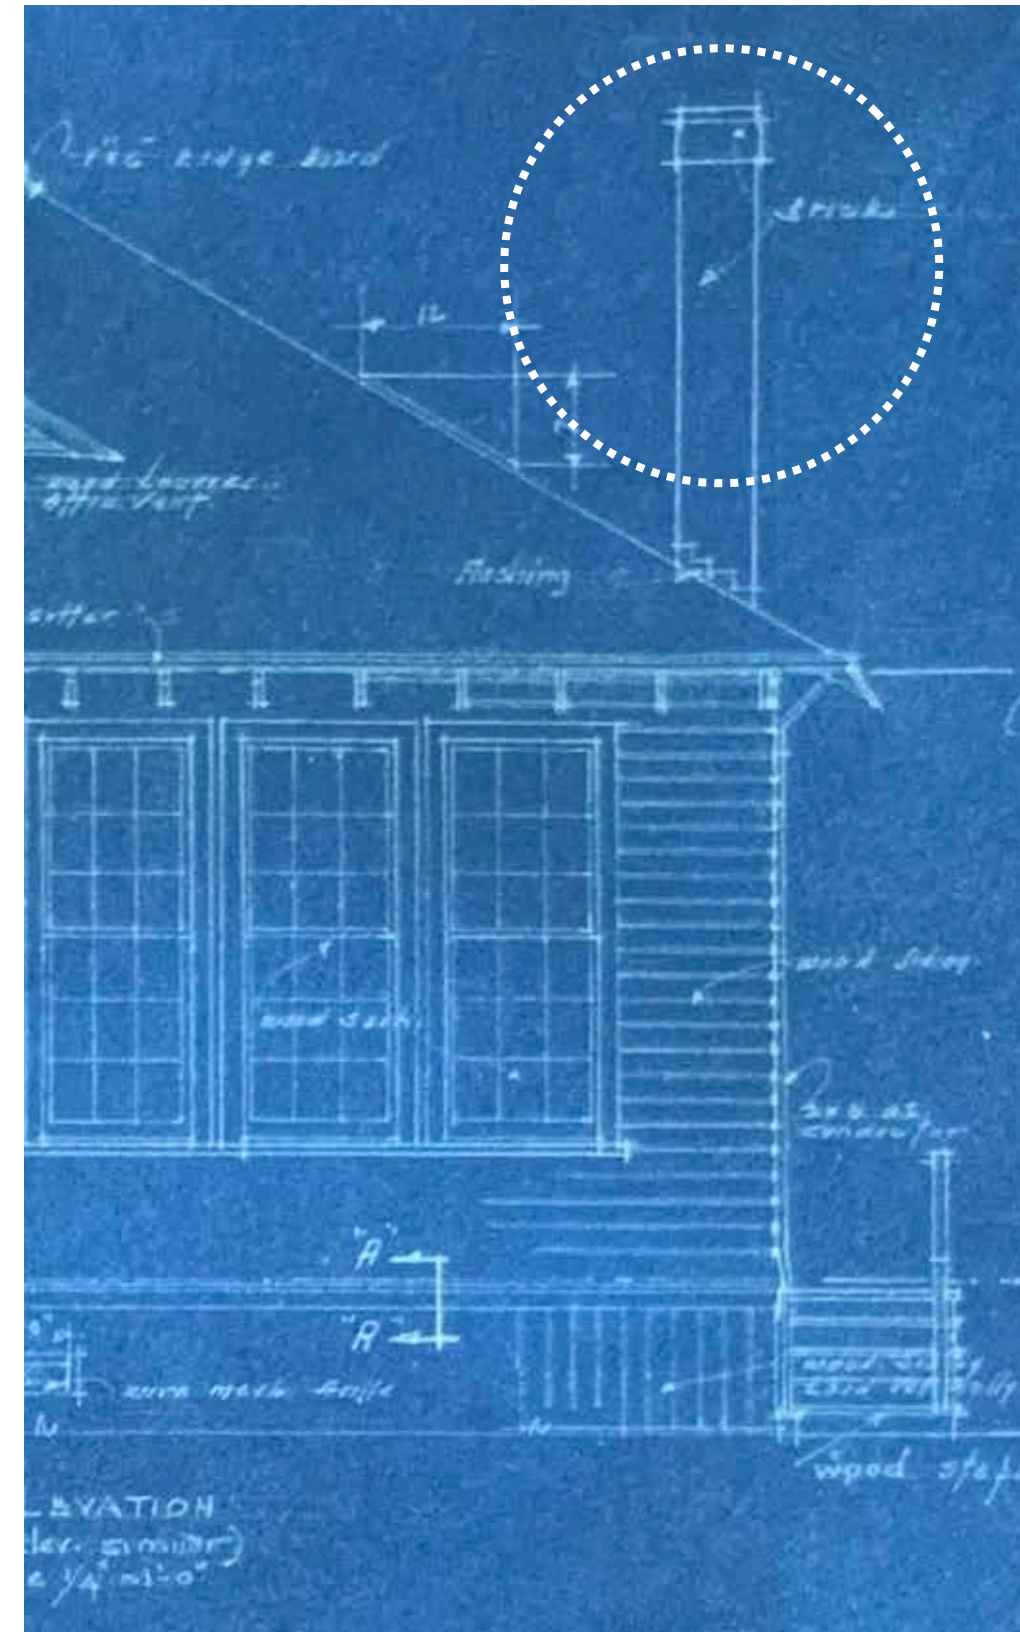
Original Blueprint South Elevation

Of the three original chimney flues, only two remain. These flues, made of 4" bricks and measuring 8" x 12", are currently unbraced and show significant signs of deterioration. This deterioration is the primary cause of water intrusion in the classrooms below and poses a safety hazard for the building, as well as for the students attending classes and the children playing outside on the deck.

Numerous previous attempts to address the issue, including patches of drywall below the lath and plaster ceiling, have been unsuccessful. The Roof Replacement Intervention proposes a full plywood re-sheeting and proposes either eliminating or reducing the size of these deteriorating flues.
