## **Sand Point Naval Air Station – Building**

## **Limited Condition Assessment**

**Project:** Mercy Housing Northwest – Building 9 Door Replacement  
7101 62nd Avenue NE  
Seattle, WA 98115

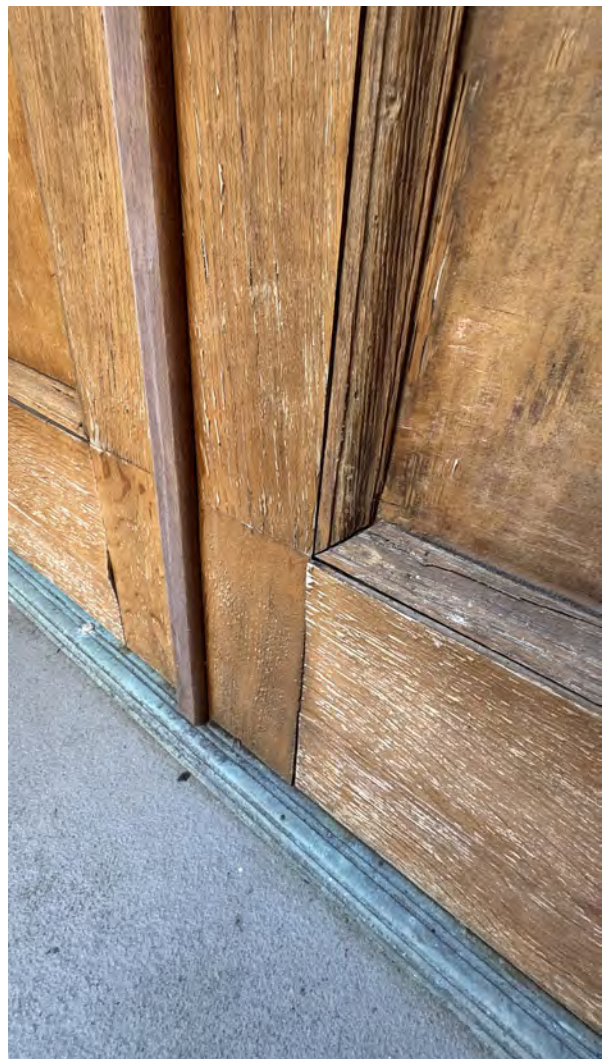
This fixed door pair is also in poor condition and has been damaged both by the failure of its protective finishes. Loss of the finish material has resulted in the exposure of wood to the open air allowing moisture to infiltrate the veneer and trim materials causing them to gray and rot. As noted in some of the documentation some of the veneer materials are cupping and pulling away from the door structure as a result of moisture infiltration and differential swelling and or shrinkage exacerbating the issue.

*Fig. 20: Details of cupping and swelling wood components.*

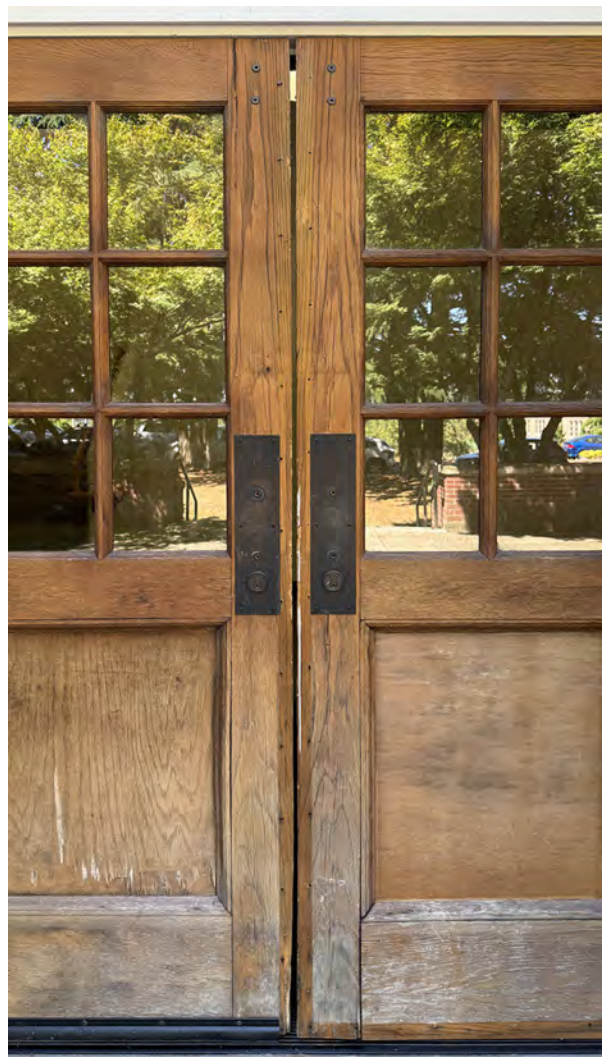
*Fig. 30: Detail of doors S-ST02-06*

This door pair is also in poor condition. The lower portion of the door especially showing exposure to the elements through loss of finish resulting in discoloration and differential swelling between members now exposed to moisture. This door has also been damaged by forced entry efforts, the astragals stripped and leaves scarred from the insertion of tools to force the locking bolts. As noted in the details some of the veneer at the base of the door is cupping due to water infiltrating behind the material and causing it to swell and split.

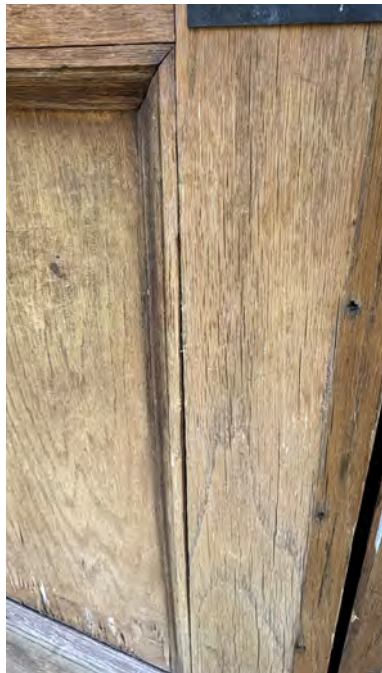
*Fig. 34, 35, and 36: Damage from moisture infiltration of failing finishes at joints causing swelling and separation of components. Details of cupping and swelling wood components.*

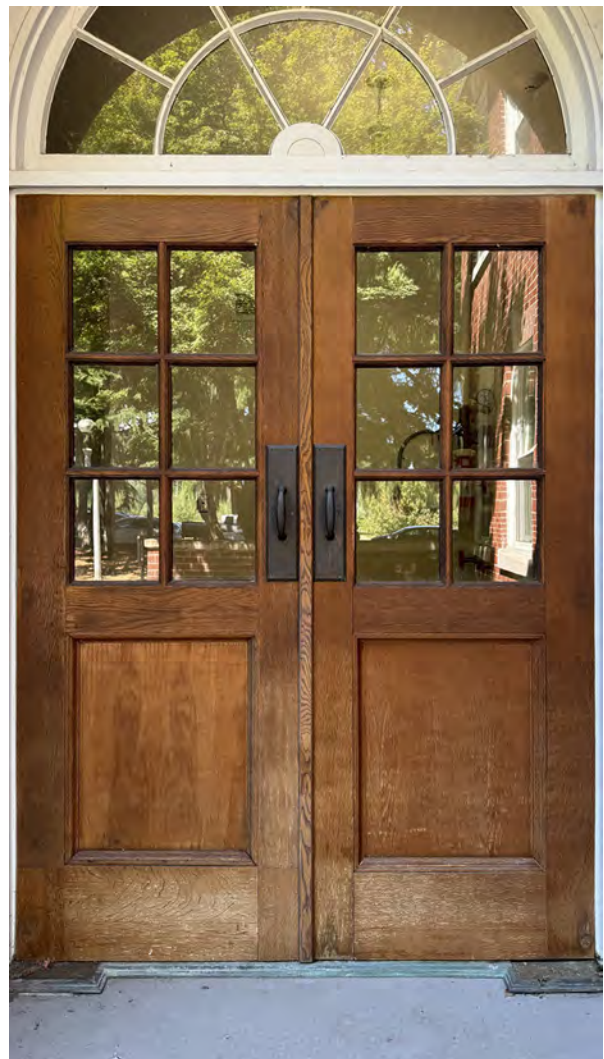
*Fig. 38: Detail of door pair S-ST02-07*

This fixed door pair is in reasonable condition, though it also exhibiting loss of finish resulting in direct exposure of the wood to the elements causing discoloration and swelling of the veneer members and moulding at the inset panels as documented in the detail photos.

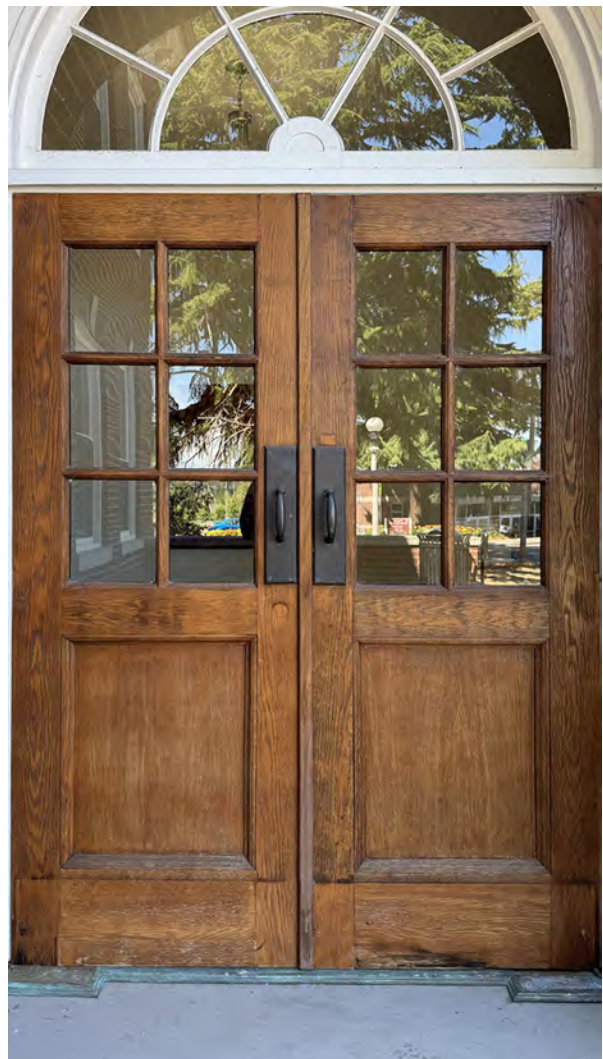
*Fig. 44: Detail of door pair S-ST01-04*

This fixed door pair is in decent condition. Most of the discoloration appears to be from previous exposure before rehabilitation and removal of a kick plate at the base of the door, as evidenced by the difference in visibility of the grain from the less exposed material.

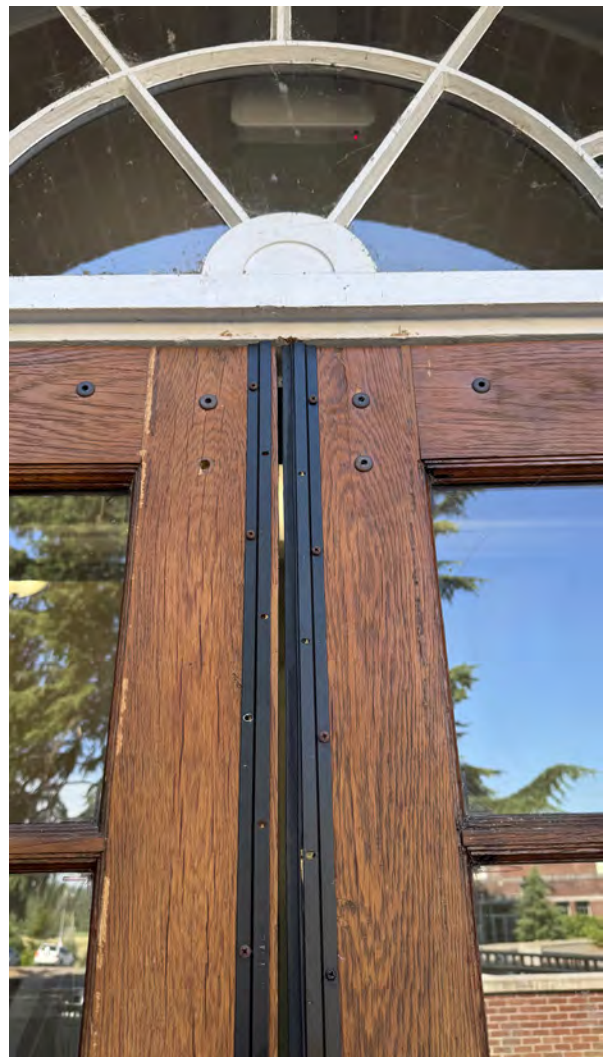
This door pair shows evidence of damage from both forced entry and exposure to moisture. Here again the weather stripping has been removed to allow for tool access to force the doors. This forcing has likely contributed to the split occurring at the stile and rail joint adjacent to the door hardware seen in figure 50 to the right. Generally the portion below the mid-point rail show bleaching from lack of protection. As the details in figures 52-54 illustrate this lack of protection has resulted in the swelling and cupping of the veneer layer, some to the point of loss.

*Fig. 48: Detail of door pair S-ST01-05 showing gap between leaves.*

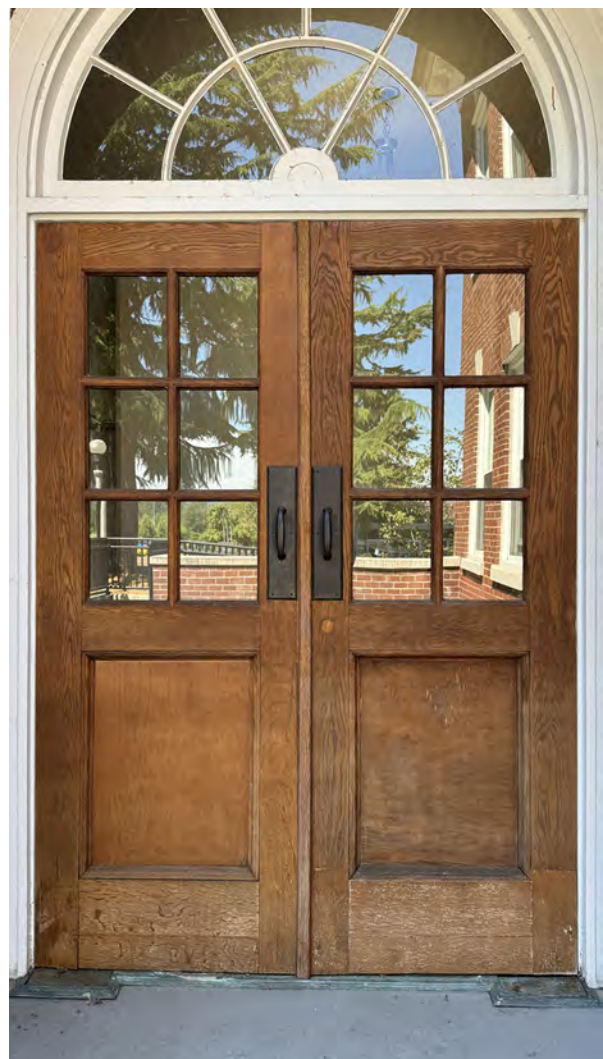
*Fig. 56: Detail of door pair S-ST01-06*

This fixed pair is also in poor condition with most of the issues occurring at the lower portion of the door where exposure to weather is greatest and where morning solar exposure on this east elevation is most extreme. The lower portion of the door shows loss of finish, bleaching from sun exposure and the patches from the rehabilitation show evidence of moisture infiltration resulting in swelling resulting in greater exposure of the edge of material.

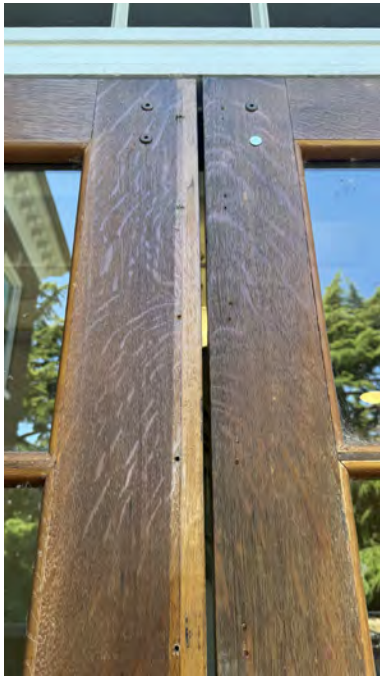
*Fig. 62: Gap at door meeting. Astragals stripped from door.*

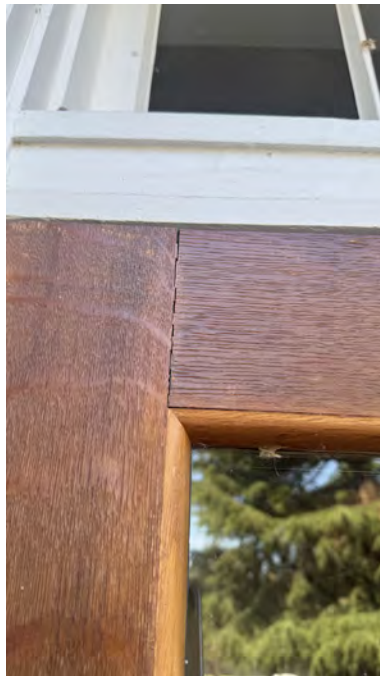
*Fig. 63: Detail of gap from differential shrinkage at joint.*

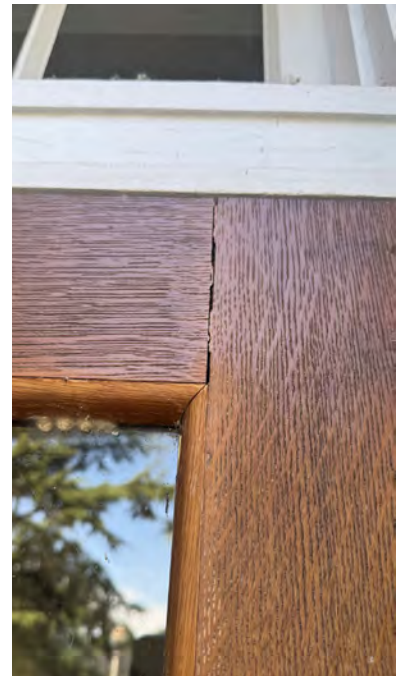
*Fig. 64: Detail of gap from differential shrinkage at joint.*

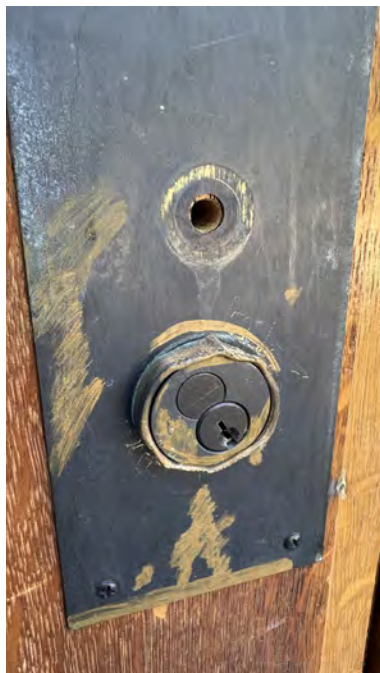
*Fig. 66: Detail of damage to locks in effort to gain entry.*

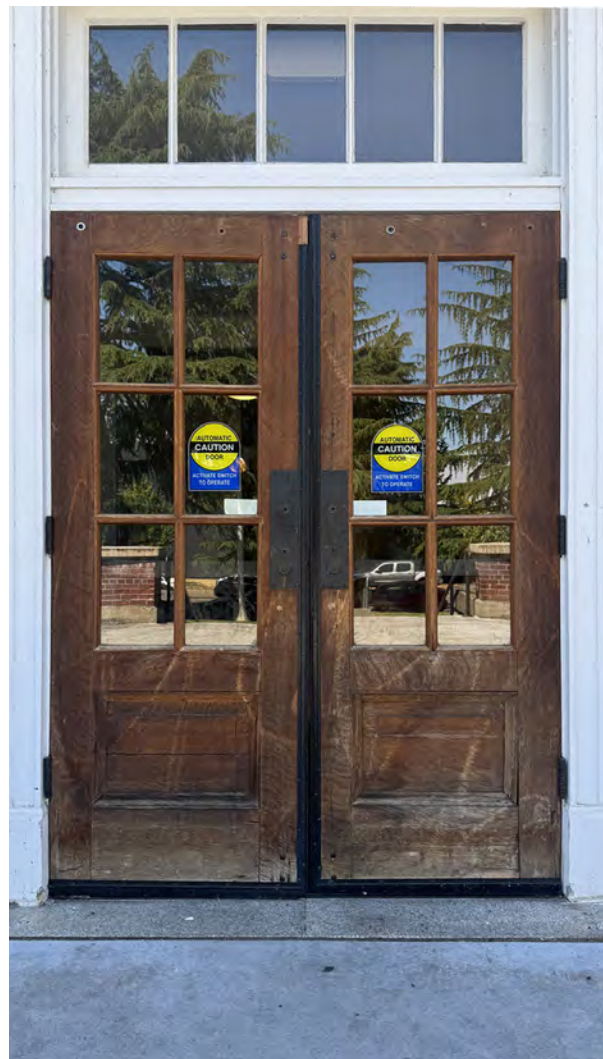
*Fig. 69: Detail of d[door pair NM115-01*

This door pair on automatic operators is in very poor condition. Loss of finish has resulted in moisture infiltration and differential shrinkage at joints exposing end grain of the rails at stile and rails joints and exposure of the wood trim at the panels insets to moisture, causing swelling. The inset panels have been badly damaged by repeated forced entry. Daylight is visible through cracks in the panels and between the door leaves. The weather stripping has been removed from the astragals. Rotting and drying have resulted in loss of the veneer material as illustrated in detail images on pages 26-29.

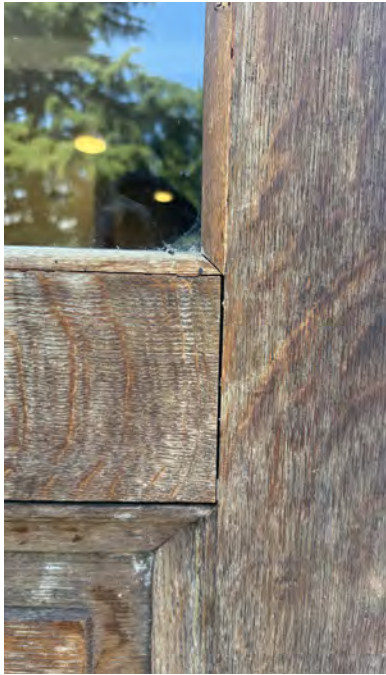
*Fig. 70: Joint separation gap from differential swelling.*

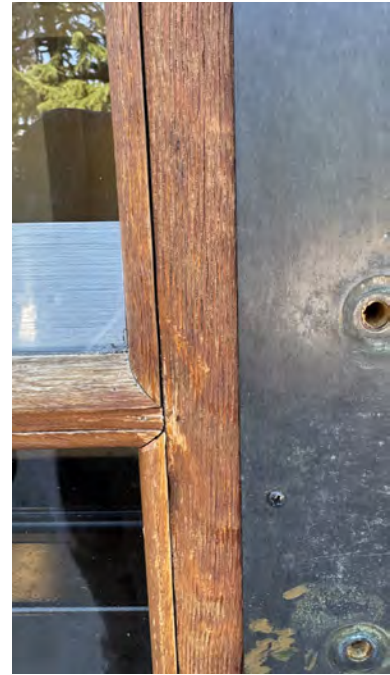
*Fig. 79: Open joints from differential swelling & drying..*

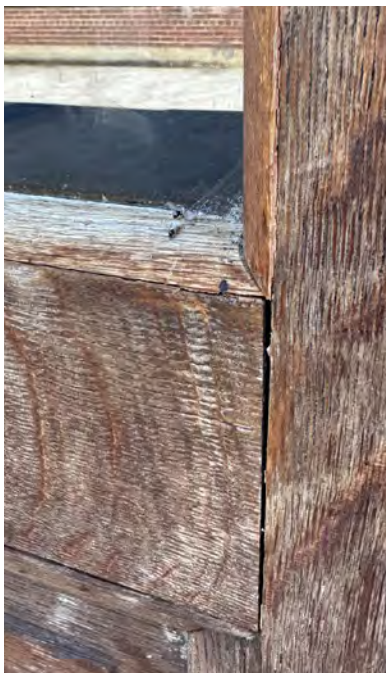
*Fig. 80: Open joints from differential swelling & drying.*

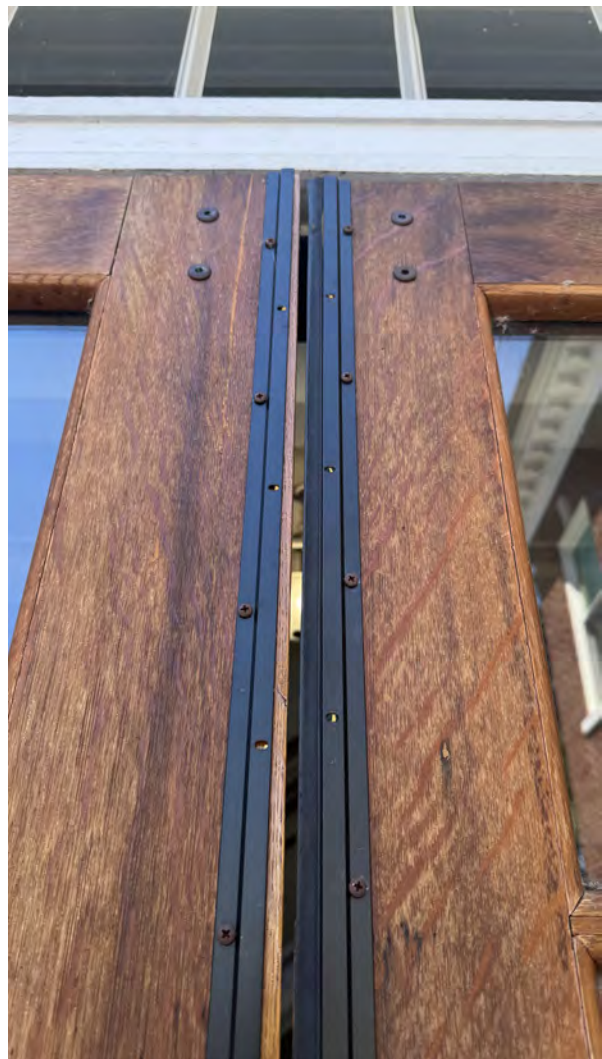
This door pair is in very poor condition. Issues include loss of finish, damage to the inset panels from entry attempts, loss of weather stripping at the astragals, loss of color from solar exposure, moisture infiltration, and repeated attempts to remove the door hardware with tools. Evidence of differential shrinkage is also apparent at stile and rail joints and at the window muntins.

*Fig. 84: Detail of door pair N-ST04-04 showing gap between doors & loss of weather stripping.*
