## **Sand Point Naval Air Station – Building**

## **Limited Condition Assessment**

**Date:** July 13, 2026

**Project:** Mercy Housing Northwest – Building 9 Door Replacement  
7101 62nd Avenue NE  
Seattle, WA 98115

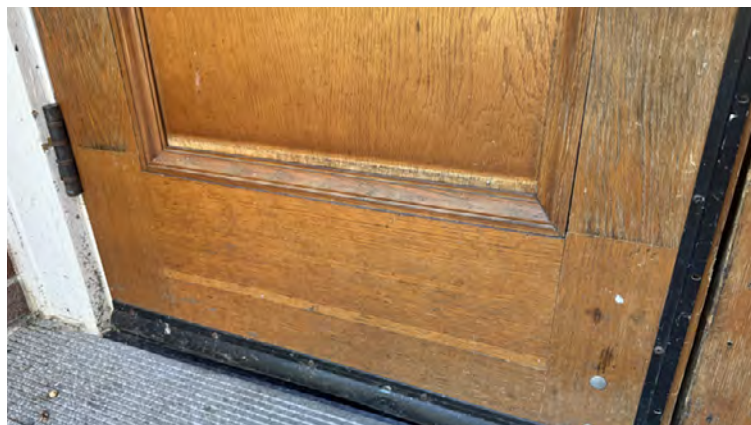
Door pair S-ST04-01 shows the poor condition of the wood as a result of weather exposure and evidence of efforts to access the building. This includes damage to the panel from brute force attacks and recent replacement of several of the upper lights. Several of the doors show previous efforts to repair rails and stiles that were severely damaged during the period of vacancy. Weatherization astragals were added to the door pairs in an effort to improve their performance but most have been damaged, or removed in part or in whole during efforts to gain access.

*Fig. 07: Left panel of door pair S-ST04-01 shows previous rail and stile patches.*

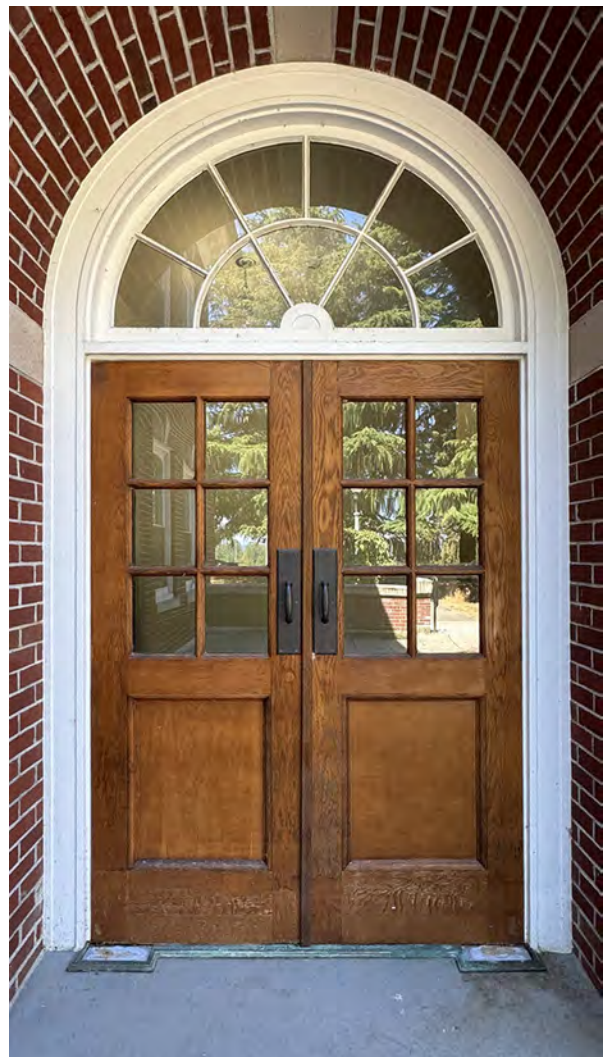
*Fig. 09: Enlarged view of door pair S-ST03-05*

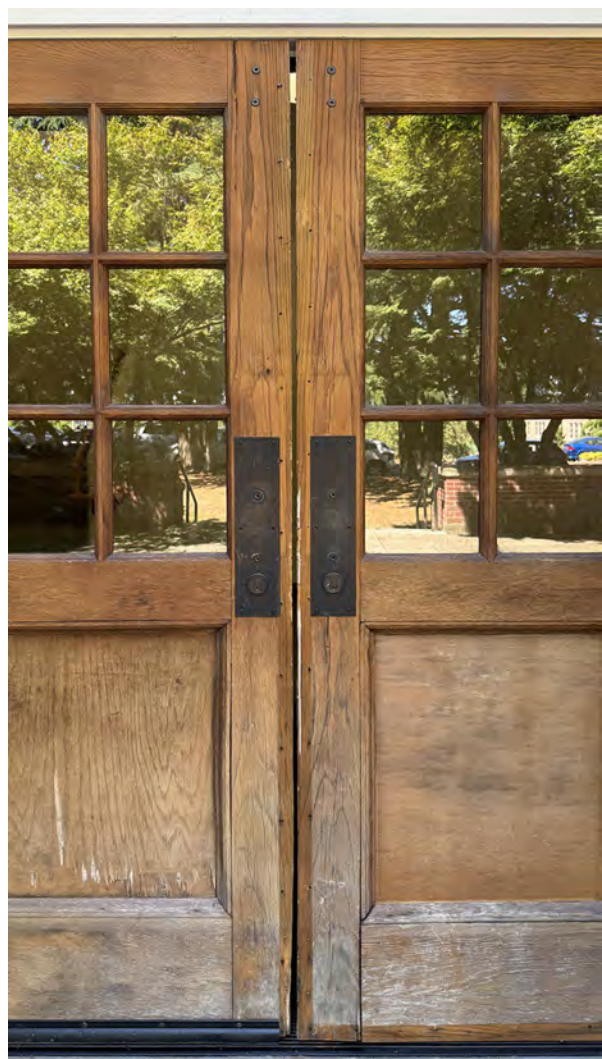
This door pair is also in poor condition. The lower portion of the door especially showing exposure to the elements through loss of finish resulting in discoloration and differential swelling between members now exposed to moisture. This door has also been damaged by forced entry efforts, the astragals stripped and leaves scarred from the insertion of tools to force the locking bolts. As noted in the details some of the veneer at the base of the door is cupping due to water infiltrating behind the material and causing it to swell and split.

*Fig. 30: Detail of doors S-ST02-06*

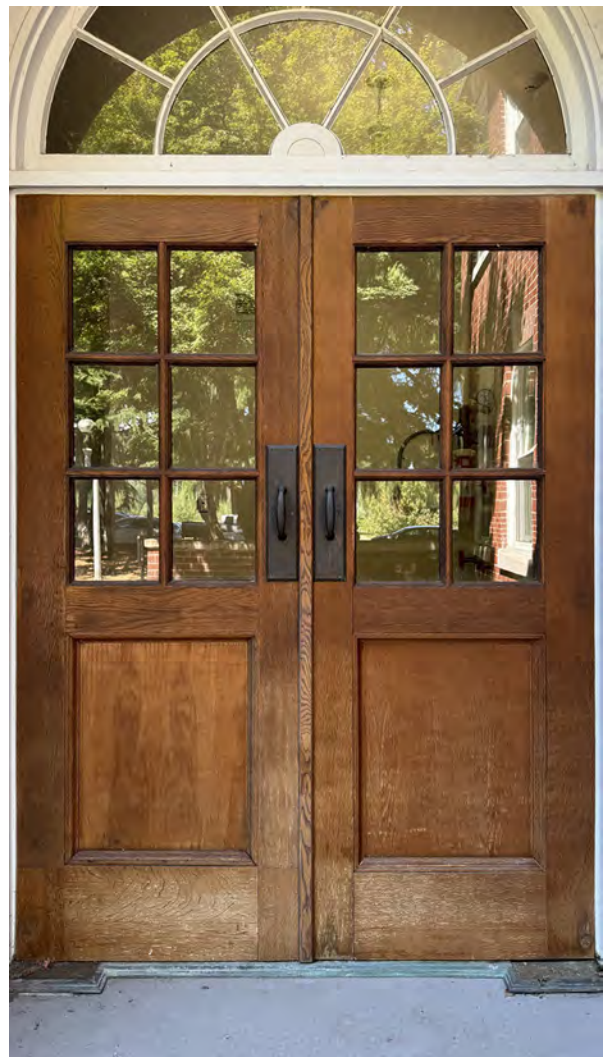
This fixed door pair is in reasonable condition, though it also exhibiting loss of finish resulting in direct exposure of the wood to the elements causing discoloration and swelling of the veneer members and moulding at the inset panels as documented in the detail photos.

*Fig. 38: Detail of door pair S-ST02-07*

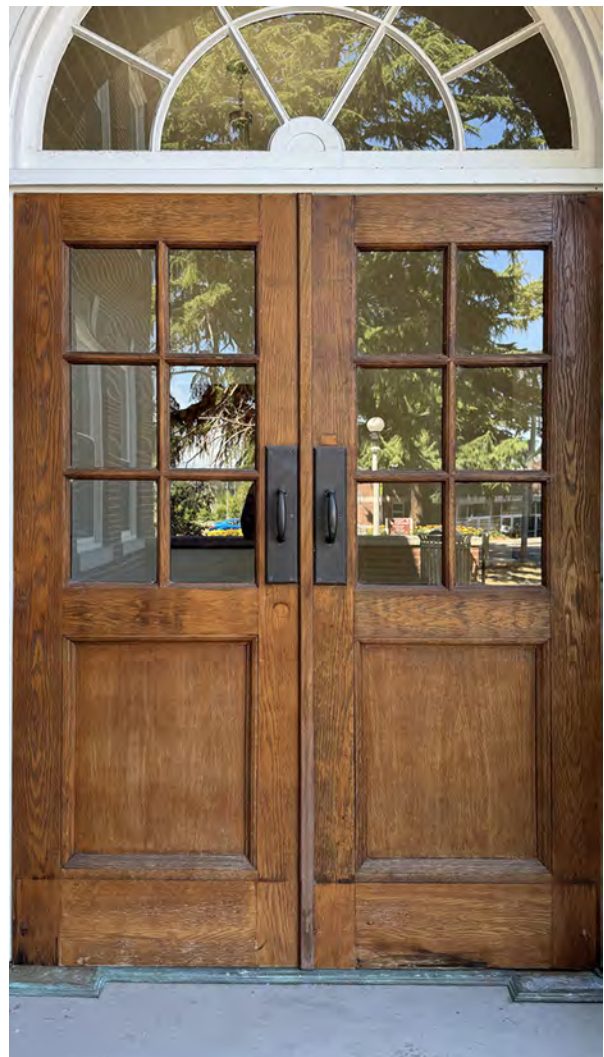
This fixed door pair is in decent condition. Most of the discoloration appears to be from previous exposure before rehabilitation and removal of a kick plate at the base of the door, as evidenced by the difference in visibility of the grain from the less exposed material.

*Fig. 44: Detail of door pair S-ST01-04*

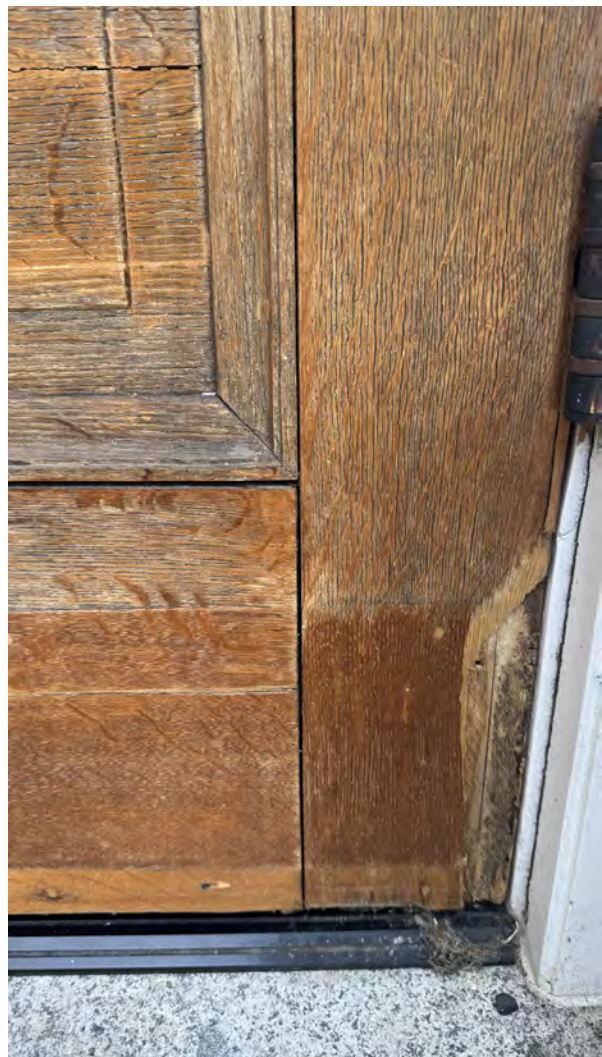
*Fig. 61: Detail, loss of veneer material at base of door. Gaps from differential swelling.*

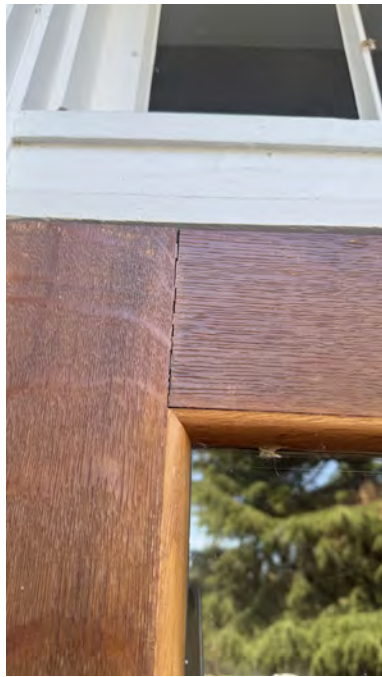
*Fig. 63: Detail of gap from differential shrinkage at joint.*

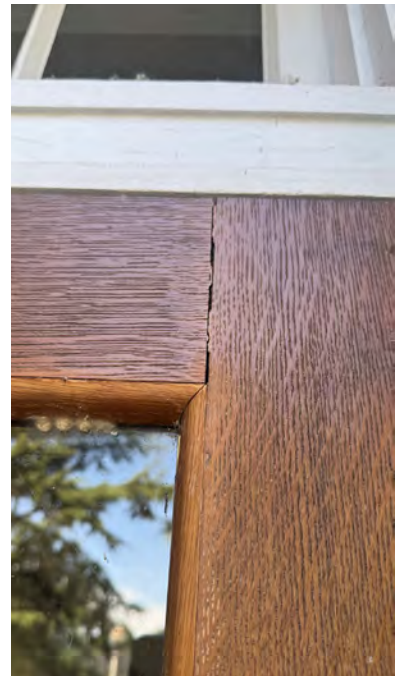
*Fig. 64: Detail of gap from differential shrinkage at joint.*

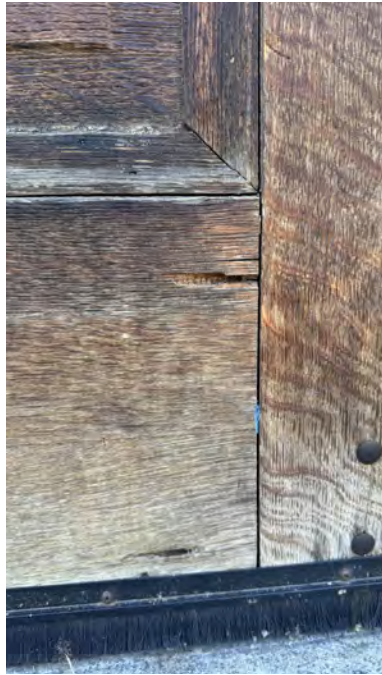
*Fig. 78: Open joints from differential swelling & drying..*

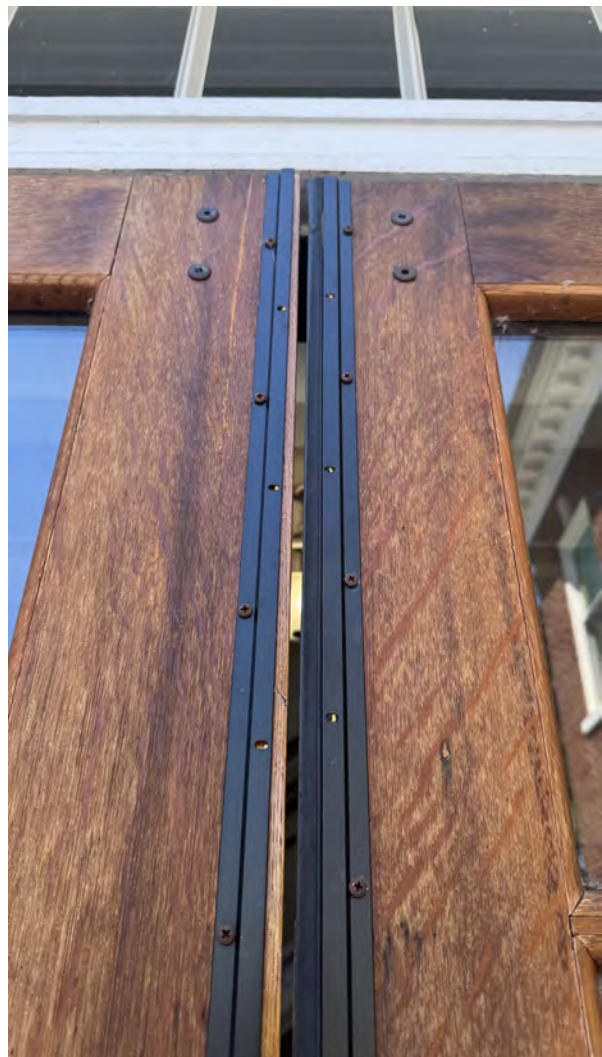
*Fig. 84: Detail of door pair N-ST04-04 showing gap between doors & loss of weather stripping.*
