Seattle  
Public  
Utilities

# Shape Our Water

Technical Memo  
**Seismic Risk Assessment**  
February 17, 2022

Deliverable title: Drainage and Wastewater Seismic Risk Assessment

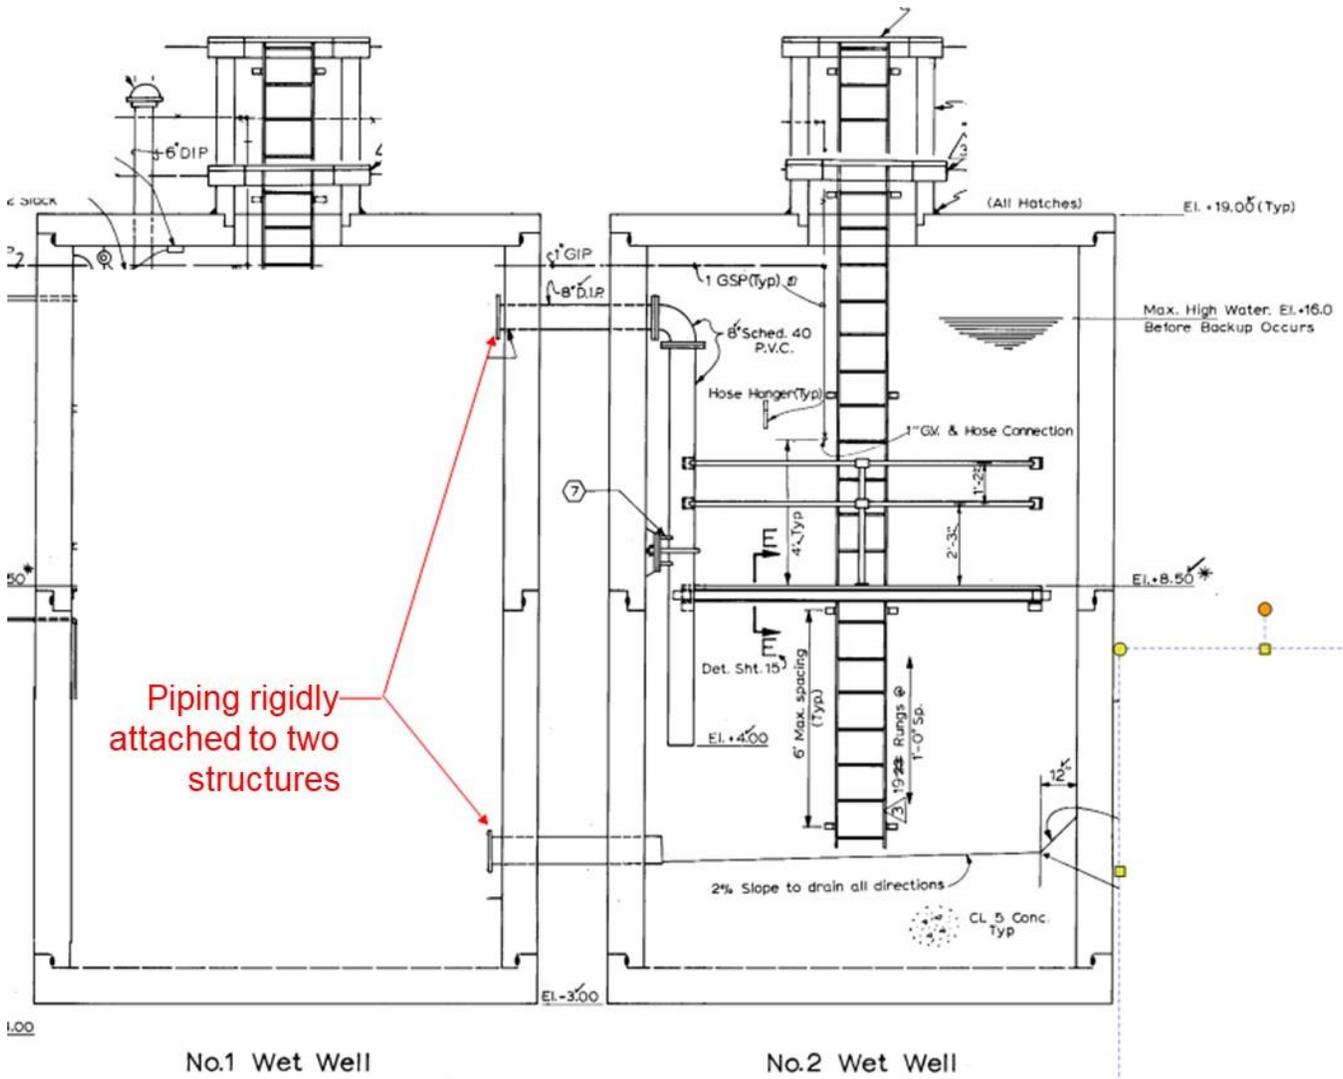
Figure E-9. Section view of PS 1

**Pump Stations 01, 06, and 20.** These three pump stations have a mainline that is rigidly attached to two adjacent structures. These mainlines have a moderate risk of failure when not located in liquefaction zones, which applies to Pump Stations 01, 06, and 20. Since these mainlines are short and stiff, the mainlines are vulnerable to differential movement between the structures. The piping shown in Figure E-9 illustrates this

issue. These pump stations will likely perform poorly in the earthquake scenarios considered in Section 3 of this report.

*Several mainlines interconnect the two wet wells making the mainline vulnerable to damage.*

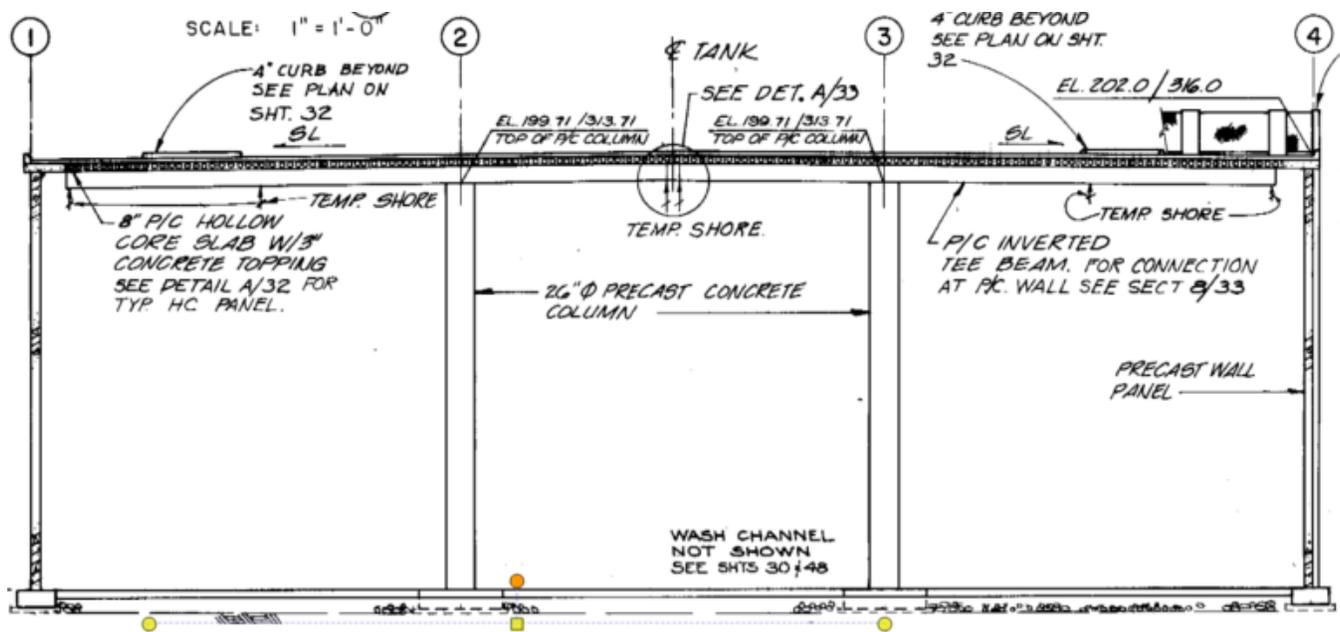
Figure E-10. Section view of Tanks 168 and 169

**CSO Facilities 2 and 3, Tanks 168 and 169.** Tanks 168 and 169 are 100-foot-diameter post-tensioned tanks. The tanks were constructed in 1987. The tanks were designed per the 1979 Uniform Building Code. Based on review of the design drawings, several deficiencies have been identified. There is inadequate load path from perimeter wall to the foundation. Roof slab is not adequately attached to perimeter wall. In addition, the shear reinforcement details of interior concrete columns are not clear, requiring a future field investigation to confirm construction details. Based on the findings of actual construction details, a structural analysis will then be performed to determine if interior columns are able to deform with the rest of the structure without experience brittle shear failure. Considering the era of construction, the design earthquake and the importance of the structure, it is recommended these tanks be evaluated using a Tier 3 evaluation per ASCE 41. See Figure E-10.

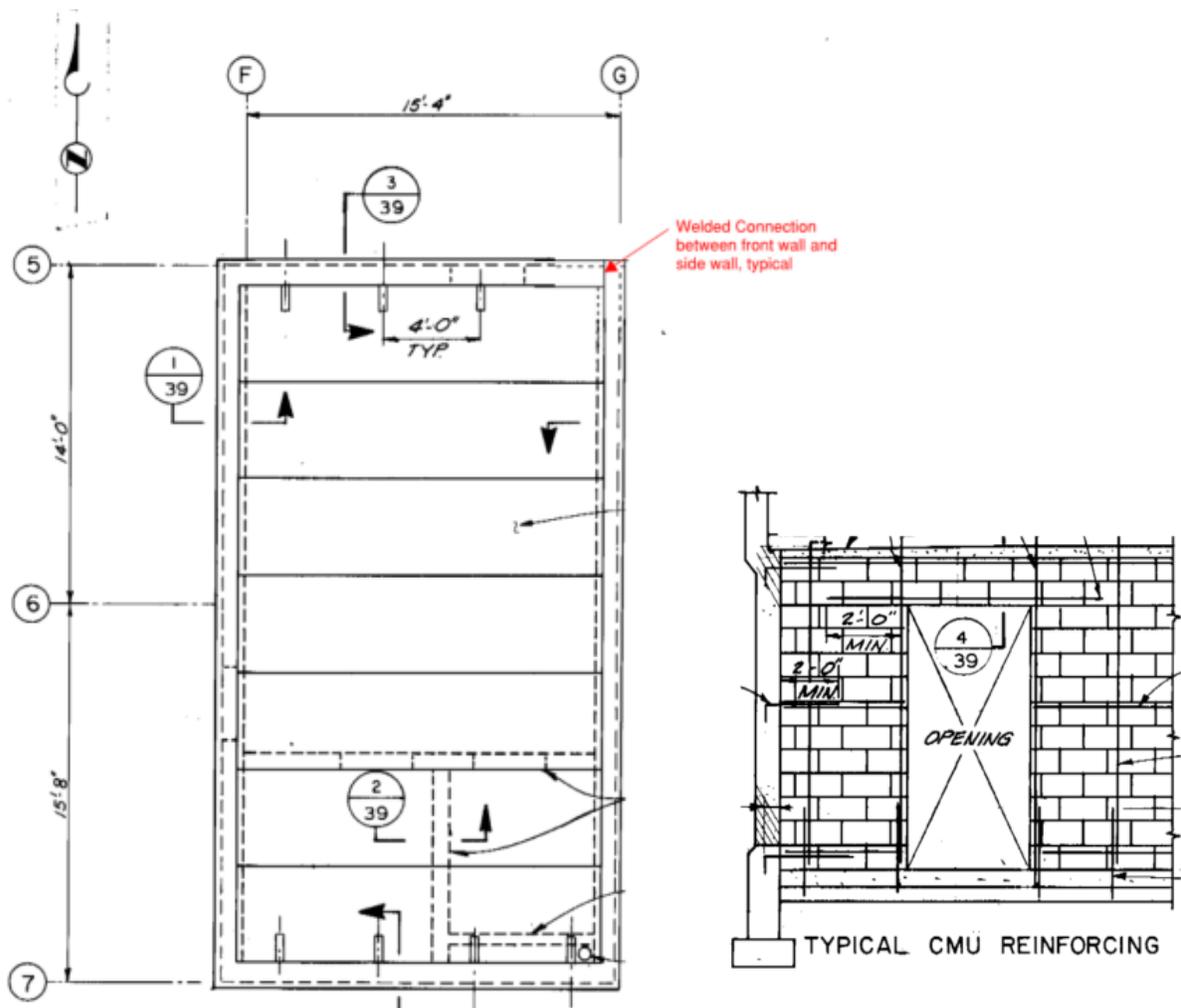
Figure E-11. Plan and section view of the CSO 2 and 3 control buildings

**CSO 2 and 3 Control Building.** The Control Building is 15'-4" x 29'-4" Cement Masonry Block Building (CMU) and was constructed in 1987. The building consists of a series of CMU panels that are joined together with welded connections. The building foundation has a stem wall foundation.

Based on review of the available drawings, a number of deficiencies have been identified. The CMU panels were joined together using welded connections. These connections lack ductility and may not have adequate strength. The roof diaphragm is constructed of precast hollow planks without any topping slab, and will have inadequate strength to resist seismic forces associated with the earthquake scenarios. Such an untopped precast concrete diaphragm cannot function as cross ties in the direction perpendicular to hollow planks. Considering the importance of the structure, the era of construction and design earthquakes being evaluated, it is recommended this structure be evaluated using a Tier 3 evaluation per ASCE 41. The connection between the roof and masonry walls should also be evaluated. See Figures E-11 and E-12.

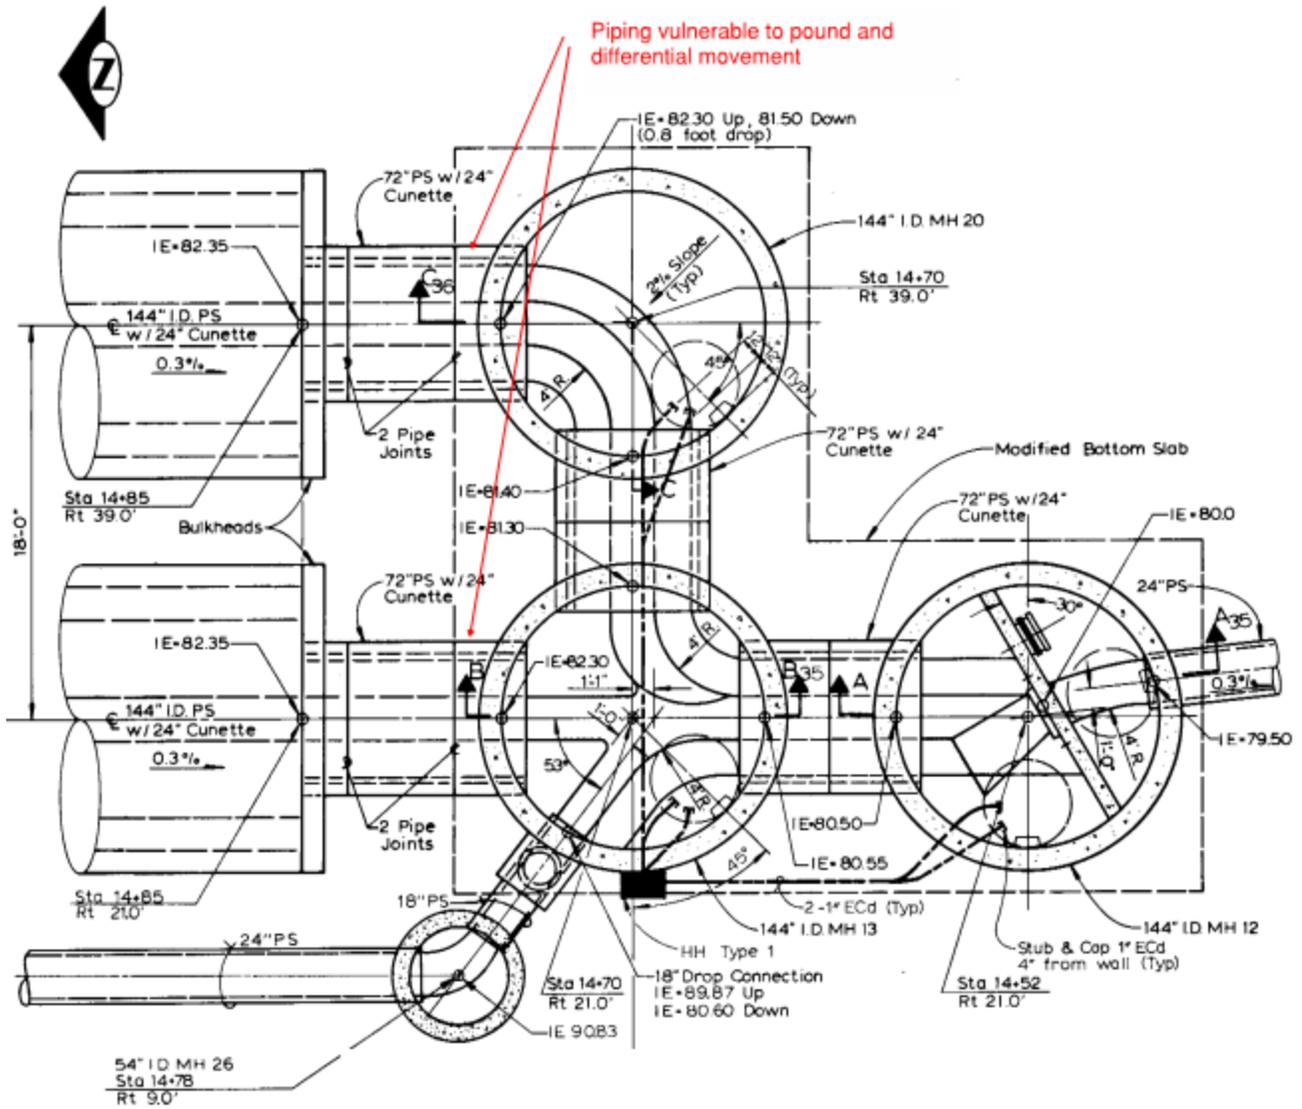
Figure E-14. Plan view of the connection between manholes 12, 13, and 20, and the 144-inch-diameter CSO piping

**CSO 24-Manholes 12, 13, and 20.** These three manholes structures are installed on a single slab. The manholes are connected to 144-inch mainlines, each with a concrete bulkhead. A 72-inch mainline interconnects the manhole structures as well as the 144-inch-diameter mainline. There are two joints between the mainline and manhole structures. The close proximity of the structures and significant stiffness associated with these large diameter mainlines make this combination of structures and mainline vulnerable to differential movement. This connection was rated a moderate risk under the earthquake scenarios described in Section 3 of this report. See Figure E-14.

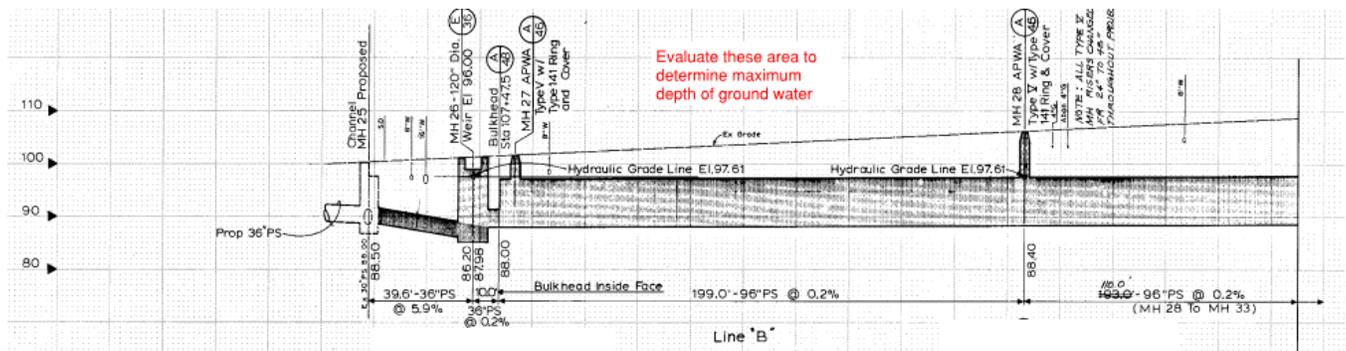
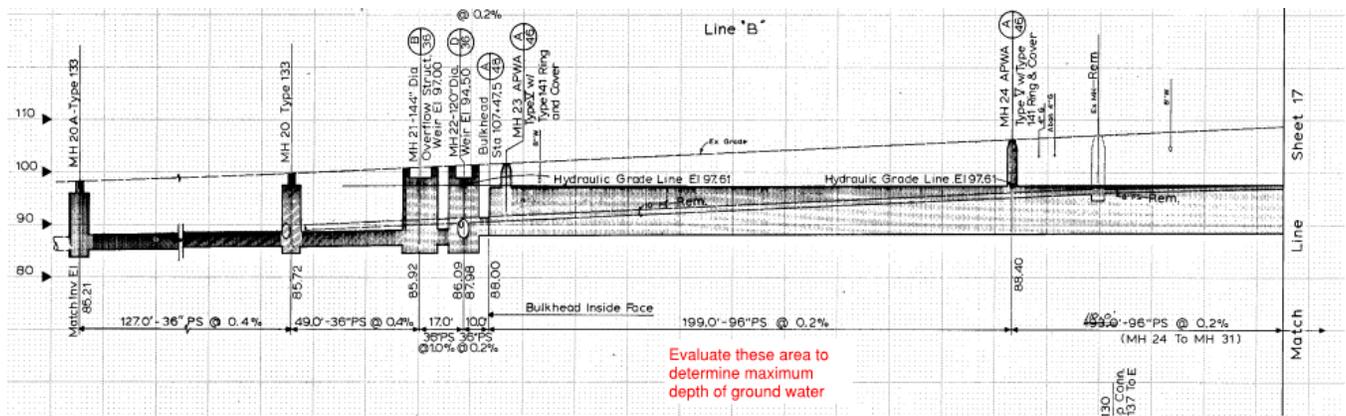
Figure E-15. CSO 22-Lake Washington North 72- and 96-inch-diameter mainlines

CSO Facility 22-Lake Washington North 72- and 96-inch Diameter Mainlines. There are several areas along the mainline alignment where the cover over the top of the mainline is less than the diameter of the mainline. This lack of cover makes it vulnerable to floatation. If the mainline floats, it will render the CSO facility inoperative.

Figure E-15 shows two profiles where the cover is less than the diameter of the mainline.

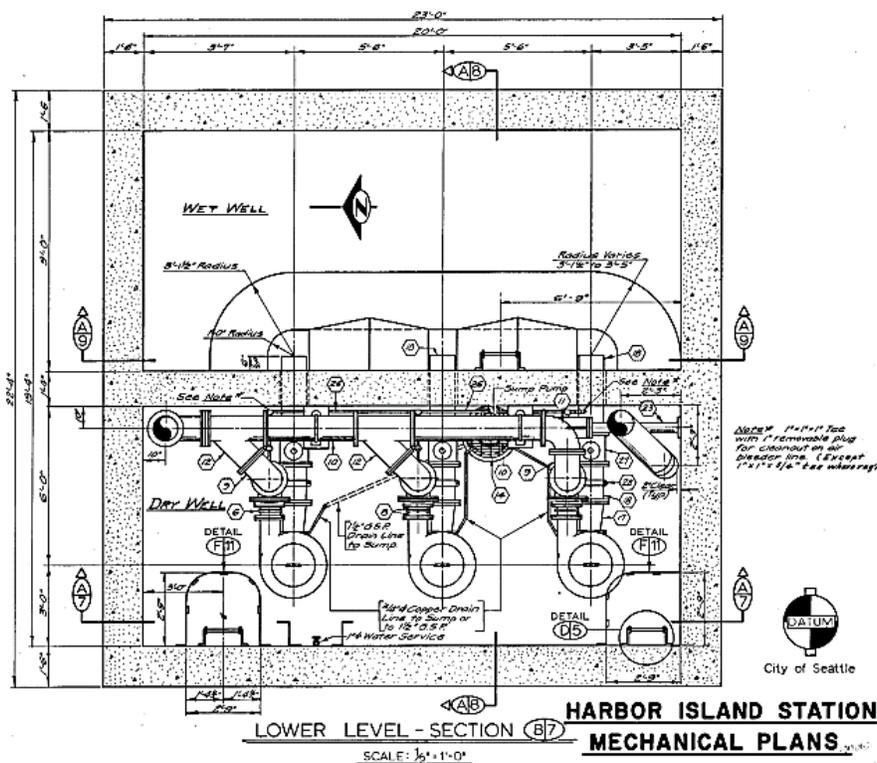
Figure H-2. Example detail from as-built drawings for Pump Station 73

- Structural Assessment.** The floor does not have rebar. The walls have 20 feet spans. All walls have hooks on outer face but not on inner face. Roof is not attached to wall. Center wall only has one hook between wet well wall and tanks wall. Walls have stirrups near the wall intersections. Roof may move relative to structure below. Structure may crack at corners. The roof could displace from the structure. Since this pumpstation is in a liquefaction zone it could cause the pumpstation to become inoperable.

- Mainline Connection Assessment.** The discharge mainline is a 12-inch CIP. It is rigidly attached to the wall. The intake mainline is a 24-inch CIP mainline. It is rigidly attached to the wall but has a bell just outside the wall to allow flexibility.
