**1005 SOUTH KING STREET,
SEATTLE NAILS SUPPLY**

Historic Property Report
1001-1005 South King Street
Seattle, WA 98104

October 2018

Prepared by
d/Arch LLC.
2412 Westlake Avenue North
Seattle, WA 98109
206.547.1761, Matt Driscoll, AIA
mattd@darchllc.com

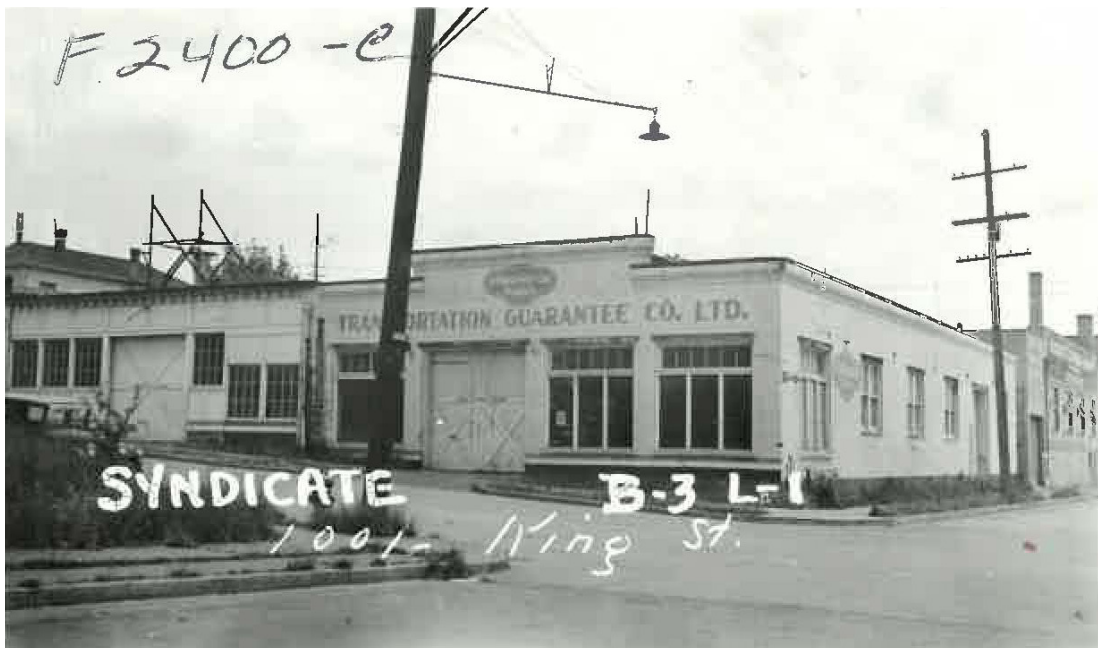
FIGURE 3.3a: 1001 S. King Street (undated)

The front facade is in poor condition and is in need of maintenance. The facade has been painted over several times with colors that do not match the colors of the plastered finish and is unevenly painted across the base of the building and around seven feet up the wall. The unused smaller storefront has been painted over and does not appear to have been maintained. The lettering from the signage of the previous owners is still visible and the material has been damaged by water. The facade has also been vandalized by graffiti that has not been painted over as of writing this report. The glass on the main front entry storefront has been broken out in multiple places and has, as of the writing of this report,

The side facade is far more similar to the original layout but is more utilitarian. The west facade of the building is composed of a series of punched windows that are evenly spaced down the facade of the building. Each punched window is equally sized except the window at the corner which is larger. There was also a former delivery door located towards the south of the building that has been removed and converted to a service door with steps leading into the raised entry. The original delivery door frame still remains and outlines the newer service area but is now clumsily boarded up and unsealed to the outside. While the original windows still remain on the facade, they have, with the exception of one, been painted or boarded over and are no longer functional. The windows have been in this state for at least a decade according to views of the building taken

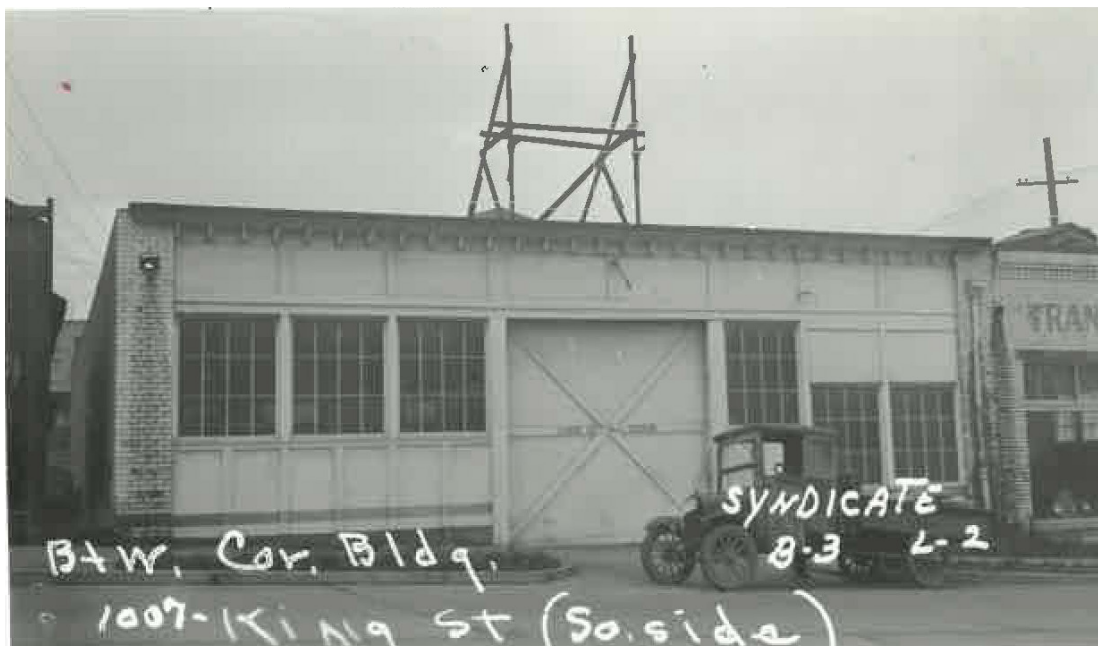
FIGURE 3.3a: 1007 S. King Street

condition than the adjoining building. The painting is uneven and patches of paint are placed in odd parts of the facade facade has been the victim of vandalism. The section of the ribbon window east of the storefront has been painted over for years and recently the west ribbon section has been postered over and is no longer usable as a window.
