ABC Herron Tree LLC  
P.O. Box 64  
Gold Bar, WA 98251  
425-293-2443  
mountainredd@comcast.net

RE: Property Name: D.A.R. Rainier Chapter House  
Taxpayer Name: Rainier Chapter Regent  
Site Address: 800 E Roy St, Seattle, WA 98102  
Parcel#: 9831200275  
Lot Size: 6,800 sq ft

ABC Herron Tree LLC is pleased to submit this report compiling the visual Tree Risk and Evaluation Assessments performed on a tree located on or near the above-reference parcel as shown on the site map in my report.

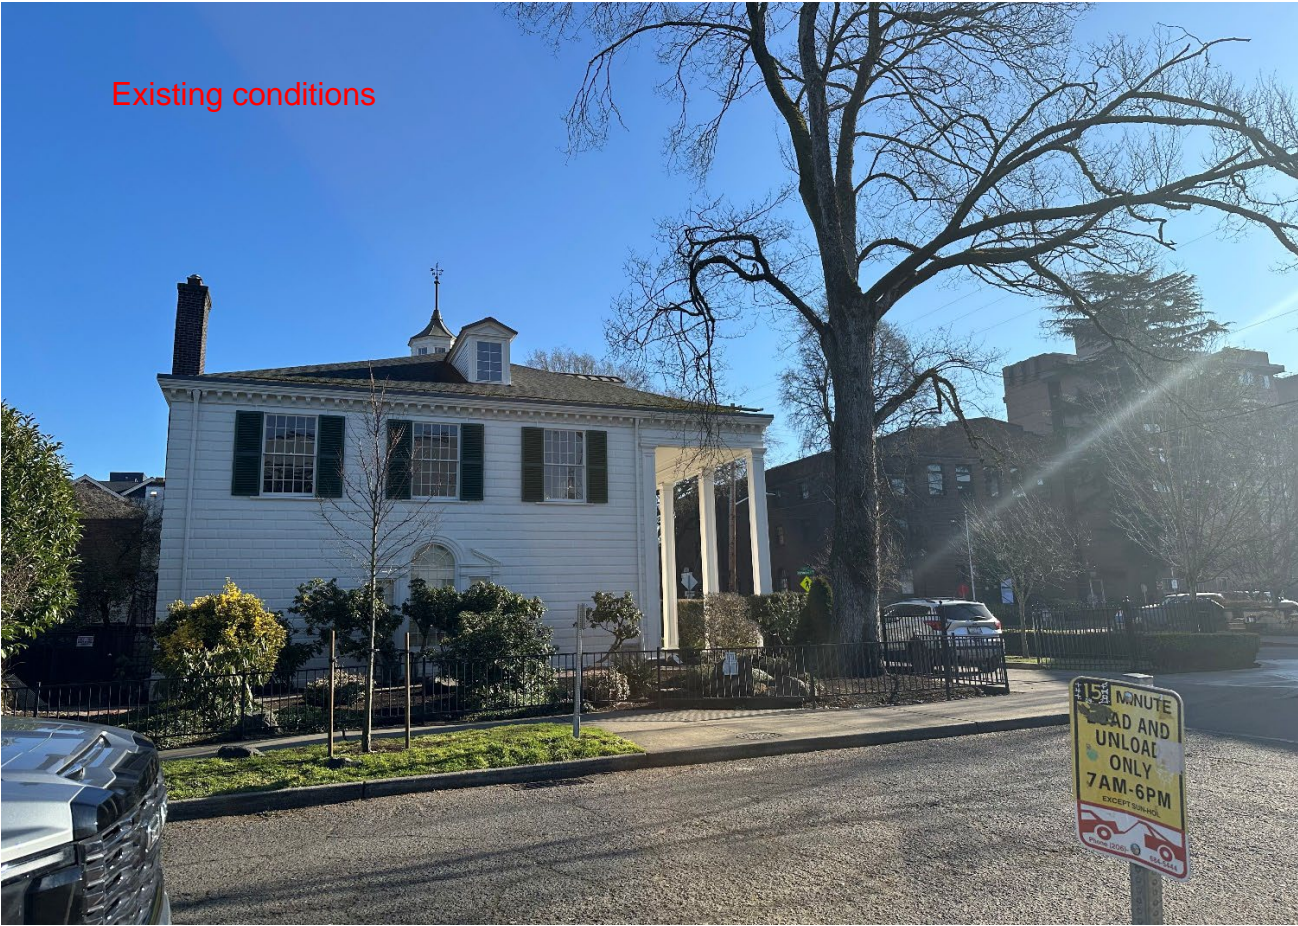
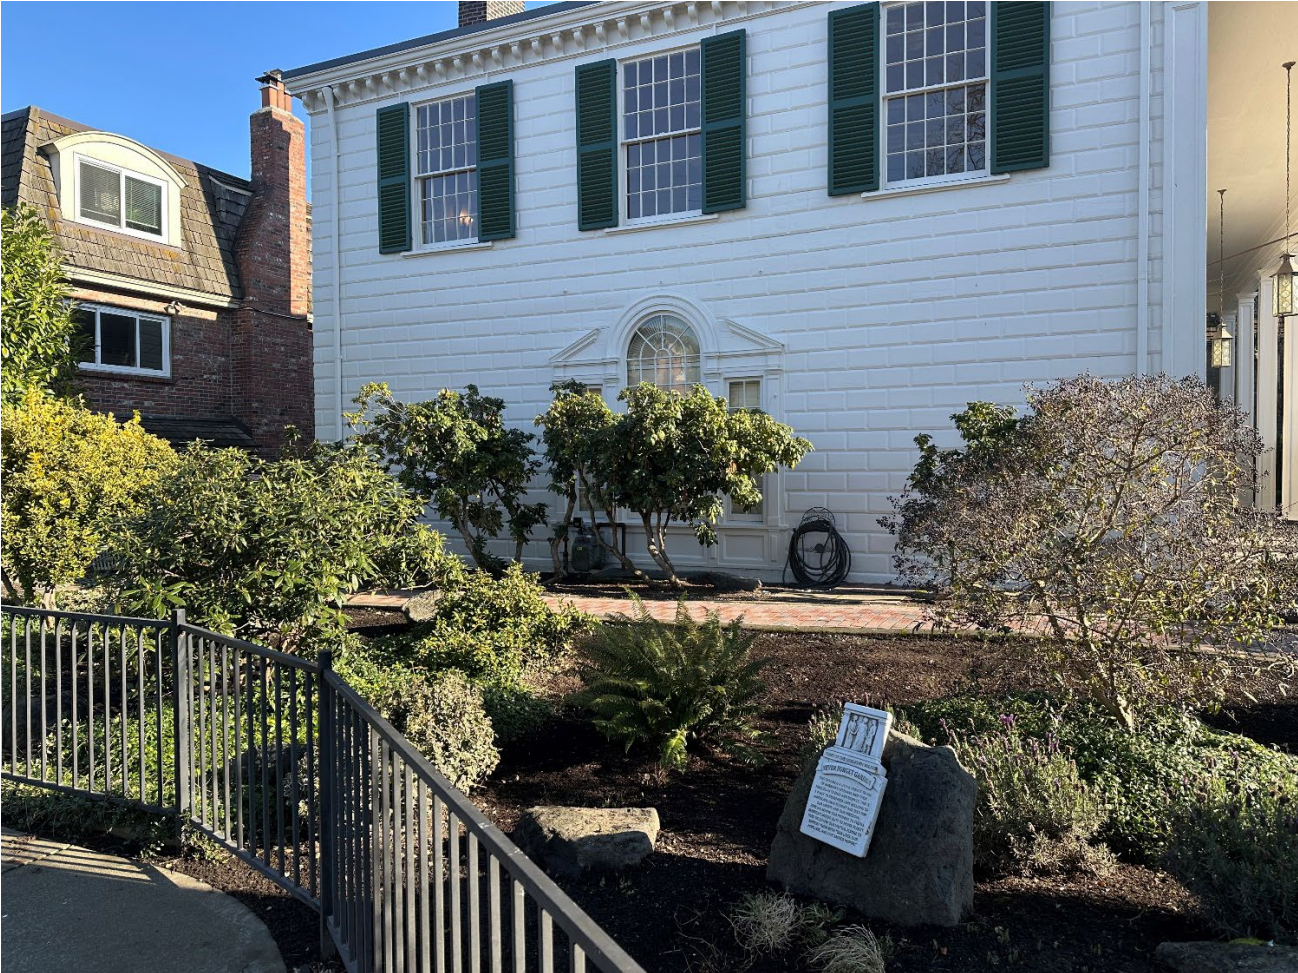
Existing conditions

X Preferred site of new trees

dead elm
