Ballard/Howe Mansion, 22 W Highland Drive – viewed from the south

Arborist Report

To: City of Seattle, SDCI
Site: 22 W Highland Dr, Seattle, WA 98119
Re: Exceptional Tree Removal Permit Application
Date: October 6, 2021
Project Arborists: Haley Galbraith,
ISA Board Certified Master Arborist PN-7512BM
ISA Qualified Tree Risk Assessor
Connor McDermott,
ISA Certified Arborist PN-8704A
ISA Qualified Tree Risk Assessor
Attached: ISA Basic Tree Risk Assessment Forms
Statement of Financial Responsibility

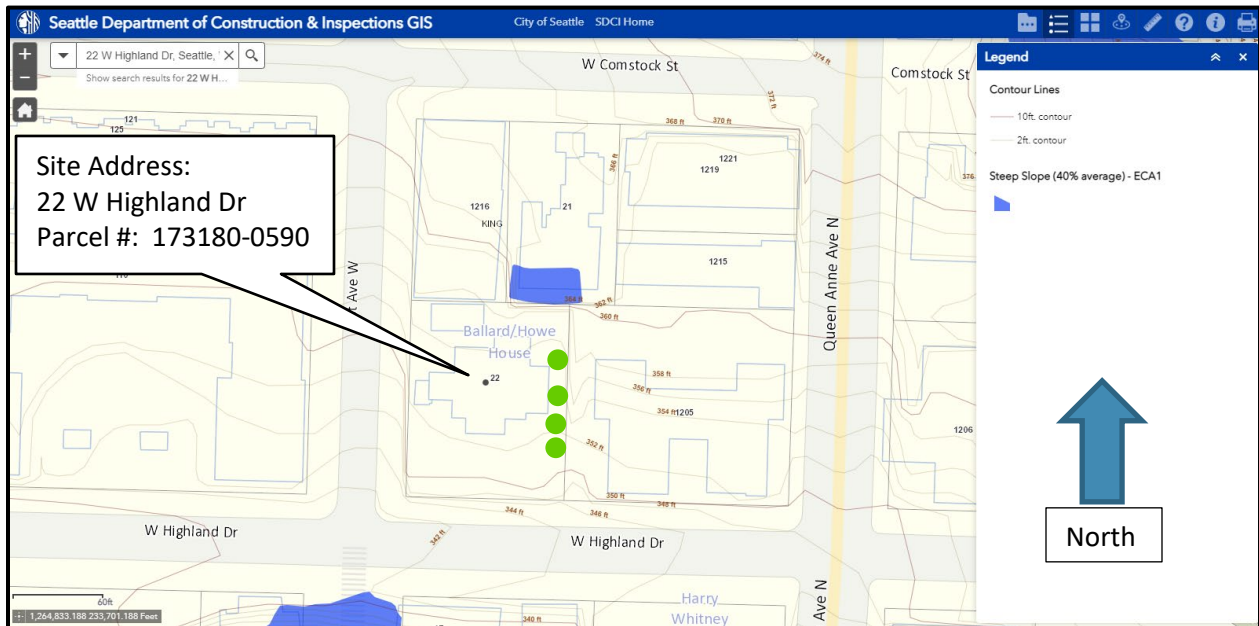
Figure 1. Screenshot of SDCI GIS map showing no ECA on site; green dots indicate approximate locations of proposed replacement trees.

The four new trees will be planted in similar locations to the four Lombardy poplars, so stumps and large surface roots of the Lombardy poplars will need to be ground out and other improvements to the growing conditions will be made. Please see Figure 1 in Appendix A for proposed replacement tree locations.

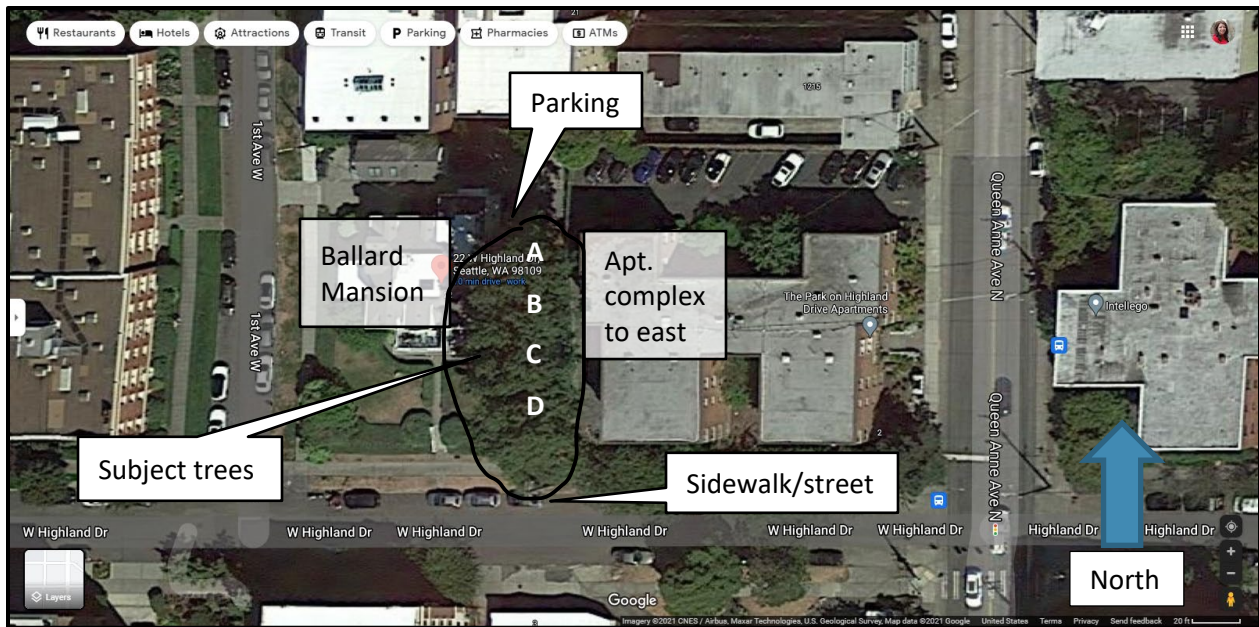
Figure 2. Screenshot of Google Maps showing subject tree locations and surrounding targets.
