DATE: October 6th 2022
BY: Marc Tegen

PART 1 – PROJECT NARRATIVE

1.1. Nathan Eckstein Middle School description

1.2. Brief Scope of work description

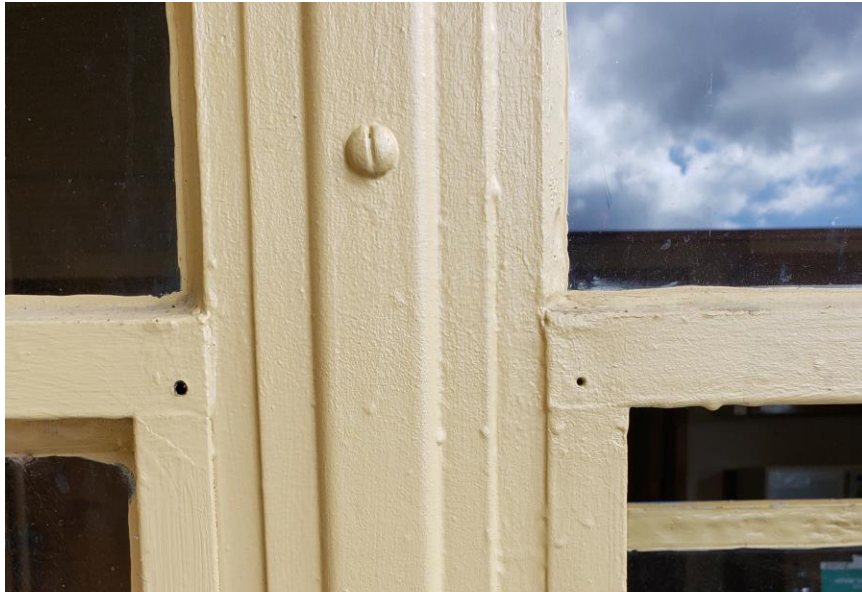
Photo-2 above is an up close view at the intersection between lower operable awnings and the fixed portion of the window.

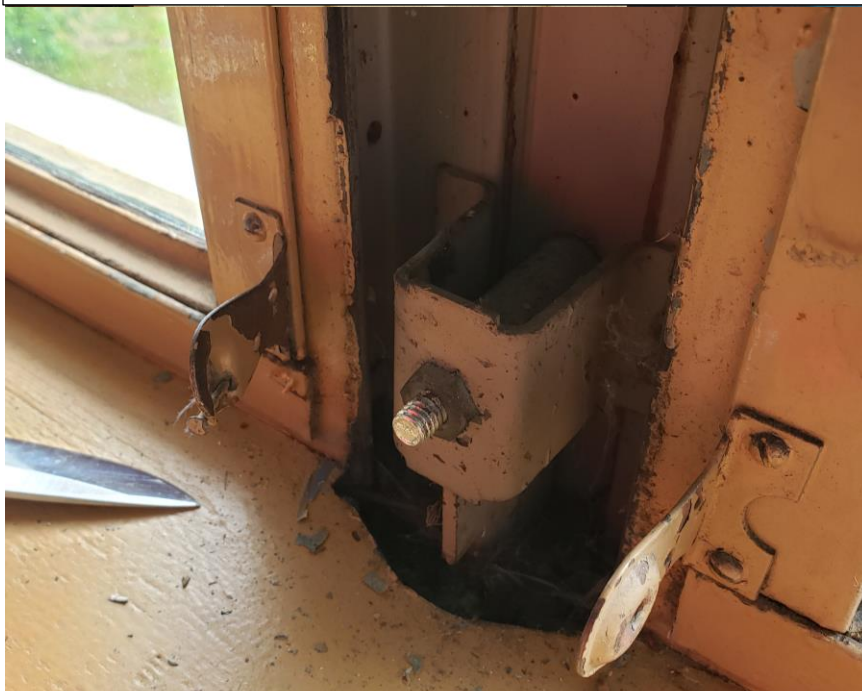
Photo-3 above depicts the concealed brackets used to connect the steel windows at the base of the existing jambs. Note: The brackets are secured to the building structure (embedded in concrete) at only the head and sill of the windows. Intermediate brackets between windows are also located every 16-to-20-inches running vertically between the windows.

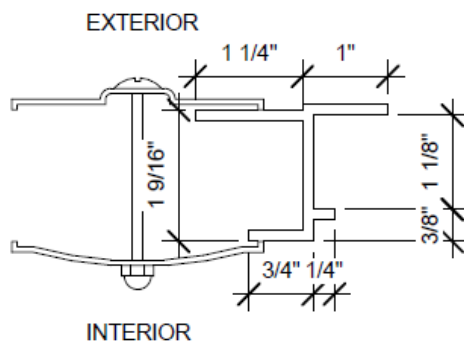
Sketch-4 below provides the field measurements of the historic interior and exterior 1/-16-inch thick steel plates used as the typical means of securement at window jambs.

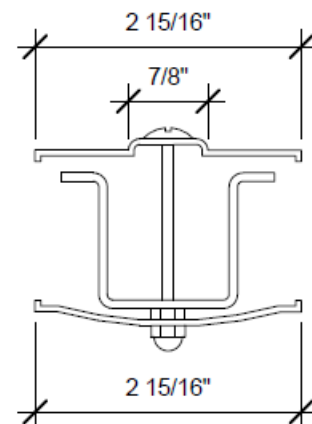
Sketch-5 below provides the field measurements of the historic fixed window frame.

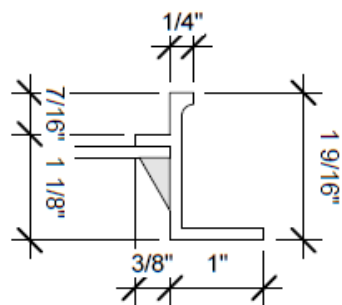
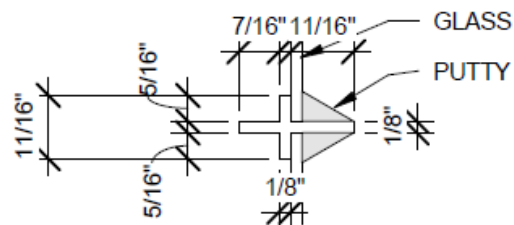
Sketch-6 below provides the field measurements of the historic muntins that existing on both fixed and operable windows.

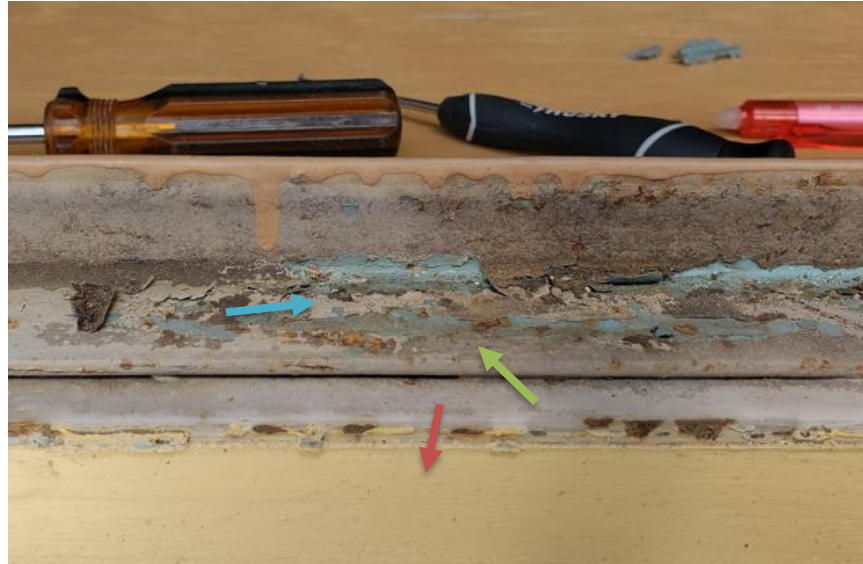
Photo-5 above was taken within the sill of an operable window sash where the current top paint coating (non-historic, see red arrow), can be seen dripping over an underlying tan colored coating (presumed historic top coat, see blue arrow) that is currently peeling off an underlying green colored coating (presumed primer, see green arrow).

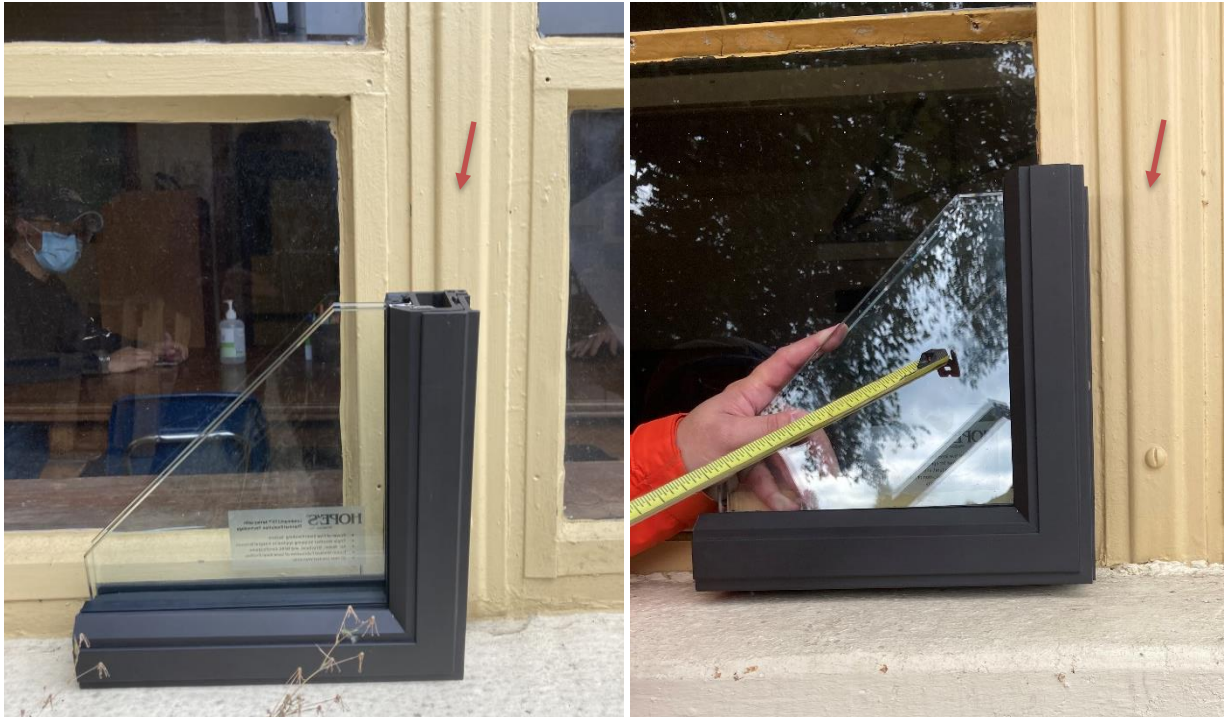
Photos above depict a Hope's Window sample, Landmarked 175 Series, inswing hopper next to the original historic steel frame/sashed windows. *Note: This sample lacks the 1-inch flange that would be specified as part of project and allow for securement behind the profiles steel bracket (red arrow).*
