Unreinforced Masonry Building Seismic Hazards Study

December 2007

City of Seattle Department of
Planning and Development

ReidMiddleton

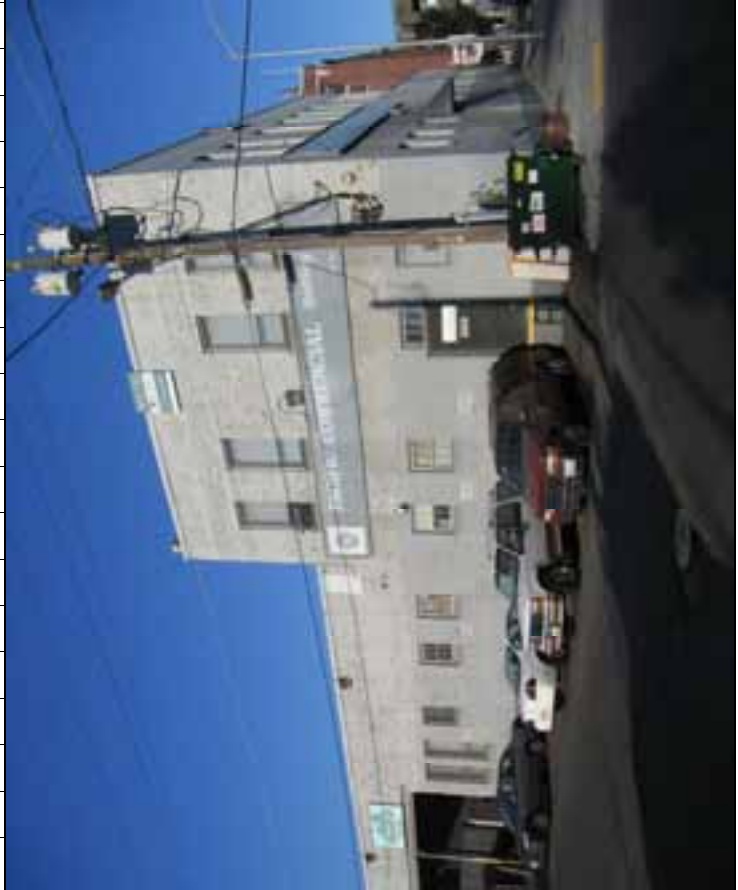
Address	85 S. Atlantic		
District	SoDo	Zip	98134
Other Identifiers			
No. Stories	2	Year Built	1937
Inspector	KMB	Date	08.14.07
Total Floor Area (sq. ft)	24,400		
Building Name	Pacific Commercial Building		
Use

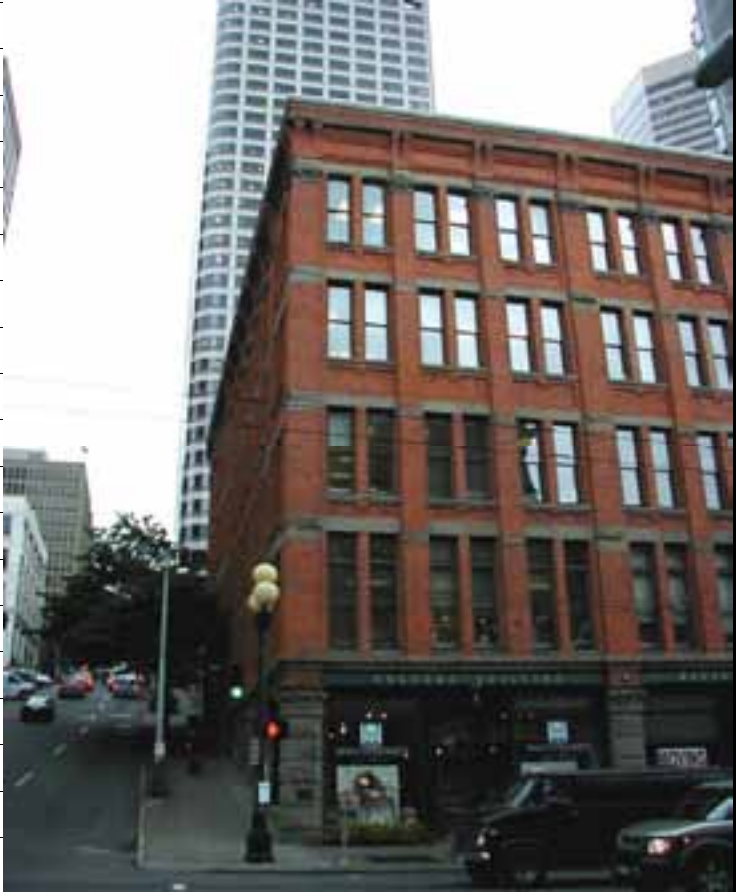
Address	107 Spring St		
District	Downtown	Zip	98104
Other Identifiers			
No. Stories	4	Year Built	1909
Inspector	ADF	Date	10.03.07
Total Floor Area (sq. ft)	39,960		
Building Name	Holyoke Building		
Use	AKA 1018-1028 1st Ave

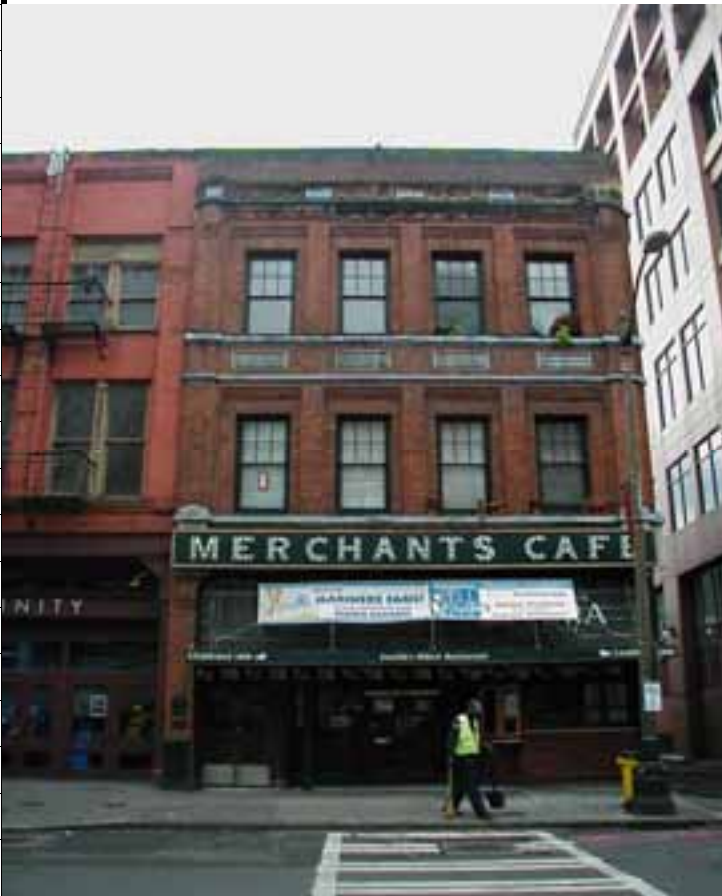
Address	109 to 109 1/2 Yesler Way		
District	Downtown	Zip	98104
Other Identifiers			
No. Stories	3	Year Built	1890
Inspector	ADF	Date	10.03.07
Total Floor Area (sq. ft)	7,500		
Building Name	Merchants Café		
Use

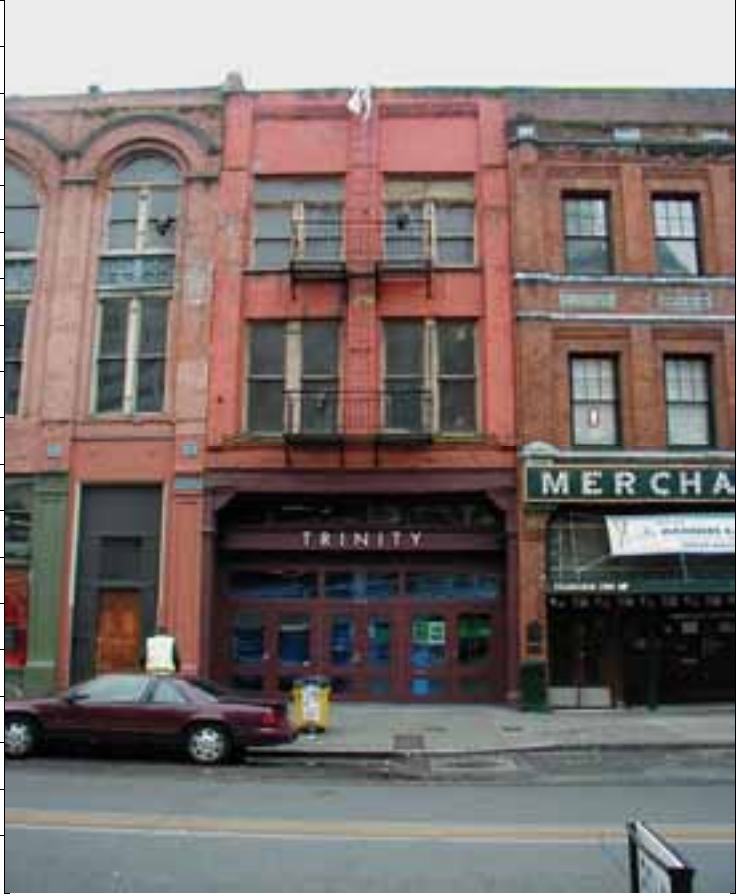
Address	111 Yesler Way		
District	Downtown	Zip	98104
Other Identifiers			
No. Stories	3	Year Built	1890
Inspector	ADF	Date	10.03.07
Total Floor Area (sq. ft)	5,100		
Building Name	Trinity		
Use

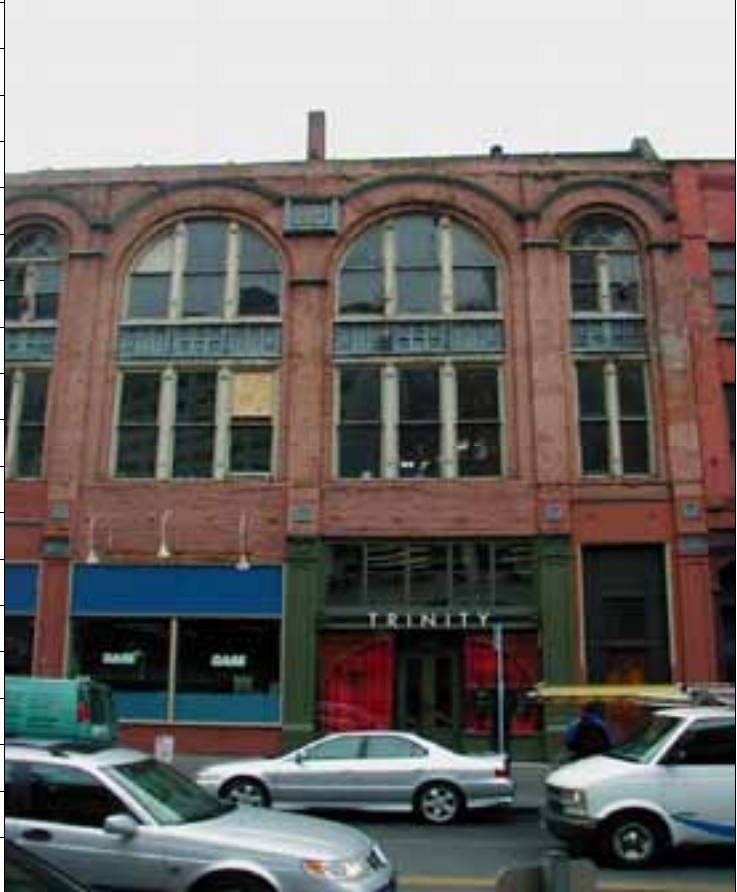
Address 117 Yesler Way
 District Downtown Zip 98104
 Other Identifiers _____
 No. Stories 3 Year Built 1890
 Inspector ADF Date 10.03.07
 Total Floor Area (sq. ft) 15,000
 Building Name _____
 Use _____

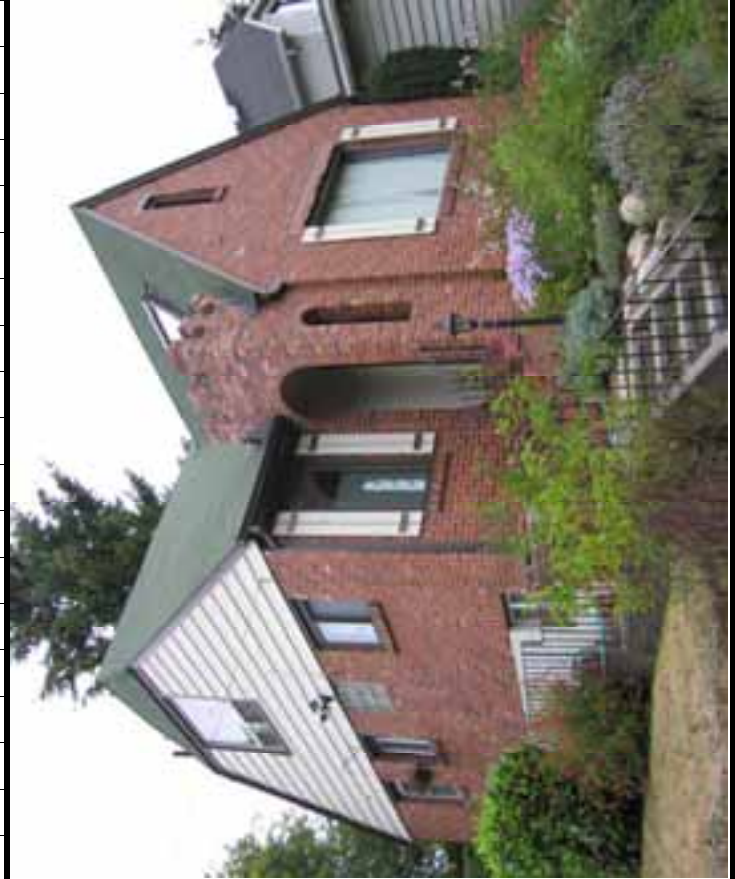
Address	308 NE 82nd St		
District	University	Zip	98115
Other Identifiers			
No. Stories	2	Year Built	1930
Inspector	KMB	Date	09.20.07
Total Floor Area (sq. ft)	1730		
Building Name			
Use	Residential

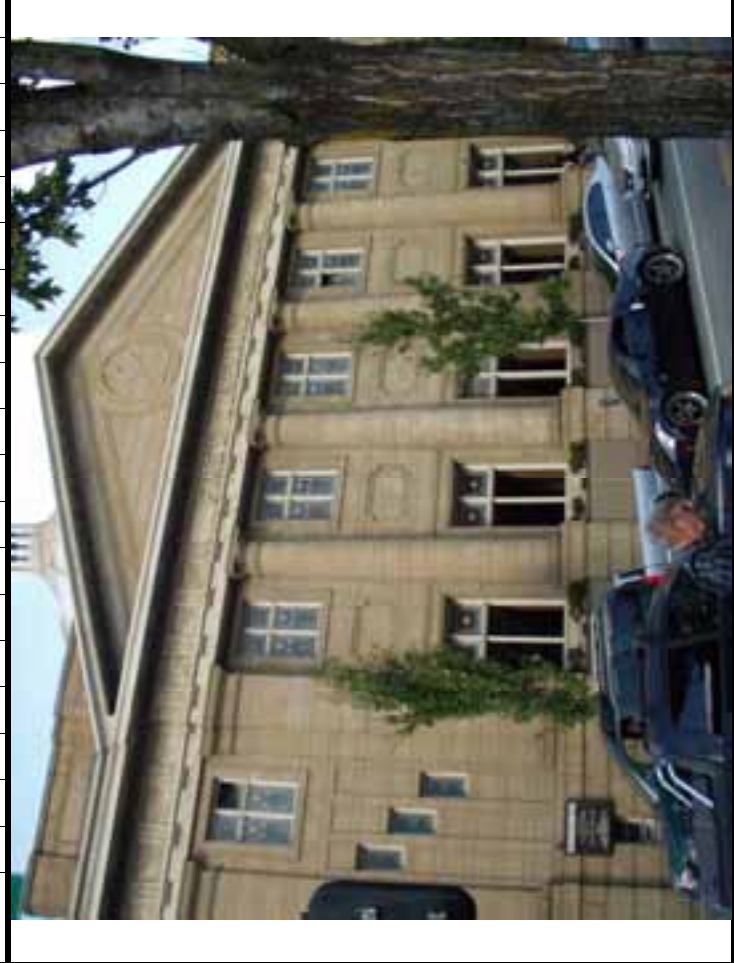
Address **400 E Pike St**
 District **Capitol Hill** Zip **98122**
 Other Identifiers **Tax roll: 1500 Bellevue Ave E**
 No. Stories **2** Year Built **1910**
 Inspector **ADF** Date **09.28.07**
 Total Floor Area (sq. ft) **24,600**
 Building Name **First Covenant Church**
 Use _____

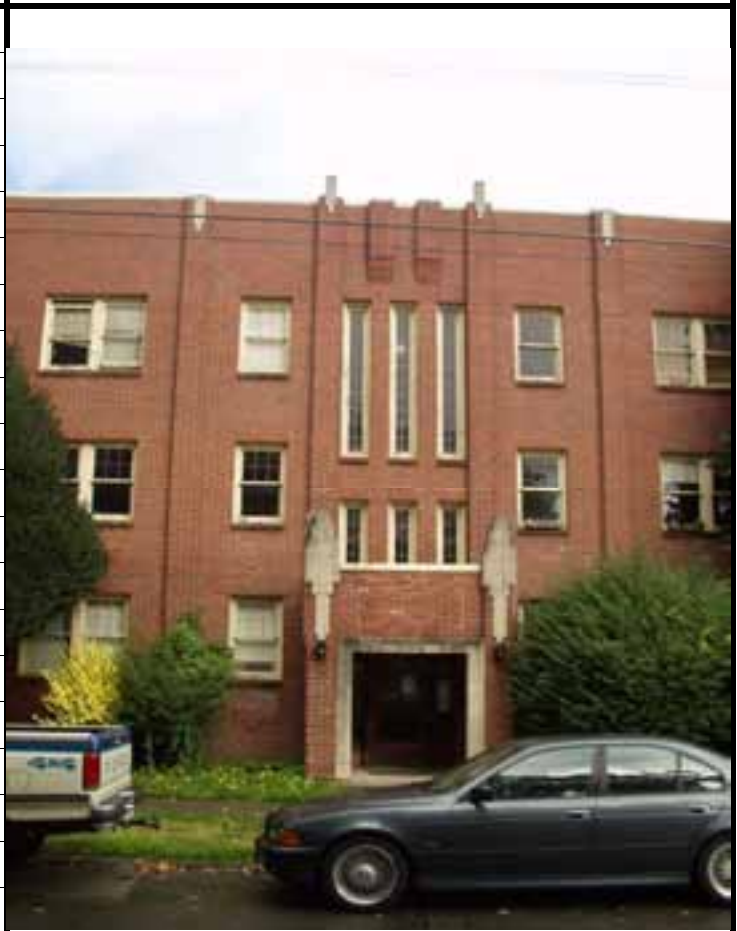
Address 448 NE Ravenna Blvd
 District Roosevelt Zip 98115
 Other Identifiers _____
 No. Stories 3+bsmt Year Built 1929
 Inspector ADF Date 09.28.07
 Total Floor Area (sq. ft) 12,060
 Building Name _____
 Use _____

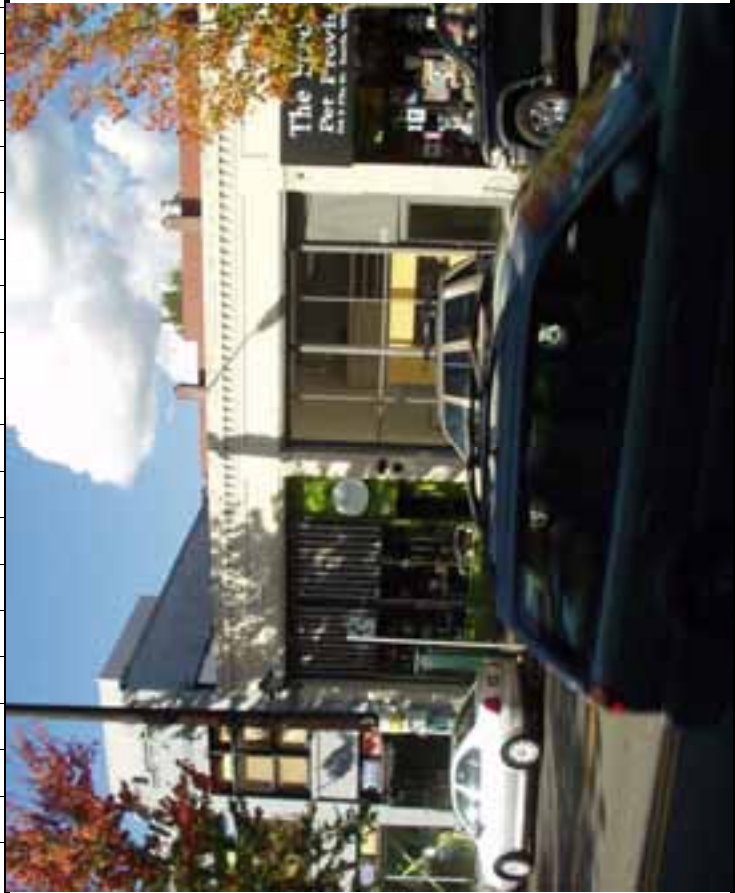
Address 512 to 518 E Pike St
 District Capitol Hill Zip 98122
 Other Identifiers _____
 No. Stories 1 Year Built 1926
 Inspector ADF Date 09.28.07
 Total Floor Area (sq. ft) 4,400
 Building Name _____
 Use _____

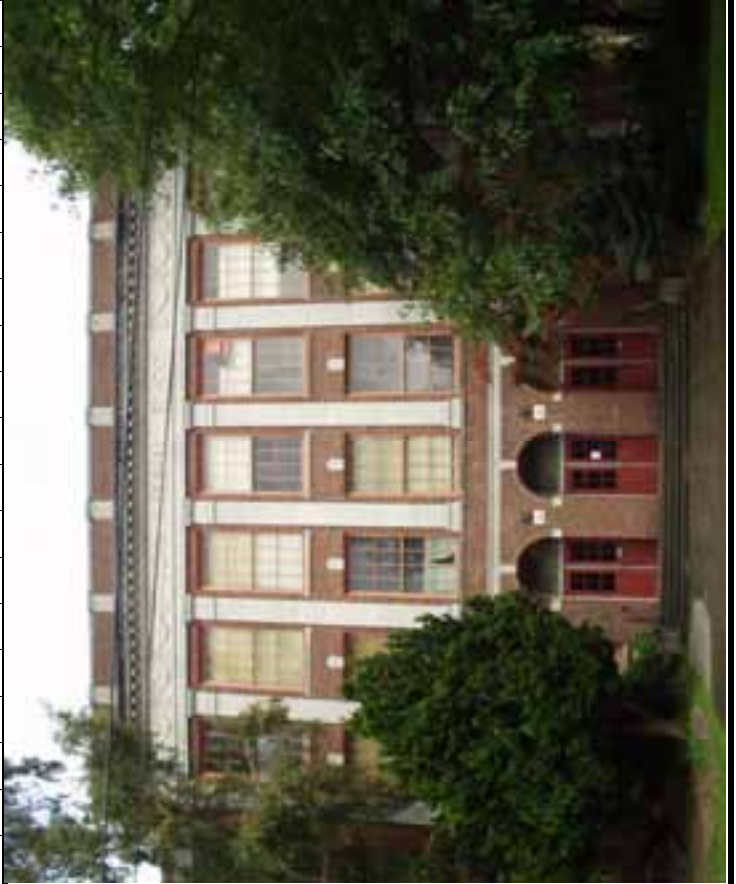
Address	520 NE Ravenna Blvd		
District	Roosevelt	Zip	98115
Other Identifiers			
No. Stories	3	Year Built	1946
Inspector	ADF	Date	09.28.07
Total Floor Area (sq. ft)	88,304		
Building Name	John Marshall School		
Use

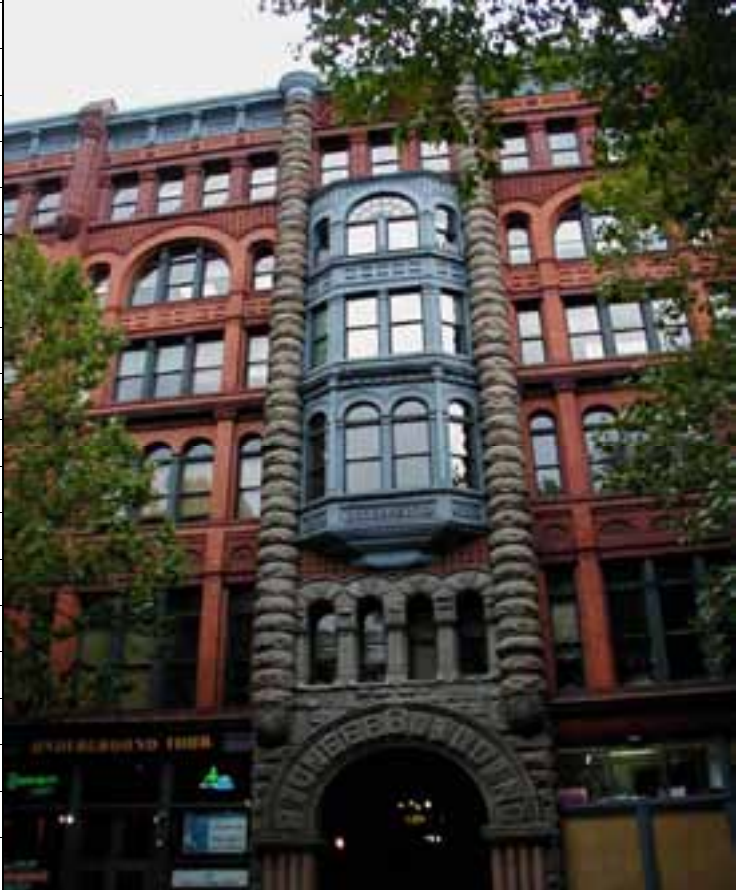
Address	600 to 608 1st Ave		
District	Downtown	Zip	98104
Other Identifiers			
No. Stories	6+bsmt	Year Built	1889
Inspector	ADF	Date	10.03.07
Total Floor Area (sq. ft)	89,000		
Building Name	Pioneer Building		
Use

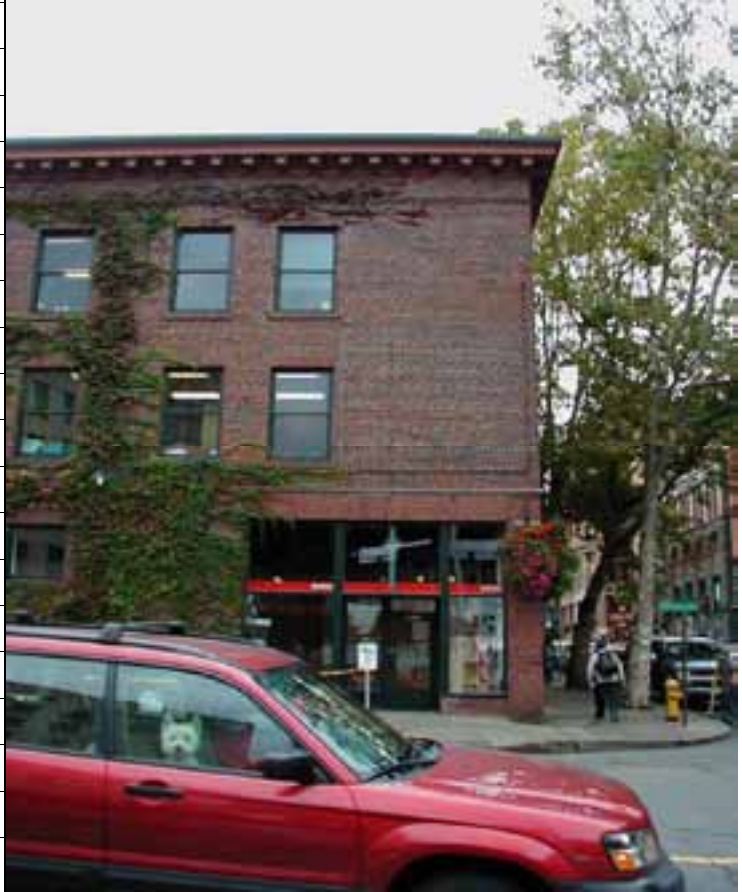
Address	600 Western Ave		
District	Downtown	Zip	98104
Other Identifiers			
No. Stories	3	Year Built	1913
Inspector	ADF	Date	10.03.07
Total Floor Area (sq. ft)	19,014		
Building Name			
Use

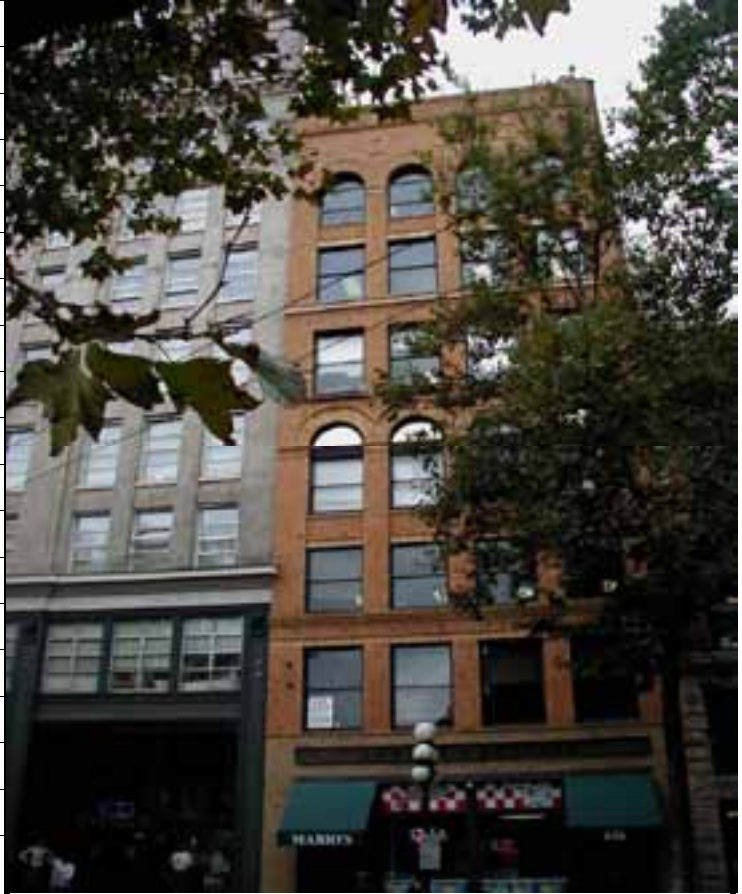
Address	616 1st Ave		
District	Downtown	Zip	98104
Other Identifiers			
No. Stories	7	Year Built	1889
Inspector	ADF	Date	10.03.07
Total Floor Area (sq. ft)	28,000		
Building Name			
Use

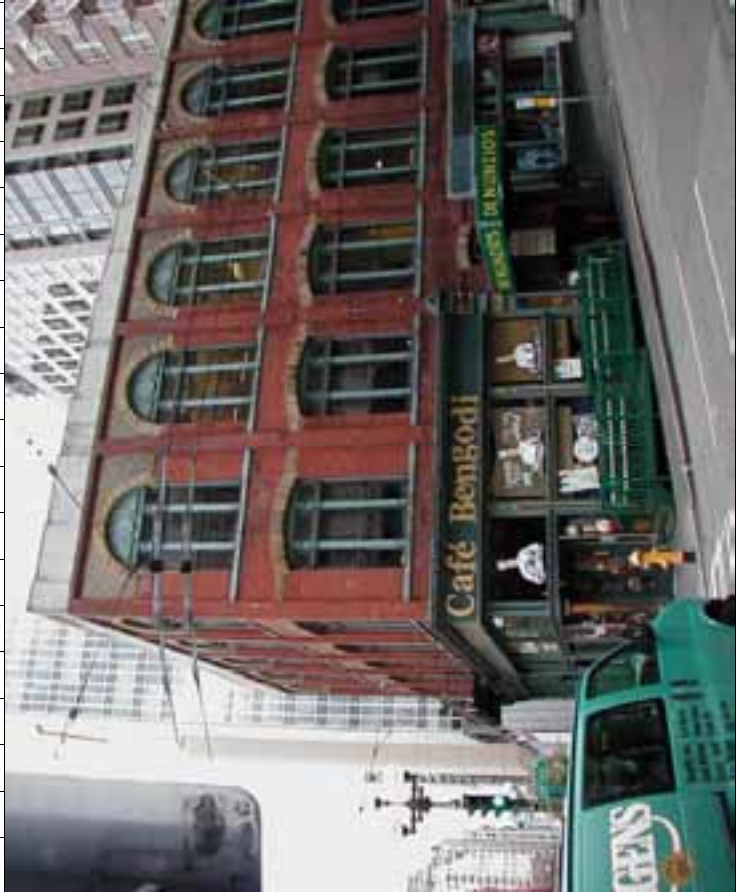
Address	700 to 704 1st Ave		
District	Downtown	Zip	98104
Other Identifiers			
No. Stories	3	Year Built	1903
Inspector	ADF	Date	10.03.07
Total Floor Area (sq. ft)	28,600		
Building Name			
Use

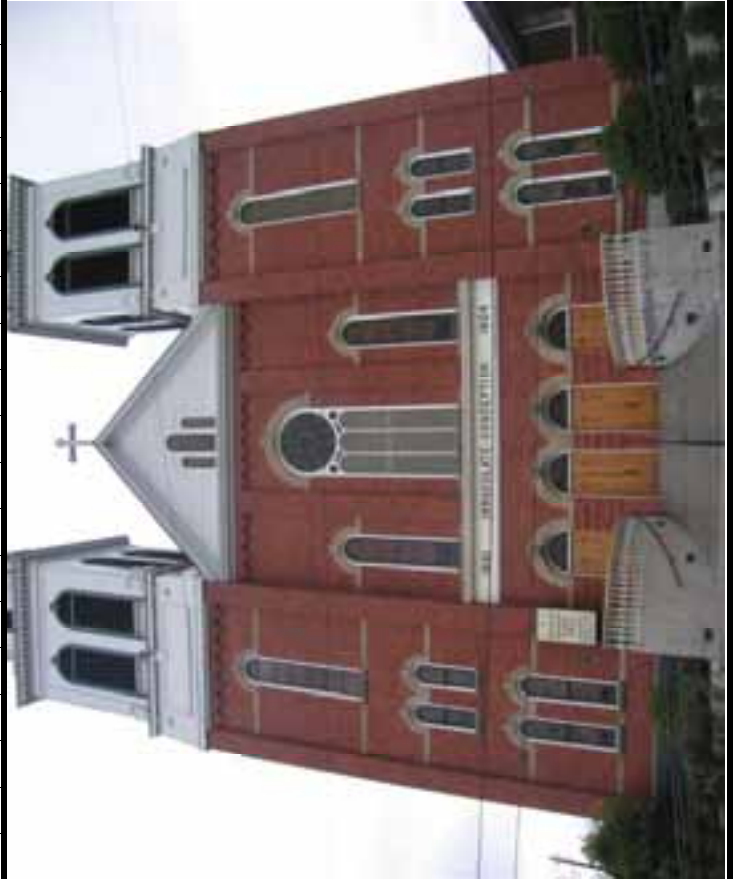
Address **800 18th Ave**
 District **Capitol Hill** Zip **98122**
 Other Identifiers
 No. Stories **1+bsmt** Year Built **1901**
 Inspector **KMB** Date **08.10.07**
 Total Floor Area (sq. ft) **26,500**
 Building Name **Immaculate Conception**
 Use

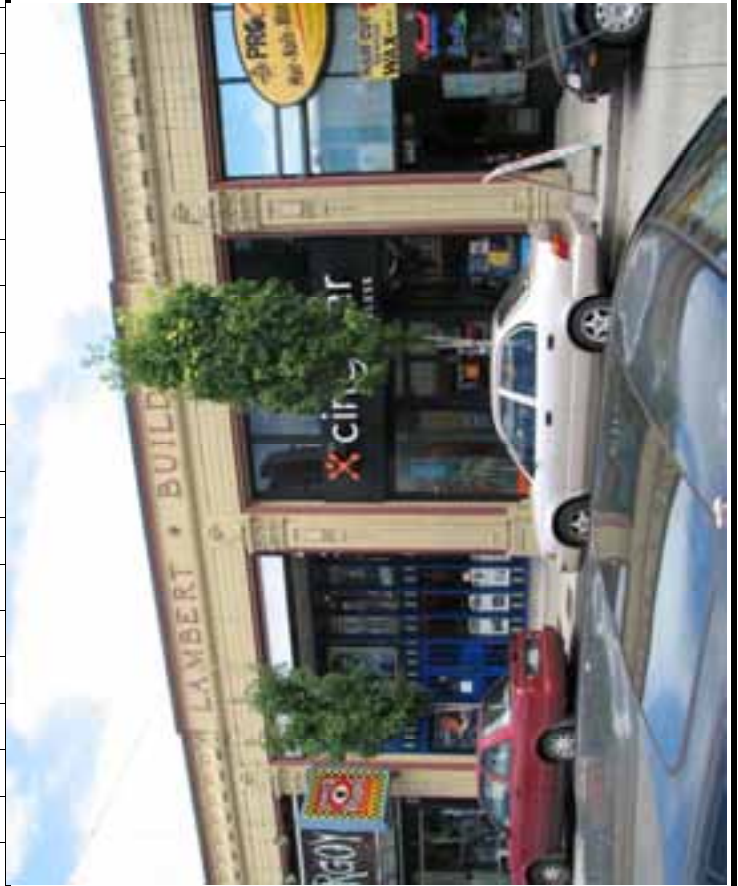
Address	4544 to 4550 University Way		
District	University	Zip	98105
Other Identifiers			
No. Stories	1	Year Built	1924
Inspector	KMB	Date	07.11.07
Total Floor Area (sq. ft)	8,080		
Building Name	Lambert Building		
Use

COMMENTS Poor condition in back of building	Detailed Evaluation Required? YES NO
---	--

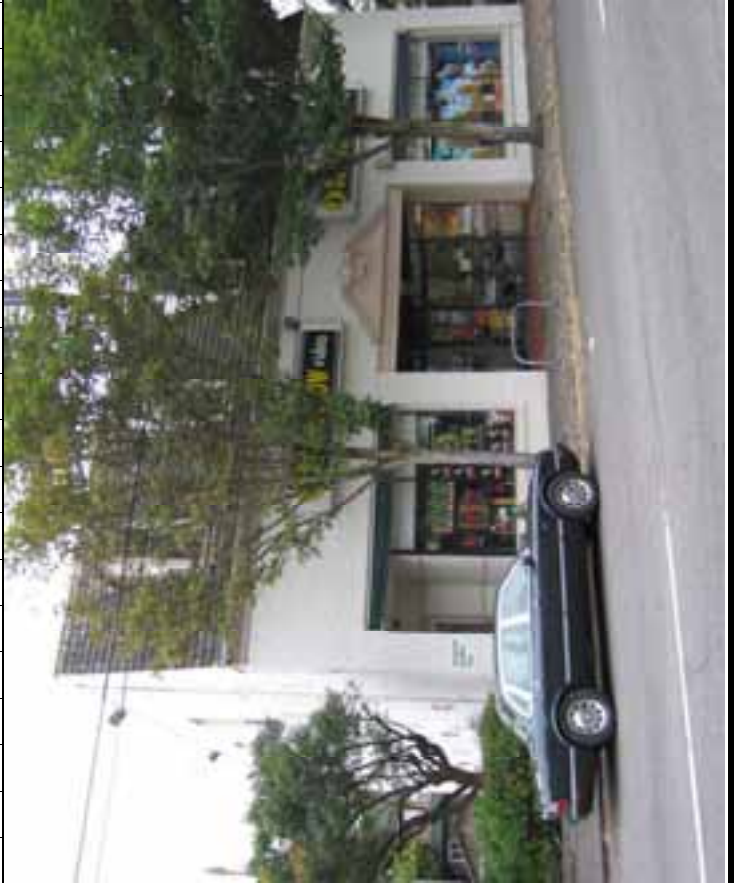
Address 5030 Roosevelt Way NE
 District University Zip 98115
 Other Identifiers _____
 No. Stories 2 Year Built 1937
 Inspector KMB Date 09.20.07
 Total Floor Area (sq. ft) 13,860
 Building Name Seavest Management
 Use _____

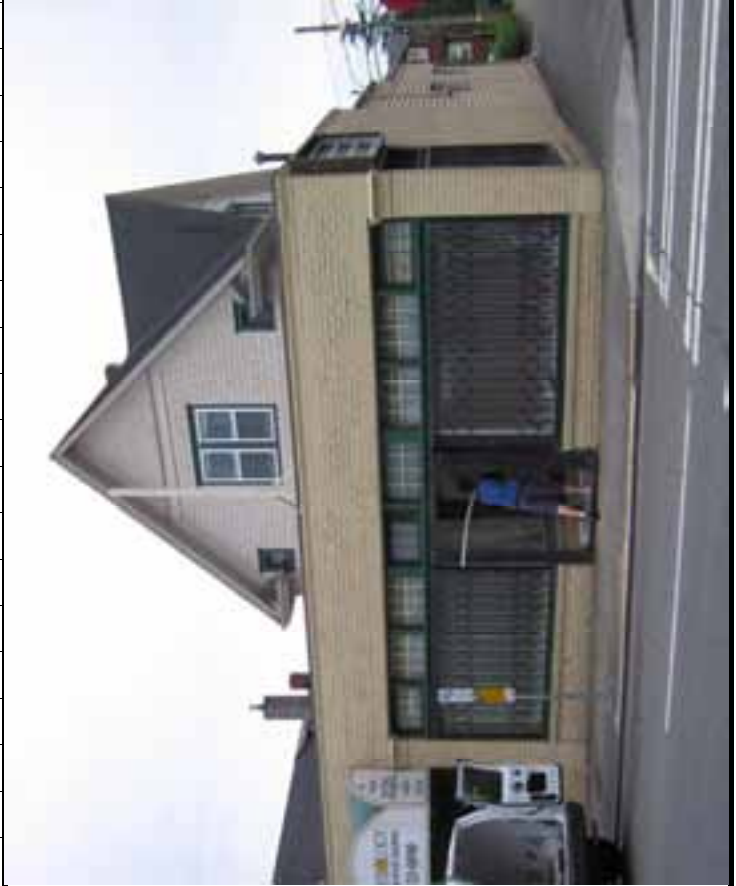
Address 6319 Roosevelt Way NE
 District University Zip 98115
 Other Identifiers _____
 No. Stories 1 Year Built 1925
 Inspector KMB Date 09.20.07
 Total Floor Area (sq. ft) 4,330
 Building Name The Landing Records
 Use _____

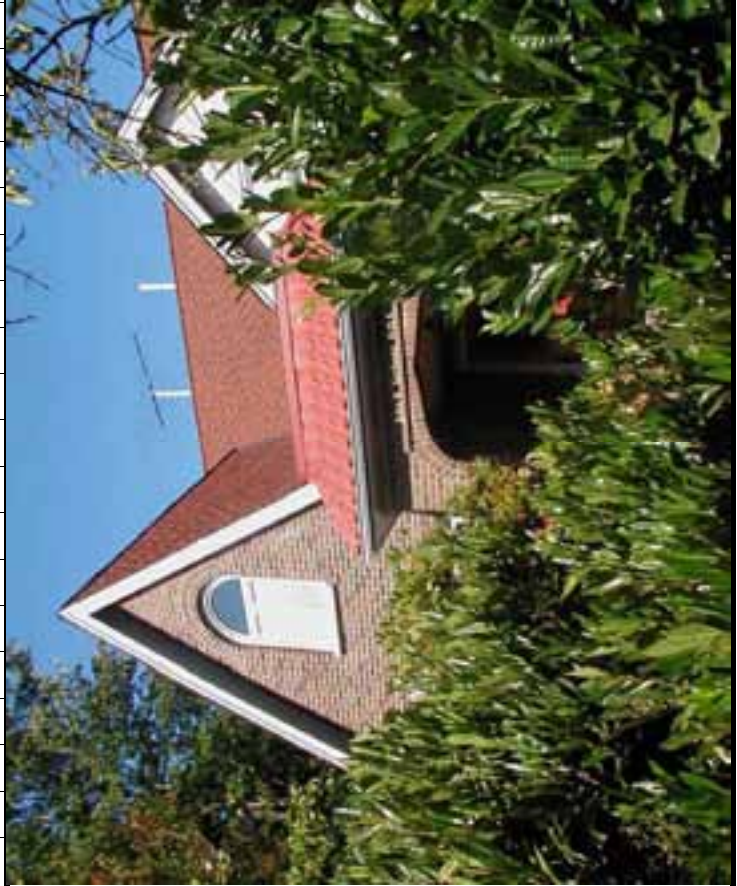
Address	12208 Greenwood Ave N	
District	North Seattle	Zip 98133
Other Identifiers		
No. Stories	2	Year Built 1928
Inspector	ADF	Date 07.12.07
Total Floor Area (sq. ft)	3,590	
Building Name		
Use	Dentist
