**SKAGIT RIVER GEOMORPHOLOGY BETWEEN GORGE DAM AND
THE SAUK RIVER STUDY INTERIM REPORT**

ATTACHMENT G

TRIBUTARY FISH PASSAGE ANALYSIS INVENTORY

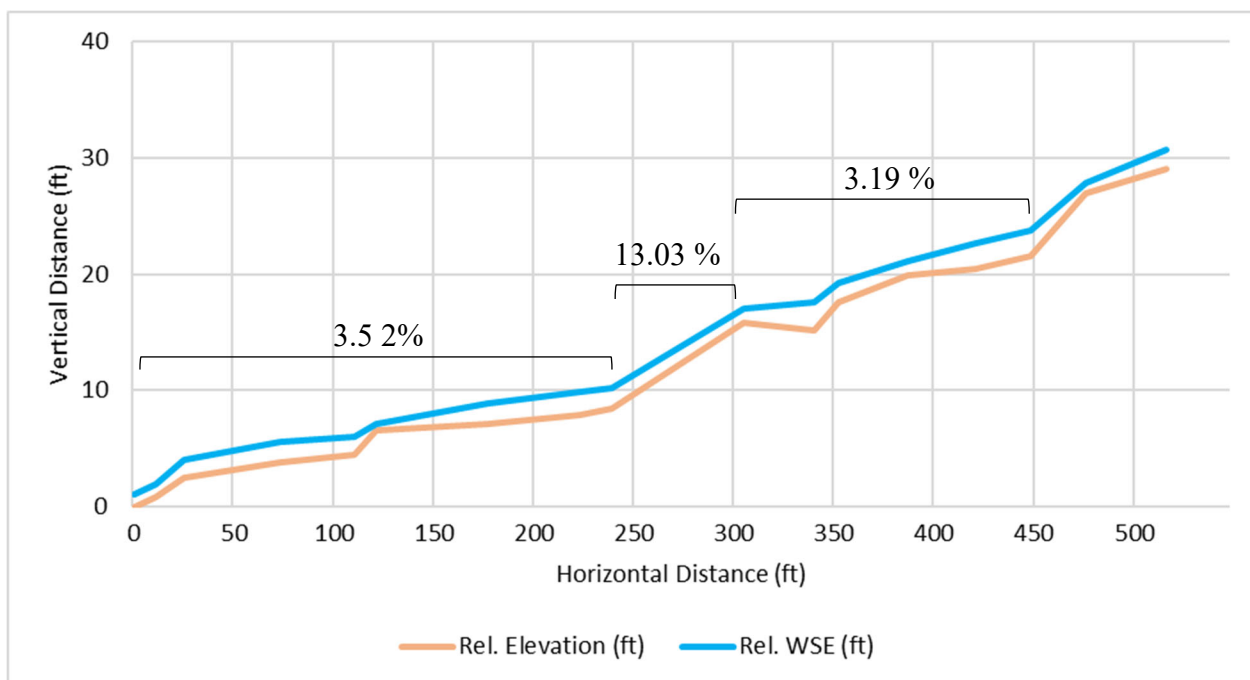
Alma Creek is characterized by a boulder cascade morphology with a predominantly cobble and boulder substrate (Figure G-1). The surveyed reach consisted predominantly of 3 percent grades with an average gradient of 5.25 percent and a wetted width of 5 ft. The average depth in the creek is 1.55 ft. The gradient is fairly consistent throughout the reach, with a series of pools between the boulder cascade sections (Figure G-2). The depth throughout the reach is also relatively consistent and there is no passage issue relative to water depth, although the gradient may be a challenge to some species (Figure G-3).

Figure G-2. Relative bed elevation and water surface elevation for Alma Creek from mouth upstream 500 linear ft.

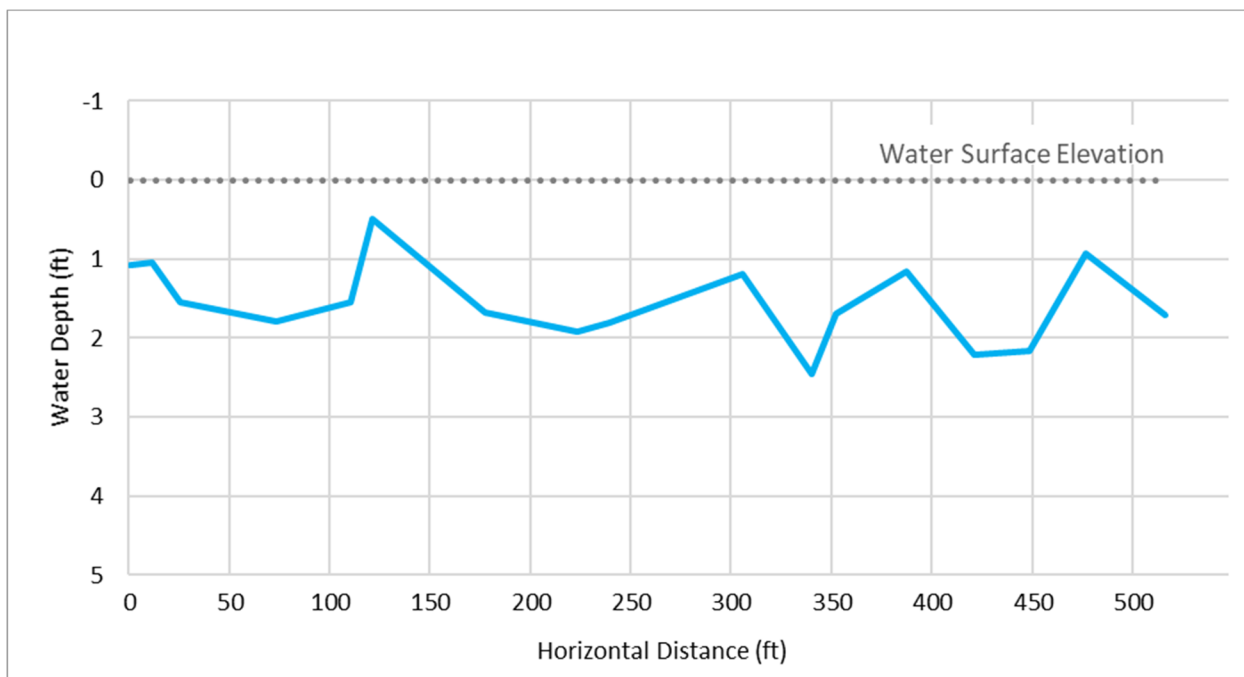
Figure G-3. Water depth profile for Alma Creek on August 3, 2021 from the mouth upstream 500 linear ft.

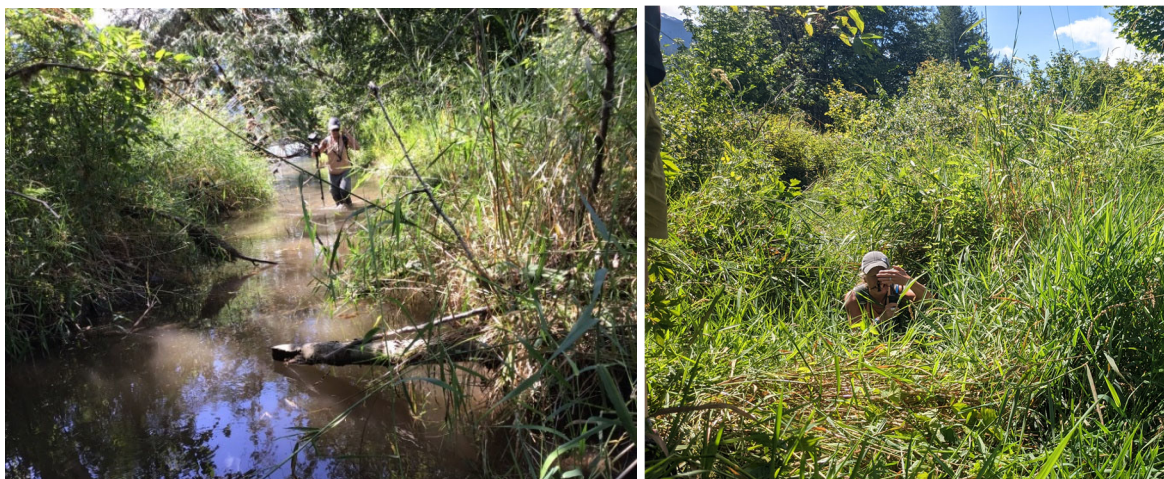
zone and the very low gradient in the lower section of the creek (Figure G-4 (left)). Based on the water depth profile and site observations, the culvert is causing scour and a plunge pool at its outlet (Figures G-5 and G-6). Approximately 304 ft upstream of the creek mouth, the stream disappears subsurface. Reed canary grass and blackberry are very dense along the stream and throughout the channel itself, preventing the survey of the entire 500 ft (Figure G-4 (right)). There is little tree canopy upstream of the culvert and the channel appears to be incised on the upstream end of the culvert by more than two vertical ft. Much of the water present below the culvert is backwatered from the Skagit River contributing to sandy substrate and a negative overall gradient of -0.21 percent throughout the reach.

Figure G-4. Babcock creek from channel center looking downstream near the mouth (left) and at survey end, approximately 300-ft upstream of the mouth (right).

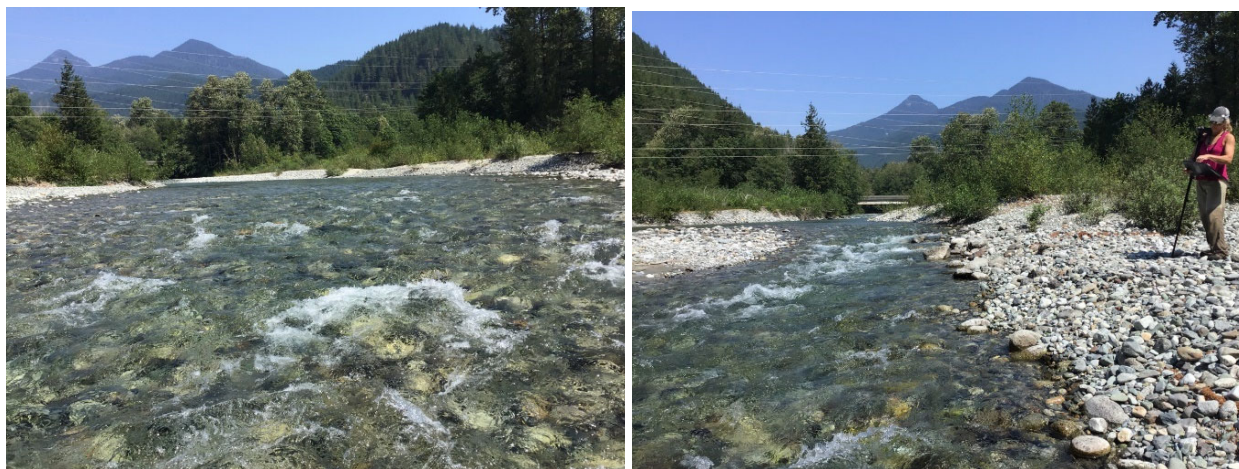
Figure G-7. Looking upstream at the primary (left) and secondary (right) mouths of Bacon Creek.

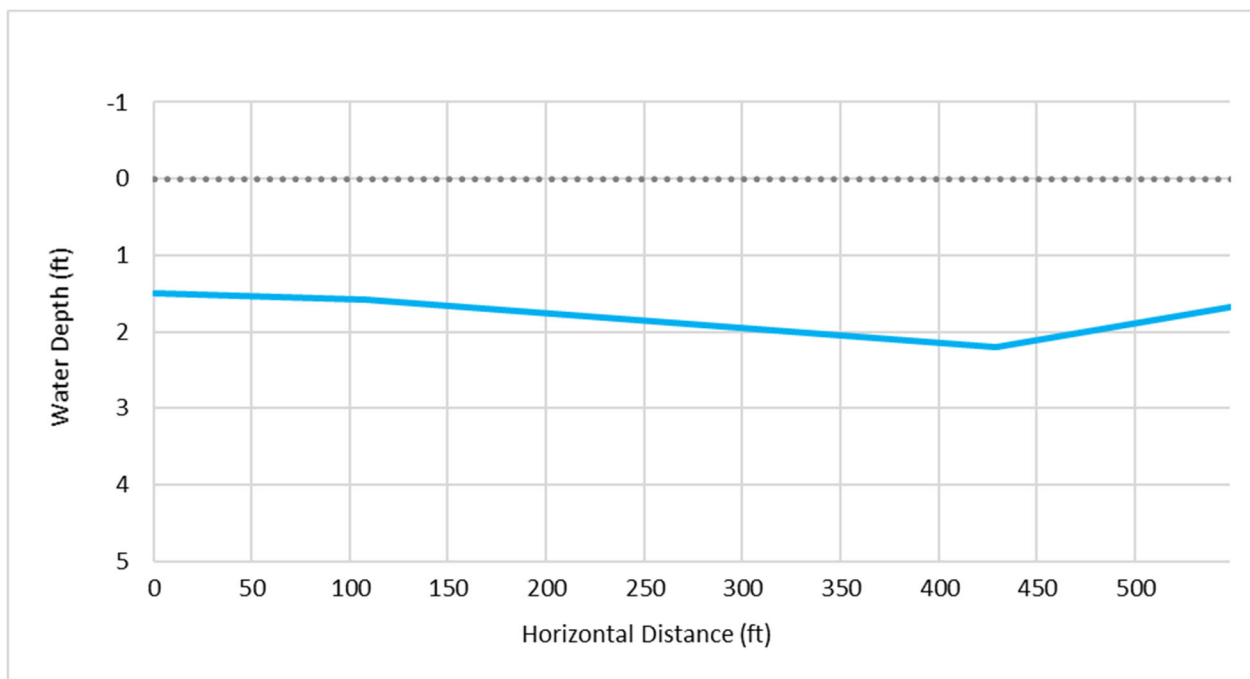
The mouth of Bacon Creek is a low gradient river with plane bed morphology. The average gradient throughout the surveyed reach is 1.17 percent and the average wetted width is 54 ft (Figure G-8). At the time of survey, the thalweg was too deep and swift to access and water depths were taken along left bank, where there was an average water depth of 1.69 ft (Figure G-9). Gradient and water depth remained fairly consistent throughout the reach with no significant pools.

Figure G-9. Water depth profile for Bacon Creek on August 4, 2021 from the mouth upstream 500 linear ft. (Water depth is taken from the bank and not representative of the true thalweg due to swift current).

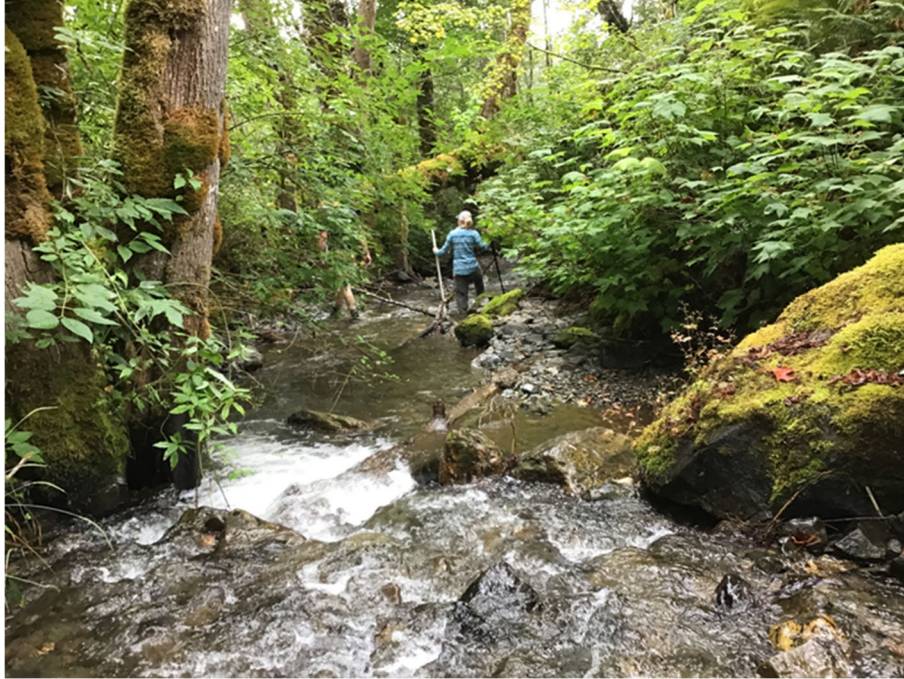
Figure G-10. Looking downstream approximately 300 ft upstream of the mouth of Barr Creek.

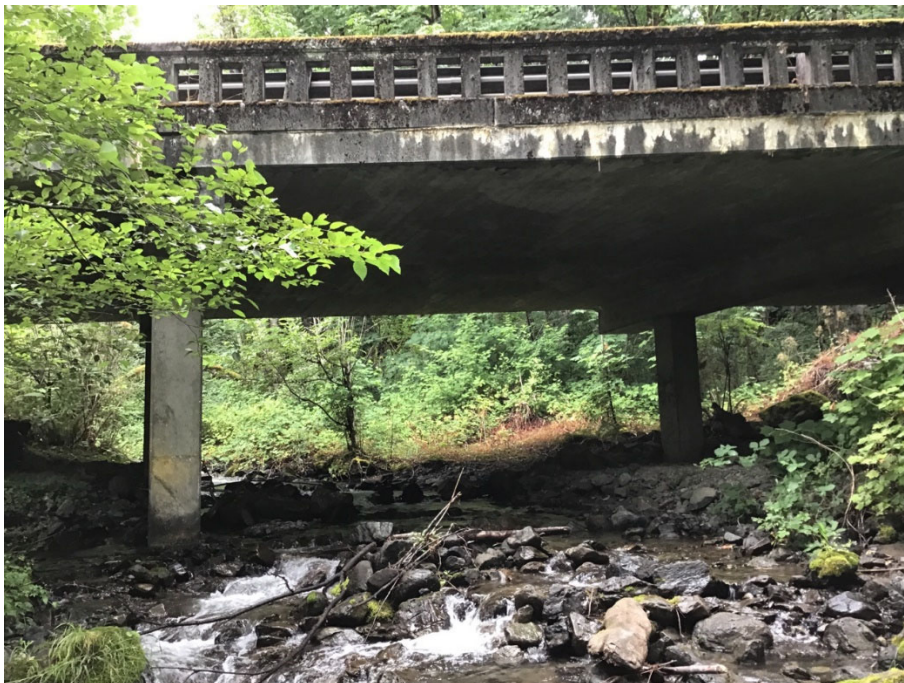
width of 15 ft throughout the survey reach (Figure G-10). There is a bridge across Barr Creek at 325 ft from the mouth (Figure G-11). The average water depth at time of field visit was 0.8 ft (Figures G-12 and G-13). The wetted width varied somewhat throughout the reach. Several small step pools occurred throughout the reach and in-stream complexity was present as forced by boulders and large woody material (Figure G-13).

Figure G-11. View of the bridge across Barr Creek.

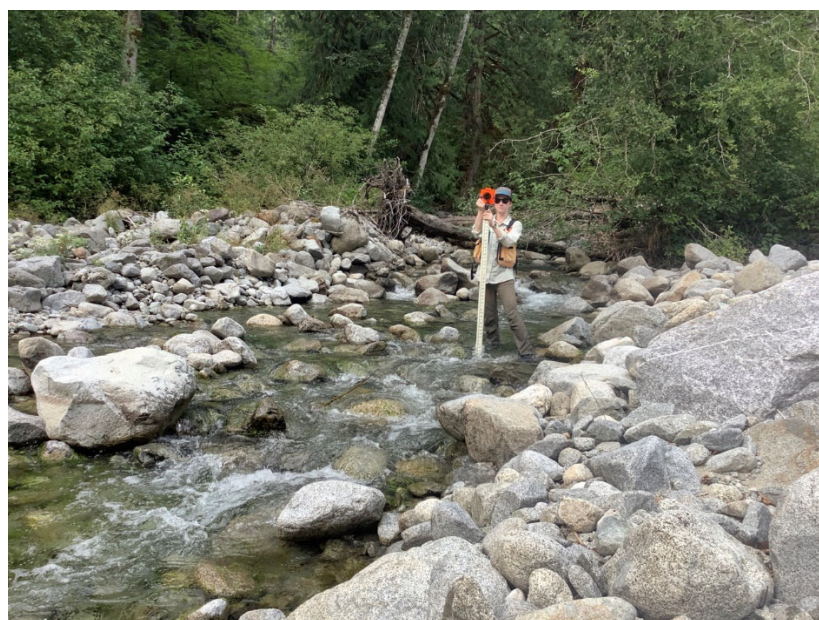
The mouth of Damnation Creek is characterized by a large, boulder dominated alluvial fan with several channels, many of which were dry at time of site visit (Figure G-21). The average gradient is 5.16 percent and the average wetted width is 20 ft throughout the survey reach (Figure G-22). The average water depth was 1.26 ft. Several boulder-forced pools exist throughout the reach (Figure G-23).

Figure G-21. Looking upstream from the mouth of Damnation Creek.

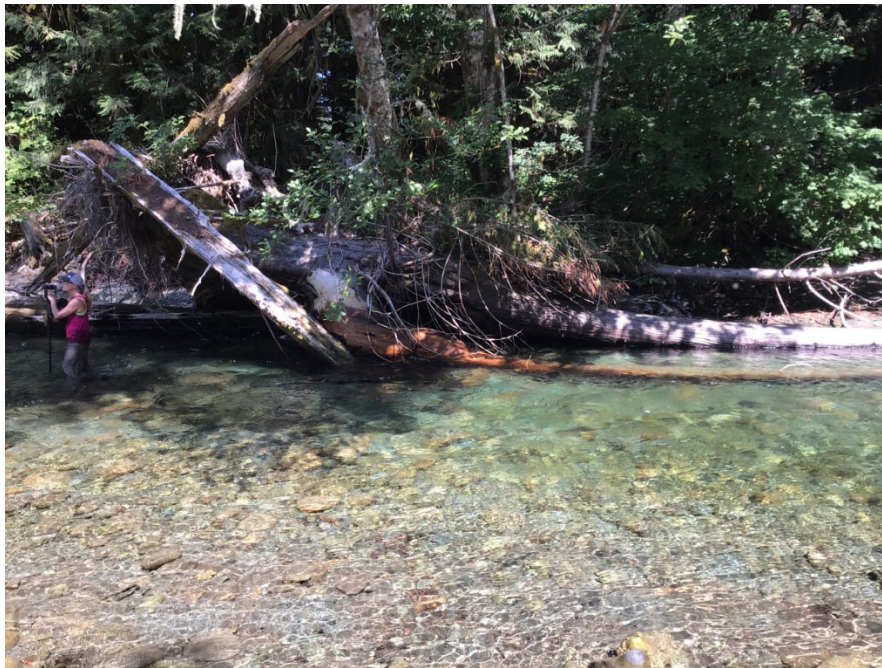
wetted width was 37 ft with an average water depth of 1.37 ft (Figure G-27). A long glide approximately 100 linear ft long with an approximate depth of 3.5 ft to 5 ft deep formed around several woody stems and their root wads along left bank (Figure G-25).

Figure G-25. A surveyor stands just upstream of the upper end of the 100-foot-long glide along left bank.

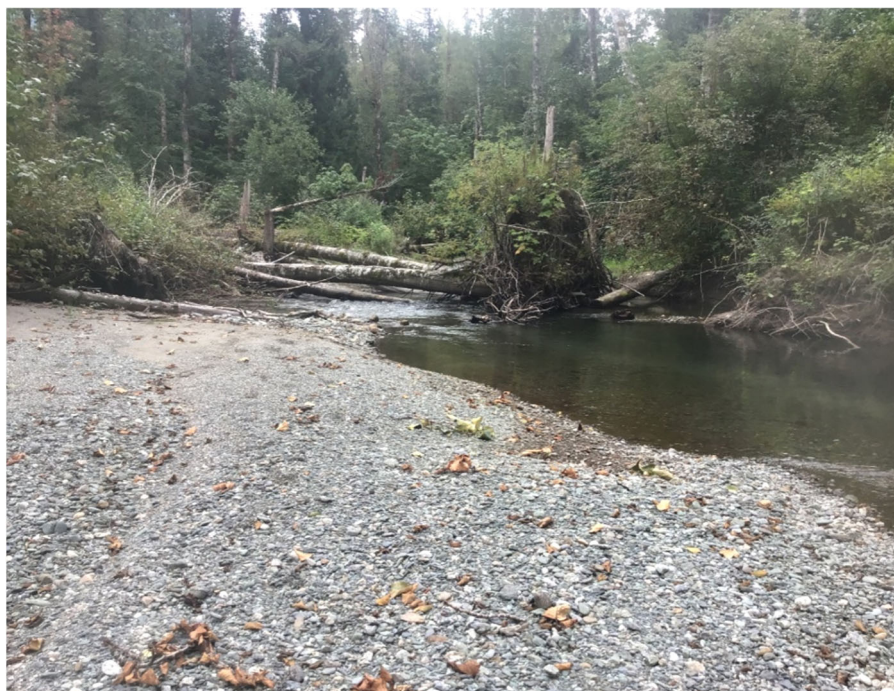
Illabot Creek flows into the larger Illabot Creek side channel complex before entering the Skagit River. The habitat in the creek includes a high level of complexity with multiple pool and riffle sequences and substantial large wood (Figure G-29). The average gradient is 2.93 percent (Figure G-30). The average wetted width was 17 ft and average water depth was 1.73 ft at time of survey with several large pools noted in the survey profile (Figure G-31).

Figure G-29. View of Illabot Creek from the bank.

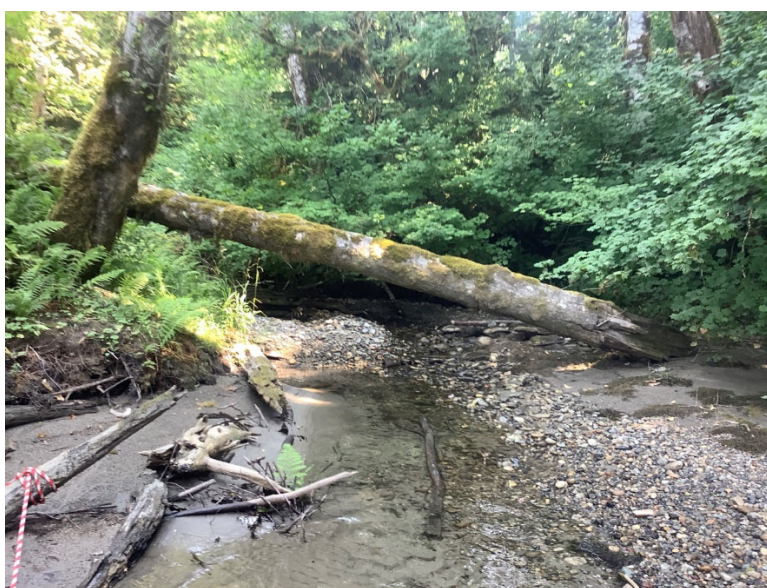
The mouth of Martin Creek is a low gradient drainage with predominantly sandy substrate in a dune-ripple morphology partially formed by the backwatering effect on the tributary as it meets the mainstem Skagit at the bend of a prominent meander (Figure G-35). The creek quickly transitions into a gravel-dominated channel bed of pool-riffle morphology, retaining a low gradient profile with an average slope of 0.86 percent (Figure G-36). At the time of field visit, the average wetted width was 9 ft and average water depth was 0.53 ft (Figure G-37).

Figure G-35. Looking upstream at creek center at the mouth of Martin Creek.

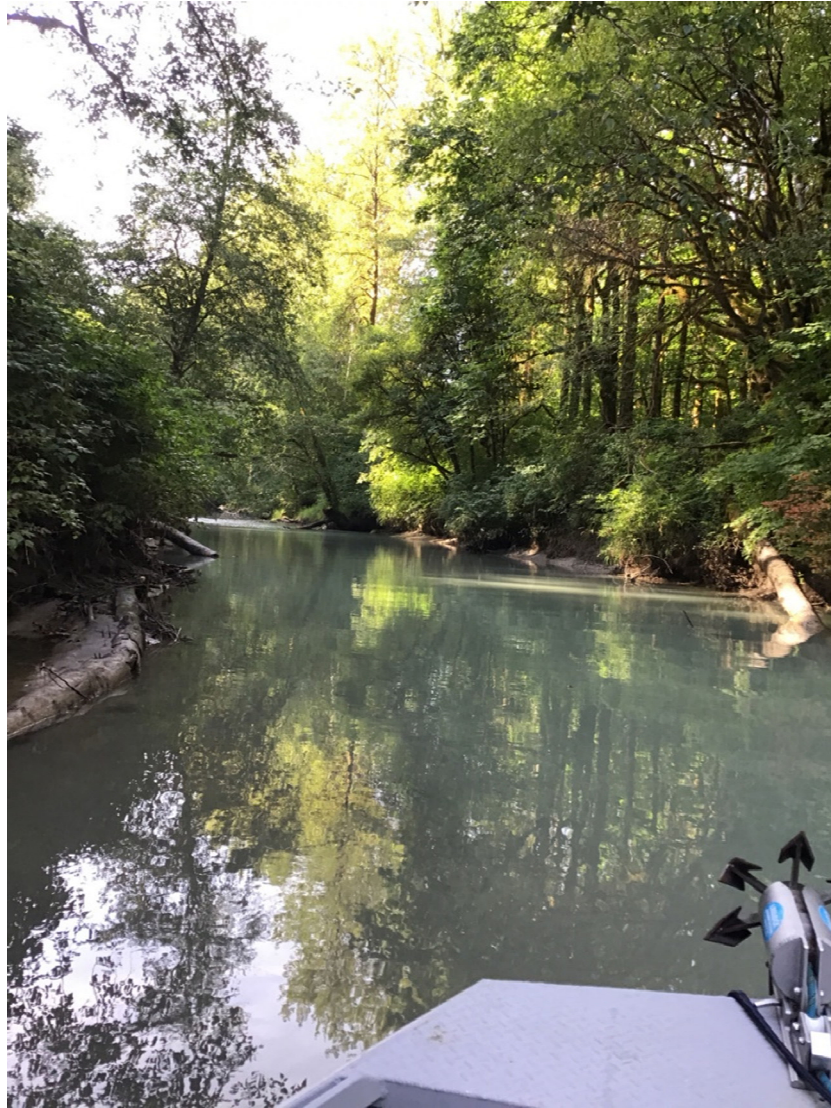
The Napoleon Side Channel is a low gradient channel that predominantly moves water from the Sauk River, not the Skagit, before funneling into the mainstem Skagit River (Figure G-38).

Figure G-38. Looking upstream at creek center at the mouth of Napoleon Side Channel.

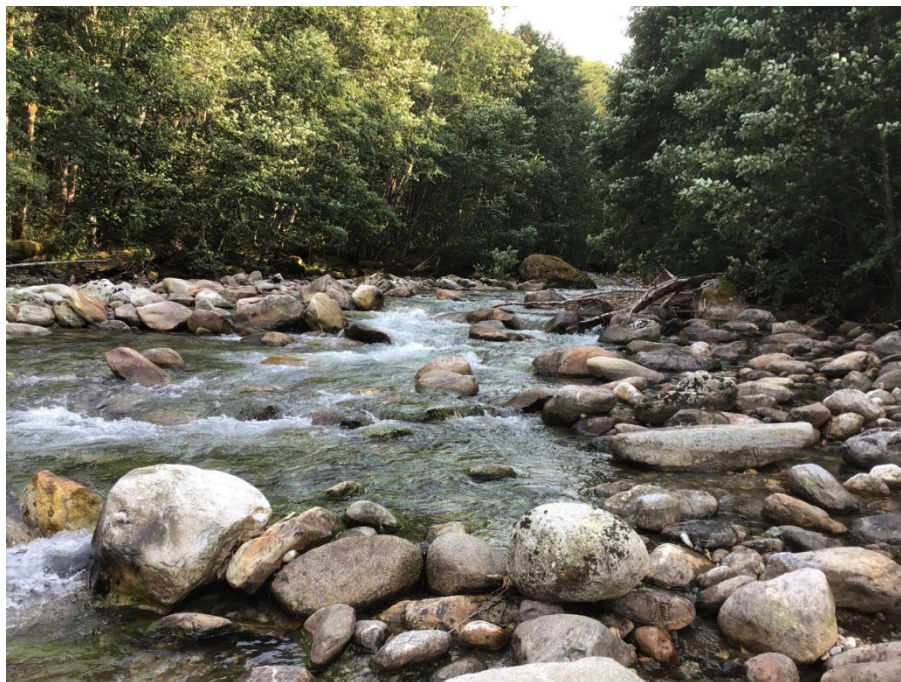
Newhalem Creek is characterized by cobble and boulder dominated substrate with two channel mouths (Figure G-41). Both channels were flowing with approximate water depths of 1.5 ft during

Figure G-41. Looking upstream at the mouth of Newhalem Creek.

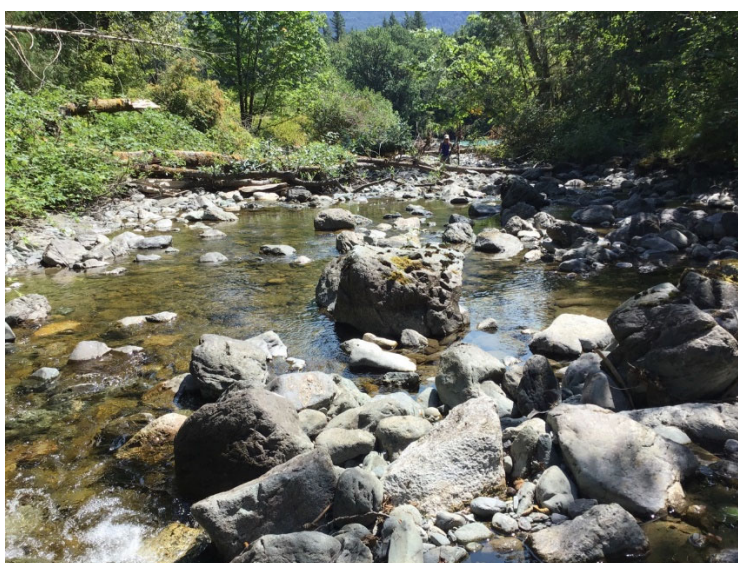
The mouth of Rocky Creek is characterized by a boulder dominated substrate (Figure G-47). The average slope is 2.83 percent, with the dominant grade being between 1.5 and 2.0 percent for the majority of the reach (Figure G-48). At the time of the field visit, the average wetted width was 19 ft and the average water depth was 0.75 ft (Figure G-49). Conditions remained consistent throughout the entire surveyed reach, with a small pool of about 1.3 ft deep occurring at about 300 ft upstream from the mouth.

Figure G-47. Stream center looking downstream in Rocky Creek.

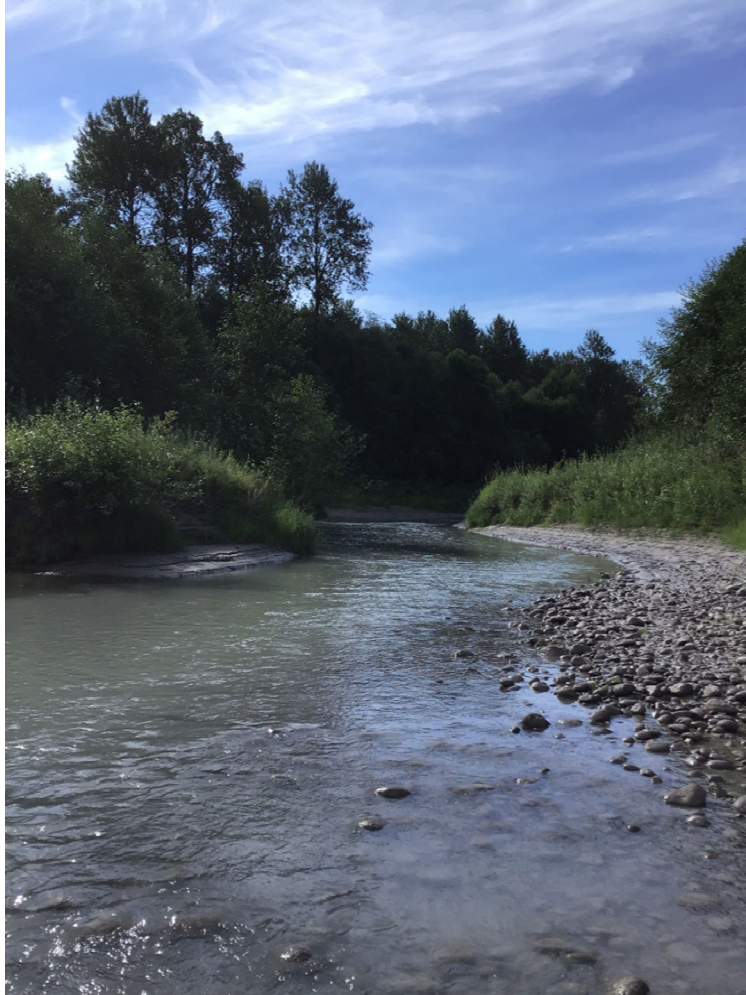
Sauk Side Channel 1 is a low gradient channel that predominantly moves water from the Sauk River, not the Skagit, before funneling into the mainstem Skagit River (Figure G-50). Therefore,

Figure G-50. Standing at the mouth of Sauk Side Channel 1, along left bank, looking upstream.

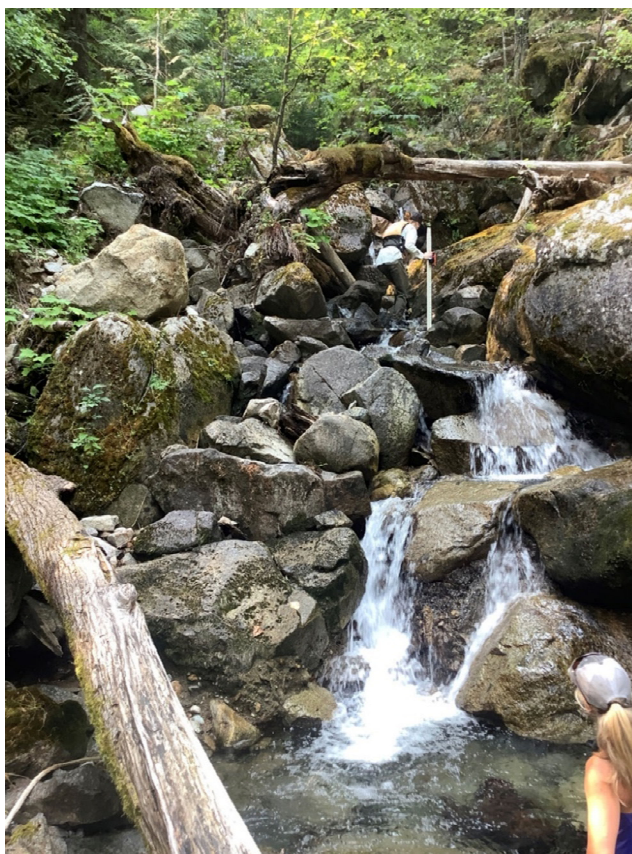
drop occurred at 2.9 ft tall. Drop heights increased and grade steepened until the survey was concluded at a hydraulic drop of 13.5 ft at 275 linear ft upstream from the mouth of the creek (Figure G-54). This drop meets the criteria for a total fish barrier (WDFW 2019). Leading up to this point, minimal pool habitat exists between drops, which precludes a fish's ability to orient its body sufficiently to prepare for a leap or give it opportunity for rest. Therefore, fish use likely concludes approximately 200 ft downstream (Figure G-55). An average width was not measured at this location but was estimated to be 9-ft. Average water depth was 0.90 ft at time of survey (Figure G-56).

Figure G-54. Looking upstream at hydraulic drop, which constituted a total fish barrier at 275 ft upstream of mouth.

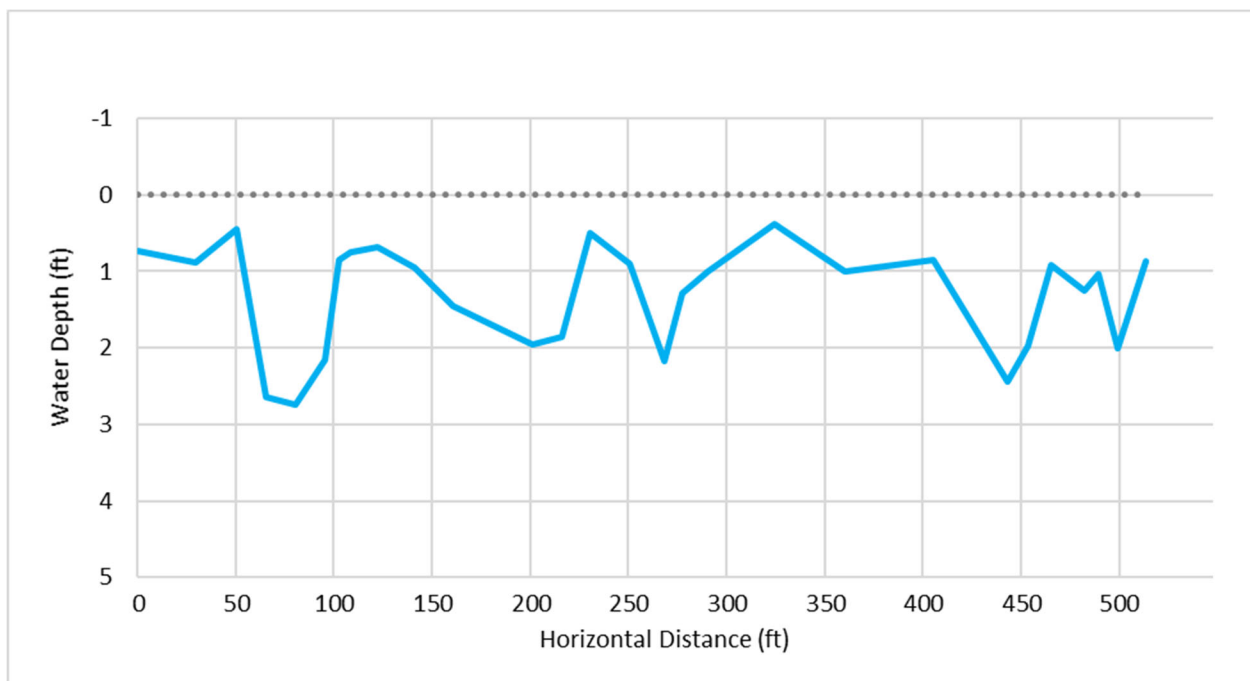
Figure G-63. Water depth profile for Thornton Creek on August 3, 2021 from the mouth upstream 500 linear ft.

boulder dominated (Figure G-61). At approximately 150 ft upstream from the mouth, the stream crossed beneath a bridge under State Rt. 20. Shortly upstream of the bridge, the channel splits around a small island and then rejoins about 100 ft later. The right bank split appeared to be the primary flow path and was the reach that was surveyed. The average stream gradient was fairly consistent at 2.67 percent throughout the surveyed reach (Figure G-62). At time of field visit, the average channel width was 33 ft and the average water depth was 1.31 ft (Figure G-63).

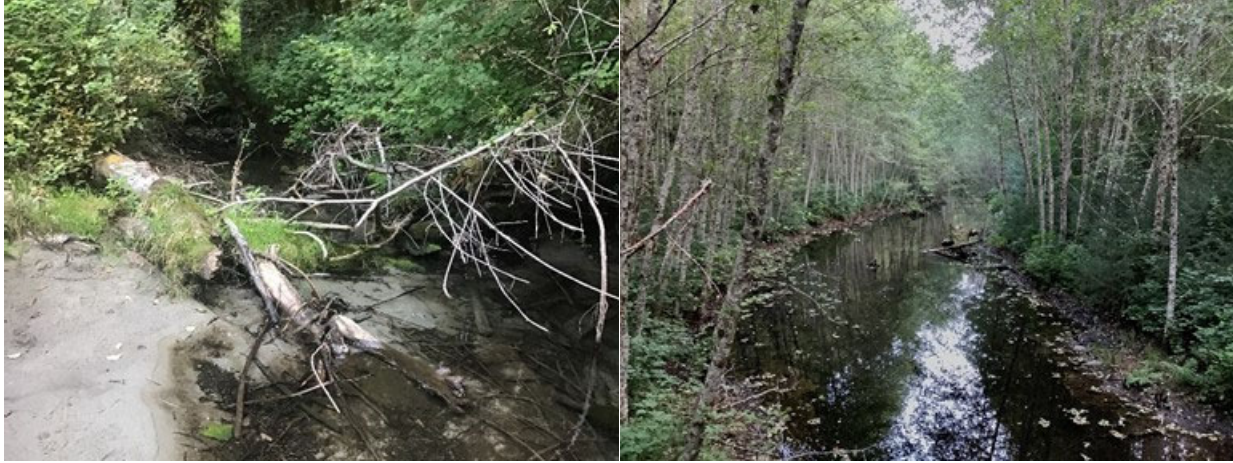
The final channel in Reach 5A is the Taylor Side Channel at PRM 80. The Taylor Side Channel is a blind spawning channel constructed in the 1990s. The channel is perennial and ground water fed as evidenced by a subsurface inlet and is a cold water refugia in the summer. During the August 2021 survey the channel was noticeably colder to the touch than the mainstem. The lower section of Taylor also has several log jams and two beaver dams creating 2+ ft deep pools, and the upper section was consistently 1.5-3 ft deep during August. The cold water refuge, protected slow water, and fish cover provide juvenile salmonid rearing habitat (Figure H-5). Spawning habitat in Taylor is still functional in some locations. In the lower section of the channel contains a large section of spawning sized gravels near the outlet and the upper half of the channel likely still functions for spawning to some degree. There is deposition of a veneer of fine sediment of placed spawning gravels, but patches with clean gravels are still present.

Figure H-5. Taylor Side Channel. Left photo (facing upstream) is in the lower section of the channel showing cover from wood and overhanging vegetation. Right photo is the upper section (facing downstream) as viewed from the foot bridge.

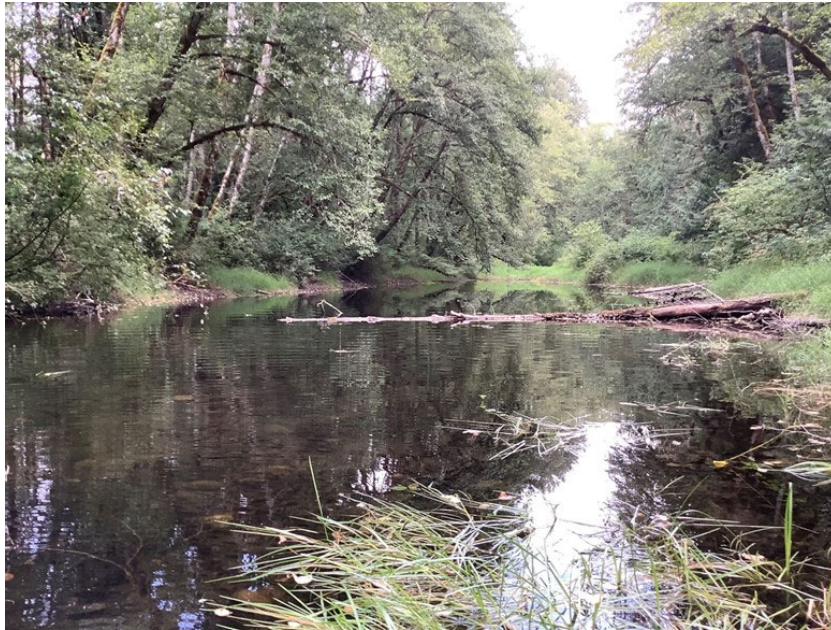
Along the same meander as the high flow side channel is another side channel, Marblegate Slough, on the left bank at PRM 77. Marblegate Slough is a partially relict side channel that in present day is only active in the downstream portion of the channel. The active portion consists of a series of large pools with gravel beds overlain with fines (Figure H6). During the August 2021 survey the pools were isolated and not connected to river. Water appears to backwater from the river at higher

Figure H-6. Isolated pool (looking upstream) in lower section of Marblegate Slough, Reach 5B.
