**GE-01 RESERVOIR SHORELINE EROSION STUDY  
INTERIM REPORT**

**SKAGIT RIVER HYDROELECTRIC PROJECT  
FERC NO. 553**

**Seattle City Light**

**March 2022  
Initial Study Report**

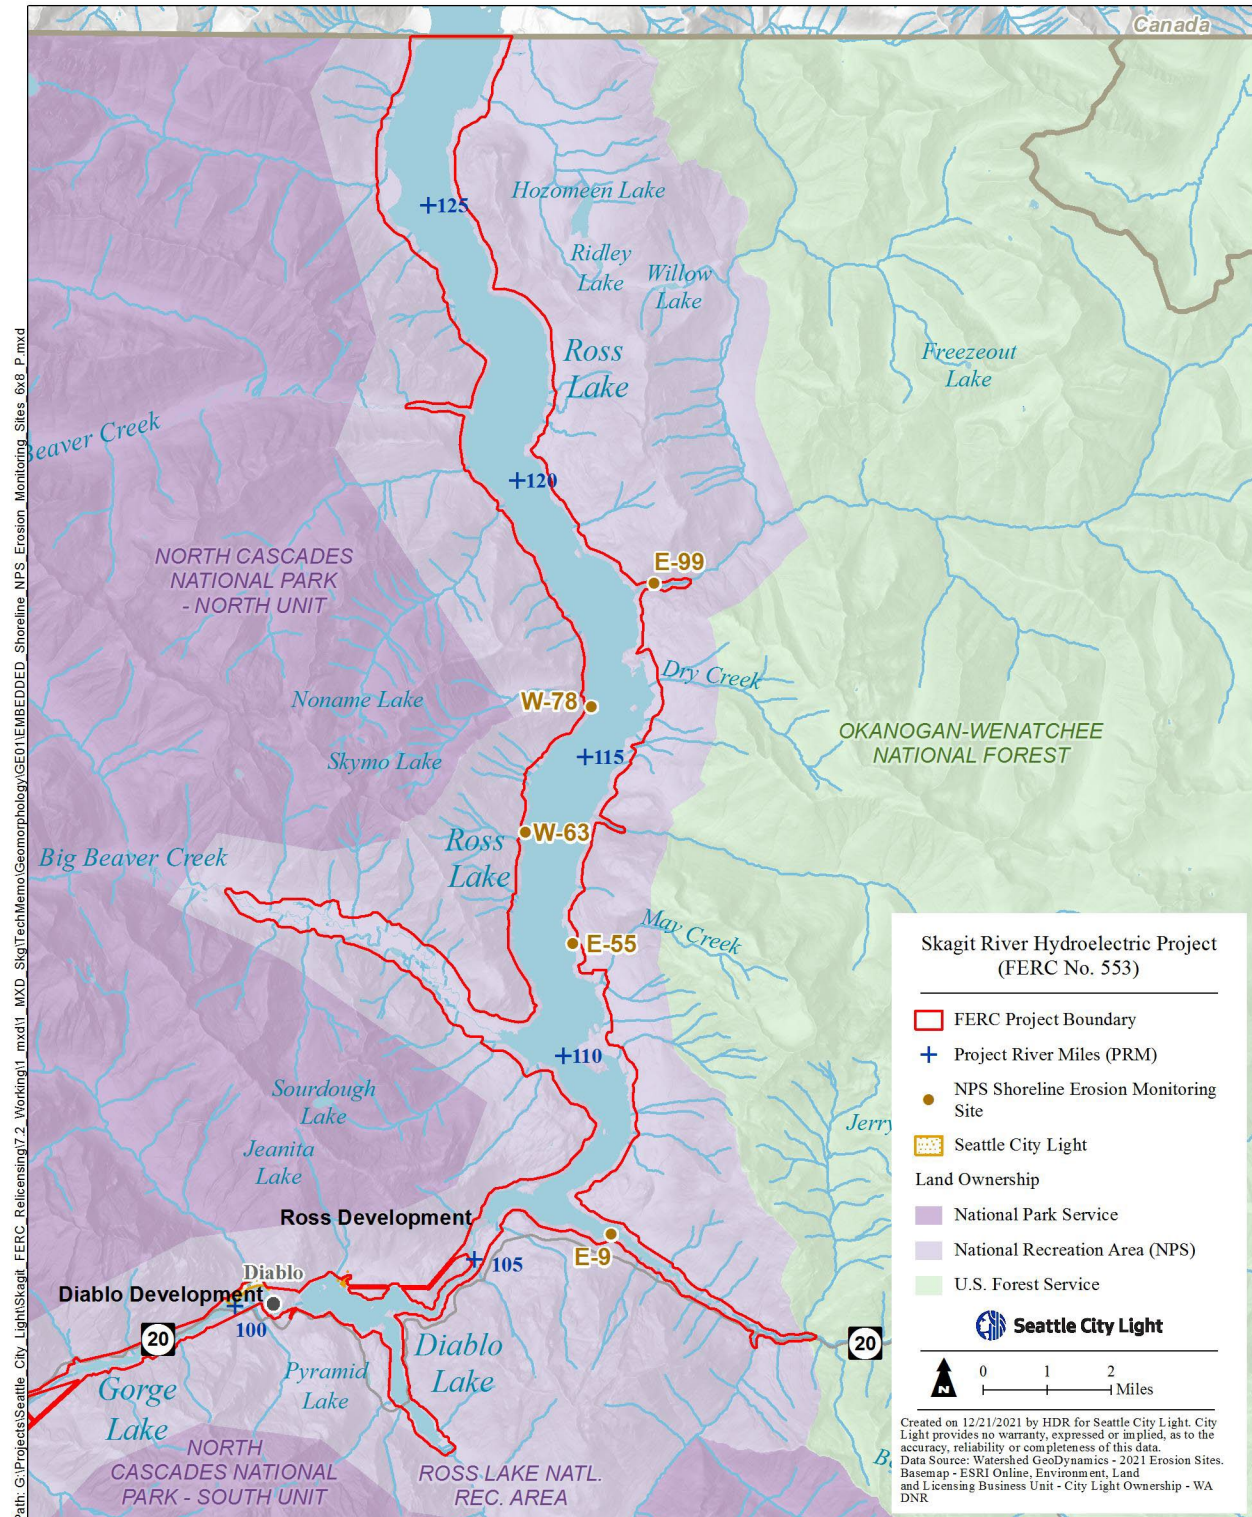
**Figure 4.3-1. NPS reservoir erosion monitoring locations.**

NPS has been measuring bank retreat in the field at five locations by measuring the distance between ground stakes and the edge of the bank. Measurements have been made in 1994, 1998, 2000, 2008, 2015, 2018, and 2021 (Figure 4.3-1; NPS 2020). NPS selected these locations to represent different underlying soil conditions, sides of the reservoir, and bank heights (Riedel 2021).

NPS has monitored five 1990 Class I bank erosion sites (22 total transects) in Ross Lake as part of the Erosion Control Plan (Ebasco Environmental and NPS 1990; and Figure 4.3-1 in Section 4.3 in this study report). The 1990 Class I sites were assumed to have the highest erosion rates compared to Class II or III sites. The most recent monitoring occurred in 2018. Each of the five sites monitored has a different rate of erosion because of varying bank material, aspect, and slope (NPS 2020; Figure 5.4-1). The site designations in Figure 5.4-1 refer to the 1990 erosion site numbers as shown on the map in Figure 4.3-1 and the maps in Attachment B. The E and W represent the east and west side of Ross Lake, respectively.

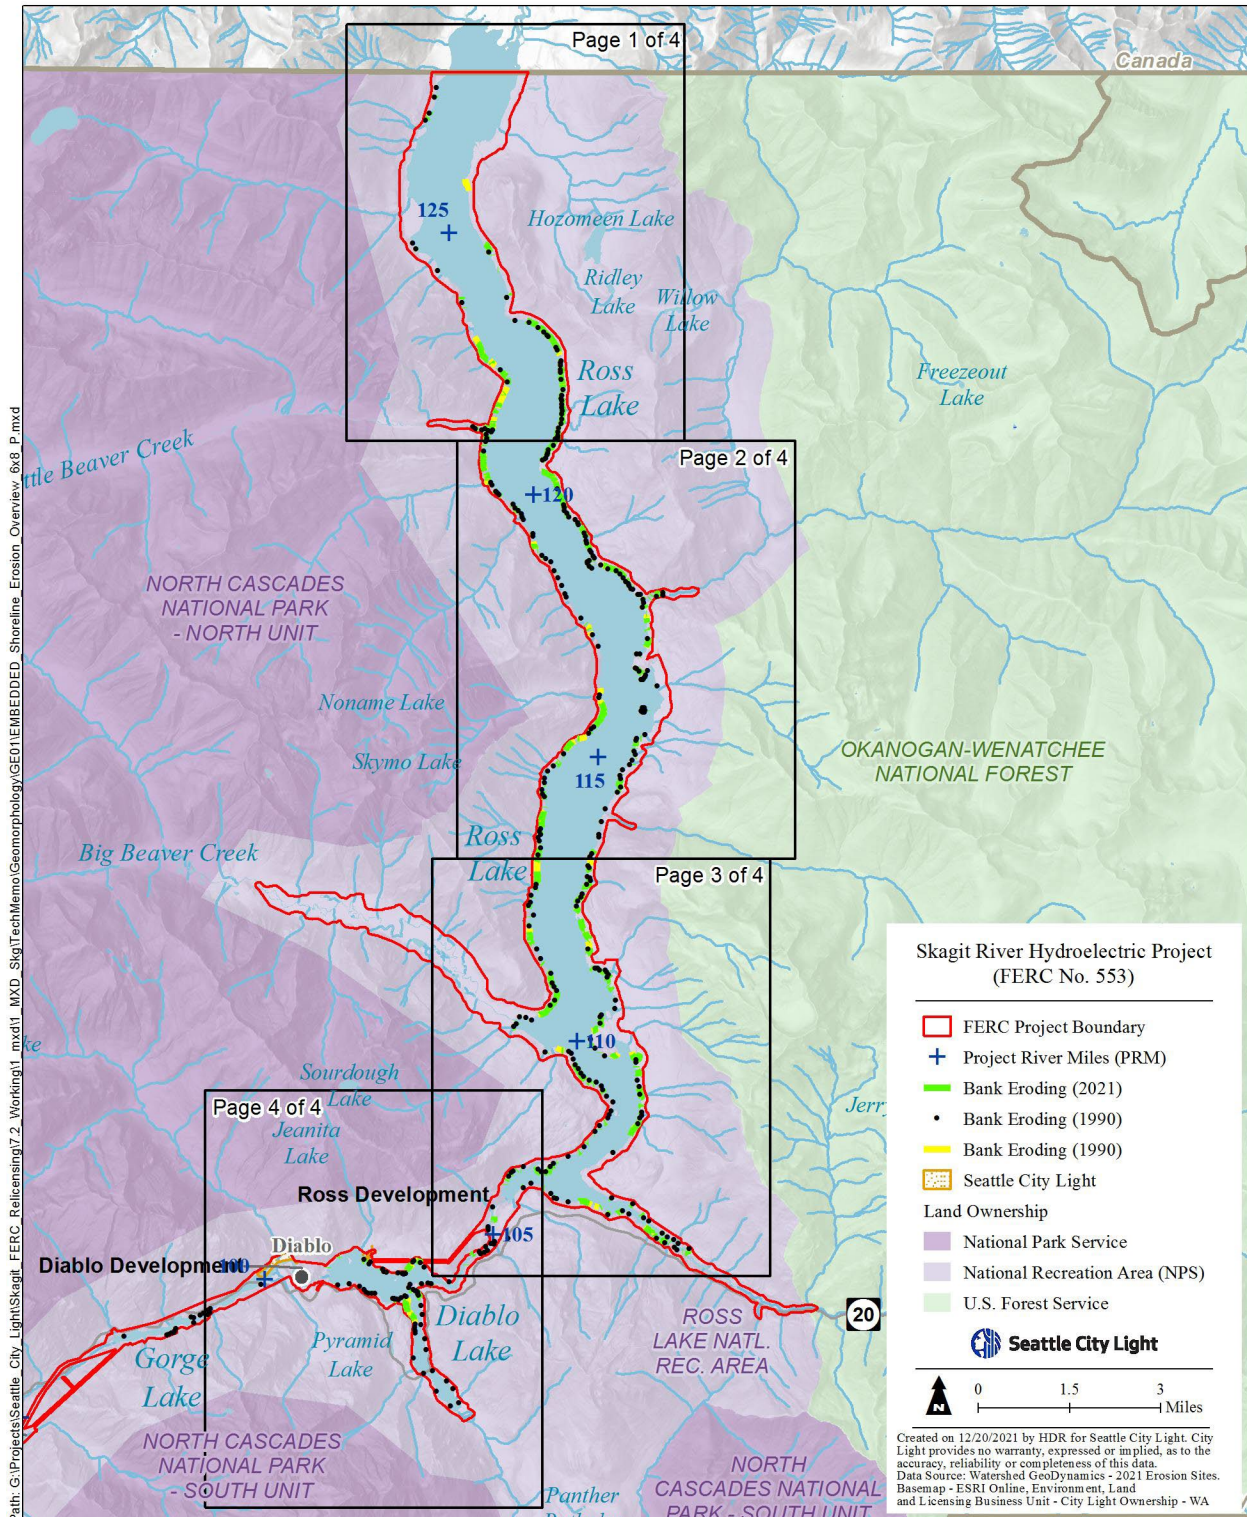
**Figure 5.3-1. Reservoir shoreline erosion sites, 2021.**

The reservoir erosion inventory conducted in 2021 identified a total of 306 erosion sites covering 74,272 feet (19 percent) of reservoir shoreline length in Ross Lake and 43 sites (4,556 feet or 4 percent of shoreline length) in Diablo Lake (Figure 5.3-1 through Figure 5.3-5 and Attachment B of this study report; detailed data available upon request). In Ross Lake, 87 of the sites shown on the 1990 map were stabilized and 79 new sites were identified. In Diablo Lake, 49 of the 1990 sites were stabilized and 15 new sites were mapped. Stabilized sites include those where erosion control measures have been implemented and sites that have re-vegetated.

On both Ross and Diablo lakes, the primary cause of erosion at sites is wave action that removes material at the toe of banks and transports it down into the lake as reservoir water surface elevations fluctuate. As noted in the 1990 report, this movement of material from the toe of the bank during reservoir fluctuations does not allow a stable shoreline to develop, particularly in areas where there is a steep slope below the eroding bluff. The seasonal reservoir fluctuations in Ross Lake are likely a contributing factor to the ongoing shoreline erosion—there was little reduction in total eroding shoreline length between the 1990 and 2021 inventory in Ross Lake (3 percent decrease) compared to Diablo Lake, which has relatively stable water surface elevations and had a 76 percent decrease in length of eroding shoreline.

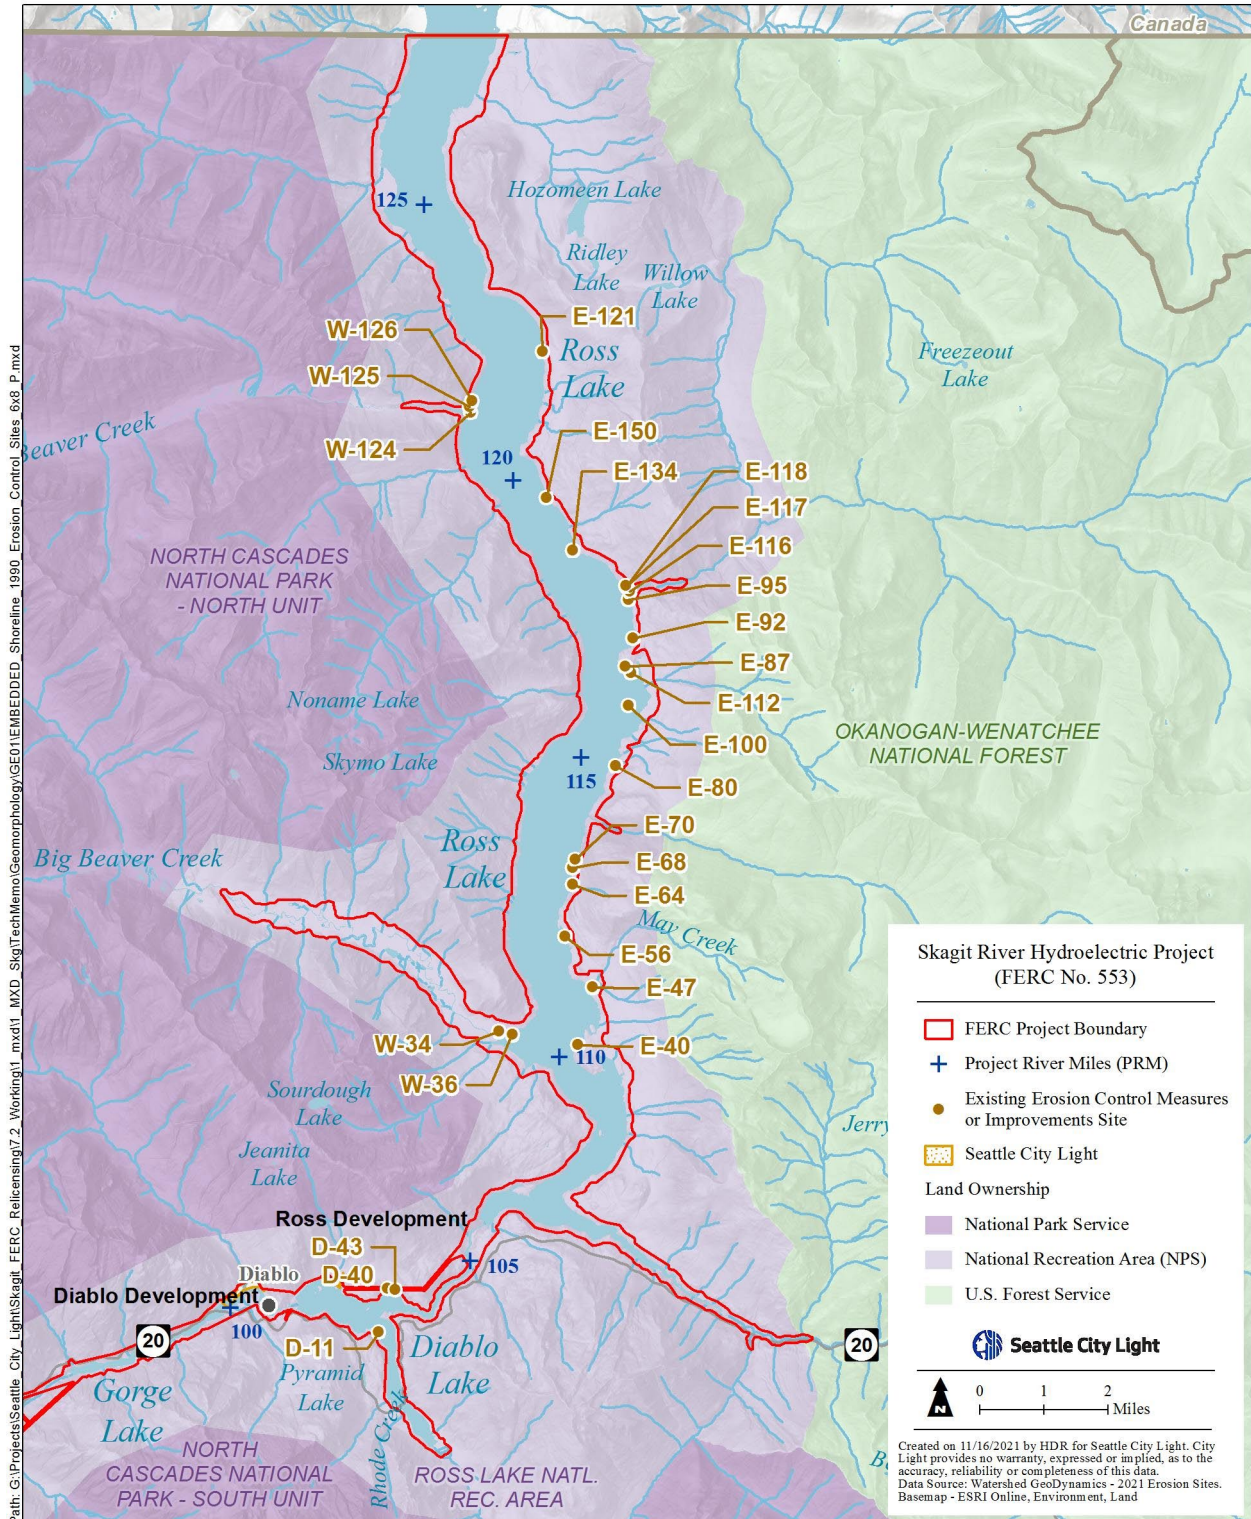
Figure 5.3-6. Existing erosion control site locations.

Thirty-two sites where erosion control measures have been implemented were evaluated as part of the reservoir shoreline erosion inventory—29 sites on Ross Lake and three sites on Diablo Lake (Figure 5.3-6). No sites are located on Gorge Lake. Observations made at each site are included in Table 5.3-2. Erosion control measures included installation of rock walls, rock stairs to access the lake, log walls, wood cribbing, and rerouted sections of trails and log booms at boat-in campsites, along trails, and at other recreation facilities (trailheads, docks). Generally, the erosion control measures are in good condition and continue to function to minimize erosion with only minor maintenance required, such as providing fill around the base rocks at walls or dock footings. Three sites need major repairs, including McMillan Campsite (site E-40; rock wall is failing); the Desolation Trailhead (site E-150; rock wall has almost totally failed and is eroding), and the rock wall and stairs at Little Beaver Campsite (site W-124 needs base support). NPS conducts biennial erosion control and revegetation surveys in more detail and files the resulting reports with FERC. The most recent report covered the 2018-2019 period (NPS 2019); the next survey was scheduled for completion in 2021 (results are forthcoming at this time).
