Multnomah County Building Ecoroof Performance Supplemental Report

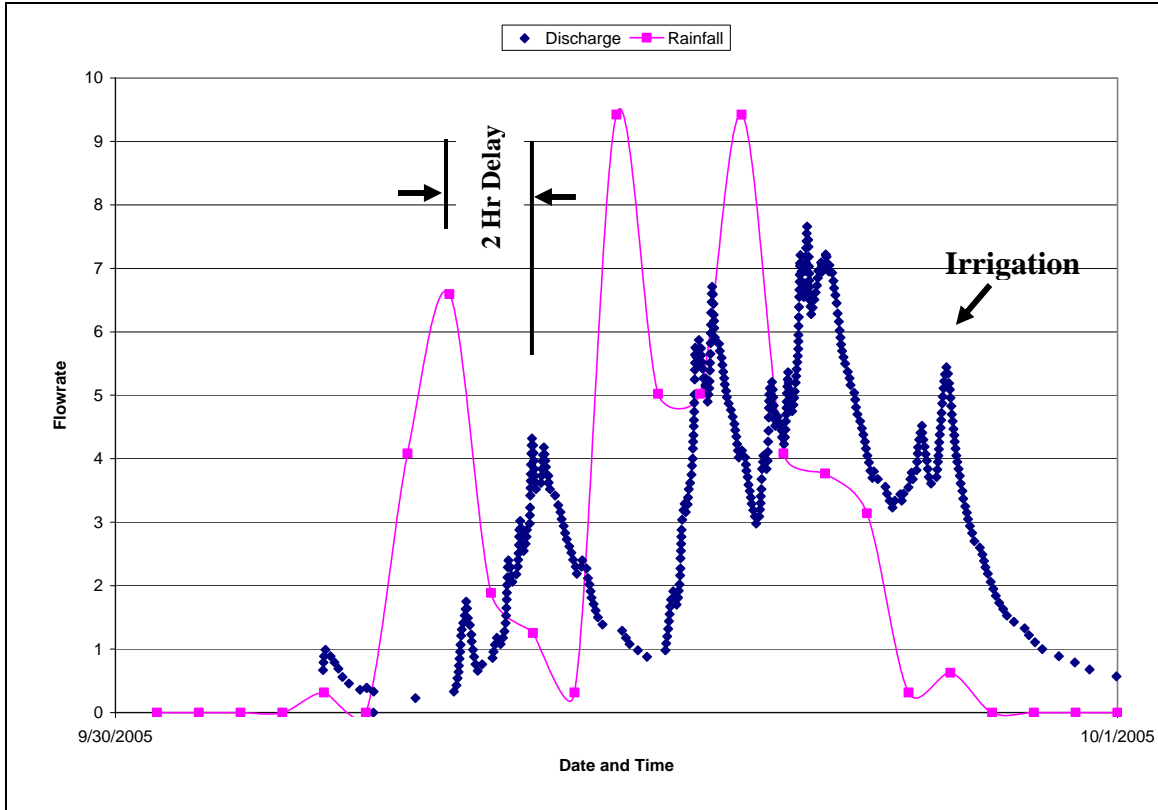
Figure 2. September 30, 2005, rain event and discharge for South ecoroof.

The time lag between the peak rainfall and the peak discharge for an event was typically about 2 hours. This is illustrated in Figure 2 for a sustained rain event on September 30, 2005. For this event, the total discharge was about 100% of the rainfall.

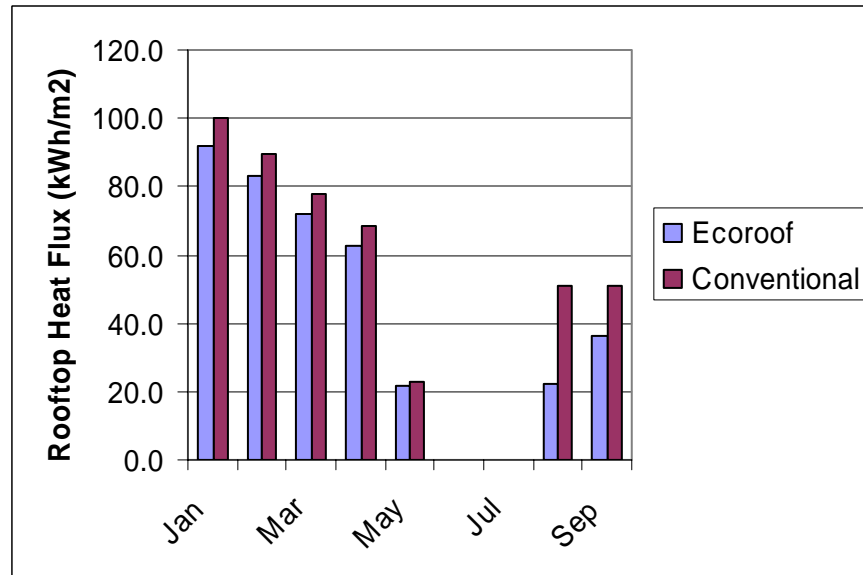
Figure 4. Rooftop heat flux for Broadway ecoroof and conventional roof

The Broadway Building on the Portland State University campus is offered as a surrogate for the MCB roof, with very similar ecoroofs. The rooftop heat flux for the Broadway ecoroof, when compared to a conventional roof construction, is shown in Figure 4.

As can be seen, the heat flux is higher in January than in May, as would be expected. The ecoroof offers a slight reduction in the heat lost from the building during the winter and spring, probably due to the thermal resistance of the soil layer on the roof. Interestingly, though, during the summer (August and September) the ecoroof appears to offer a significant reduction of heat gain through the roof. This effect may be attributed to evaporative cooling occurring from the ecoroof, either plant evapotranspiration or evaporation of surface water from the soil layer, due to irrigation water. More testing is necessary to confirm the consistency of this trend. But, if validated, the MCB should be receiving a comparable benefit from its ecoroof relative to summer cooling demand.
