Mitigation “Triage” Workshop: School Pilot Project Case Study

WASHINGTON STATE SCHOOL SEISMIC SAFETY PILOT PROJECT— Providing Safe Schools for Our Students

Seismic Evaluation Pilot Project

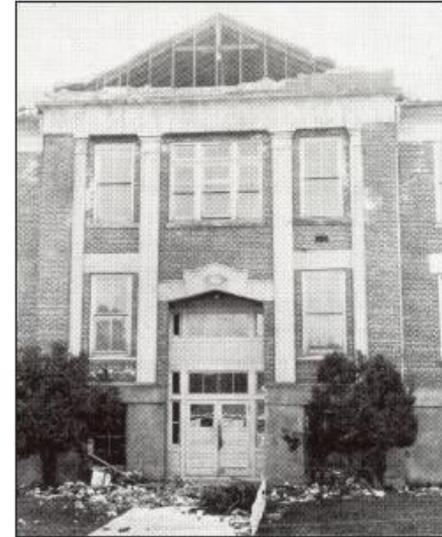
Figure 2. At Castle Rock, a high school student was killed as unanchored gable masonry cascaded to the walk outside the entrance. There could have been more casualties. (From Edwards, 1951.)

At Castle Rock High School, however, falling masonry killed the student body president as he tried to escape from the building .

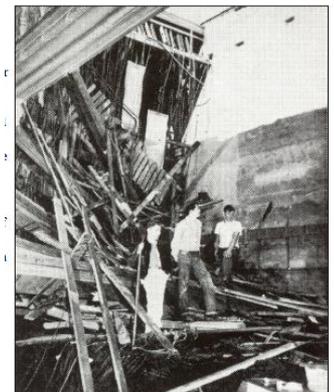
Figure 1. Open air theatre—Three members of the stage crew at Puyallup High School survey the wreckage of the stage, which was caved in by the earthquake just as they were leaving for lunch. Under the debris are a ping-pong table and a grand piano. Seattle Times staff photo by Larry Dion (from Ulrich, 1949).

1949, a large earthquake collapsed the gymnasium roof at Puyallup High School. The earthquake occurred at 11:58 a.m., and the gym had just been vacated by students for lunch.

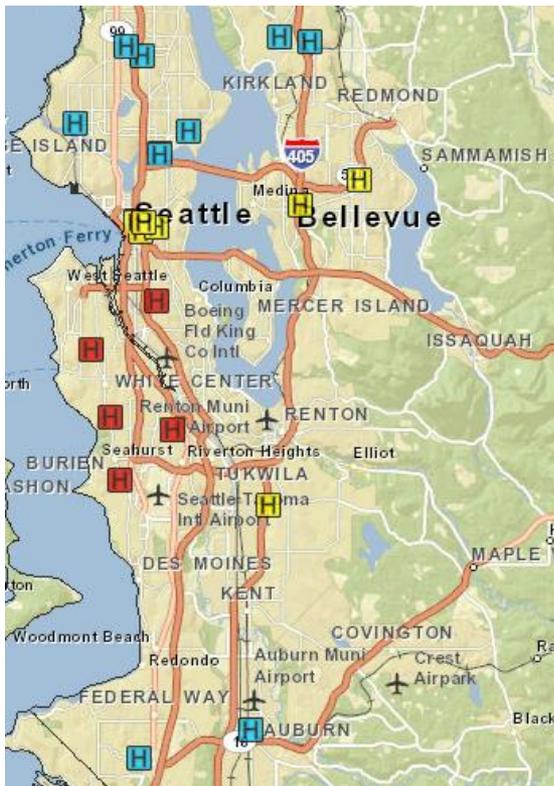
Hospitals

- OSHPD uses for hospital building screening in CA
- Scenario-Based Planning
 - WA State Seismic Hazards Catalog
