City of Seattle Neighborhood Fire Station 9

Design Commission Review - Concept Design October 1, 2009

Fire Station 9

3829 Linden Avenue N

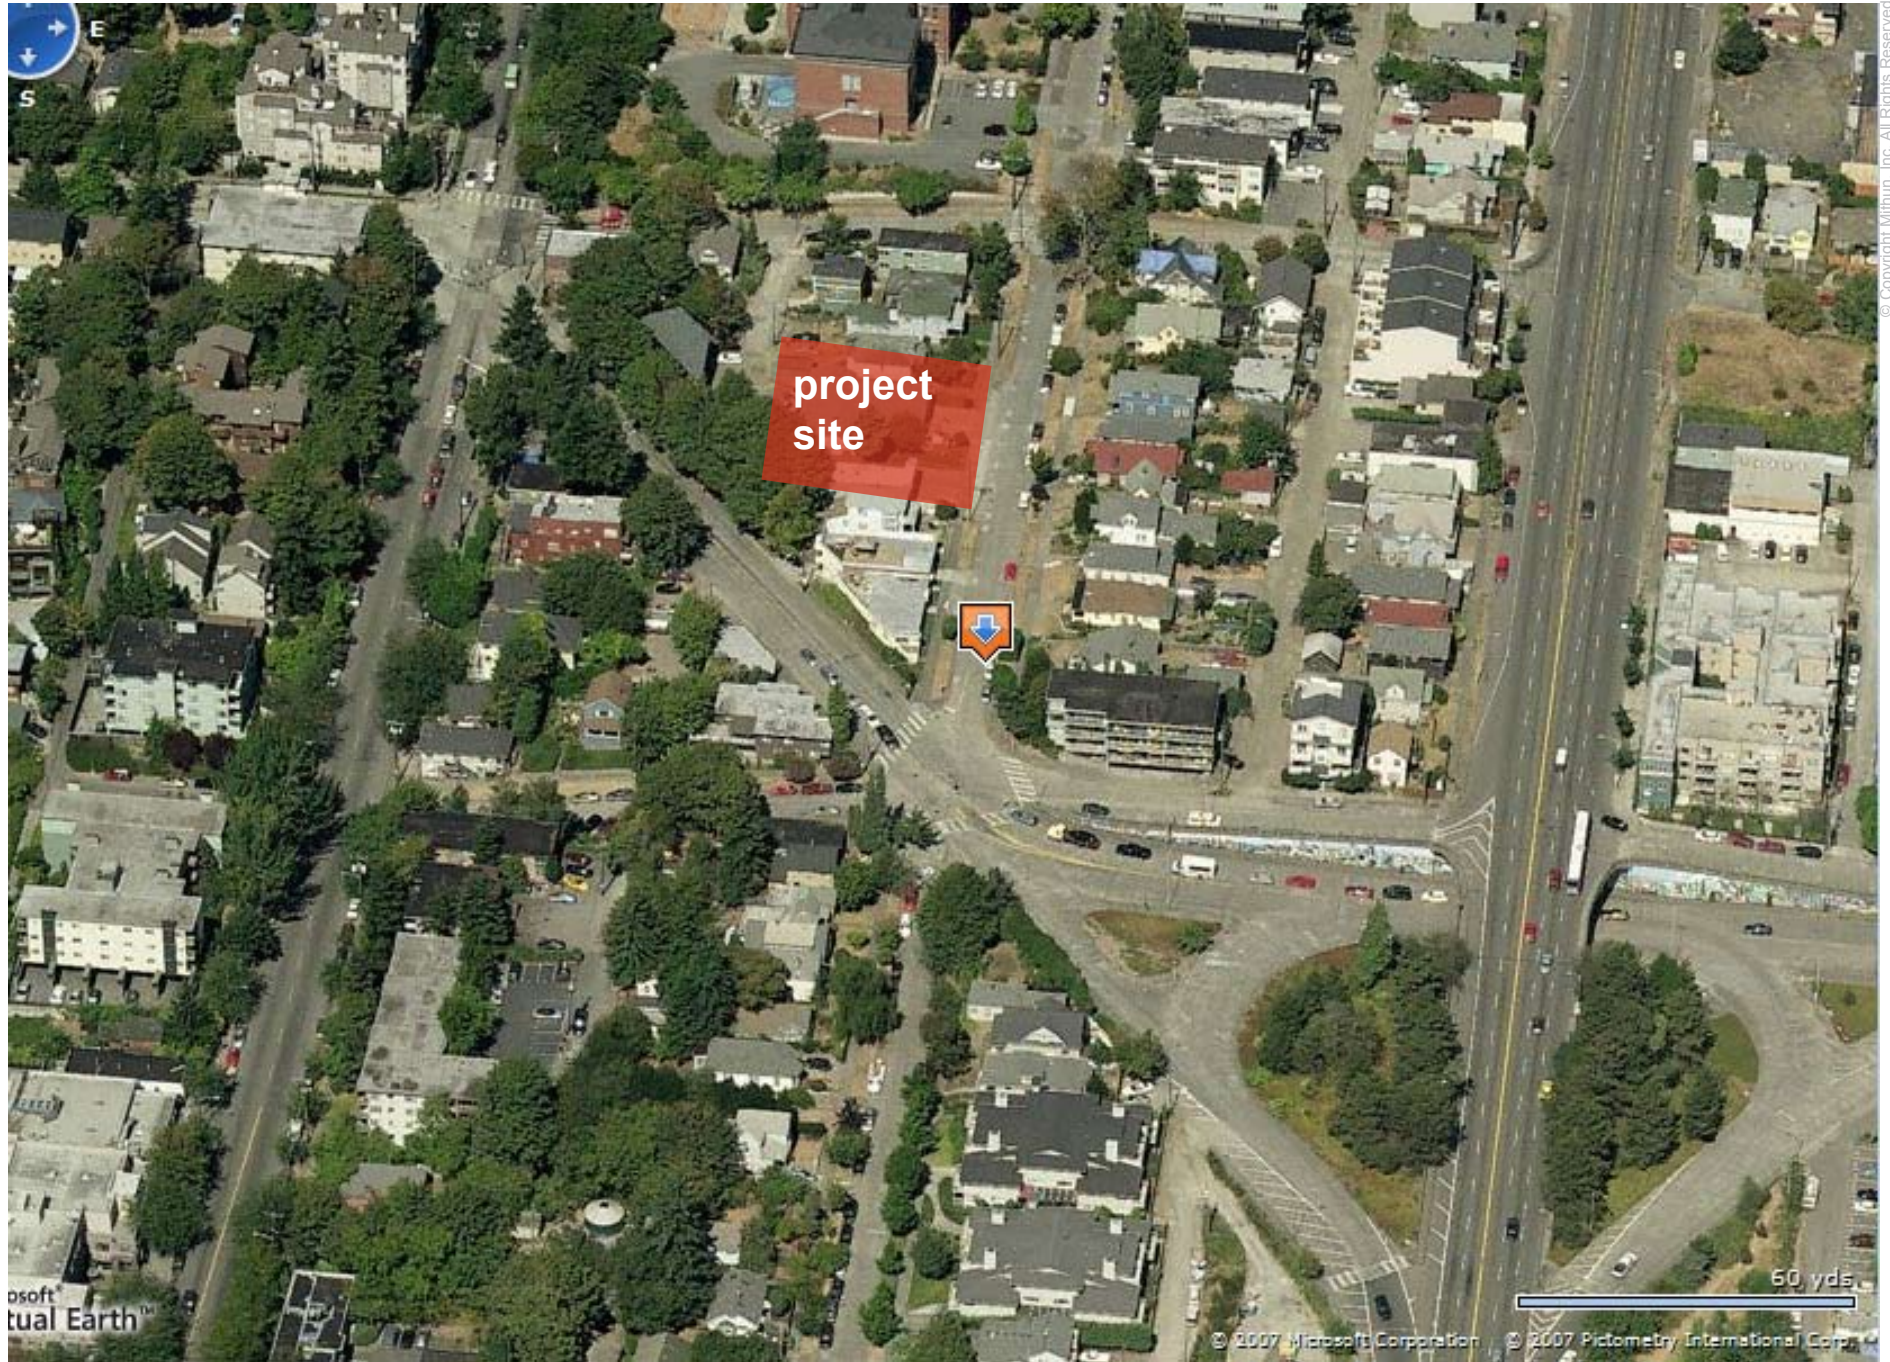
Surrounded by L1 zone, lowrise 1, residential, multi-family. Maximum structure height, 25'. Adjacent structures almost on lot line.

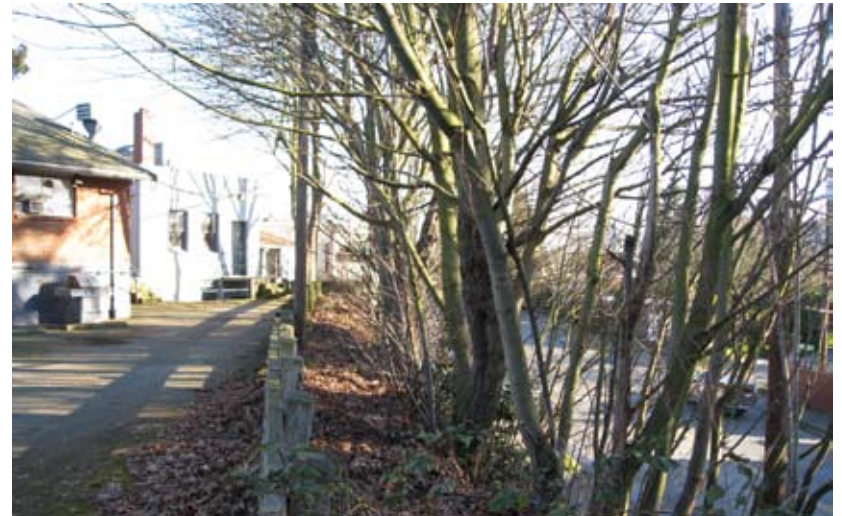
steep slope with existing trees at back of site

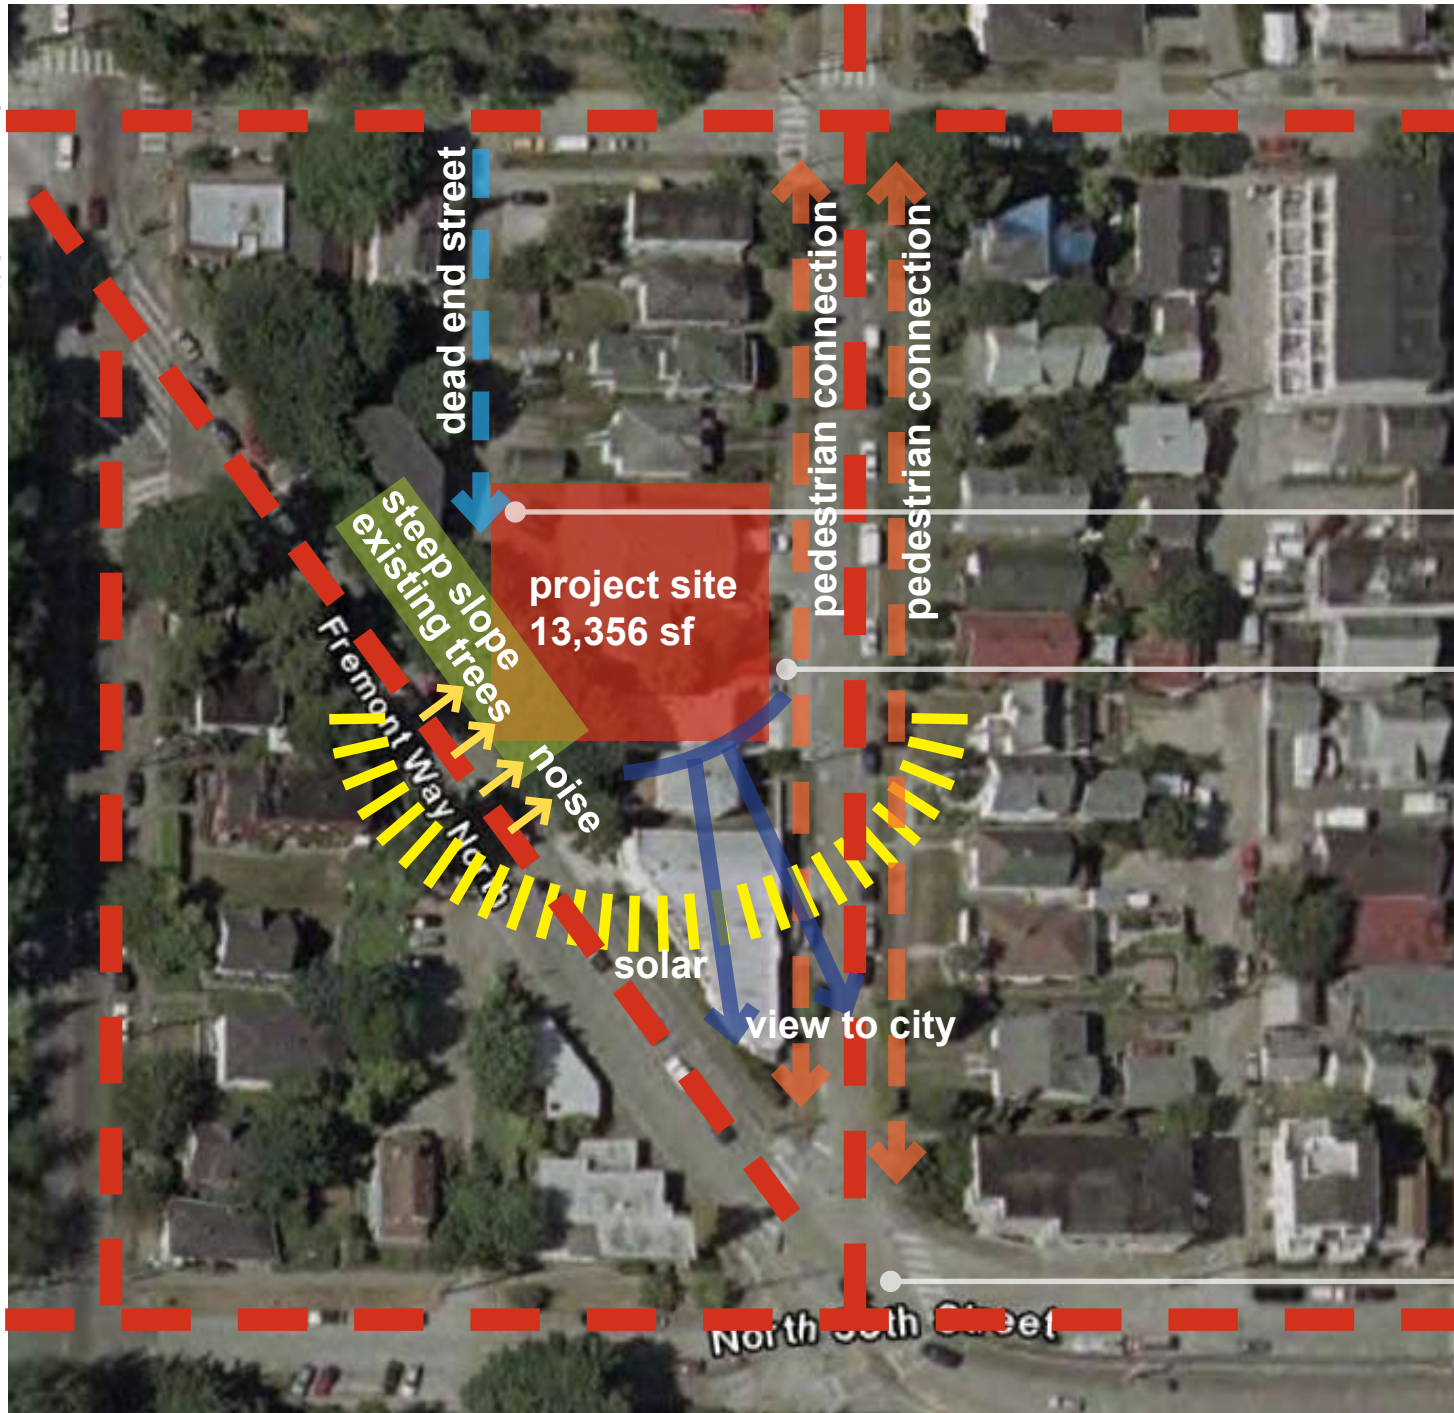
site access
 pedestrian connection
 site topo
 steep slope
 existing trees
 adjacent structures
 view
 noise
 solar
 wind

existing staff parking
 & staff entry access
 off Fremont Lane N.

existing fire truck
 access off Linden
 Avenue N.

steep slope 15'
 in vertical rise

controlled light

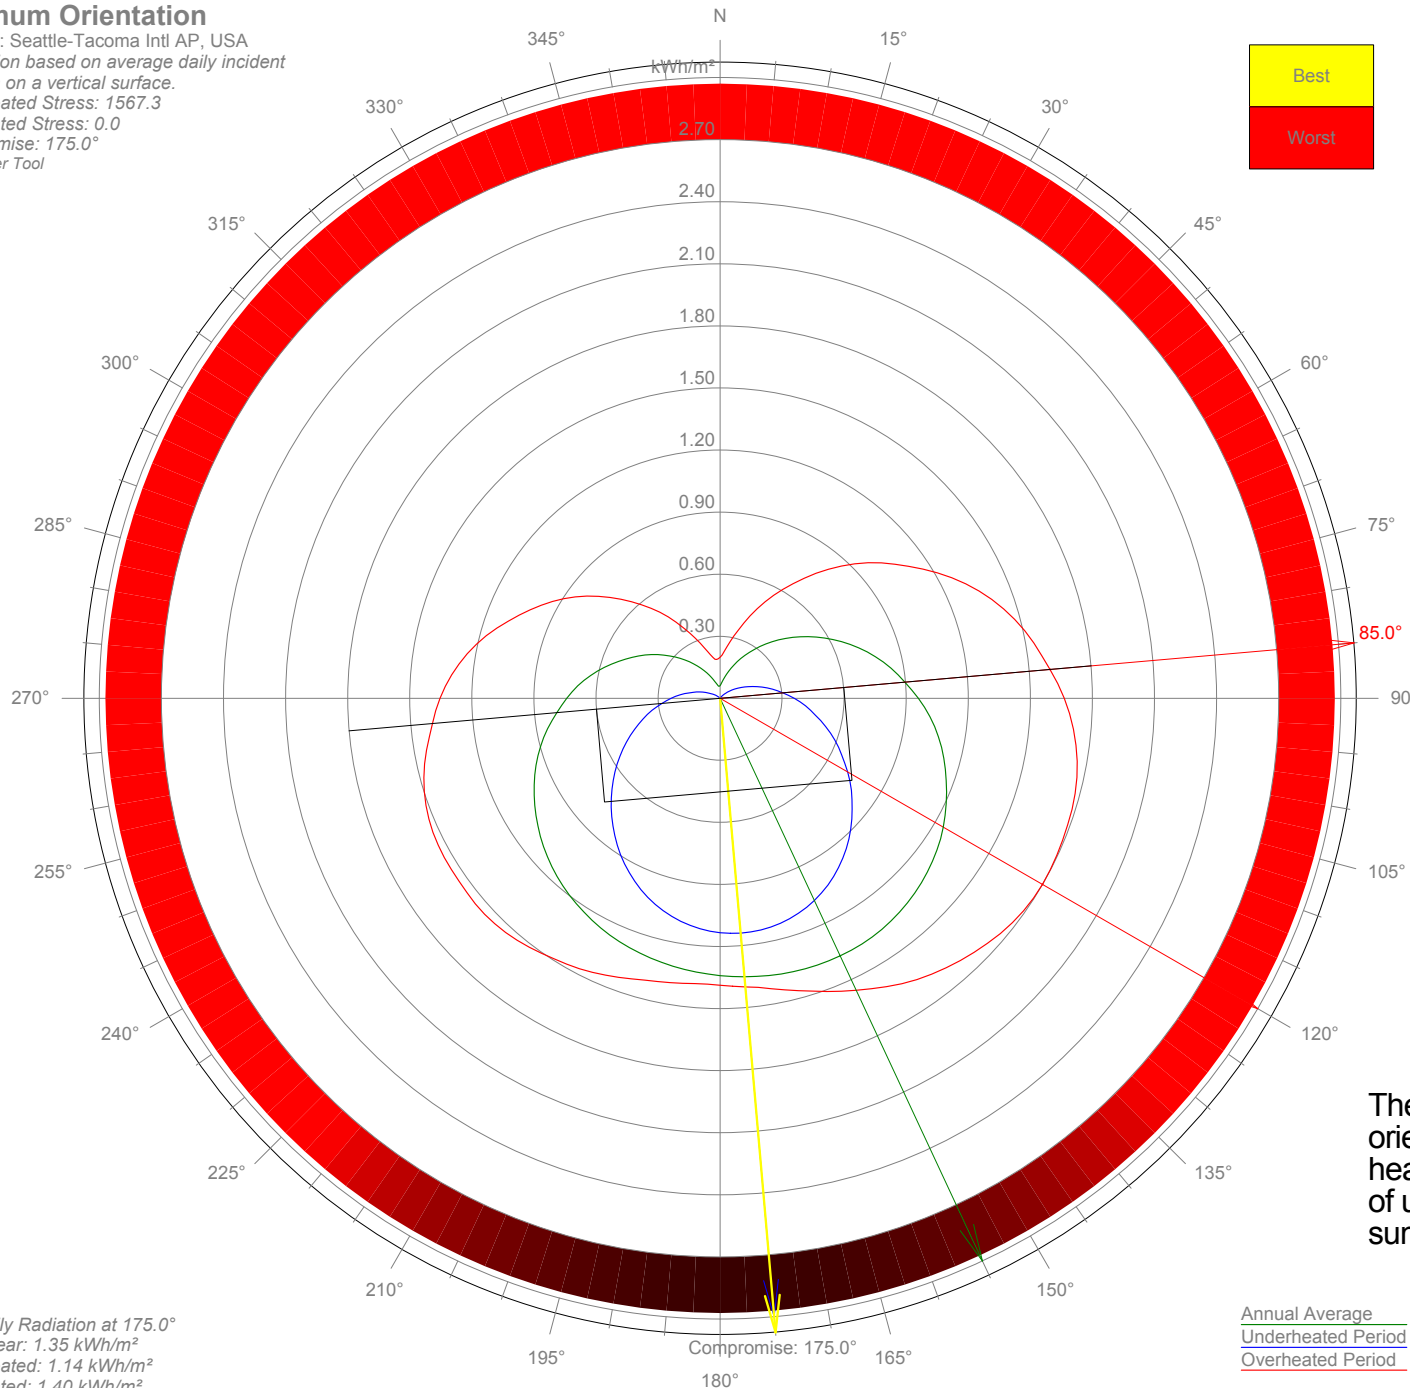
Optimum Orientation

Location: Seattle-Tacoma Intl AP, USA
 Orientation based on average daily incident radiation on a vertical surface.
 Underheated Stress: 1567.3
 Overheated Stress: 0.0
 Compromise: 175.0°
 © Weather Tool

Avg. Daily Radiation at 175.0°
 Entire Year: 1.35 kWh/m²
 Underheated: 1.14 kWh/m²
 Overheated: 1.40 kWh/m²

Annual Average
 Underheated Period
 Overheated Period

The most favourable range of orientations for passive solar heating, considering the effects of unwanted solar gains in summer.

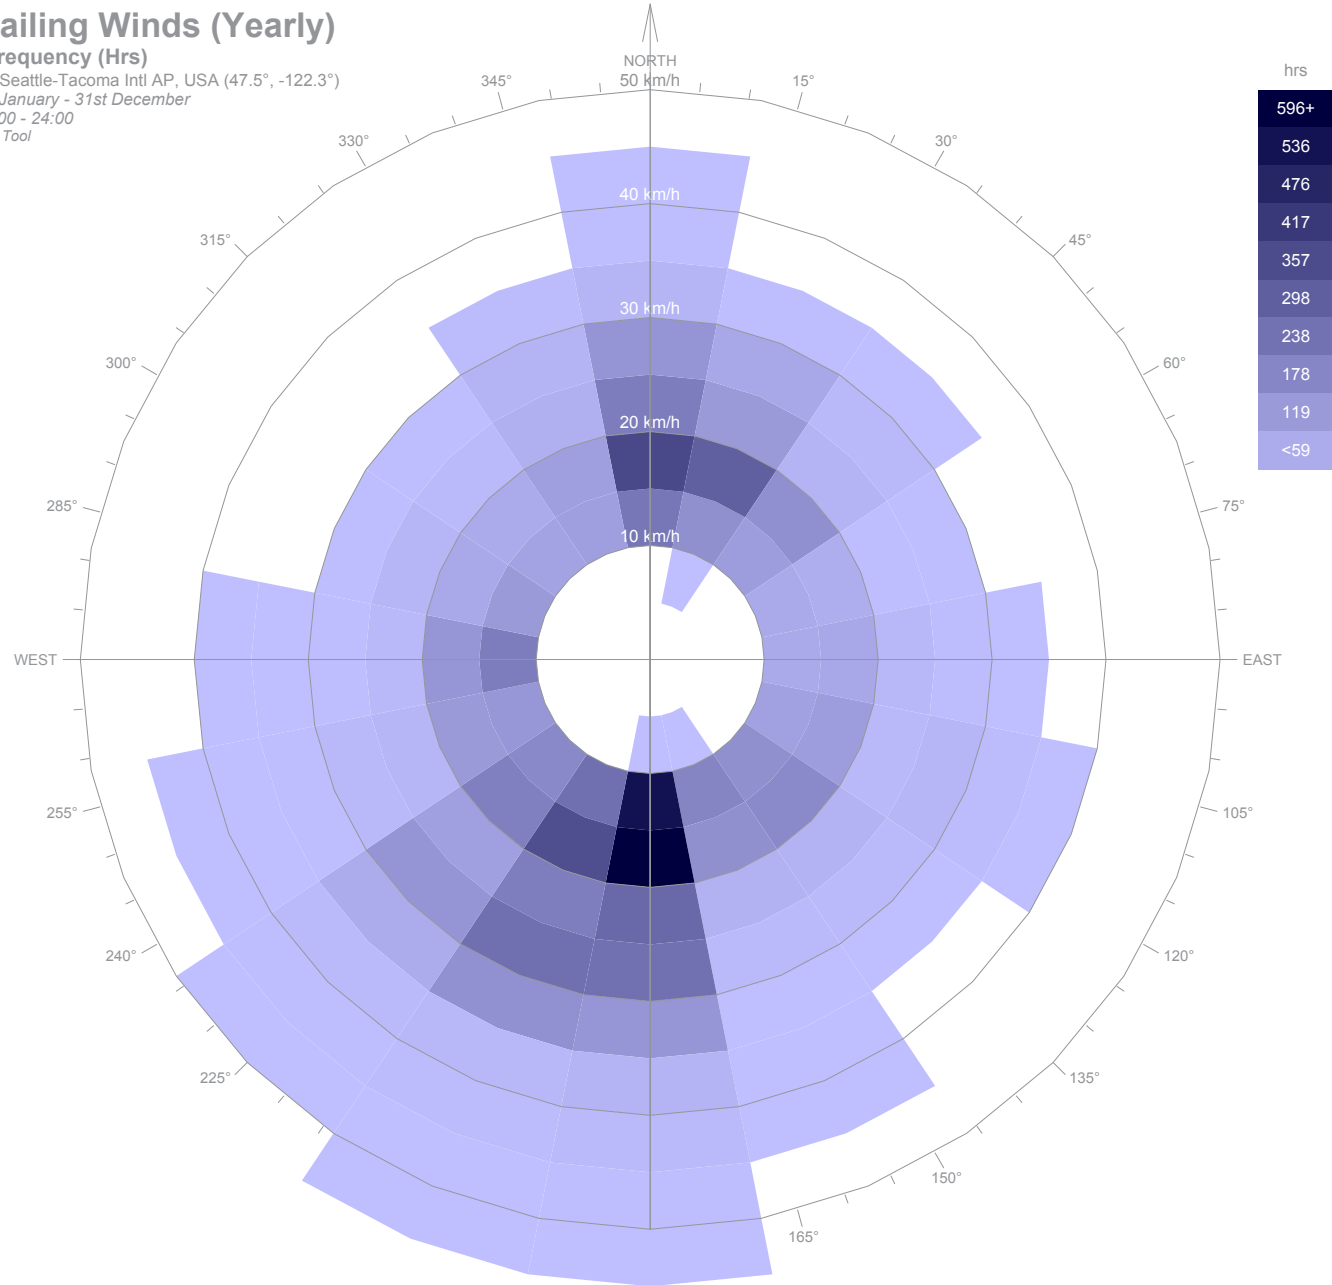
Prevailing Winds (Yearly)

Wind Frequency (Hrs)

Location: Seattle-Tacoma Intl AP, USA (47.5°, -122.3°)
Date: 1st January - 31st December
Time: 00:00 - 24:00
© Weather Tool

Prevailing wind:
south & southwest

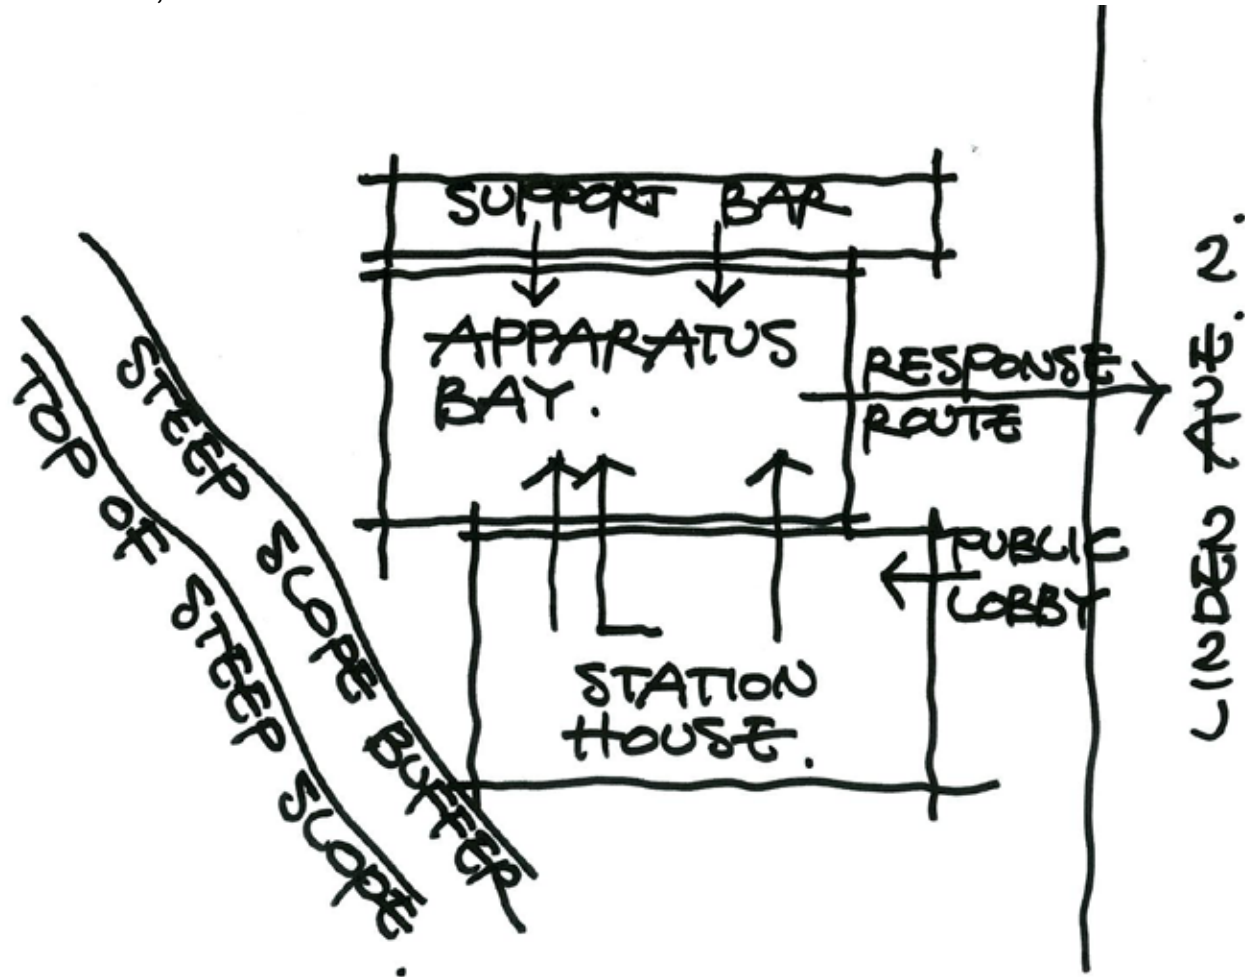
Concept Diagram

BE EVER READY

provide an **EVER READY** station to firefighters,
functional, efficient & comfortable.

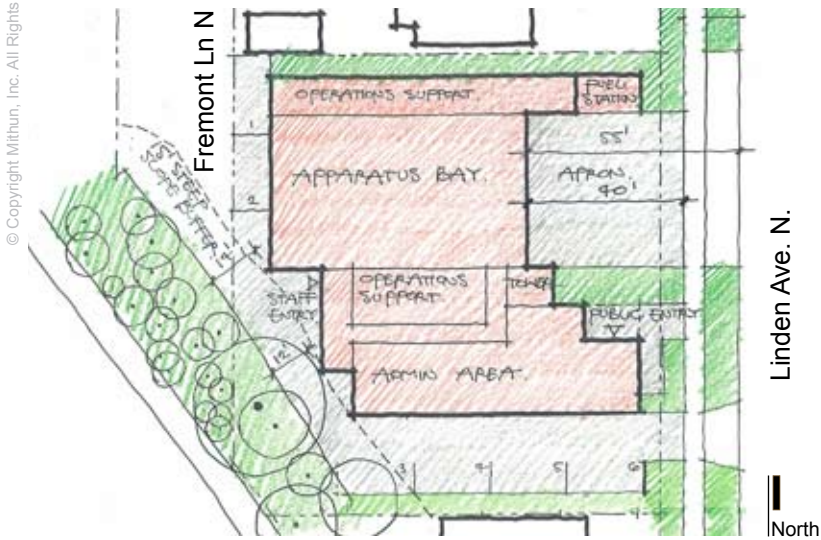
Option 1a Apparatus Bay & Support Bar @North Station House & Staff parking @South

Site is too tight for Drive-through Apparatus Bay & rear apron.
Fire Truck Access from Fremont Lane N. does not work.

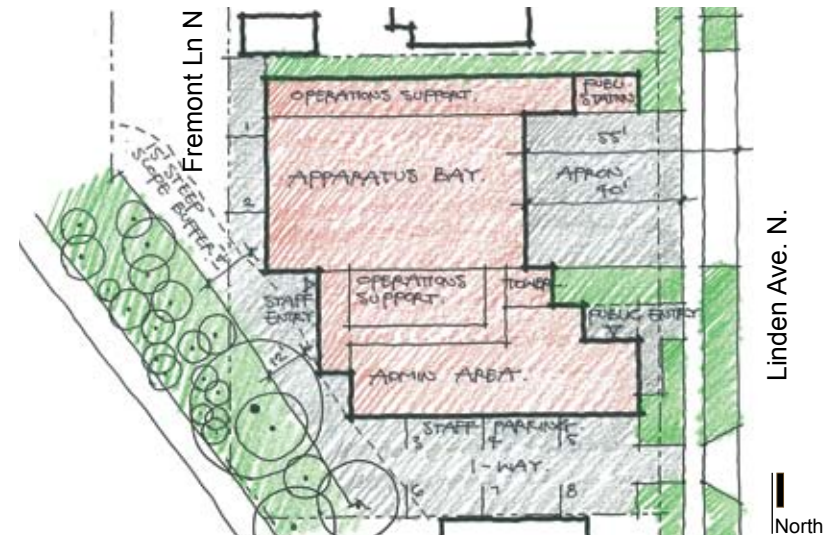
Option 1b Apparatus Bay & Support Bar @North Station House & Staff parking @South

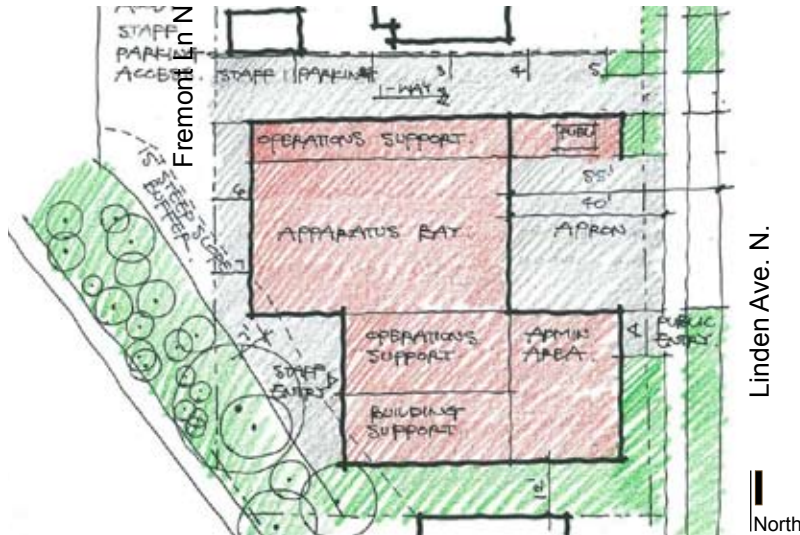
Option 2 Apparatus Bay & Support Bar @North Station House @South
Staff parking @South
Staff parking @North
Building footprint in steep slope buffer

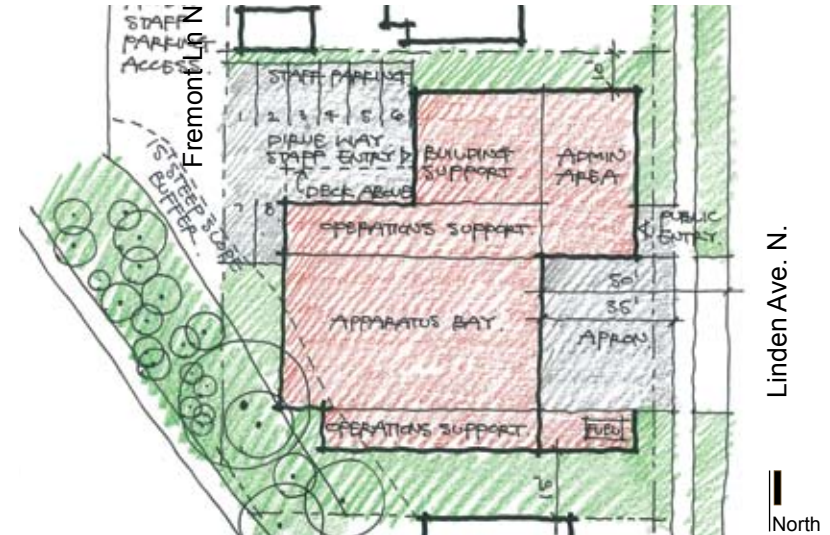
Option 3 Apparatus Bay & Support Bar @South Station House & staff parking @North
Building footprint in steep slope buffer
Less Apron depth

Site Plan Options

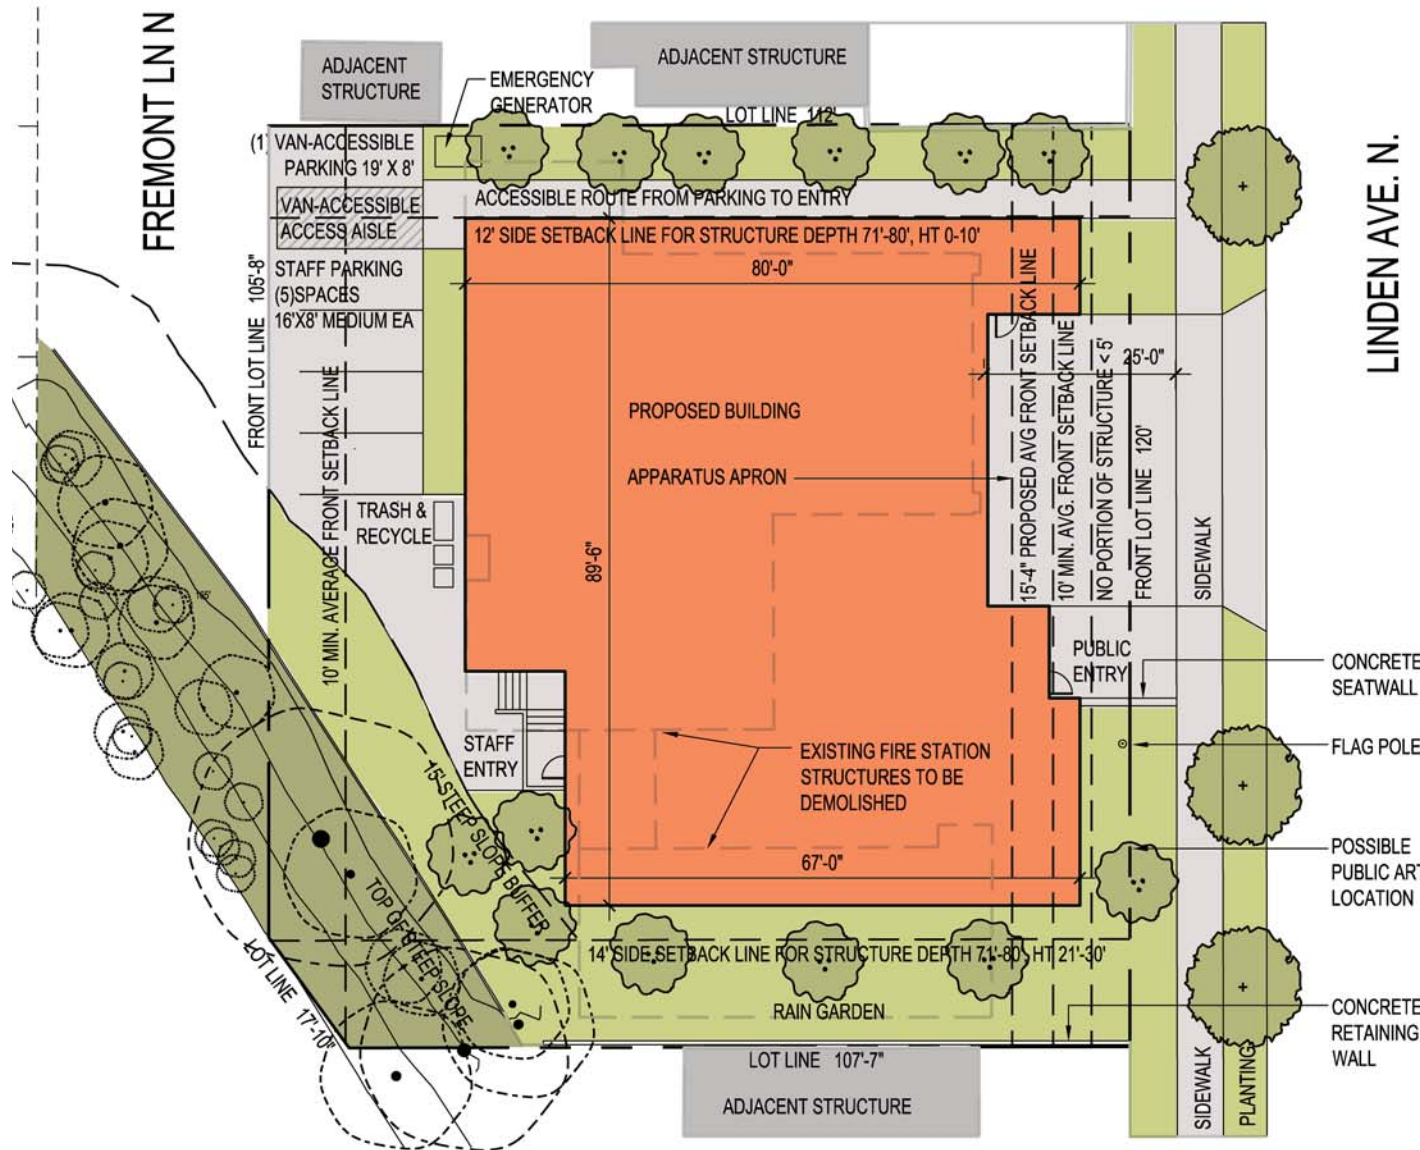
Response to site & program

Apparatus Bay is located at north to maximize apron depth.

Station house is located at south to maximize southern exposure.

Building footprint & path to staff entry are away from steep slope buffer.

Staff parking & entry are located at back of station.

Public entry with public art is located along Linden Ave. N.

Public entry is recessed to maximize sightline from Apparatus Bay.

To reduce the appearance of bulk, the front facade is modulated, landscaping is provided in front of the building & the proposed average front setback is 15', 5" more than 10' min. average front setback requirement.

Native planting connects to natural steep slope area.

Intercept limited amounts of water through rain gardens.

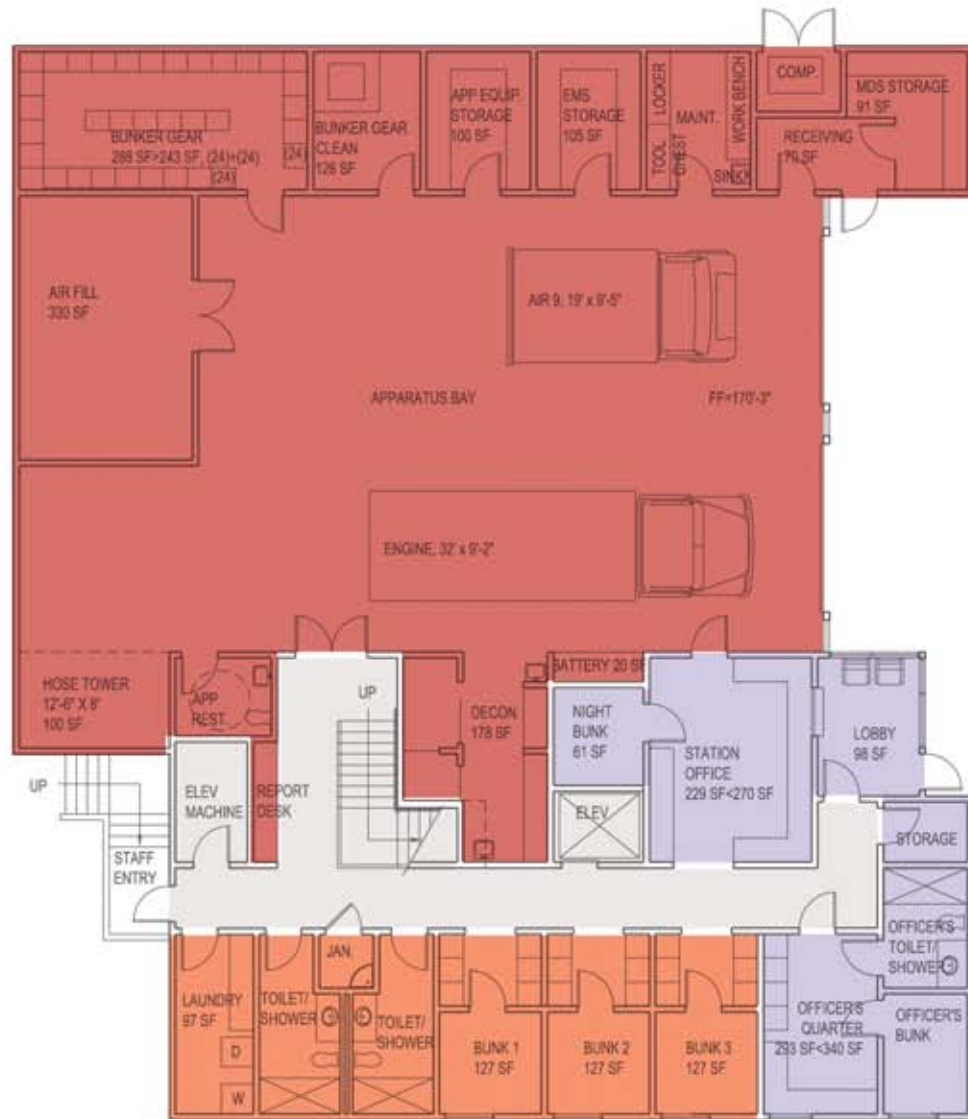
Response to program

Compact building footprint is away from steep slope buffer.

All operation support spaces are accessed directly from Apparatus Bay.

All sleep rooms are located on 1st floor for quick response time.

Rest of crew spaces & outdoor beanery area are located on 2nd floor to take advantage of city view & stay away from traffic noise from Fremont Way N.

Extra wide “L” shaped open stair is designed for quick response time with visual connection & min. turns.

Public Lobby & Physical Training are more visible while the rest spaces are more private.

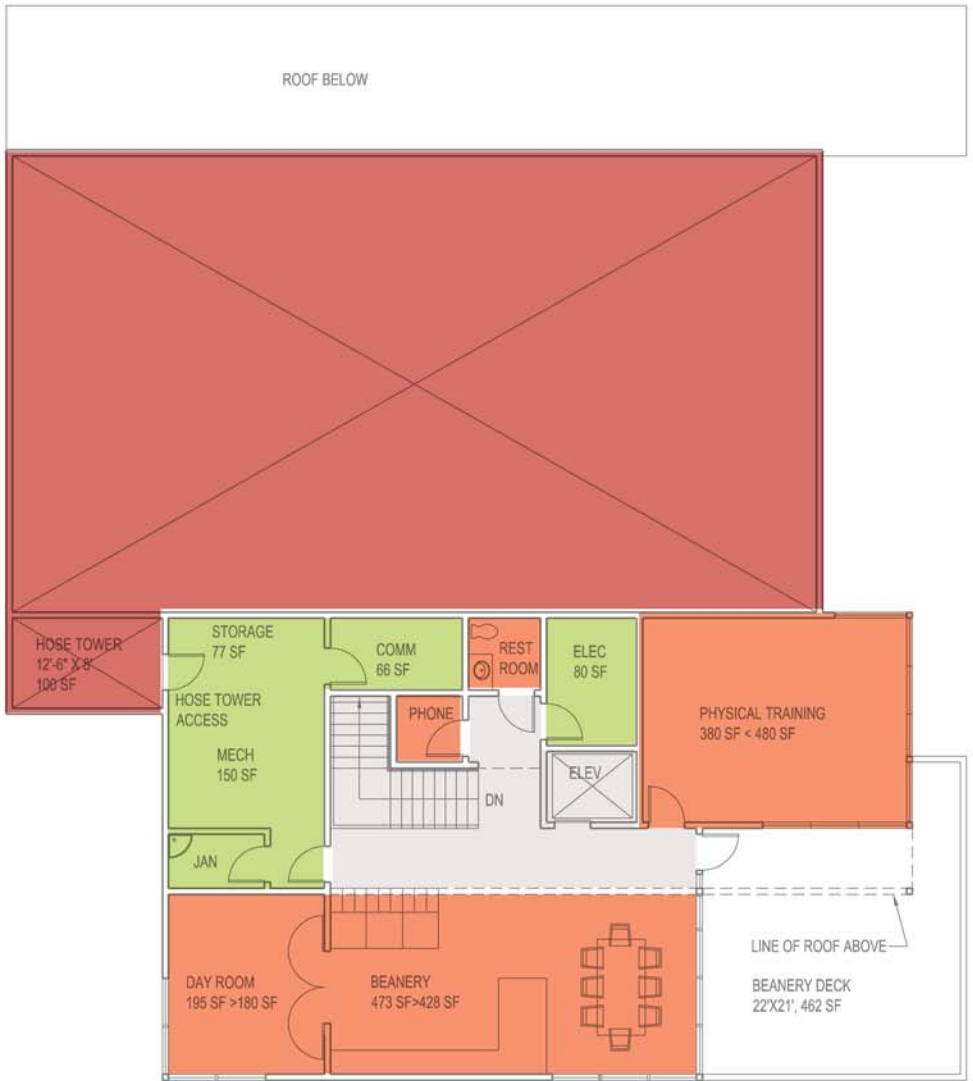
Response to program

■ OPERATIONS
 ■ ADMINISTRATION
 ■ CREW AREA
 ■ EQUIPMENT
 ■ CIRCULATION

Compact building footprint is away from steep slope buffer.

All operation support spaces are accessed directly from Apparatus Bay.

All sleep rooms are located on 1st floor for quick response time.

Rest of crew spaces & outdoor beanery area are located on 2nd floor to take advantage of city view & stay away from traffic noise from Fremont Way N.

Extra wide “L” shaped open stair is designed for quick response time with visual connection & min. turns.

Public Lobby & Physical Training are more visible while the rest spaces are more private.

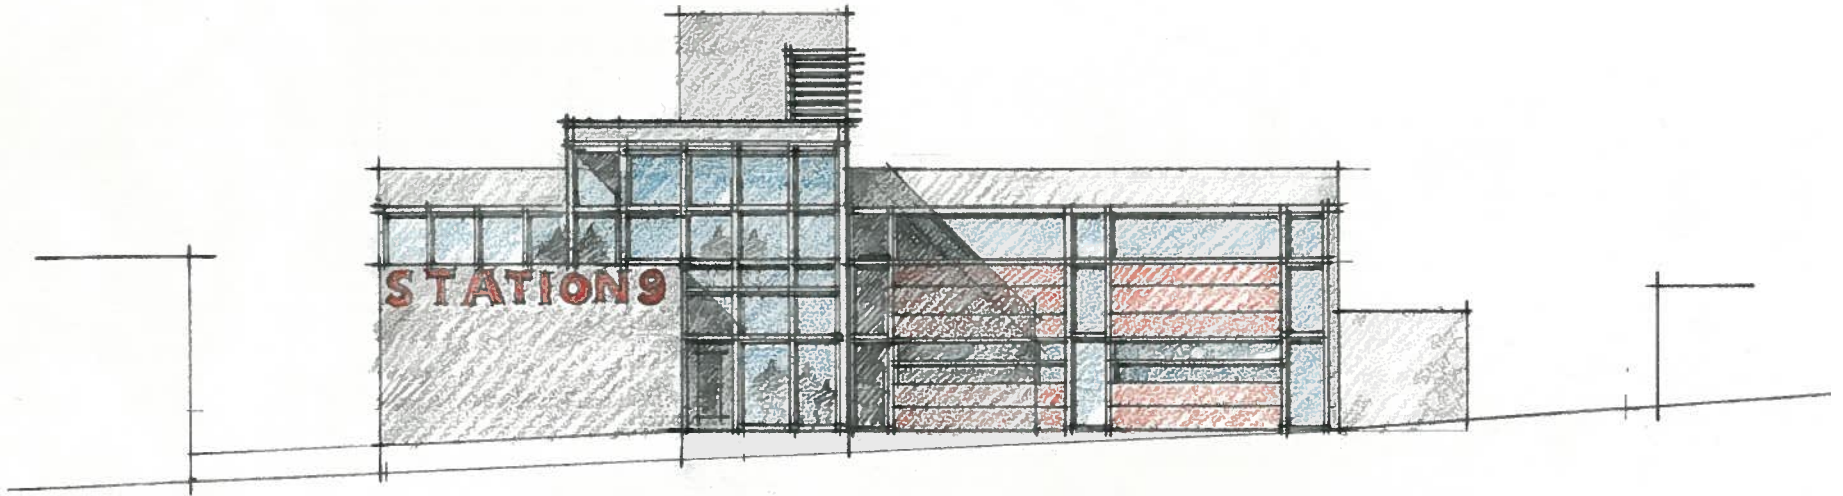
Key Sustainable Strategies

Rain garden, natural daylighting, high performance

- Site**
 - Urban site
 - Secured Bike storage to encourage biking
 - Pedestrian access to public transportation
 - Preferred parking for fuel efficient cars

- Reduced Heat Island (low albedo roofing)
 - Reduced light pollution through fixture locations and cut-off valances
- Water Efficiency**
 - Water efficient landscaping(Native plants,Engineered soil)

- High efficiency drip irrigation
 - Reduced potable water consumption(Dual flush toilets, low flow fixtures)
- Energy & Atmosphere**
 - High efficiency HVAC system to ensure nearly 17.5% better than code

- Building system commissioning and one year post occupancy commissioning
 - CFC free equipment
- Materials & Resources**
 - Recycling collection area
 - Minimum of 75% of construction/demolition waste recycled

- 20% Recycled content materials(Steel/rebar/gyp board/rubber flooring)
 - 10-20% Local/Regional materials w/i 500mi
- Indoor Environment Quality**
 - Non-smoking facility

- Indoor air quality plan being administered by contractor throughout construction process
 - Low VOC finishes(Paints,Sealants/Adhesives, Carpets, etc.)

- Controllability of lighting and HVAC systems
 - Operable windows for natural ventilation
 - Daylight & views provided in inhabited spaces
- Innovation**

- Green Housekeeping practice program
 - Sustainable Education program
