**ASBESTOS SURVEY**

**NAVAL STATION PUGET SOUND  
SEATTLE, WASHINGTON**

**BUILDING 2  
RESERVES**

**DRAFT SUBMITTAL**

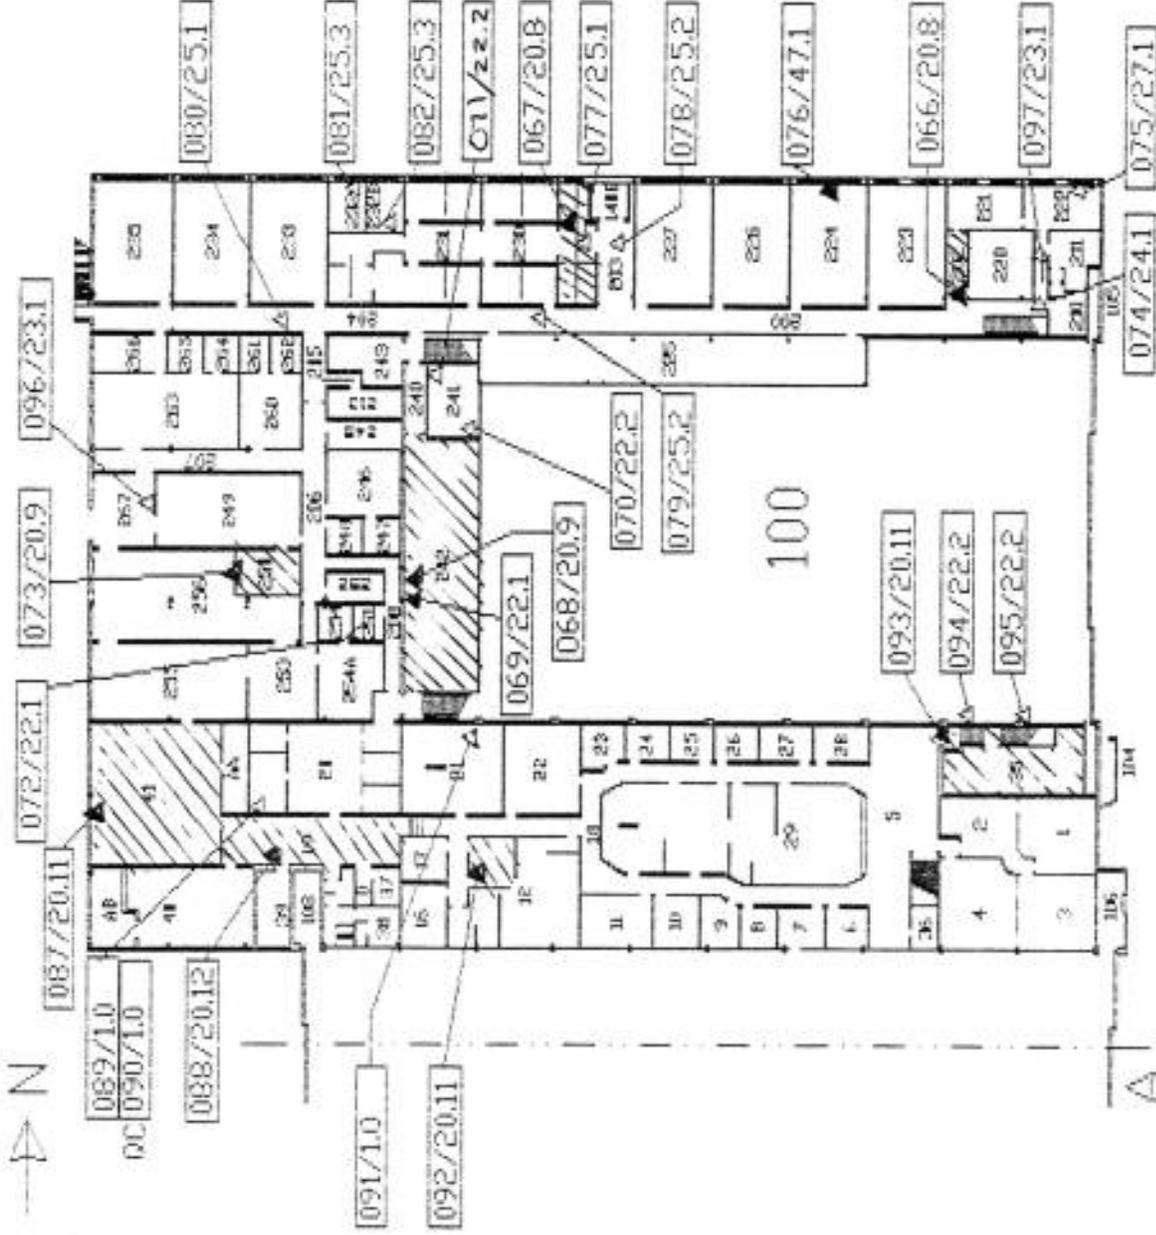
DEPARTMENT OF NAVY  
 NAVAL STATION OF PUGET SOUND  
 COAST GUARD & MARINES BLDG-2  
 RESERVE TRAINING  
 SECOND FLOOR SH 4 OF 6

/ Positive VFT / Linoleum / Mastic
