LOWMAN BEACH PARK SHORELINE RESTORATION

Draft 60% Design Report

Prepared for
Seattle Parks & Recreation Department

June 2019

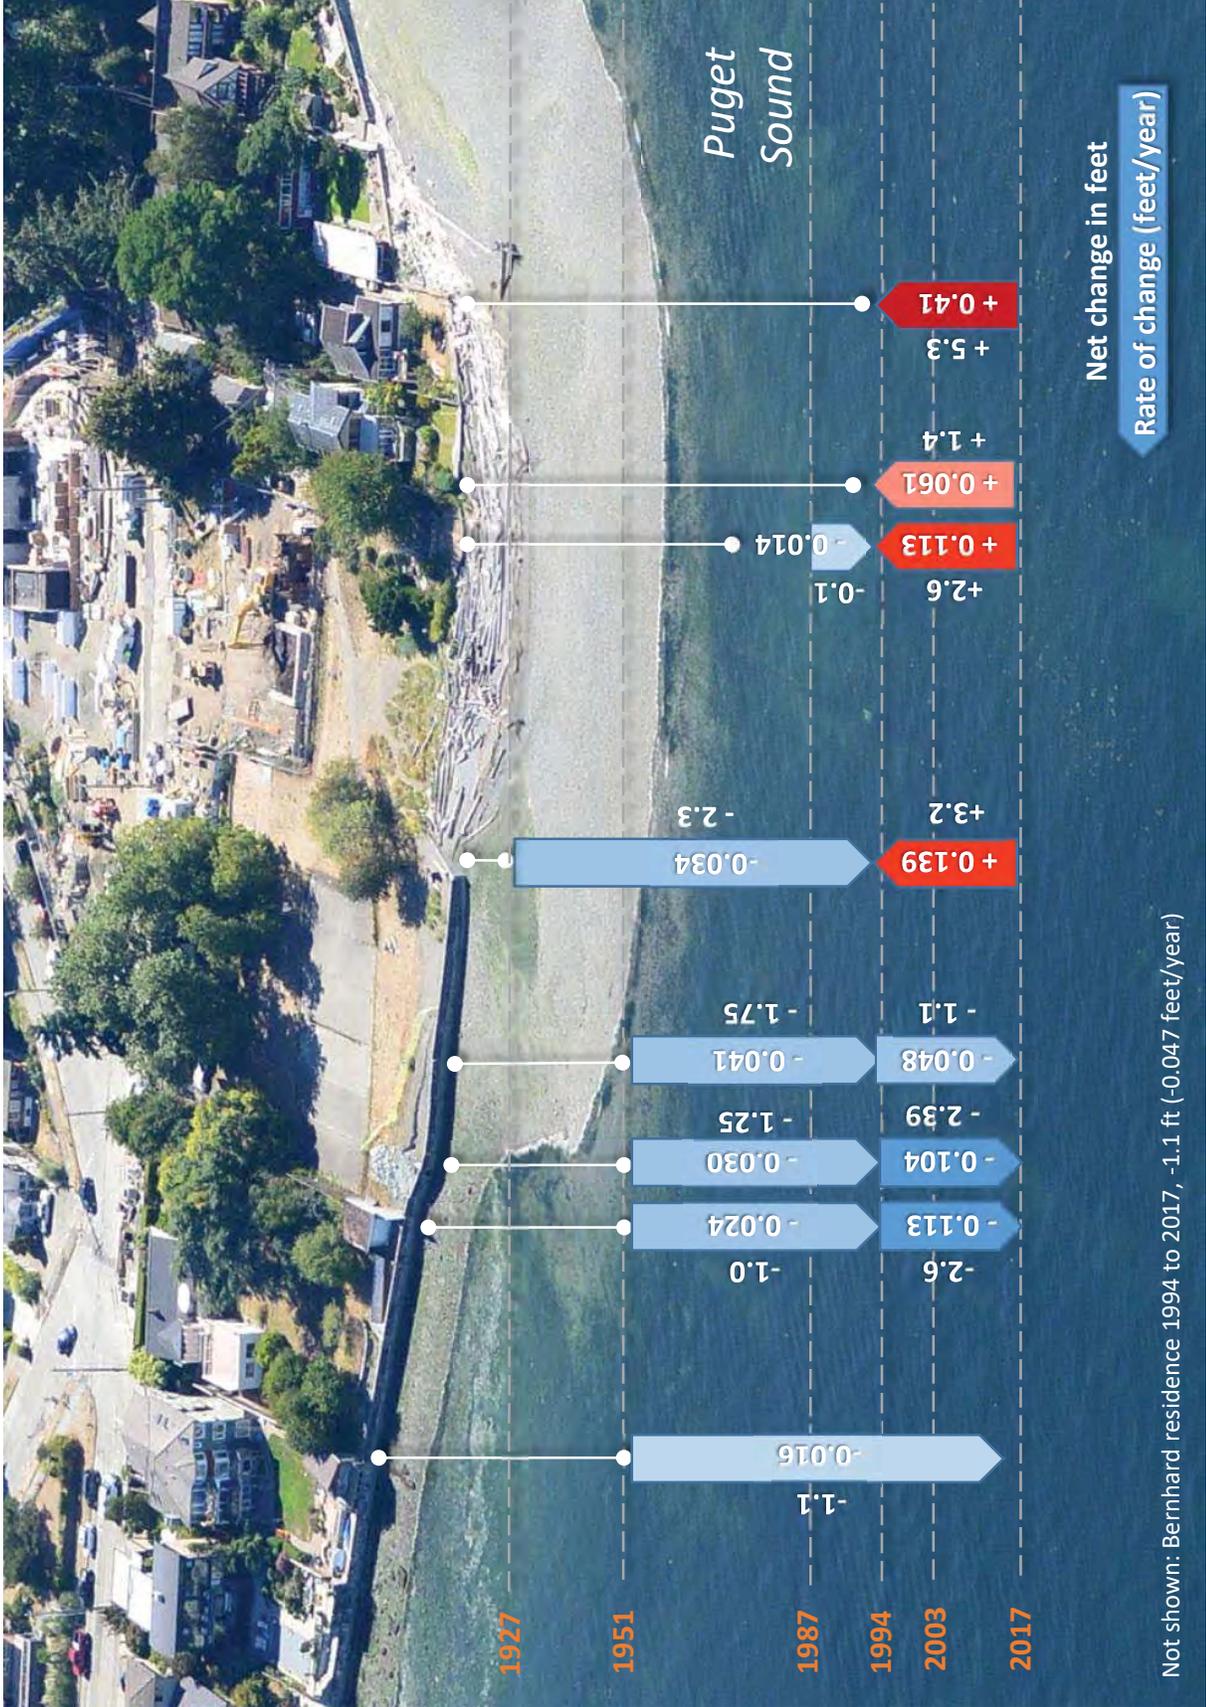
Not shown: Bernhard residence 1994 to 2017, -1.1 ft (-0.047 feet/year)

- Notes: 1. Positive values (red) indicate accretion, negative values (blue) indicate erosion
- 2. Beach restoration occurred in 1995.

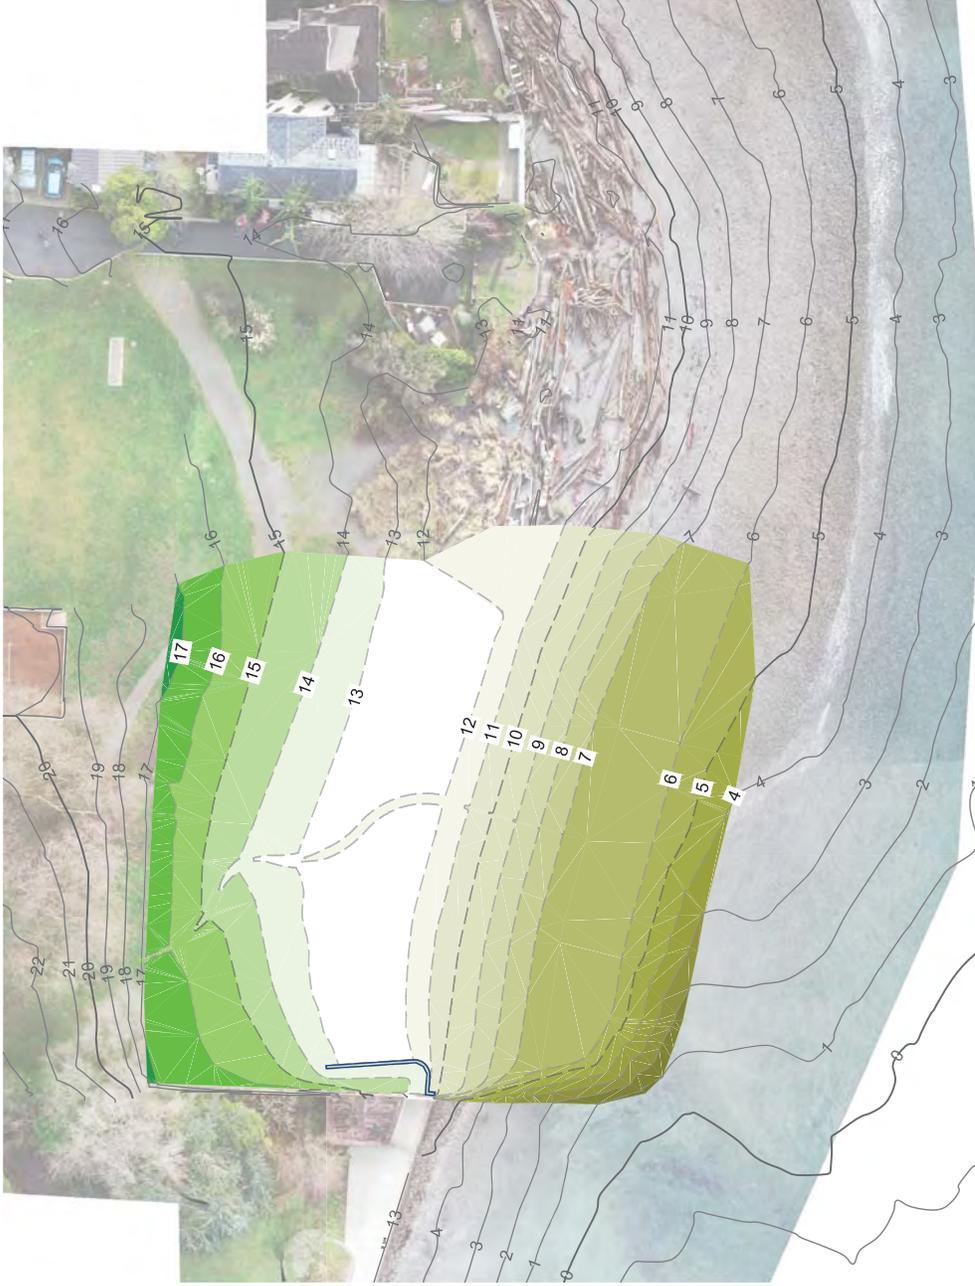
Lowman Beach Park - Shoreline Restoration
Figure 4-1
Beach Nourishment
Plan View

MIN ELEV	MAX ELEV	COLOR
0.0	1.0	[Dark Green]
1.0	2.0	[Medium-Dark Green]
2.0	3.0	[Medium Green]
3.0	4.0	[Light-Medium Green]
4.0	5.0	[Light Green]
5.0	6.0	[Very Light Green]
6.0	7.0	[Pale Green]
7.0	8.0	[Very Pale Green]
8.0	9.0	[Off-White]
9.0	10.0	[Lightest Green]
10.0	11.0	[White]
11.0	12.0	[Very Light Green]
12.0	13.0	[Light Green]
13.0	14.0	[Medium Green]
14.0	15.0	[Medium-Dark Green]
15.0	16.0	[Dark Green]
16.0	17.0	[Very Dark Green]
17.0	18.0	[Darkest Green]
18.0	19.0	[Black]

The proposed beach nourishment would be approximately 200 ft long and contemplates placing approximately 1,800 CY of native material back into the littoral system. **Figure 4-1** shows a plan view of the proposed beach grading. The beach profile has been designed to be constructed/restored as far seaward as possible such that an erosion response is elicited after initial construction rather than accretion as occurred after 1995. The beach profile after construction is shown in **Figure 4-2** (top). The width of the backshores varies from 20-30 ft, and it goes from El 12.5 ft to El 12.0 ft. The beach foreshore goes from El. 12.0 to El 6.0 ft in a slope

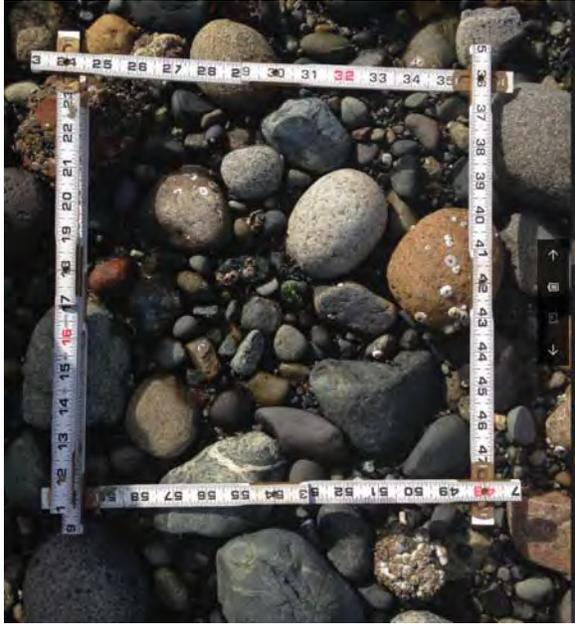
Beach Toe - Cobble and Gravel

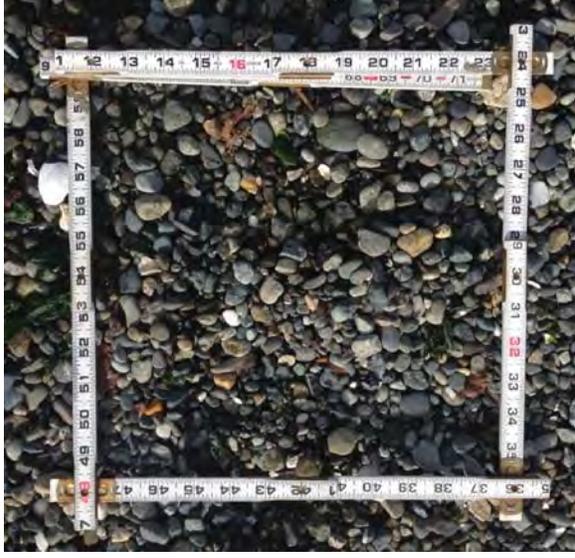
Foreshore - Mix Gravel and Coarse Sand

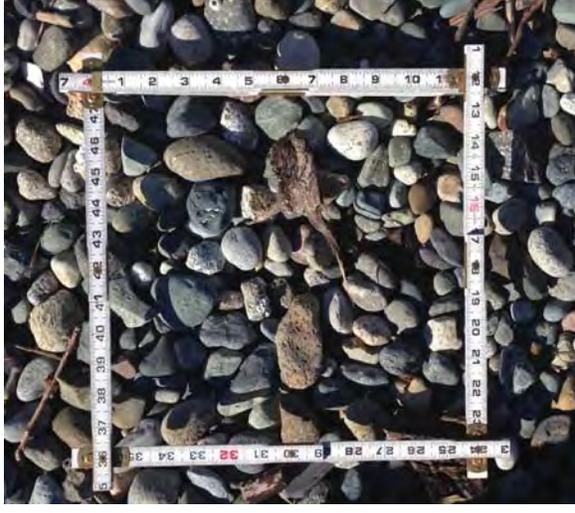
Backshore – Coarse Gravel

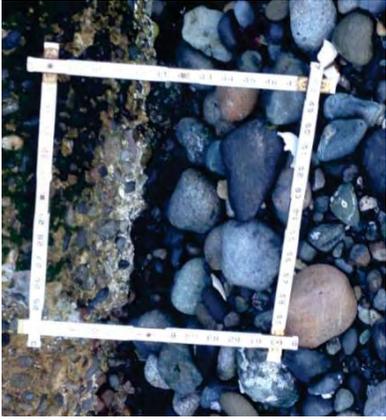
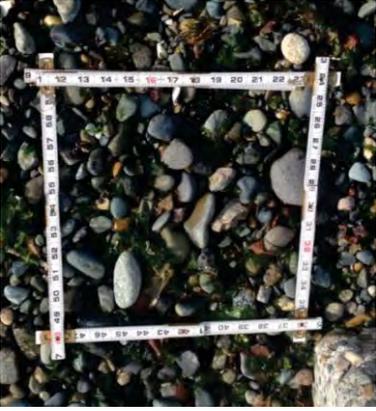
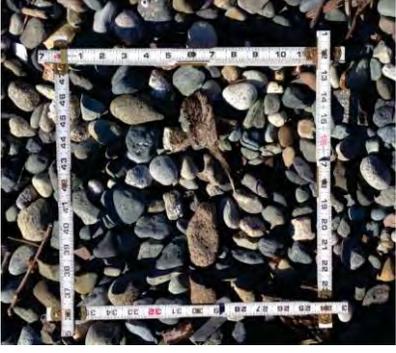
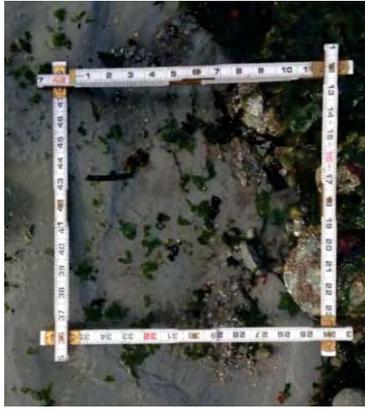
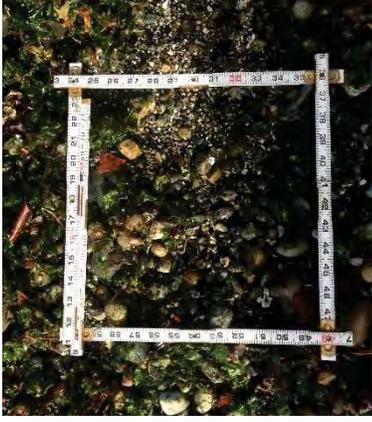
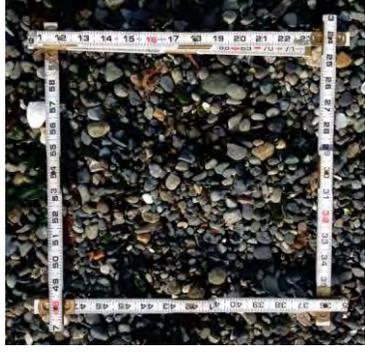
Lowman Beach Park Feasibility Study, D160292.00
Figure 10
 Sediment Size & Distribution

A. Private seawall toe cobble north of park

B. Gravel upper foreshore at wing-wall

C. Gravel backshore at south end of park

D. Exposed clay & cobble at north end of park

E. Small gravel foreshore and wrack

F. Gravel foreshore in central beach

ESA observed widely variable sediment size distributions alongshore and offshore of the project site. Sediments generally coarsen from south to north, with sandy gravel at the south end of the park transitioning to larger gravel and cobble at the north end of the park. Coarse surface gravels compose the lower foreshore and offshore areas out to MLLW. Beaches north of the park are characterized by large gravel and cobble at the surface, and in some cases underlain by grey clay. Some pockets of sand and smaller gravel are present north of the park in the lee of concrete steps and ramps that protrude out from seawalls. Beaches south of the park generally consist of smaller surface gravel and higher percentage of sand. Figure 10 depicts typical surface sediment size from north (left) to south (right) in the park vicinity. In surface sediments dominated by gravel, sand mixed with gravel, silt, and shell can typically be found just below the surface.

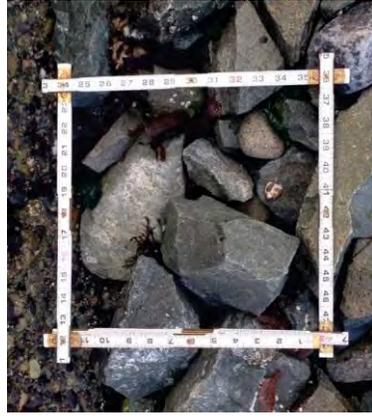
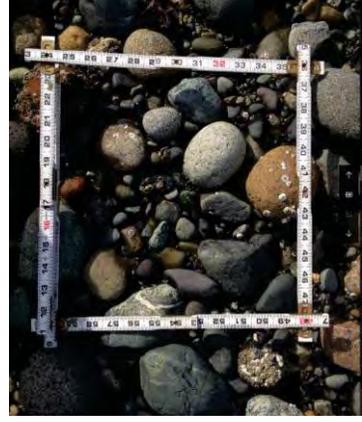
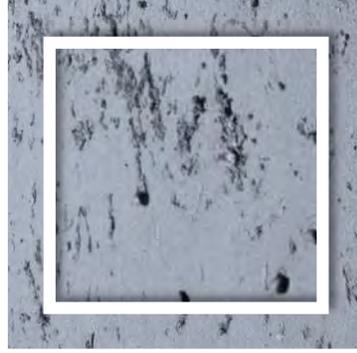
G. Quarry spalls at north park boundary

H. Cobble/gravel lower foreshore at park

I. Sandy beach 165 feet southeast of park

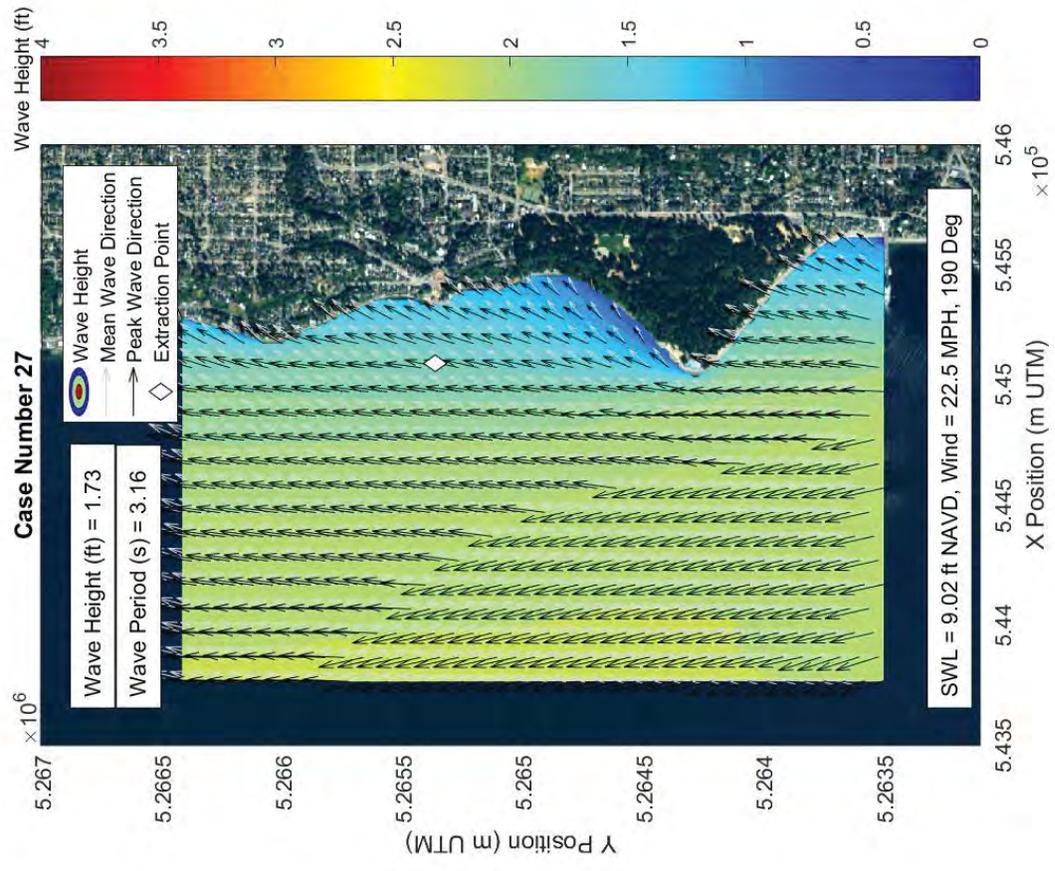
(A) Waves from South

Wind waves are the primary driver of sediment transport on Puget Sound beaches, however wave measurements are not available at the project site. Therefore, ESA employed numerical methods to simulate wave conditions in the vicinity of Lowman Beach Park. To model wind-waves at the site, ESA applied the industry-standard SWAN model (Deltares 2011). Modeling was accomplished by developing three scaled grids of Puget Sound (Figure 13) and the project area. The largest SWAN grid accounts for wave growth and propagation throughout Puget Sound, while the smaller grids simulate the localized effects of bathymetric variation and wave sheltering. Example modeling results for winds from the north and south cases are provided in Figure 14.

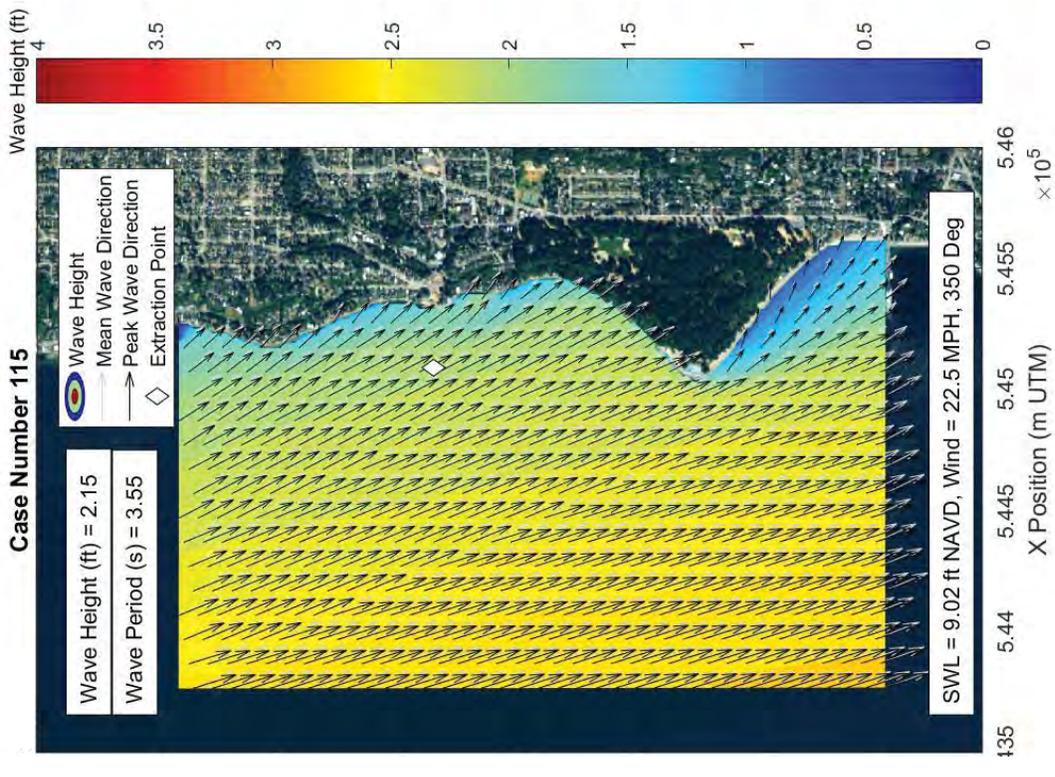
(B) Waves from North

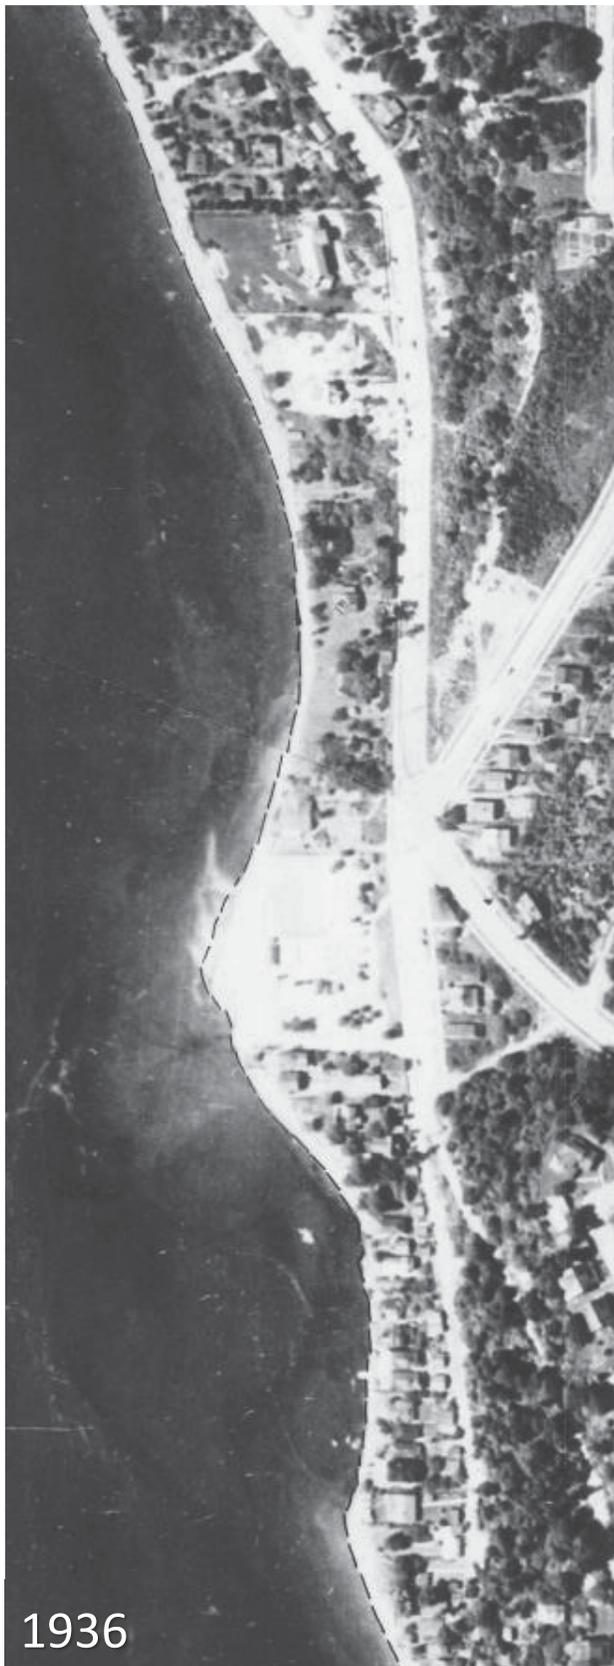
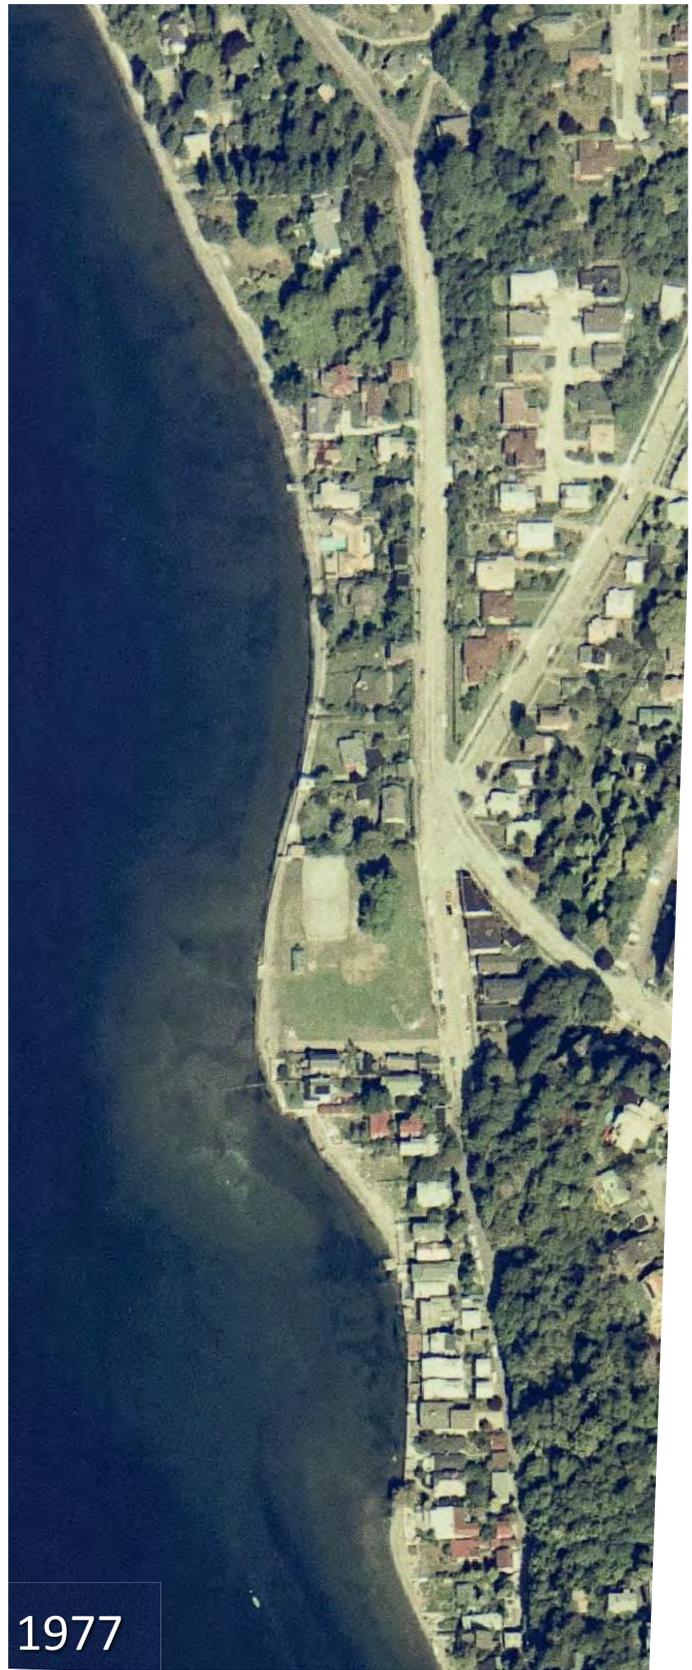
Figure 17
Comparison of Aerial Photographs
from 1936 and 1977

1936

1977

Erosion at Loman Beach Park is evident from review of the available topographic data and photographs dating back to the late 1920s. Figure 17 & 18 provides photographic comparisons of the shorelines from 1936 to present time, for reference. While historic data are sparse, the information available supports the concept that erosion has been occurring at Lowman Beach Park (and presumably adjacent areas) since the seawall improvements were originally completed in 1936. Table 5 provides a summary of data and interpretation of beach elevation changes and Figure 19 presents the rates of change in a visual manner within the park vicinity. Beach restoration at the south end of the park was completed in 1995 and design surveys from 1994 are a primary source for computing historic and recent rates of erosion. Historic erosion rates (prior to 1994) are estimated to average about -0.025 feet/year whereas after 1994, rates averaged -0.078 feet/year. Therefore, it appears that average erosion rates are higher during the recent period, when compared to rates before 1994. For reference, Figure 20 provides the visual estimate of beach elevation change at the Bernhard residence (400 feet north of the park) referenced in Table 5.

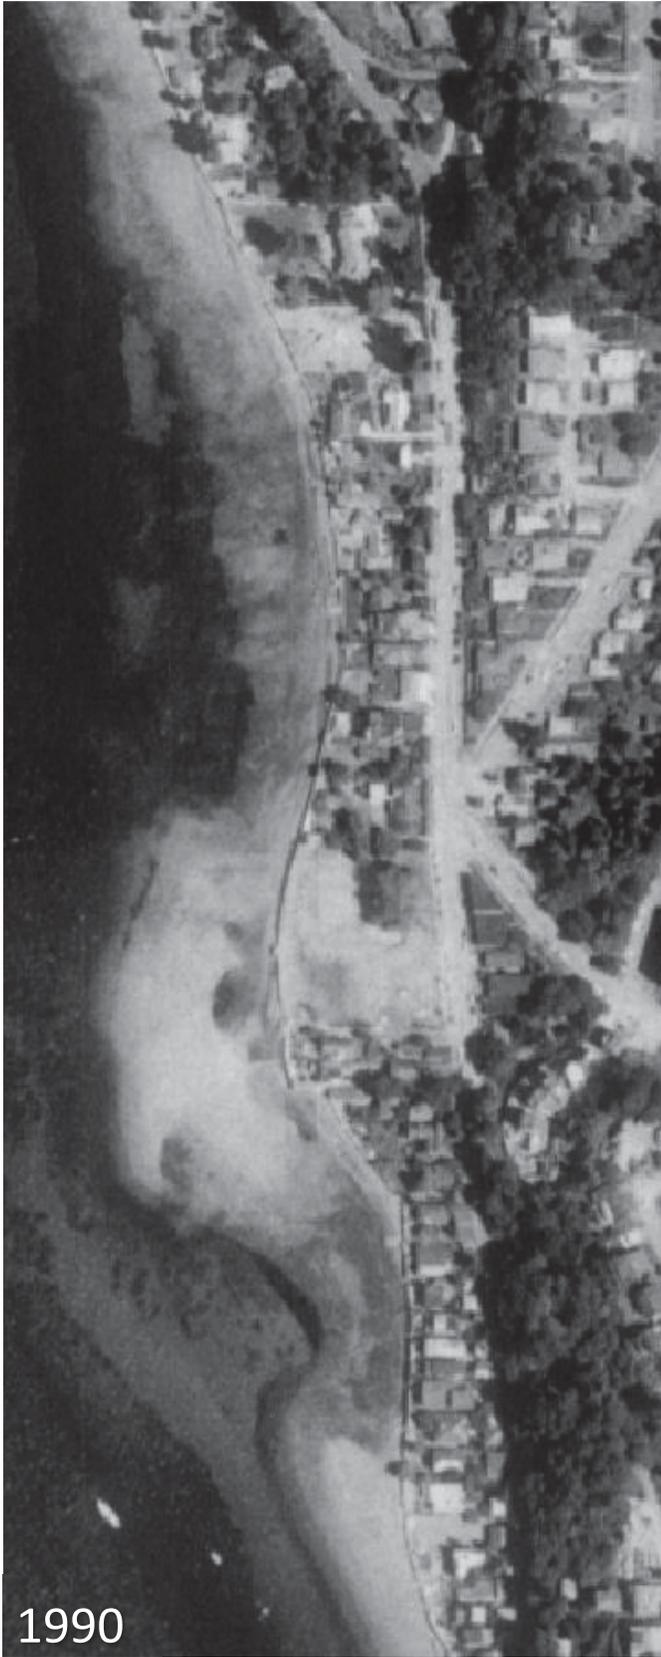
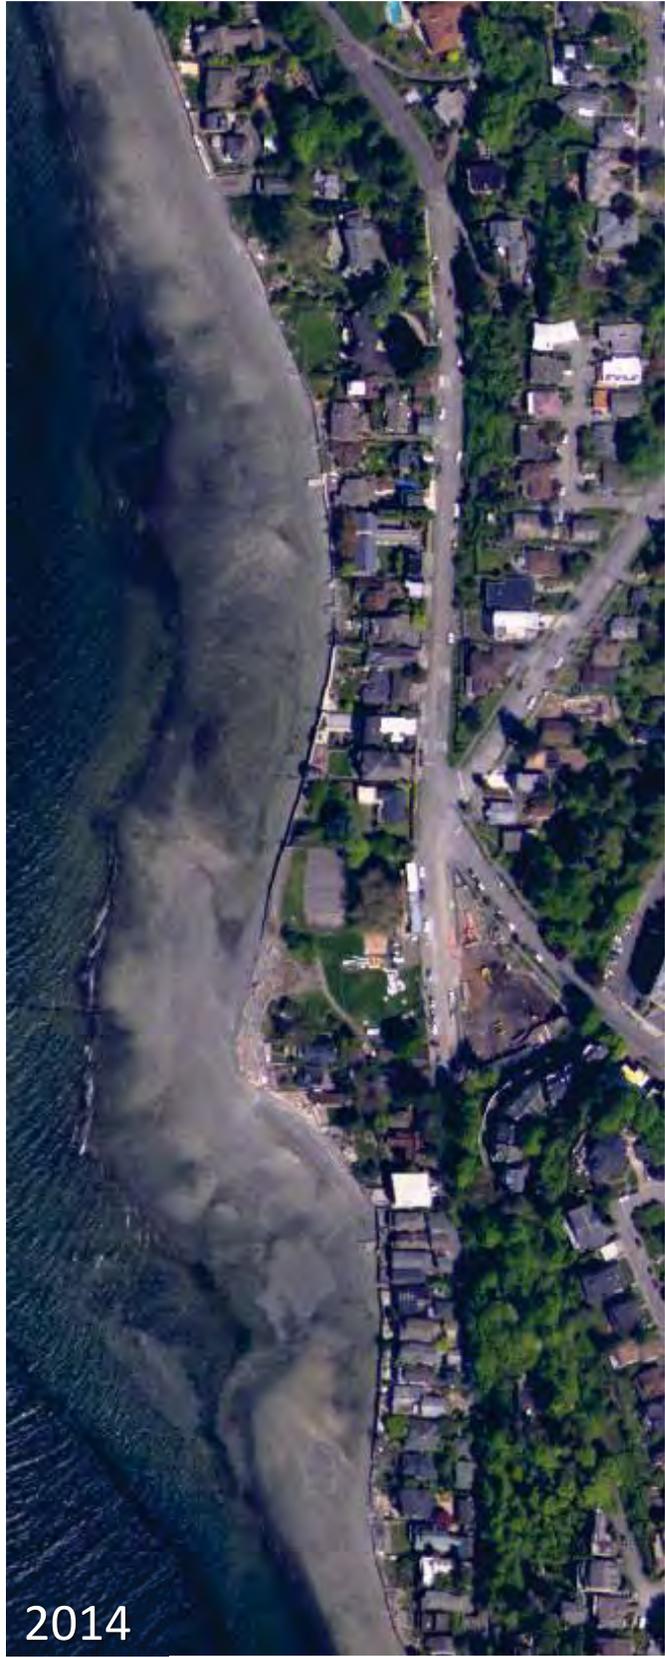
Figure 18
Comparison of Aerial Photographs
from 1990 and 2014

1990

2014

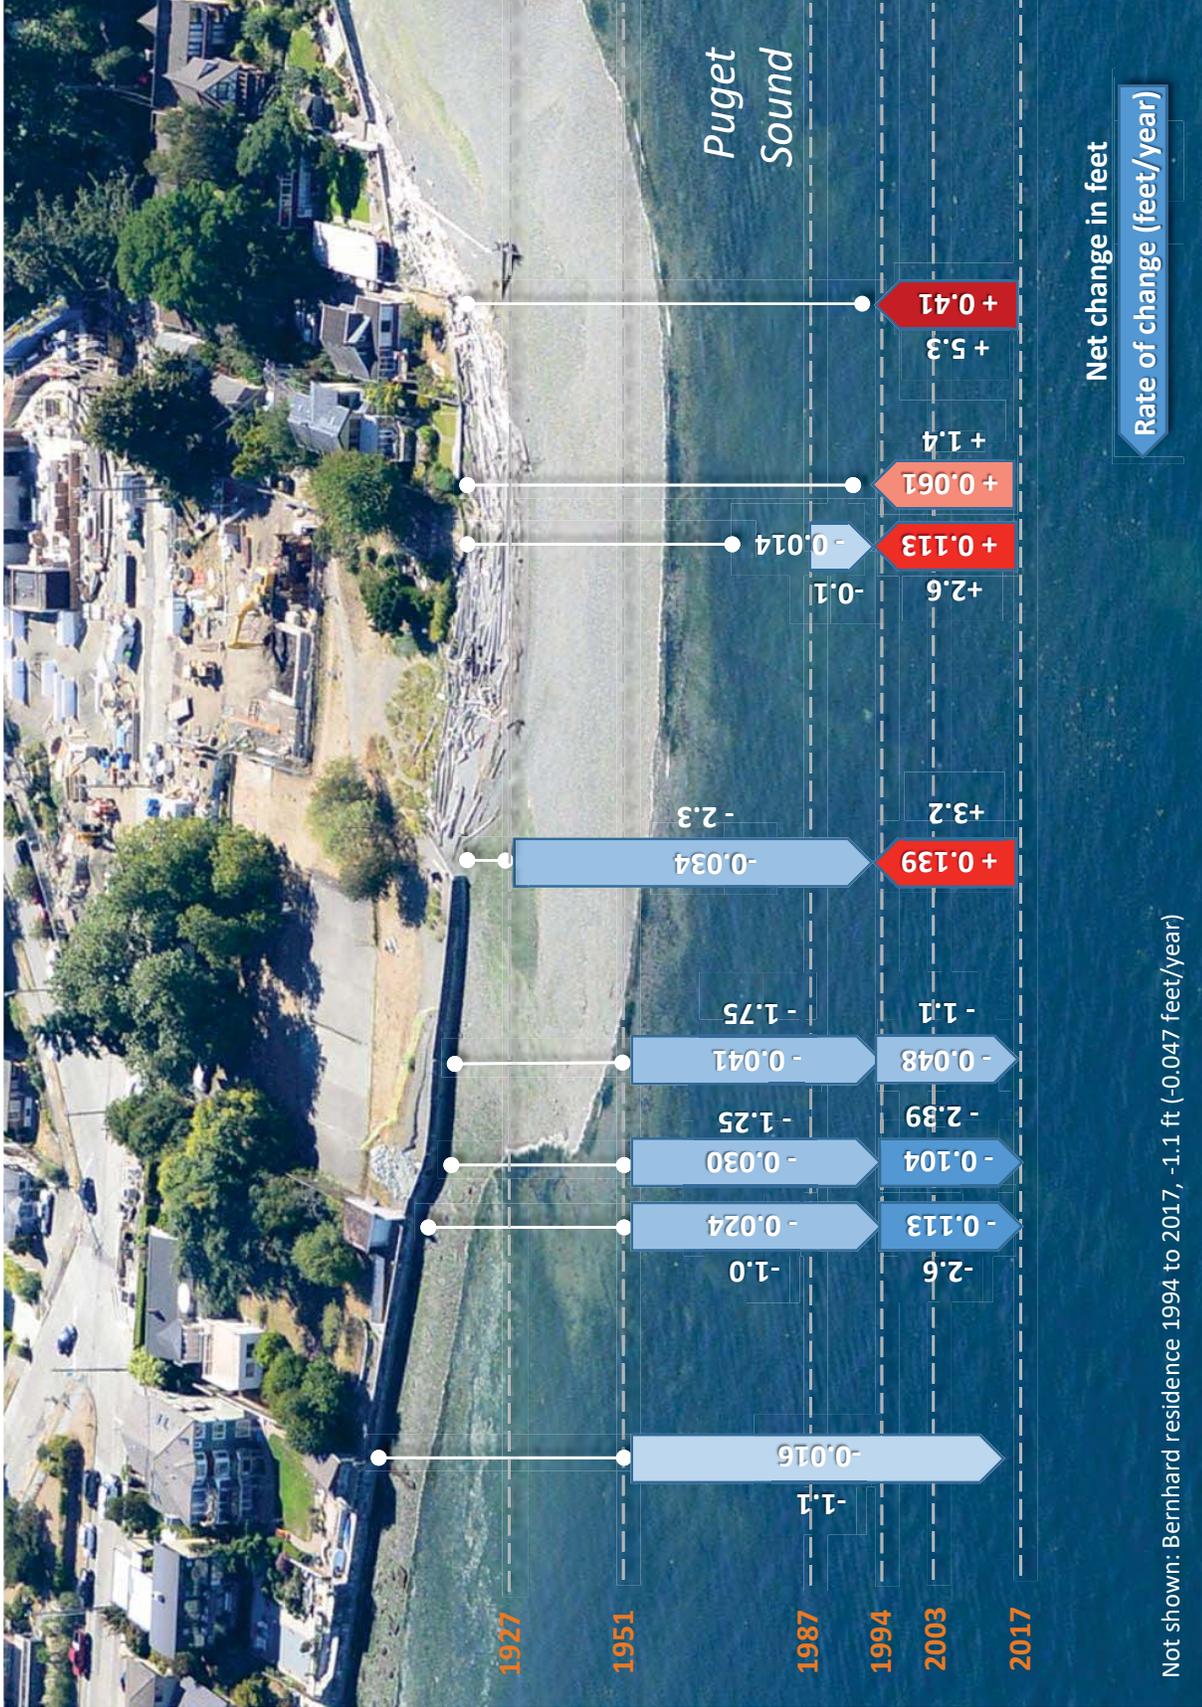
Not shown: Bernhard residence 1994 to 2017, -1.1 ft (-0.047 feet/year)

- Notes:
1. Positive values (red) indicate accretion, negative values (blue) indicate erosion
 2. Beach restoration occurred in 1995.

From 1994 to 2017 the beach grades at the north end of park lowered by almost 3 feet. At the middle point of the existing seawall, beaches grade lowered by about 1.5 feet. In the restored beach area, accretion (rising elevations) has occurred near the existing return wall and restored beach to the south of the seawall. Beaches immediately to the north of the park have continued to experience erosion from 1994 to 2017. Based on limited data, beach elevations at the toe of seawalls north of the park are estimated to have lowered by 1.0 to 2.5 feet during this period, with the most pronounced erosion occurring immediately north of the park and diminishing further to the north. Beaches to the north of the park have also lost the veneer of sand that was present near the toe of bulkheads in historical photos from 1993 and ground-level photos from 1994. Areas of grey clay are exposed at the surface, making fine sediment and small gravel deposition unlikely. Approximate beach elevation derived from LiDAR survey data near structure toes north of the park is depicted in Figure 21.

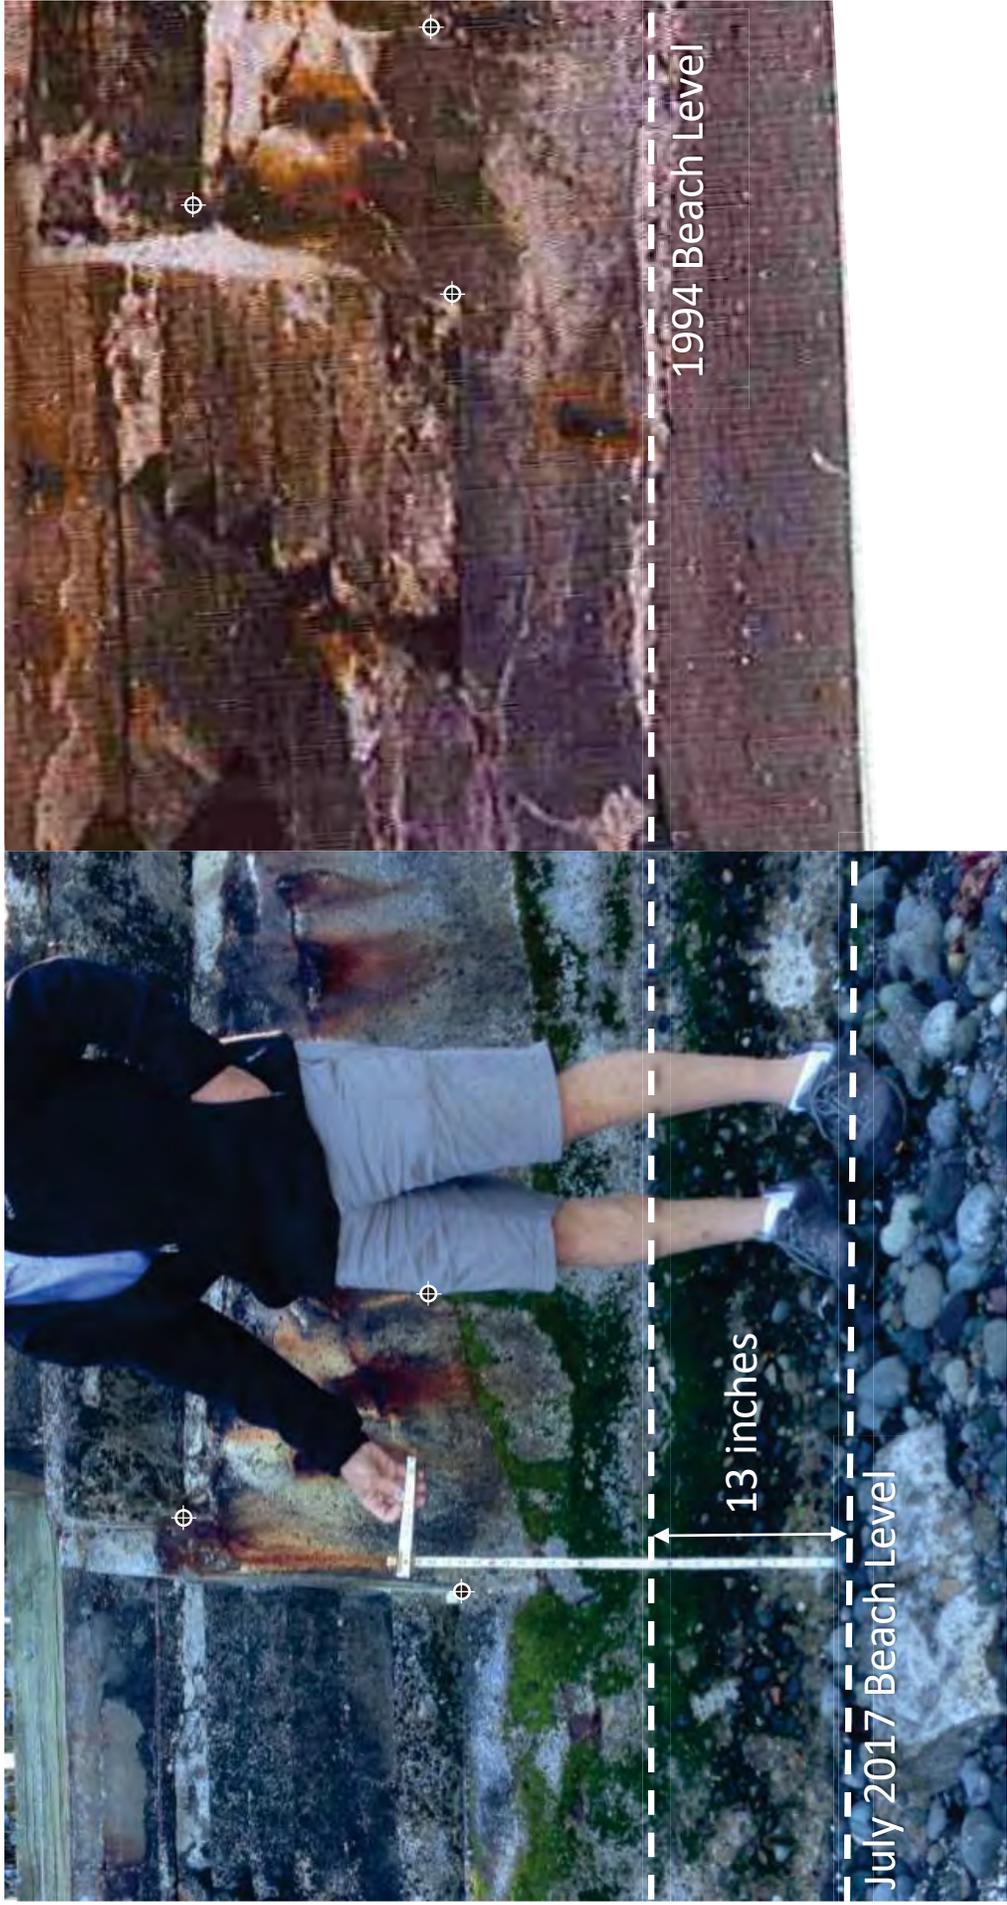
Figure 20
 Comparison of Ground Photos of Beach
 Level at 6751 Beach Dr. SW

SOURCE: ESA 2017 (photo to left). J. Bernhardt 1994 (photo to right).

9.9 feet. Higher beach grades (about 3 feet) at the south end of park are apparent before wall removal. Bernhard residence beach elevation photograph is available circa this year (see Figure 20).
2000	LiDAR data flown at mid-high tide obscures beach elevations along structure toes, except at the south boundary where elevations were in the range of 10.0 to 10.5 feet.
2003	LiDAR survey flown using water-surface penetrating technology does not provide adequate survey density north of the park. At south property boundary, EL. 10.0 to 10.5 feet.
2016	King County LiDAR indicate an accreting beach from 2003 to 2016 within the south portion of the park and on private properties to the south of the park. Elevations increased by approximately 6 feet to south of the park and beach increased elevation and extents. Data are inconclusive north of the park due to tide conditions in 2000 survey and sparse coverage in 2003 but trends of beach erosion from 1994 to present are suspected per residents comments, site observations, and photographs.

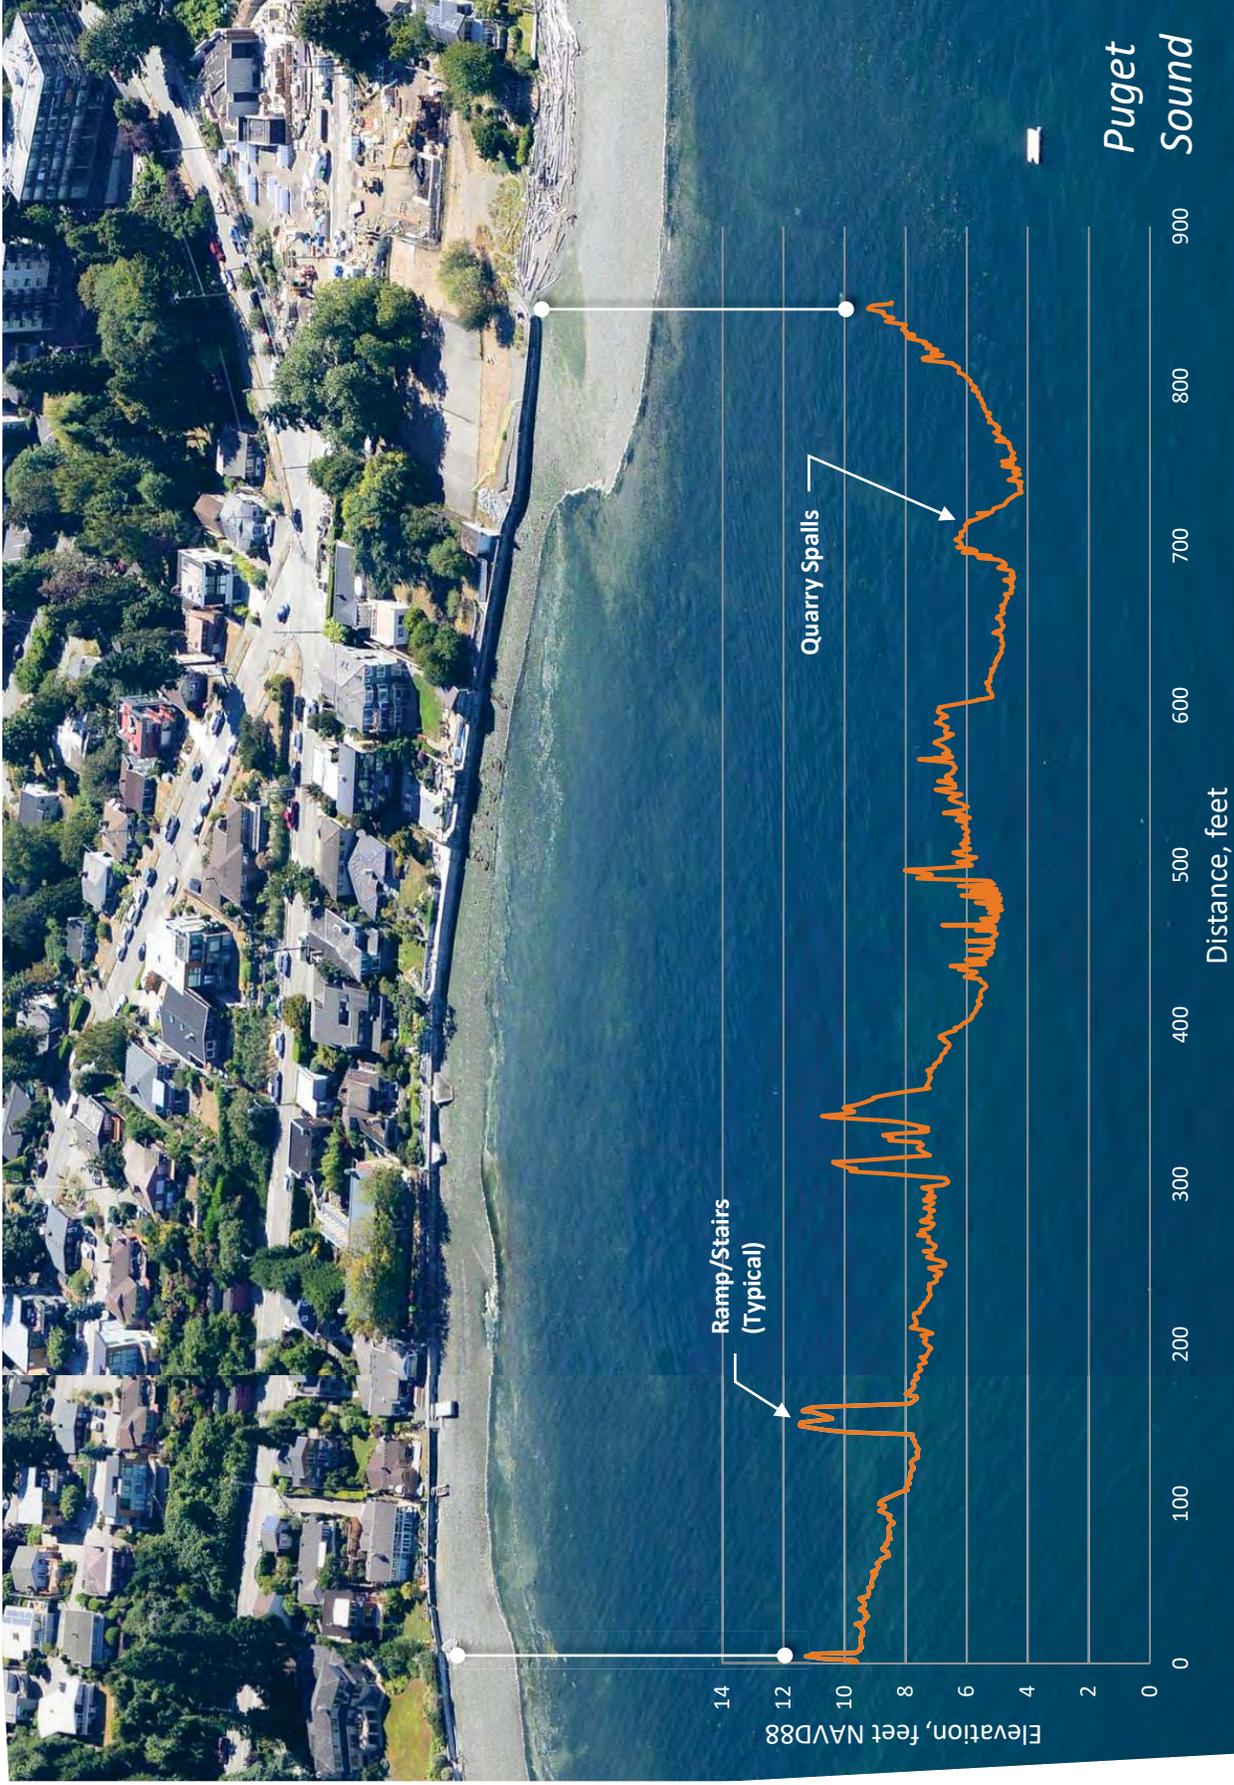
Figure 21
 Beach Elevation Near Structure Toe
 from 2016 King County LiDAR

SOURCE: Photo by Dept. of Ecology 2016. Elevation data adapted from King County LiDAR 2016.

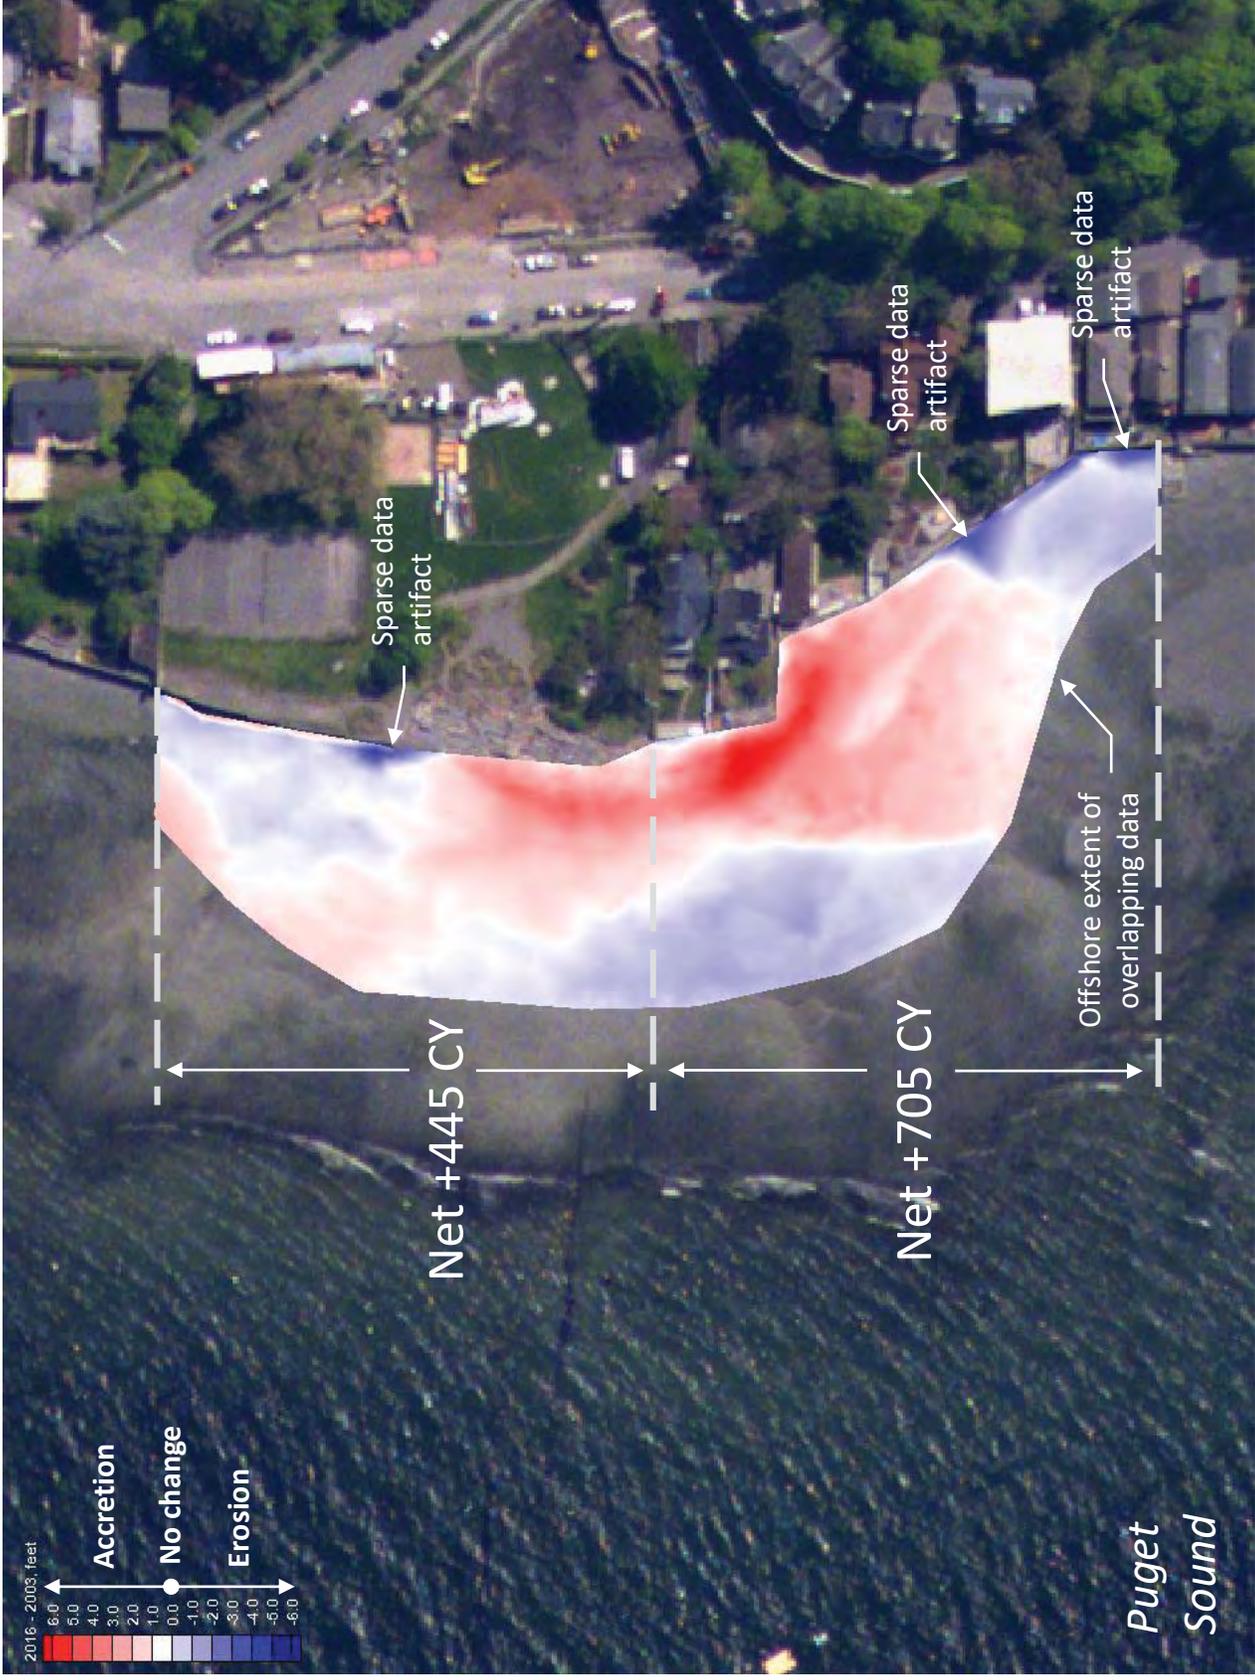
SOURCE: USACE 2003 LiDAR, King County 2016 LiDAR
 Notes: LiDAR accuracy ±0.5 ft; surface difference accuracy ±1.0 ft.

Lowman Beach Park Feasibility Study, D160292.00
Figure 22
 Elevation change from 2003 to 2016

From 1994 to 2017, properties the south of the park have experienced accretion of more than 6 vertical feet in some areas, where the beach has built out seaward and elevated. Comparison of LiDAR surveys from 2003 to 2016 confirm accretion on beaches fronting the park and properties to the south; net increase in beach sediment volume in the park vicinity is approximately 1,150 cubic yards (CY) during this period. Figure 22 depicts the location and magnitude of beach elevation change and net volumetric change from 2003 to 2016 where red indicates accretion, and blue erosion. Approximately 60 percent of the accreted beach sediment has deposited south of the park. The source of the accreted sediments has not been definitively determined but likely includes a combination of sediment supplied from beaches located to the south at Lincoln Park, offshore sediments redistributed landward onto the beach, and sediments from north of the park.
