LOWMAN BEACH PARK SHORELINE RESTORATION

Draft 60% Design Report

Prepared for
Seattle Parks & Recreation Department

June 2019

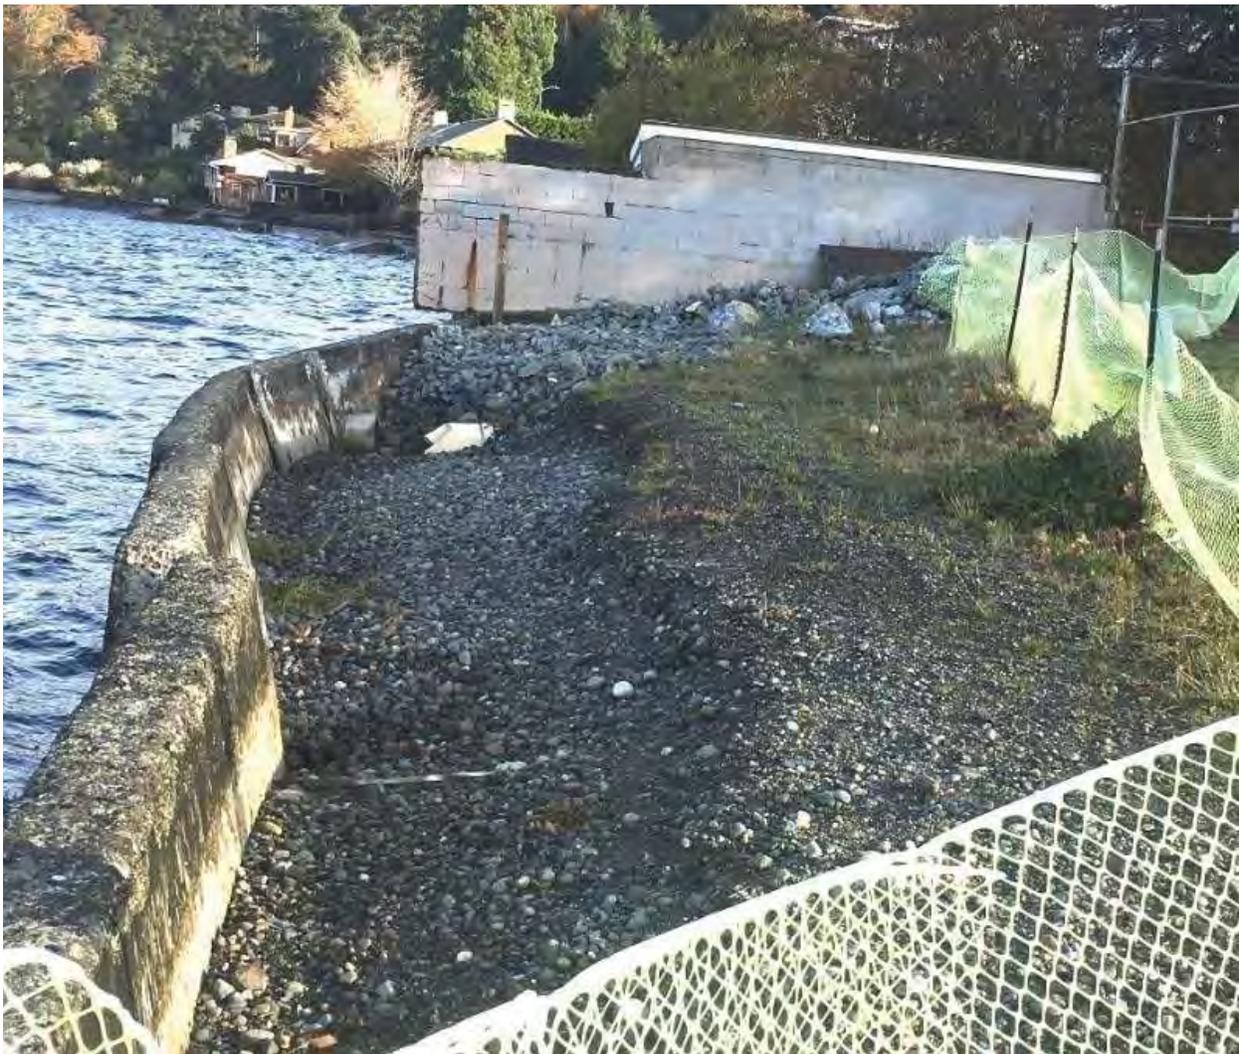
Figure 1. Failed Seawall (Photo taken on 10/18/2016).

Lowman Beach Park is located within the city of Seattle, Washington, and is operated by the City of Seattle Parks and Recreation Department (Seattle Parks & Rec). The park consists of a seawall, a beach, and an uplands area containing a tennis court. The seawall had a notable failure near its northern end (see Figure 1), and Reid Middleton was asked to perform a condition assessment of the entire length of seawall.

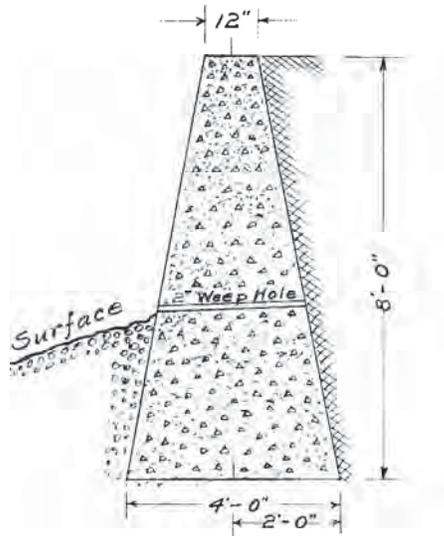
SECTION "A-A" - NEW WALL

Figure 3. 1951 Seawall Design, Zones A-B through P-Q.

Structures of this type would typically be anticipated to have a thirty to fifty year design life. In the case of the Lowman Beach Seawall, the wall has aged beyond its anticipated service life. Drawings from 1951 show a few feet of beach material above the toe of the seawall which is now exposed, causing undermining at some locations. This undermining caused a loss of global stability and partial collapse. The portions of the seawall constructed around 1951 are beyond their anticipated service life, and if re-used as part of a seawall replacement project, they may have a service life less than the other new project elements.

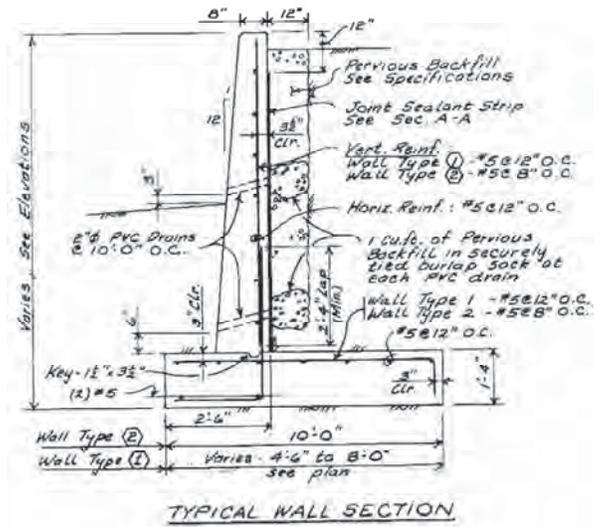
TYPICAL WALL SECTION

Figure 4. 1995 Seawall Design, Zone R-S.

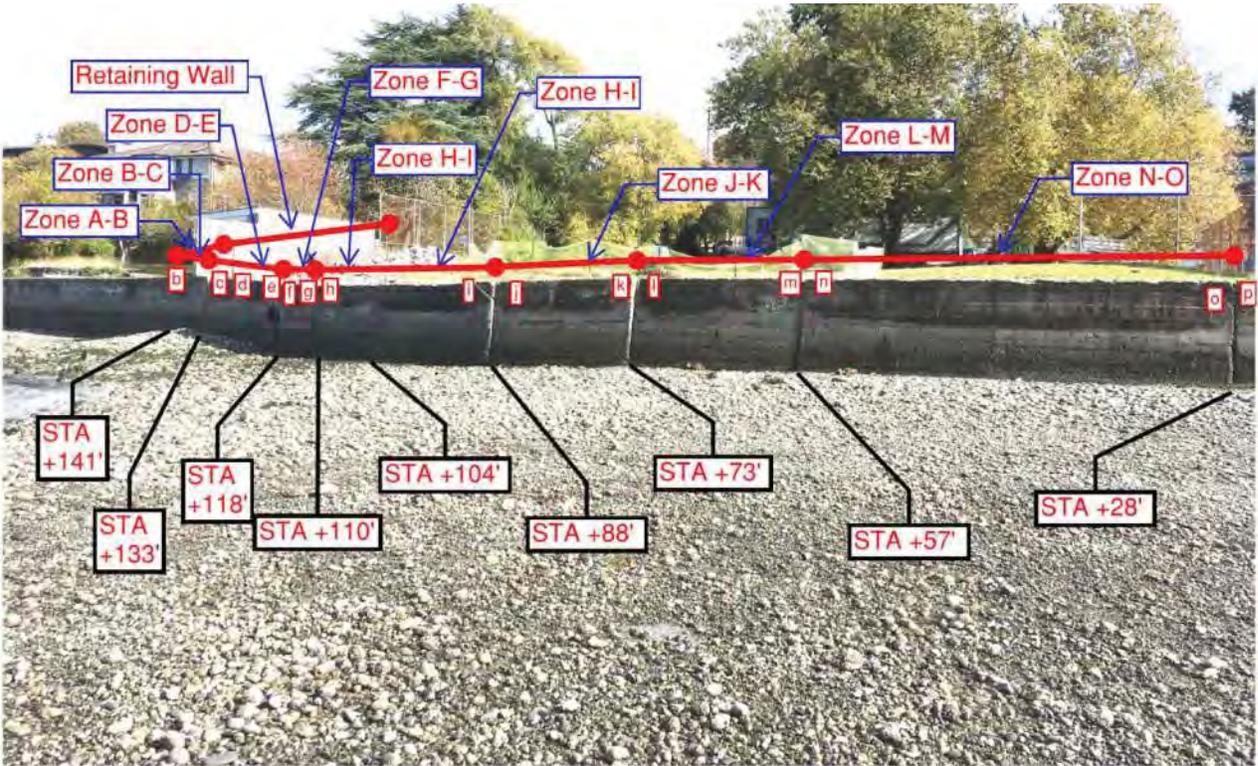
Photo 1. North Portion of Seawall.
 Source: Reid Middleton Site Visit 10/18/2016
 Note: Dimensions roughly field measured – for assessment purposes only.

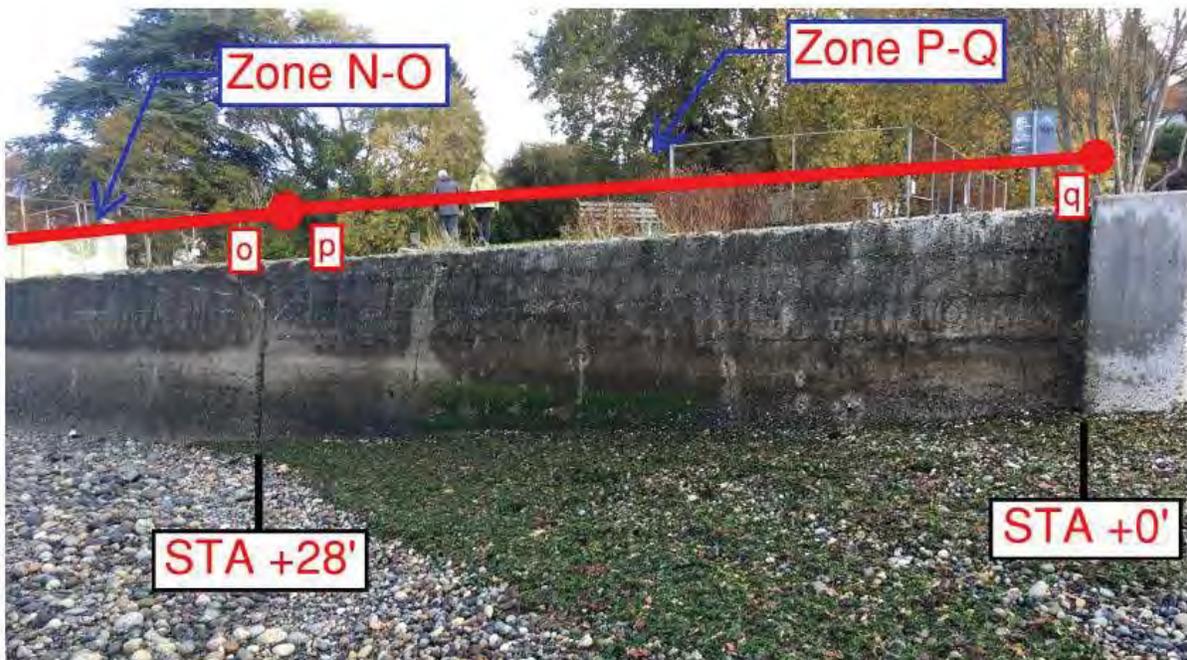
Photo 2. South Portion of Seawall.
 Source: Reid Middleton Site Visit 10/18/2016
 Note: Dimensions roughly field measured – for assessment purposes only.

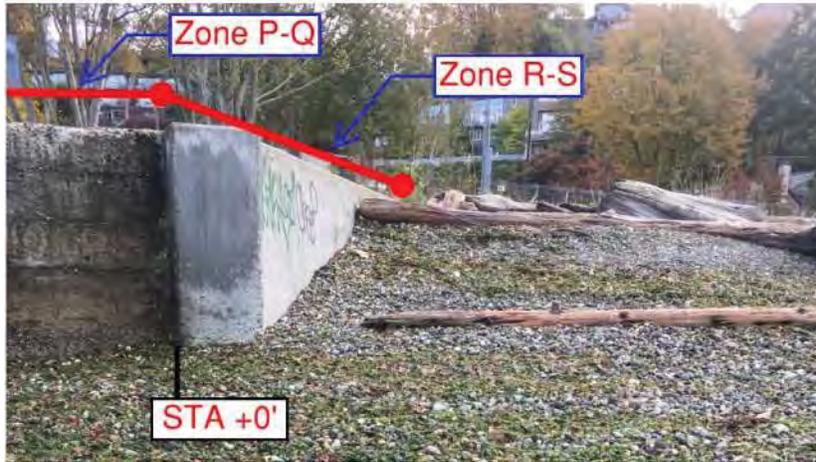
Photo 3. Southern Seawall Return.
Source: Reid Middleton Site Visit 10/18/2016

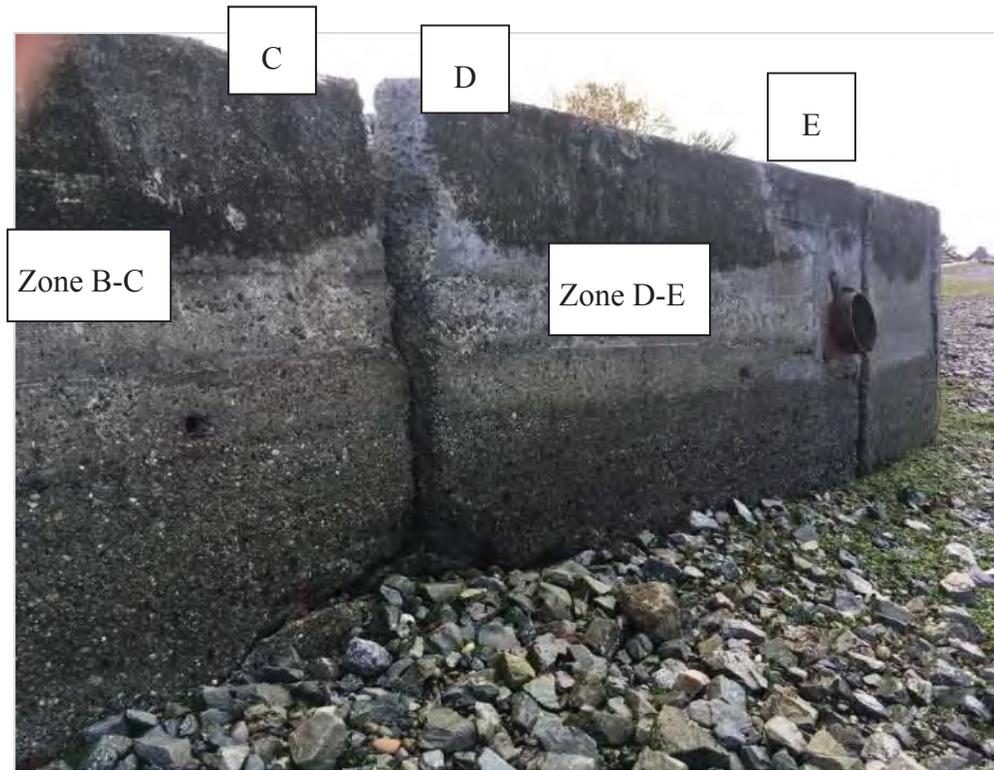
Photo 11. Zones B-C & D-E, Outfall.
Source: Reid Middleton Site Visit 10/18/2016

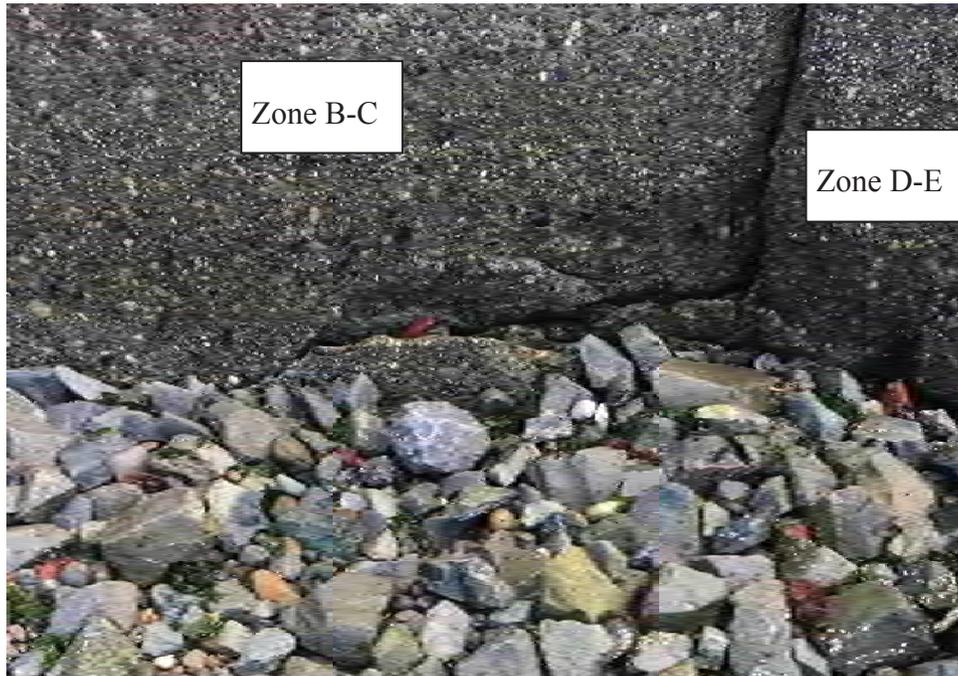
Photo 13. Zones B-C & D-E, Beach Material.
 Source: Reid Middleton Site Visit 10/18/2016

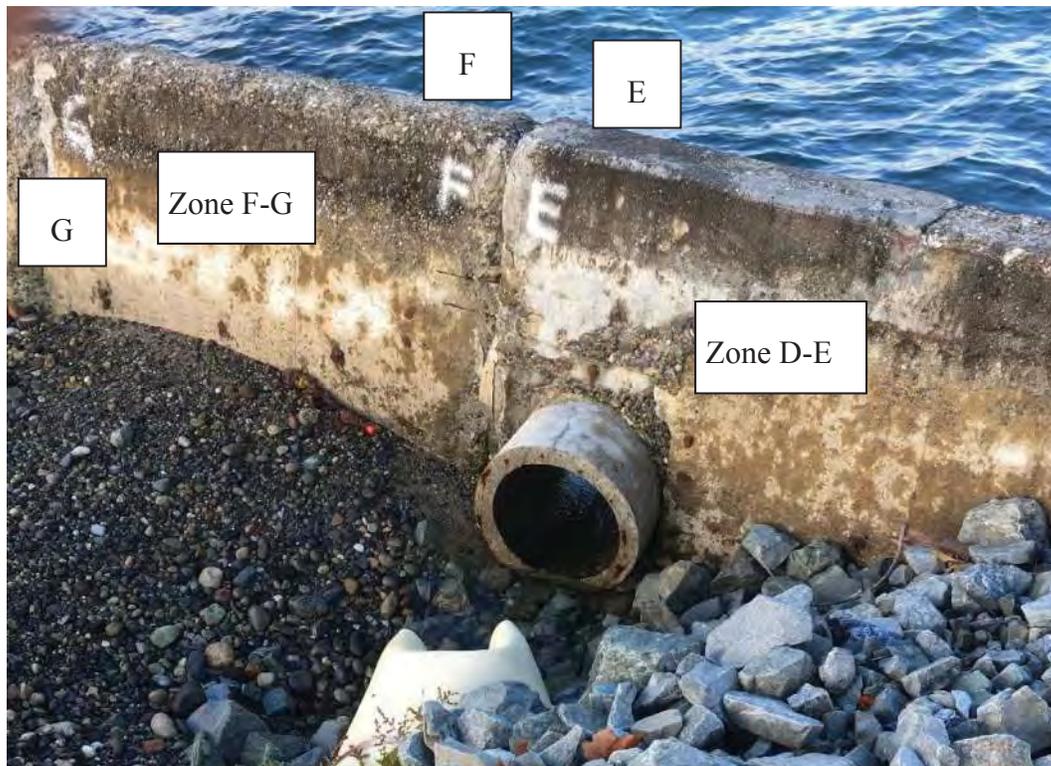
Photo 16. Zones D-E & F-G, Broken Outfall.
 Source: Reid Middleton Site Visit 10/18/2016

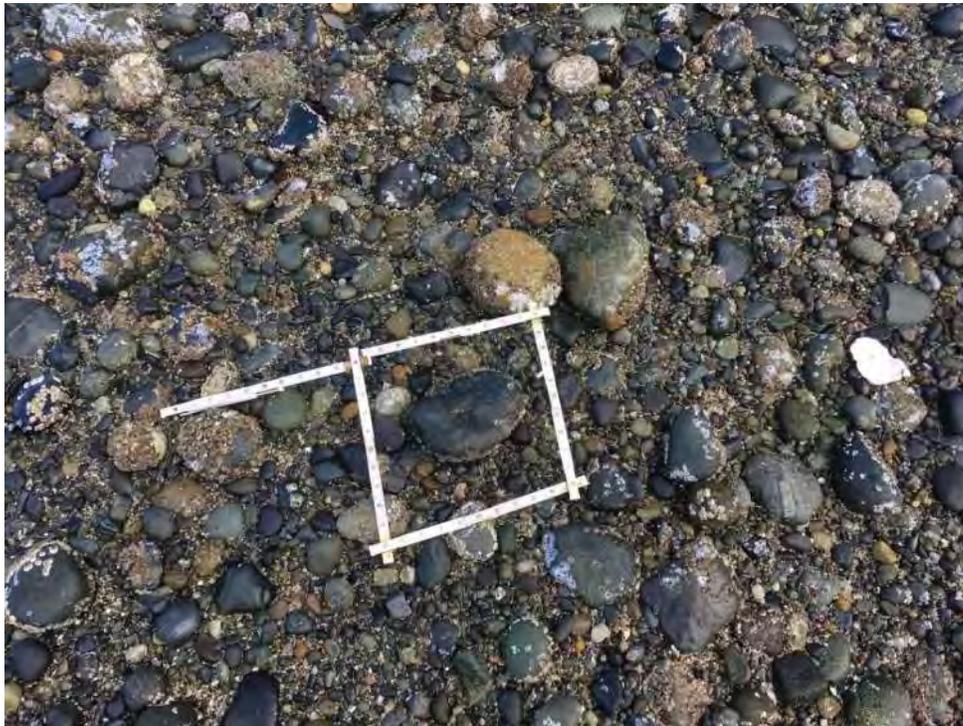
Photo 20. Beach Material at Zone J-K.
Source: Reid Middleton Site Visit 10/18/2016

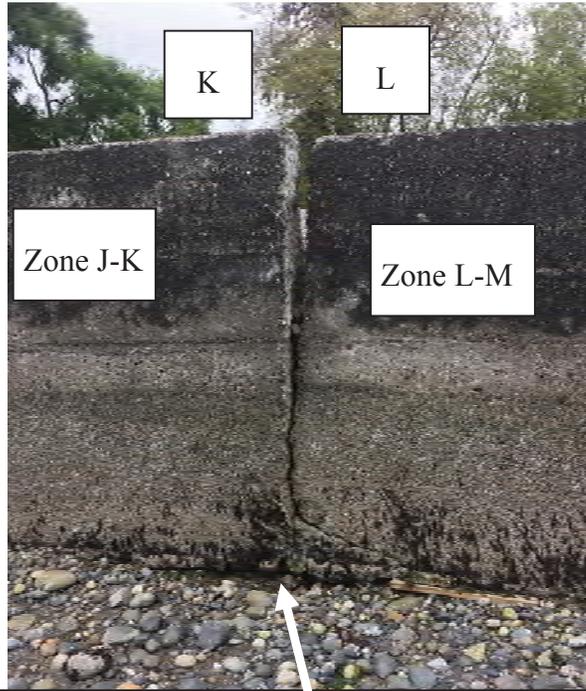
Photo 23. Zone J-K & L-M.

Additional undermining since 10/18/2016 visit

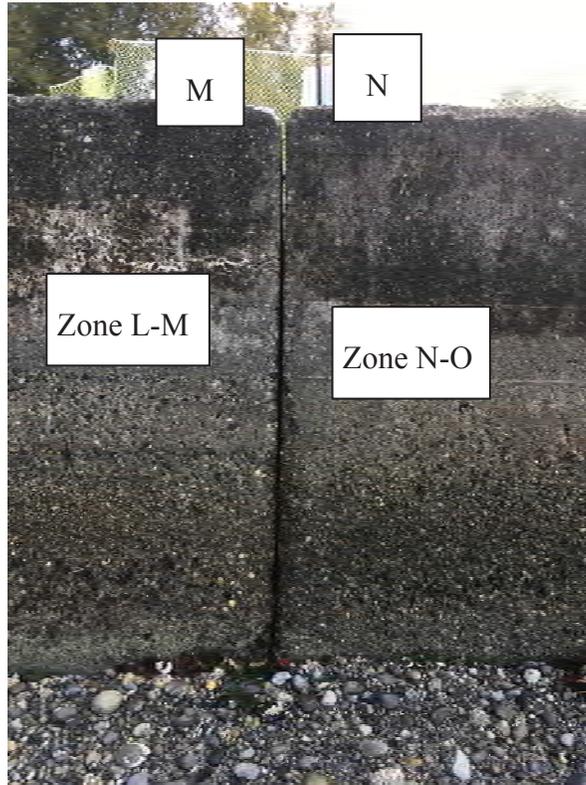
Photo 25. Zones L-M & N-O.
Source: Reid Middleton Site Visit 10/18/2016

Photo 25. Zones L-M & N-O.
Source: Reid Middleton Site Visit 10/18/2016

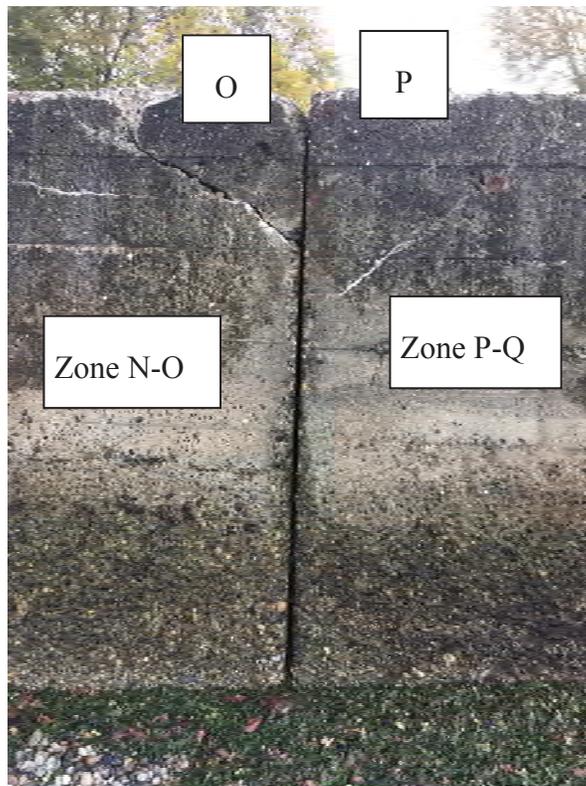
Photo 26. Zones N-O & P-Q.
Source: Reid Middleton Site Visit 10/18/2016

Photo 26. Zones N-O & P-Q.
Source: Reid Middleton Site Visit 10/18/2016

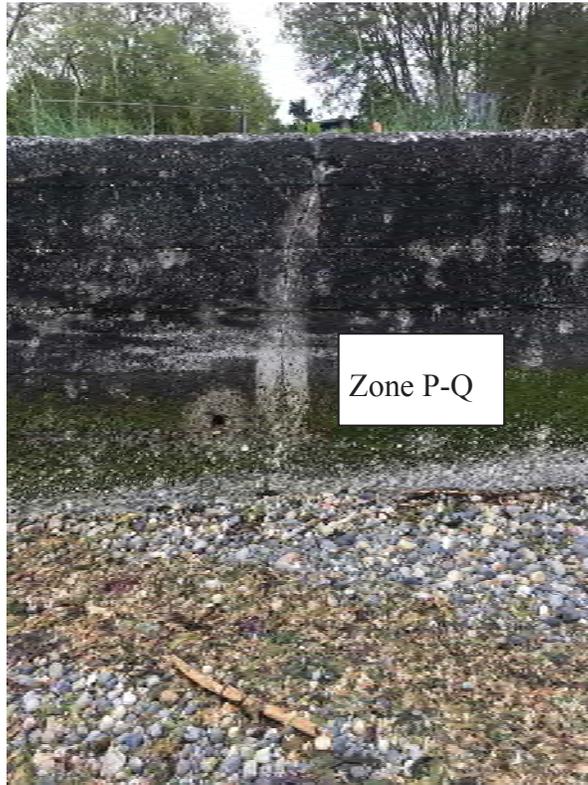
Photo 27. Zone P-Q.
Source: Reid Middleton Site Visit 5/31/2017

Photo 27. Zone P-Q.
Source: Reid Middleton Site Visit 5/31/2017

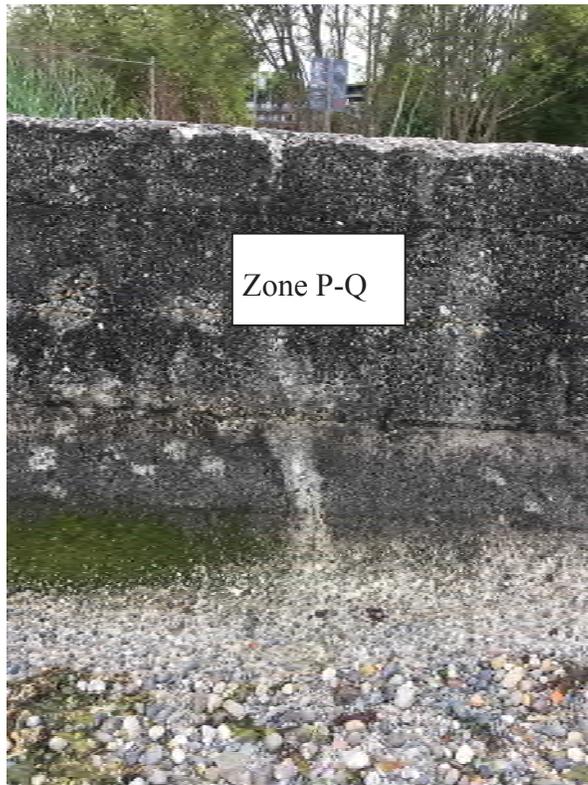
Photo 28. Zone P-Q.
Source: Reid Middleton Site Visit 10/18/2016

Photo 28. Zone P-Q.
Source: Reid Middleton Site Visit 10/18/2016

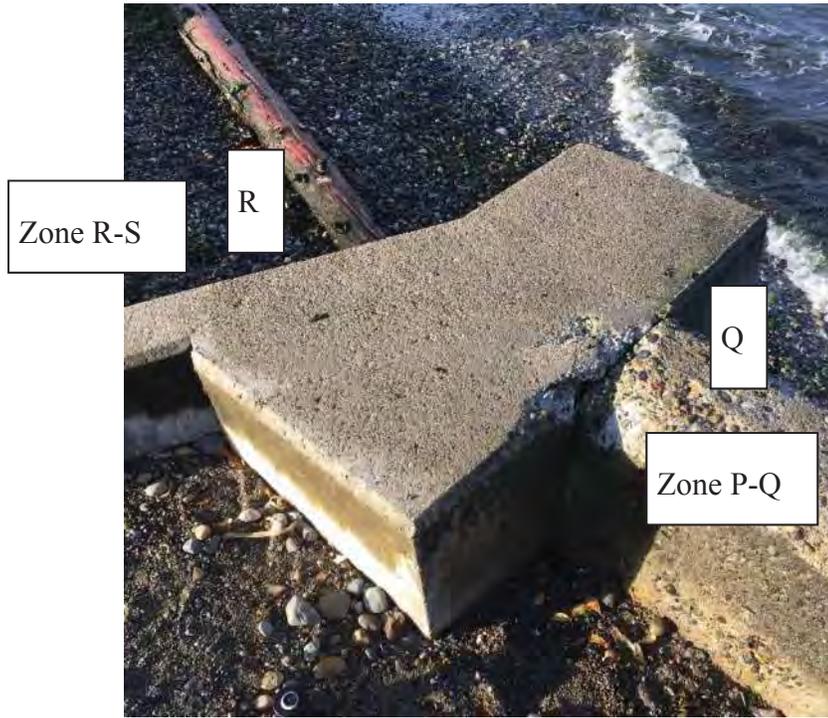
Photo 29. Zones P-Q & R-S.
 Source: Reid Middleton Site Visit 10/18/2016

Photo 29. Zones P-Q & R-S.
 Source: Reid Middleton Site Visit 10/18/2016

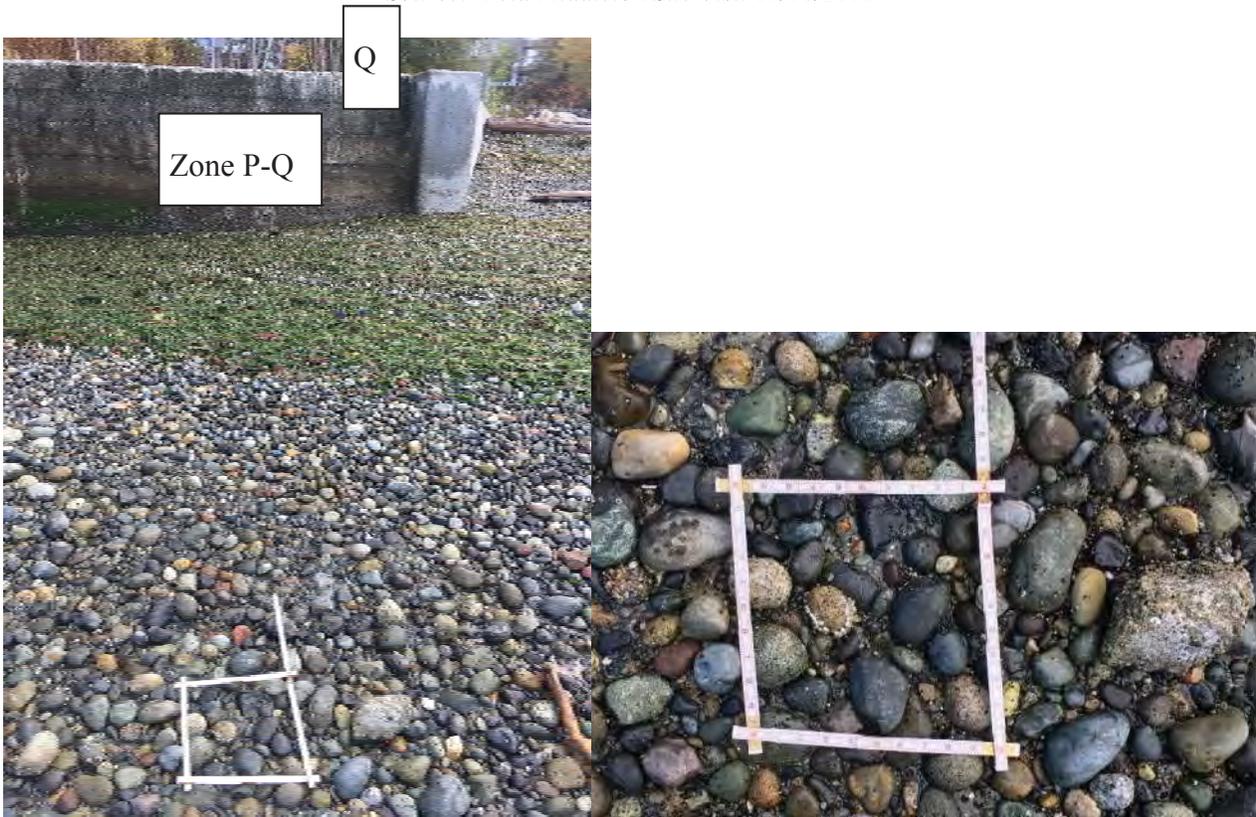
Photo 30. Zone P-Q, Lower Beach Material.
 Source: Reid Middleton Site Visit 10/18/2016

Photo 30. Zone P-Q, Lower Beach Material.
 Source: Reid Middleton Site Visit 10/18/2016

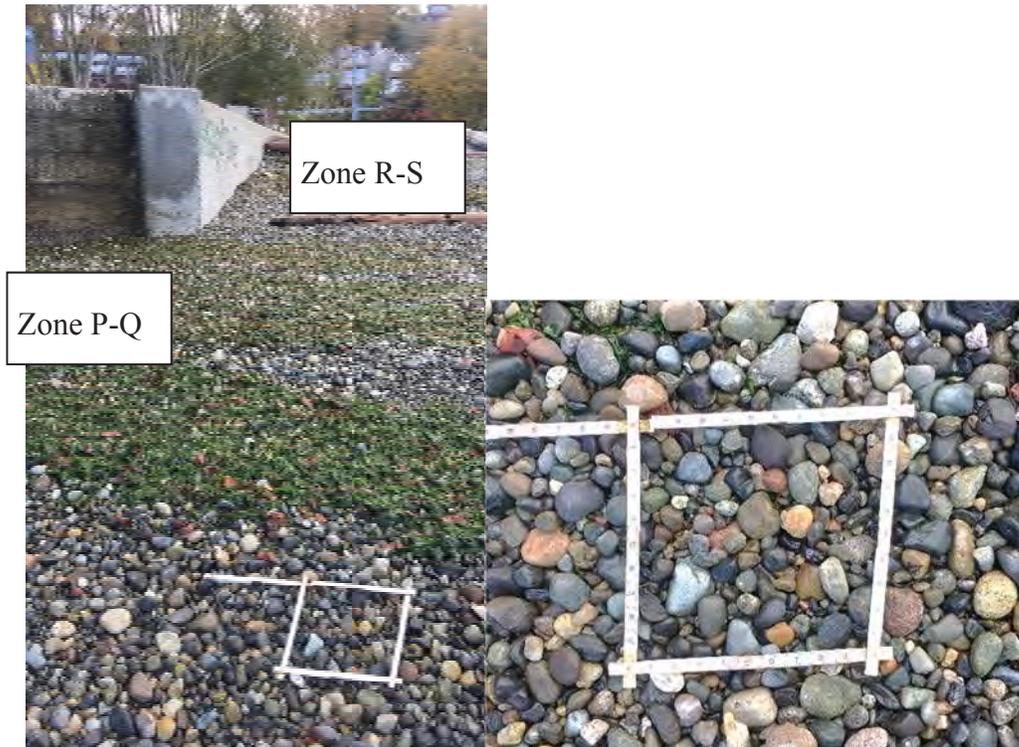
Photo 31. Zones P-Q & R-S, Upper Beach Material.
 Source: Reid Middleton Site Visit 10/18/2016

Photo 31. Zones P-Q & R-S, Upper Beach Material.
 Source: Reid Middleton Site Visit 10/18/2016

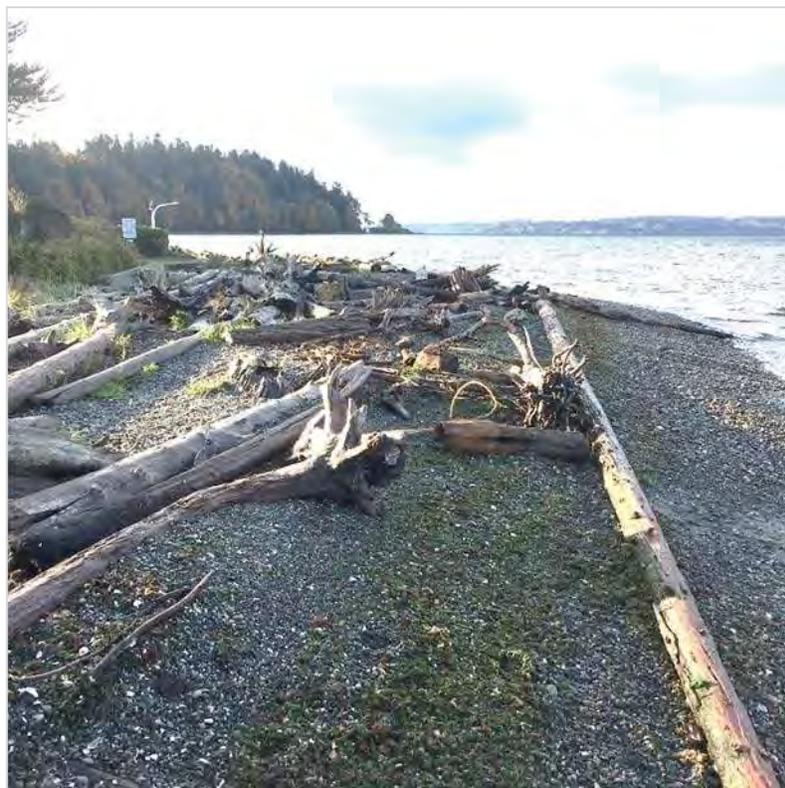
Photo 32. View to the South from Zone R-S.
 Source: Reid Middleton Site Visit 10/18/2016

Photo 32. View to the South from Zone R-S.
 Source: Reid Middleton Site Visit 10/18/2016

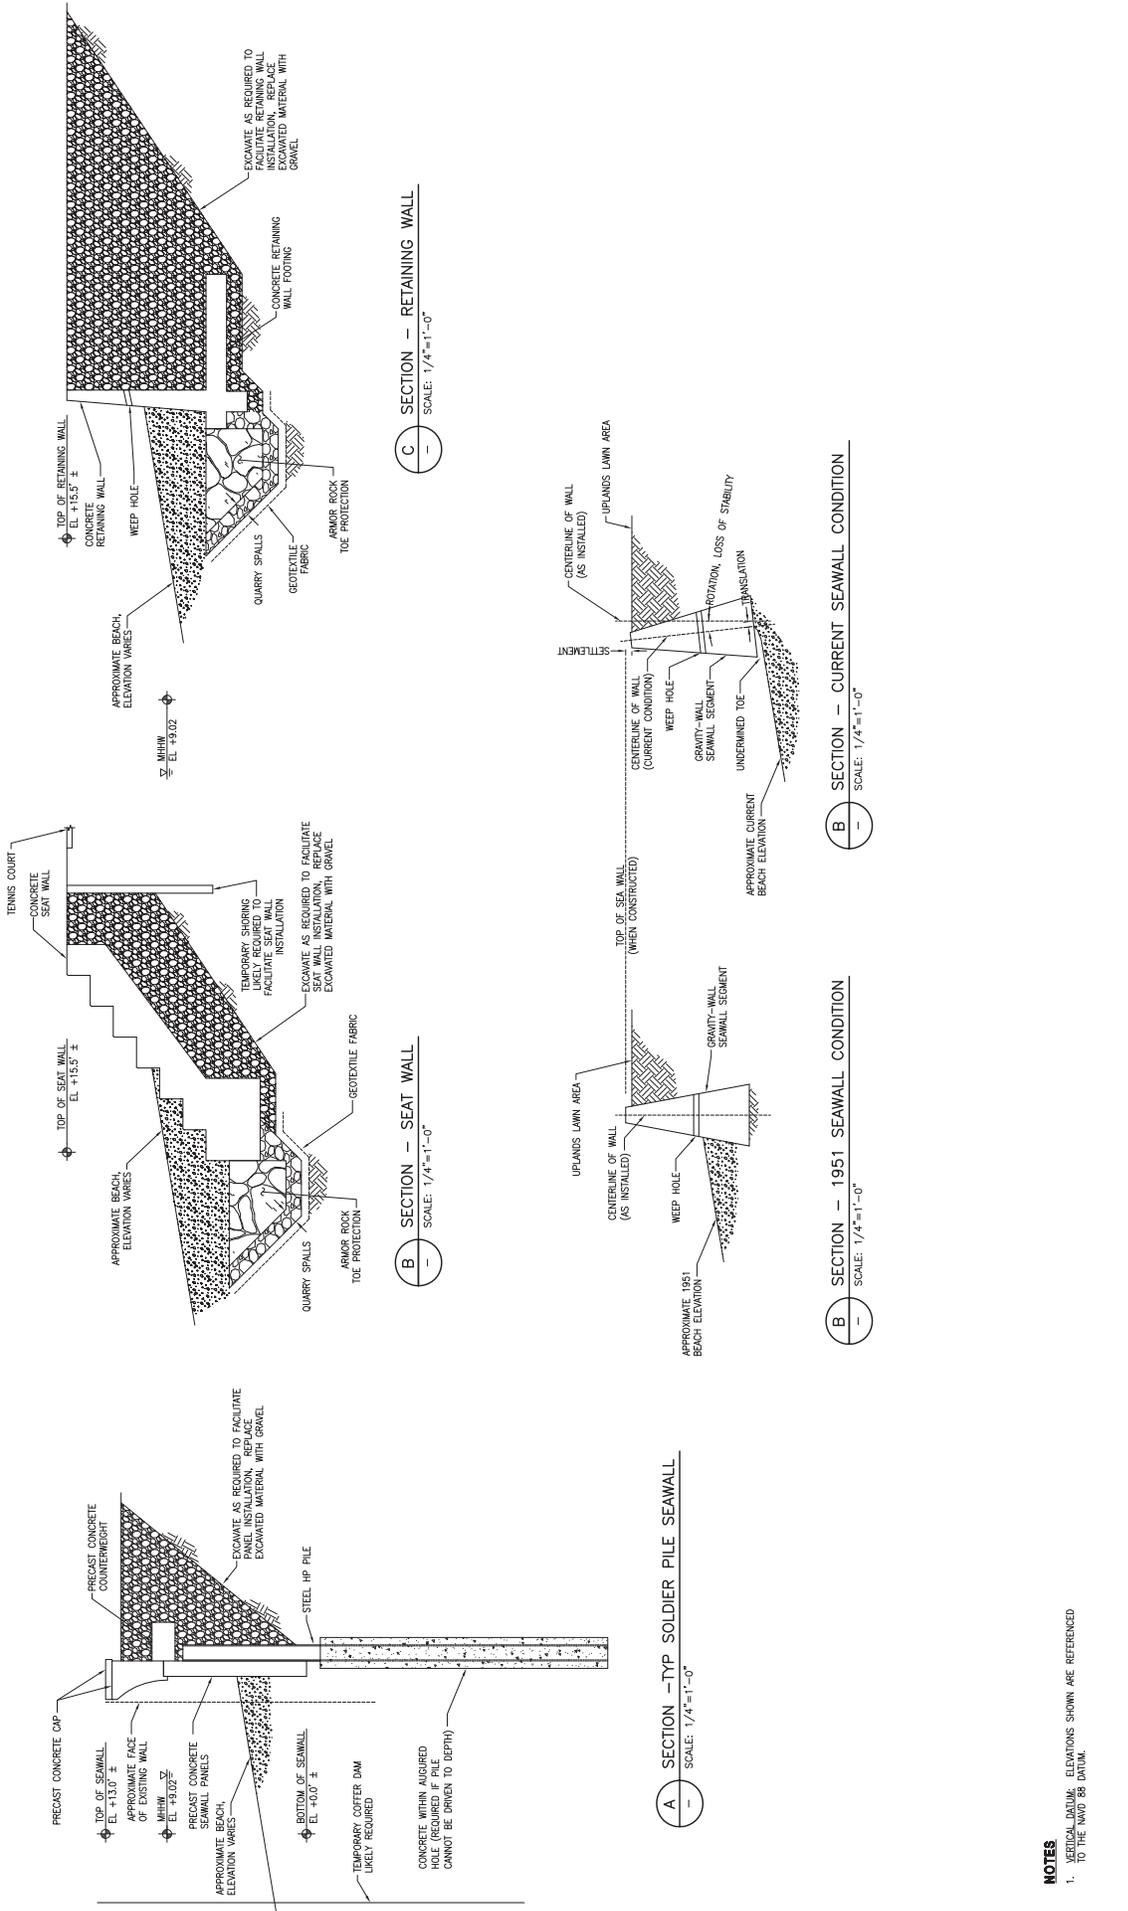
Figure 1 provided below contains detailed drawings of the design elements, and Table 1 provided below contains an alternative evaluation.

test pits. The soil borings can be used by the geotechnical engineer to determine pile driving conditions, and the likelihood of premature refusal or driving obstructions. This concept is depicted in Figure 1, Section A.

Design and installation of a seat wall would need to be carefully coordinated to avoid damage to the large stormwater outfall that extends waterward of the existing seawall. This concept is depicted at a conceptual level in Figure 1, Section B.

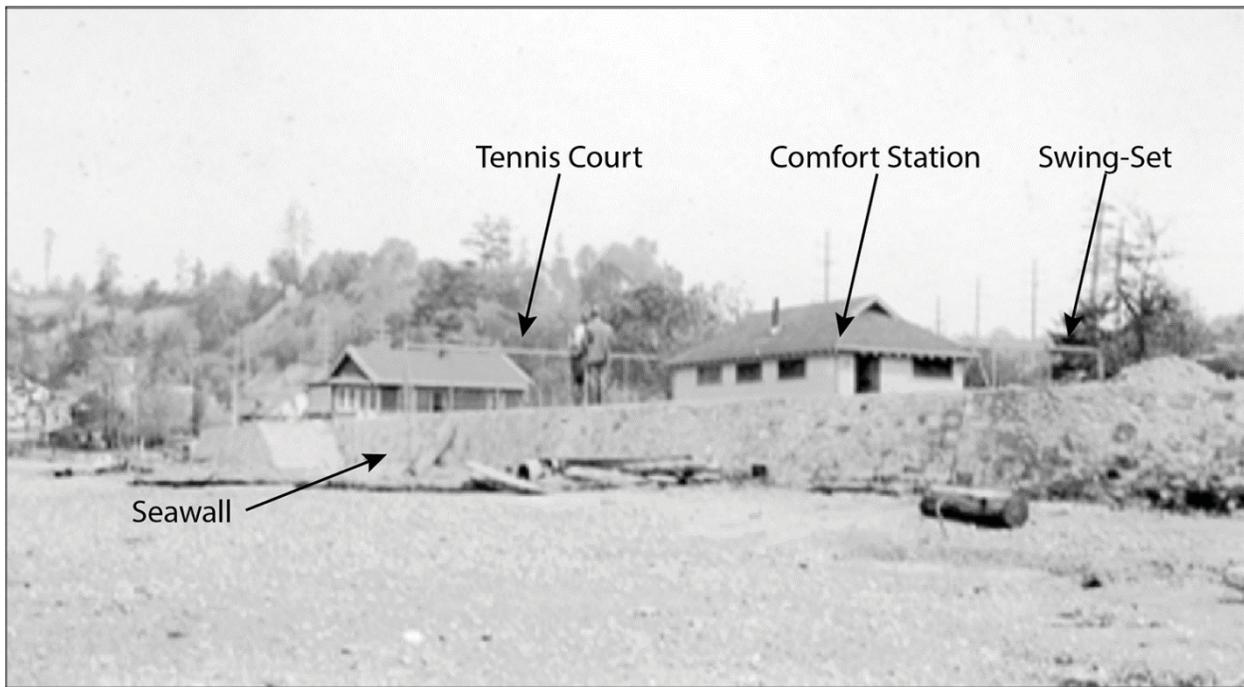
Figure 3
Lowman Beach Par, circa 1936

In 1936 the SPR built a stone and mortar seawall using federal grant funds from the Works Progress Administration (WPA) (Figure 3). That same year the tennis courts were also constructed as a WPA-funded project. Between 1935 and 1939, Seattle undertook many infrastructure improvement projects using funding made available by the WPA. Projects were carried out across the SPR and local laborers were hired whenever possible (Phelps 1976:182-185). Other WPA projects in West Seattle were seeding the Highland Park playground, earthwork at the Duwamish Head Park (now Hamilton Viewpoint Park), and constructing the West Seattle Golf Course (Eals 1987:200). The WPA was a national program created

The 1936 seawall originally extended across the entire shoreline of the park and featured a pair of steps connected to a platform at the seawall's center point (Seattle Department of Parks 1936). In 1950 the north portion of the original seawall began to fail, and in 1951 the portion of the seawall north of the steps was replaced and the portion to the south of the steps was reinforced with a concrete support along its base (Seattle Department of Parks 1951). In 1973, a combined sewer overflow outfall was constructed in the Park, necessitating closure of the tennis courts for several months (Seattle Times 1973). In 1994, the south portion of the 1936 seawall failed, and in 1995 a portion of the remaining seawall was replaced with a new concrete return wall and gravel beach restoration (Pascoe & Talley, Inc. 1995). It appears that the original seawall steps were also removed at this time.

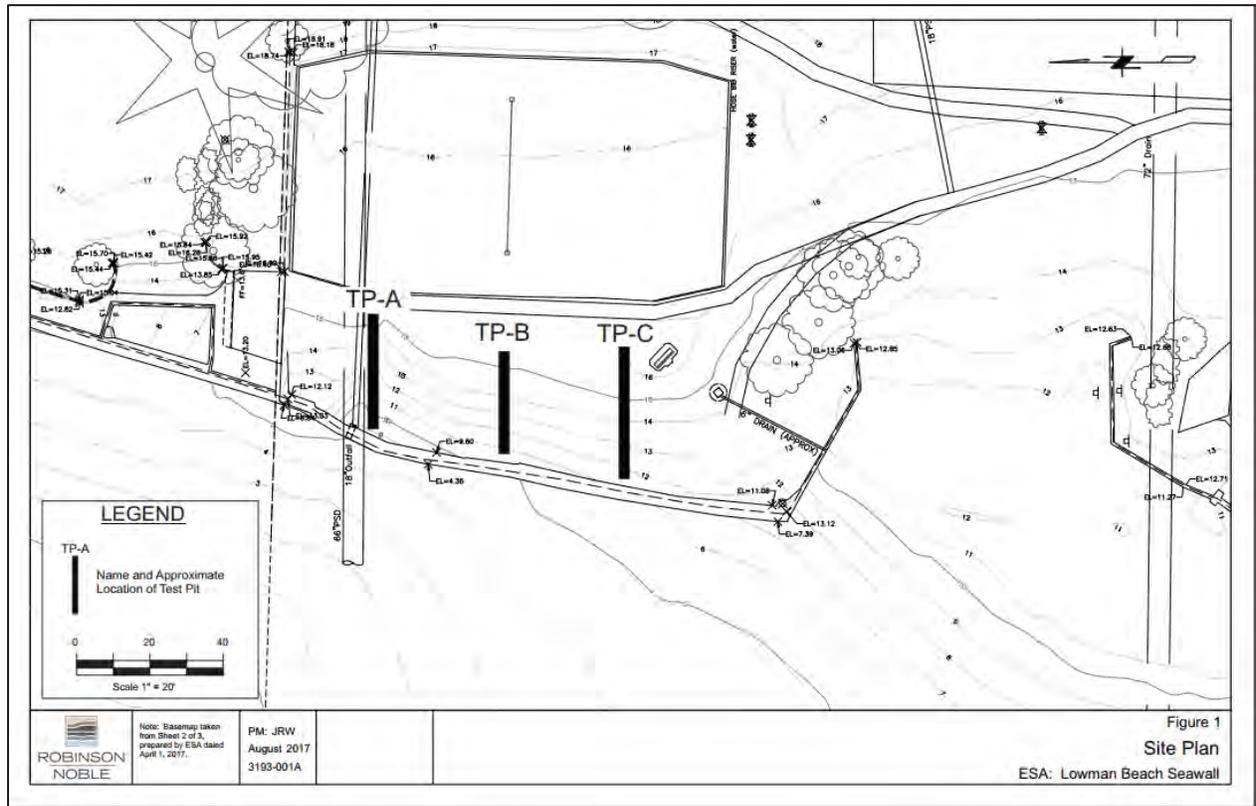
Figure 4
August 2017 Trenching Plan

On May 3, 2017, ESA and Robinson Noble conducted archaeological and geotechnical and field investigations consisting of three mechanical test pits between the seawall and the tennis court (Figure 4). Dr. Chris Lockwood, ESA Senior Archaeologist and Geoarchaeologist, observed the test pits and stratigraphy, examined spoils piles, and recorded historic and recent debris. No precontact artifacts or features were encountered.

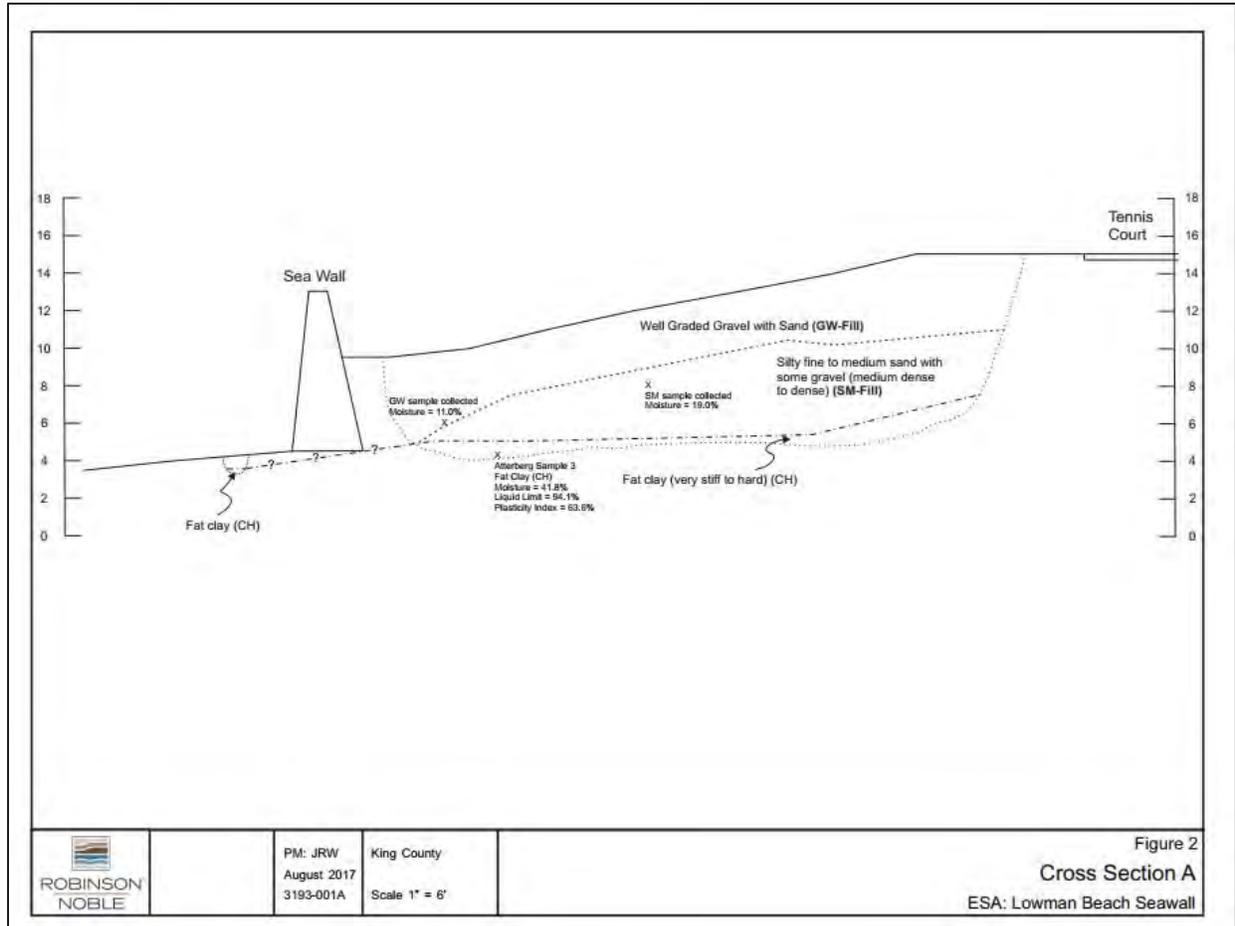
Figure 5
 Trench A Cross-section

Test Pit A (Figure 5), the northernmost test pit, contained well graded gravel with sand (fill) overlying gravelly sand (fill) overlying very stiff clay (likely Pleistocene-aged Lawton clay). Given the proximity of the test pit to two existing storm pipes, the fill is interpreted to have been placed during pipe installation. The fill contained an approximately 6-foot long length of dock or anchor chain and several fragments of lumber.

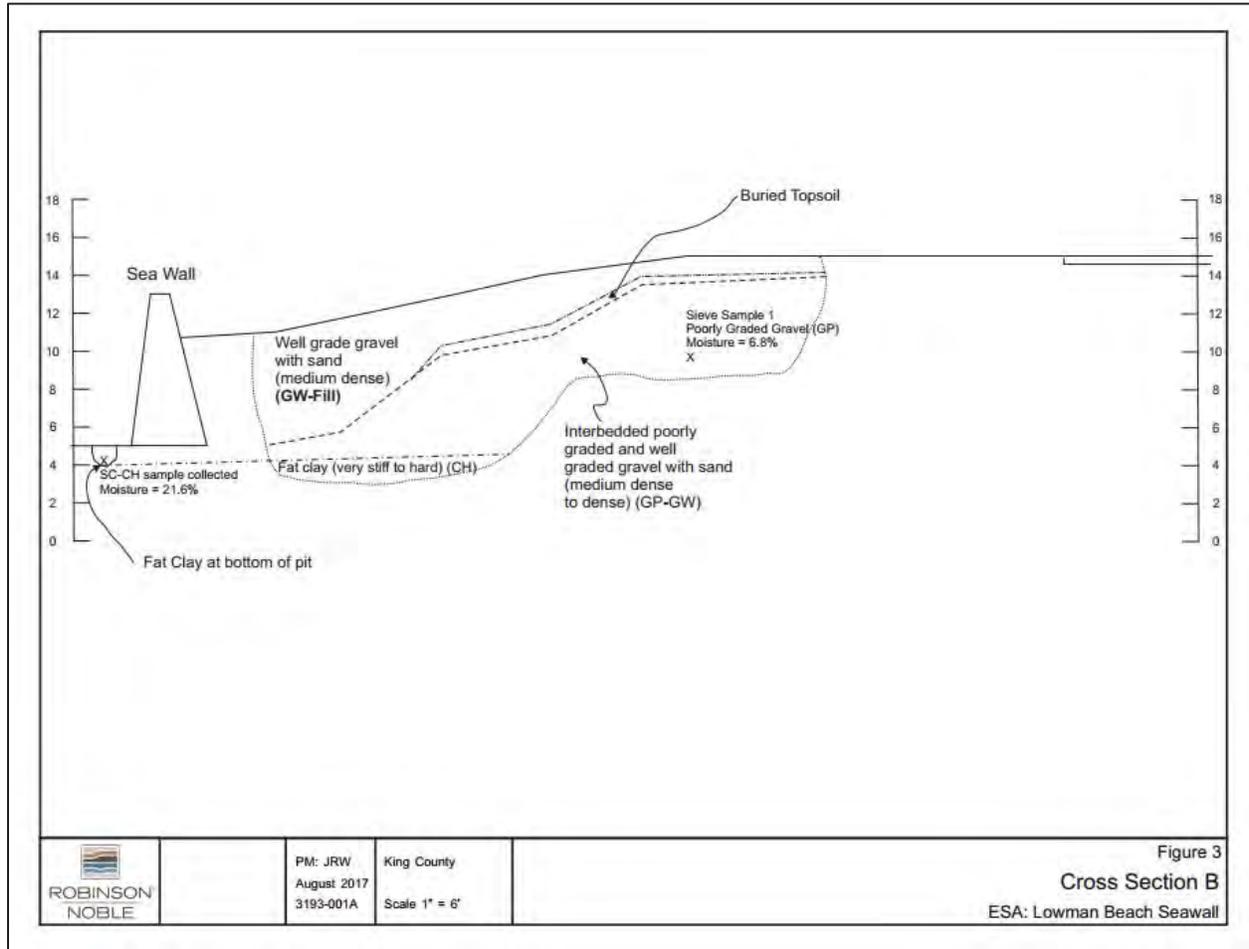
Figure 6
Trench B Cross-section

Test Pit B (Figure 6), the center pit, contained well graded gravel with sand (fill) overlying interbedded gravel with sand (uplifted beach) overlying very stiff clay (likely Pleistocene-aged Lawton clay). The top of the uplifted beach deposit contained a partially intact topsoil, marking the original “pre-fill” ground surface. The extreme west end of the test pit contained abundant, highly-corroded, ferrous cable, possibly the remains of kind of structural tieback, as well as concrete fragments. Test Pit B also contained trace amounts of highly-fragmented, clear, green, and brown bottle glass.

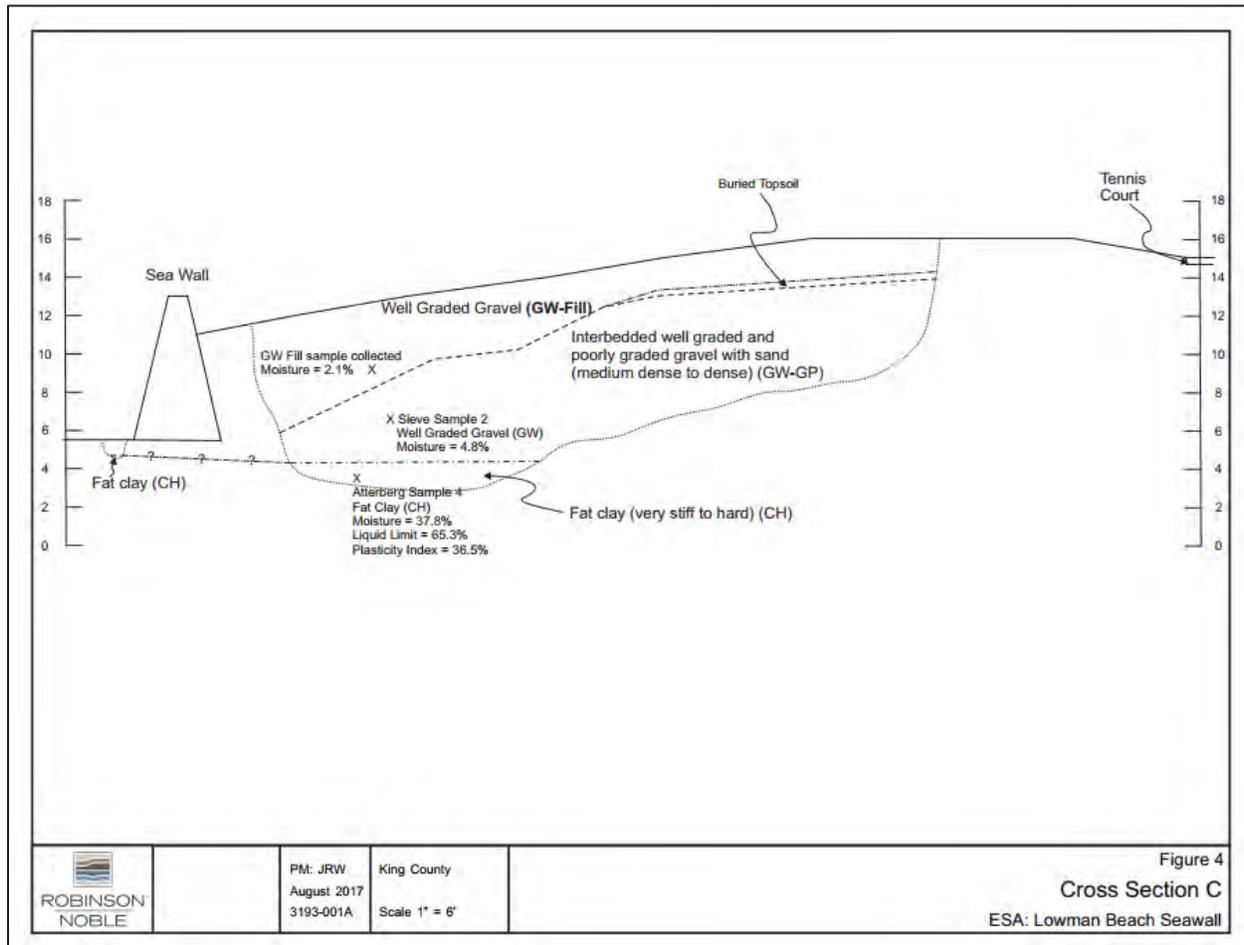
Figure 7
Trench C Cross-section

Test Pit C (Figure 7), the southernmost pit, contained well graded gravel (fill) overlying interbedded gravel with sand (uplifted beach) overlying very stiff clay (likely Pleistocene-aged Lawton clay). Similar to Test Pit B, the top of the uplifted beach deposit in Test Pit C contained a partially intact topsoil. The extreme west end of Test Pit C contained a moderate amount of highly-corroded, ferrous cable, as well as concrete fragments. Test Pit C also contained trace amounts of highly-fragmented, clear, green, and brown bottle glass.

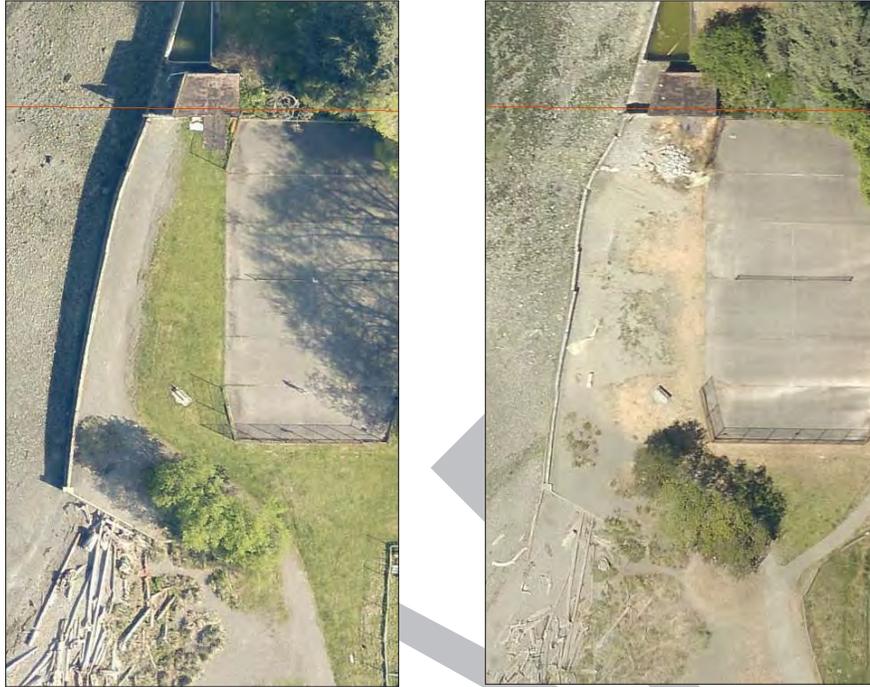
The seawall on the western side of the project area is composed of a segmental concrete gravity wall system dating from the 1950's. Segments are approximately 8 feet in height and 16 feet in length. The concrete gravity wall segments appear to be rotating outwards and towards Puget Sound at the top, and sliding towards the Sound to the west. We did not observe structural connections between the wall segments. Surface grade behind the seawall appears to have dropped as much as 2 feet because the wall has shifted outwards. The outwards shifting of the wall has separated the 18-inch diameter outfall storm pipe that extends through the wall. The wall appears to be sitting on top of consolidated clay soils. There appears to be minimal to no embedment of the front side of the wall in the northern region of the alignment where the wall appears to be failing. In the southern region of the alignment, up to approximately 3 to 4 feet of embedment exists. This region of the wall has not shown signs of failure.

Satellite images of the Lowman Beach Park seawall in 2015, left, and 2017, right, showing the failure of the northern segment of the seawall over time. Source: King County iMap.
