LOWMAN BEACH PARK SHORELINE RESTORATION

Draft 60% Design Report

Prepared for
Seattle Parks & Recreation Department

June 2019

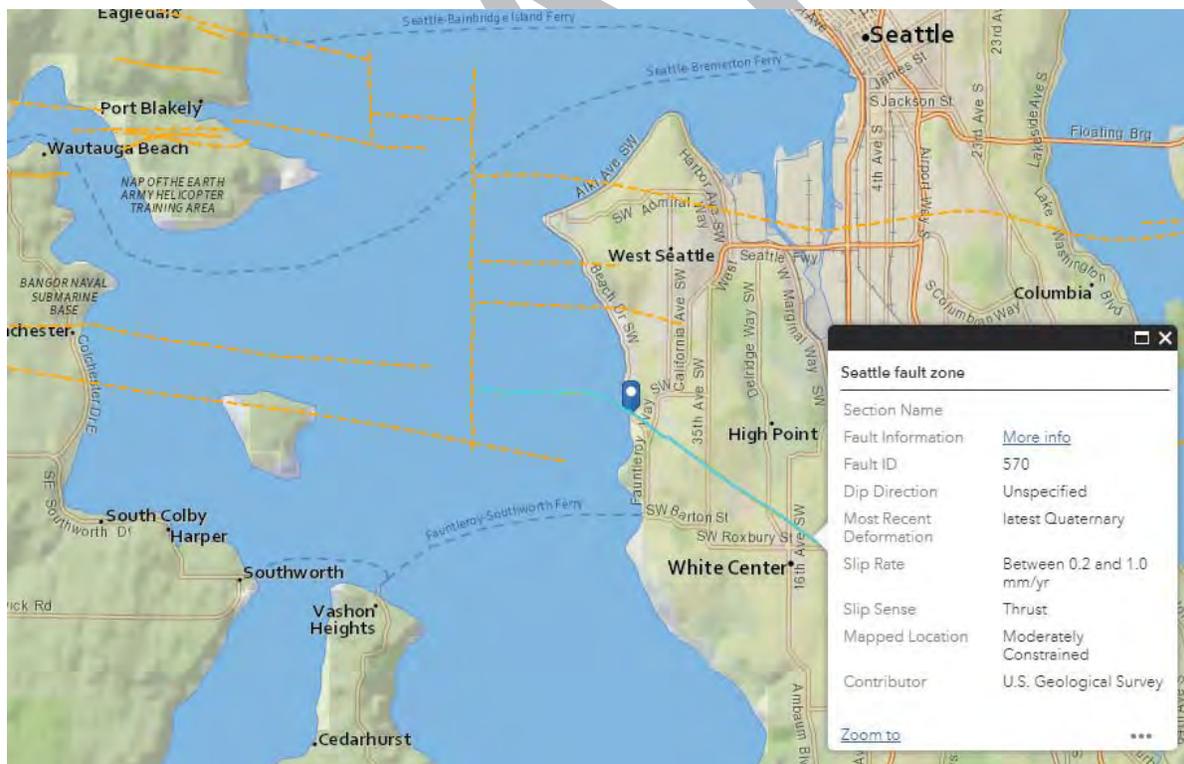
The site is mapped on the [U.S. Quaternary Faults and Folds Database](#) web app by the U.S. Geological Survey as located within the Seattle Fault Zone. The nearest mapped fault is the southernmost thrust fault of the Seattle Fault zone approximately 200 feet to the north. The last suspected deformation of the Seattle Fault Zone is estimated to be approximately 1,100 years ago. Past deformation along this strand of the Seattle Fault Zone is evident as the uplift of older Pre-Olympia sediments visible on the hillside to the south of the park are the same elevations as more recent Vashon strata visible on the hillside to the north. This is a class A fault and is considered to have a low potential for surface displacement because of the age since the last suspected deformation and its slip-rate category of between 0.2 and 1.0 mm per year.

Blue line shows one of documented earthquake offsets from the Seattle Fault. Source: USGS

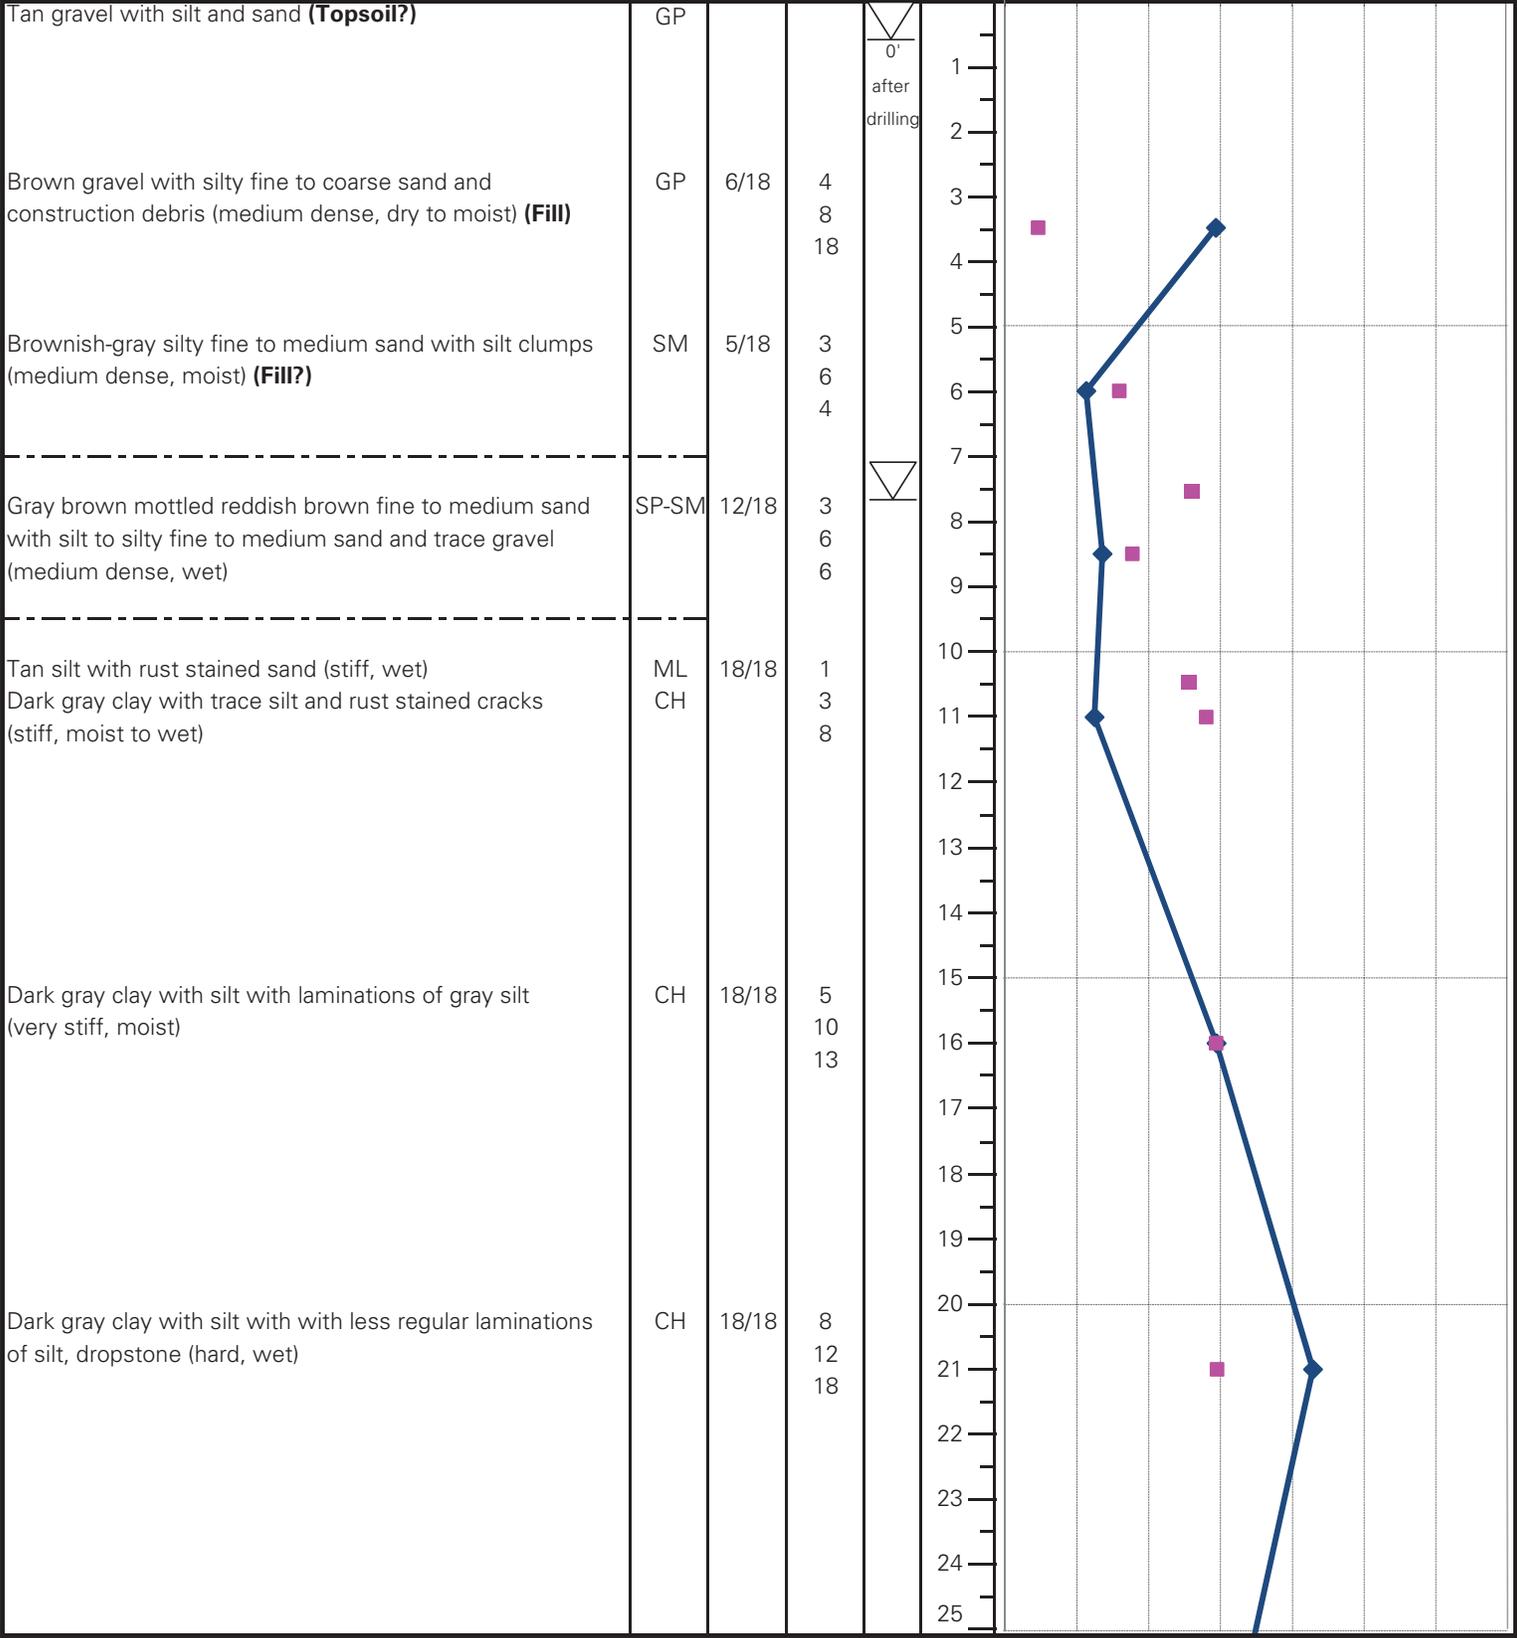
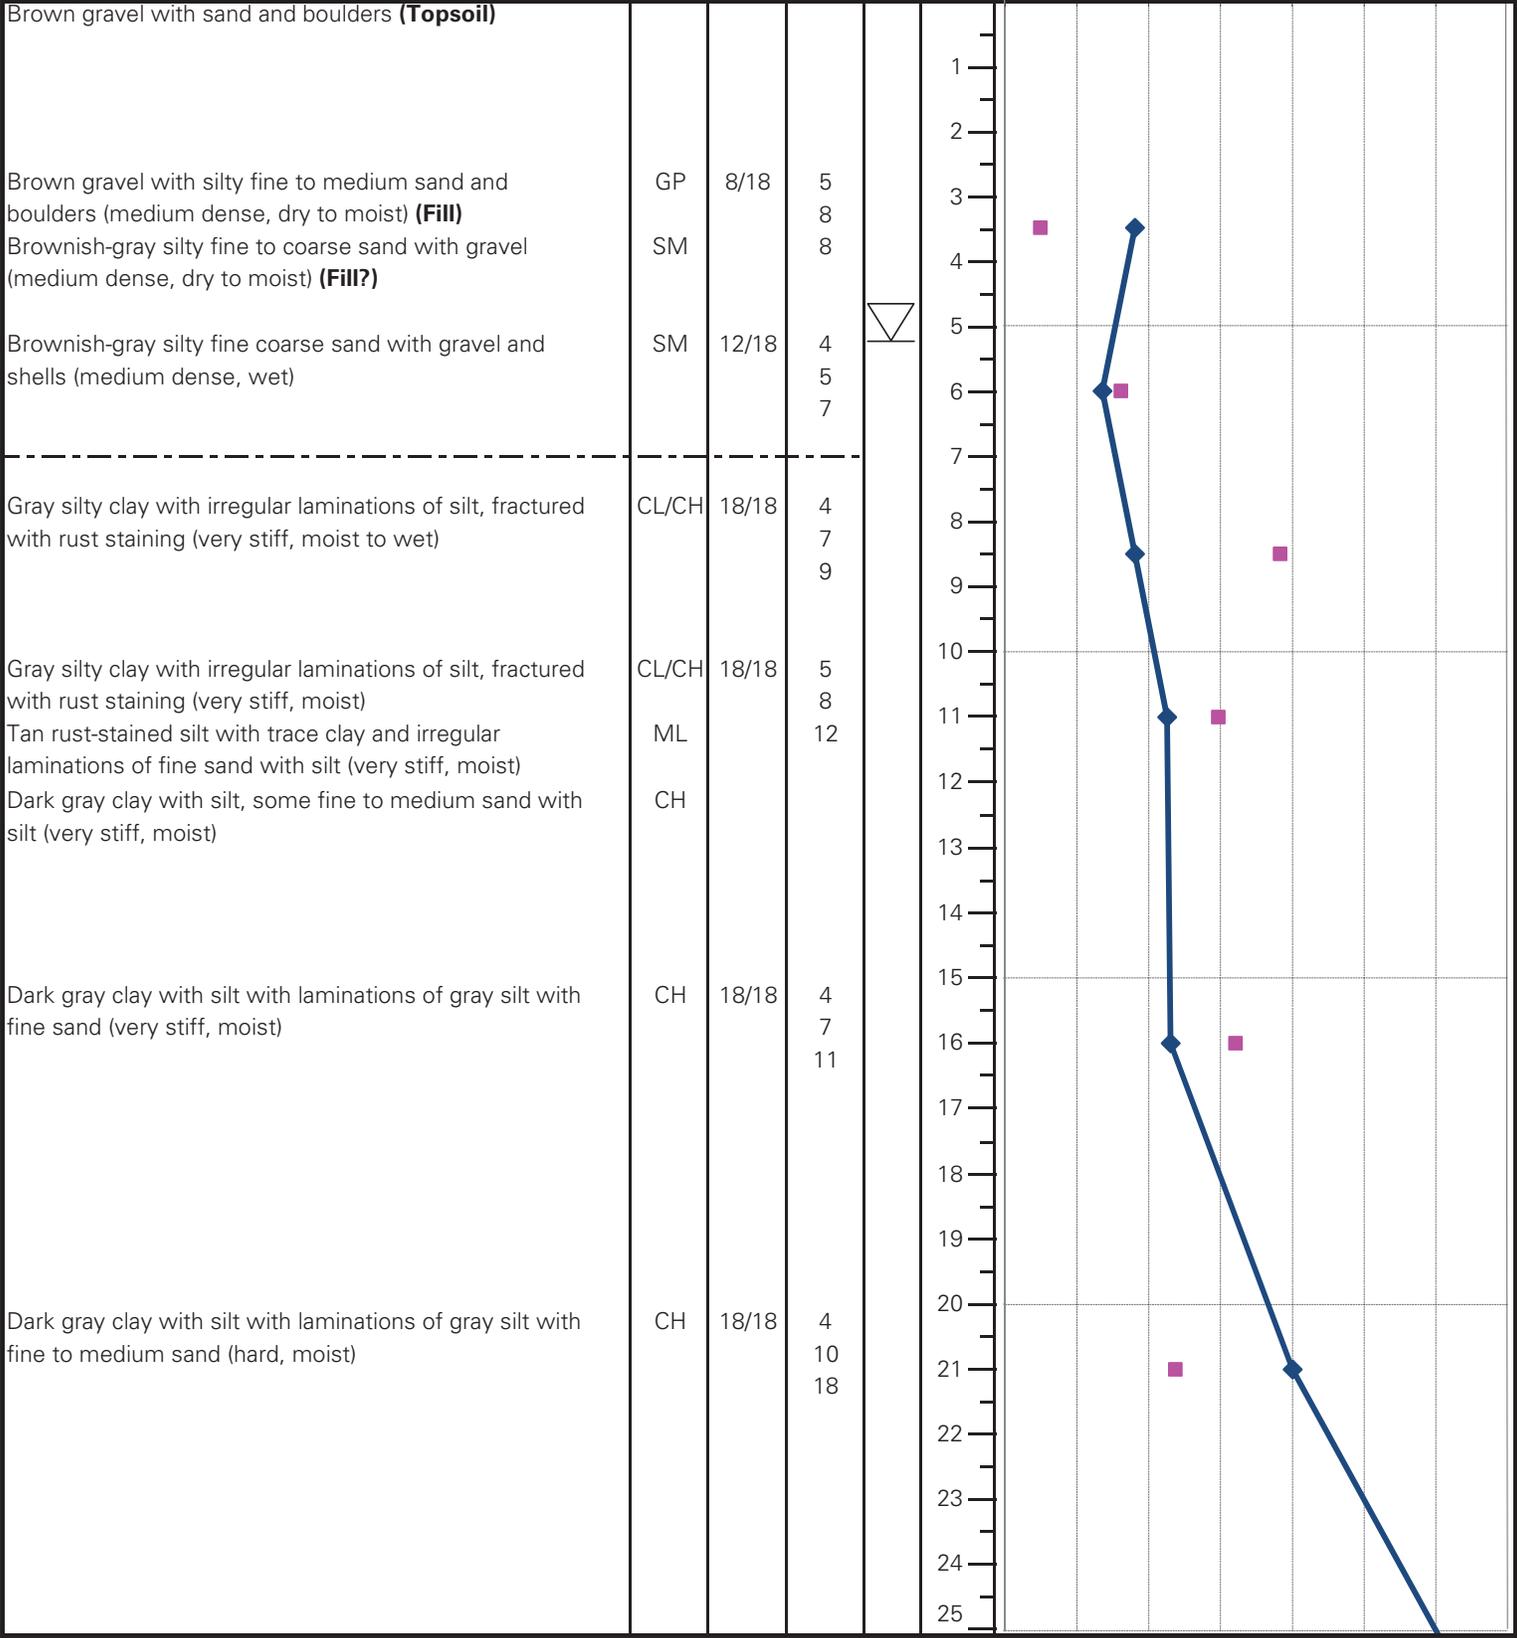
B-3 Date 6/22/18 Hole dia. (in) 6
 Logged by BRP/JRW Hole depth ft 41.5'
 Driller Holt Well dia. (in) N/A
 Elevation (ft) 12.0 Well depth N/A
 Sample Liner Yes Hammer Eff. 86%

Boring was completed at 41.5 feet on 6/22/2018
 Groundwater observed at 5 and 35 feet during drilling

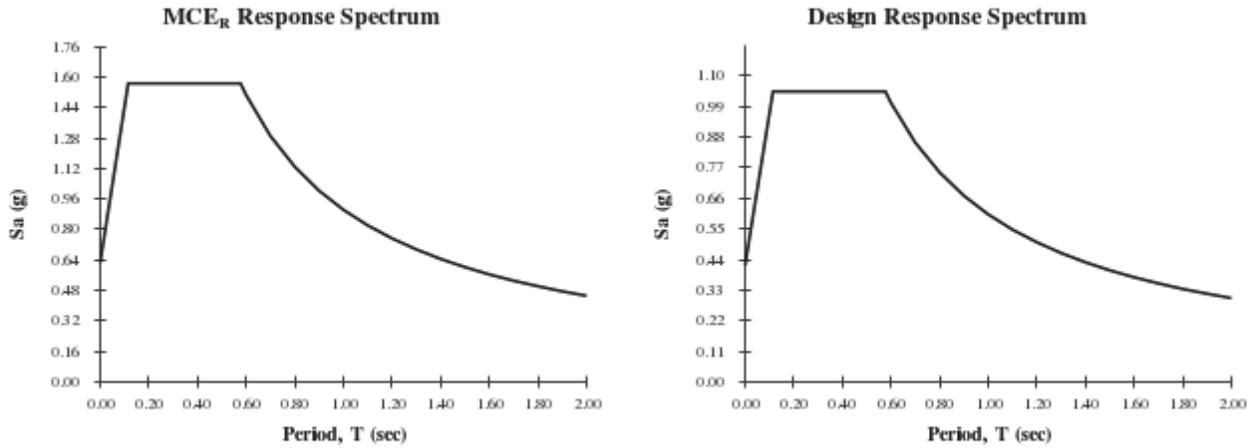
$S_s = 1.566 \text{ g}$	$S_{MS} = 1.566 \text{ g}$	$S_{DS} = 1.044 \text{ g}$
$S_1 = 0.602 \text{ g}$	$S_{M1} = 0.903 \text{ g}$	$S_{D1} = 0.602 \text{ g}$

For information on how the S_s and S_1 values above have been calculated from probabilistic (risk-targeted) and deterministic ground motions in the direction of maximum horizontal response, please return to the application and select the “2009 NEHRP” building code reference document.

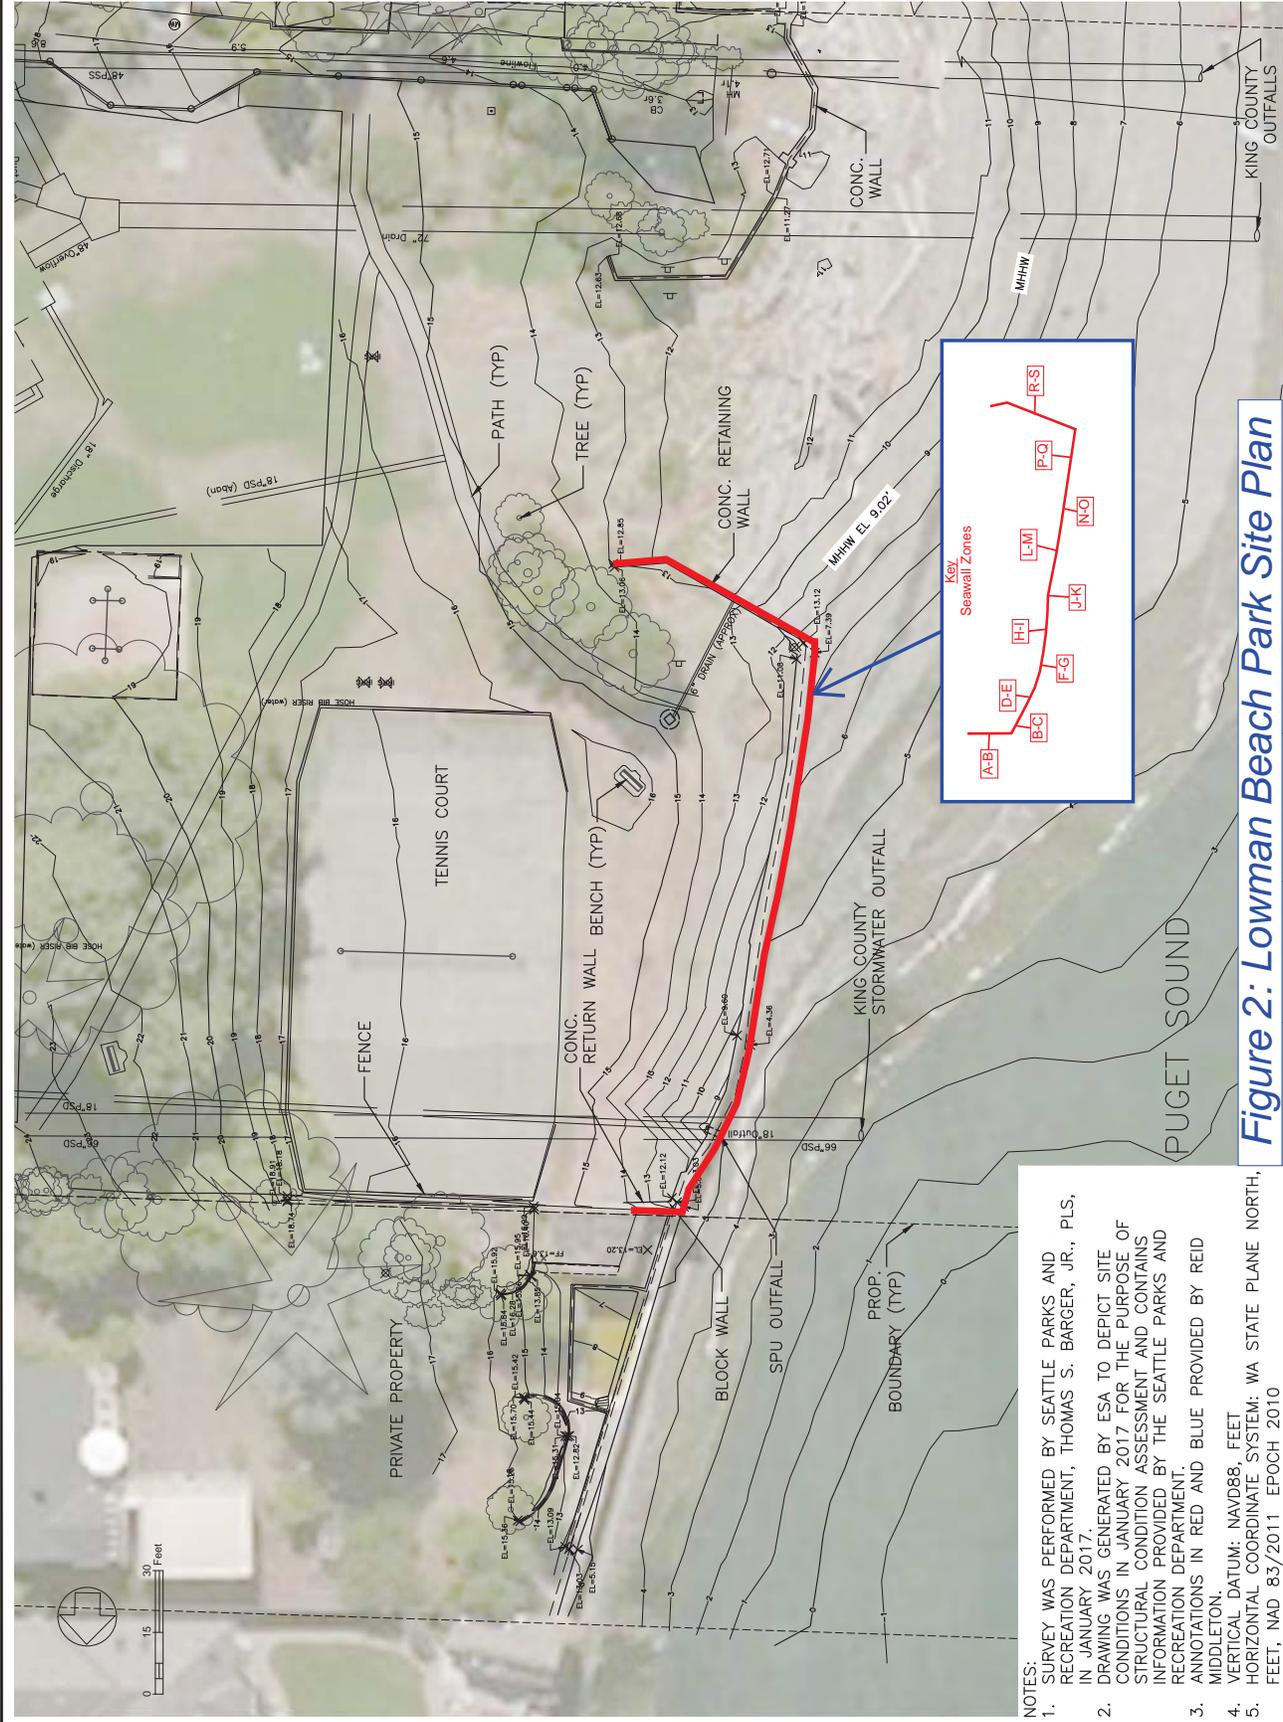
Figure 2: Lowman Beach Park Site Plan

The history of the seawall was investigated, a site visit performed, and the condition of the seawall documented by zone, as shown in Figure 2.

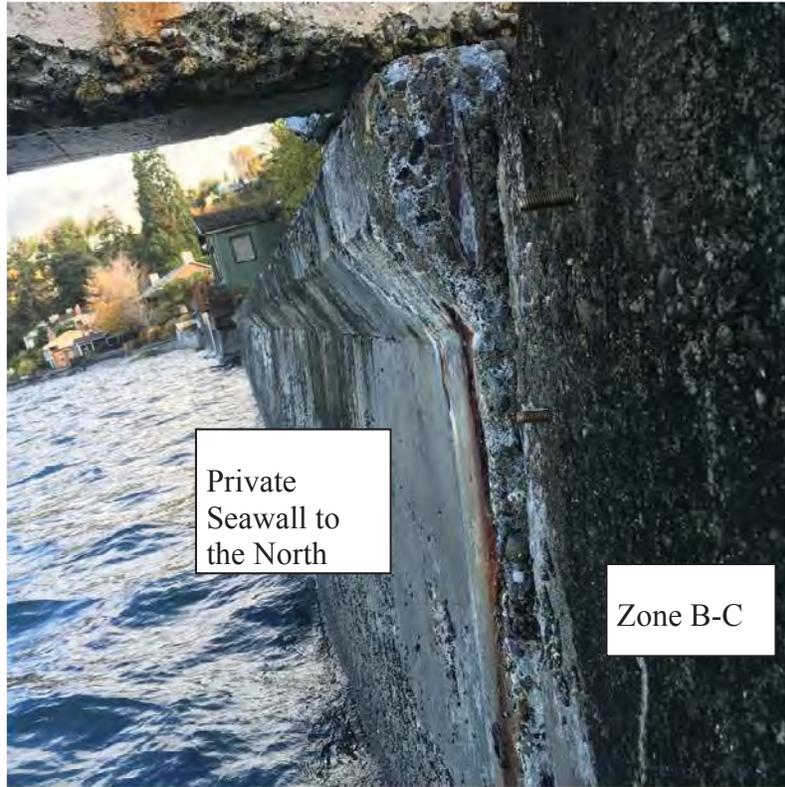
Photo 9. Private Seawall to the North.
 Source: Reid Middleton Site Visit 10/18/2016

Photo 9. Private Seawall to the North.
 Source: Reid Middleton Site Visit 10/18/2016

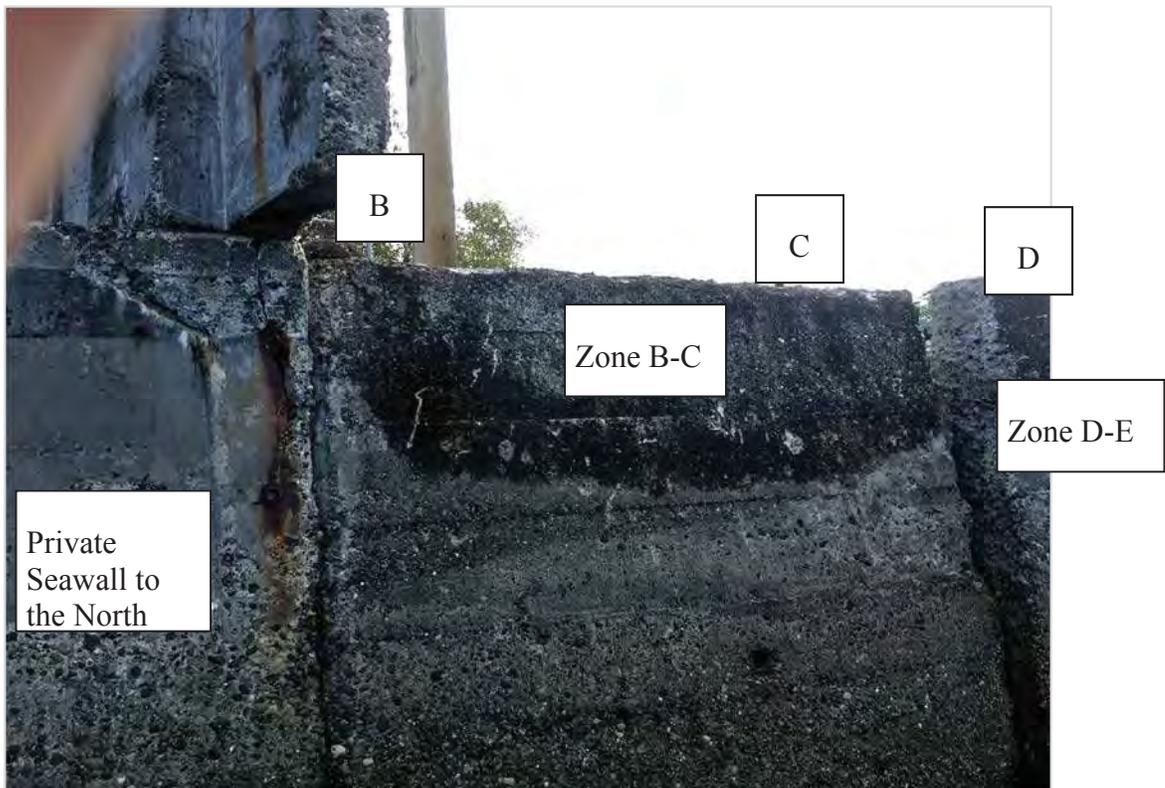
Photo 10. Zones B-C & C-D.
 Source: Reid Middleton Site Visit 10/18/2016

Photo 10. Zones B-C & C-D.
 Source: Reid Middleton Site Visit 10/18/2016

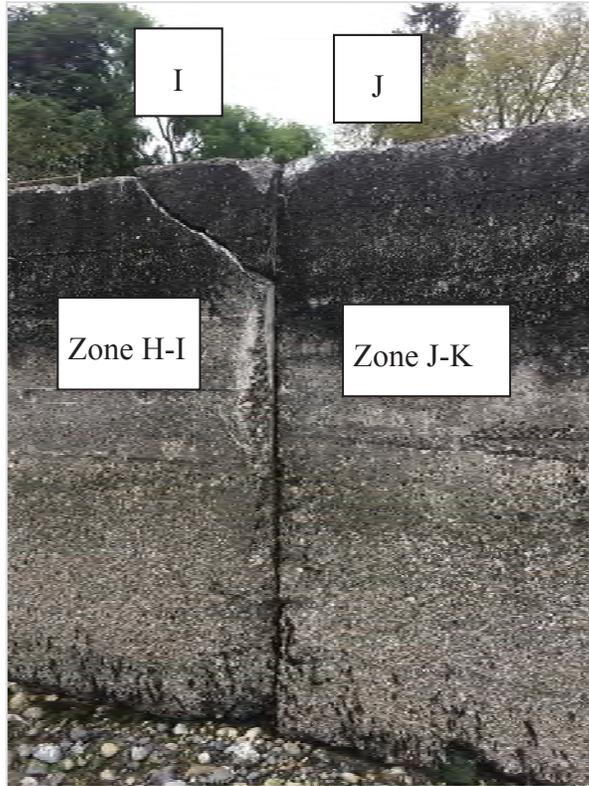
Photo 19. Zones H-I & J-K.
Source: Reid Middleton Site Visit 5/31/2017

Photo 19. Zones H-I & J-K.
Source: Reid Middleton Site Visit 5/31/2017

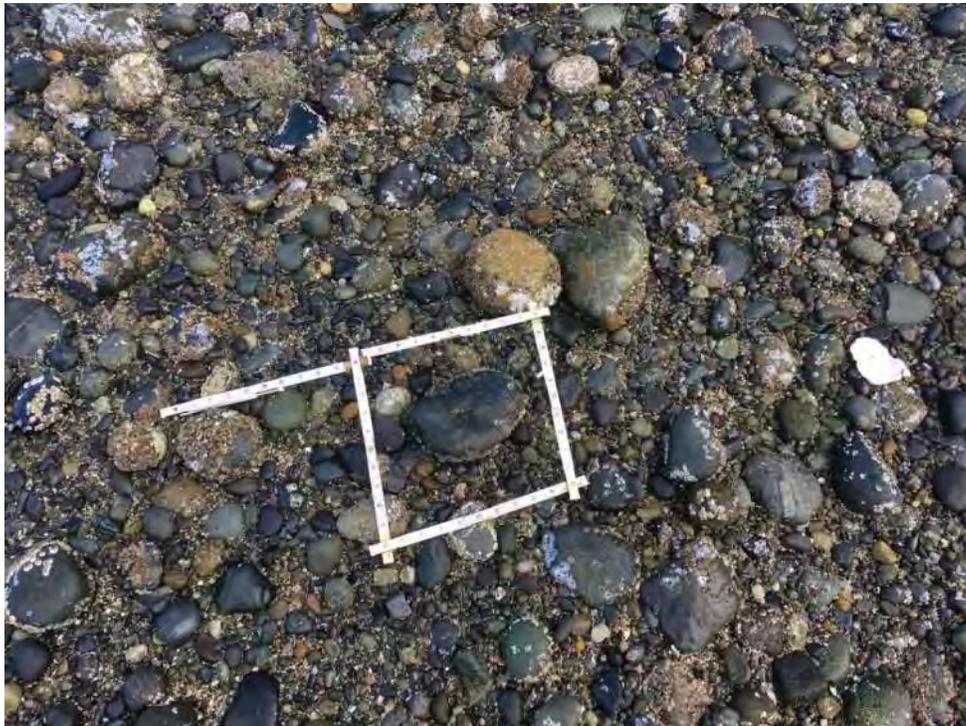
Photo 20. Beach Material at Zone J-K.
Source: Reid Middleton Site Visit 10/18/2016

Photo 20. Beach Material at Zone J-K.
Source: Reid Middleton Site Visit 10/18/2016

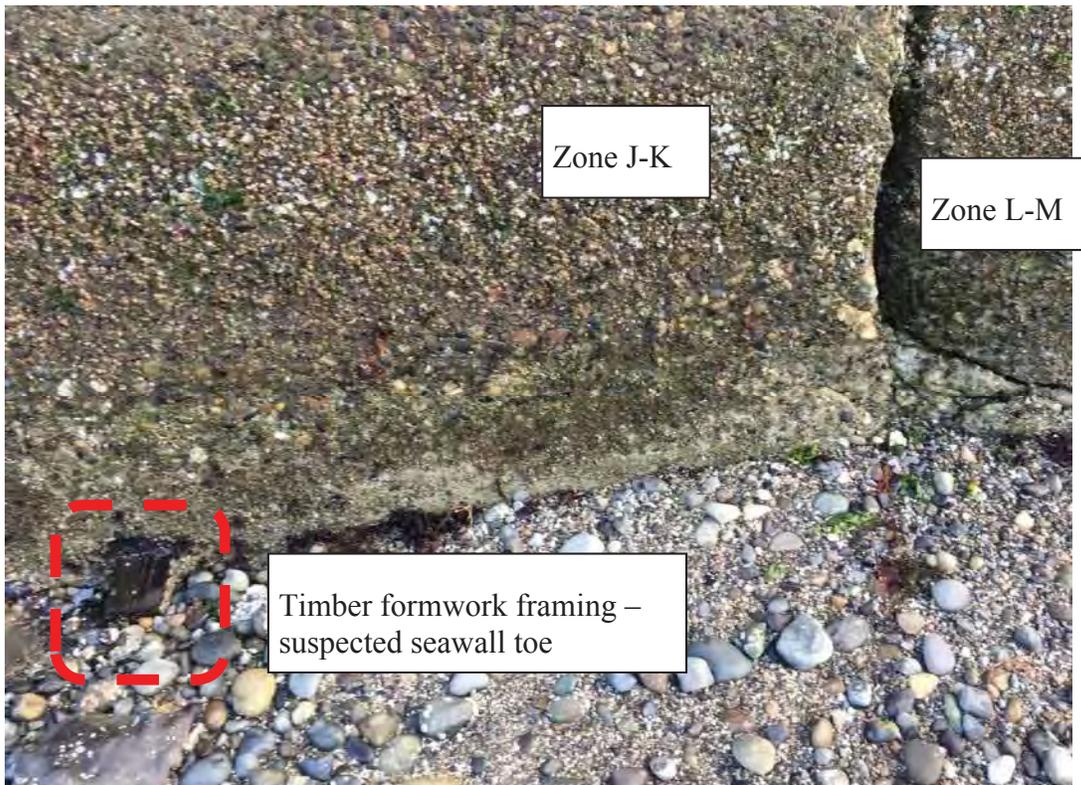
Photo 24. Zone J-K & L-M.

Photo 24. Zone J-K & L-M.

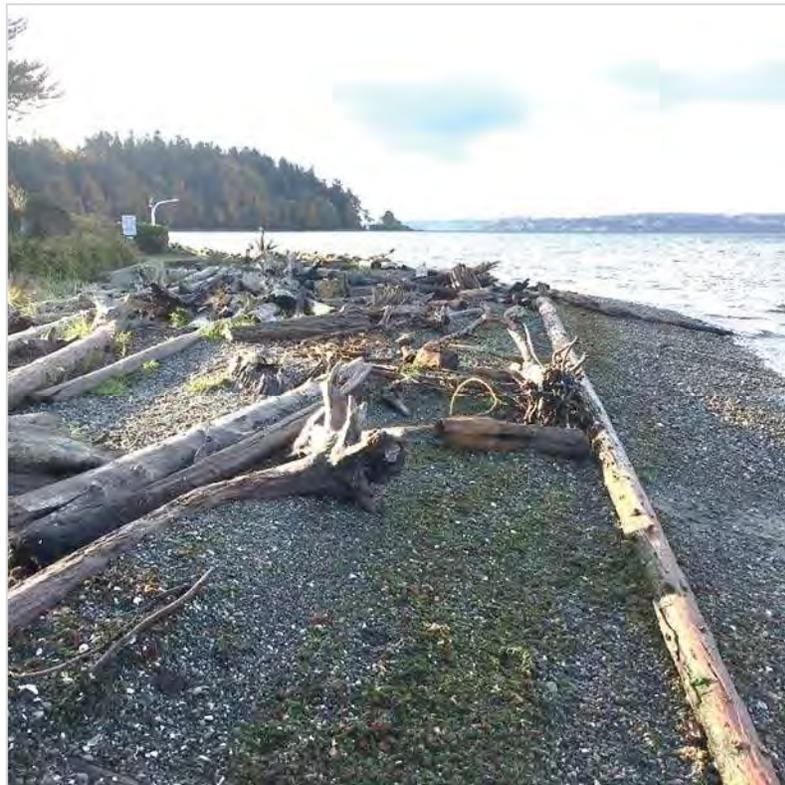
Photo 32. View to the South from Zone R-S.
 Source: Reid Middleton Site Visit 10/18/2016

Photo 32. View to the South from Zone R-S.
 Source: Reid Middleton Site Visit 10/18/2016

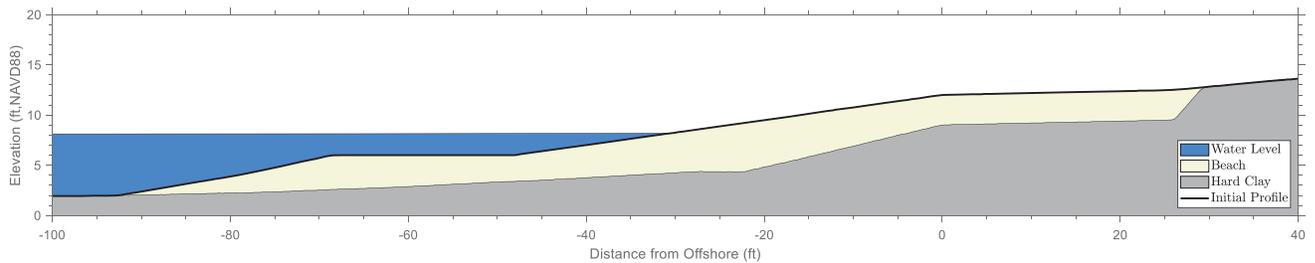
, shown 25' from distance 0 to 25 in Figure 1

Figure 1. Typical Beach Design Profile, After Construction

terms like backshore and thickness can be clarified by describing or marking on figures 1 and 2

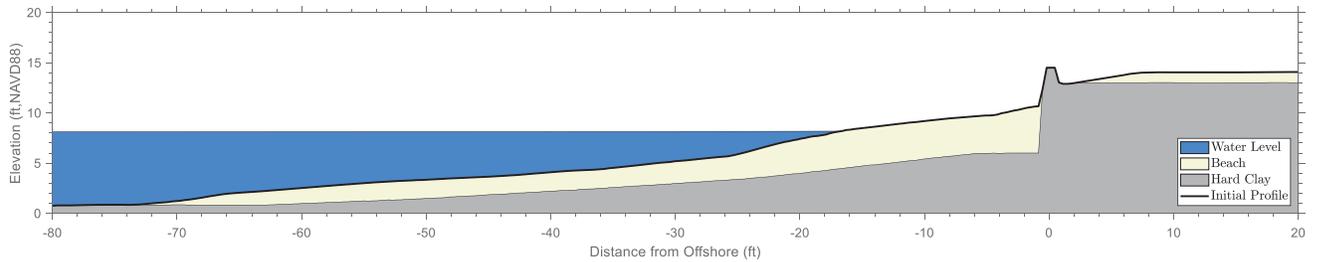
The beach design profile in front of the seawall (Figure 2) places along with the first 10 ft from the seawall at least 4 ft of beach material above the MHHW (9.02, ft NAVD). The material is placed to reduce the effects of erosion due to the seawall and in essence, placing the seawall landward of the typical action of the waves it reduces the effect of the seawall on the coastal process.

Figure 2. Beach design profile in front of the new Seawall, After Construction

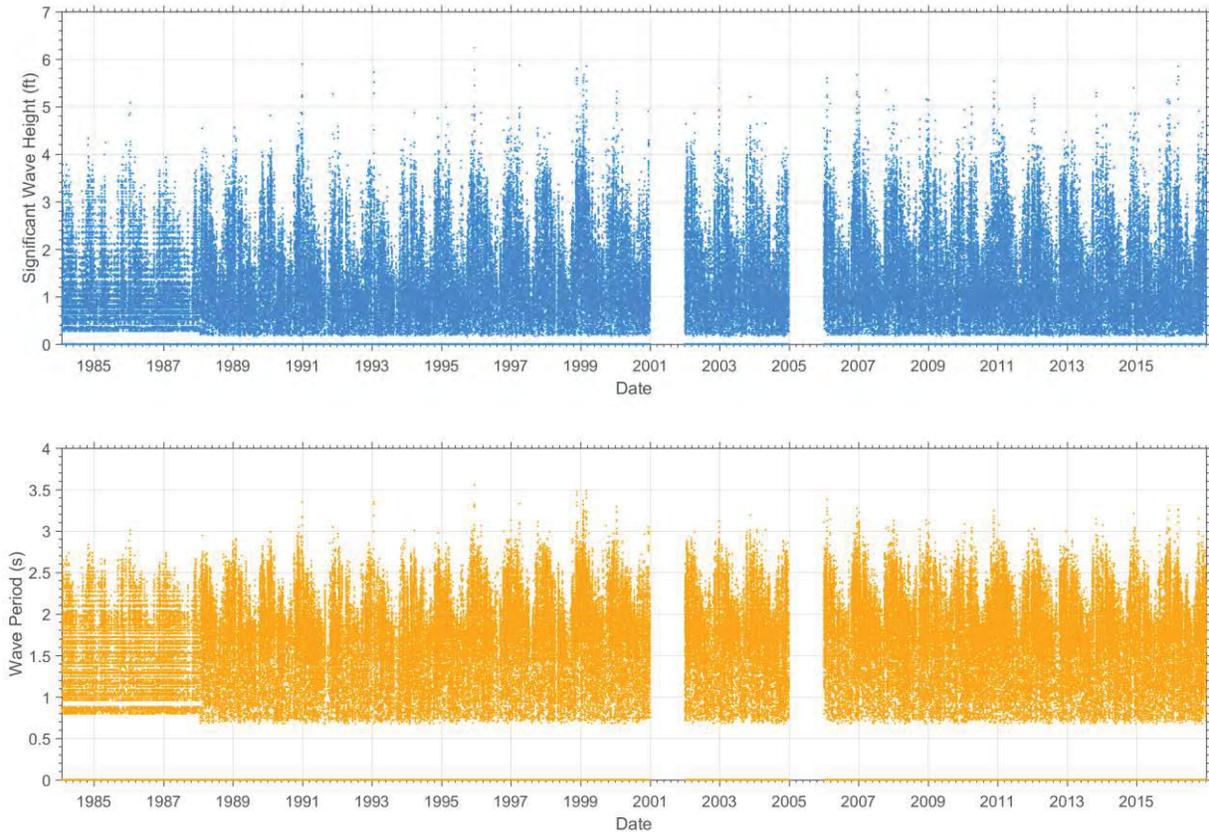
To model the wave conditions near the site, ESA applied the industry-standard Simulating Waves Nearshore (SWAN) model. This 2-dimensional model predicts waves likely to occur in response to wind speed, wind direction, water level, shoreline geometry, and bathymetry. The reader is referred to Appendix A for details on the implementation and validation of the model. The model was used to generate a 33-year wave height and wave period time series offshore of Lowman Beach Park (Figure 3). Maximum wave heights are typically less than 5 ft, and typical events are below 2 ft. Wave periods are typically very short with most of the wave periods being less than 3 seconds and maximum wave periods are not higher than 3.5 seconds.

Figure 3. Simulated Significant Wave Height and Wave Period Time Series offshore of the park.

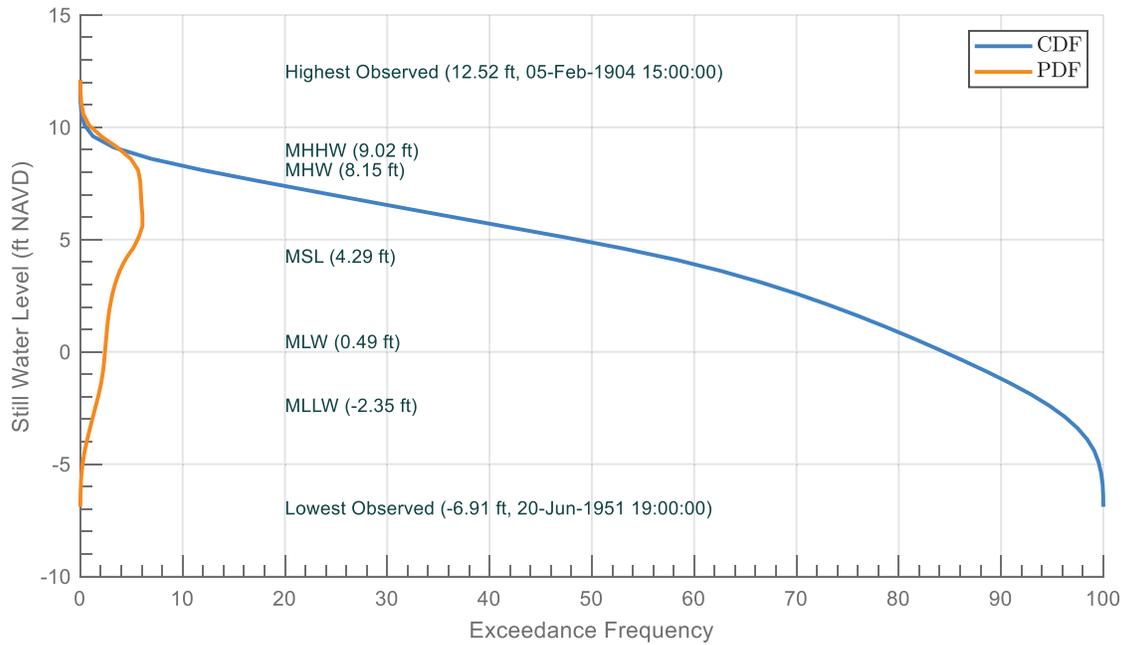
Water level records for the project site was obtained from the Seattle Tide Station (NOAA NOS# 9447130) 118 year from 1899 to 2016 was analyzed for this project. The station is located approximate 5.2 miles north of the site. Tidal datums and the probability and cumulative distribution of the water levels are shown in Figure 4.

Figure 4. Still Water Level Probability (orange) and Cumulative Distribution (blue)

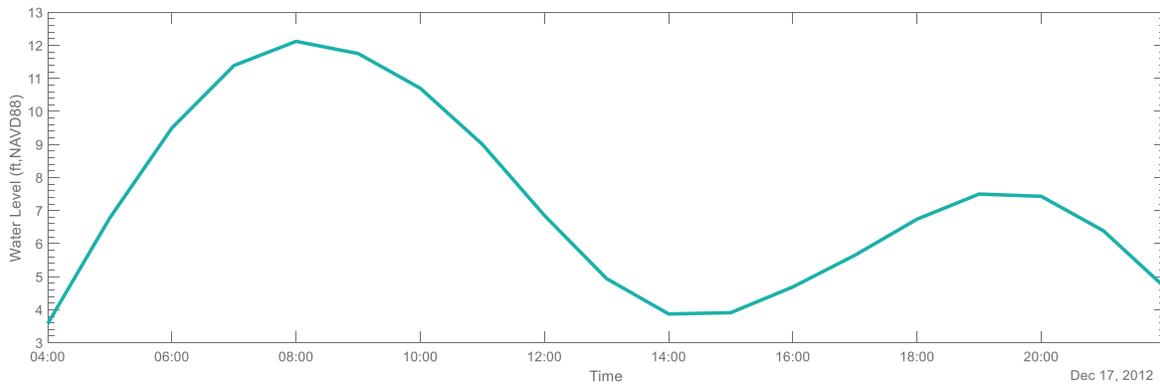
Typical conditions, and storm conditions were analyzed to evaluate the impacts on the beach after construction. The model was run through a tide cycle (Figure 5) that include it a 20-year water level event ~~or for 3-hours when a specific water level or water level event was used.~~ Water levels below 4 ft will not reach the designed beach, and therefore there were not considered on this modeling.

Figure 5. High Tide Event on December 17, 2012. (Sta. 9447130, NOAA, 2019)

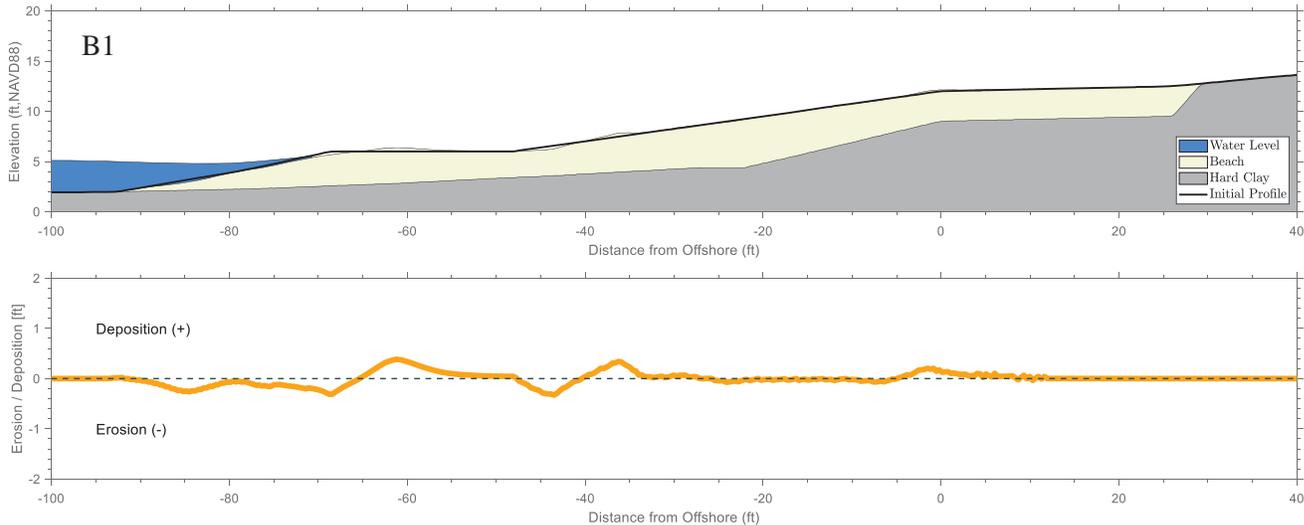
The results of a typical wave event during the tide cycle (Figure 6) shows that the typical waves will have little or no effect on the accretion/erosion of the design beach profile. A 10-year storm event with the full tide cycle will have significant effects on the beach profile (Figure 7) eroding the lower bench, pushing the lower material upwards and building a storm berm before the backshore of the beach and maintaining the foreshore at the same location, maintaining a foreshore slope of 8:1. The resulted beach profile mimics existing natural beach profiles found south of the site and other places in the Puget Sound (Johannessen *et al.*, 2014).

Figure 6. Beach Profile Response Under Typical Wave Conditions and Full Tide Range.

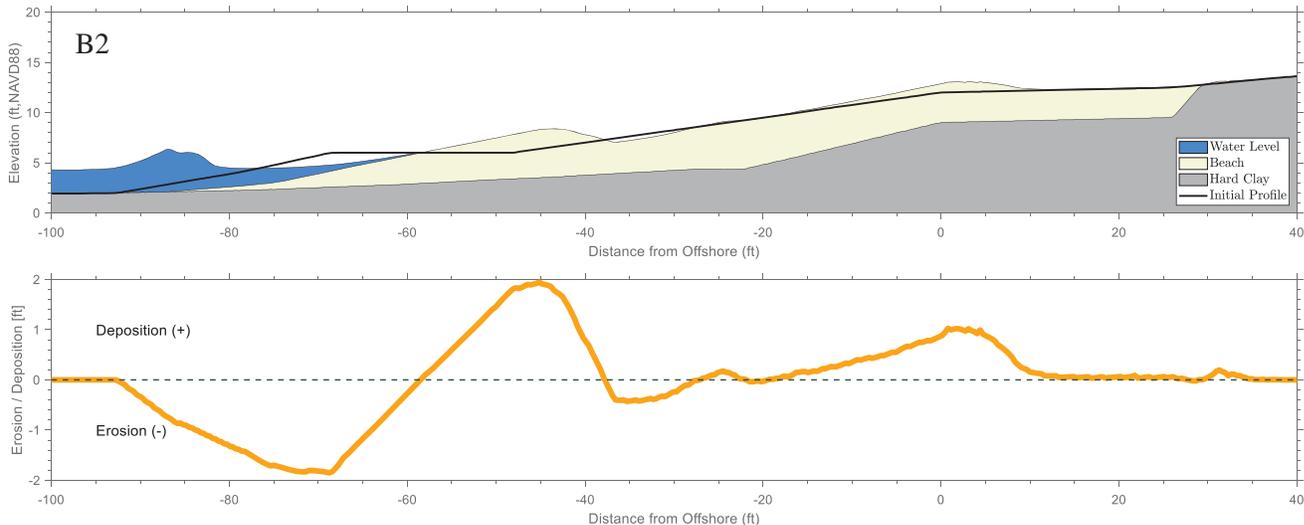
Figure 7. Beach Profile Response Under Storm Wave Conditions and Full Tide Range.

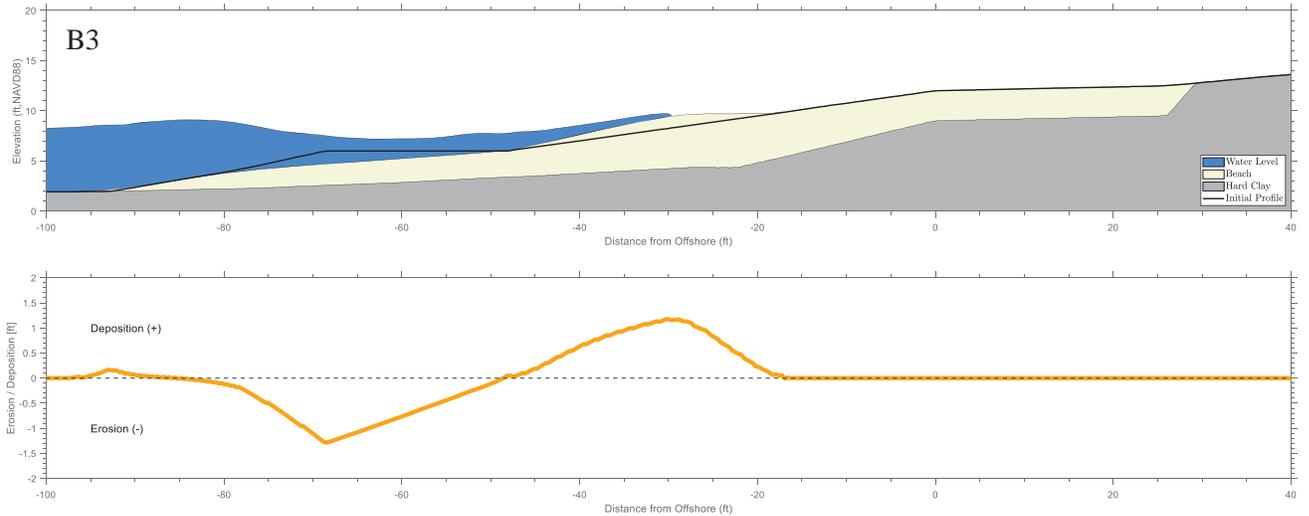
During a 10-year wave storm, event and MHW water level (Figure 8) the beach responds by eroding the lower berm and move the sediment up and landwards. The berms flatten at a slope of 15:1 which is close to the beach slope of the reference beach to the south ~~at this elevation that ranges from 15:1 to 20:1. A 10-year wave storm event.~~ During a 1-year water level event (Figure 9) ~~shows that~~ the lower berm slightly eroded, and the material ~~place at the end of the lower bench moves up and~~ accretes the backshore of the beach.

Figure 8. Beach Profile Response Under Storm Wave Conditions and MHW Tide.

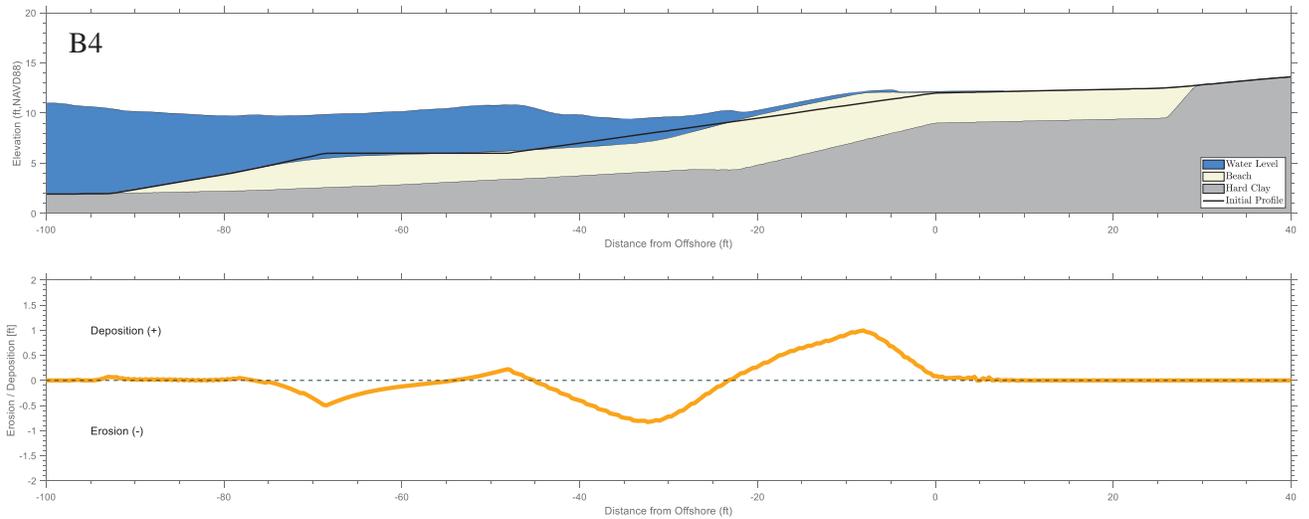
Figure 9. Beach Profile Response Under Storm Wave Conditions and 1-Year SWL Event

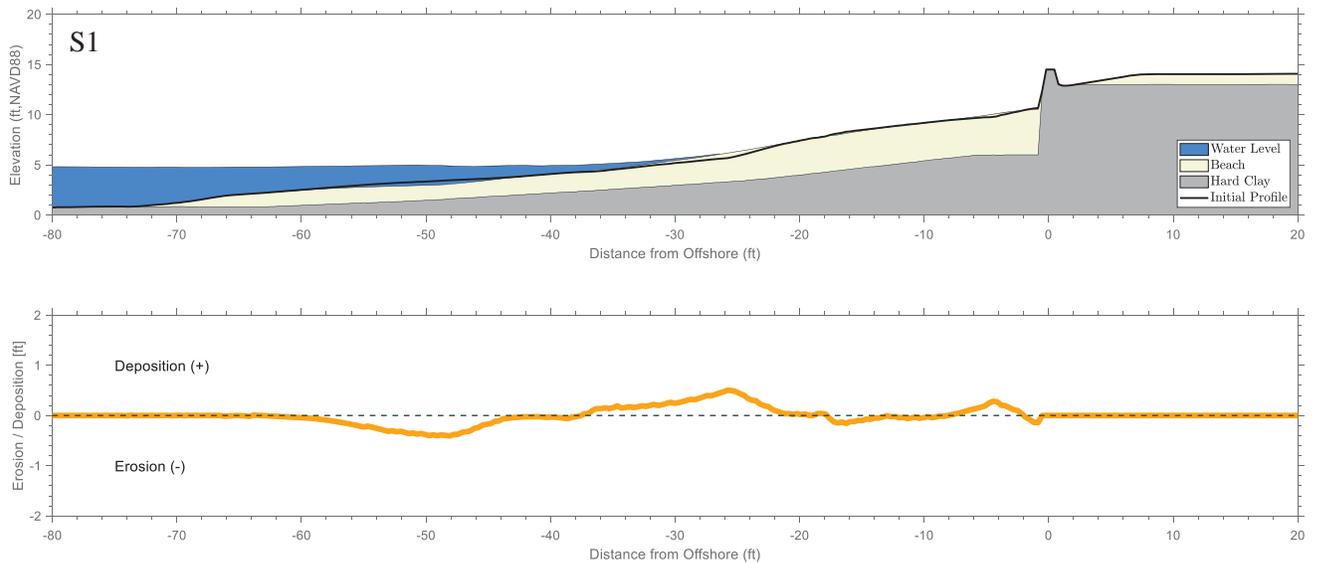
The results of a typical wave event during the tide cycle on the beach front of the seawall (Figure 10) shows that the typical waves will have minor effects on the initial beach by causing some small erosion on the lower end, adjusting the slope to be close to a steep slope of the foreshore between 5:1 to 6:1. Moreover, causing some accretion and minor erosion in front of the seawall. A 10-year storm event with the full tide cycle will have significant effects on the beach, front of the seawall by adjusting the beach profile eroding the lower bench, accreting the foreshore of the beach and erode the beach below the seawall. The beach will then adjust to a more natural state on a slope of approximately 8:1.

Figure 10. Seawall-Beach Profile Response Under Typical Wave Conditions and Full Tide Range.

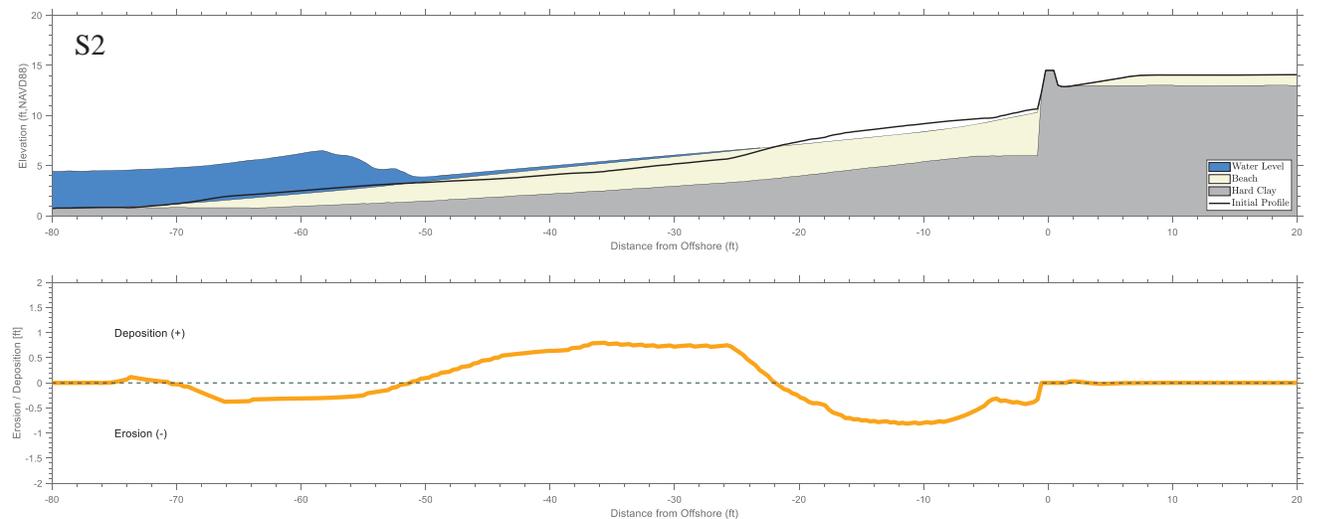
Figure 11. Seawall-Beach Profile Response Under Storm Wave Conditions and Full Tide Range.

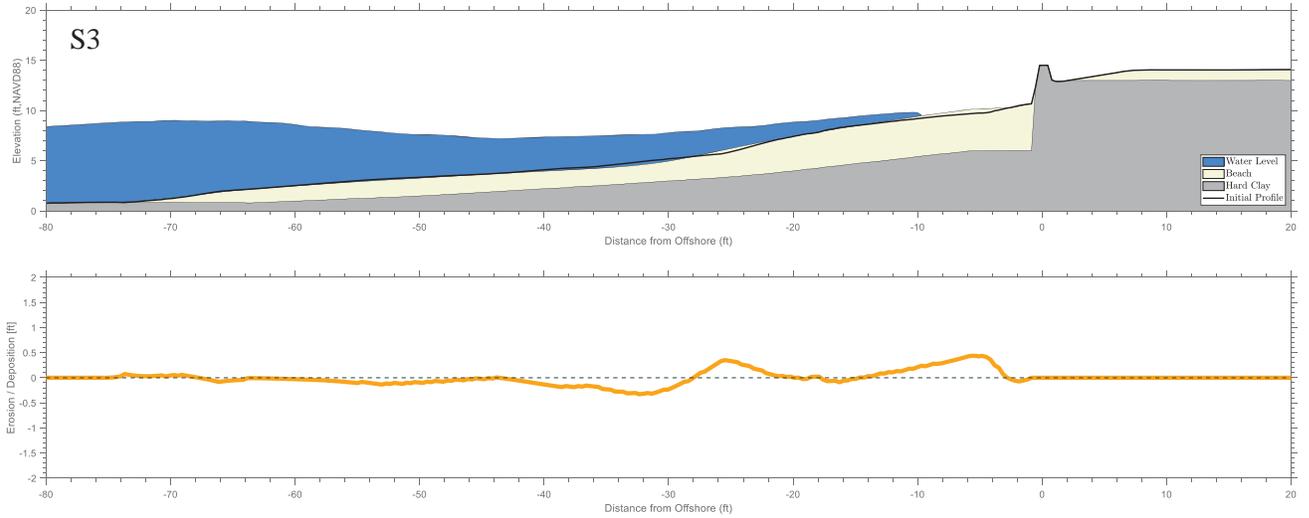
During a 10-year wave storm, event and MHW water level (Figure 12) the beach in front of the seawall will show relatively small changes on the beach profile by eroding the lower foreshore of the beach and accreting material on the top of the beach adjacent to the seawall. Some erosion of the beach below the seawall is also present during these conditions. A 10-year wave storm event. During a 1-year water level event (Figure 13) shows that the beach in front of the seawall will experience some accretion of the material on the upper part and that the slope of the beach will become steeper in a slope of approximately 5:1 to the toe of the seawall. A small amount of accretion below the seawall is present during this conditions.

Figure 12. Seawall-Beach Profile Response Under Storm Wave Conditions and MHW Tide.
