LOWMAN BEACH PARK SHORELINE RESTORATION

Draft 60% Design Report

Prepared for
Seattle Parks & Recreation Department

June 2019

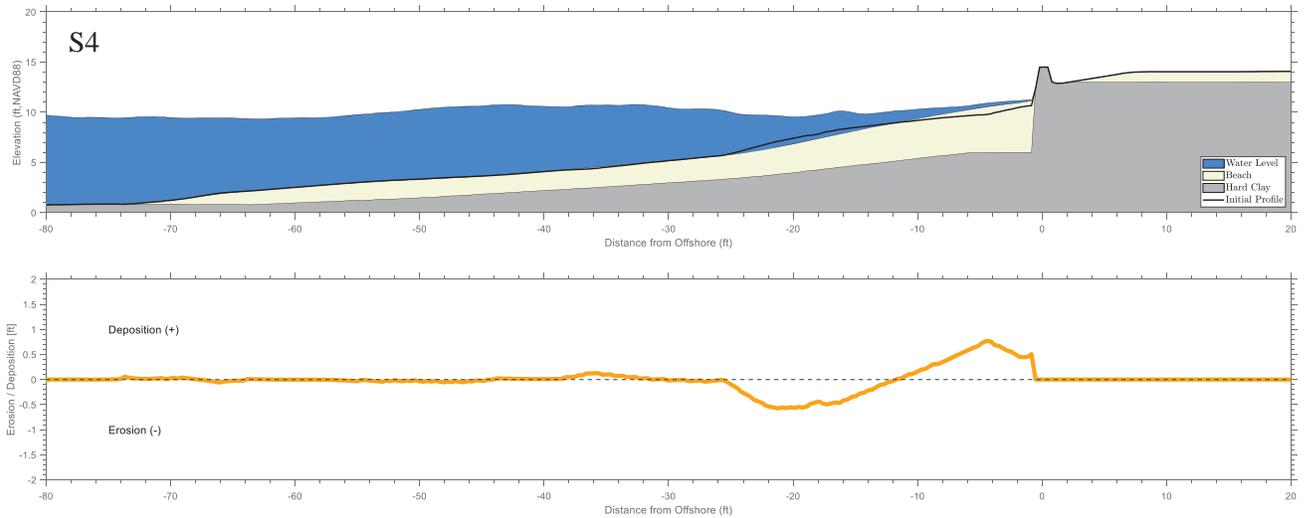
Figure 13. Seawall-Beach Profile Response Under Storm Wave Conditions and 1-Year SWL Event.

During a 10-year wave storm, event and MHW water level (Figure 12) the beach in front of the seawall will show relatively small changes on the beach profile by eroding the lower foreshore of the beach and accreting material on the top of the beach adjacent to the seawall. Some erosion of the beach below the seawall is also present during these conditions. A 10-year wave storm event. During a 1-year water level event (Figure 13) shows that the beach in front of the seawall will experience some accretion of the material on the upper part and that the slope of the beach will become steeper in a slope of approximately 5:1 to the toe of the seawall. A small amount of accretion below the seawall is present during this conditions.

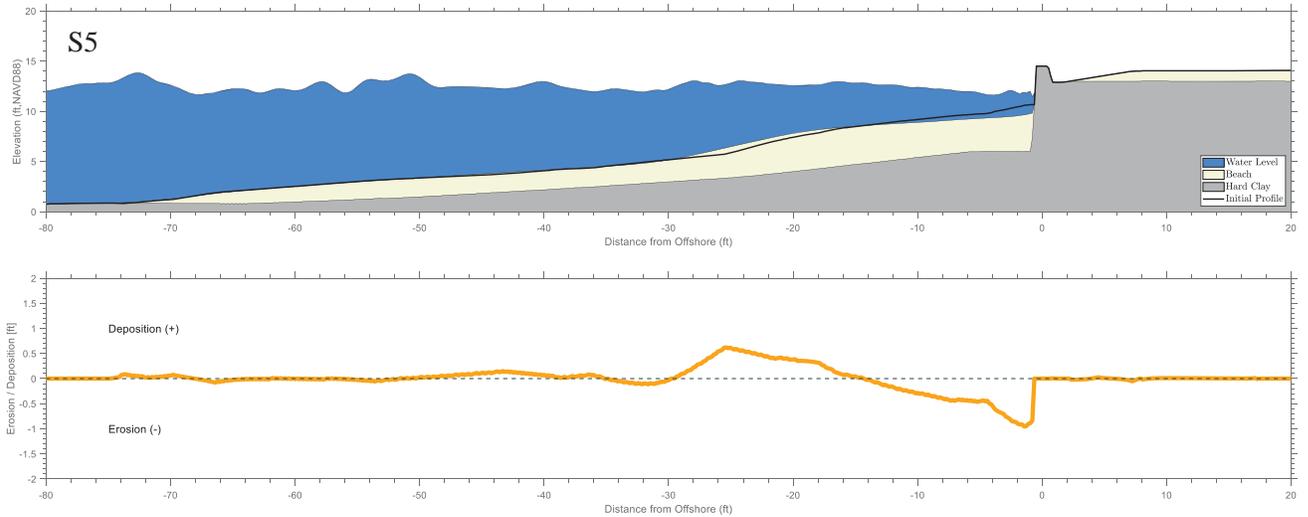
An unlikely extreme event with a combined 10-year storm wave event with a 100-year water level event (Figure 14) was also considered to evaluate the performance of the beach in front of the seawall. The results show that during this event some wave overtopping will occur and that the beach material below the seawall will significantly erode and move seawards. The lowest part of the beach does not show significant changes during this event.

Figure 14. Seawall-Beach Profile Response Under Storm Wave Conditions and 100-Year SWL Event
