ANALYSIS OF RECENT DEVELOPMENT IN THE PIKE-PINE CORRIDOR

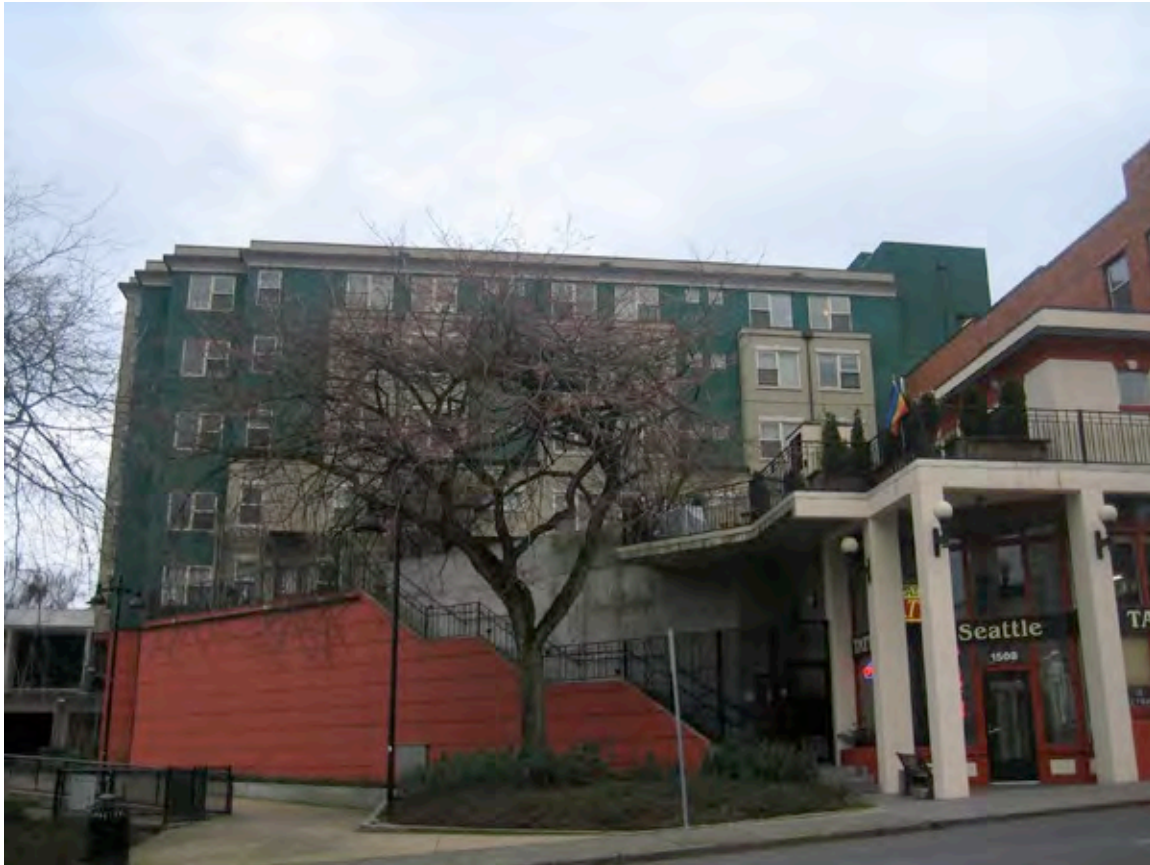
1. 1508 Boren Avenue (attached to Villa Apartments, 1106 Pike Street)

From Boren Avenue, the most visible portion of the new structure is a small one-story retail space that is attached to the Villa Apartments building. The major massing of the building, however, is significantly set back from Boren Avenue, so as to appear as a separate building from the Villa.

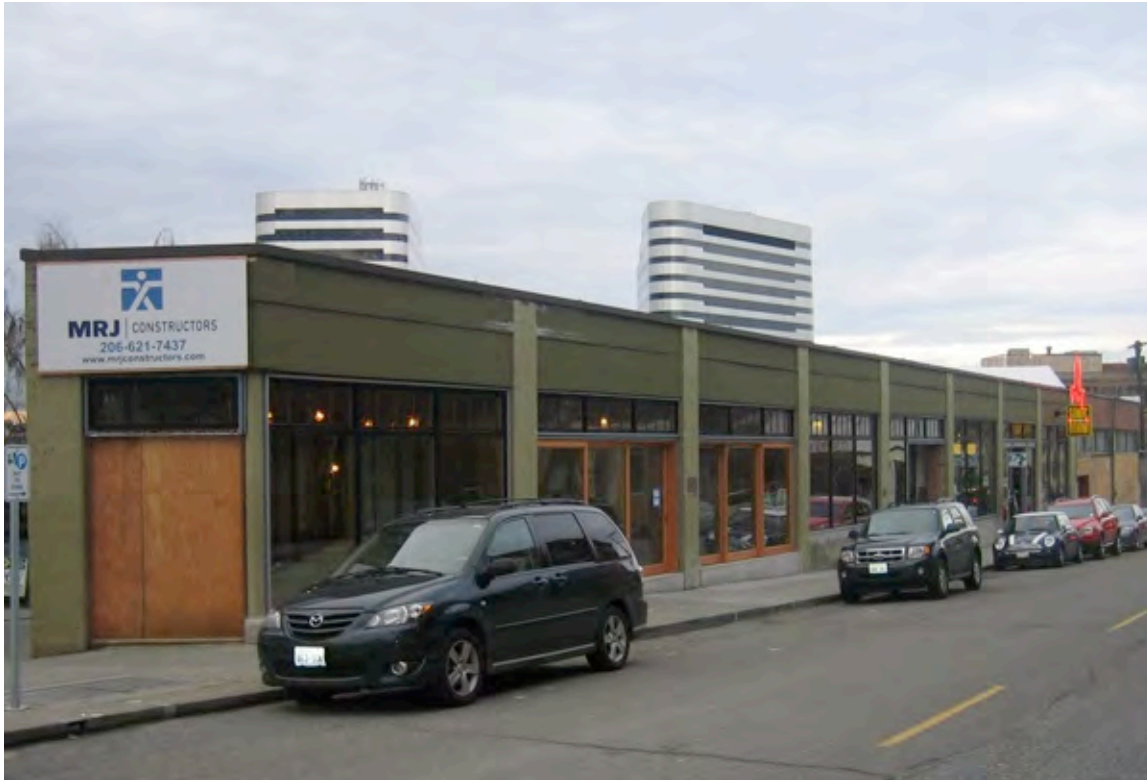
2. Melrose Triangle: 1521-1531 Melrose Avenue

This is a character building of the Pike-Pine corridor, albeit an understated “background” building. Constructed in the 1920s, this one-story, former garage was still used for automobile repair until the 2009 renovation.

The 1521-1531 Melrose building is essentially a single-story brick frame of ten bays, each measuring approximately fifteen feet in length, giving the building an overall length of approximately 150 feet. Each

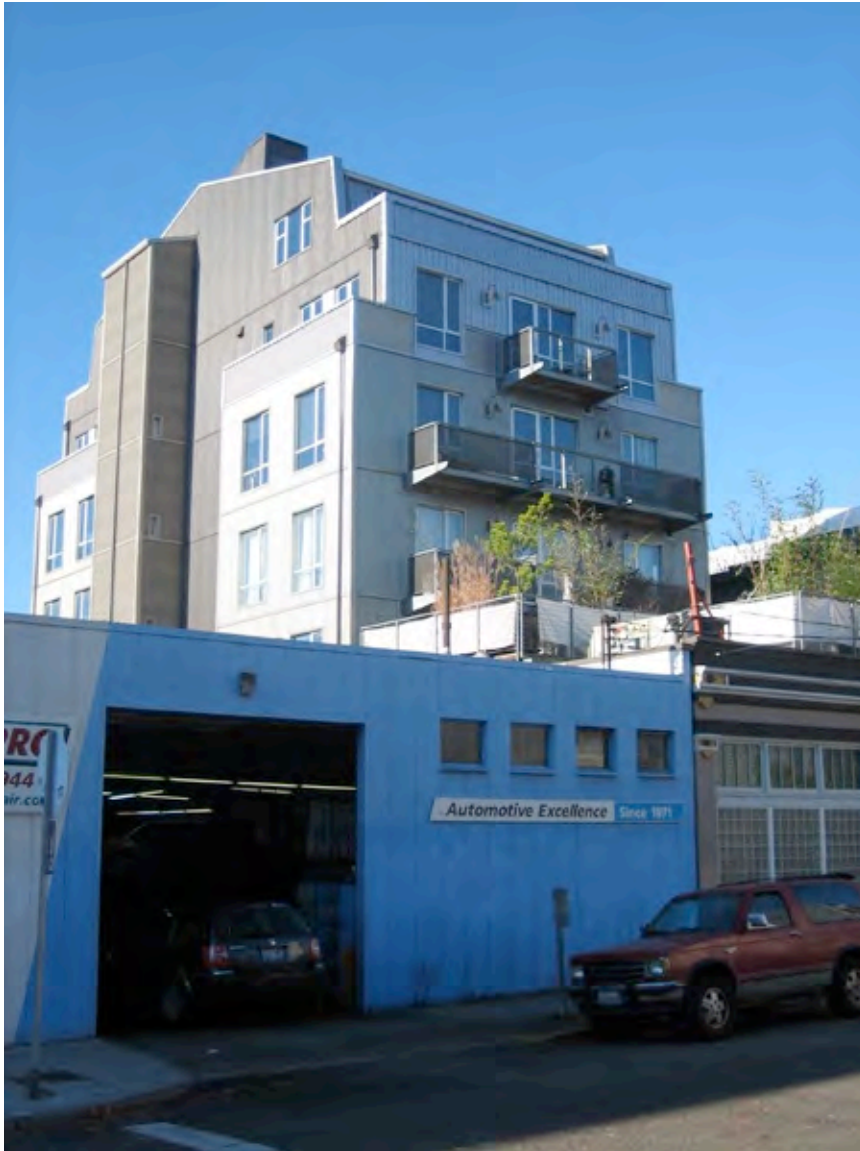
3. 1609 Summit Avenue (The Crawford)

This modest six-story apartment building was constructed near the corner of Summit Avenue and E Pine St. Its front façade is set back behind an existing one-story storefront building. Its rear façade faces Crawford Place.

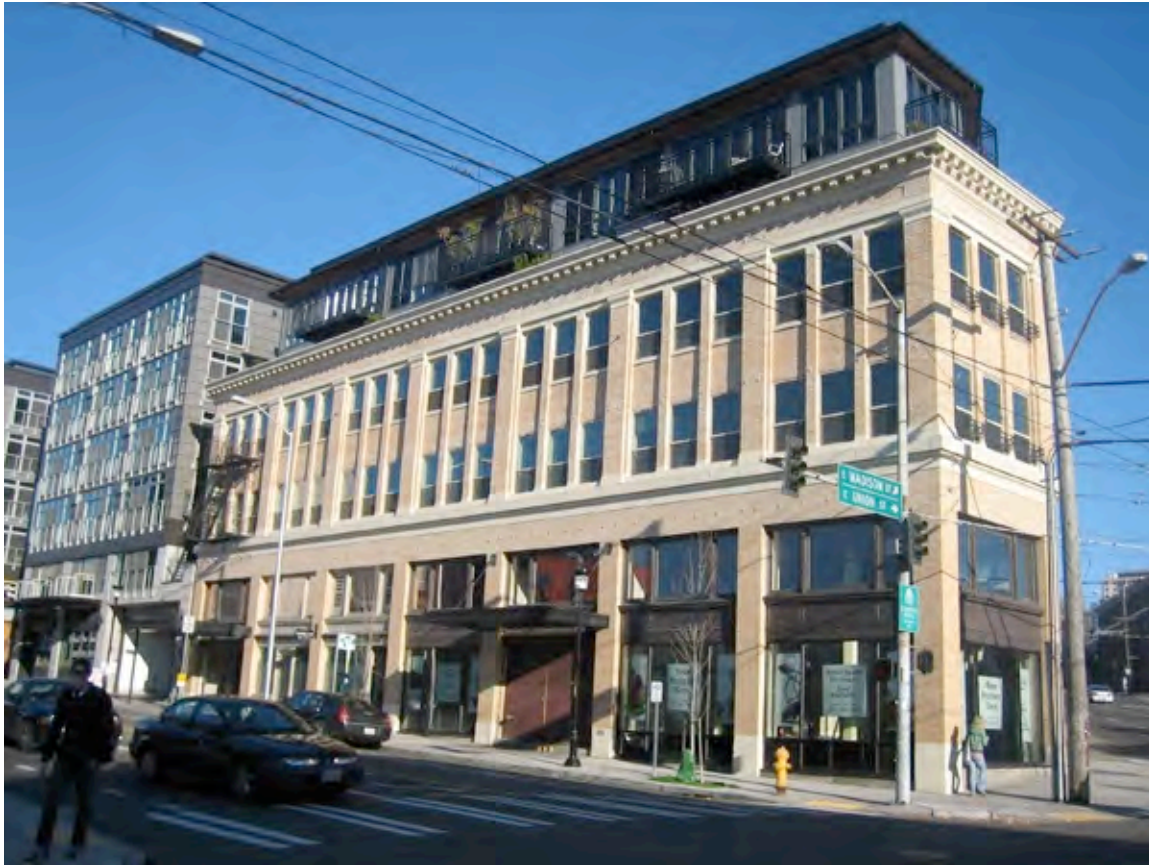
4. 1400 12th Avenue (Trace Lofts)

This structure is an early warehouse, significant for its architecture and prominent location at the intersection of 12th Avenue and Madison Street. The building was used as a storage warehouse from 1935 until the 1970s.¹ The building was renovated in 2008-09 for a mix of residential and commercial uses. The observations and analysis pertain only to the renovated building, and its rooftop addition, and not to the new building to the north, The Trace North.

The new building respectfully steps back from each façade, physically separating it from the older building. Its dark color causes it to appear to float above the older yellow brick/terra cotta building, and its metal finish material further distinguishes it from the original structure.

The upper-story addition has the same form as the original building in plan, but on a smaller scale, as it is set back from each of the exterior walls. Its small scale and setback diminish the impact of the addition on the original structure. The massing of this top floor addition is a simple volume, broken by full-length windows. The proportions of the new addition are different from those on the original building, as the amount of building mass devoted to windows may be greater on this upper story.

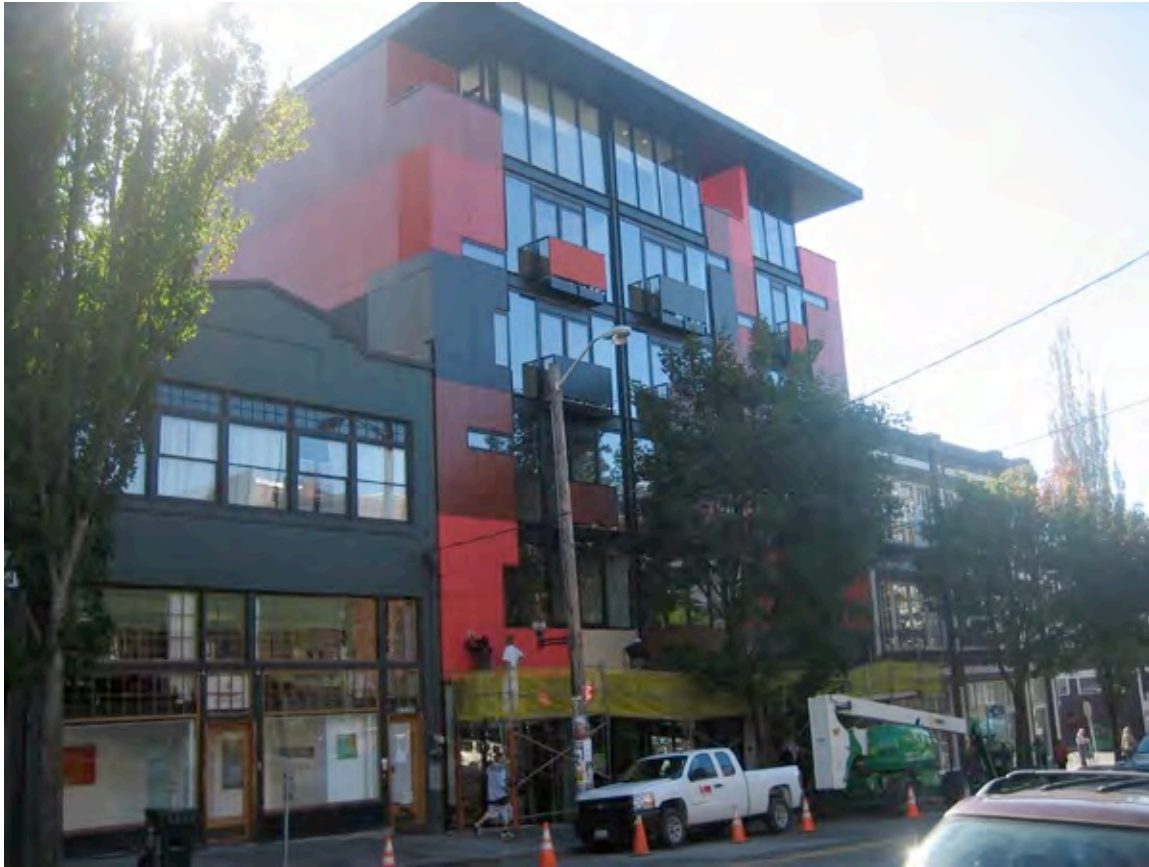
5. 1111 E Pike St

This mixed-use commercial and residential building, located on the south side of Pike Street between 11th and 12th Avenues, was completed in 2009.

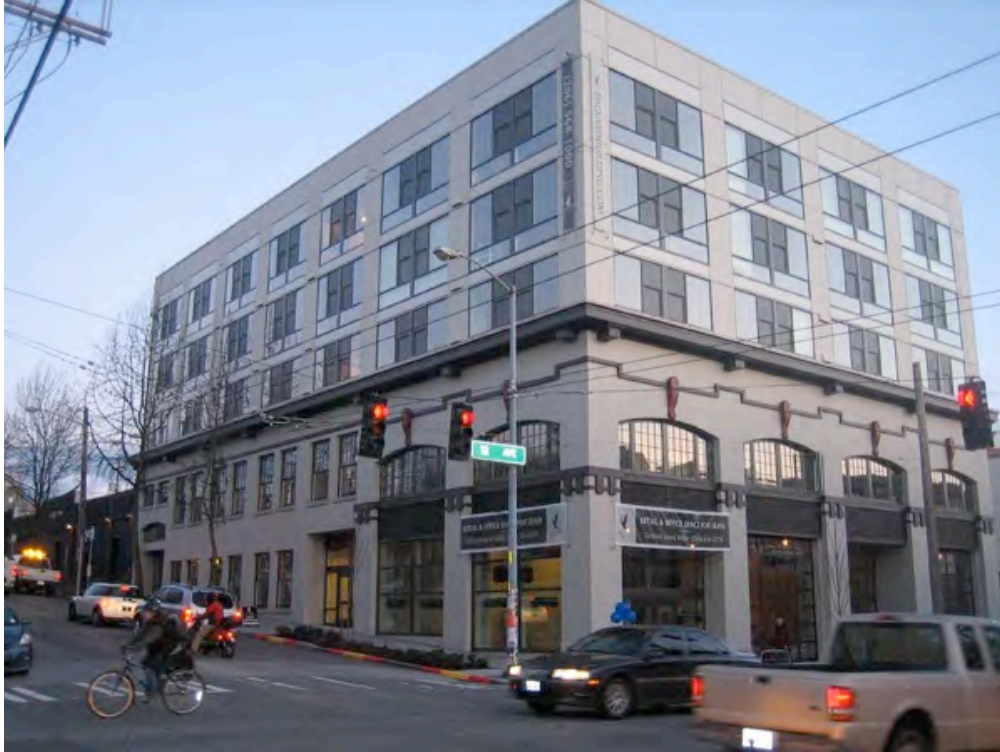
6. 1530 12th Avenue (The Packard Building, The Foley Sign Building)

This is a very good and intact example of the automobile showroom building type. This reinforced-concrete fireproof building is distinguished by its solid presence at the corner of 12th and Pine. A 2009 addition to the building incorporates the façade into a new mixed-use residential building.

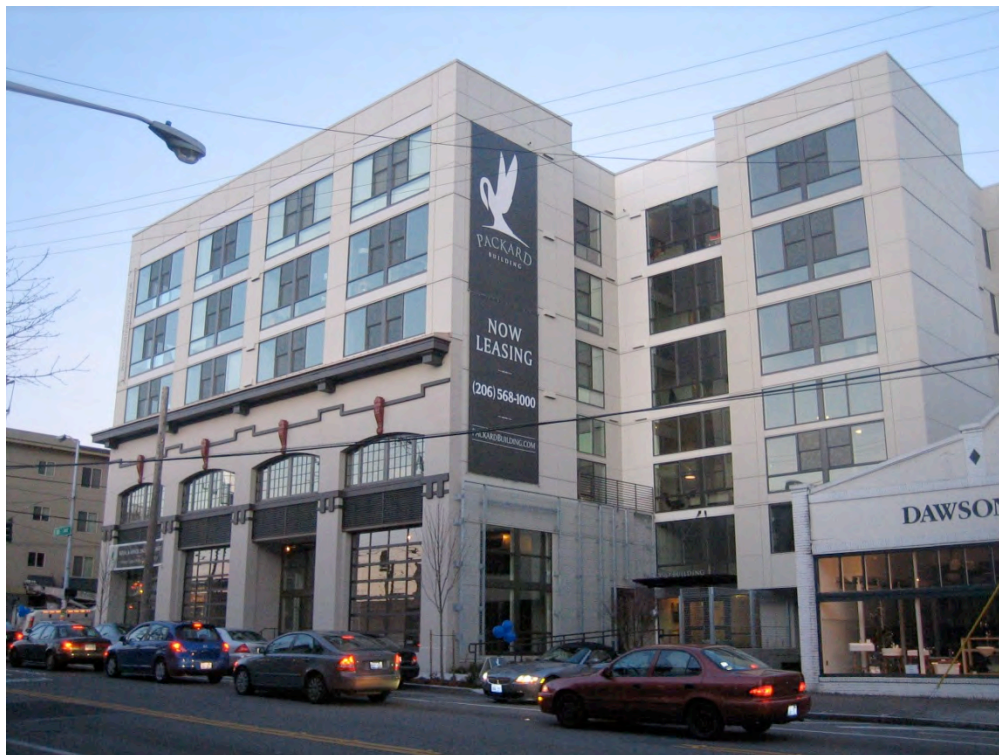
An addition was built atop and adjacent to this building in 2009. Three residential stories were added to the top of the original structure, as well as a new six-story residential structure south of the character building. The bay system of the original building, four bays wide on 12th Avenue and seven bays deep on Pine St, was respected by the addition. The addition two bays of width added by the new building are set back from the sidewalk by approximately 30 feet. The original garage entry on E Pine St was kept, and another garage was added in the recessed portion of the new building, off 12th Avenue.

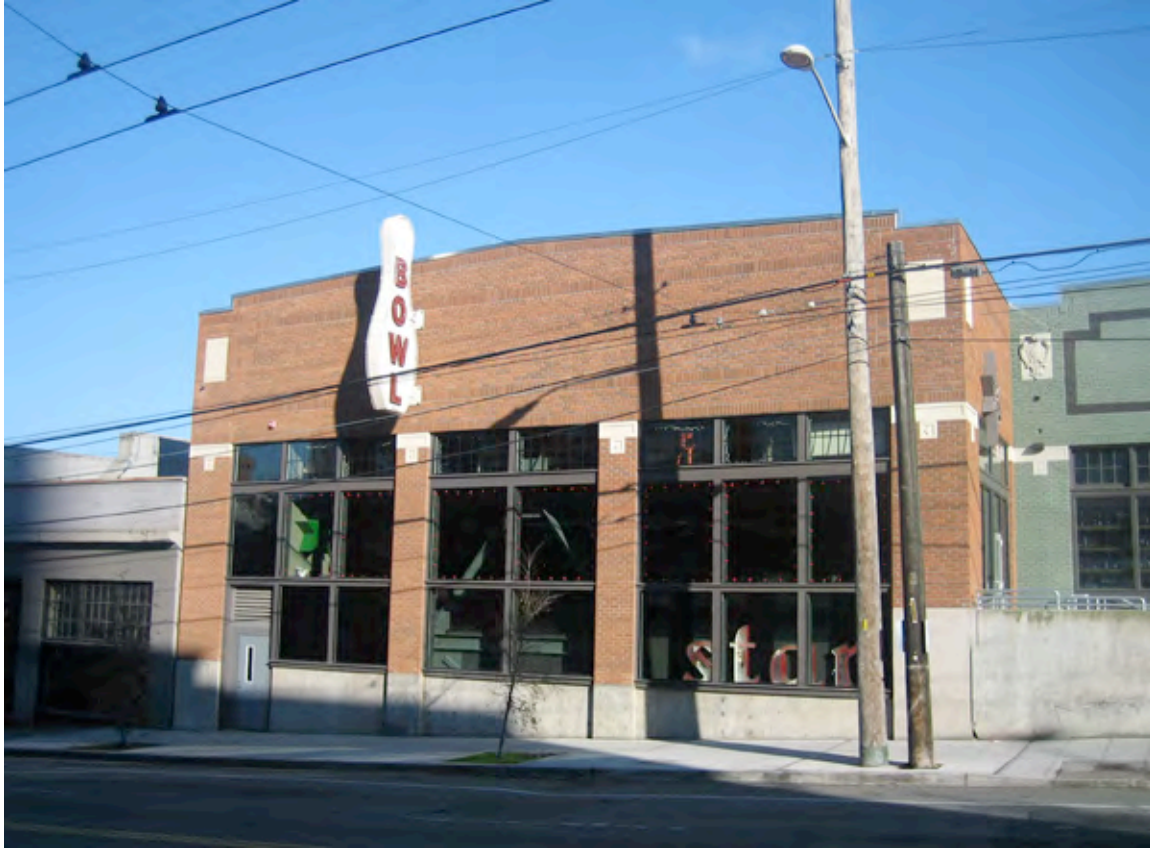
7. 1136 Broadway (addition to The Garage)

In 2009, an addition to this building was completed. The addition was built upon a vacant parcel, immediately to the north of the original building.

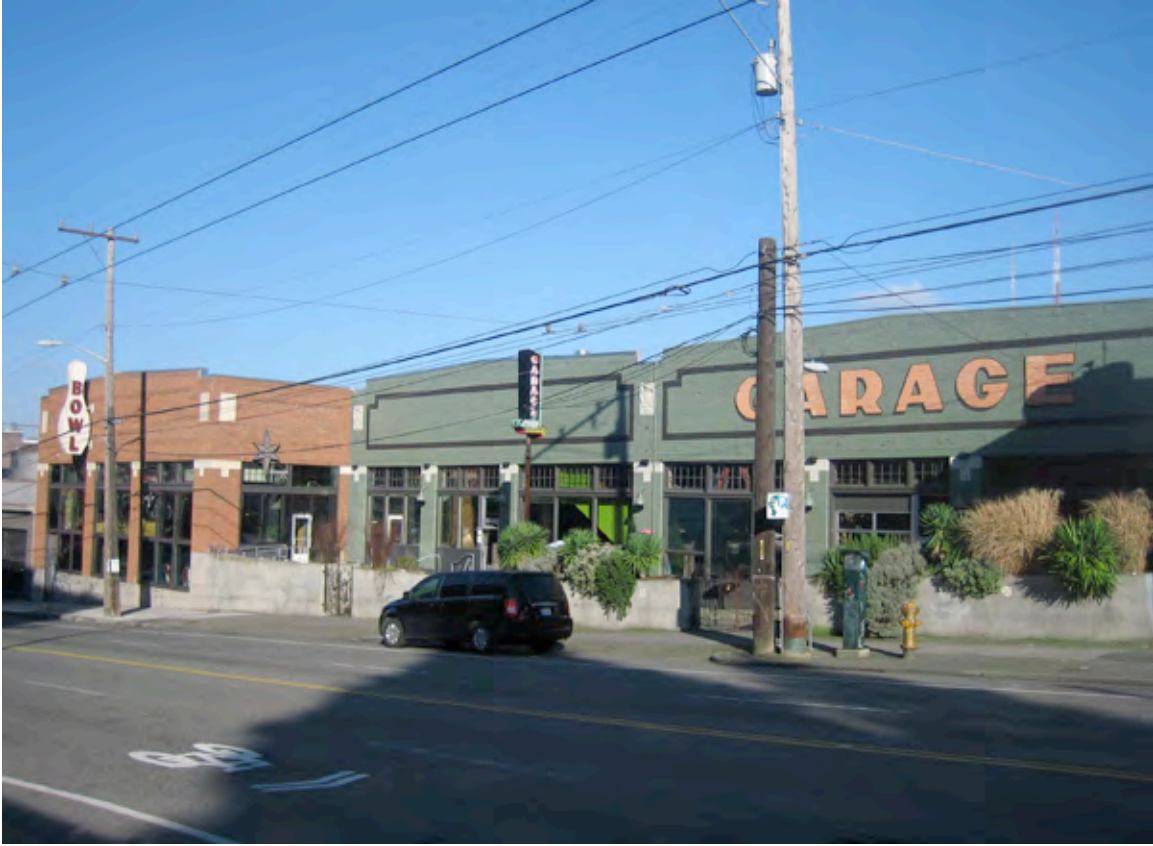
The 2009 addition to these garage buildings is essentially a replica of the two 1927 buildings, with some slight differences. In essentially all architectural aspects—form, scale and massing, fenestration pattern, exterior finishes—the building mimics the original garages. There are two singular distinctions between this addition and the original: the brick façade is not painted, and, more important, this building is flush to the sidewalk with no setback. The 2009 addition contains a utility door, but no public entry from the street; the setback of the two 1927 buildings creates an alcove, so the entry to this building is on the south facade, immediately adjacent to the outdoor seating area.

The primary visual distinction that is made between the old and new structures is that the new structure is set forward from its predecessors. It is not painted, as the original buildings are, although exterior painting of brick is a mutable condition. The construction is distinguishable in that it attaches to a minor façade of the original building.
