HWA Project No. 2014-177-21

Subject: **DRAFT GEOTECHNICAL ENGINEERING REPORT  
Cheasty Greenspace Mountain Bike Trail  
City of Seattle Parks and Recreation  
Seattle, Washington**

Cheasty Greenspace  
Mountain Bike Trail  
Seattle, Washington

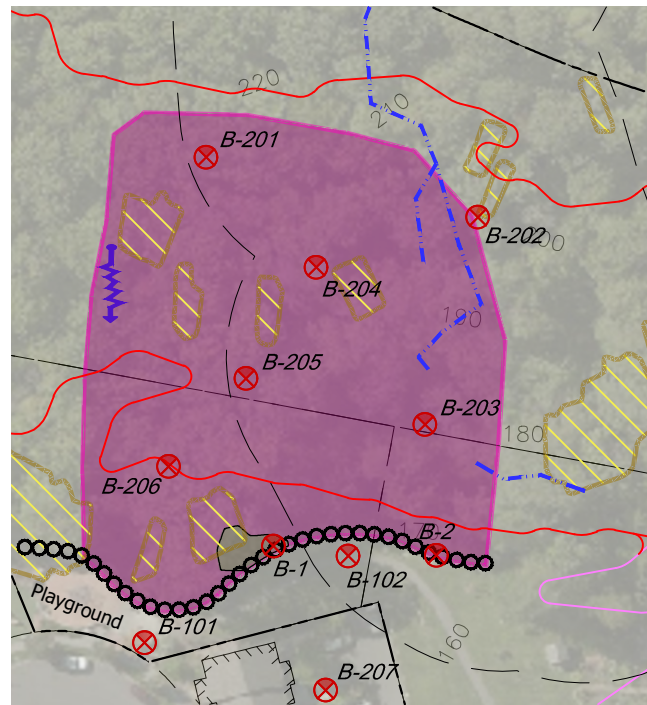
DRAWN BY	FIGURE #
BFM	2A
CHECK BY	PROJECT #
BT	2014-177-21
DATE:	
06.21.2018

**ENLARGED PLAN**  
Scale: 1" = 100'-0"

- HH-13 HANDHOLE DESIGNATION AND APPROXIMATE LOCATION (HWA 2015, 2018)
- B-207 BOREHOLE DESIGNATION AND APPROXIMATE LOCATION (ECI, 2003-2004)
- B-2 BOREHOLE DESIGNATION AND APPROXIMATE LOCATION (LSI ADAPT, 2001)
- GC-32 BOREHOLE DESIGNATION AND APPROXIMATE LOCATION (GOLDER, 2001)
- B-6 BOREHOLE DESIGNATION AND APPROXIMATE LOCATION (ECI, 2000)
- TP-7 TEST PITS DESIGNATION AND APPROXIMATE LOCATION (ECI, 2000)
- B-2 BOREHOLE DESIGNATION AND APPROXIMATE LOCATION (HARTCROWSER, 1986)
- 9 BOREHOLE DESIGNATION AND APPROXIMATE LOCATION (SEATTLE ENG. DEPT., 1973)

**CHEASTY GREENSPACE MOUNTAIN BIKE TRAIL**  
Scale: 1" = 250'-0"

SITE AND  
EXPLORATION  
PLAN

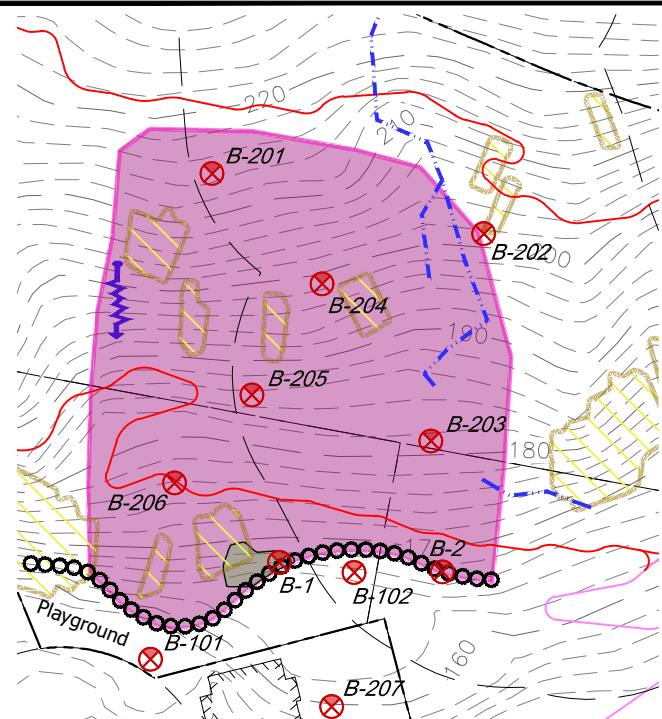
**ENLARGED PLAN**  
Scale: 1" = 100'-0"

- LEGEND**
- GROUND WATER SEEPAGE AND RUNOFF (HWA, 2015)
  - WATER COURSES
  - MAPPED STEEP SLOPE AREA (SEATTLE GIS; 2016 UPDATE)
  - MAPPED POTENTIAL SLIDE AREA (SEATTLE GIS; SHANNON & WILSON, 2000)
  - MAPPED WETLAND AREA (ESA, PRESENT STUDY)
  - APPROXIMATE AREA OF 2003 LANDSLIDE (ECI, 2004)
  - APPROXIMATE LOCATION OF DOCUMENTED LANDSLIDES AND ERA (SHANNON & WILSON, 2000)
  - SOLDIER PILE WALL
  - PROPOSED MOUNTAIN BIKE TRAILS
  - PROPOSED CONNECTOR TRAILS
  - PARK BOUNDARY

- EXPLORATION LEGEND**
- HH-13 HANDHOLE DESIGNATION AND APPROXIMATE LOCATION (HWA 2015, 2018)
  - B-207 BOREHOLE DESIGNATION AND APPROXIMATE LOCATION (ECI, 2003-2004)
  - B-2 BOREHOLE DESIGNATION AND APPROXIMATE LOCATION (LSI ADAPT, 2001)
  - GC-32 BOREHOLE DESIGNATION AND APPROXIMATE LOCATION (GOLDER, 2001)
  - B-6 BOREHOLE DESIGNATION AND APPROXIMATE LOCATION (ECI, 2000)
  - TP-7 TEST PITS DESIGNATION AND APPROXIMATE LOCATION (ECI, 2000)
  - B-2 BOREHOLE DESIGNATION AND APPROXIMATE LOCATION (HARTCROWSER, 1986)
  - 9 BOREHOLE DESIGNATION AND APPROXIMATE LOCATION (SEATTLE ENG. DEPT., 1973)

**CHEASTY GREENSPACE MOUNTAIN BIKE TRAIL**  
Scale: 1" = 250'-0"

**Columbia Way Area:** We recommended placing the trail outside of the existing road cut which is a mapped steep slope area. Due to the presence of wetlands above, the trail was routed even farther from the roadcut to avoid the wetlands and their buffers.

**Top of 2003 Slide Area:** At the top of the 2003 slide area, retained by the soldier pile wall, we recommended the upslope portion of trail be rerouted outside of the slide area (closer to Cheasty Blvd).

Where the trail will cross the lower portion of the 2003 slide, a short distance above the soldier pile wall, we recommend that surface runoff be collected from the trail and tightlined to the storm system in front of (downslope from) the wall. The purpose of this is to prevent inadvertently concentrating runoff into slide scarps or other ground cracks, which could result in increased pore pressures in the slide plane and thus increased pressure on the soldier pile wall.

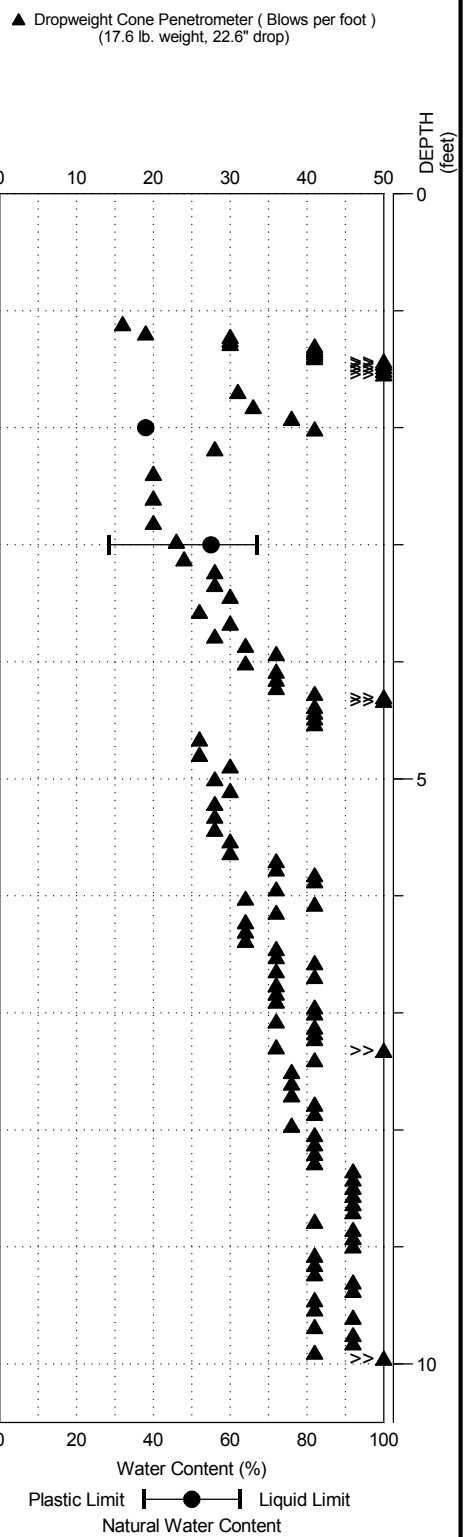
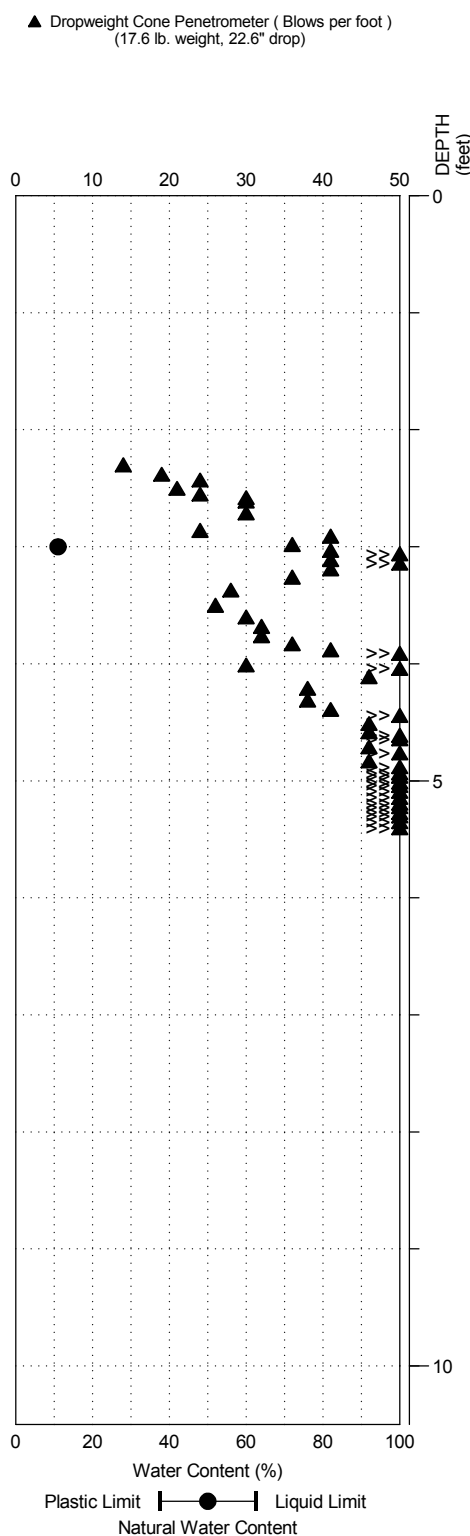
DRILLING COMPANY: HWA GeoSciences Inc.  
 DRILLING METHOD: Hand Auger  
 SAMPLING METHOD: Grab  
 LOCATION: See Figure 2

DEPTH (feet)	SYMBOL	USCS SOIL CLASS	DESCRIPTION	SAMPLE TYPE	SAMPLE NUMBER	PEN. RESISTANCE (blows/6 inches)	OTHER TESTS	GROUNDWATER
0		SM	Medium dense, dark brown, silty, fine SAND, moist, with rootlets and scattered fine to coarse gravel. <b>(TOPSOIL)</b>		S-1			
		SM	Medium dense to dense, olive brown, silty, gravelly, fine to medium SAND, moist to wet. <b>(COLLUVIUM)</b>		S-2		GS	
5					S-3

Handhole terminated at 5.3 feet below ground surface (bgs) due to refusal on gravel.  
 No ground water seepage encountered.  
 No caving.

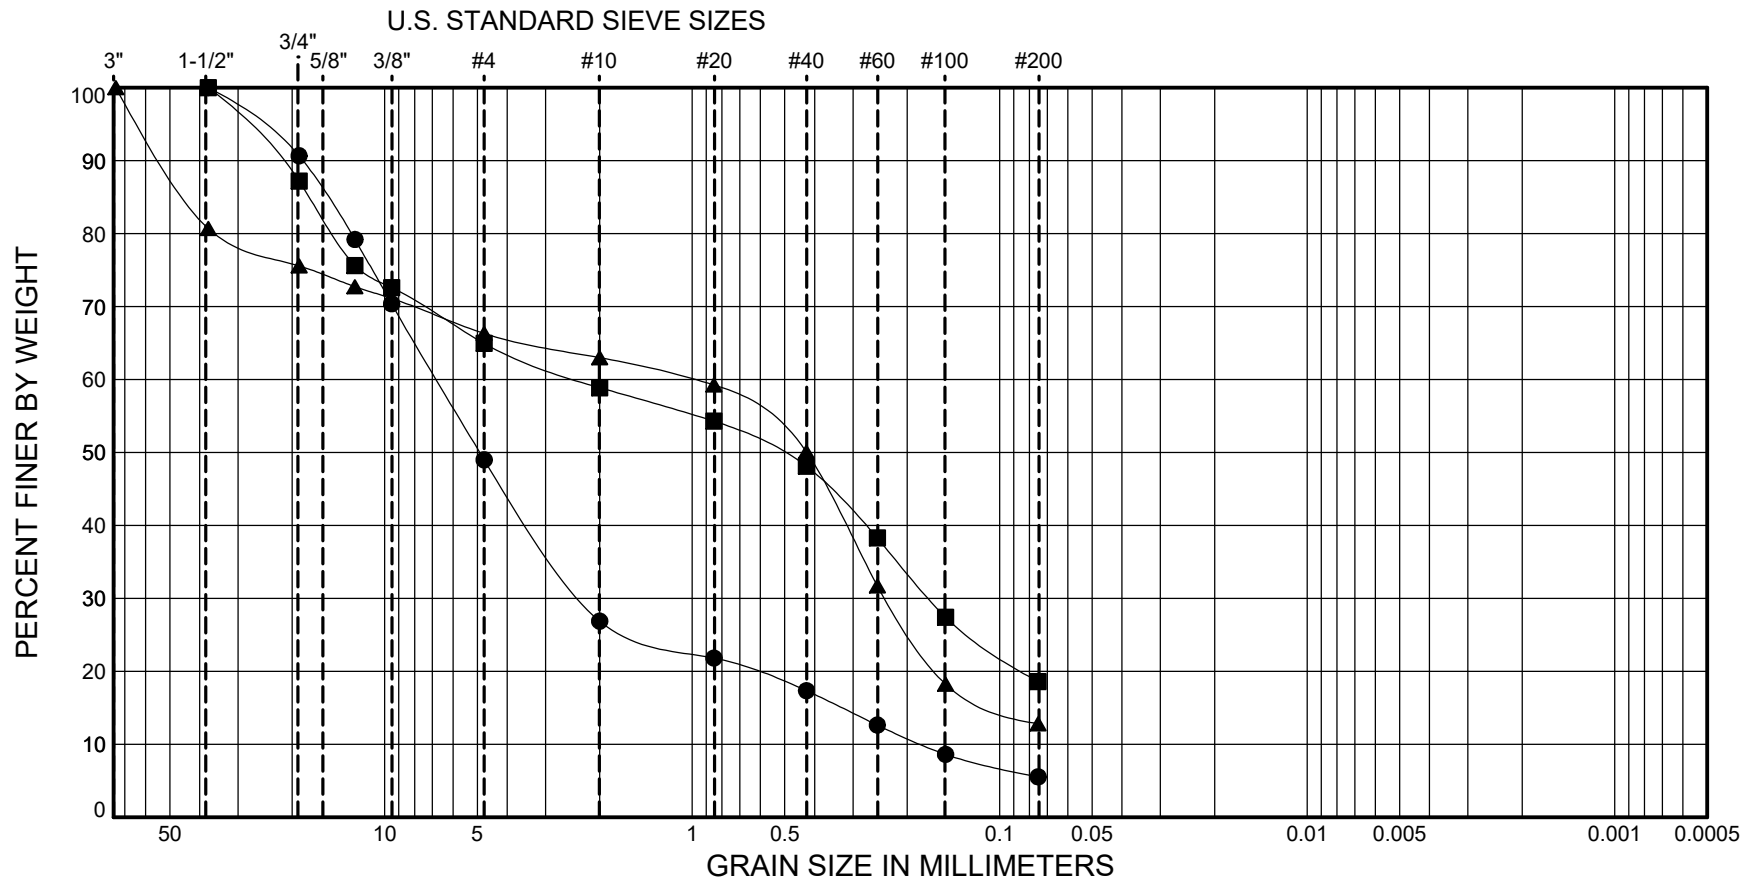
FIGURE: B-1

GRAVEL		SAND			SILT	CLAY
Coarse	Fine	Coarse	Medium	Fine

SYMBOL	SAMPLE	DEPTH ( ft. )	CLASSIFICATION OF SOIL- ASTM D2487 Group Symbol and Name	% MC	LL	PL	PI	Gravel %	Sand %	Fines %
●	HH- 8	S-1	0.5 - 1.0 (GP-GM) Very dark brown, poorly graded GRAVEL with silt and sand	9				51.0	43.5	5.5
■	HH-10	S-1	1.0 - 1.5 (SM) Yellowish-brown, silty SAND with gravel	11				35.1	46.3	18.6
▲	HH-12	S-2	3.0 - 3.5 (SM) Olive-brown, silty SAND with gravel	11				33.7	53.5	12.8

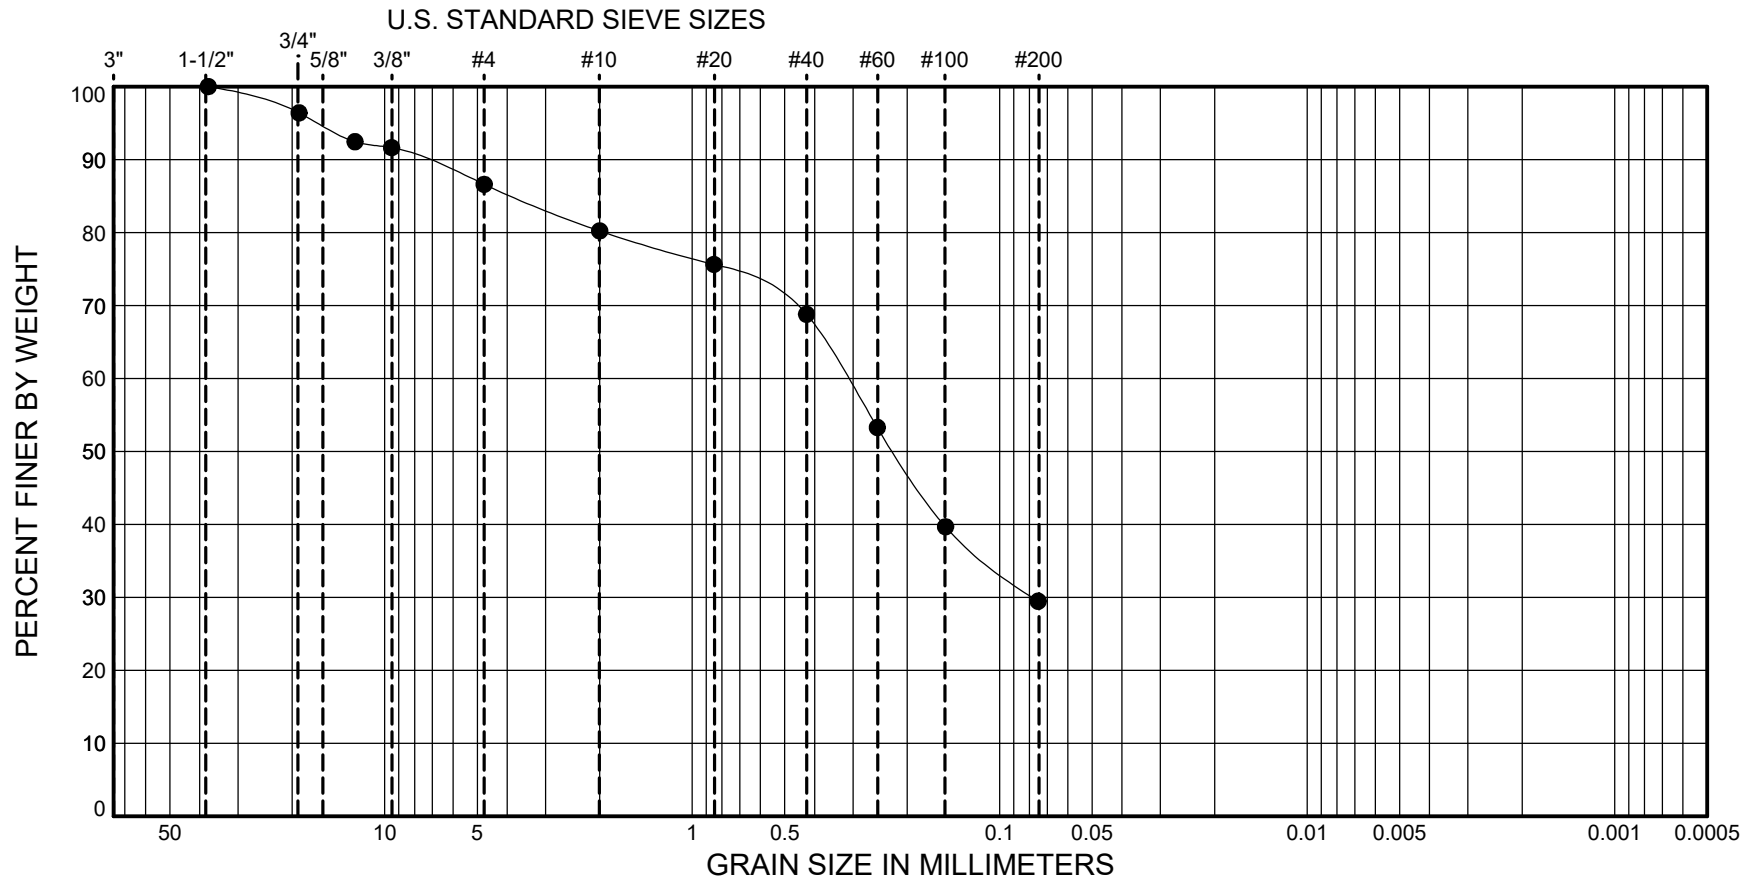
PARTICLE-SIZE ANALYSIS  
OF SOILS  
METHOD ASTM D6913

GRAVEL		SAND			SILT	CLAY
Coarse	Fine	Coarse	Medium	Fine

SYMBOL	SAMPLE		DEPTH (ft.)	CLASSIFICATION OF SOIL- ASTM D2487 Group Symbol and Name	% MC	LL	PL	PI	Gravel %	Sand %	Fines %
●	HH-13	S-1	1.0 - 1.5	(SM) Dark yellowish-brown, silty SAND	13				13.4	57.1	29.5

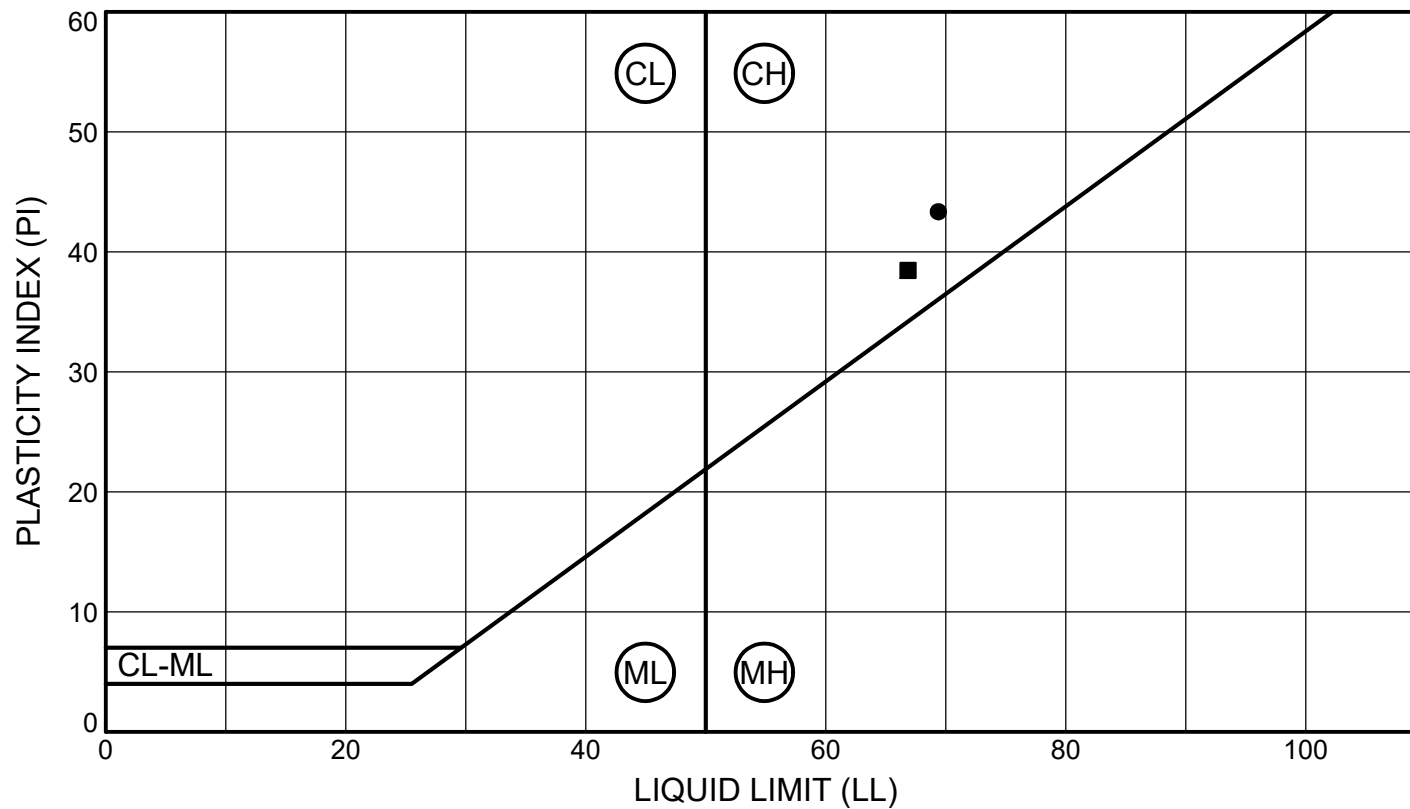
SYMBOL	SAMPLE		DEPTH (ft)	CLASSIFICATION	% MC	LL	PL	PI	% Fines
●	HH-7	S-1	1.0 - 1.5	(CH) Gray, fat CLAY	34	69	26	43	
■	HH-11	S-3	3.0 - 3.5	(CH) Yellowish-brown, fat CLAY with sand	55	67	28	39

EXPLORATION DESIGNATION	TOP DEPTH (feet)	BOTTOM DEPTH (feet)	MOISTURE CONTENT (%)	ORGANIC CONTENT (%)	SPECIFIC GRAVITY	ATTERBERG LIMITS (%)			% GRAVEL	% SAND	% FINES	ASTM SOIL CLASSIFICATION	SAMPLE DESCRIPTION
						LL	PL	PI					
HH- 7,S-1	1.0	1.5	34.1			69	26	43				CH	Gray, fat CLAY
HH- 8,S-1	0.5	1.0	9.4						51.0	43.5	5.5	GP-GM	Very dark brown, poorly graded GRAVEL with silt and sand
HH- 8,S-3	3.3	3.8	26.2									ML	Olive-brown, SILT with sand
HH- 8,S-4	4.0	4.5	30.8									CL	Grayish-brown, lean CLAY
HH- 9,S-1	0.5	1.0	25.5									CL	Grayish-brown, lean CLAY
HH-10,S-1	1.0	1.5	10.8						35.1	46.3	18.6	SM	Yellowish-brown, silty SAND with gravel
HH-10,S-2	3.5	4.0	12.7									SM	Dark yellowish-brown, silty SAND with gravel
HH-10,S-4	6.5	7.0	23.9									ML	Yellowish-brown, sandy SILT
HH-11,S-2	2.0	2.5	37.7									ML	Olive-brown, SILT
HH-11,S-3	3.0	3.5	55.1			67	28	39				CH	Yellowish-brown, fat CLAY with sand
