FEBRUARY 7, 2020  
2018 MAJOR PROJECT CHALLENGE FUND  
BUILDING 31 REHABILITATION STUDY

# Feasibility Report

**2018 MAJOR PROJECT CHALLENGE FUND  
 BUILDING 31 REHABILITATION STUDY  
 REPORT**

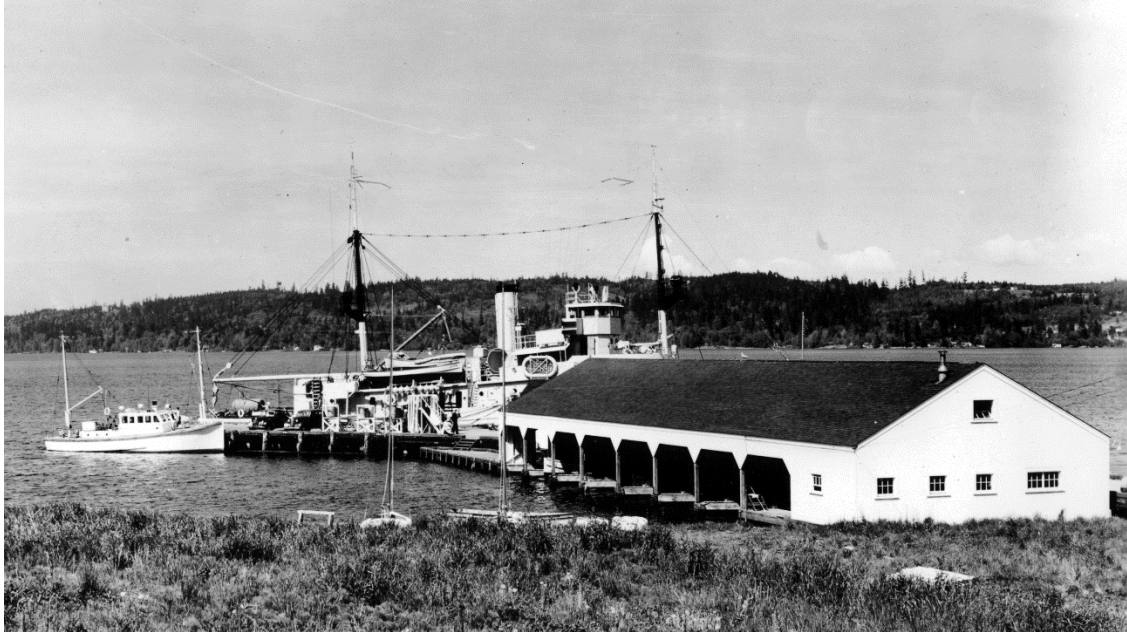
*Image 5*

Building 31, constructed in its first iteration and form in 1938.<sup>14</sup>

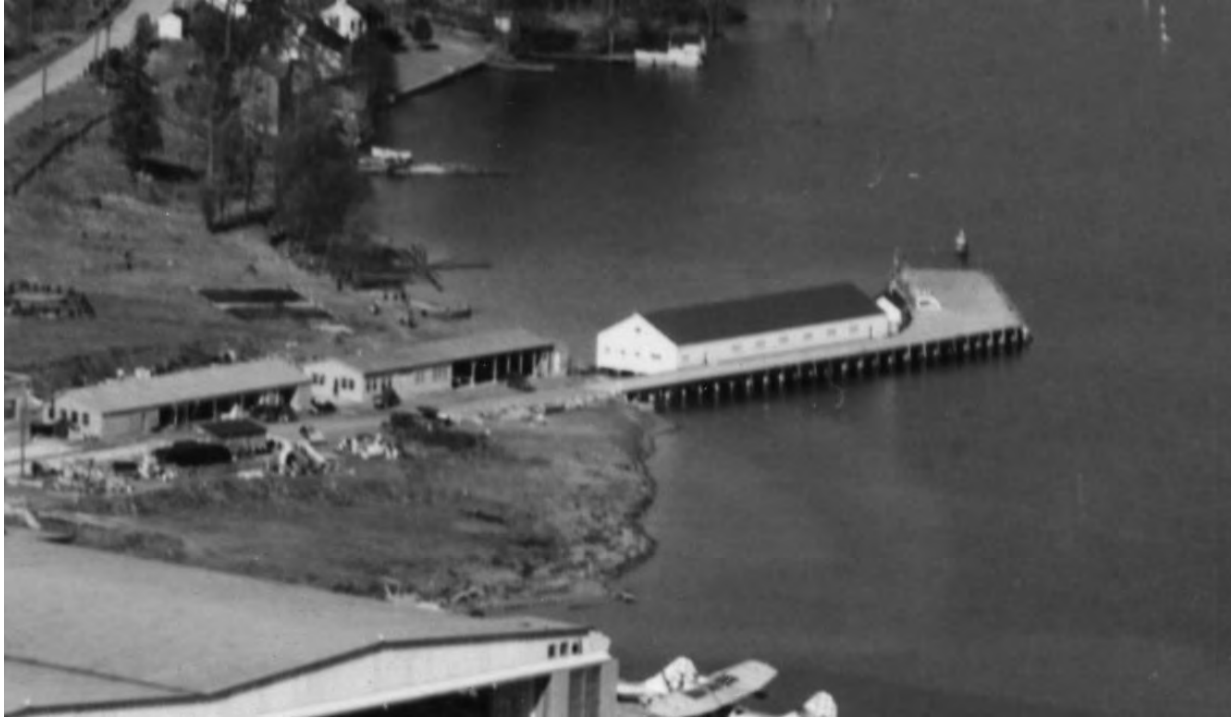
*Image 6*

Enlargement of aerial photograph showing Building 31 with the C.P.O.'s quarters to the north of the covered moorage bay.<sup>16</sup>

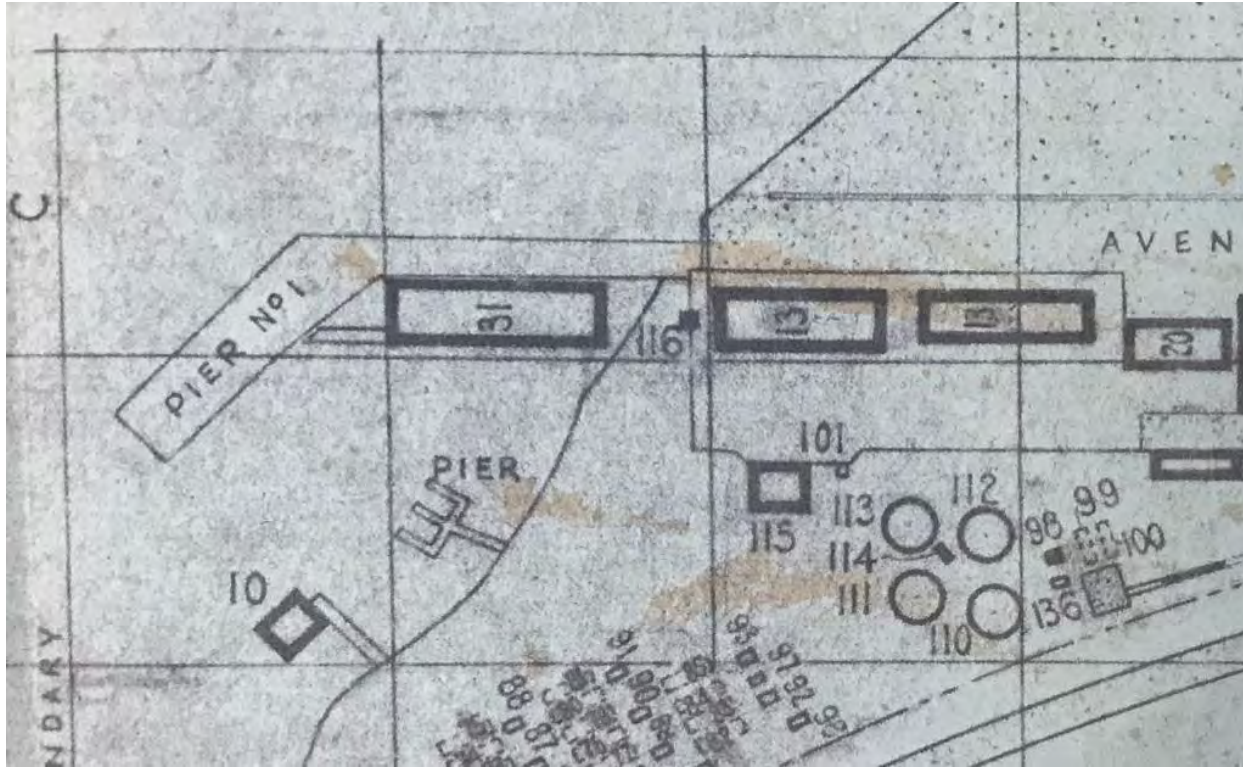
*Image 7*  
 Enlargement of a photograph showing site conditions in 1942. Building 115 is constructed to the southwest of B31.<sup>17</sup>

The same year that the U.S. declared war on Japan, Building 115, whose historic names include “Sewage Sludge Bed Building,” or “Tank Farm Repair Storage,” or “P.W. Maintenance Shop” was constructed along with an expanded area of tarmac around Building 13. This building was “part of the former sanitary sewer” tank farm on site.<sup>18</sup> The building “was used to house equipment for the repair of pumps and tanks employed at the tank farm located to the west, as well as the storage of related spare parts and equipment.”<sup>19</sup> The year before, 1940, the Lake Washington Floating Bridge (I90) is commissioned and the Tacoma Narrows bridge is dedicated, opened, and collapses.

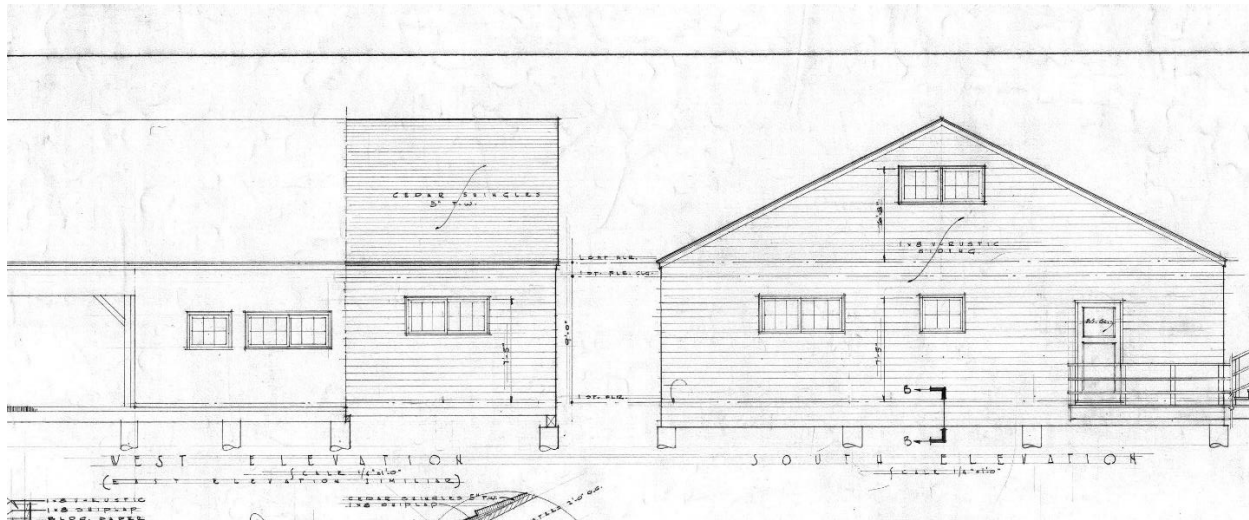
*Image 8*  
 An enlargement of drawings showing the additional bay added to B31 in 1942.<sup>20</sup>

An additional 15' bay of sixteen bunks is added along with a new, expanded head. The former bunk quarters within the original Boat House are converted to "Office." The existing shop, head and storage area remains.

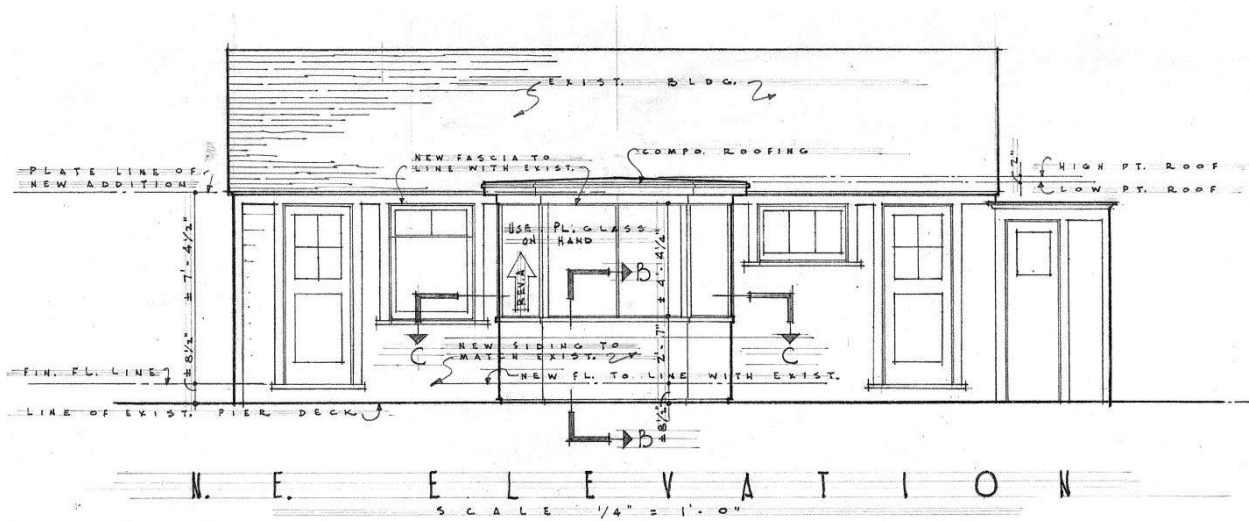
Image 9

An enlargement of a drawing showing the "Lookout Room" added to the original C.P.O.'s quarters in 1942. The small portion of the building to the right of the page is a telephone room.<sup>21</sup>

In 1943, a lookout room is drawn as an addition to the C.P.O.'s quarters. No photographic evidence exists that proves this addition was ever built. However, the lookout appears on NAS Drawings # 1615 (SPR 55207), 1616 (SPR 55208), 2303 (SPR 55210), 1836 (SPR 46556), and 2455 (SPR 46558). The room as drawn contained a desk and radiator.

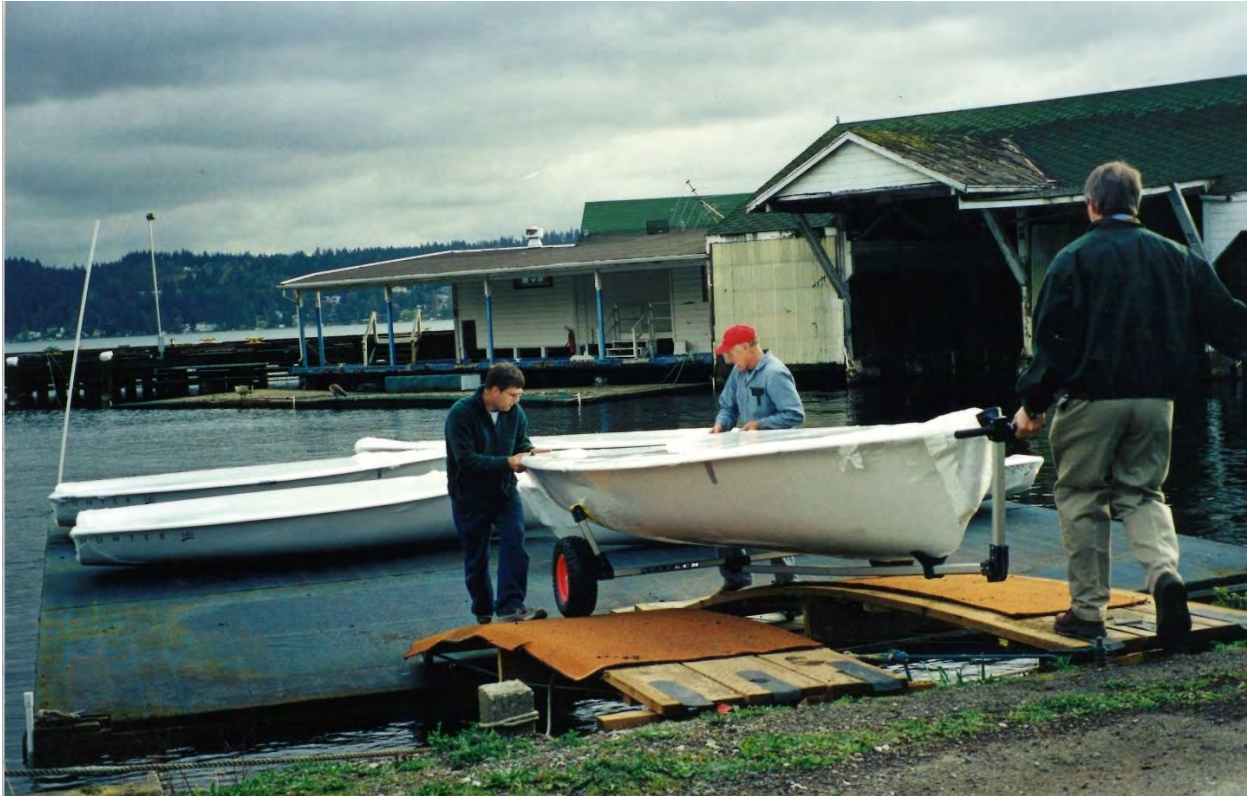
*Image 15*

A photograph from the early 21<sup>st</sup> century showing the extent of the gable dormer addition to the west façade of the covered moorage.<sup>28</sup>

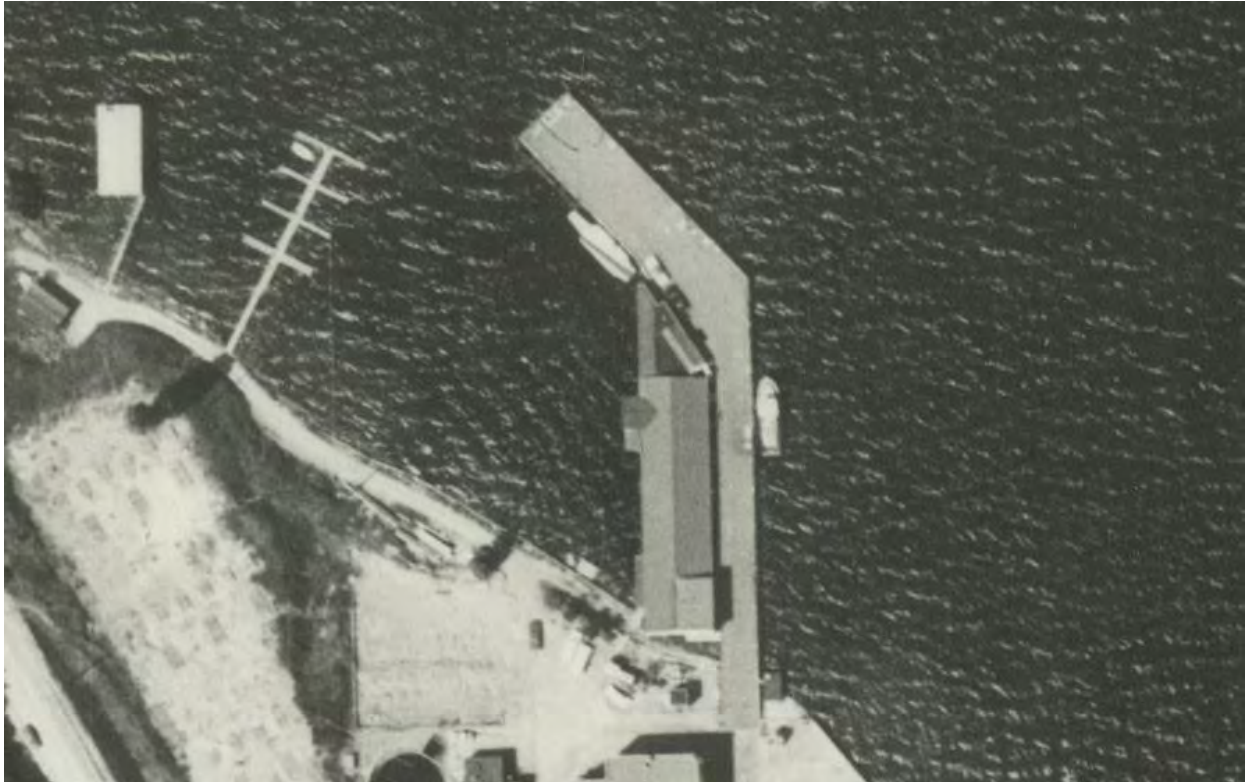
*Image 17*

An enlargement of an aerial photograph taken in 1970, documenting the addition of a shed roof covering to the south of the gable dormer alteration.<sup>30</sup>

A shed roof extension over crash boat no. 2 slip is constructed on the west façade. No drawings of this alteration have been found, however photo-documentation confirms its existence.

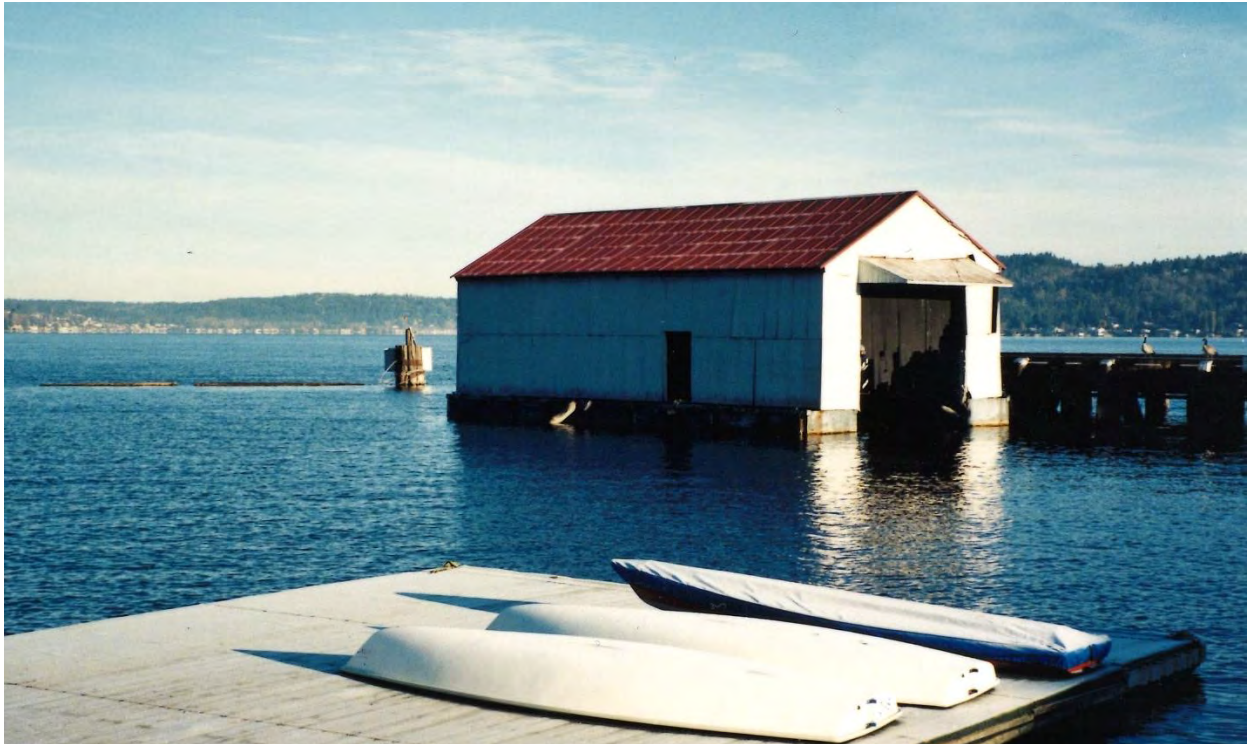
*Image 18*

A photograph from the early 21<sup>st</sup> century showing Building 402, moored to Pier 1.<sup>31</sup>

The “Floating Boat House” (Building 402) is brought into the site. 1976 is the earliest year that photo documentation and site existing conditions drawings show Building 402. The building is named “Admiral’s Floating Boat House” within the Sand Point Historic Properties Reuse and Protection Plan. See: Drawing 3430 (SPR # 46567), UW Libraries Aerial Photographs 1970 KP-70 28-105, 106

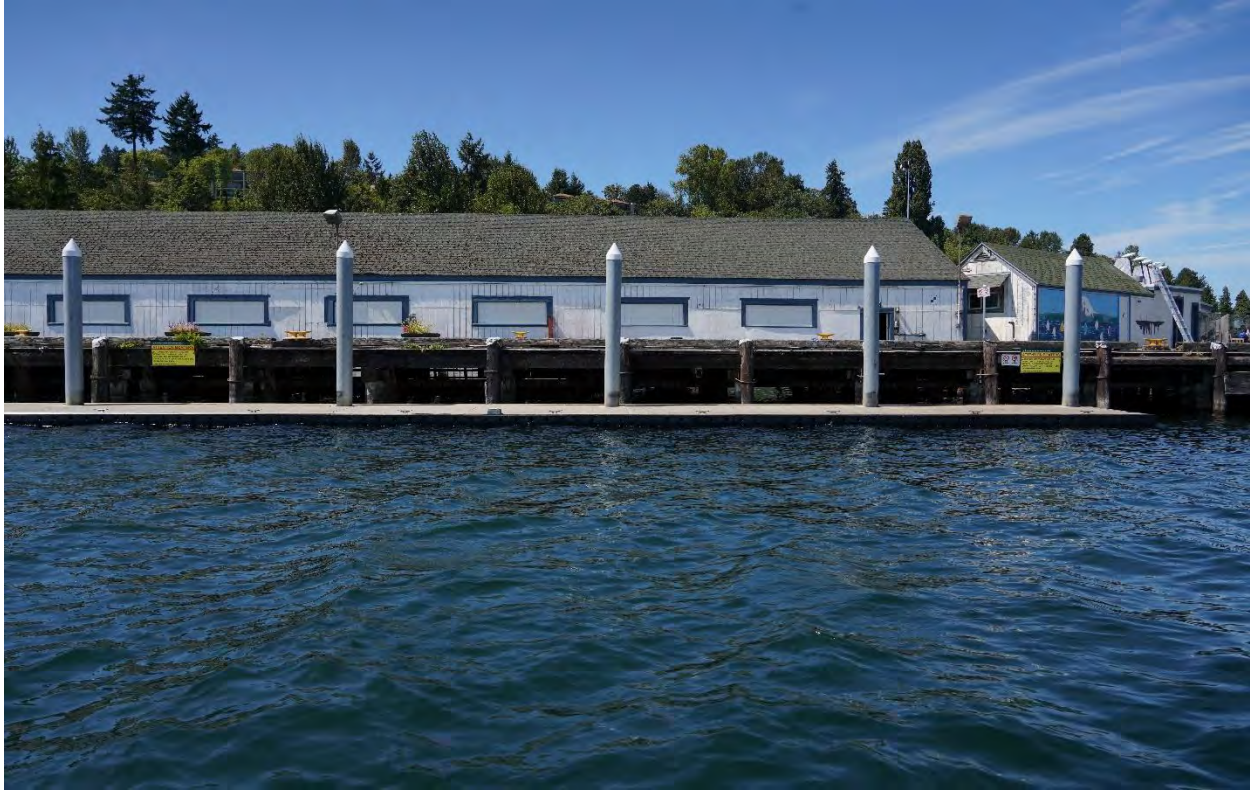
*Image 20*

A contemporary photograph showing the extent of boarded windows along the east façade of the covered moorage of B31.<sup>33</sup>

Lead and Asbestos abatement within B31 was executed by Grayhawk construction. This included sandblasting and removing lead paints and asbestos materials from B31. In addition to the paint removal, it was found that the windows within the covered moorage area contained lead within each of the divided lites. These windows were encapsulated with plywood on both sides as part of the lead remediation. Since this work in 2016, no further work or alterations have taken place.

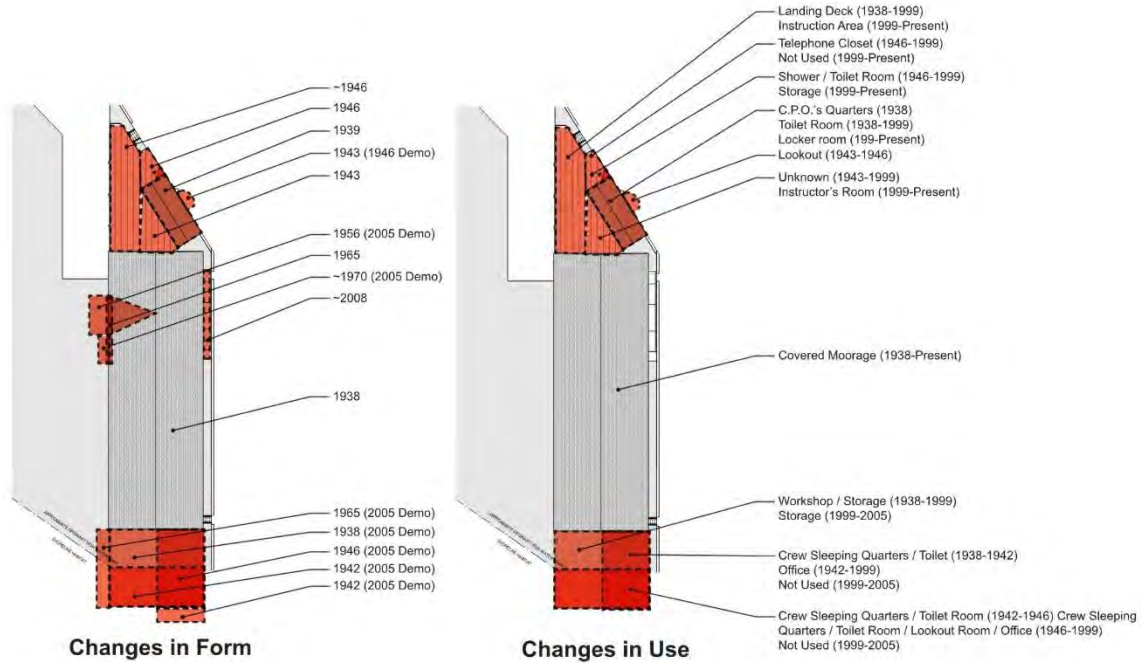
*Image 21*  
 Diagrams outlining the known changes in form (red) and changes in use (red) of B31 over its entire lifespan since first construction in 1938.

As the navy rapidly constructed its wartime operations, building in haste was very common. This has led to buildings that look disjointed or are a conglomeration of uses. B31 is no exception to this rule. Stepping back and viewing the aggregation of changes to B31 through Navy use and occupation, it becomes clear that the singular constant of the building is the volume of covered moorage. To the north and south of the covered moorage, form and uses of the building have changed consistently over time.

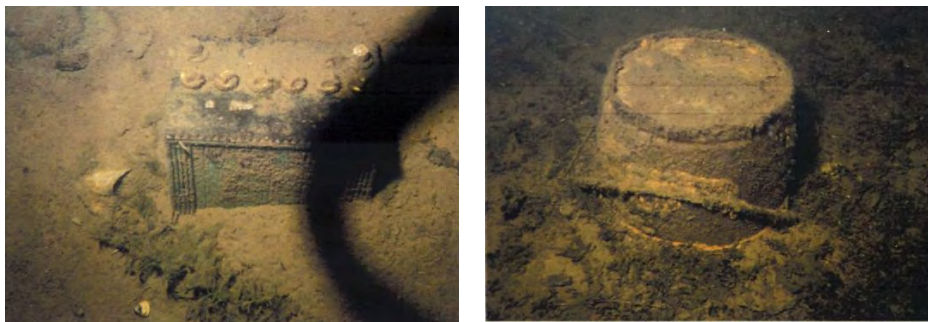
Image 23  
 Photographs taken in 1998 showing debris at the mudline below B31 and Pier 1.<sup>46</sup>

The nature of humans working and doing things overwater inevitably leads to “Oops!” moments where items are dropped into the water, never to be retrieved again. There is certainly this type of debris underneath B31. The nature and extent of this debris is unknown at this point in time. However, as part of the 1998 underwater pile assessment, a photograph was taken at the mudline showing a marine battery. In 2018, Echelon Engineering dove as part of pile assessment for B31. They were not concerned with debris, and thus, did not document the mudline with a focus on debris in mind.

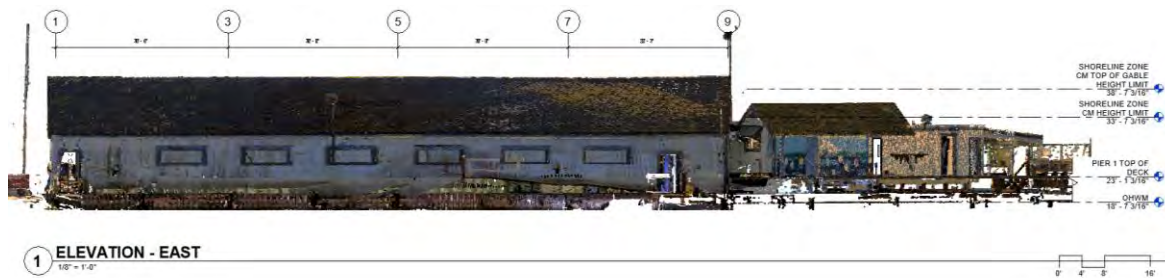
*Image 25*  
 East Elevation of B31, as documented through LiDAR scanning. Elevations are relative to the NAVD 88 datum.

The design team reviewed 18 historic drawings. None accurately reflected the current conditions of B31. With the goal of accurately depicting the site, as it exists today, Light detection and ranging (LiDAR) scanning was completed, documenting the building and site conditions on 8/14/19. This LiDAR scan was used within the design team’s 3D BIM model to document the as-built conditions of B31. These drawings can be found in [Appendix F](#). Additional site photographs can be found in [Appendix G](#).

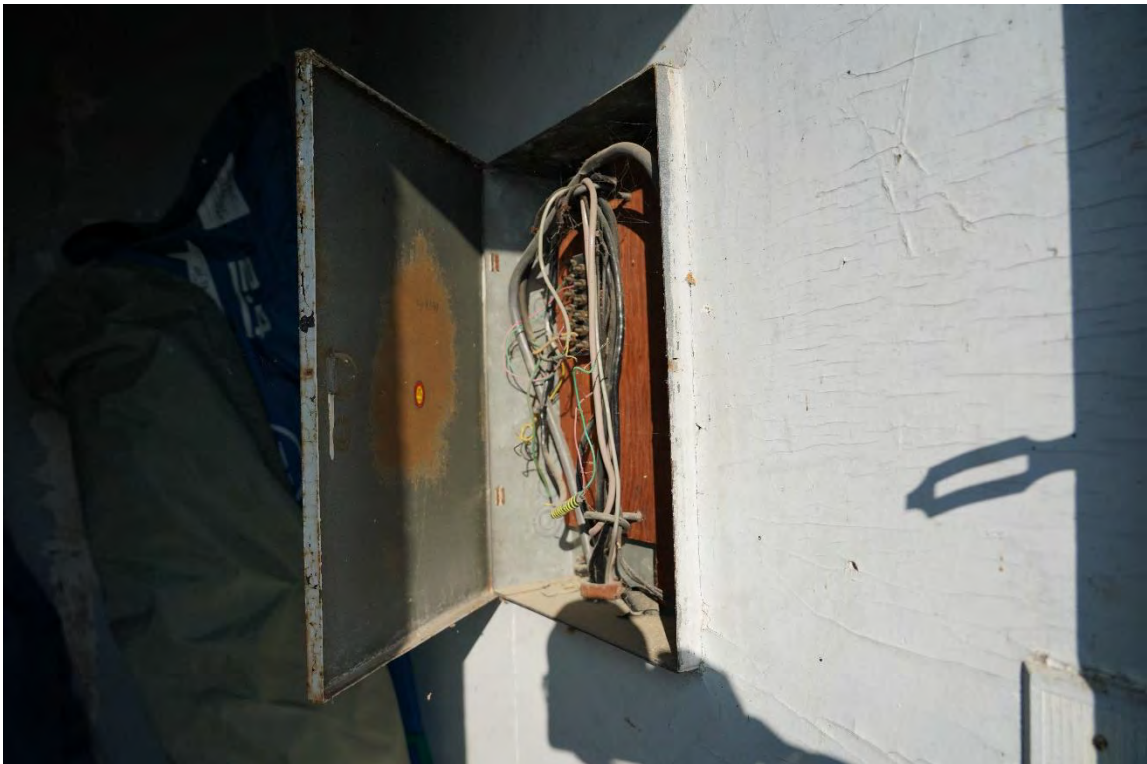
*Image 26*

Existing telephone room service box at the northernmost end of B31. Photo: Glen Stellmacher, Miller Hull Partnership.

A telephone room existed on the northern end of B31. Since the Navy quit use of the site, this room has not been utilized. The historic telecom infrastructure still exists within the room.

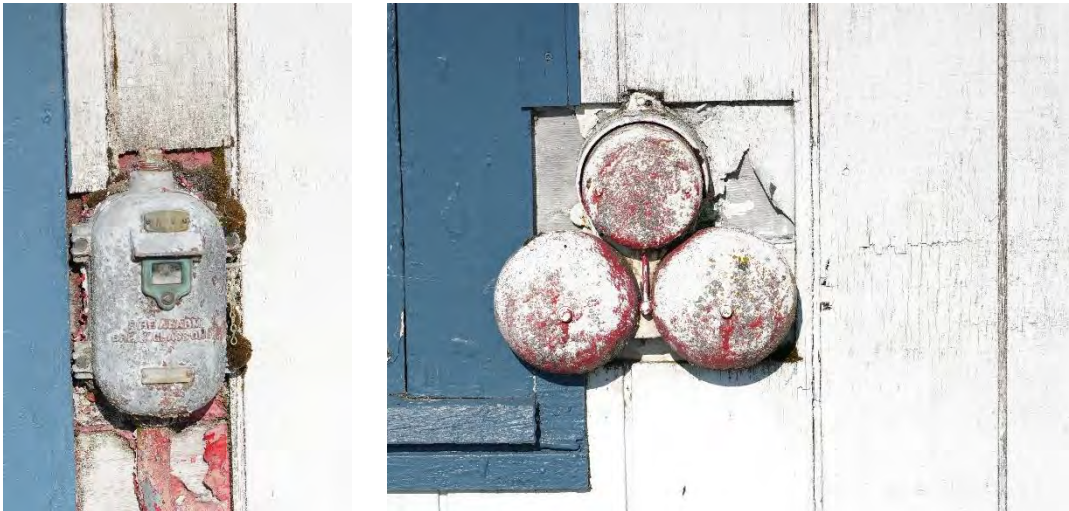
*Image 27*  
 Existing Fire Alarm infrastructure on the exterior of B31. Photo: Glen Stellmacher, Miller Hull Partnership.

Infrastructure for historic fire alarm equipment exists within B31. However, it is unclear if it is functioning. A new code compliant fire alarm system will need to be installed.

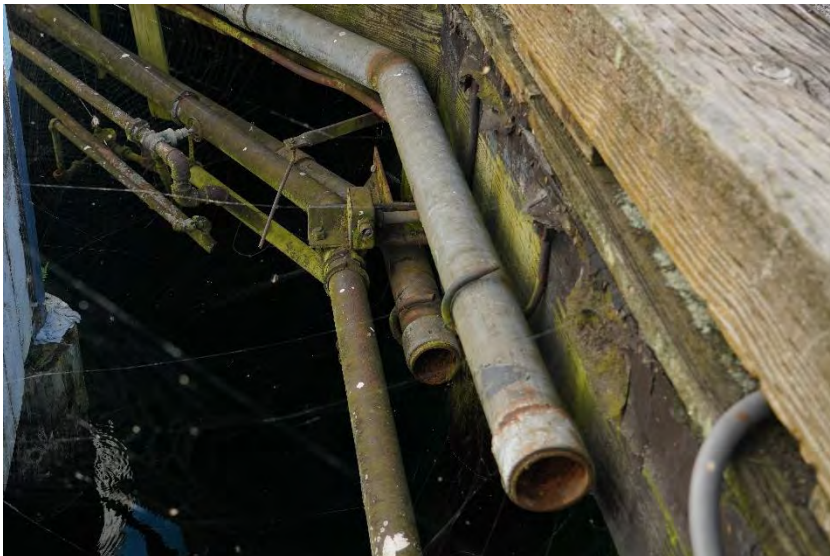
*Image 28*

Example of abandoned piping from  
Navy use of Pier 1. Photo: Glen  
Stellmacher, Miller Hull Partnership.

As a working and functioning former Naval Air Station, a significant amount of infrastructure was developed and installed to serve the functions and operations on base. Today, a majority of this infrastructure is obsolete and not utilized, however remains in place.

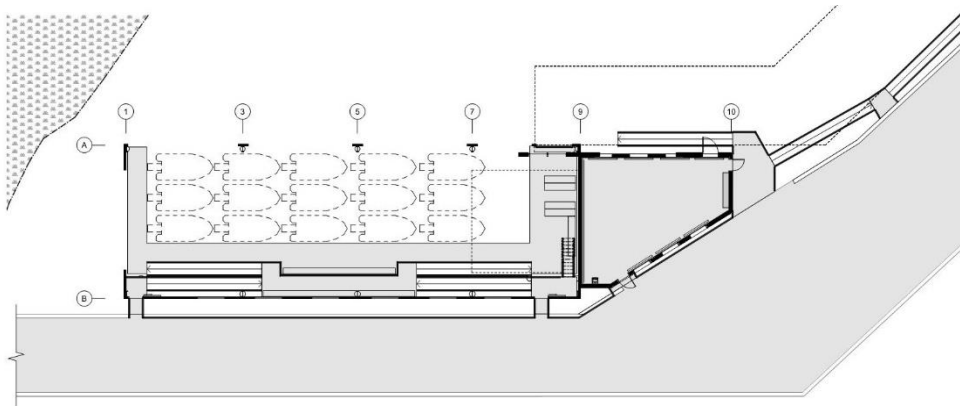
Image 29  
 Option 1- B31 conceptual floor plan  
 \*Not to scale

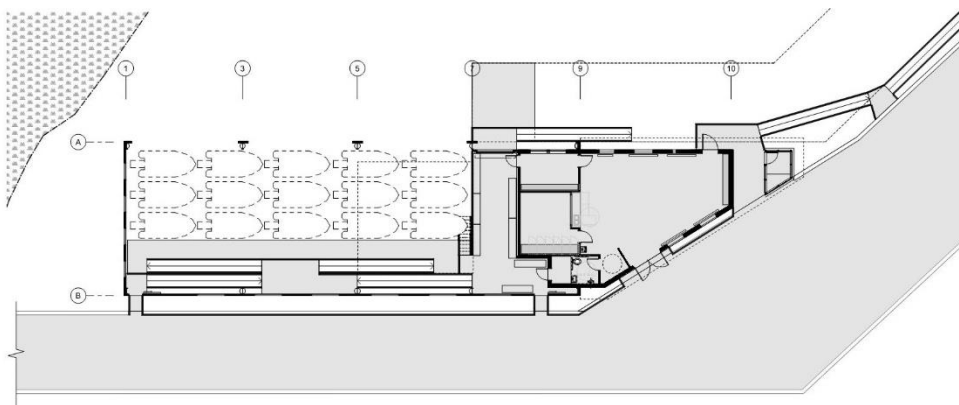
Image 30  
 Option 2- B31 conceptual floor plan  
 \*Not to scale

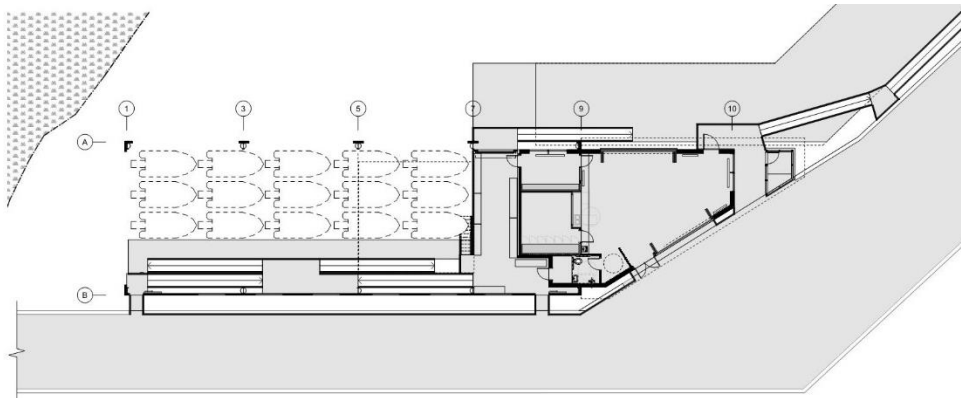
Image 31  
 Option 3- B31 conceptual floor plan  
 \*Not to scale

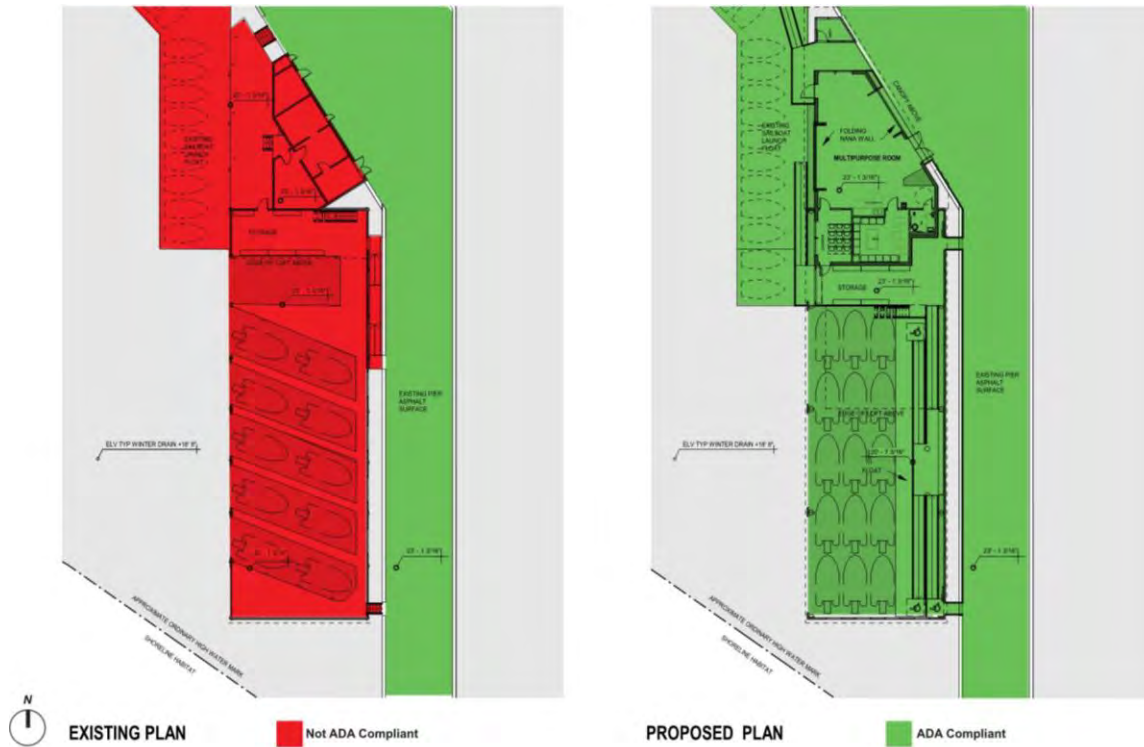
*Image 33  
 Proposed accessibility improvements  
 between existing and proposed  
 building.*

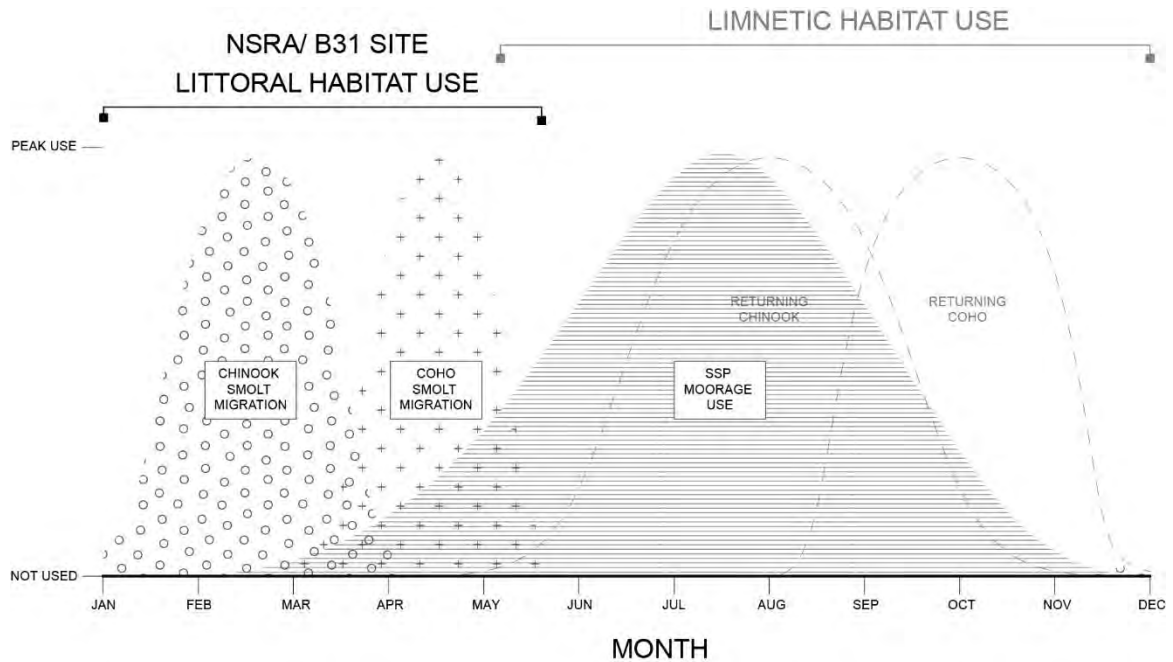
Image 36  
 Use of littoral habitat below B31 by  
 ESA listed and considered species  
 overlaid with SSP use intensity of the  
 covered moorage volume. Information  
 based on 2002 NSRA Biological  
 Evaluation by Anchor Environmental.

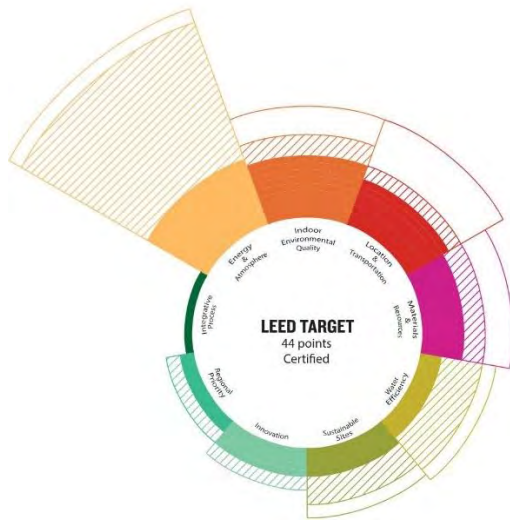
*Image 37*  
 LEED point distribution across all credit categories to achieve LEED certification. The graph visually conveys the weight of each credit category, with Energy and Atmosphere representing the largest potential for points credit category. Solid color areas represent points achieved, shaded areas represent potentially achievable points, and white fill indicates points that are impossible to achieve for this project.

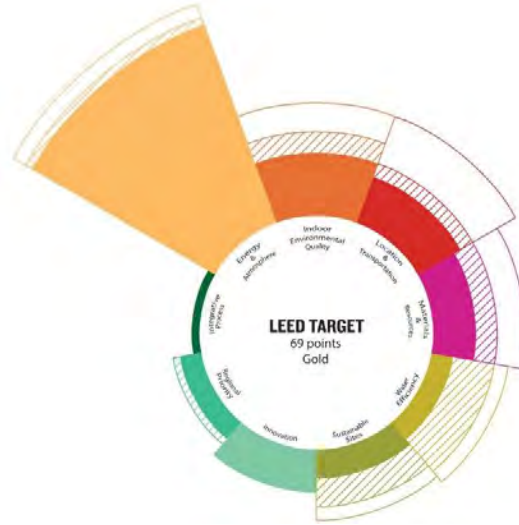
*Image 38*  
 LEED point distribution across all credit categories to achieve LEED Gold certification. By pursuing net zero energy, the project is able to meet LEED Gold. Solid color areas represent points achieved, shaded areas represent potentially achievable points, and white fill indicates points that are impossible to achieve for this project.

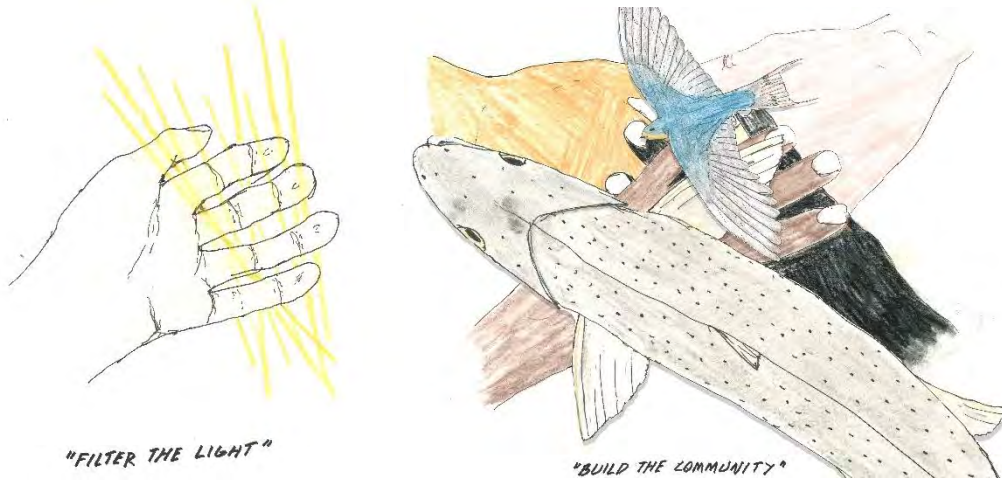
Image 39

At a project level, the team aims to build community at every level of the project, inclusive of ESA listed and non-ESA listed wildlife that actively use the site. In addition, a primary concept within the covered moorage area is to filter the light through the roof to the littoral zone below.

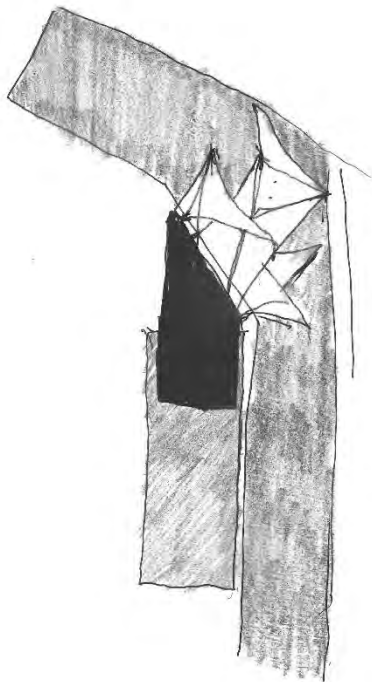
Image 40

A conceptual diagram of the new addition in black emerging from the historic covered moorage volume. The addition of temporary site tents adds life and vibrancy to the site during events throughout the year.

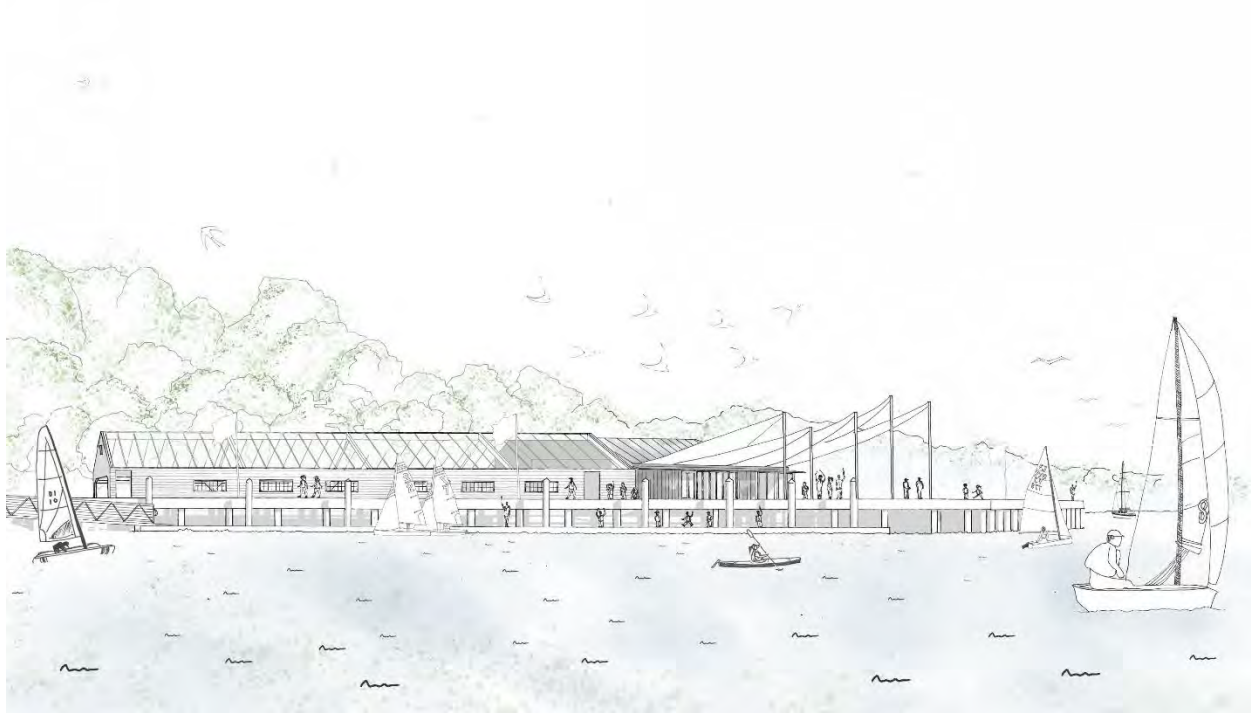
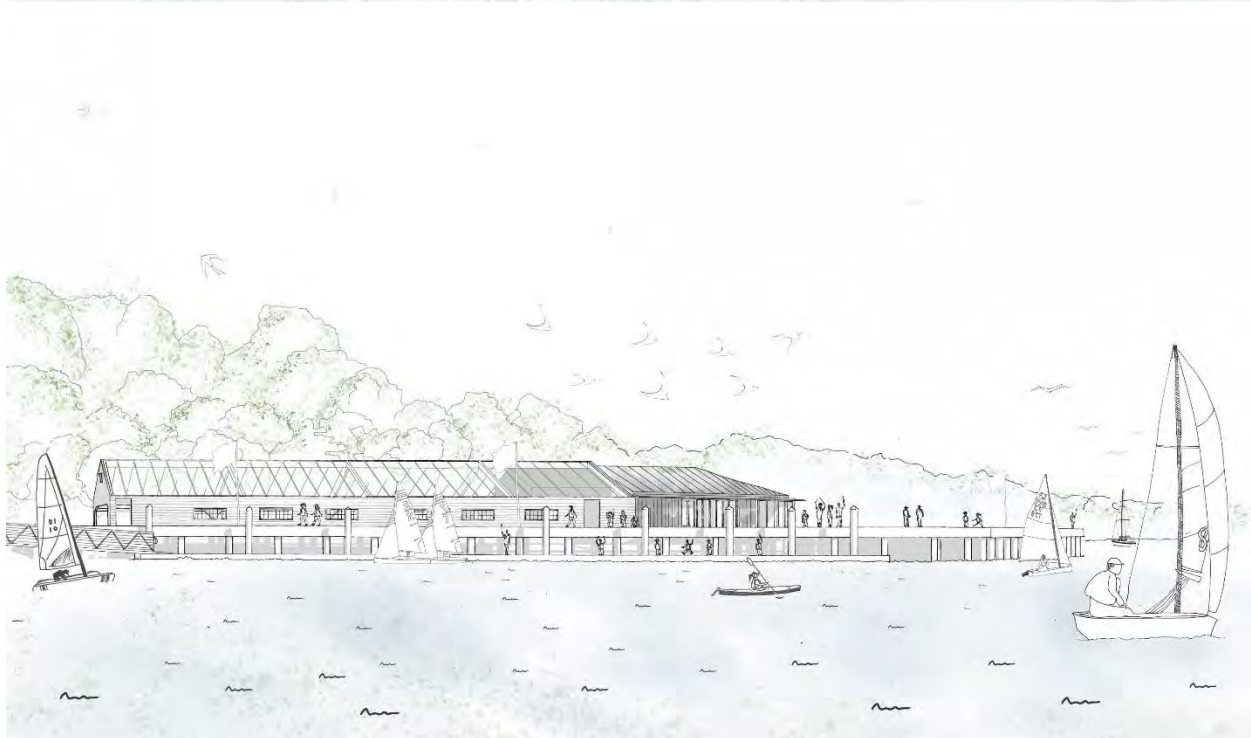
*Image 42  
View from Lake Washington of  
proposed boathouse rehabilitation,  
with and without temporary canopies.  
\*Not to scale.*

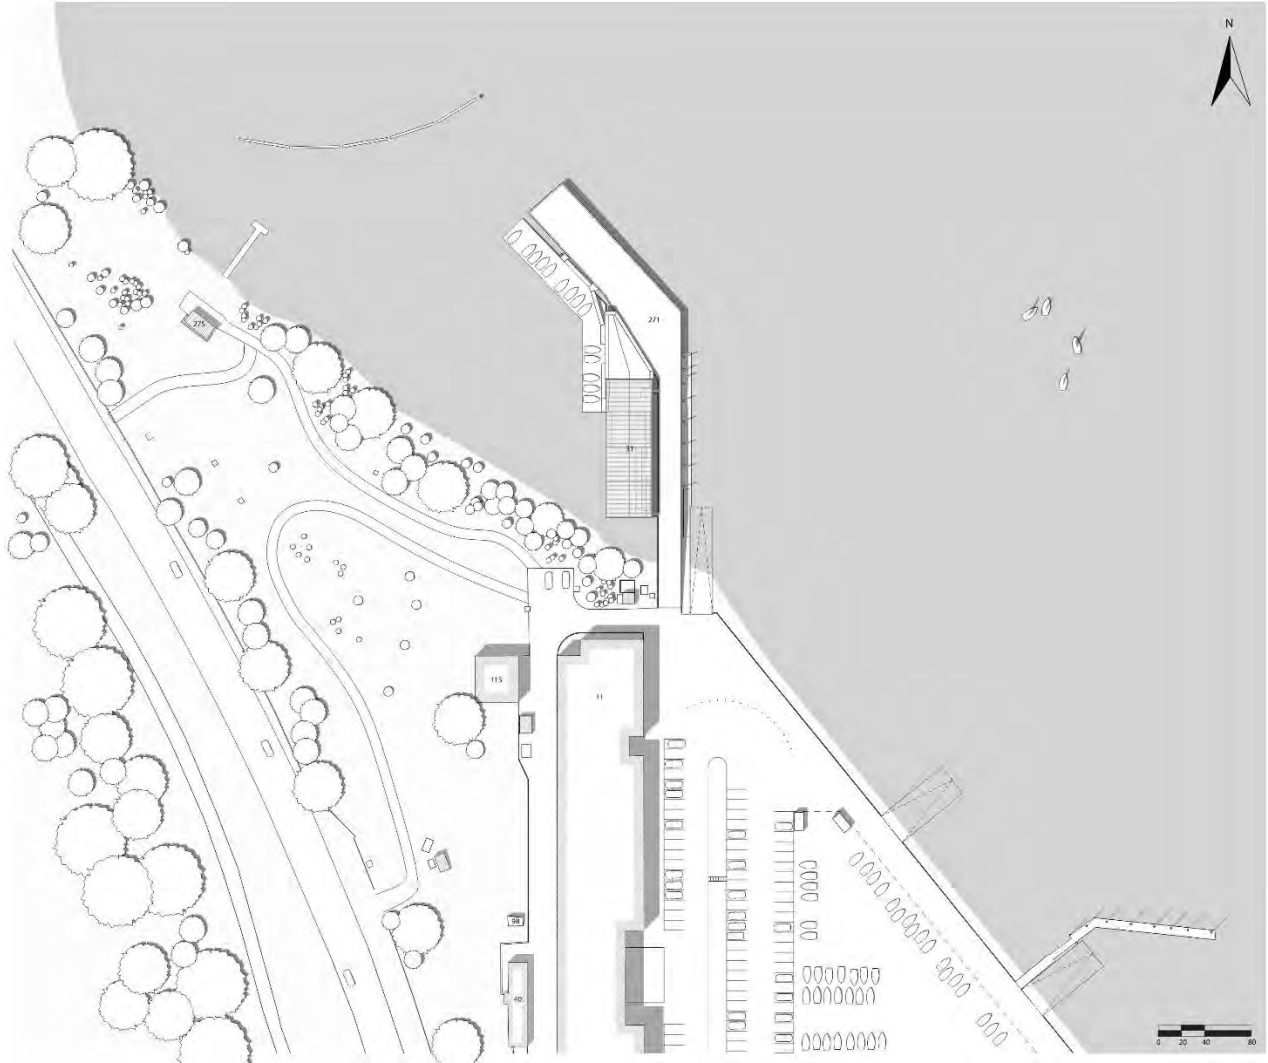
Image 43  
Site plan of proposed B31  
rehabilitation work.  
\*Not to scale

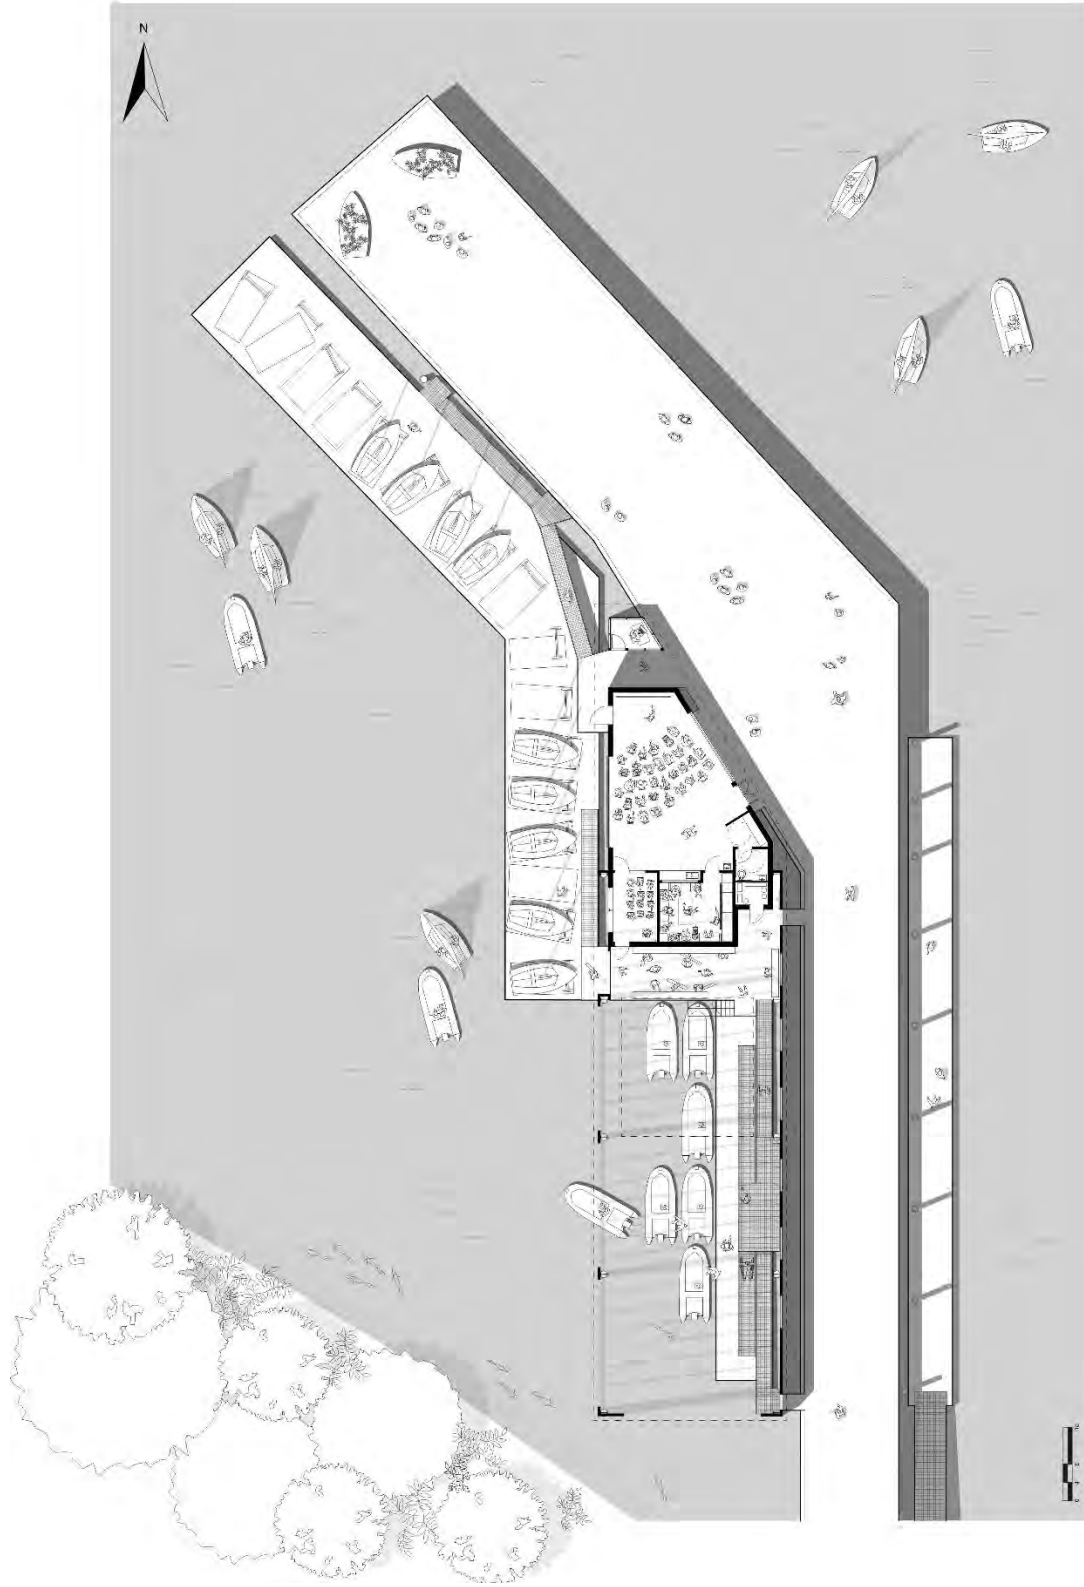
Image 44  
Plan view of proposed B31  
rehabilitation. \*Not to scale.
