FEBRUARY 7, 2020  
2018 MAJOR PROJECT CHALLENGE FUND  
BUILDING 31 REHABILITATION STUDY

# Feasibility Report

**2018 MAJOR PROJECT CHALLENGE FUND  
 BUILDING 31 REHABILITATION STUDY  
 REPORT**

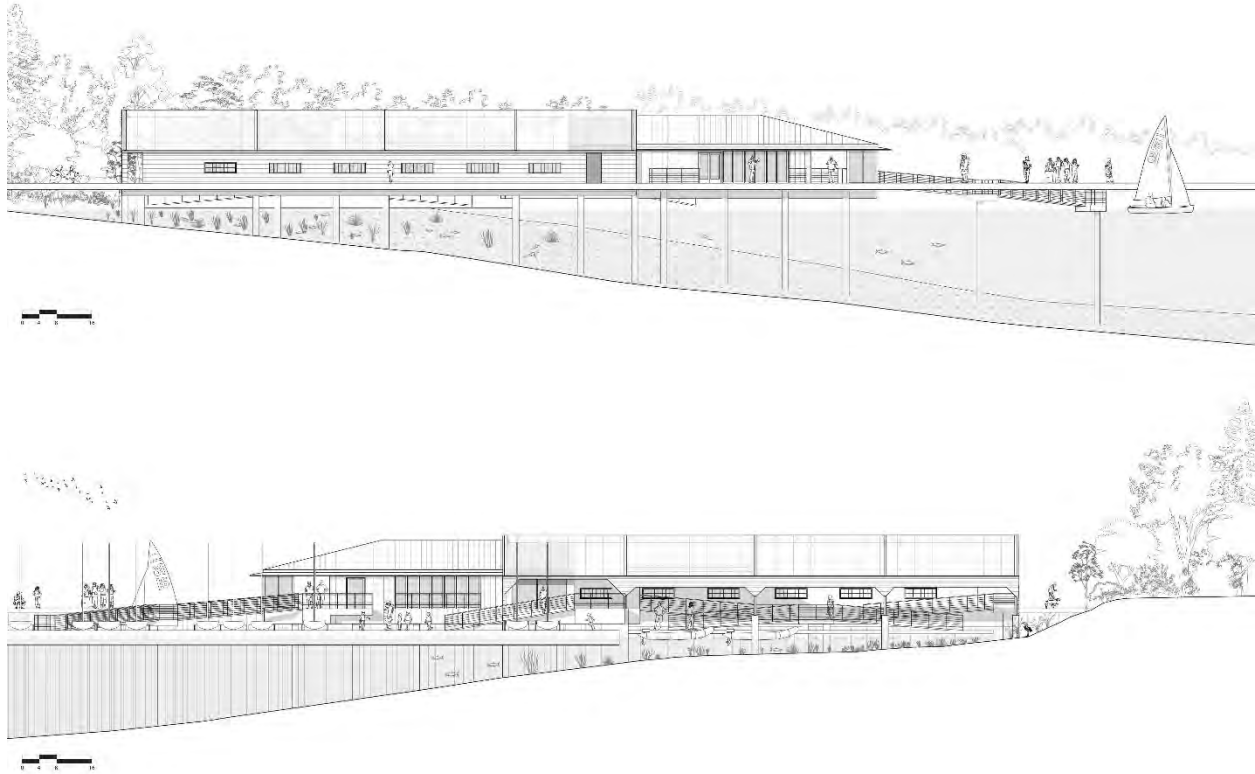
*Image 45*  
*East (Top) and West (Bottom)*  
*elevations of the proposed B31*  
*rehabilitation.*  
*\*Not to scale.*

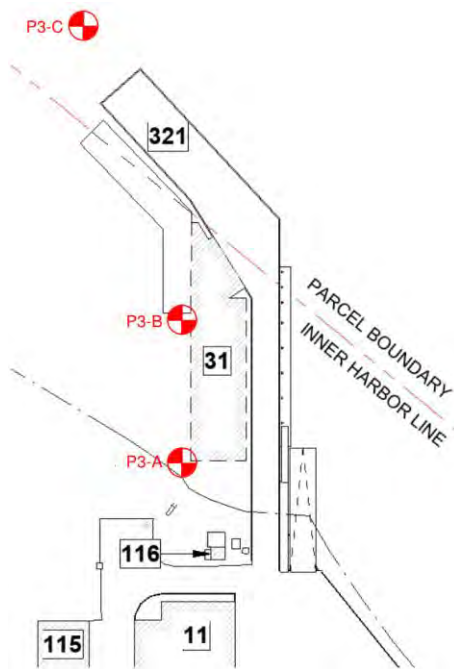
*Image 47*  
 Proposed locations for further geotechnical soil exploration are indicated by the following symbol:

Existing geotechnical soil explorations do not form an adequate picture of the below grade soil conditions along the length of B31. It is anticipated that a minimum of two explorations will be needed. These are to be located at the southwest edge of B31 (P3-A below), and at the south edge of the existing launch float to the west of B31 (P3-B below). A 3<sup>rd</sup> boring near the existing dolphin (P3-C below) would be desirable to get the holistic scale of the site and lake bottom conditions, if desired by SPR. This 3<sup>rd</sup> boring would likely not be needed for B31 work, however, would provide information for SPR to replace the dolphin piles, or any future work on Pier 1. An additional boring, P3-D, may be desired at Opti Land with the intent of assessing conditions around a future pile and dock location. At the time of mobilization, with a barge, it may not be that much more to take a 3<sup>rd</sup> or 4<sup>th</sup> boring. Doing the boring now, would be cost advantageous due to future escalation as well. All soil explorations will be done from a barge over the water. It is advocated for these explorations to be coordinated within September of 2020.
