DRAINAGE SYSTEMS ANALYSIS

Aquatic Habitat

Technical Memorandum

October 28, 2020

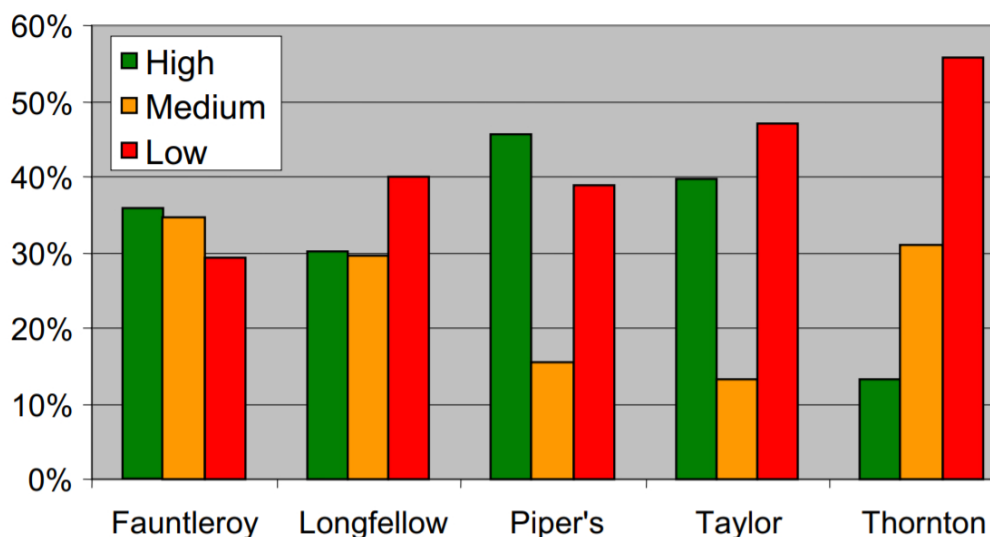
The maps in Appendix C, which show the overall quality of instream habitat, indicate that quality varies considerably among the five main creek watersheds. Although new graphs were not created for this TM, Figure 51 from the SOTW report (reproduced below as Figure 4-1) shows the percent of stream length characterized as high-, medium-, and low-instream habitat quality for each of the five streams.

Source: SOTW 2007, Figure 51

Figure 4-1: Percentages of High, Medium, and Low-Instream Habitat Quality in Major Seattle Watercourses 15

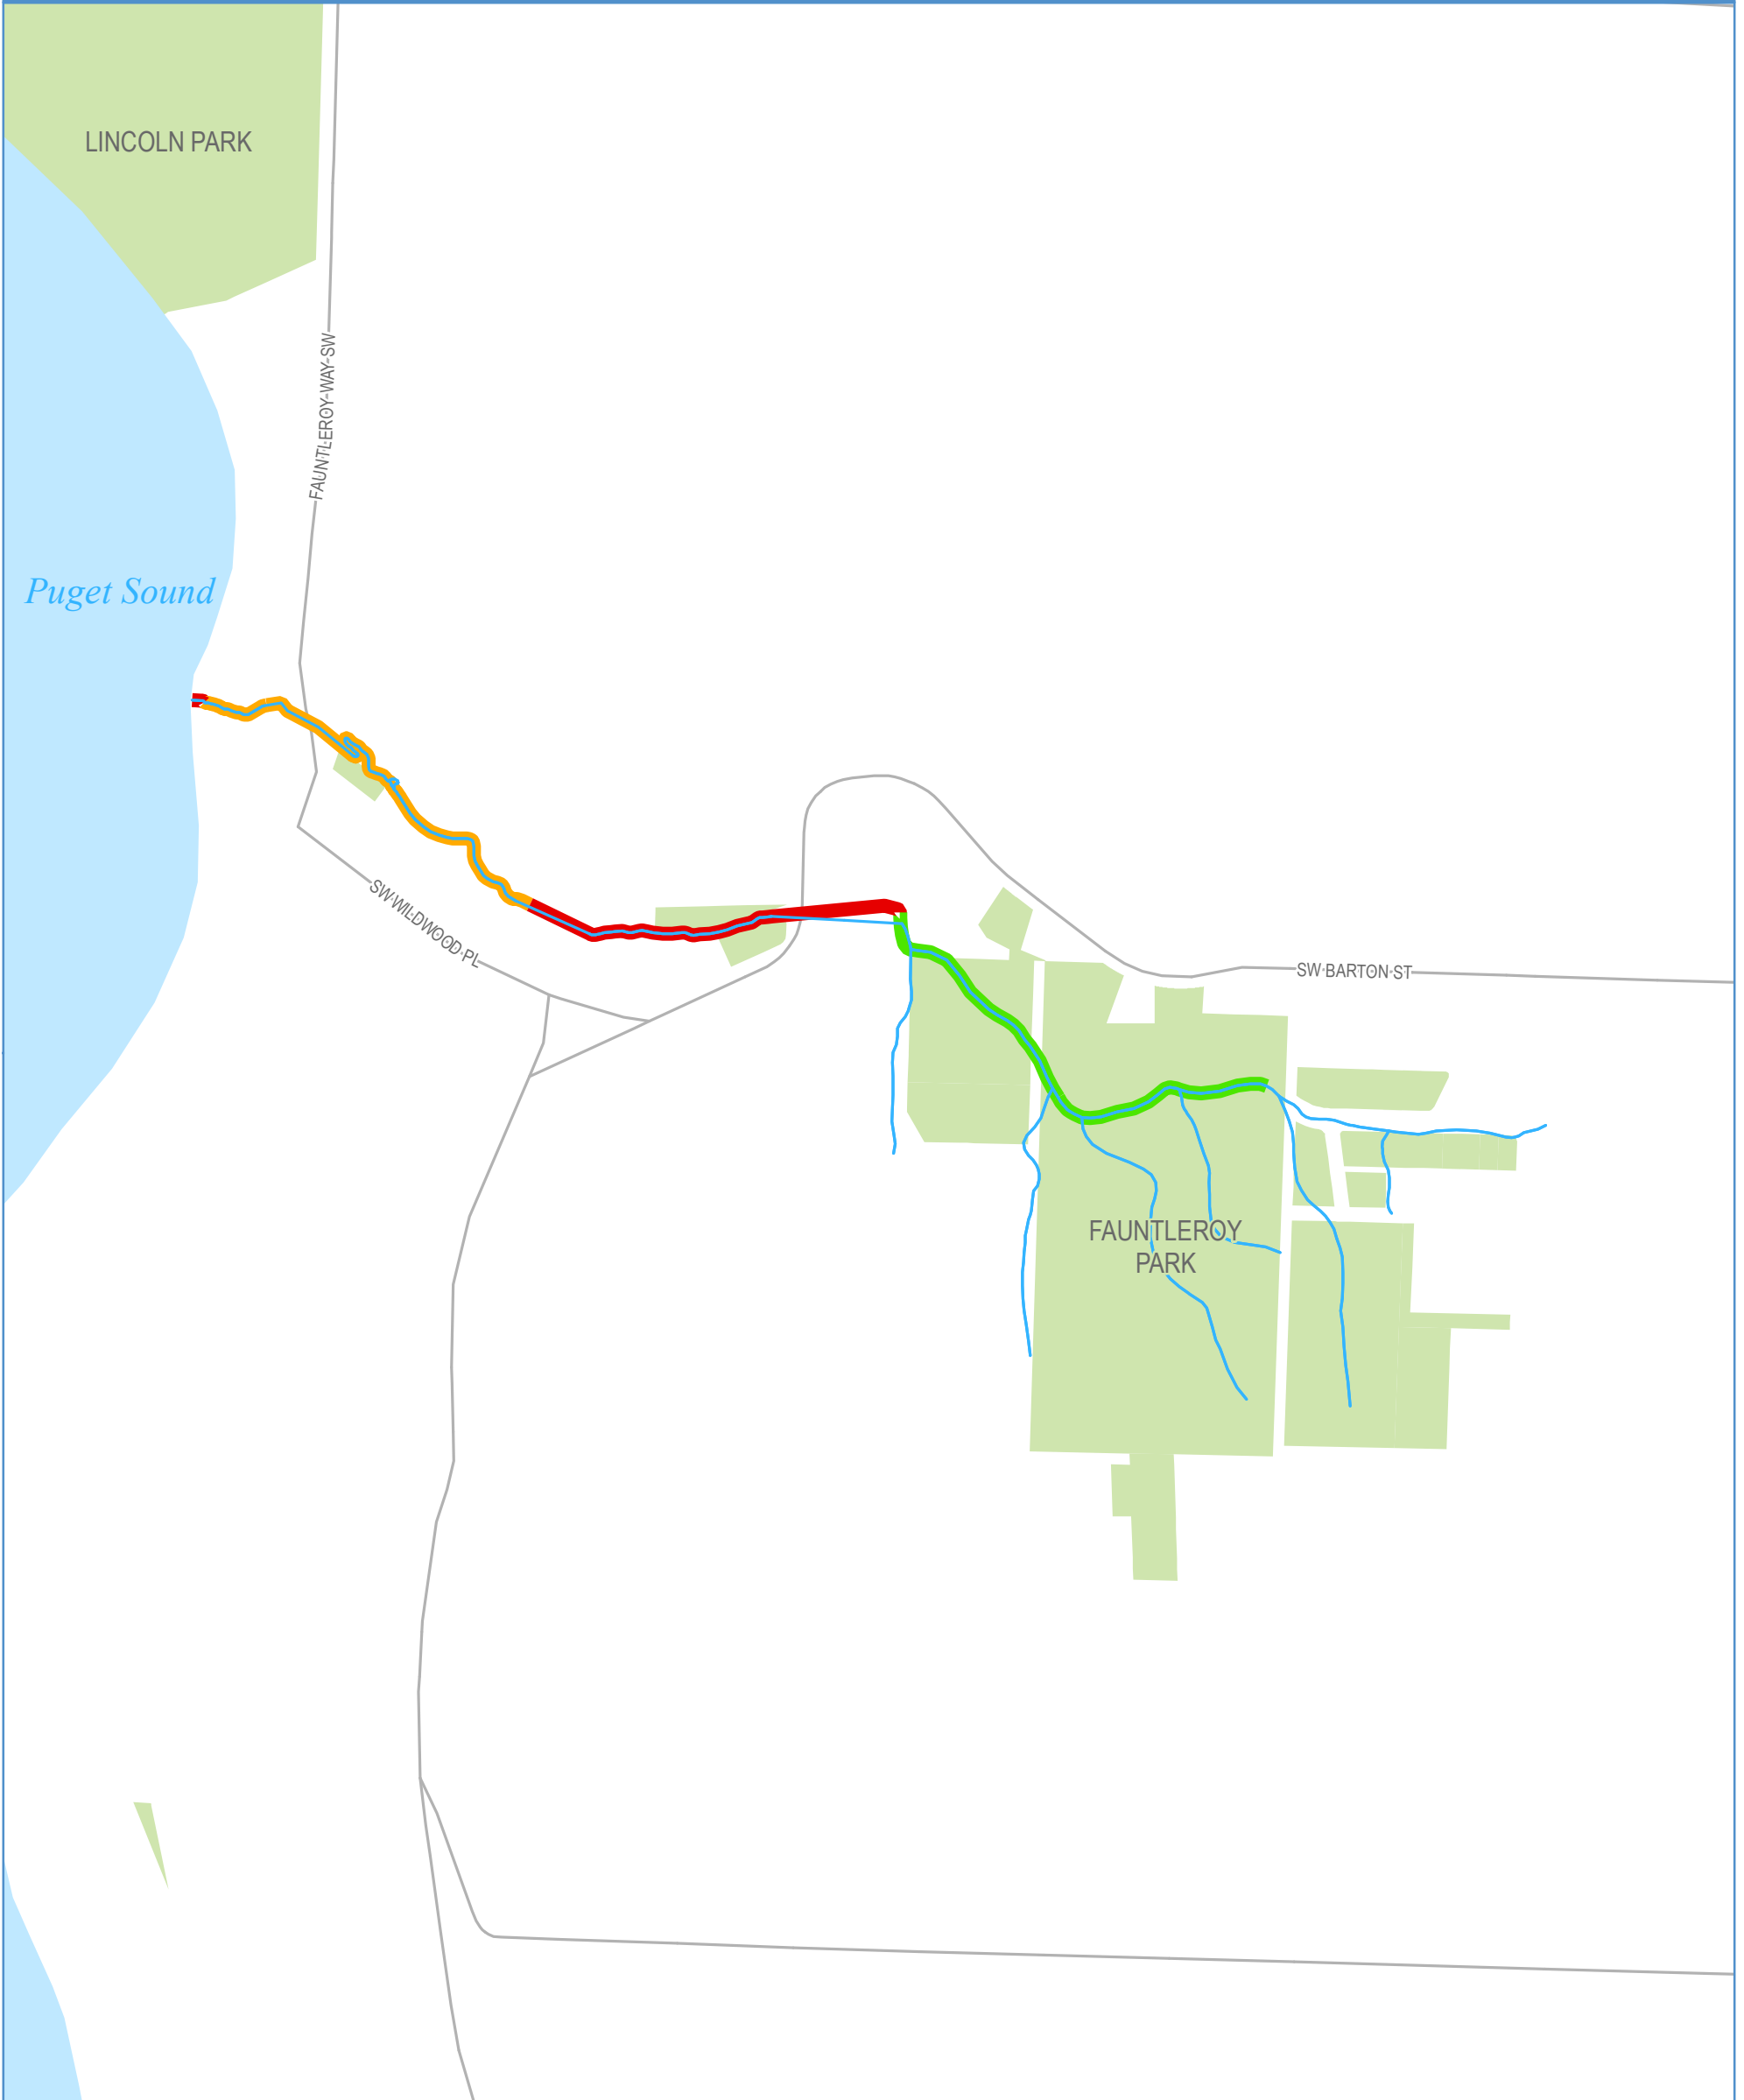
Based on composite scores of channel morphology, sediment regime, and physical habitat conditions for supporting stream biota generated for the 2007 State of Waters report.

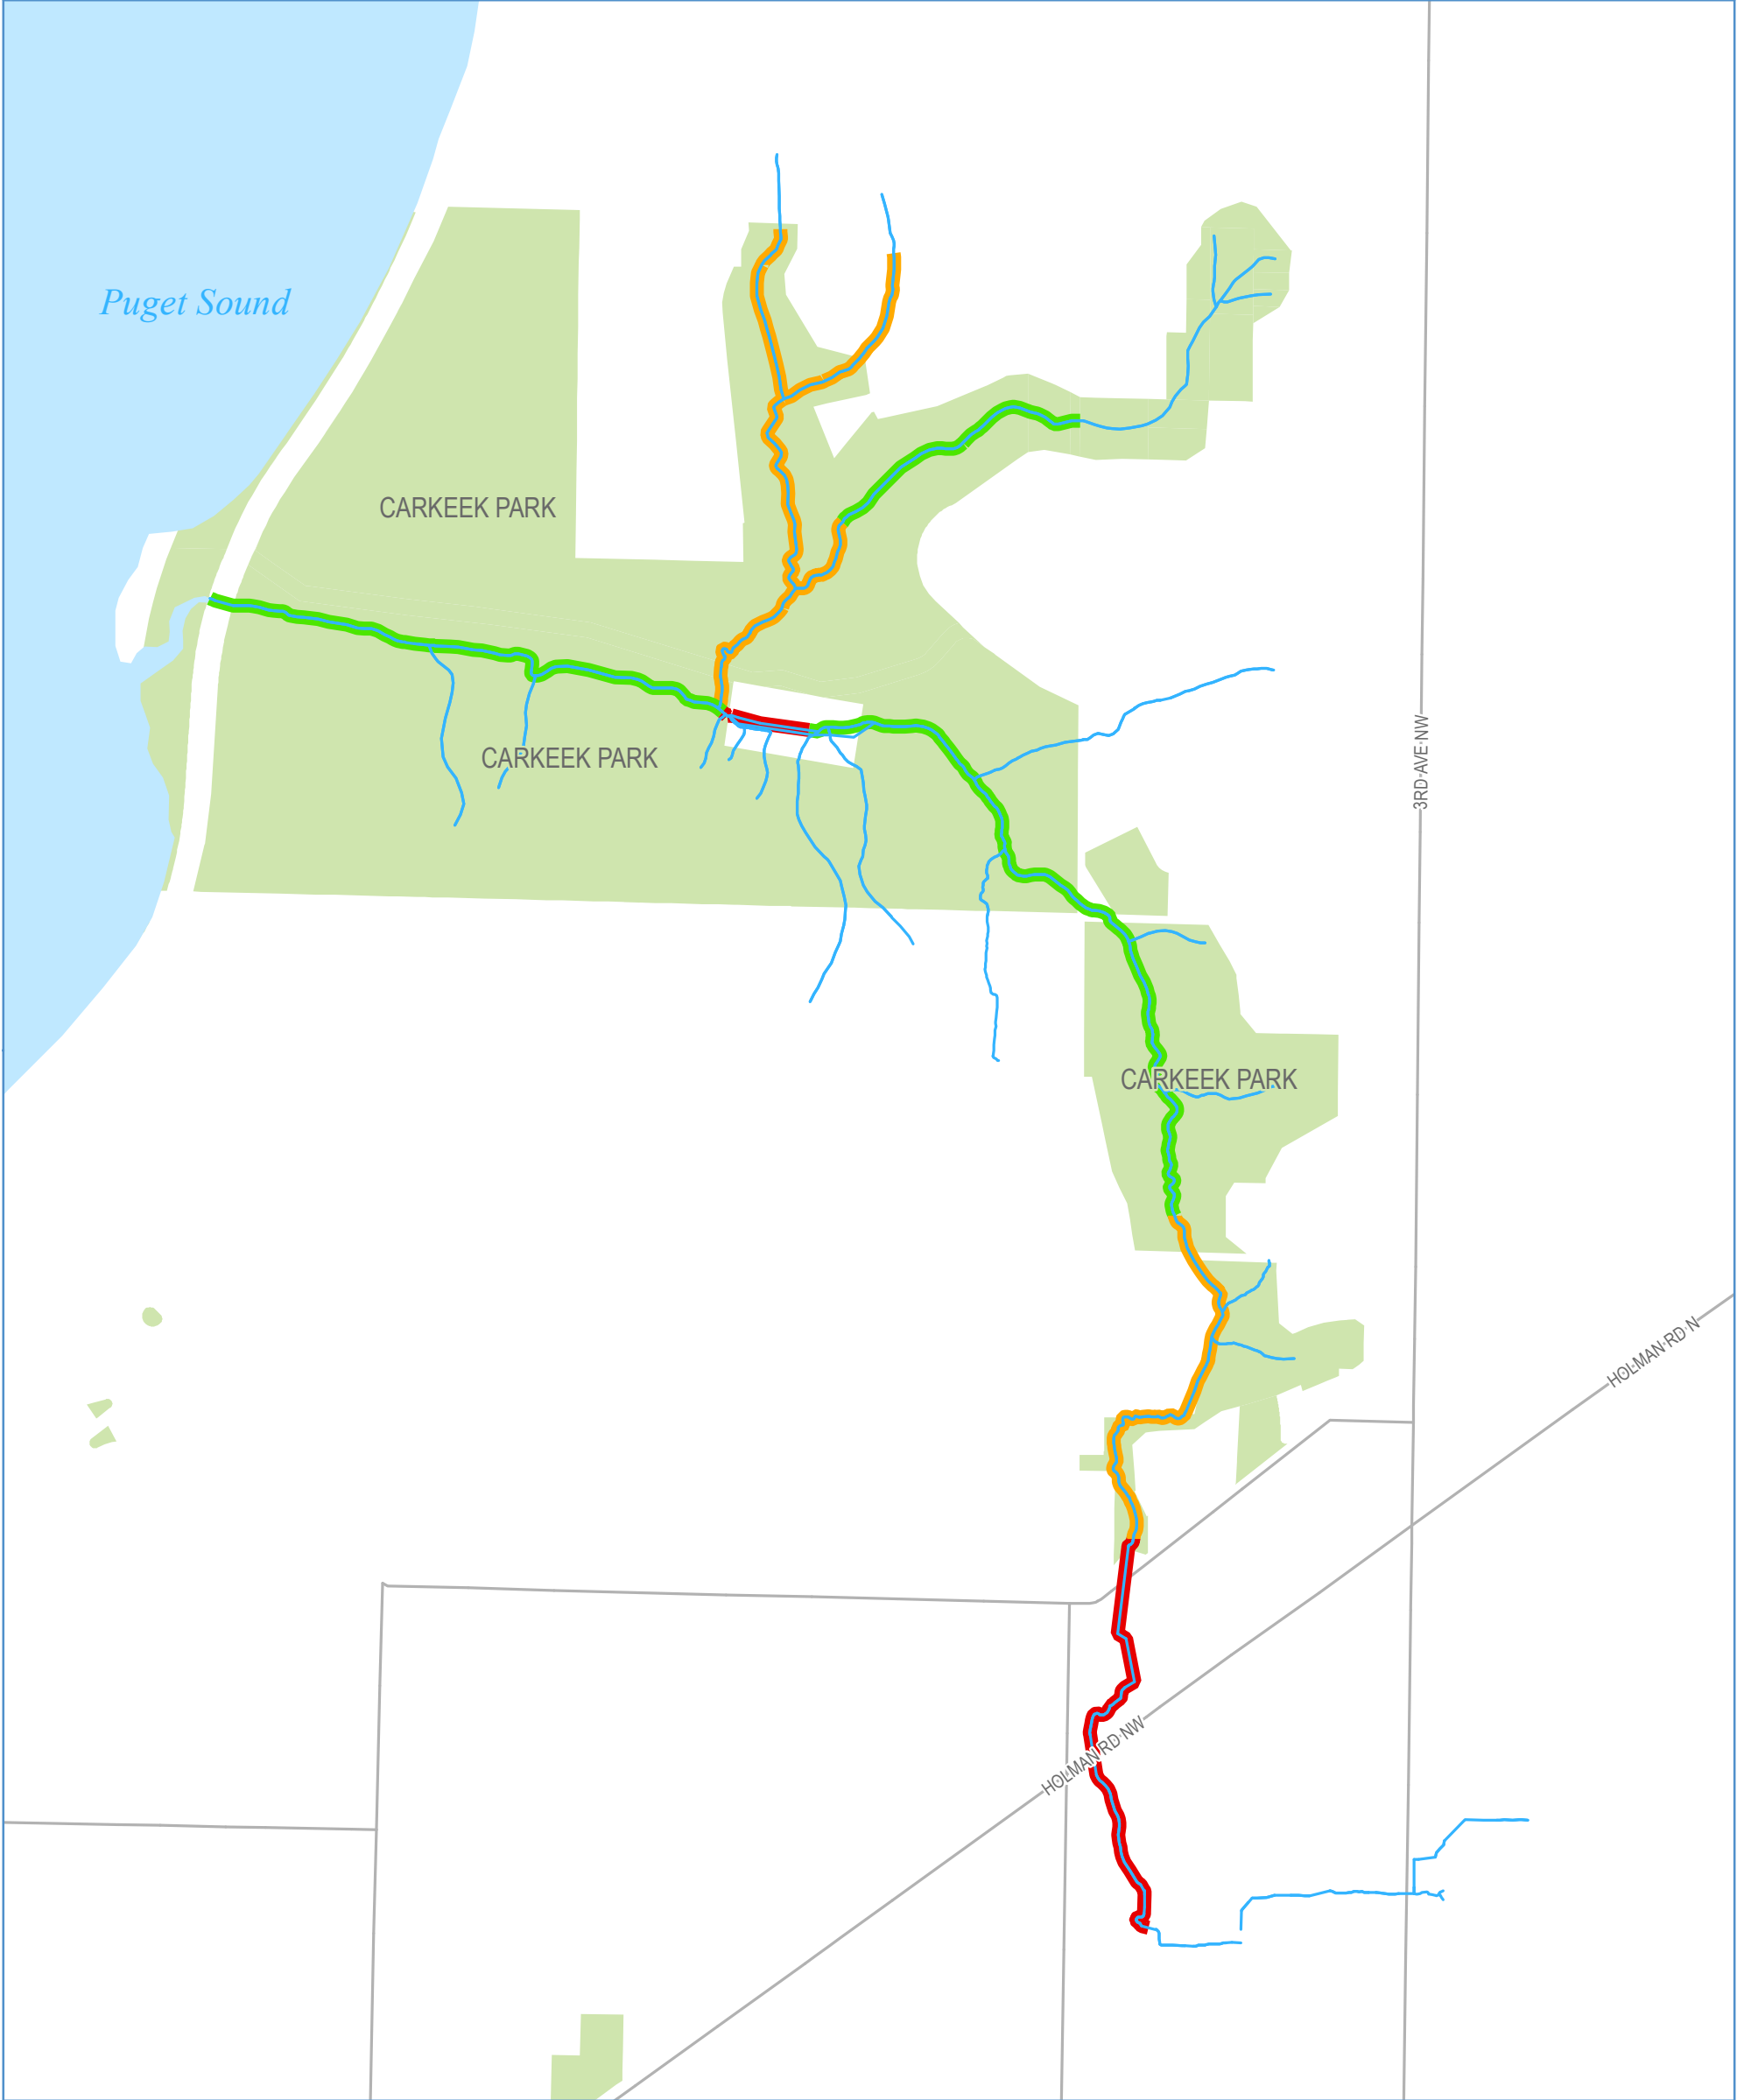
Based on composite scores of channel morphology, sediment regime, and physical habitat conditions for supporting stream biota generated for the 2007 State of Waters report.
