City of Seattle Neighborhood Fire Station 9

Design Commission Review - Concept Design October 1, 2009

Fire Station 9

3829 Linden Avenue N

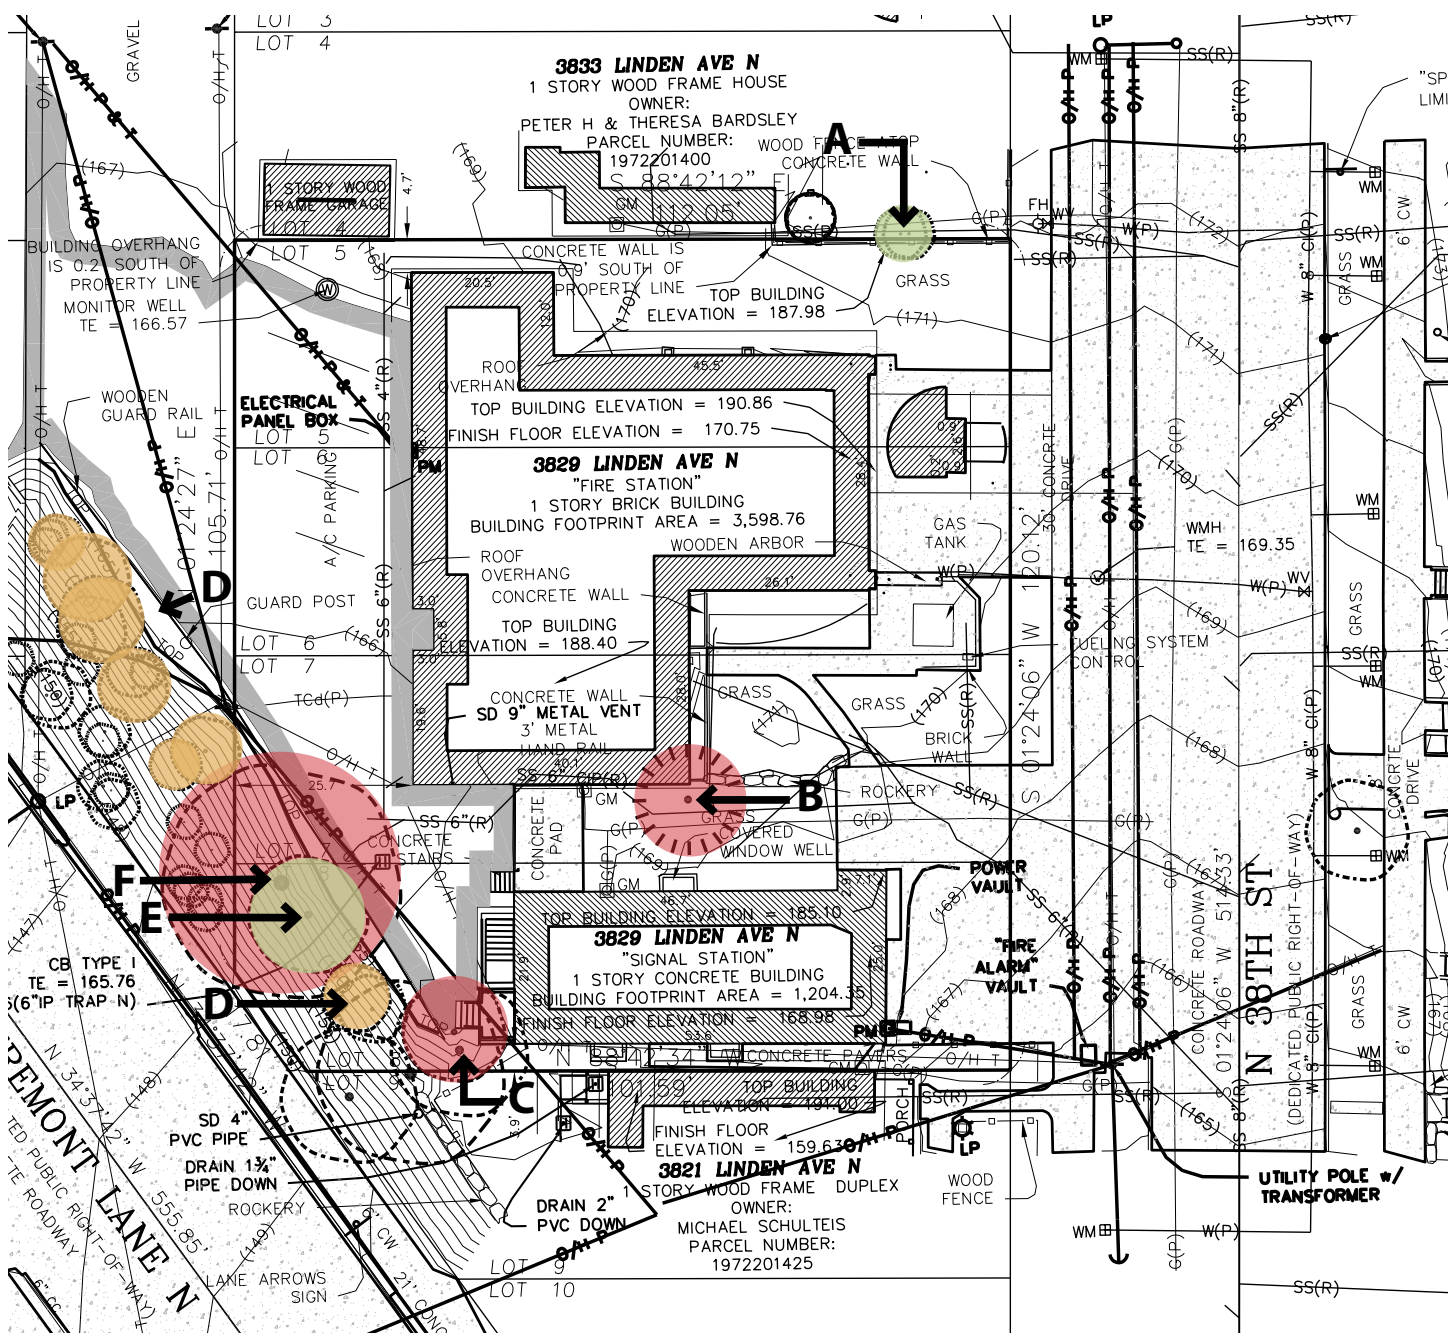
Existing Tree Evaluation Site Analysis

- A *Acer macrophyllum* (big-leaf maple)
Located on adjacent property - topped w/ some girdling by a bird-feeder. Overhangs property by 10' +/- . May need to do some branch pruning during construction. Observe and coordinate during construction.

- B *Chamaecyris pisifera* (sawara cypress)
Not exceptional - REMOVE.
- C *Acer macrophyllum* (big-leaf maple)
REMOVE - demolition of building and stairs will damage root collar. Comply with DPD requirements for steep slope removal, grind stump. Replace on a 2:1 basis, evergreen Douglas Fir, hand planted, 4' height acceptable.

- D *Acer macrophyllum* (big-leaf maple)
Need to hire an arborist to EVALUATE trees along edge of site that may be impacted during demolition of existing building, demolition of existing asphalt, and construction of new building. Structural roots may be extending to the existing building foundation.

- E *Acer macrophyllum* (big-leaf maple)
RETAIN, care should be taken not to damage when taking down adjacent tree.
- F *Acer macrophyllum* (big-leaf maple)
Hazard tree - REMOVE ASAP due to large rotted trunk hanging over street below. Leave stump with 5'-6' snag for habitat. Consult with SDOT tree crew supervisor, Joe Markovich, 206/684-4121. Fire station is responsible for tree removal as it is within the property; may contract with the city.

● RETAIN
● EVALUATE
● REMOVE
 North

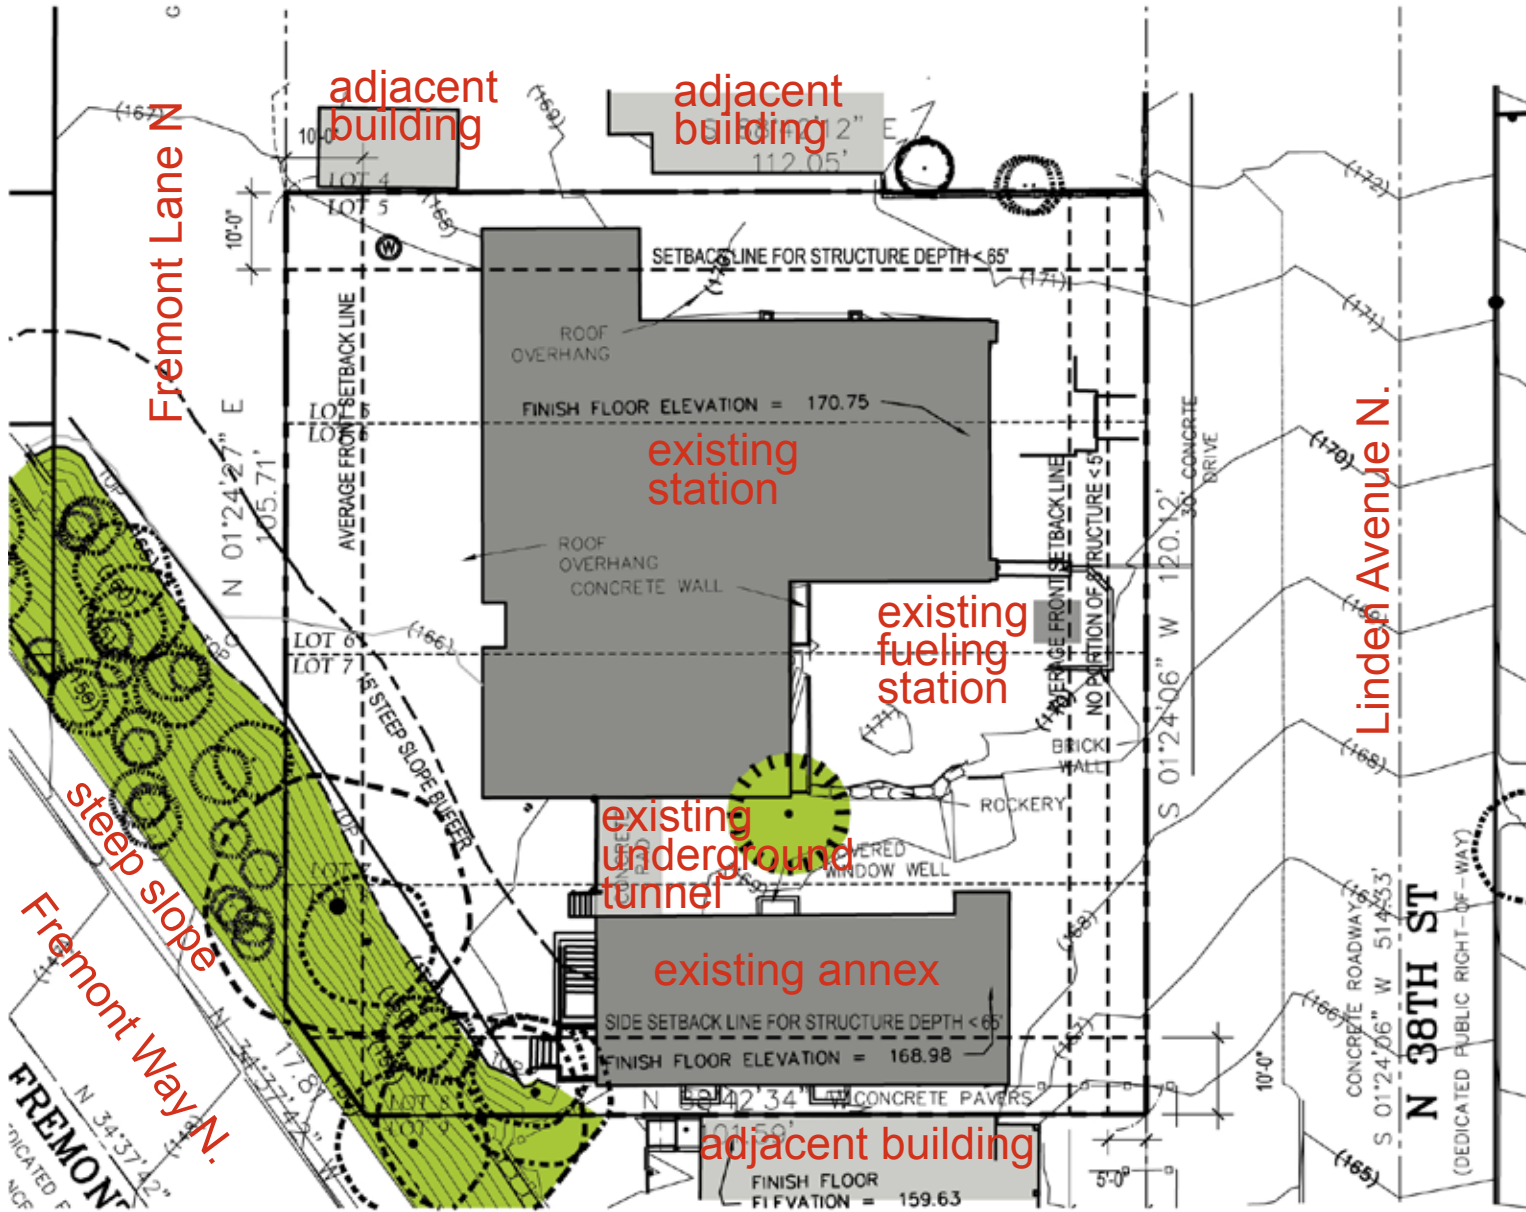
Site Challenges

Challenges & Constraints

Public facility in residential zone
zoning restrictions

Steep slope
steep slope area & 15' steep slope buffer at southeast corner

Limited visibility
only front elevation facing Linden Ave. N. visible, neighbor buildings on lot lines

Site slope
5% slope from North to South,
4% slope from East to West

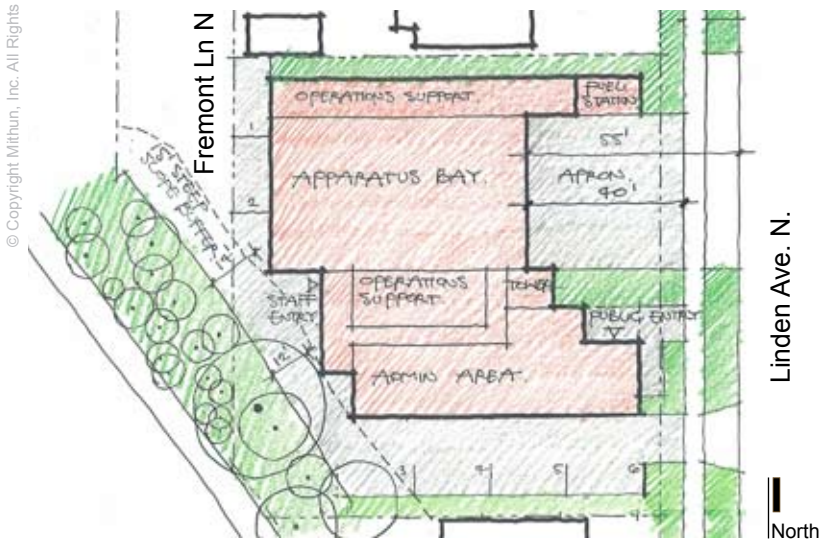
Option 1a Apparatus Bay & Support Bar @North Station House & Staff parking @South

Site is too tight for Drive-through Apparatus Bay & rear apron.
Fire Truck Access from Fremont Lane N. does not work.

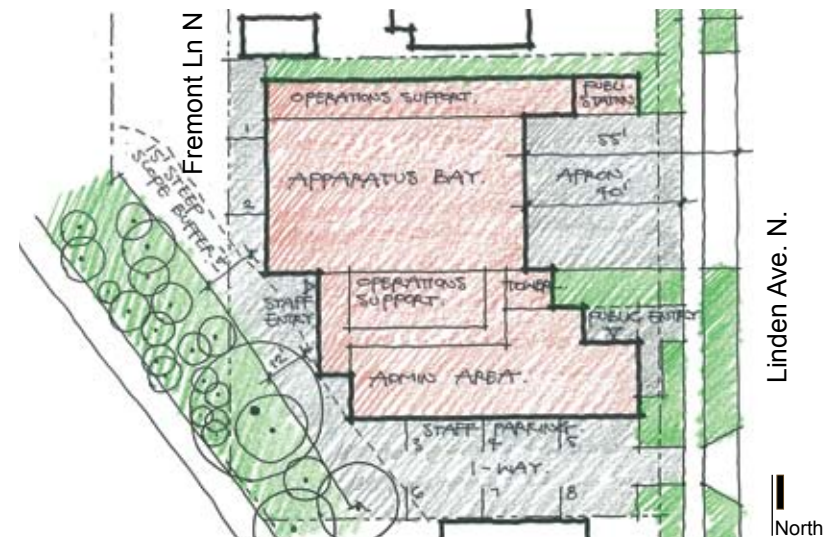
Option 1b Apparatus Bay & Support Bar @North Station House & Staff parking @South

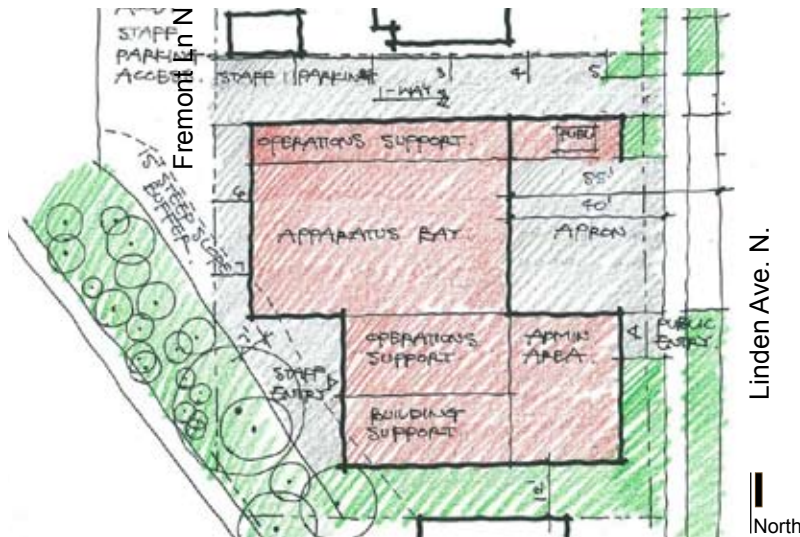
Option 2 Apparatus Bay & Support Bar @North Station House @South
Staff parking @North
Building footprint in steep slope buffer

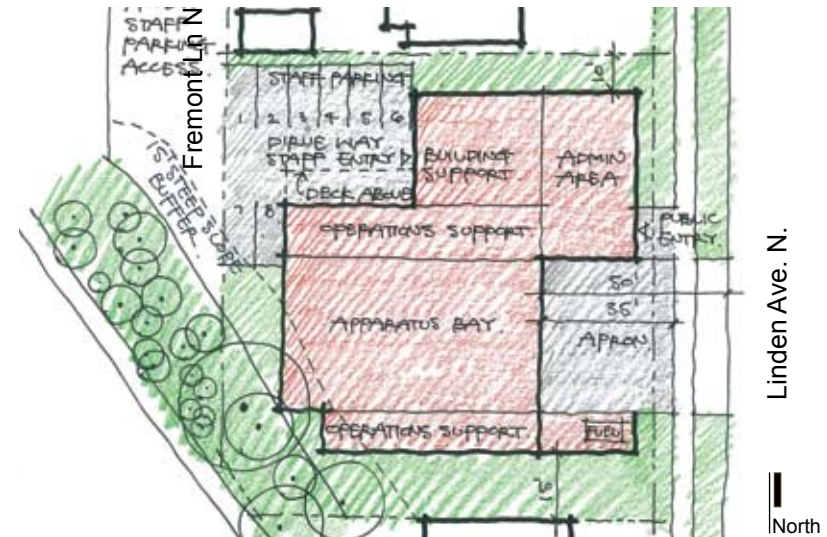
Option 3 Apparatus Bay & Support Bar @South Station House & staff parking @North
Building footprint in steep slope buffer
Less Apron depth

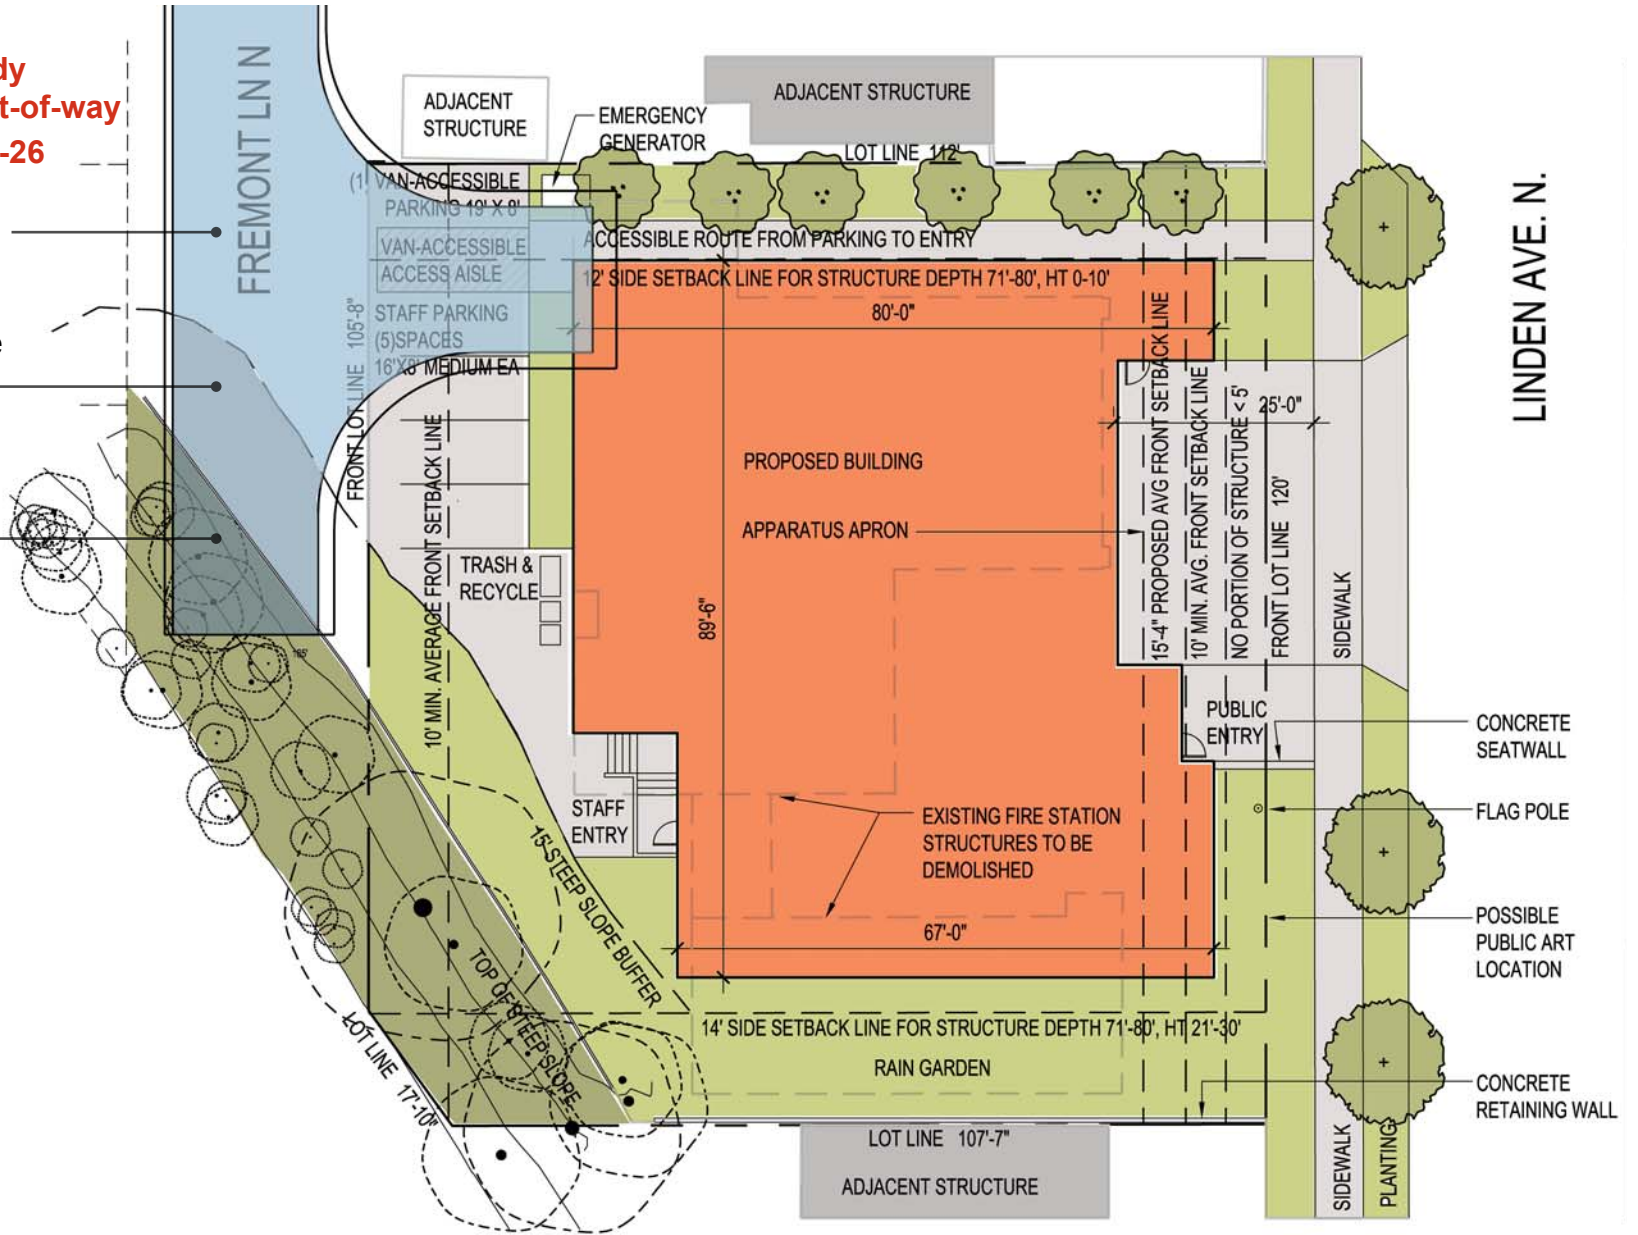
Turnaround study per Seattle Right-of-way Manual Figure 4-26

- Turnaround area
- Turnaround area in 15' steep slope buffer
- Turnaround area in steep slope area
